## THE BREAK-IN STAGE OF CYLINDER-RING WEAR: A CORRELATION BETWEEN FIRED ENGINES AND A LABORATORY SIMULATOR

G. C. BARBER and K. C. LUDEMA

*Mechanical Engineering Department, University of Michigan, Ann Arbor, MI 48109 (U.S.A)*

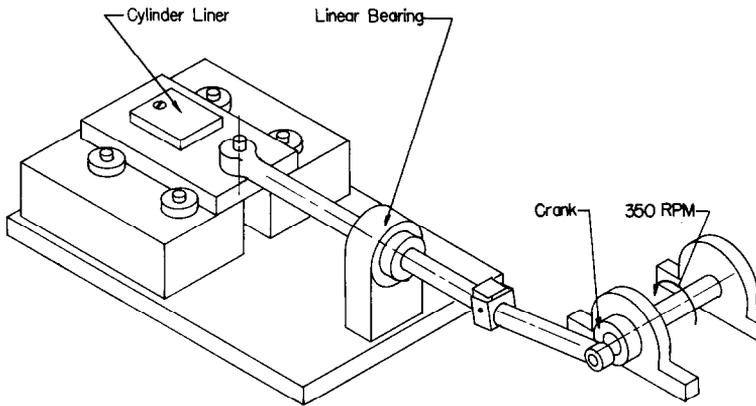
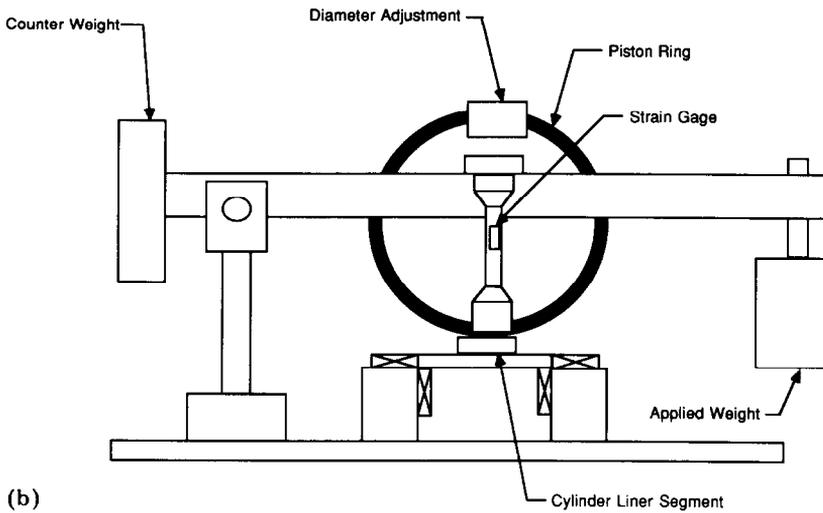
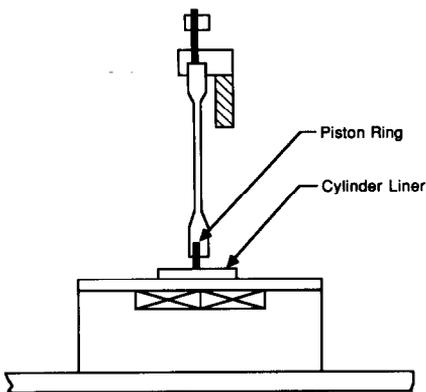
Fig. 1. (a) Mechanisms used to oscillate the cylinder liner specimen. (b) Piston ring support and load application system. (c) Cross-section of piston ring support.

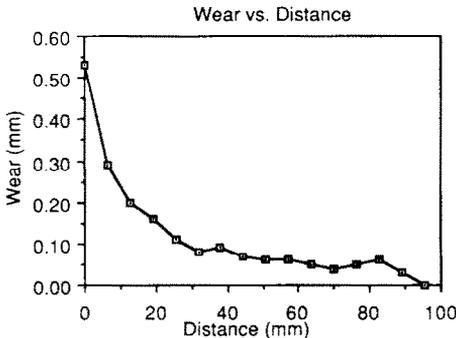
Fig. 2. Diametral wear of cylinder bore, 1971 Chevy pickup run for 94 000 miles, thrust direction: 0 = TDC; 95.25 = bottom dead center.

The surface roughness and general surface topography of several cylinder walls were measured with a surface tracer system. The surface roughness of the original cylinder was usually in the range  $0.20 - 0.25 \mu\text{m } R_a$ . After long use and in the most worn regions the roughness was found to be in the range  $0.10 - 0.11 \mu\text{m } R_a$ . Figures 2 and 3 show the wear profile of the engine

run for 94 000 miles in the thrust and non-thrust (perpendicular to thrust) directions respectively. The wear was measured using a dial bore gauge and was determined by comparing the diameters measured within the piston ring travel with the diameter at the top of the cylinder where no wear had occurred. The maximum wear depth can be seen to be approximately 0.5 mm in both the thrust and the non-thrust directions. This is a factor of about 1000 times the asperity height of the original surfaces.

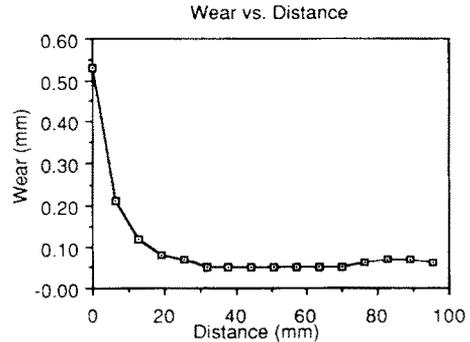
Fig. 3. Diametral wear of cylinder bore, 1971 Chevy pickup run for 94 000 miles, non-thrust direction: 0 = TDC; 95.25 = bottom dead center.

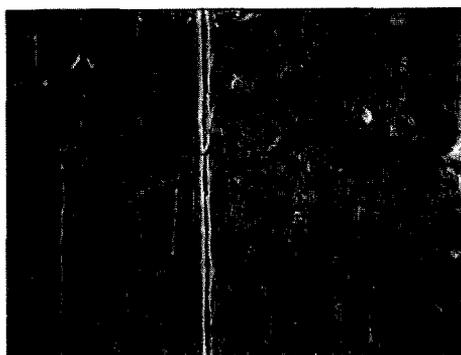
Fig. 6. Run for 20 min (magnification 265 $\times$ ).

scratch marks from the honing operation. Figure 5 is the reproduction of the surface topography of an unworn Cadillac cylinder obtained by a surface tracer. The remaining figures show the progression of surface change during running. From these observations a pattern of wear became evident. The grooves made by the hone should be noted, which is a pattern deliberately and carefully made in manufacture. It also should be noted that alongside these grooves there are ridges that have been ploughed aside by the abrasive (honing) operation.

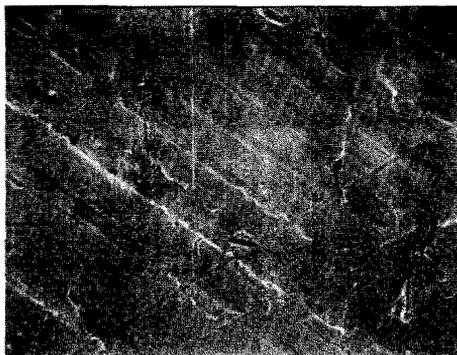
Fig. 7. Run for 15 h (magnification 265 $\times$ ).

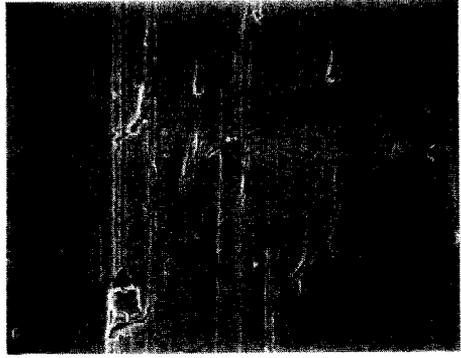
Fig. 9. Run for 72 000 miles (magnification 265×).

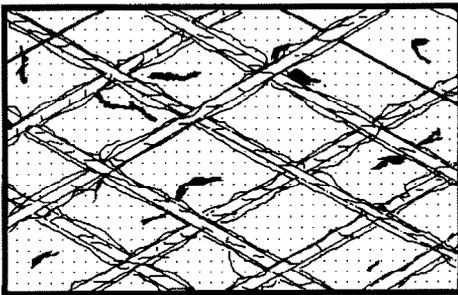
Fig. 11. Simulated micrograph at 302× magnification of a honed cylinder wall. The surface is smooth between grooves. Ploughed metal is attached to the sides of the grooves. The curved dark lines represent graphite flakes.

Since a progression of wear on one small area of surface could not be obtained we have prepared a schematic series of "micrographs" to illustrate our observations. These are shown in Figs. 11 - 19. In the very first stages of operation the piston ring picks up some ploughed metal and uses it as a

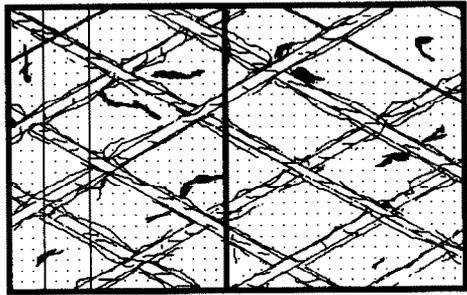
Fig. 12. Simulated micrograph at 302× magnification. After a few minutes of sliding the piston ring loosens some metal from the edges of the grooves and the resulting debris "scratches" vertical grooves on the cylinder wall.

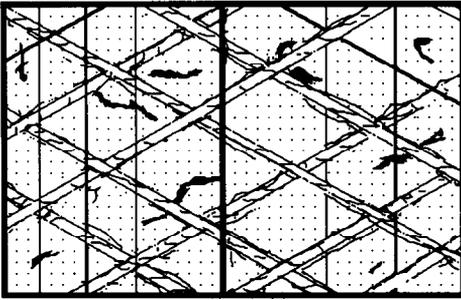
Fig. 13. Simulated micrograph at 302 $\times$  magnification. After more sliding there are more vertical grooves and less metal attached to the sides of the grooves.

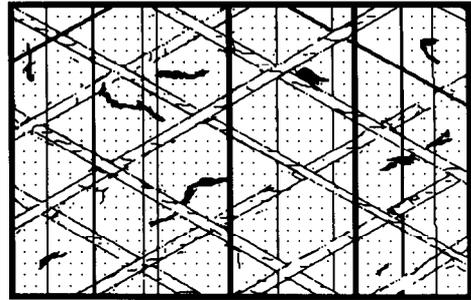
Fig. 14. Simulated micrograph at 302 $\times$  magnification. Most of the edge material has been removed.

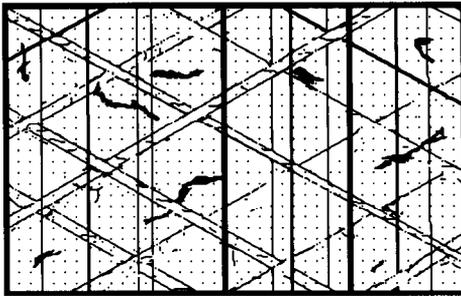
Fig. 15. Simulated micrograph at 302 $\times$  magnification. The hone marks are becoming shallow owing to wear.

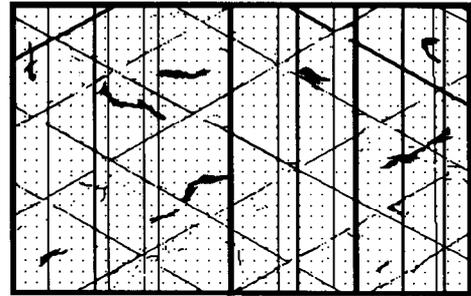
Fig. 16. Simulated micrograph at 302 $\times$  magnification. Some hone marks have disappeared.

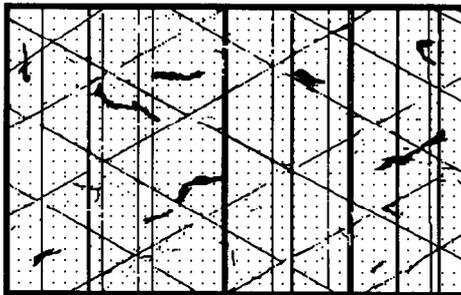
Fig. 17. Simulated micrograph at 302 $\times$  magnification. Some vertical scratch marks have become shallow.

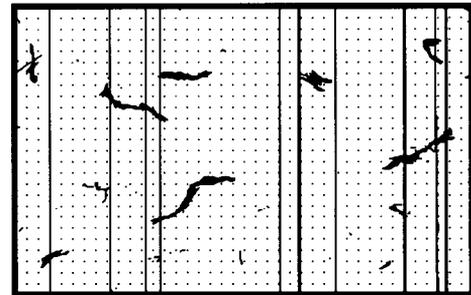
Fig. 18. Simulated micrograph at 302 $\times$  magnification. The hone marks are no longer visible.

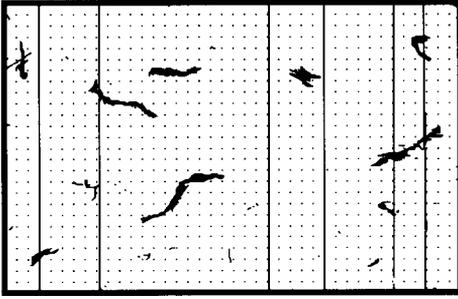
Fig. 19. Simulated micrograph at 302 $\times$  magnification. A well-worn cylinder surface.

After still further operation the vertical scratches also are worn away. This may all occur in about 15 000 miles or less and at this point the surface roughness is approximately 0.10  $\mu\text{m}$  AA. In the background of all sketches there are dark lines that represent the flake graphite in the iron. Actually, the graphite flakes are not as prominent in new engines as in well-used engines, probably because boring and honing smears metal over the graphite flakes.

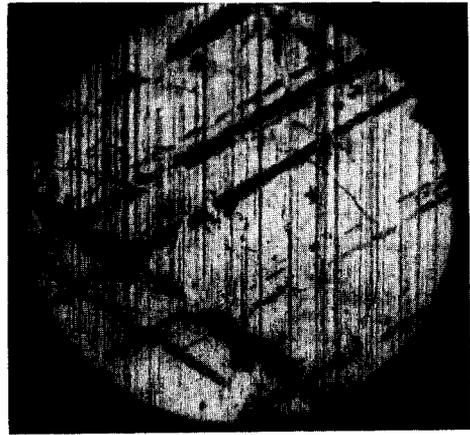
Fig. 21. Run for 72 000 miles. Location shown is at midstroke (magnification 202 $\times$ ).

Below the TDC position of the second compression ring vertical scratches appeared on the cylinder wall in the first few minutes of operation. After these vertical scratches appeared there seemed to be relatively little wear in this region of the cylinder throughout the life of the cylinder. Figure 21 shows that the original hone marks were intact even after an operation distance of 72 000 miles.
