UM-HSRI-82-26

**EVALUATION OF HEAVY  
EQUIPMENT OPERATORS'  
SAFETY BELT RESTRAINT  
SYSTEM**

**Richard G. Snyder  
John W. Melvin**

**SEPTEMBER 1982  
INTERIM REPORT**

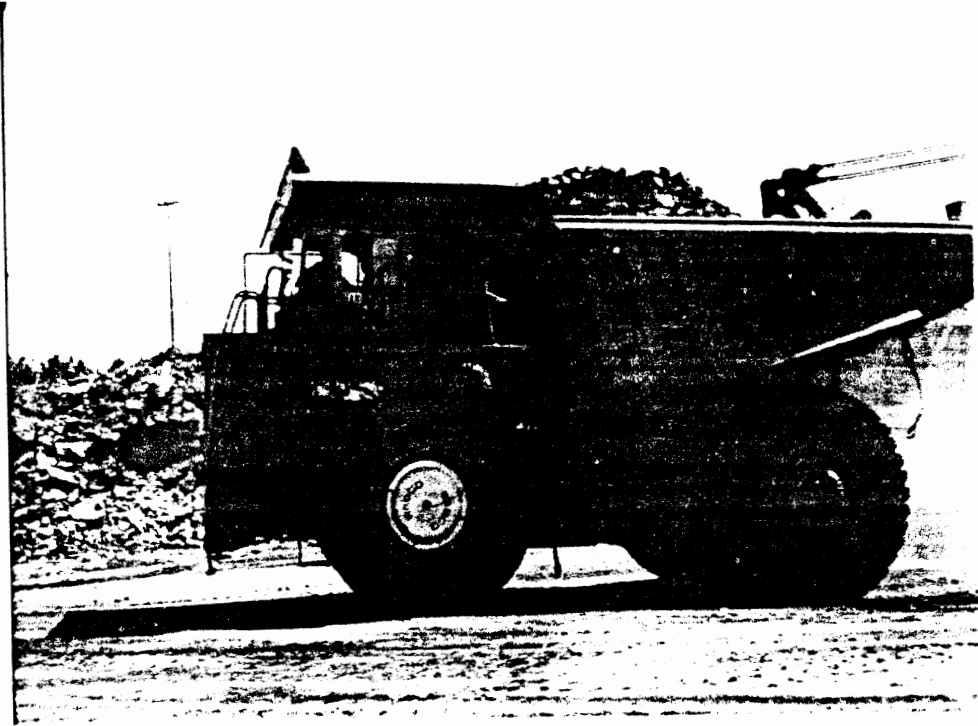
Fig. 4. Wabco Haulpak is another load hauling truck in use, with 120 ton capacity (loaded).

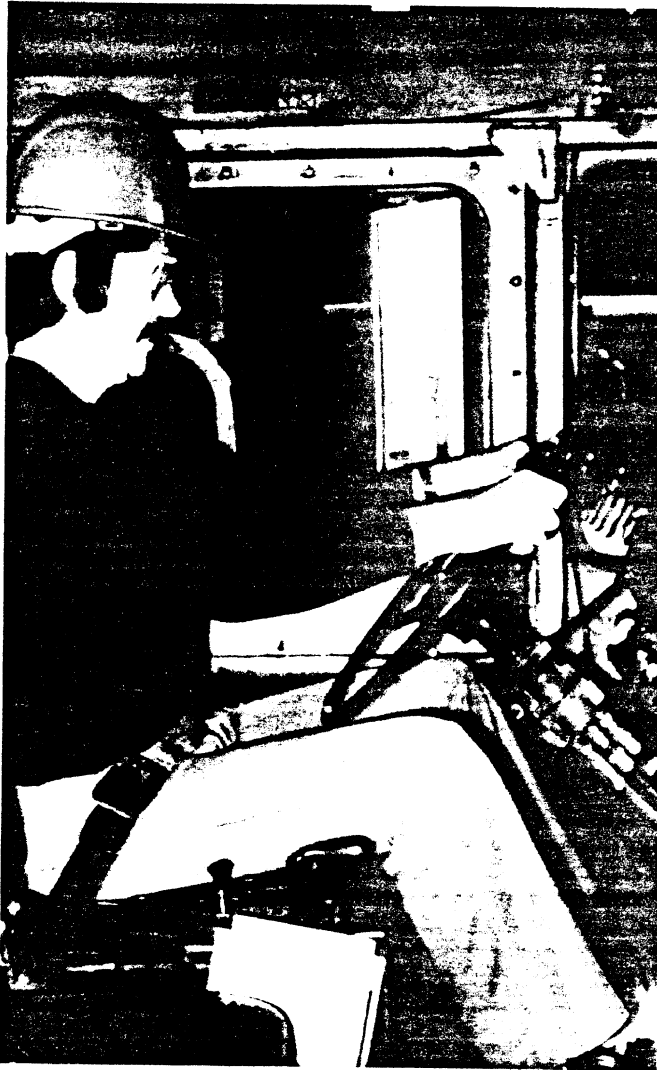
Fig. 13. The driver in position relative to the cab environment.

Most of the vehicles inspected or rode in appeared to have lap belts installed, except for the graders in which the operator primarily stands. As shown in Figure 13, belts checked used nylon webbing conforming to SAE and DOT FMVSS standards with metal-to-metal type buckles, and provided a reasonable belt angle (45-55°). The WABCO Haulpak and CATS such as the D10 and 992C inspected were equipped with

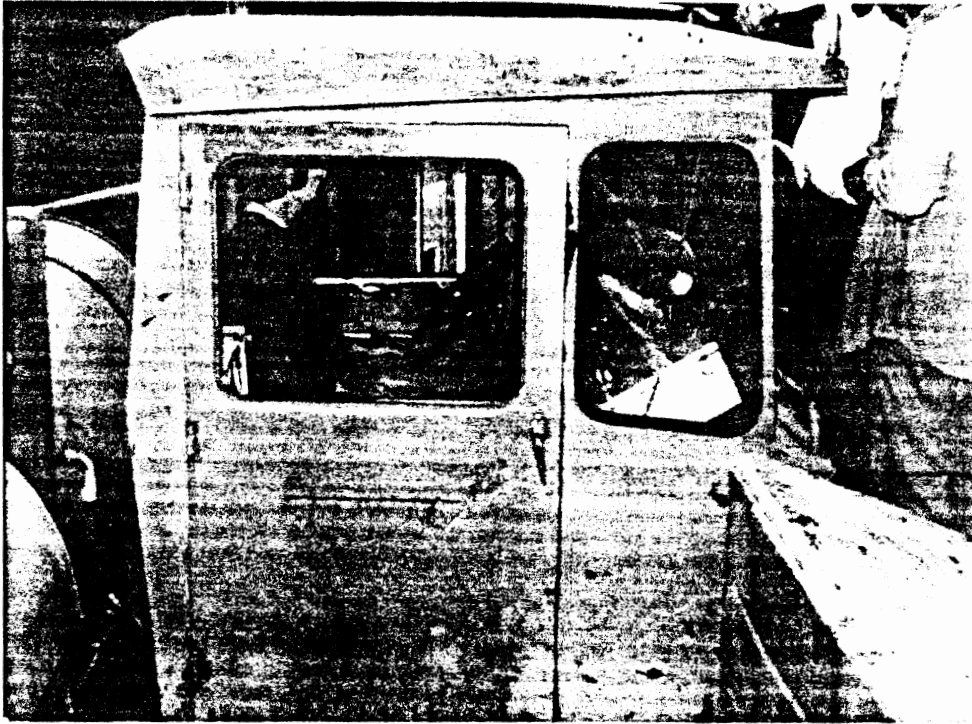
Fig. 14. View of Model M100 Unit Rig truck cab.

From a potential injury point of view the truck, tractor, and loader cabs present generally hazardous impact environments. The heavy non-yielding and sharp steel edges of the instrument panels present injurious contact points to the driver in a jolt or impact situation, as do the door side panels, cab roof structures, and rear of the cab. In particular the metal boxes and water containers are located where injury could result. The CAT 992, for example, has a steel box with sharp edges to the left of the rear of the head, as well as sharp metal surfaces on the right door such as the window opener. The truck cabs usually have an open metal box attached to the rear of the right side of the driver's seat (Figure 12). Some more recent models of the same make truck have improved panels, although much more could be done to provide driver protection. The latest model WABCO truck was observed to have a much better panel from an impact point of view than the previous model; sharp metal edges had been rounded and metal boxes removed.

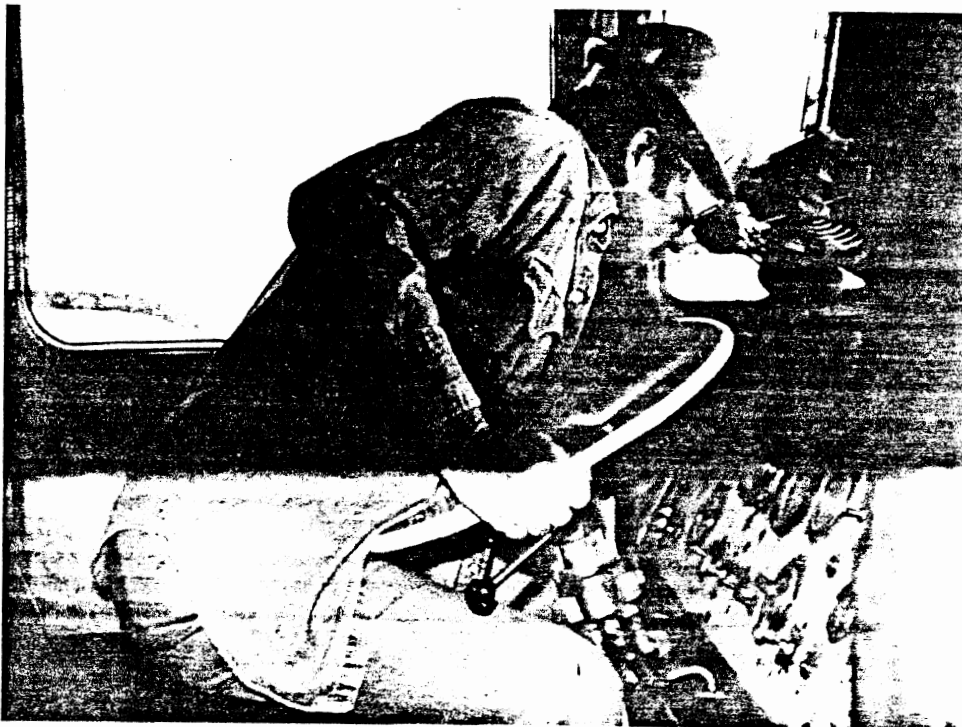
Fig. 15. An unrestrained driver could be thrown forward.

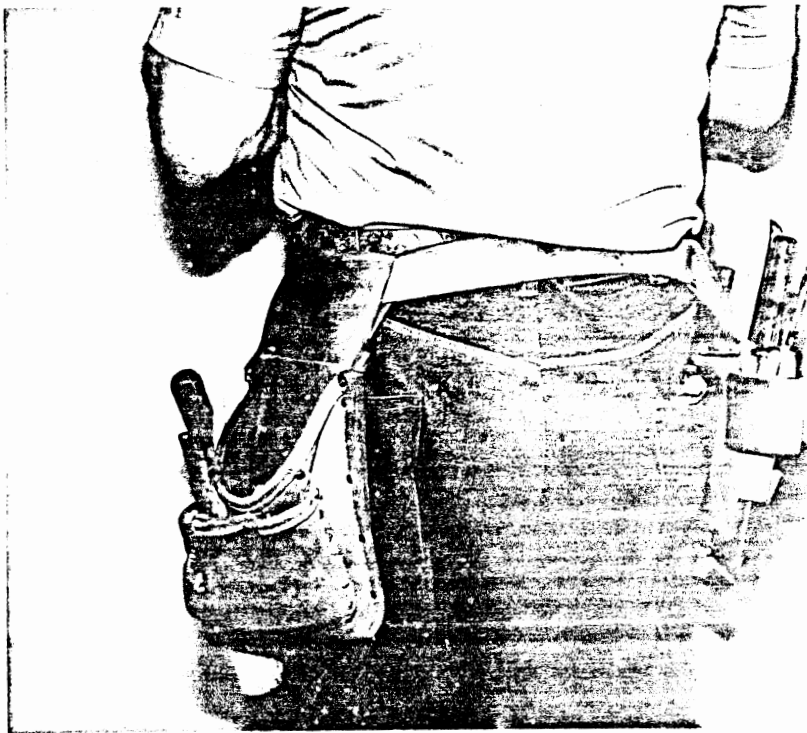
Fig. 18. Rear view of electrician's belt. This weighed 22 lbs. but additional tools could be carried. In comparison the proposed truck driver restraint weighs 2-1/2 lbs.

An example is illustrated in Figures 15-16, showing the belt worn by an electrician daily in his work. In this case two tool pouches (much heavier and bulkier than the proposed truck driver belt) fitted with various tools are worn. This particular belt weighed 22 lbs. and the electrician claimed that it was comfortable to him. Police belts examined weighed 13 lbs. In comparison, the proposed Miller restraint for truck drivers weighs only between 2-1/4 and 2-1/2 lbs. Since this would be worn by female truck drivers as well as males, weight is a factor along with comfort. This belt has been worn by the investigators, and for long periods in one case. It was subjectively found to be quite acceptable relative to comfort, and after an initial period the user forgot it was being worn.

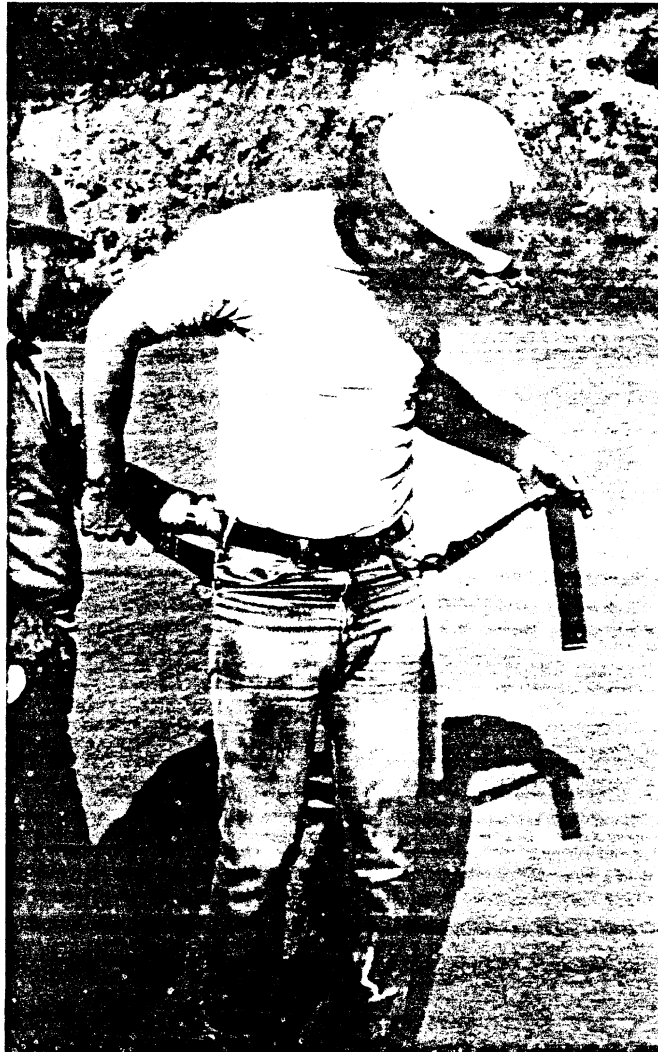
Fig. 19. Driver putting on proposed lap belt restraint.

Figure 19 shows the truck driver illustrated above donning this restraint system (in Figs. 17 & 18) seated in his cab. This operator is 70" tall and weighs 185 lbs. The driver states he has a 34" waist. Areas were examined where improvements might be necessary. As shown in Figure 19 note the angle that the attachment belt makes in relation to the seated operator. This angle is about 90 degrees in the normal seated position, and is estimated to be 80-85 degrees when the operator is extended forward in his seat. The recommended angle is  $50^{\circ} \pm 5^{\circ}$ . It has been found in previous studies that too steep an angle, as well as too shallow an angle, can result in lack of adequate pelvic support and may result in abdominal injuries due to belt impingement. However, it should also be noted that previous systems have essentially involved a belt from anchorage to anchorage across the thighs. In this belt the lap belt portion is hooped around the body and this difference in configuration may also result in a different reaction under dynamic loading. The effect, if any, this extreme 90 degree angle has on restraining the operator and the potential for contributing to injury should be evaluated during the Phase II tests.

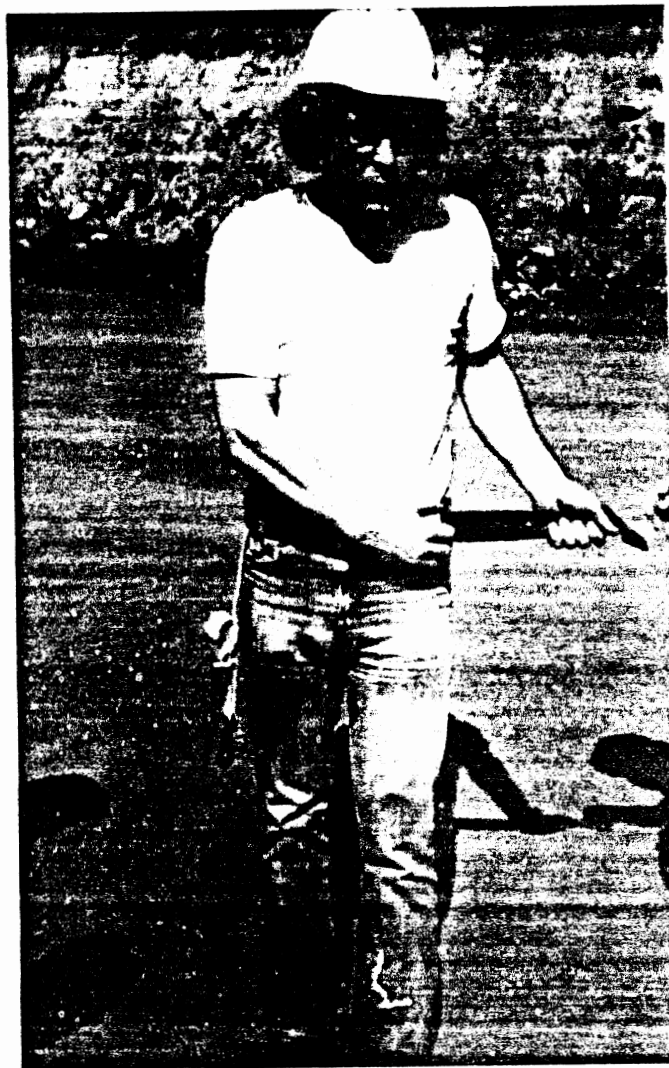
Fig. 20. The belt can be comfortably adjusted. Note how the attach belt hangs to the side, ready to plug into the vehicle. This can be snapped up out of the way on the belt when wearing outside the vehicle.

Figure 20 illustrates a second area which needs further analysis and testing. The seat belt does not plug in to the floor anchor point
