CYCLIC RESPONSE OF REINFORCED CONCRETE
CONNECTIONS USING CAST-IN-PLACE
SIFCON MATRIX

By
Hossam M. Abdou, Antoine E. Naaman
and
James K. Wight

July 1989 Report No. UMCE 89-1

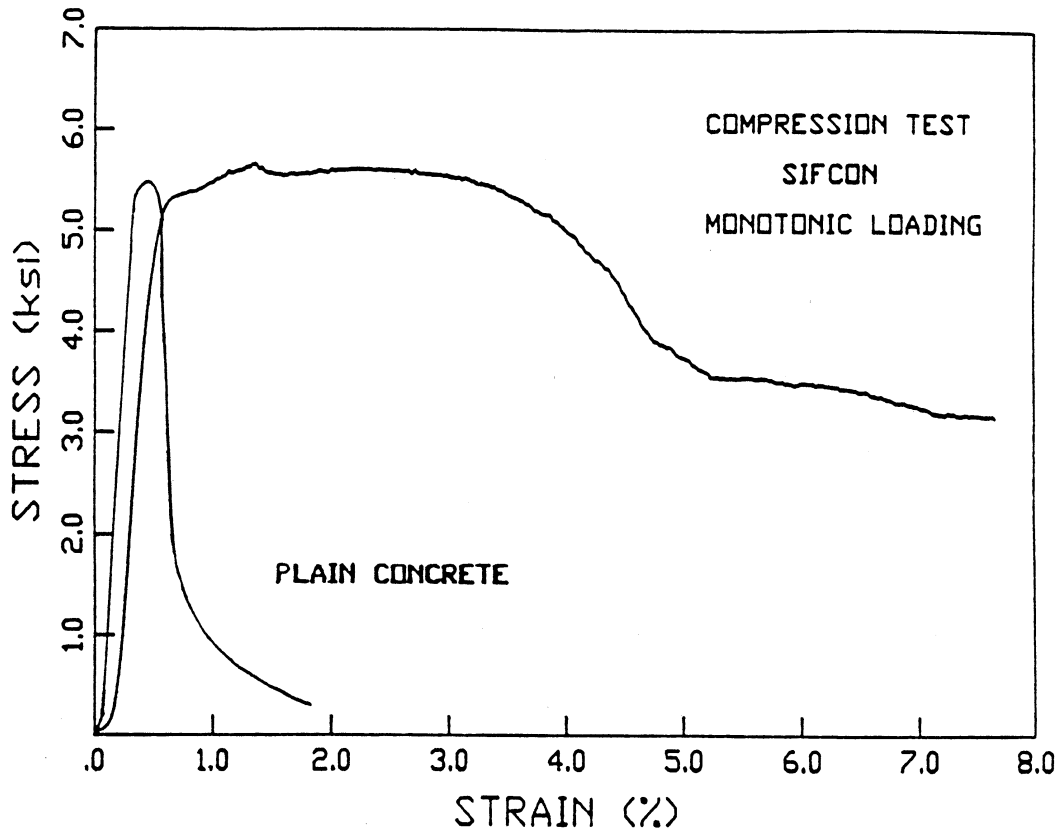
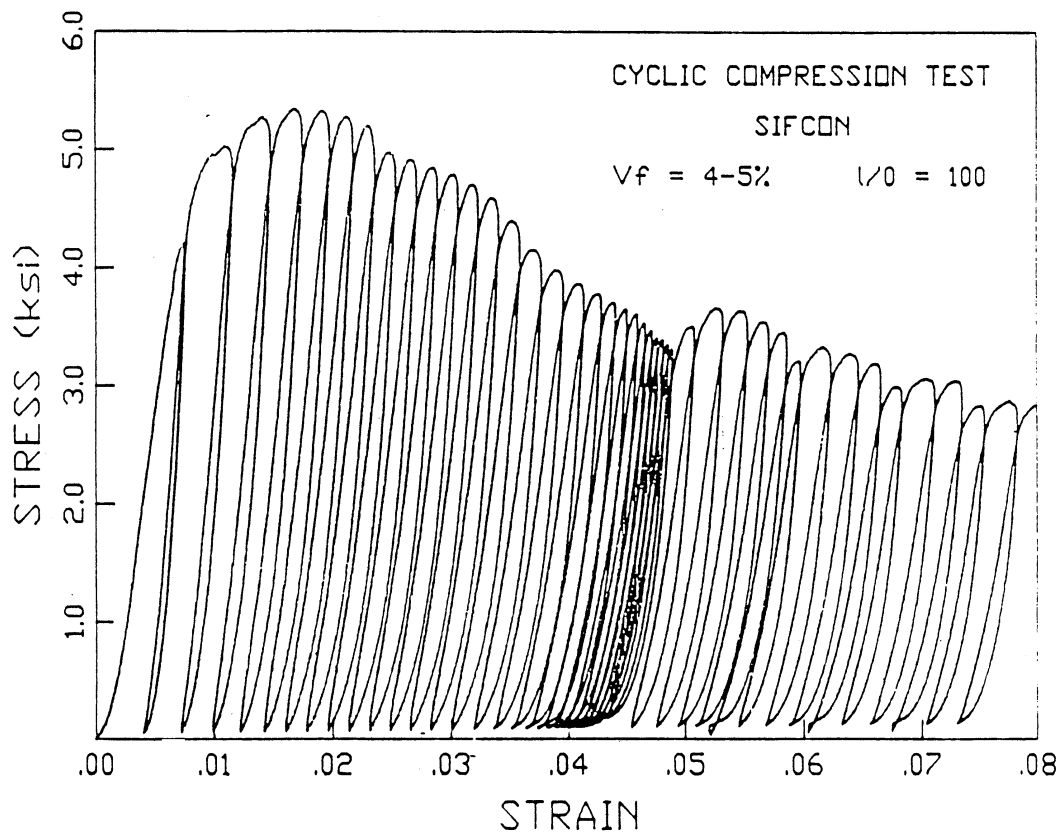
Fig. 2.3- (a) Typical stress-strain response to monotonic loading for the SIFCON mix.
(b) Typical stress-strain response to cyclic loading for the mix.

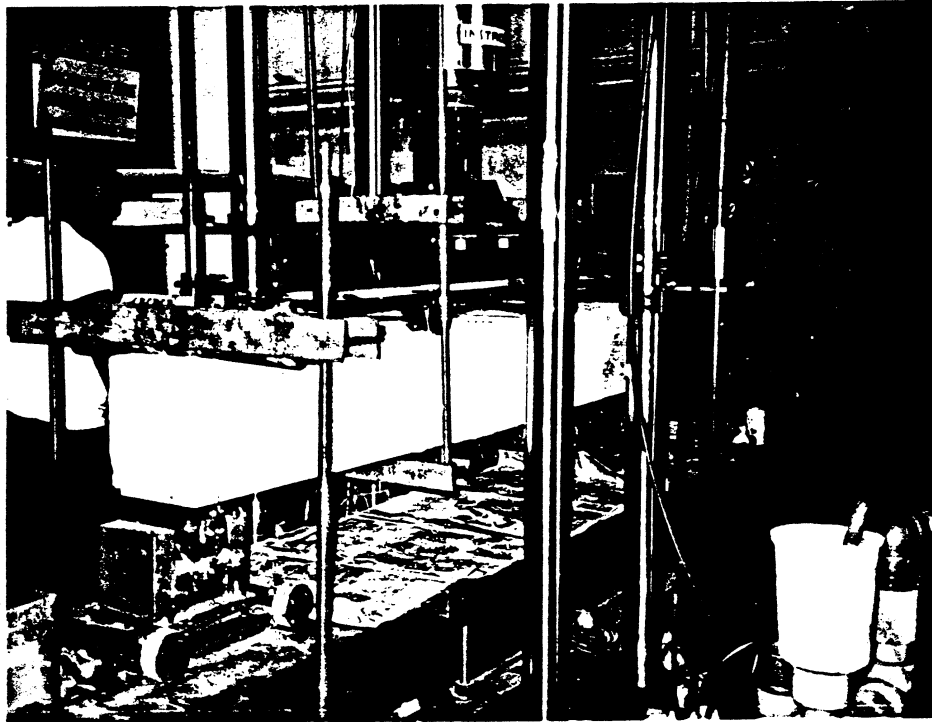
Fig. 2.7- Beam type configuration and testing set-up.

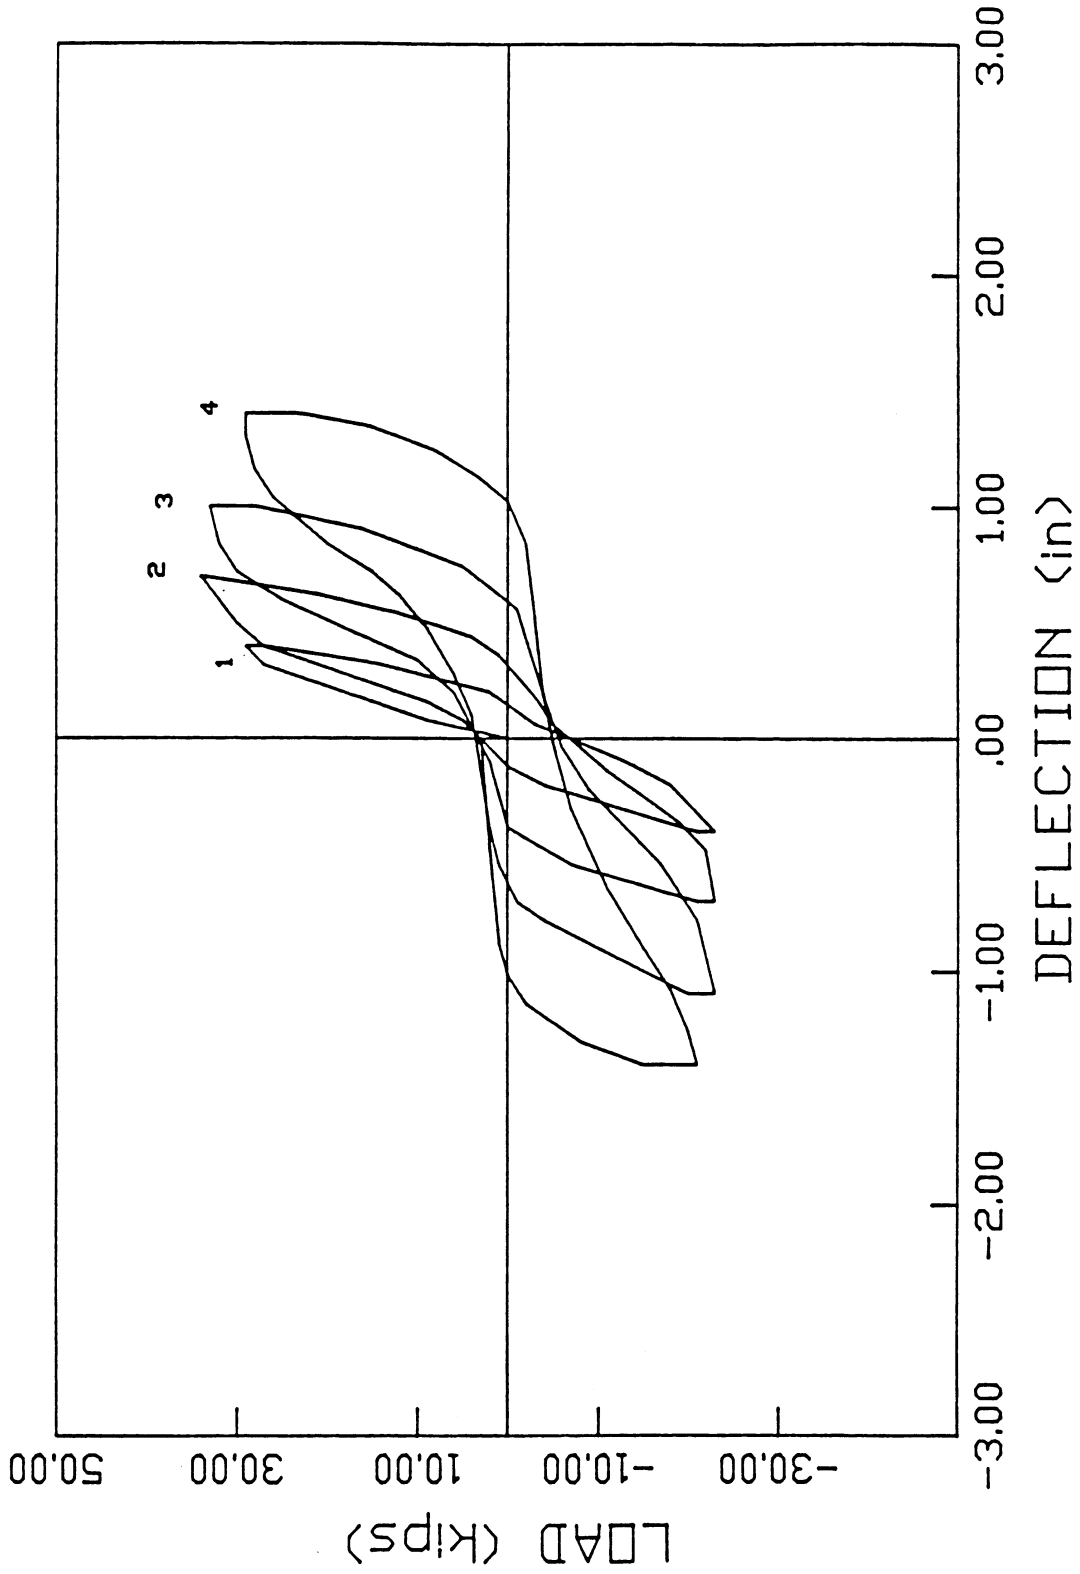
Fig. 3.2 (d)- Load vs. Deflection hysteresis curve for specimen B4.

From the load-deflection curve, Fig.3.2-d, it can be concluded that the specimen performance was satisfactory at least during the first three cycles of loading. The specimen was loaded through four cycles with maximum displacement ductility of 3.5. A sudden drop of strength and stiffness and excessive pinching marked the behavior in the fourth cycle. Failure at one of the interfaces with a maximum shear force of 17 kips indicated that the moment at the interfaces was still not fully developed and slippage of the cutoff bars must have occurred.

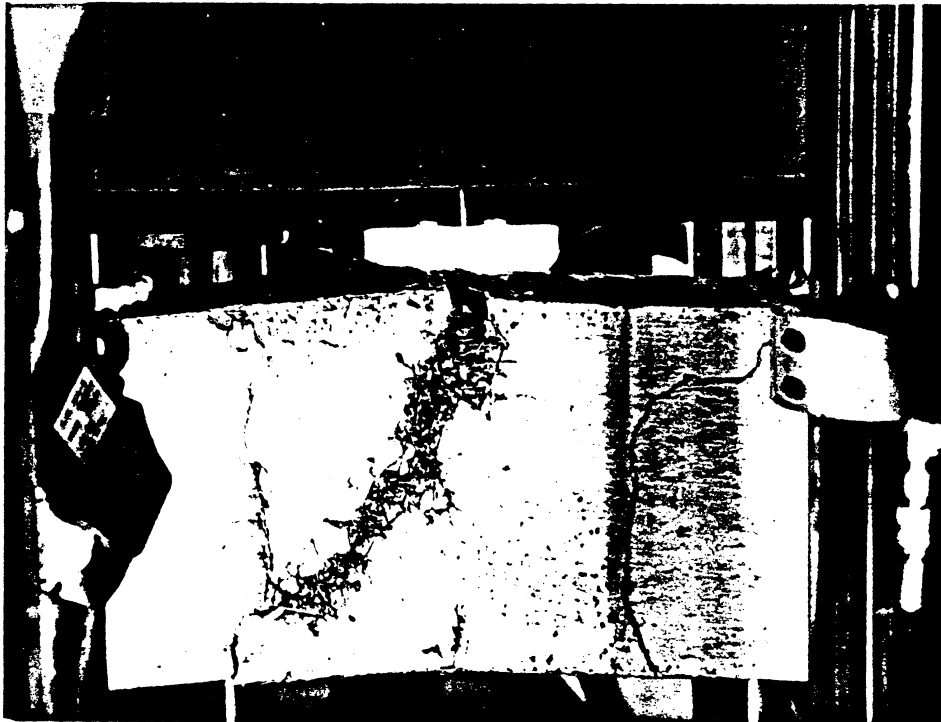
Fig. 3.3 (a)- Specimen B1 at the end of the test in the upward and downward directions.

to widen while those at the interfaces continued to widen. As the test progressed a crack formed parallel to the inclined bars inside the CIP joint and was connected to the crack developed by the crack initiator at the bottom of the beam. Ultimately, failure occurred at the interface for downward loading and in the CIP for upward loading. Figure 3.3(a), shows Specimen B1 in the downward loading direction during the test and at the end of the test in the upward loading direction.

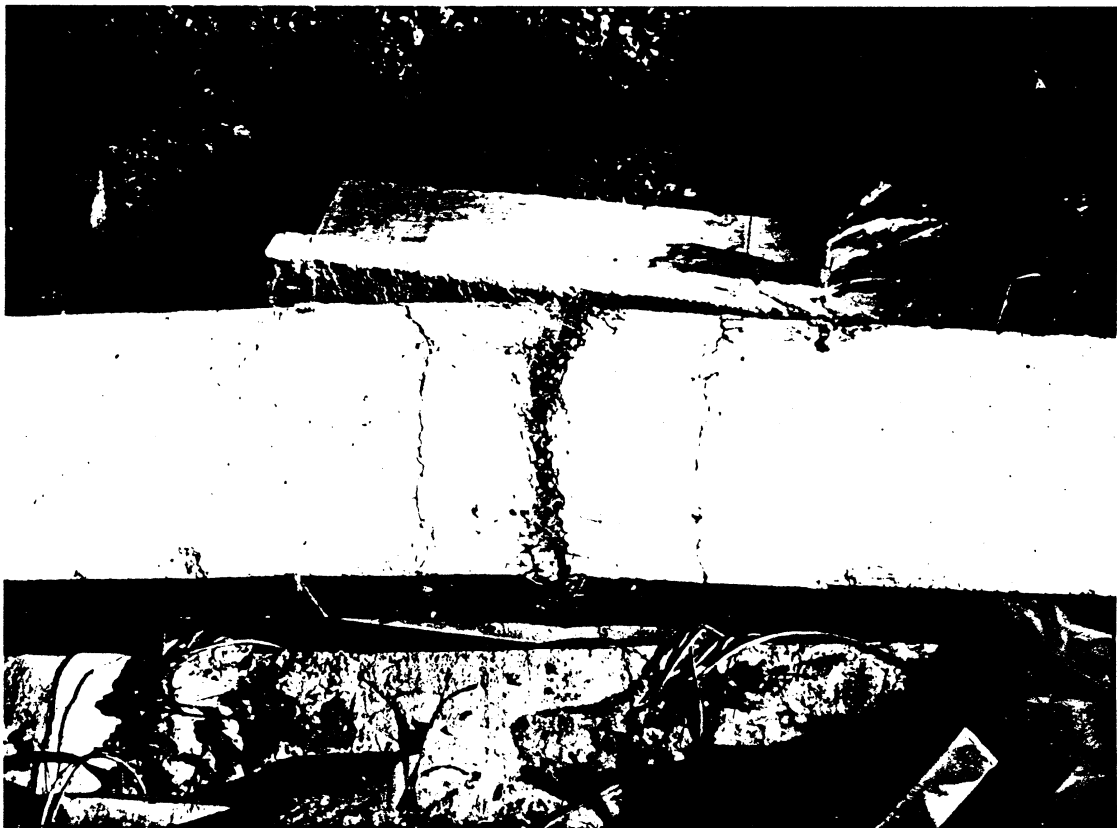
Fig. 3.3 (i)- Specimen B9 at failure.

nor cracking occurred in the shear span accompanied by cracks at the interfaces. In the second cycle a crack was visible inside the CIP joint. In subsequent cycles, all the deformation was concentrated in this crack and no more action was visible in the cracks at the interfaces, Fig 3.3(i).
