Effects of Poly(vinyl alcohol) on Fiber Cement Interfaces.

Part II: Microstructures

Changes in the microstructure of hydrated cement paste around steel, brass, brass-coated steel, and polypropylene fibers induced by the addition of 1.4% poly(vinyl alcohol) (PVA) have been examined by scanning electron microscopy. The microstructures were examined both after the fibers had been carefully peeled from the matrix and after the fibers had been pulled from the matrix along their axes. The previously noted enhancement by PVA of the pull-out properties from ordinary Portland cement matrix of steel fibers is attributed to the formation of a ductile, fine-grained interfacial layer. The formation of this microstructure is suggested to arise from the effect of PVA on the nucleation of CH and C-S-H at the fiber surface and on the presence of polymer around the fibers. The enhancement of the pull-out properties for brass and brass-coated steel fibers is attributed to the formation of a strong bond between the fiber and matrix that diverts failure to the porous zone surrounding the fiber. Interfacial structures against low surface energy fibers, like polypropylene, showed minimal effect from th

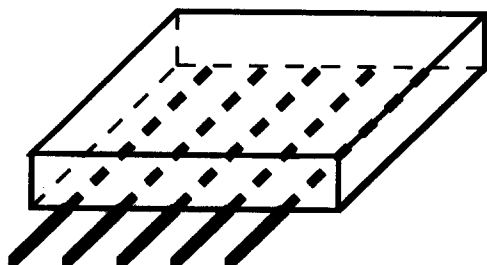
FIGURE 1. Locations of fibers in the mold for fiber-peeling experiments.

Two types of specimens were made. In the first, the fibers were embedded in the matrix for pull-out testing; in the second, the fibers were embedded for observation of the structure before pull-out. For the pull-out test specimens, a block of matrix 1 in. (25.4 mm) thick was used. Four fibers were placed vertically in each block, about 2 in. (50.8 mm) apart, with the fibers extending above the top surface but not extending through the bottom surface. Further details of the pull-out specimens are described in the accompanying article [1]. For specimens made to observe the structure before pull-out, the fibers were placed horizontally near the bottom of the mold, as shown in Figure 1. Specimens with and without PVA were prepared in the same ways. The specimens were cast into plastic molds, and all specimens were vibrated to reduce air entrapment.

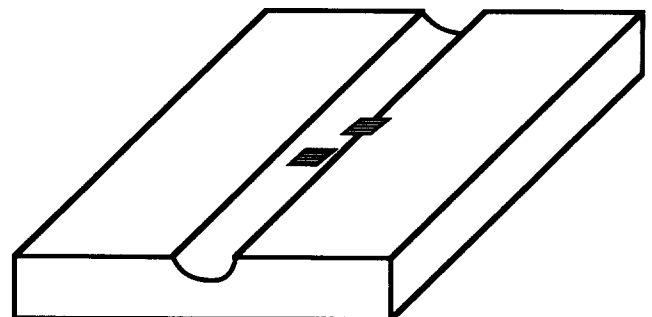
FIGURE 2. The groove after fiber peeled away, and the locations of scanning electron micrographs.

After demolding and overnight vacuum drying of the specimens, the fibers were peeled away from the matrix with great care, leaving grooves of mainly undisturbed matrix at the fiber interface. The fiber and matrix surfaces were examined by scanning electron microscopy (Hitachi S-800). Micrographs of the matrix were taken of both the top (as molded; bottom, when

turned over) and sides of the groove, as indicated in Figure 2. Stereo pairs were used to examine the three-dimensional topography.

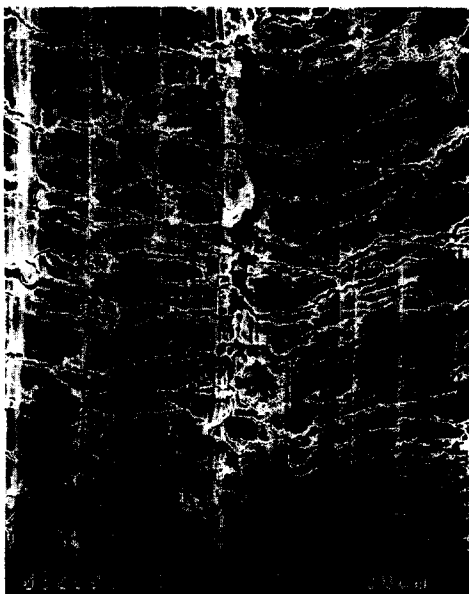
FIGURE 8. Surface of matrix with PVA after removal of steel fiber by pull-out.

After the fiber had been pulled out from the PVA-modified matrix, the matrix in the vicinity of the interface with steel fibers was found to have a smooth, dense, and fine-grained structure (see Figure 8). Though this layer contains surface cracks perpendicular to the pull-out direction, it appears to have behaved

in a largely ductile manner during pull-out, which has resulted in longitudinal corrugations being inscribed in the surface (see also Figures 7 to 11 in ref 1). That the superficial cracks are perpendicular to the pull-out direction suggests that they were caused by the fiber pull-out. They may have been further opened by shrinkage during drying of the specimen in preparation for scanning electron microscopy, however. A side-view of the interfacial zone is shown in Figure 9. The loose structure existing around the fiber before pull-out has been compacted, and the 1 μm -thick denser surface layer has merged with the less dense material beneath it. The entire surface layer is likely to be an inorganic/PVA composite.

The degree of ductility of the interfacial matrix layer is indicated by the pattern of surface cracking seen in Figure 8. The cracks seen are mostly perpendicular to the direction of fiber pull-out; there are very few in other directions. As described above, this layer is estimated to be about 10% PVA by volume, the rest being inorganic hydration products. The ductility observed is greater than would be expected from a composite consisting of 90% hard particulate filler, 10% polymer. This suggests that the composite gains some of its ductility from the inorganic phase. The PVA has probably acted also to nucleate C-S-H particles, and these particles may have incorporated some of the PVA to attain a degree of ductility. The very fine-grain texture of the interfacial layer seen in Figures 8 and 9 and the change from that in Figure 7 indicates the degree to which the inorganic phase has accommodated the moving fiber as it was being pulled out.

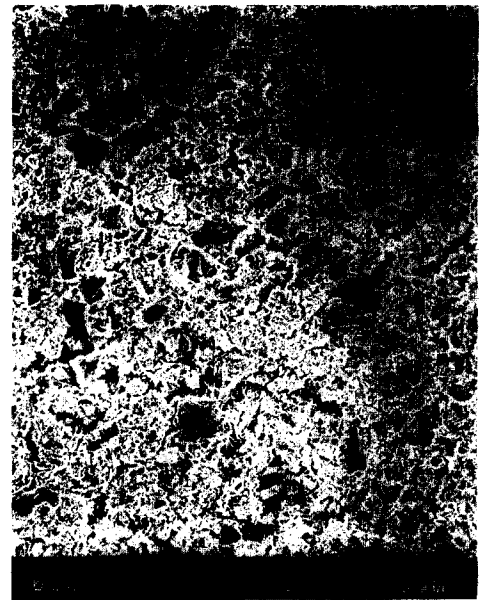
FIGURE 12. Surface of matrix with PVA after removal of brass-coated steel fiber by peeling.

The surface of the matrix with PVA after carefully peeling away a brass-coated steel fiber is shown in Figure 12. The structure of the matrix is similar to that without PVA except that the surface plates are smaller and are less dense, with space between the plates. In addition, the interfacial zone of the matrix appeared to the naked eye to be greenish, suggesting a distribution of Cu^{+2} ions in the matrix. The surface of the fiber that had been peeled away from the matrix is shown in Figure 13. More material remains adhered to this fiber than to the fiber peeled from the matrix without PVA.

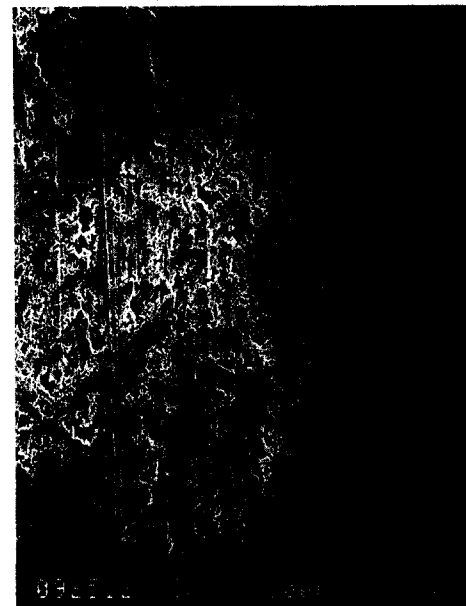
FIGURE 16. Surface of matrix with PVA after removal of polypropylene fiber by peeling.

out is shown in Figure 16. The surface layer is less dense than without PVA and is again mainly composed of hydration products (probably most C-S-H) that appeared to grow against the fiber from the bulk. After fiber pull-out, the matrix surface remained essentially the same, with perhaps some of the pores having been closed by fiber slippage. Again, the pull-out force was very low, about 1 lb (5 N).

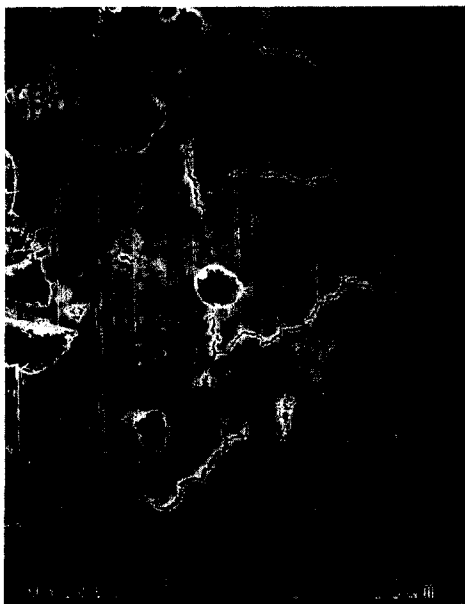
FIGURE 15. Surface of matrix without PVA after removal of polypropylene fiber by peeling.

The matrix surface without PVA after peeling away a polypropylene fiber is shown in Figure 15. The surface is quite smooth with a few cracks, possibly arising from drying in preparation for scanning electron microscopy. Also visible are striations replicated from the

fiber. At higher magnification, the material at the surface was found not to be especially dense. The entire surface appeared to be filled with hydration products growing out from the matrix, rather than nucleating at the fiber surface. After pull-out, the matrix remained undamaged, maintaining a smooth texture. The force required to pull the polypropylene fiber from the matrix was very low, about 1 lb (5 N).
