UM-HSRI-81-20

**SIDE IMPACTS OF PASSENGER CARS:
AN ANALYSIS OF FARS & NCSS DATA**

APRIL 1981

**THE UNIVERSITY OF MICHIGAN
HIGHWAY SAFETY RESEARCH INSTITUTE**

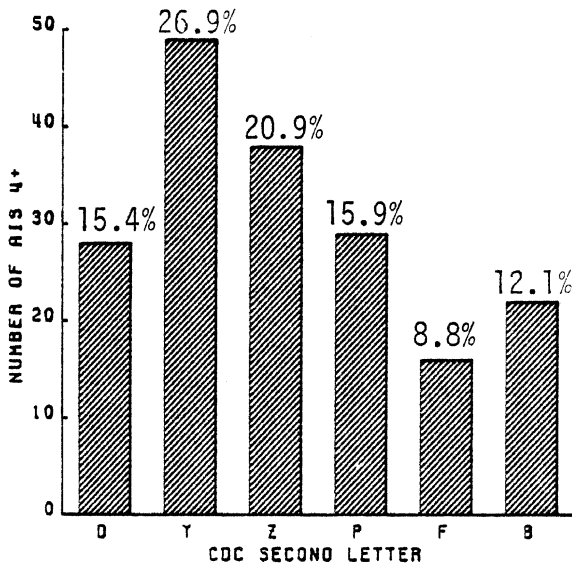
FIGURE 2

NCSS 1 - Number of Occupants in Side Impacts With Severe Injury by Second Letter of the CDC

The likelihood of injury for each of these crash types is different, and is illustrated in Figures 1 through 3. Figure 1 shows the total number of (exposed) occupants of side-impacted vehicles by the CDC second letter, indicating that the largest groups are those struck only in the front or back. Figure 2 shows the number of persons seriously injured for the same variable, with the largest group comprising the "front and passenger compartment" damage. Figure 3 represents the ratio of the first two graphs, and indicates that occupants of cars with distributed side damage are much more likely to sustain serious injuries than others, about seven times more likely than occupants of vehicles struck in the side front or side rear. Distributed damage is some indication of a generally more severe (or higher speed) crash, but the injury rates are high any time there is passenger compartment involvement.

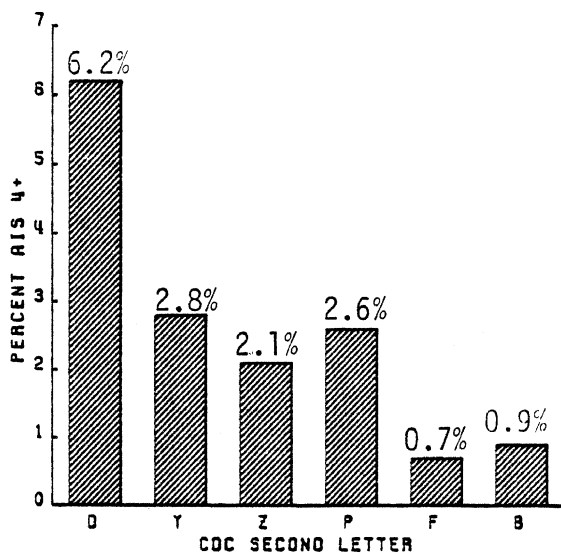
FIGURE 3

NCSS 1 - Proportion of Occupants with Severe Injury by Second Letter of the CDC

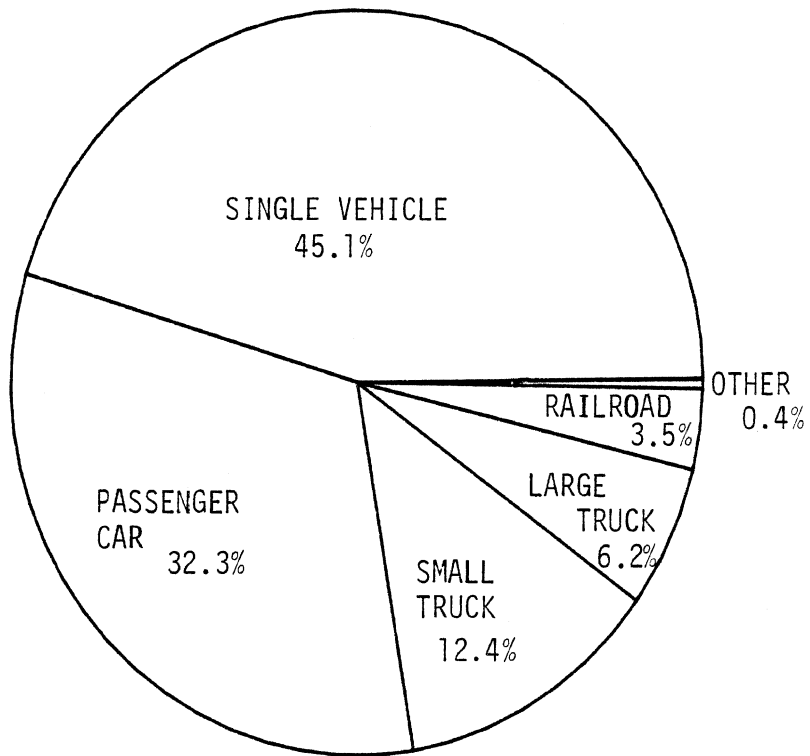
FIGURE 5

Distribution of Striking/Struck Object for All Ejected Occupants

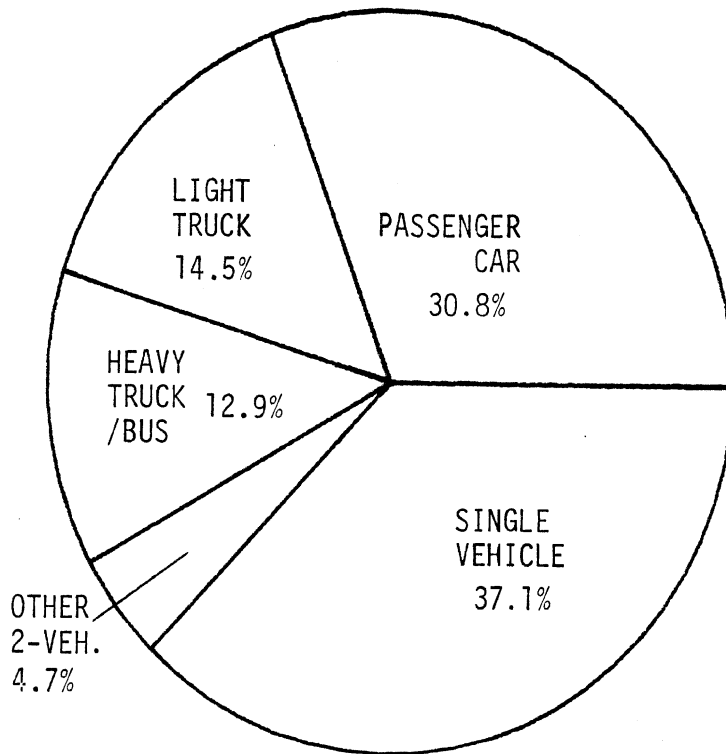
FIGURE 8
Fatalities by Object Struck

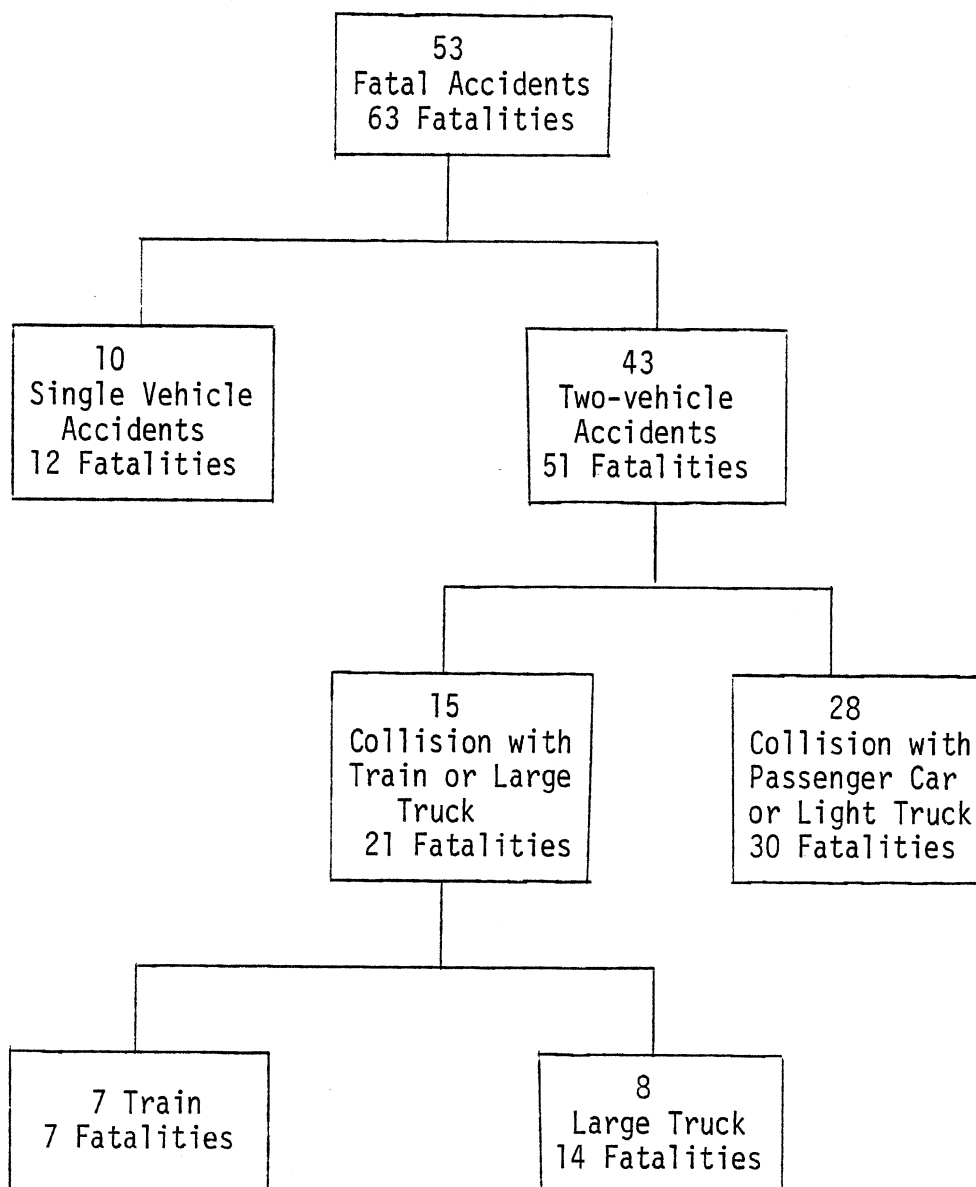
FIGURE 11

Numbers of Vehicles and Fatalities by Type of Accident

Occupants were ejected from 14 (26%) of the vehicles. It is interesting to note that, while the single-vehicle, large truck, and railroad cases had high ejection frequencies (60, 50, and 43 percent respectively), the rate for cars struck by other passenger cars or light trucks was only 3.6 percent. While the number of cases is small, the much lower incidence for collisions with passenger cars is significant and interesting. These figures are based on all occupants in the subject vehicles. Ejection among all fatal occupants of side-impacted cars in the NCSS file is shown in Table A2 for comparison. The percentages shown are the percent of fatally-injured occupants (for each

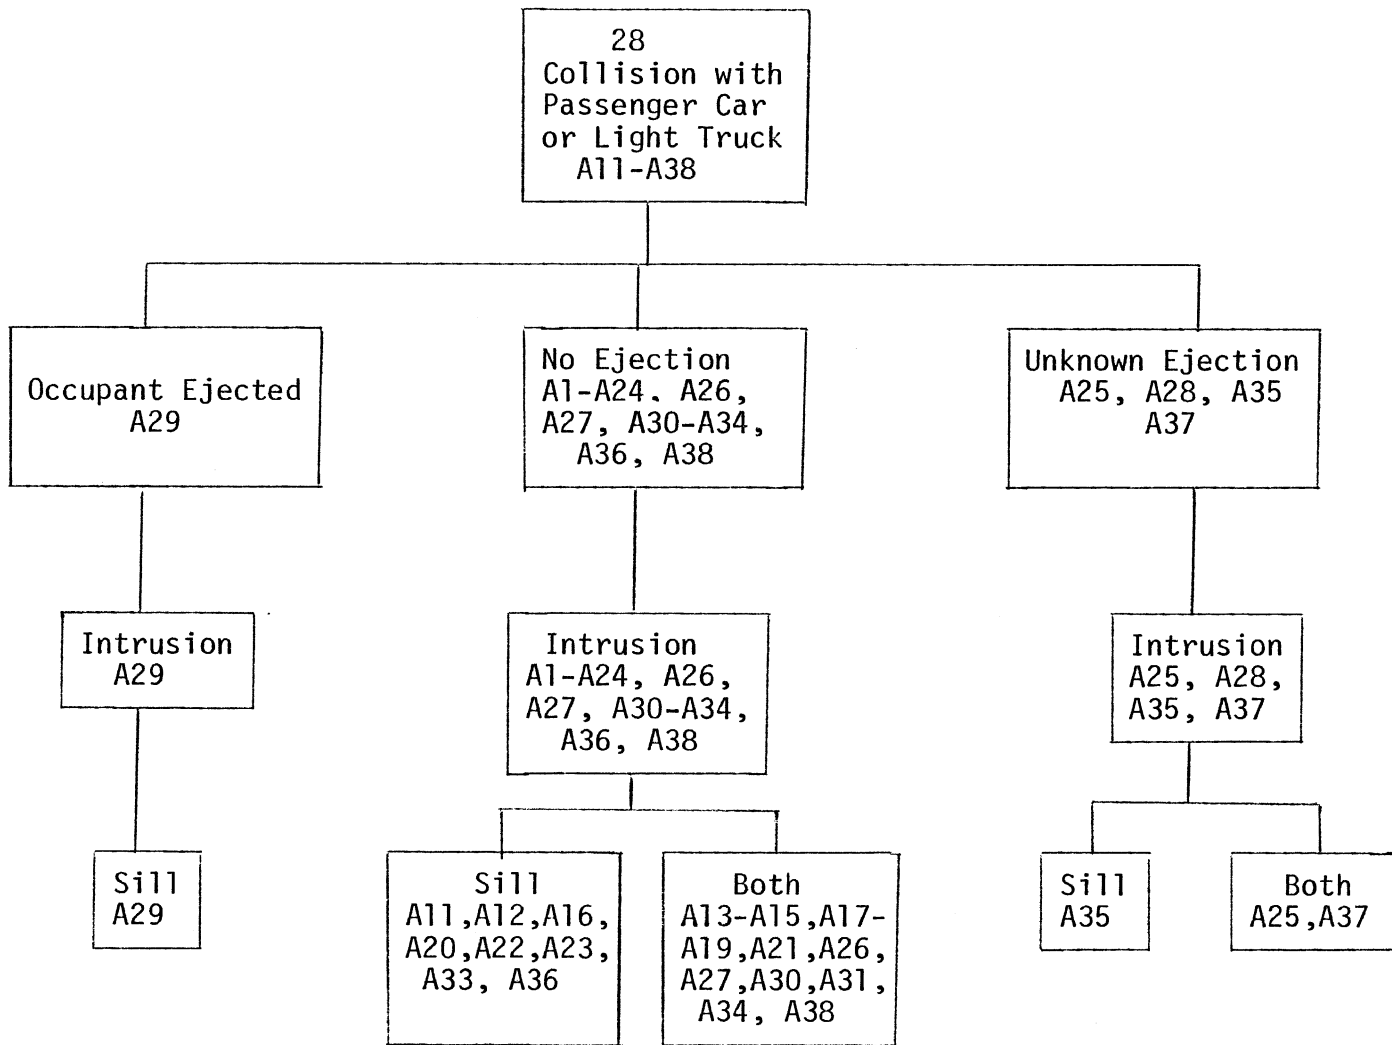
FIGURE 13

Ejections, Intrusions, and Sill/Roof Rail Involvements for Impacts by Passenger Cars or Light Trucks

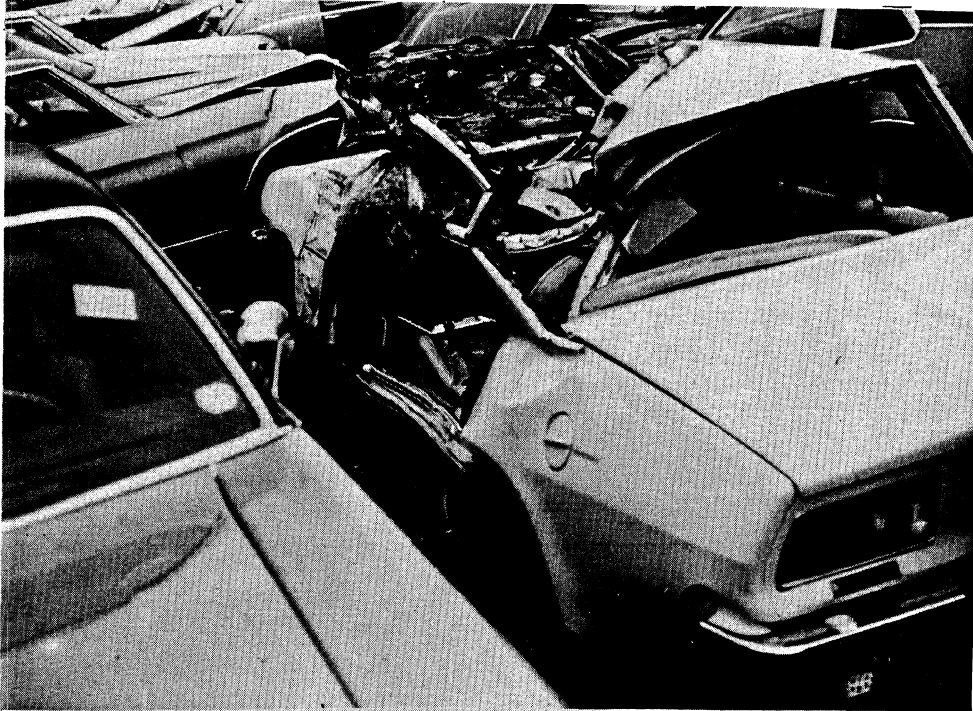
CDC (Case Vehicle) 11 LYAW 4
Delta-V's Not Computed

The left front door latch released, the door hinges separated, and the door opened. The maximum intrusion was 20 inches at the A-pillar. The driver was ejected through the open door. The roof side rail intruded. Intrusion was regarded as a factor in the injuries..

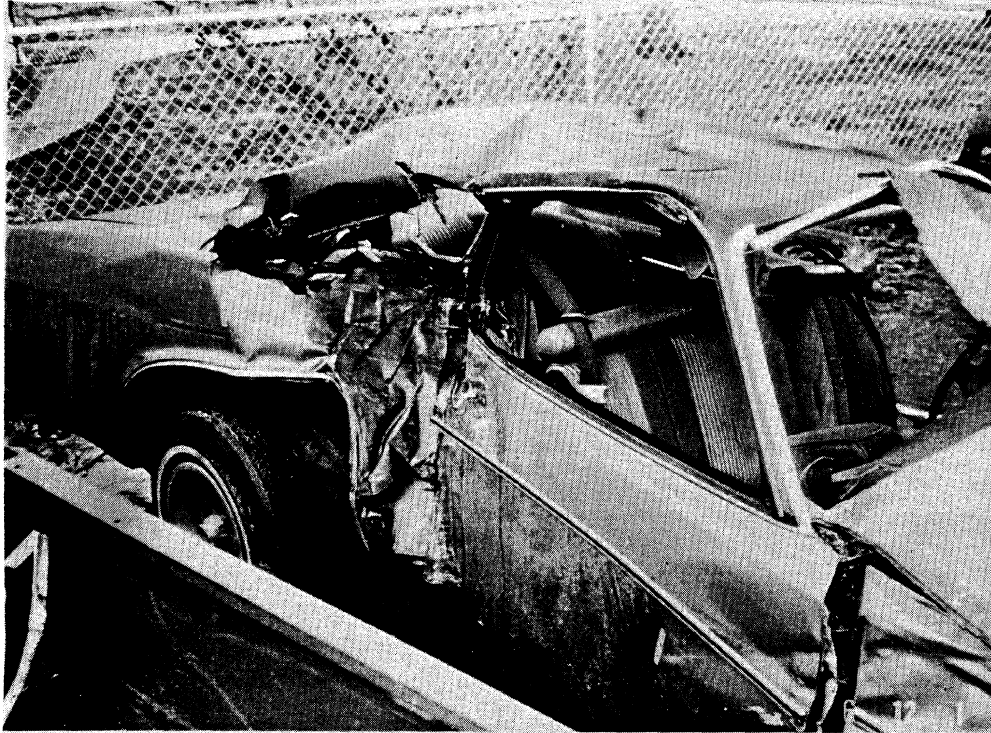
CDC (Case Vehicle)	02 RZAW 4
Total Delta-V	18 mph.
Long. Delta-V	-09 mph.
Lat. Delta V	-15 mph.

Right front door latch damage. No hinge damage. No doors opened. Intruding components: side panels, A-, B-, C-pillars, roof side rail. Maximum intrusion: 28 inches (B-pillar). Driver contacted Steering Wheel, Instrument Panel and Windshield. Windshield broken and driver ejected through windshield. Intrusion not considered a factor in injury.

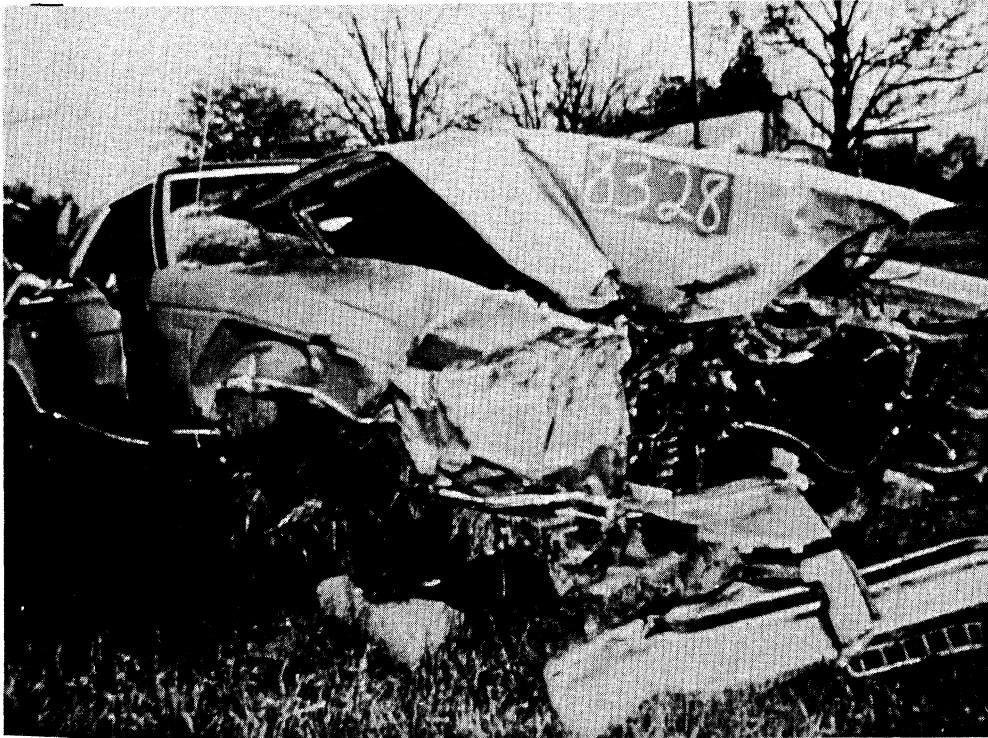
CDC (Case vehicle) 02 RFEW 7 (Third impact)
Total Delta-V's 32 mph.
Long. Delta-V -16 mph.
Lat. Delta-V -28 mph.

Doors did not "open" as such--no latch or hinge separation. However, the gap between the A-pillar and the window glass (glass out of track) provided an ejection portal for the driver. No lateral intrusion.

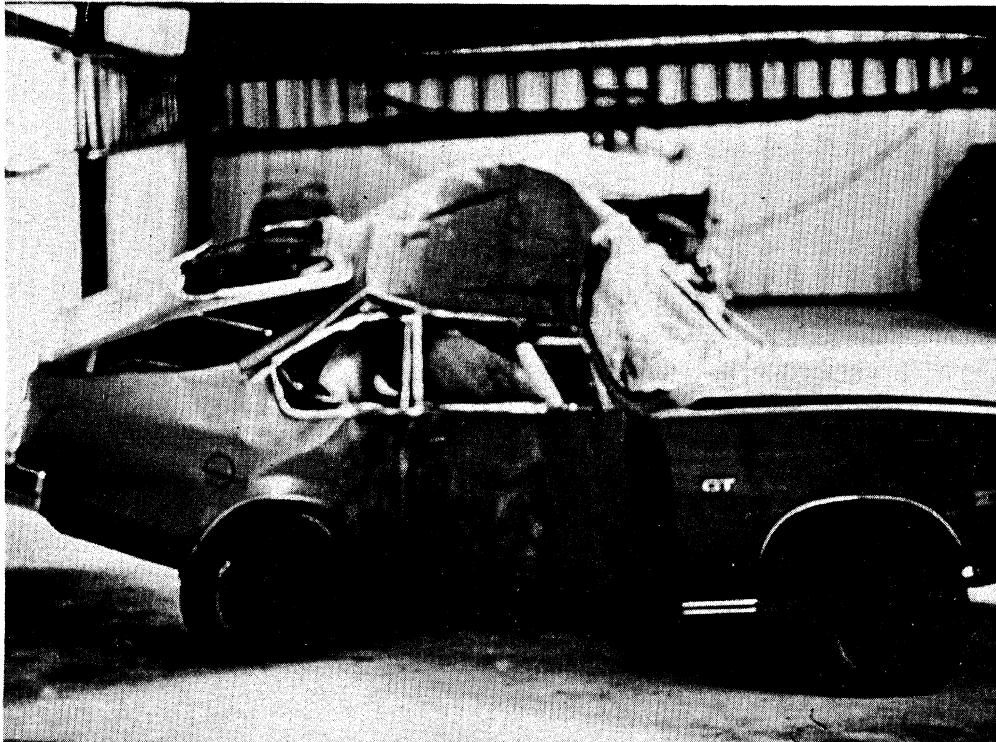
CDC (Case Vehicle, Second Impact) 03 RPAW 5
Total Delta V 34 mph.
Long. Delta-V 00 mph.
Lat. Delta-V -34 mph.

Right door damaged by direct contact. No latch or hinge damage. Right door did not open. Left door opened at some time. Driver partial ejection through left door. Intruding components. (Right side). A-, B-, C-pillar, both right door area panels, window frame and roof side rail. Maximum intrusion of 14 inches (B-pillar).

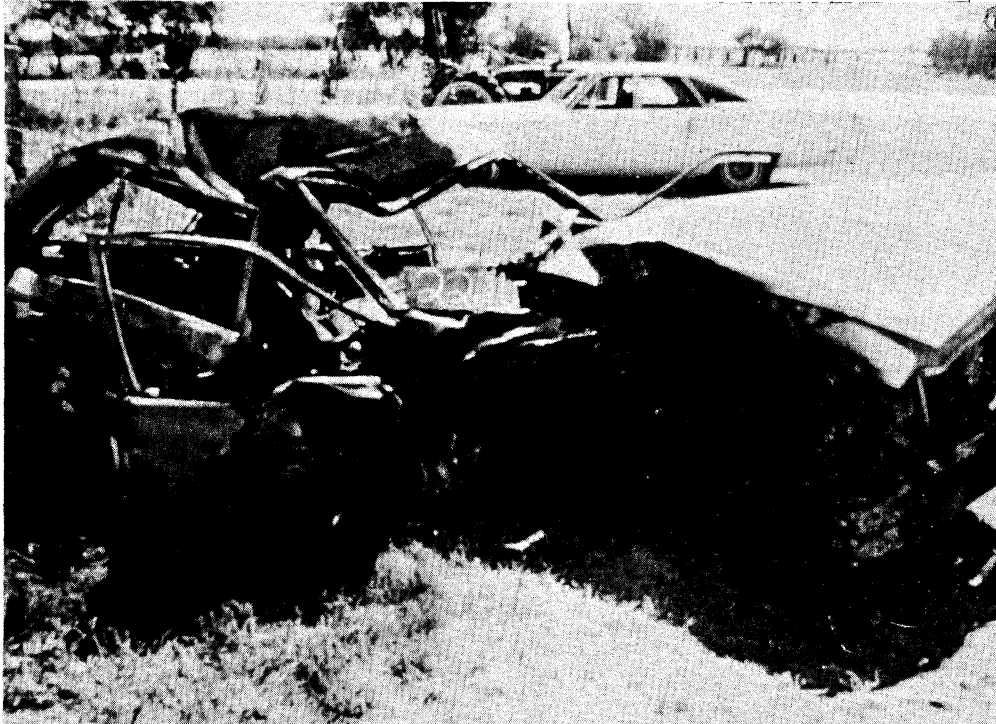
1976 Buick Skylark 4-door with B-pillar struck a deer, lost control, and slid into a large tree. The right front fender and right front door were damaged. The maximum penetration (lateral) was less than 10 inches (right front door). There was considerable deformation to the windshield header and right roof side rail. This may be induced damage or it is possible that the deer became airborne and struck the superstructure. Fire reported as starting in engine compartment.

CDC (Case Vehicle) 01 RYAW 4
Total Delta-V 58 mph.
Long. Delta-V -50 mph.
Lat. Delta-V -29 mph.

Right front door impacted. Latch and hinge damage. Latch released and door opened. No ejection. The only obvious side intrusion was the roof side rail. The primary intrusion listed in the original report was longitudinal--involving the instrument panel, etc. Intrusion was not a factor.

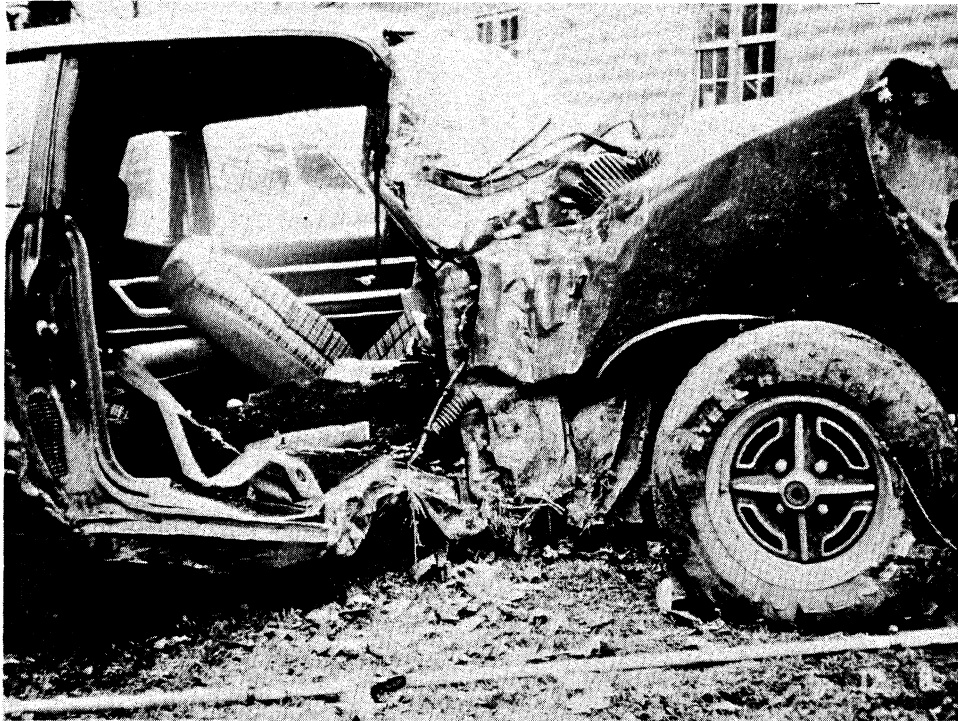
1976 Ford Mustang 2-door with B-pillar went out of control, knocked down two wooden guard rail posts and then slid sideways into the end of a concrete bridge rail. The main area of impact was the right A-pillar and the right front door. The sill was engaged the full amount. The roof rail was not engaged. The maximum penetration was 36 inches (right front door).

CDC (Case Vehicle) 03 RYEW 4 (Bridge)
Total Delta-V 26 mph.
Long. Delta-V 00 mph.
Lat. Delta-V -26 mph.

Right front door impacted. Latch damaged and released. Hinge separation. Door opened. Right front occupant ejected through door. Intrusion of 22 inches (A-pillar and right front door--before opening). Intrusion did not increase the severity of the injuries.

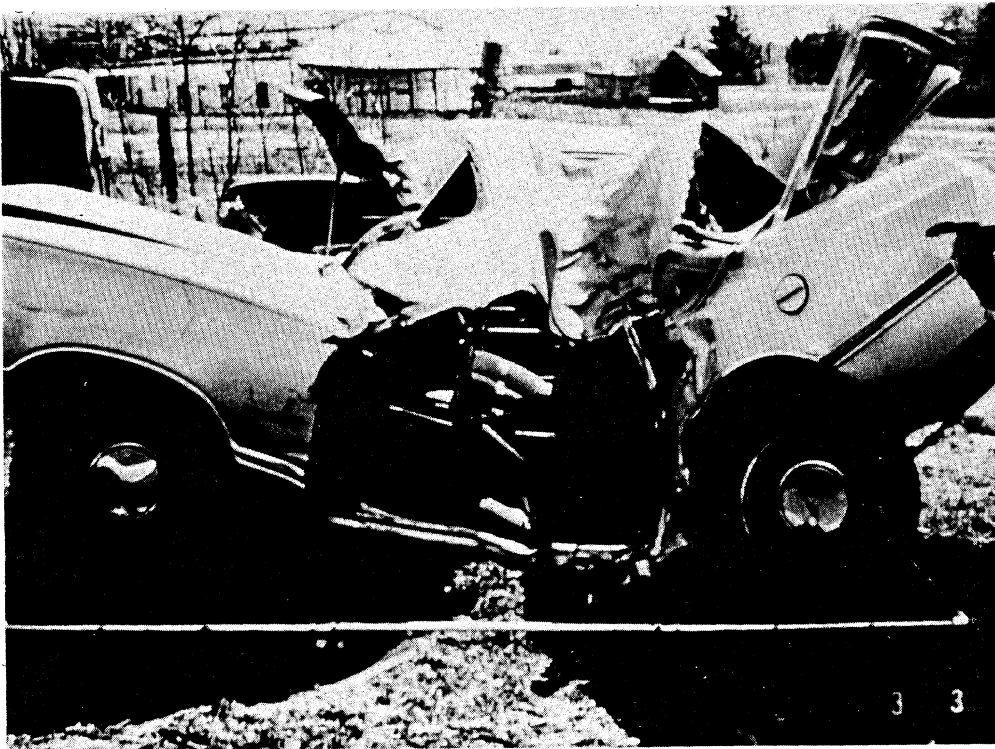
CASE # 6704090/A-10

1974 Lincoln Mark IV 4-door with B-pillar struck a bridge rail with the left side. The maximum penetration was over 18 at the left front door. Both the rocker panel and roof rail were engaged.

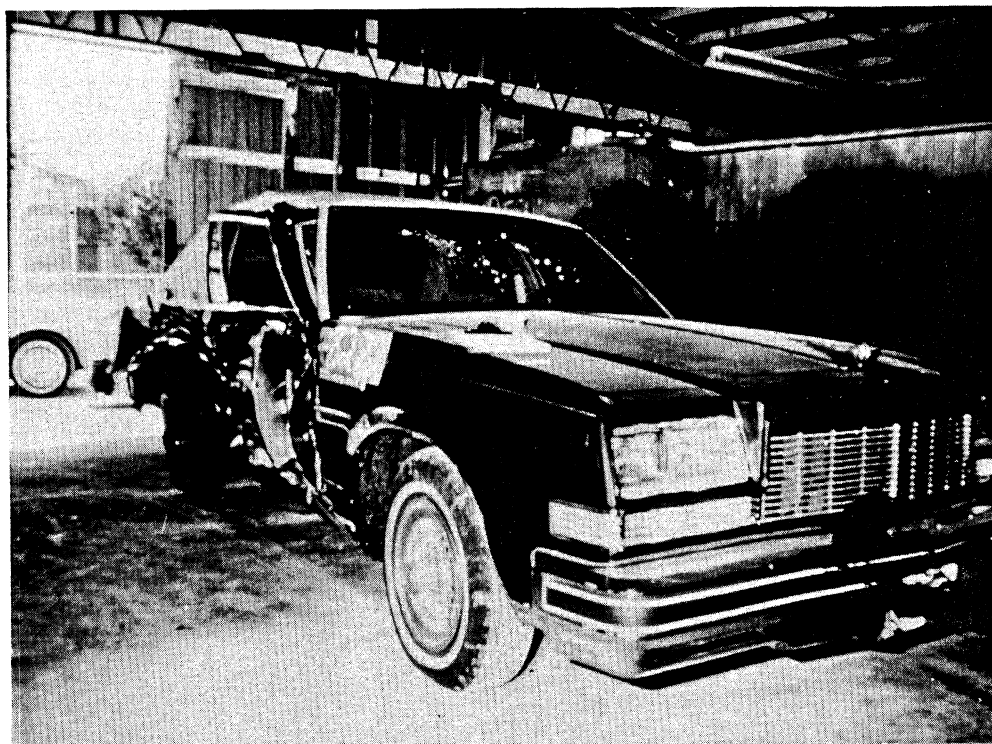
<u>Case Vehicle</u>	<u>Other Vehicle</u>
CDC	01 RZEW 3	10 FDEW 3
Delta V's	Not Computed	Not Computed

Intrusion - both door panels, window frame and B-pillar. Maximum intrusion of 11 inches (right front door).

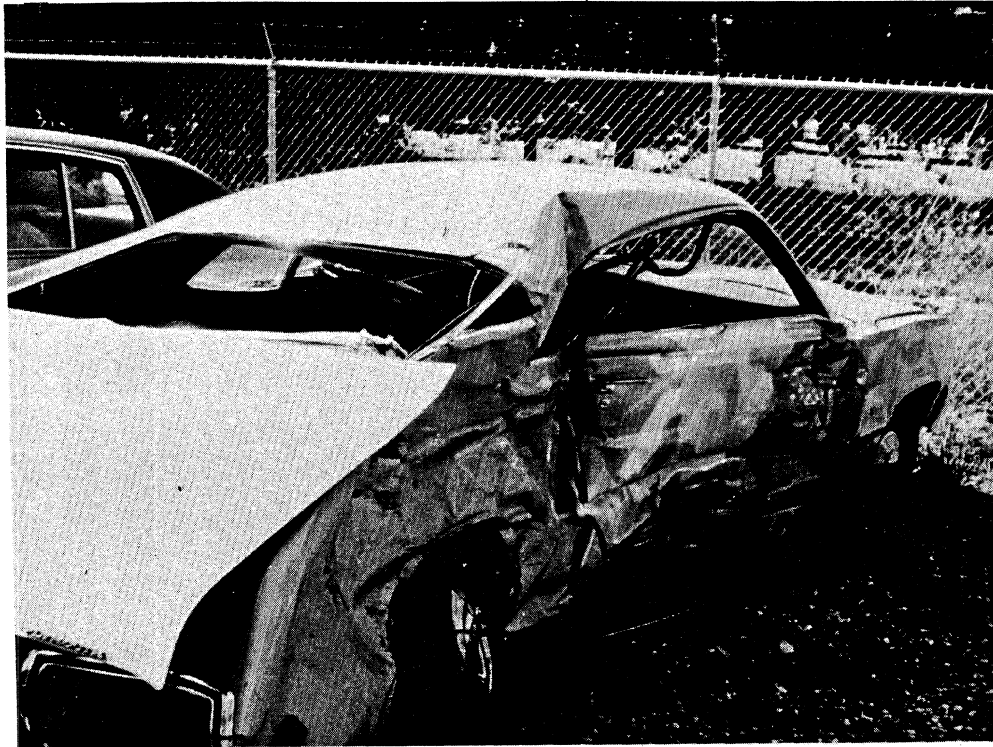
1973 Plymouth Duster 2-door with no upper B-pillar was struck in right side by a Pontiac Catalina. The damaged area extended from the right front door to just behind the right rear wheel. Sill engaged less than maximum. Roof rail engaged an unknown amount. The maximum penetration was 28 inches in the right rear door area.

<u>Case Vehicle</u>	<u>Other Vehicle</u>
CDC	04 RZEW 4	12 FDEW 2
Total Delta-V	34 mph.	27 mph.
Long. Delta-V	+17 mph.	-30 mph.
Lat. Delta-V	-30 mph.	+00 mph.

The right front door latch was damaged. There was no release or separation. No ejections. Intruding components - right front and right rear door areas, A-, B-, and C-pillars, window frame and roof side rail. Maximum intrusion of 19 inches (door panel).

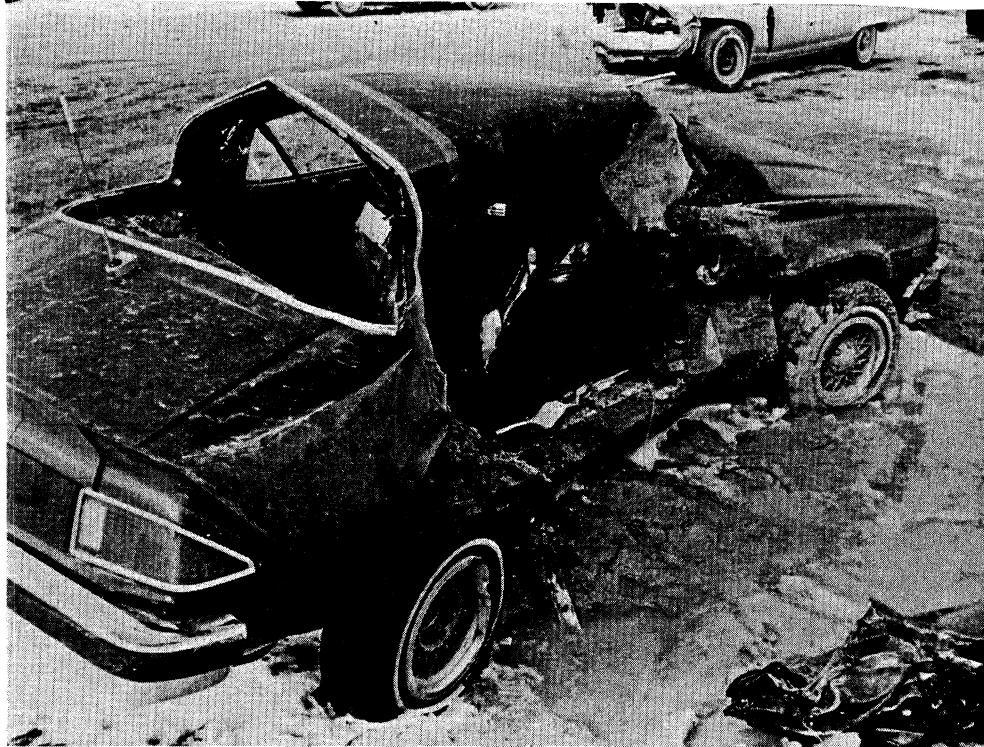
1976 Chevrolet Camero, 2 door, B-pillar, was struck by a Buick Electra in the right side. The damaged area extended from the rear of the front wheel to the rear of the passenger area. The sill and rail were deformed less than maximum. Maximum penetration of "over 18 inches" halfway up the lower B-pillar.

<u>Case Vehicle</u>	<u>Other Vehicle</u>
CDC	02 RYAW 4	11 FDEW 3
Total Delta-V	22 mph	18 mph.
Long. Delta-V	-11 mph.	-15 mph.
Lat. Delta-V	-19 mph.	+9 mph.

Right door latch damage. Door did not open. (Door removed by rescue squad by cutting hinges.) There was a possible partial ejection (unknown portal). Intrusion of right door, right rear door area, A-, B-, and C-pillars and roof rail. Maximum intrusion of 24 inches (right front door panel).

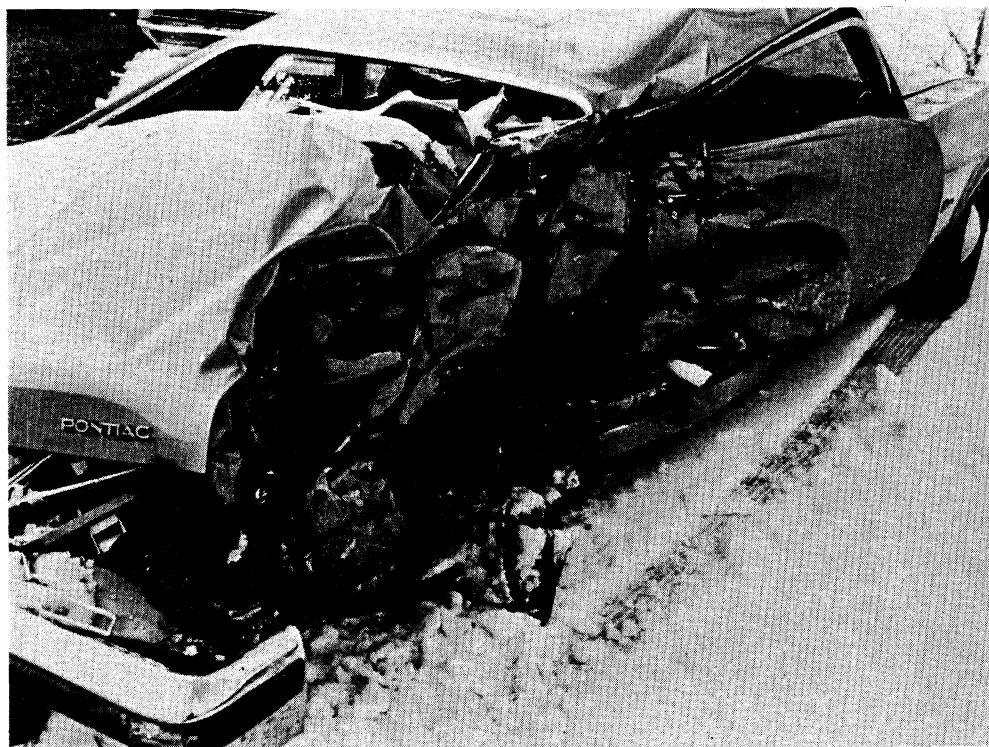
1974 Pontiac Ventura 2-door with B-pillar was struck in the right side by a Lincoln Continental. Both right door areas and the quarter panel received direct damage. The door sill and the roof side rail were coded as "engaged less than the full amount." It is possible that this is induced damage. The maximum penetration was 20 inches at the leading edge of the rear door area.

<u>Case Vehicle</u>	<u>Other Vehicle</u>
CDC	02 RZEW 4	11 FDEW 2
Total Delta-V	26 mph.	17 mph.
Long. Delta-V	-7 mph.	-16 mph.
Lat. Delta-V	-25 mph.	+4 mph.

Right front door latch and hinge damage. No opening, no ejection. Intrusion--both right door area panels, B- and C-pillars, window frame and roof side rail. Maximum intrusion of 20 inches (right rear panel). Role of intrusion unknown.

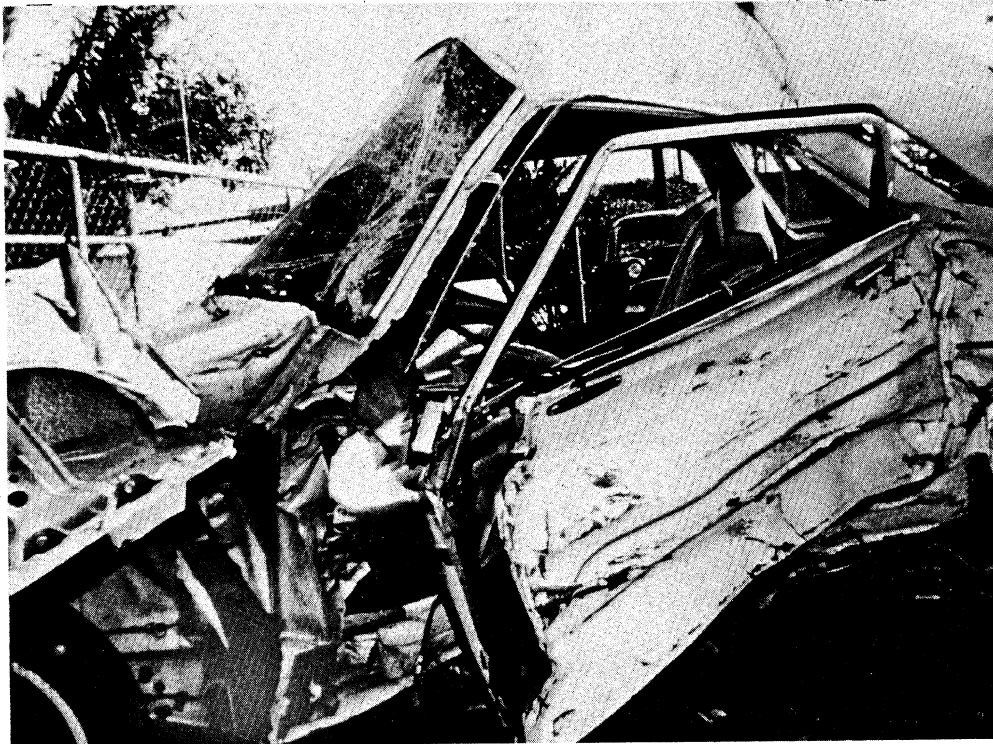
1977 Ford Granada 2-door with B-pillar was struck in the left side by a Ford Fairlane. The maximum penetration occurred at the left B-pillar (27 inches). The door sill and roof rail were deformed about 70 percent of the maximum. This was the first of two impacts.

<u>Case Vehicle</u>	<u>Other Vehicle</u>
CDC	10 LPEW 4	01 FDEW 2
Total Delta-V	22 mph.	1 mph.
Long. Delta-V	-06 mph.	-21 mph.
Lat. Delta-V	+22 mph.	-05 mph.

Left door impacted. Door opened with hinge separation. No ejection. Intrusion--A-, B-, C-pillars, roof side rail, left front window frame, both left door area panels. Maximum intrusion of 22 inches. (B-pillar). Intrusion probably did not increase severity of injuries.

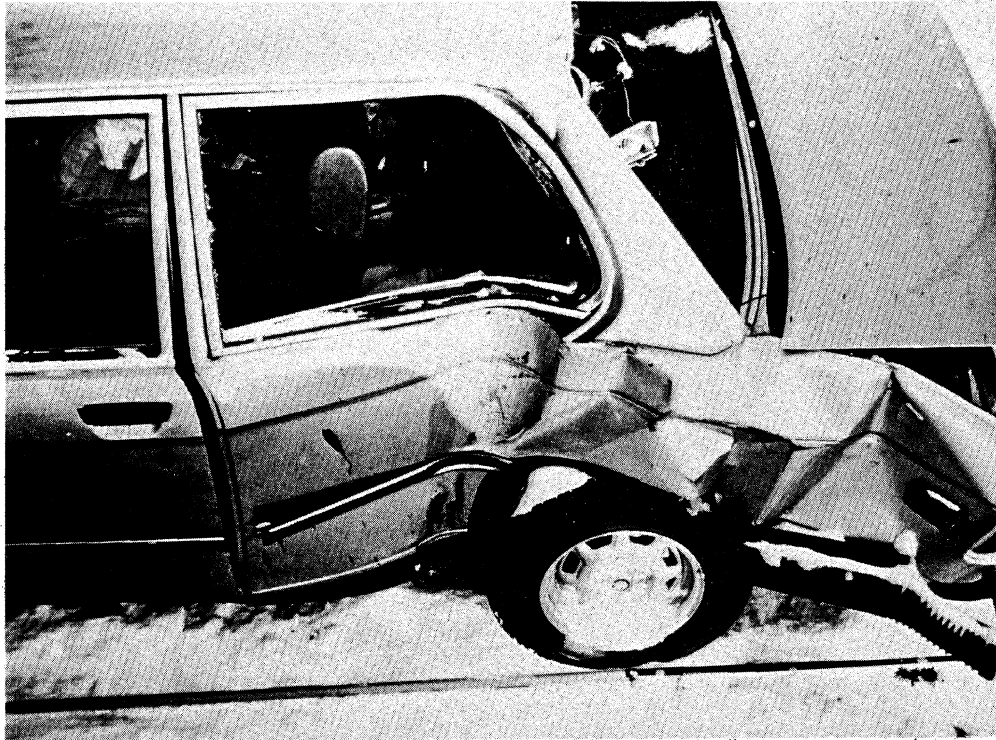
1976 BMW 320 2-door with B-pillar was initially struck by an Oldsmobile Cutlass in the right rear (04 RBEW 3). This impact apparently threw the driver backwards--with seat track separation. At this point, the case vehicle slid sideways into a pole making contact in the area of the left C-pillar. The maximum penetration was 12 inches. The roof side rail and door sill were engaged less than maximum.

CDC (Case Vehicle)	09 LPAN 3
Total Delta-V	05 mph.
Long. Delta-V	00 mph.
Lat. Delta-V	+05 mph.

Left front door not impacted and did not open. Intrusion--left rear door area panel, C-pillar and window frame. Maximum intrusion of 12 inches (rear panel).

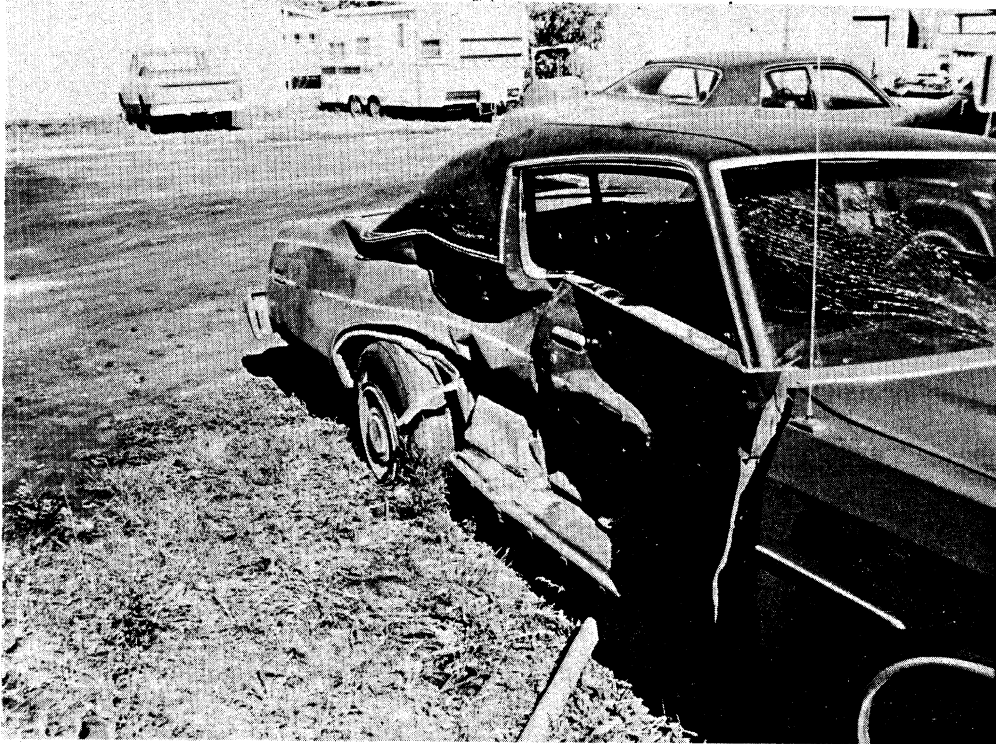
1974 Ford Galaxie 500 2-door no upper B-pillar was struck in the right side by a Chevrolet Impala. The direct damage included the front and rear door areas. The maximum penetration was 18 inches at the rear of the front door. The door sill was engaged an unknown amount. The roof side rail may have had some induced damage.

<u>Case Vehicle</u>	<u>Other Vehicle</u>
CDC	02 RPEW 3	11 FDEW 2
Total Delta-V	19 mph.	18 mph.
Long. Delta-V	-09 mph.	-16 mph.
Lat. Delta-V	-16 mph.	+09 mph.

No latch or hinge damage. Doors did not open. No ejection. Intrusion--right door panels, lower B-pillar, C-pillar, Maximum Intrusion of 9 inches (right front door panel). Intrusion did not increase severity of injury.

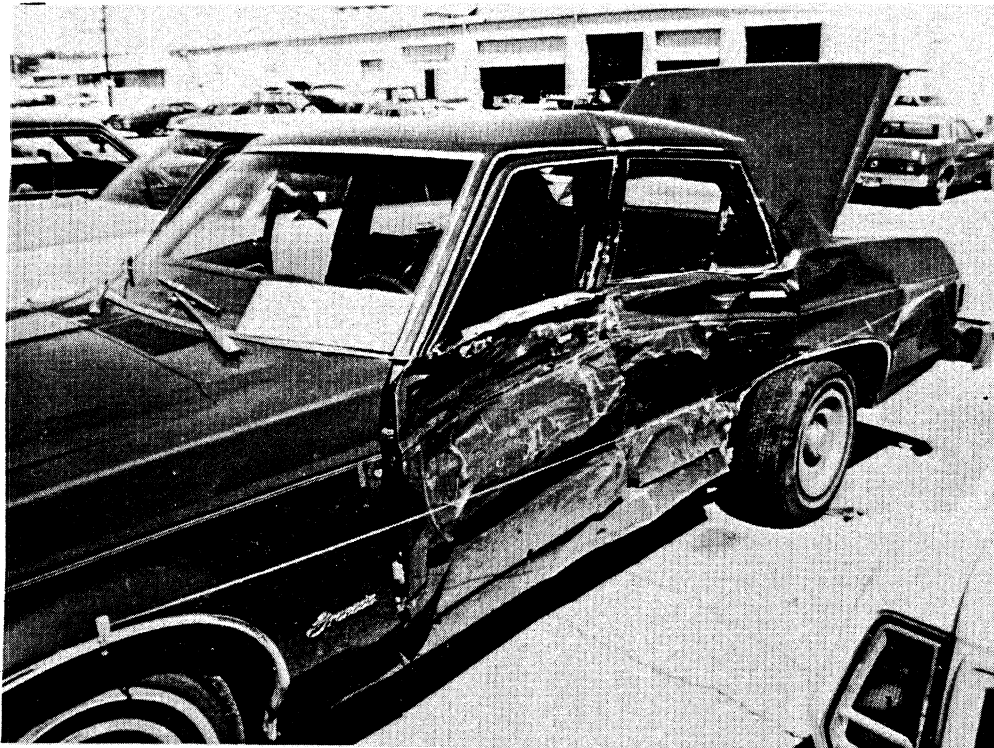
1975 Ford Granada 4-door with B-pillar was struck in the left side by a Ford F-100 pickup. Both left doors, the B-pillar, and the lower C-pillar were damaged. There was some direct damage to the trunk area--but mostly induced damage. The sill and rail appear to have been damaged. The amount was recorded as "unknown amount." The maximum penetration was 16 inches--centered in the left rear door.

<u>Case Vehicle</u>	<u>Other Vehicle</u>
CDC	10 LZAW 3	01 FYEW 1
Delta-V's	Not Computed	Not Computed

Both left door latches were damaged. No release and none opened. No ejection. Intrusion--Both door panels, and B-pillar. Maximum intrusion of 8 inches (rear door panel). Intrusion did not increase the severity of the injuries.

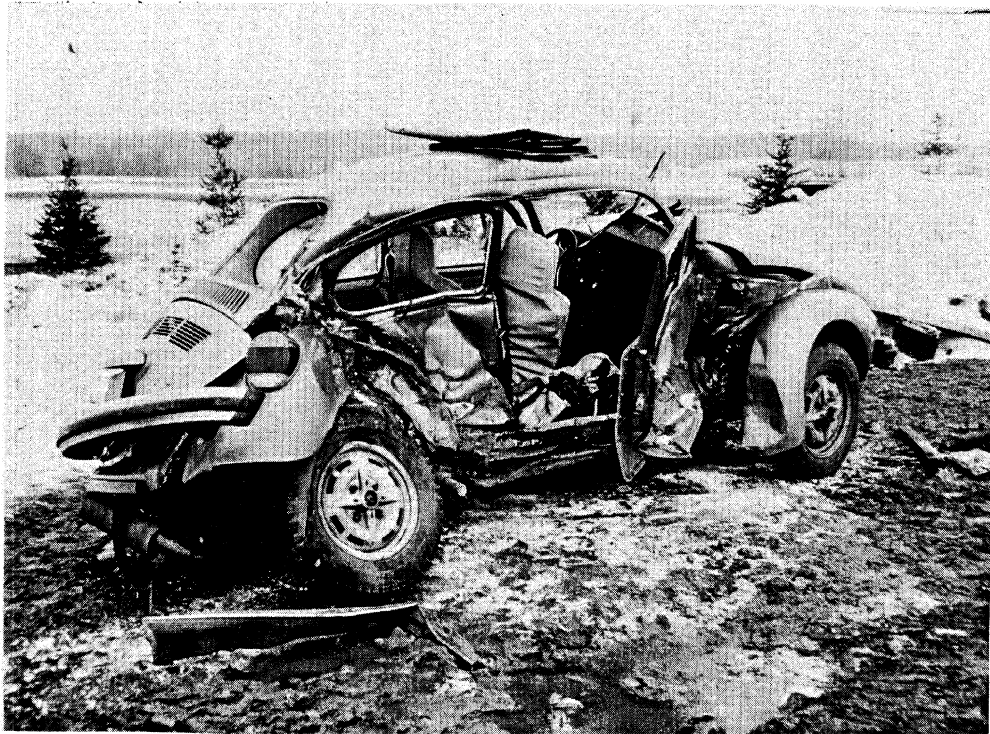
1975 VW Super Beetle 2-door with B-pillar was struck in the right side by a Ford Thunderbird. The damaged area extended from just behind the front wheel to the rear of the rear wheel. The maximum penetration (18 inches) occurred just behind the B-pillar. The sill was engaged less than the full penetration. The roof side rail had some induced damage.

<u>Case Vehicle</u>	<u>Other Vehicle</u>
CDC	04 RDEW 4	11 FDEW 2
Total Delta-V	33 mph.	16 mph.
Long. Delta-V	00 mph.	-14 mph.
Lat. Delta-V	-33 mph.	+08 mph.

Right front door impacted. Latch damaged. Door did not open. No ejection. Intrusion--right rear door area panel, B-pillar, C-pillar, Roof side rail. Maximum intrusion of 11 inches (panel). Intrusion not a factor.

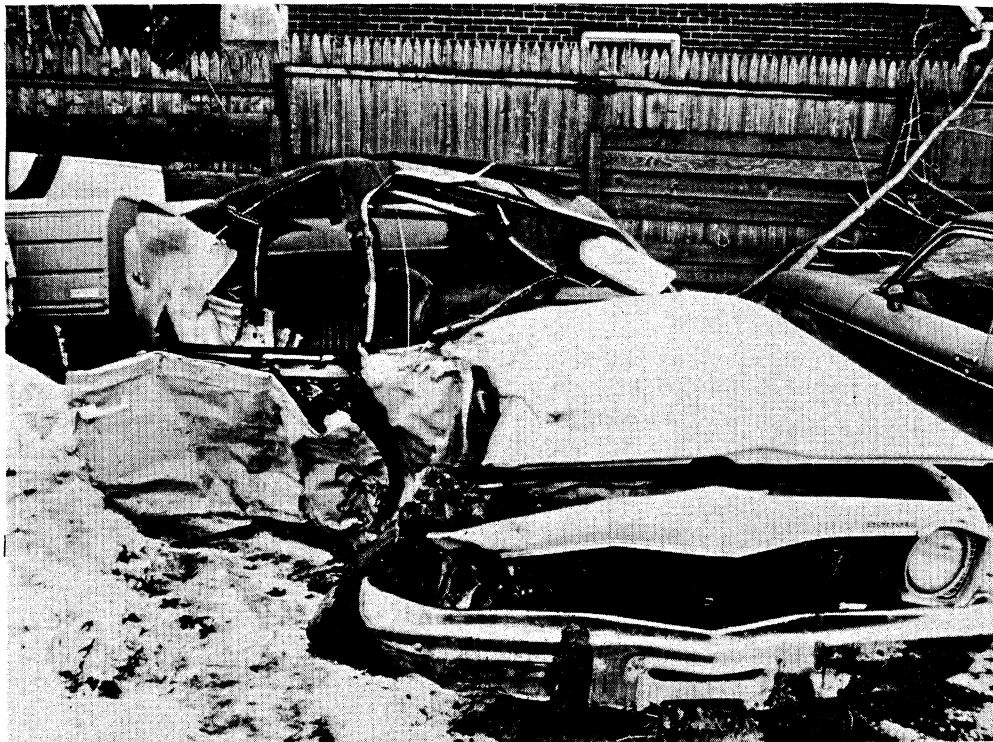
1973 Dodge Dart 2-door B-pillar was struck in the right side by a Chevrolet El Camino (pick-up car). The damaged area included the right front fender, A-pillar, and door. The sill was engaged the full amount. The roof rail had severe induced damage. The maximum penetration was 10-18 inches at the right A-pillar.

<u>Case Vehicle</u>	<u>Other Vehicle</u>
CDC	02 RYAW 3	11 FDEW 3
Total Delta-V	42 mph.	31 mph.
Long. Delta-V	-21 mph.	-27 mph.
Lat. Delta-V	-36 mph.	+15 mph.

The right front door was jammed closed and was forced open after the accident. The latch was damaged. There were no ejections. Intruding components: A-pillar, right front door panel, B-pillar, right rear door area, window frame and roof rail. The maximum intrusion was 10 inches (A-pillar).

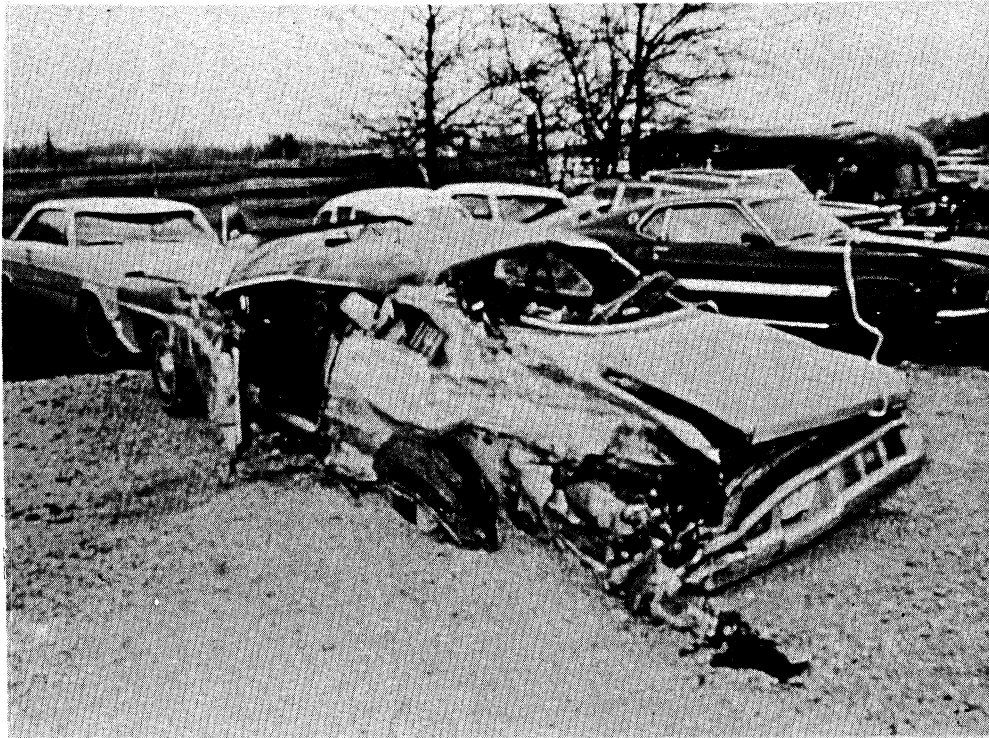
1973 Chevrolet Impala, 2-door, No B-pillar was struck in the left side by a Chevrolet C-10 truck. The distributed side damage extended from the rear of the front wheel to the back of the vehicle. The maximum penetration was just in front of the C-pillar. The sill and rail were engaged less than the maximum.

<u>Case Vehicle</u>	<u>Other Vehicle</u>
CDC	11 LDAW 3	01 FDEW 3
Delta-V's	Not Computed	Not Computed

Both left door areas damaged by direct contact. The left front opened with latch damage and release. Hinges were damaged--no separation. The driver was trapped. The ejection--entrapment situation for the remaining occupants is unknown. Intruding components--B-pillar, left rear door area, C-pillar and roof side rail. Maximum intrusion of 18 inches (C-pillar). Intrusion not a factor.

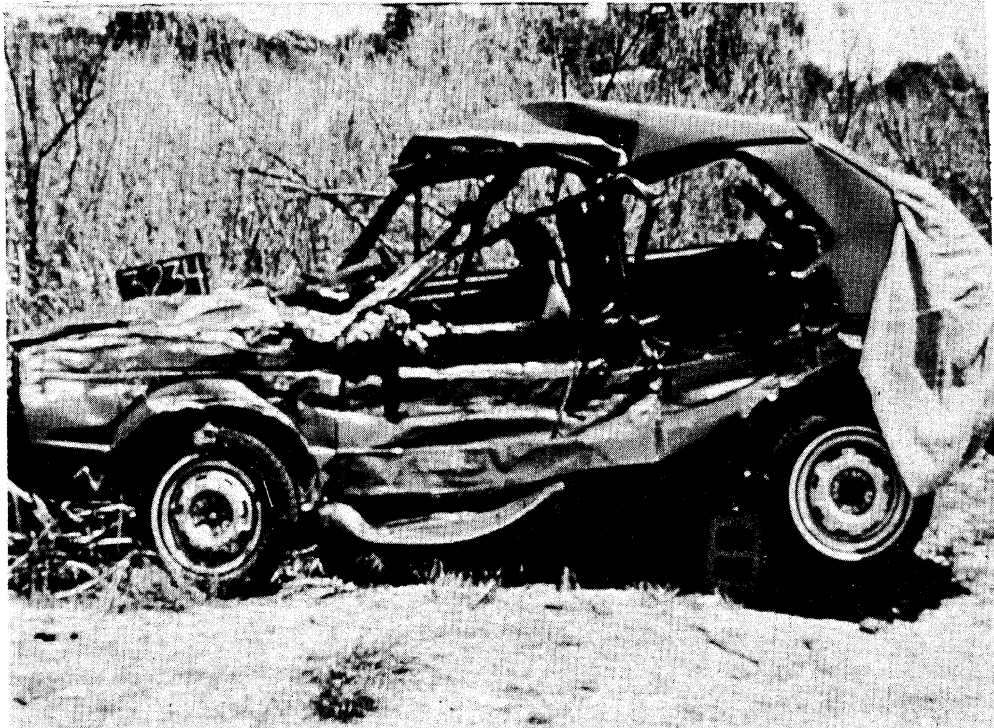
1975 VW Rabbit, 2-door with B-pillar was struck in the left side by a small Ford dump truck (pickup chassis). The distributed side damage extended from the front of the vehicle to the C-pillar. The maximum penetration was 21 inches (left front door--center at beltline). The sill and rail were engaged less than the maximum. After the first impact, the case vehicle went off the right side of the road and rolled onto its right side.

<u>Case Vehicle</u>	<u>Other Vehicle</u>
CDC	11 LDAW 4	01 FYEW 1
Total Delta-V	39 mph.	13 mph.
Long. Delta-V	-34 mph.	-11 mph.
Lat. Delta-V	+19 mph.	-06 mph.

Left front door impacted. Latch and hinge damage. Door did not open. No ejection. Intruding components--A- and B-pillar, left front and left rear door area panels. Maximum intrusion of 21 inches (B-pillar). Intrusion probably not a factor.
