UM-HSRI-81-20

**SIDE IMPACTS OF PASSENGER CARS:
AN ANALYSIS OF FARS & NCSS DATA**

APRIL 1981

**THE UNIVERSITY OF MICHIGAN
HIGHWAY SAFETY RESEARCH INSTITUTE**

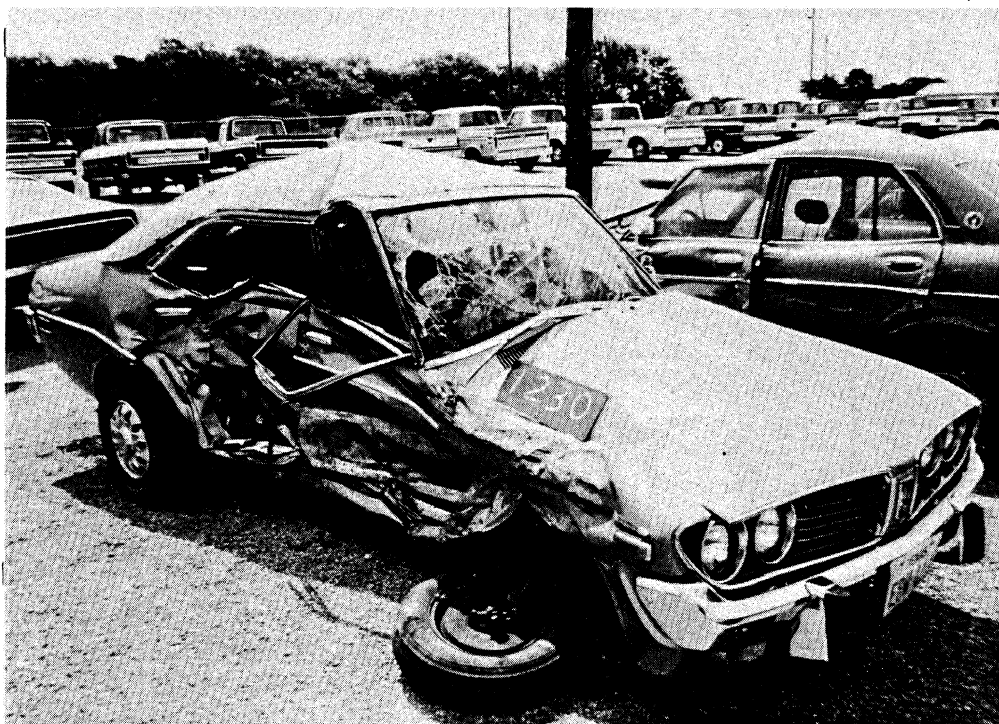
1973 Toyota Corona 4-door with B-pillar was struck in the right side by a Plymouth. The damaged area extended from the front wheel to the C-pillar. The maximum door penetration was 18 inches (right rear--low and center). There was induced damage to the roof rail and door sill.

<u>Case Vehicle</u>	<u>Other Vehicle</u>
CDC	02 RYEW 3	11 FDEW 3
Total Delta-V	38 mph.	23 mph.
Long. Delta-V	-19 mph.	-20 mph.
Lat. Delta-V	-32 mph.	+12 mph.

Both right doors impacted. Latch and hinge damage. Neither door on right side opened. Left front door opened due to body distortion. Unknown if driver was ejected at some time. Probably not at first impact. Driver struck and bent floor-mounted shift lever, contacted right A-pillar and general area in right front. There were two impacts. Intrusion--both right door panels, A- and B-pillars. Maximum intrusion of 20 inches (right rear door panel). Intrusion not a factor in injury.

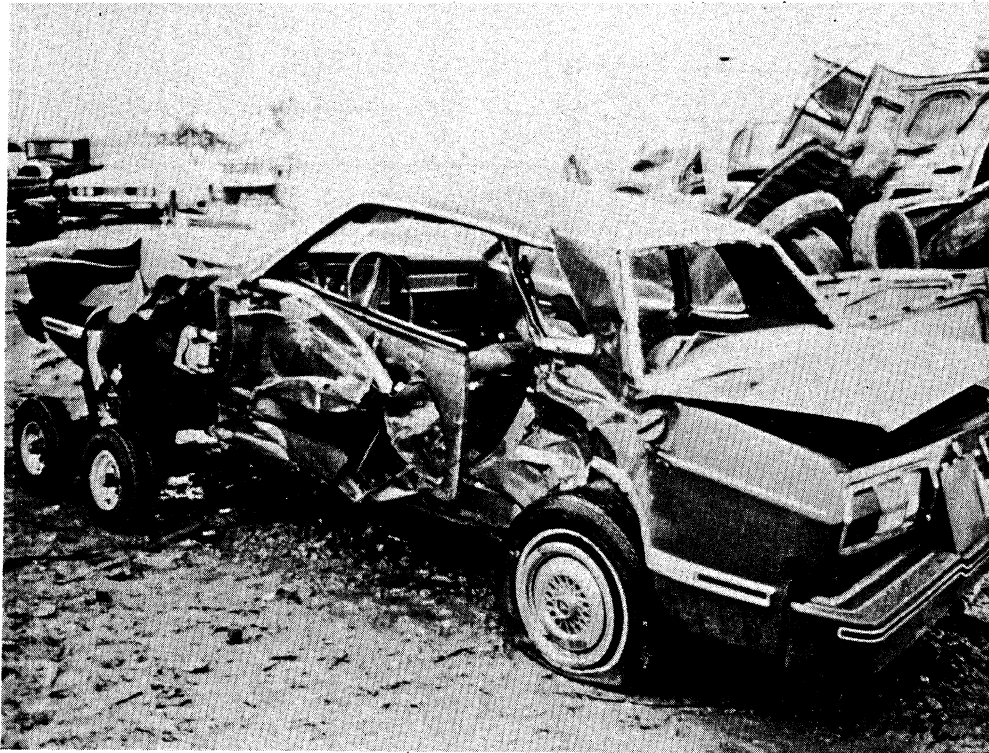
1977 Ford Mustang 2-door with B-pillar was struck in the left side by a Dodge Coronet. The damaged area extended from the A-pillar to the C-pillar. The sill was engaged less than maximum. The roof side rail had induced damage. Maximum penetration of 20 inches (left rear door area).

<u>Case Vehicle</u>	<u>Other Vehicle</u>
CDC	10 LPEW 4	01 FDEW 2
Total Delta-V	24 mph.	19 mph.
Long. Delta-V	-17 mph.	-15 mph.
Lat. Delta-V	+17 mph.	12 mph.

Left front door impacted. Latch damage. Door did not open. Driver ejected through unknown portal. Intrusion--B-pillar, left rear door area panel and window frame. Maximum intrusion of 15 inches (door area panel).

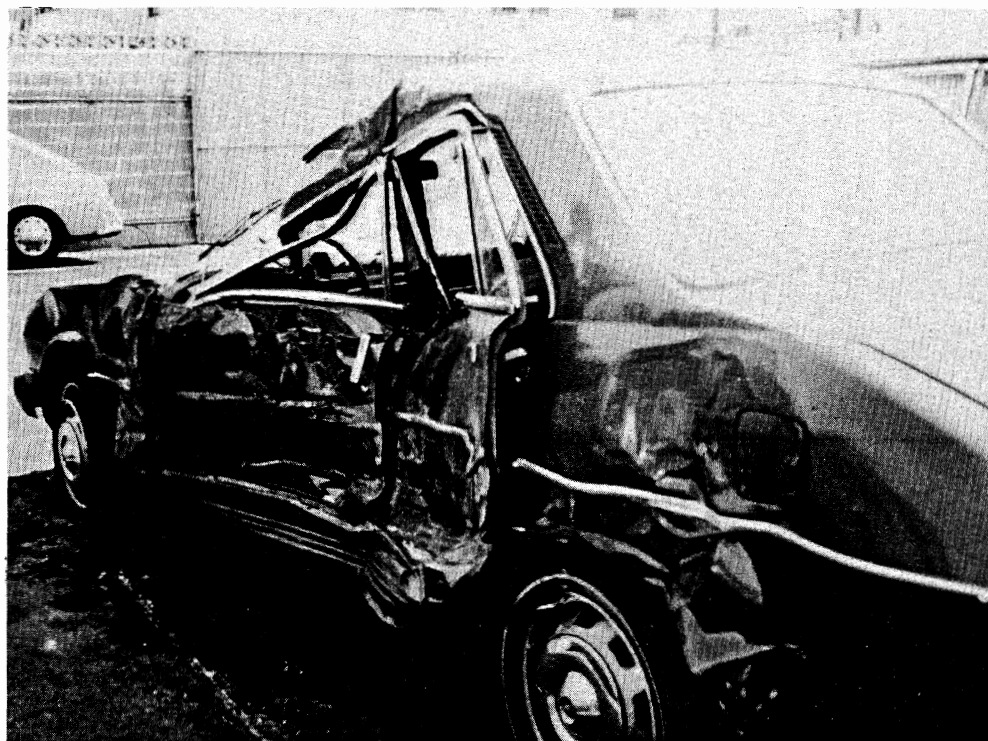
1975 Peugeot 504, 4-door with B-pillar was struck in the left side by a Ford 600 truck. The damaged area extended from the front wheel to just behind the rear wheel with the greatest penetrating (12 inches) at the left front door (low at the rear edge). The sill was engaged less than the full amount. The roof side rail was engaged an unknown amount.

<u>Case Vehicle</u>	<u>Other Vehicle</u>
CDC	10 LDAW 3	01 FDEW 1
Total Delta-V	16 mph.	10 mph.
Long. Delta-V	-6 mph.	-10 mph.
Lat. Delta-V	+15 mph.	-03 mph.

Both doors impacted. Both with latch and hinge damage. Neither latch released. Doors did not open. No ejection. Intrusion--both door panels, A- and B-pillars, window frame, and roof side rail. Maximum intrusion of 7 inches (left front door panel). Intrusion probably not a factor.

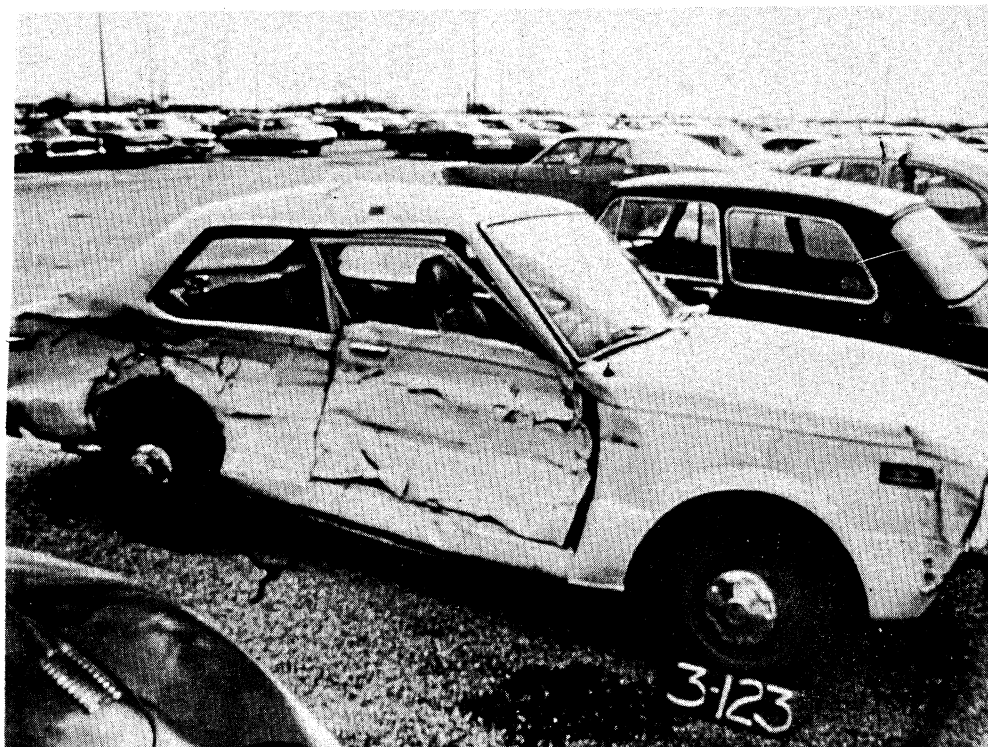
1975 Toyota Corolla 2-door with B-pillar was struck in the right side by a Buick Riviera. The damage extended from the A-pillar to the rear of the vehicle. The sill and roof rail were not engaged. The maximum penetration (17 inches) was in the right rear door area (beltline, near the B-pillar).

<u>Case Vehicle</u>	<u>Other Vehicle</u>
CDC	02 RZMW 4	11 FDEW 1
Total Delta-V	26 mph.	15 mph.
Long. Delta-V	-18 mph.	-9 mph.
Lat. Delta-V	-19 mph.	11 mph.

Latch and hinge damage. No release or separation. Door did not open; no ejection. Intrusion--right front and right rear door area panels, B- and C-pillars. Maximum intrusion--11 inches (B-pillar).

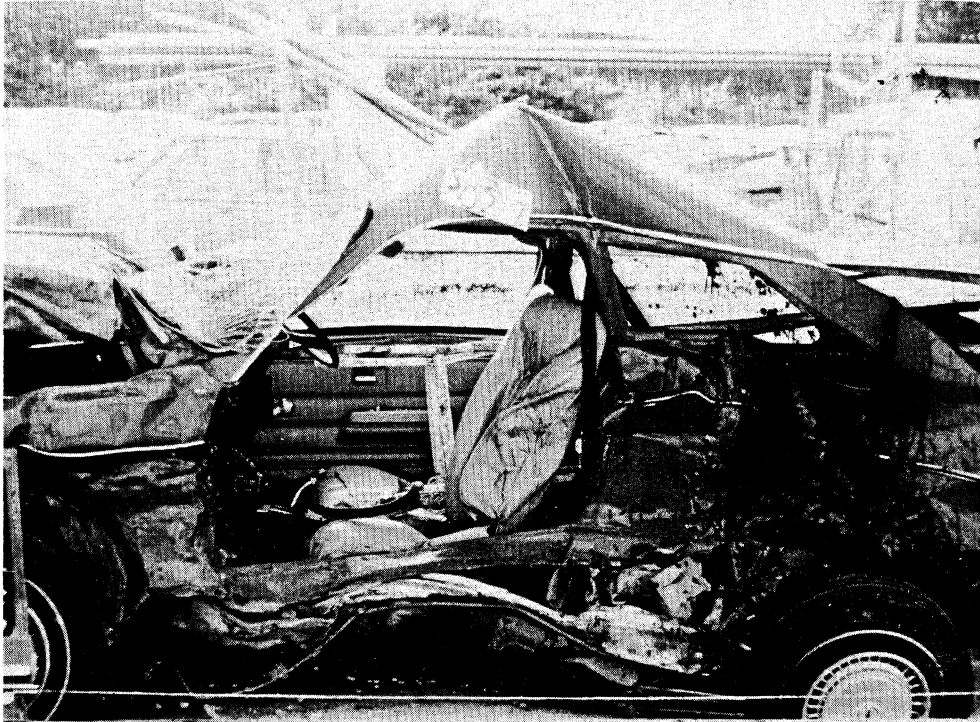
1976 Chevrolet Chevette 2-door with B-pillar was struck in the left side by an Oldsmobile 98. Direct damage to entire left side with greatest penetration (38 inches) in the left rear door area. The sill was engaged less than the maximum. The roof side rail was not engaged but was subject to induced damage.

<u>Case Vehicle</u>	<u>Other Vehicle</u>
CDC	10 LDEW 6	Unknown
Delta-V's	Not Computed	Not Computed

Left front door latch and hinge damage. No release or separation. Door did not open. Door had to be removed by rescue team to extricate driver. No ejection. Intrusion--both left door areas, A- and B-pillars, roof side rail and left front door window frame. Maximum intrusion--32 inches (left rear door area panel).

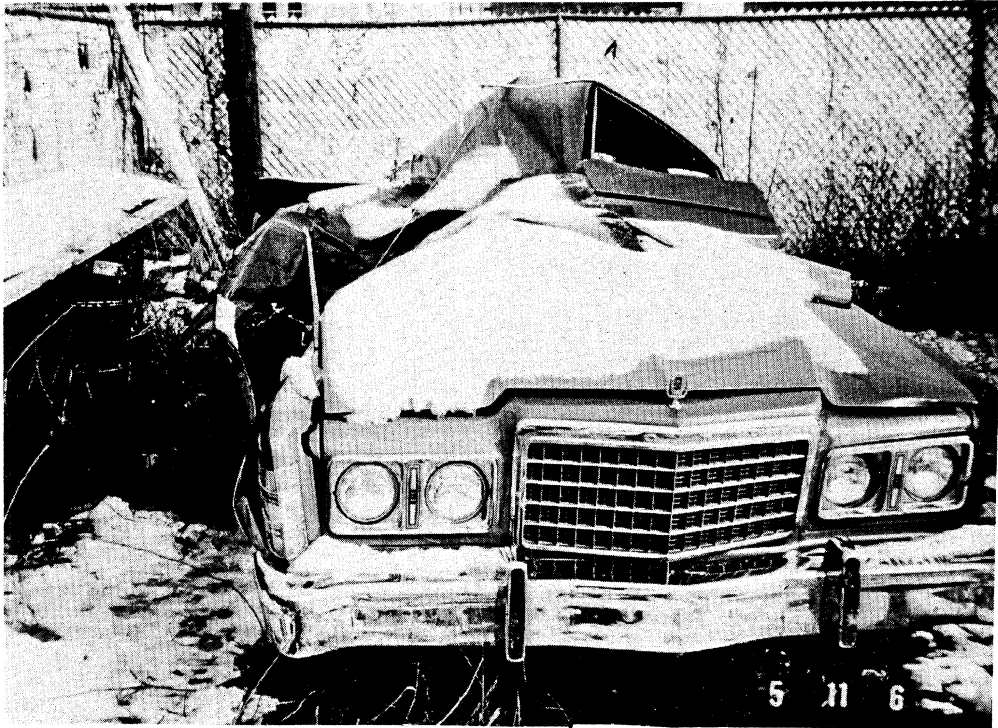
1975 Ford LD 4-door with B-pillar was struck in the right side by a Ford Walk-in Van. The right side of the passenger compartment, the roof side rail, and the roof were damaged by direct contact. A maximum of 46 inches penetration occurred just forward of the B-pillar at the beltline. The sill and roof rail were engaged less than maximum.

<u>Case Vehicle</u>	<u>Other Vehicle</u>
CDC	03 RDAW 6	12 FDEW 5
Total Delta-V	33 mph.	25 mph.
Long. Delta-V	00 mph	-25 mph.
Lat. Delta-V	-33 mph.	00 mph.

Both right doors impacted. Right front latch and hinge damage. No release, no separation. Doors did not open. No ejection. Intrusion--both door panels, A-, B-, and C-pillars, and roof rail. Maximum intrusion of 40 inches (B-pillar). Intrusion probably not a factor.

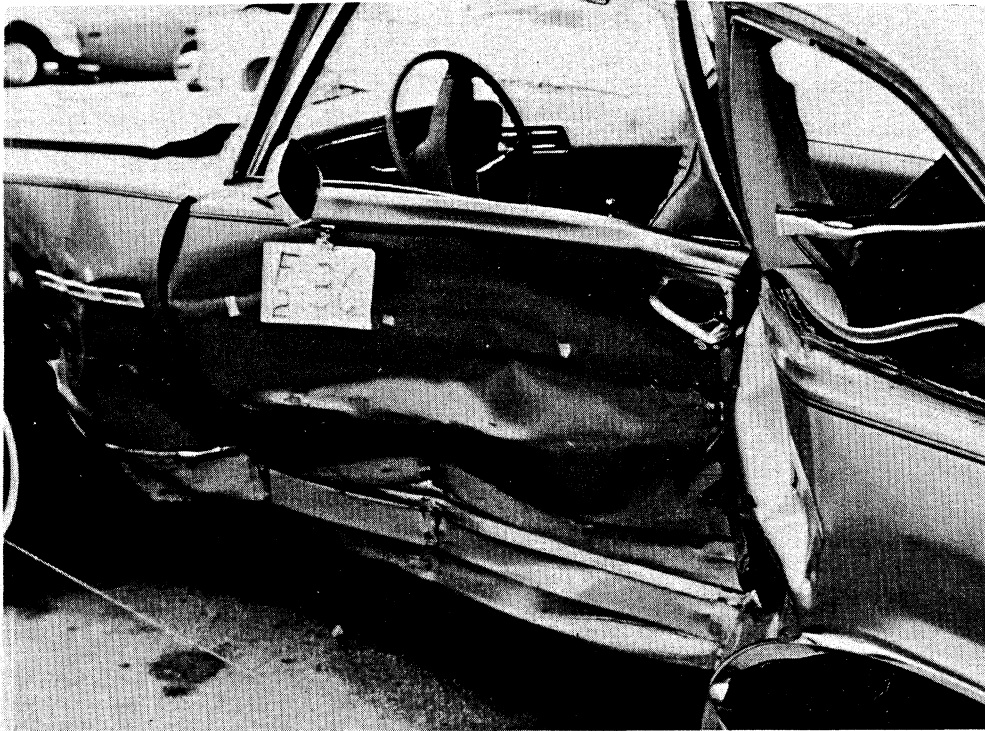
1975 Buick Skylark 2-door with B-pillar was struck in the left side by a Dodge. Damaged area included the left front fender, left front door, and left rear door area. Sill was engaged less than maximum. The roof rail was not engaged. The maximum penetration (26 inches) occurred at the lower right corner of the left front door.

<u>Case Vehicle</u>	<u>Other Vehicle</u>
CDC	10 LYEW 4	Unknown
Delta-V's	Not Computed	Not Computed

Left front door impacted. Latch and hinge damage. No release. No separation. Door did not open. No ejection. Intrusion--Left front and left rear door area panels, A- and B-pillars and window frame. Maximum intrusion of 11 inches (left front panel). Intrusion probably not a factor.

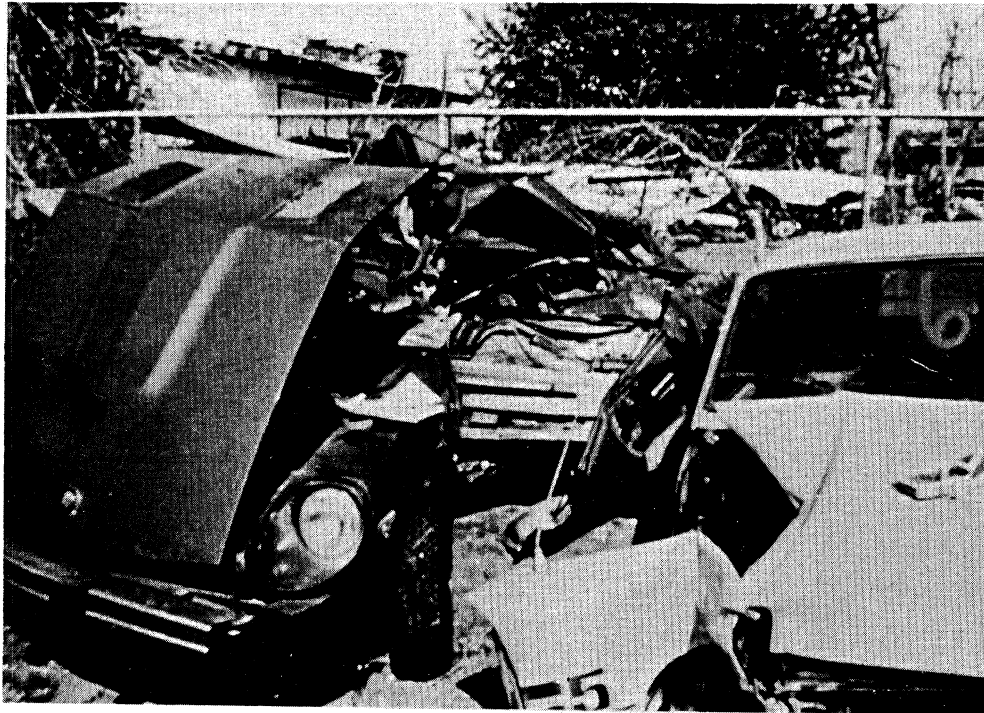
1978 Datsun 280Z, 2-door with B-pillar was entering a rest area (at high speed) and slid into the right rear corner of a parked Semi-trailer. The initial impact was in the left front door. The sill was engaged less than the full amount. The roof rail was engaged fully. The maximum penetration was 35 inches (left front door).

<u>Case Vehicle</u>	<u>Other Vehicle</u>
CDC	10 LZAW 5	Unknown
Total Delta-V	38 mph.	Unknown
Long. Delta-V	+05 mph.	Unknown
Lat. Delta-V	+38 mph.	Unknown

Latch and hinge damage. Latch released, no hinge separation. Doors did not open, no ejection. Intruding components: A- and B-pillar, left front door, window frame and roof side rail. Maximum intrusion of 23 inches (rail). Intrusion was a factor.

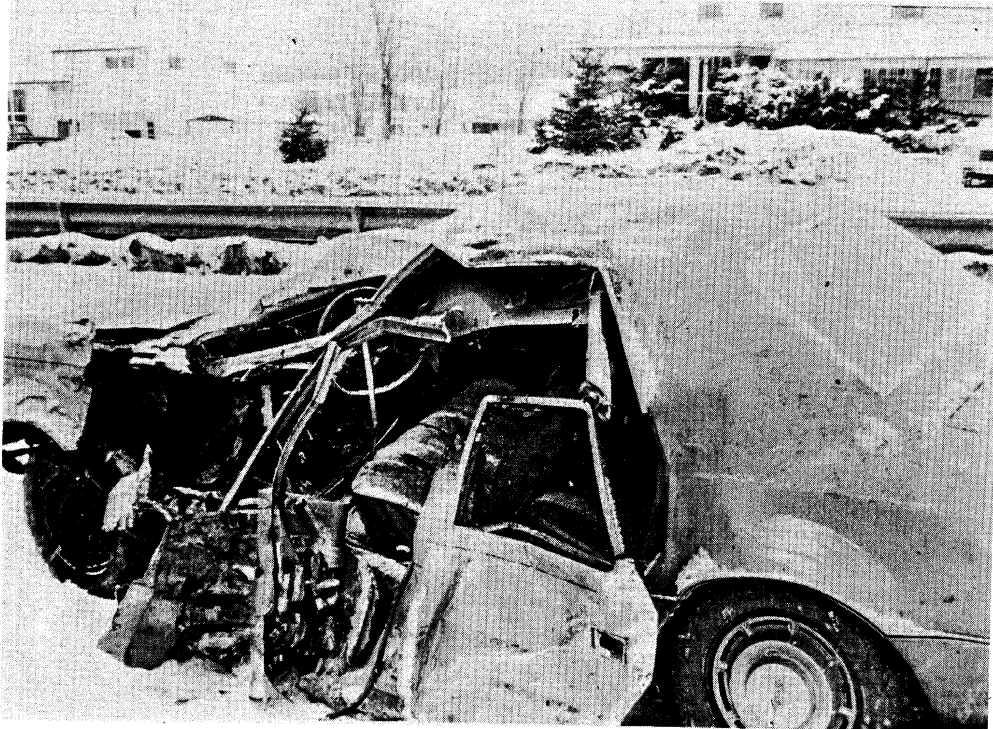
1973 AMC Hornet 4-door with B-pillar was struck by a White Freightliner. The tractor-trailer had jackknifed in such a manner that the trailer was still aligned with the roadway and the tractor was at right angles to the on-coming traffic. The unit was still sliding in the original direction of travel when it struck the case vehicle in the left side. The case vehicle was pushed backwards approximately 60 feet where it struck a guard rail with the right rear corner. The case vehicle then rolled over.

<u>Case Vehicle</u>	<u>Other Vehicle</u>
CDC	11 LYAW 4	03 RFEW 4
Delta-V's	Not Computed	Not Computed

Both left doors damaged by direct contact. Left front door--latch damage and release, hinge separation. Left front door ripped off. Left rear door--latch damage and release. Ejection through left front door. Intrusion--A- and B-pillars, both door panels, both window frames, and roof side rail (left front door panel). Maximum intrusion of 20 inches (left front door panel). In the initial impact, the roof side rail and the door sill were engaged less than the full amount. Intrusion probably a factor.

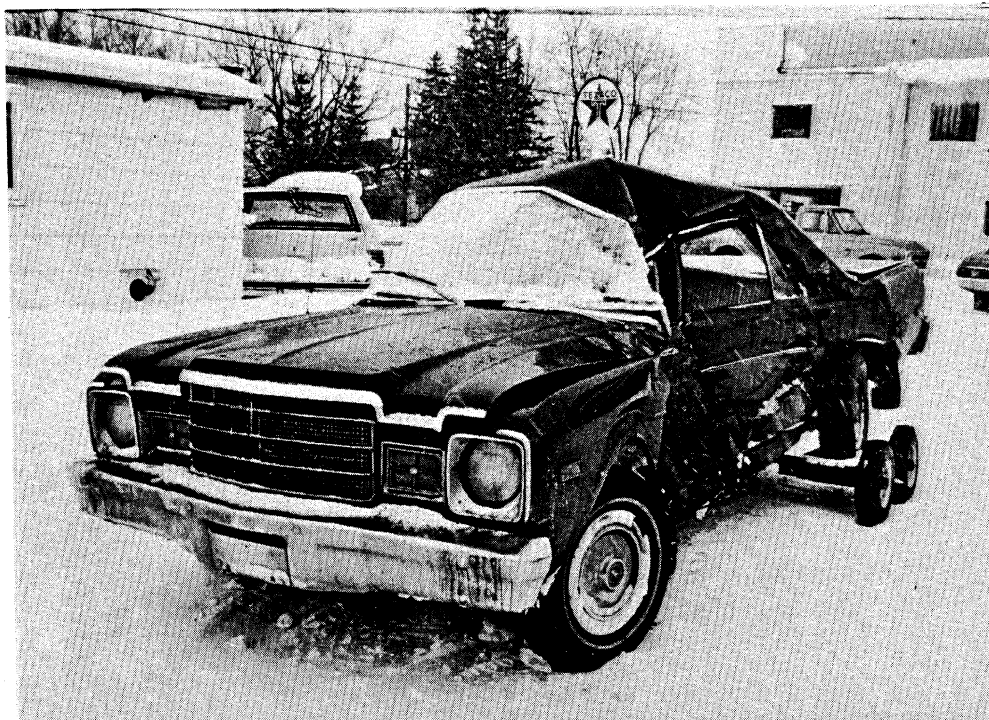
1975 Plymouth Volare 4-door with B-pillar was struck in the left side by a Ford Tractor-Semitrailer. Both left doors received direct damage. The door sill and the roof side rail were engaged less than the full amount.

<u>Case Vehicle</u>	<u>Other Vehicle</u>
CDC	09 LDAW 4	12 FDEW 1
Delta-V's	Not Computed	Not Computed

Both left doors impacted. Both with latch and hinge damage. None opened. Maximum penetration of 33 inches (upper right corner, left front door). Intrusion A-, B-, and C-pillars, both door panels, window frames and roof side rail. Maximum intrusion--13 inches (B-pillar). No ejection. Intrusion probably did not increase severity of injuries.

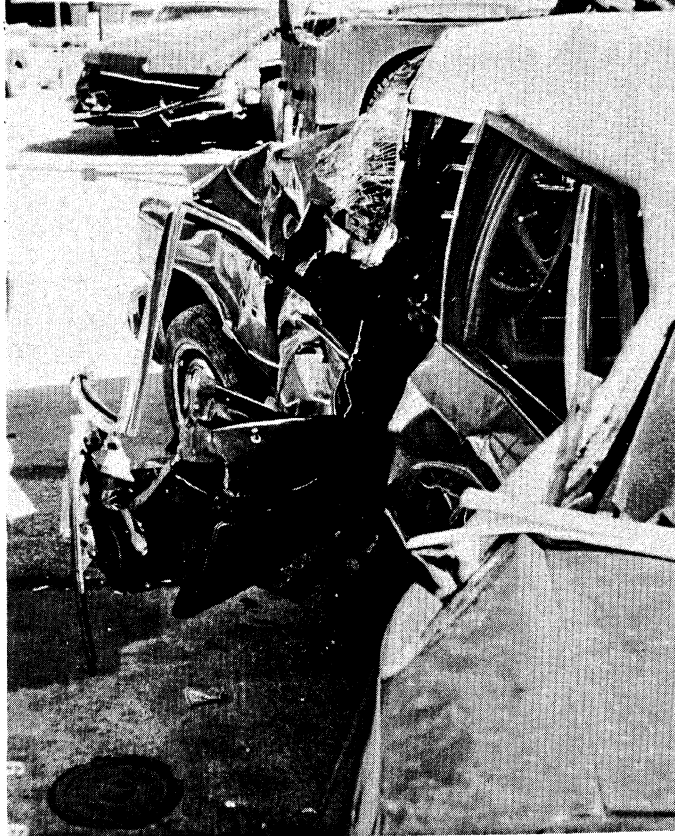
1976 Buick Le Sabre 4-door with B-pillar was struck in the left side by a GM locomotive. The damage extended from the front fender to the rear door. The maximum penetration was 37 inches (center at front door).

<u>Case Vehicle</u>	<u>Other Vehicle</u>
CDC	9 LDAW 4	Unknown
Delta-V's	Not Computed	Not Computed

The hinges and latches on both left doors were damaged. There was no separation. The doors did not open. No ejection. Left front door intruded 37 inches. Driver's legs pinned between door and seat. Driver's feet pinned against foot controls. Other intrusion--left rear door, A-, B-, and C-pillars, window frame, roof rail. Intrusion a factor.

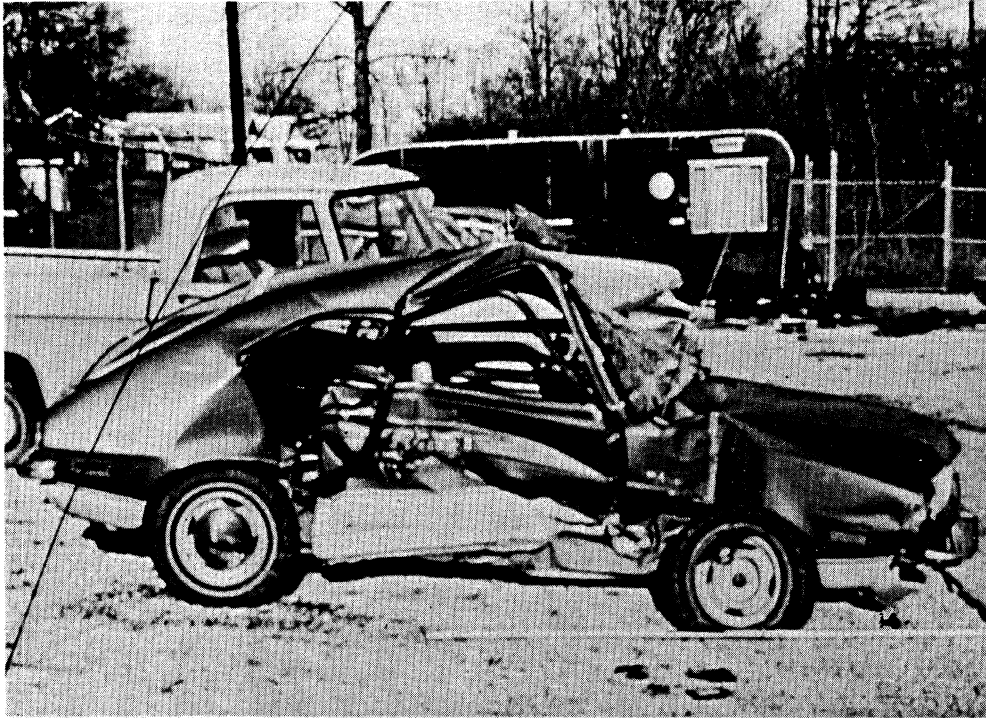
1973 Ford Pinto, 2-door hatchback with B-pillar was struck on the right side by a locomotive. The damage extended from the front of the vehicle to the rear window. Maximum penetration of 30 inches (just above sill at the front edge of the door). The sill was engaged less than maximum. The roof rail was not engaged.

<u>Case Vehicle</u>	<u>Other Vehicle</u>
CDC	02 RVEW 4	Unknown
Delta-V's	Not Computed	Not Computed

Right front door impacted. Latch and hinge damage. Door did not open. No ejection. Intrusion--Both right door area panels, A-, B-, C-pillars, front window frame, roof side rail (induced). Maximum intrusion of 26 inches (right rear door area). Intrusion may have been a factor.

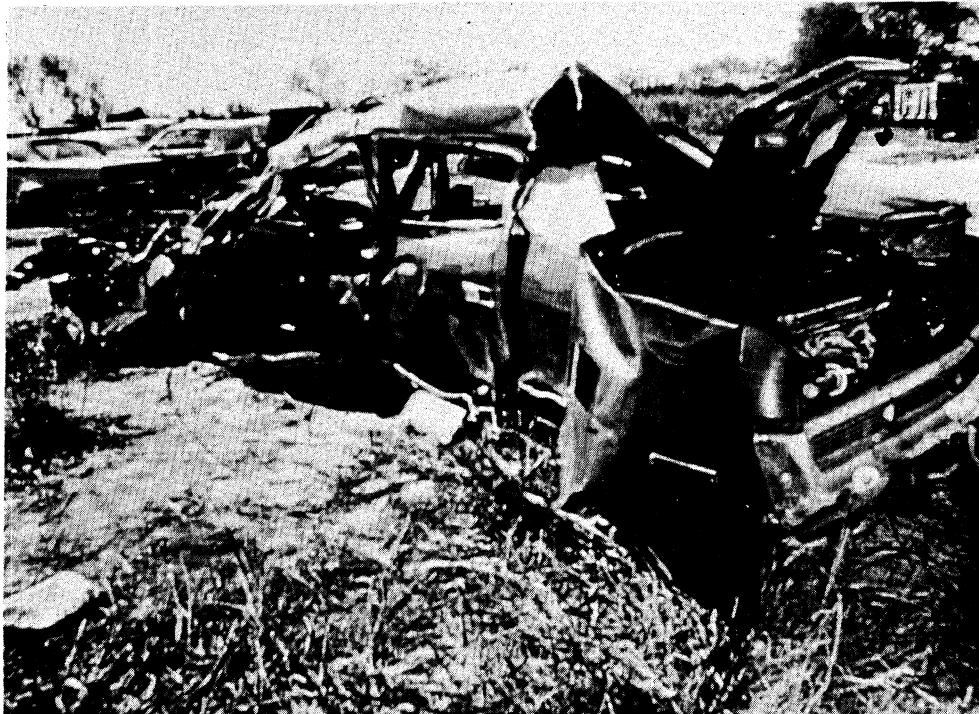
1973 AMC Ambassador 4-door with B-pillar was struck in the left side by a locomotive. The damaged area extended from the front of the vehicle to approximately the rear wheel. Both sill and roof rail were engaged less than the full amount. The maximum penetration was 37 inches at the left front door.

CDC (Case Vehicle) 09 LDAW 6
Delta-V's Not Computed

Both left doors had latch and hinge damage. No hinge separation. None opened. No ejection. Intrusion included, left front door panel, A- and B-pillar, window frame, roof side rail. Maximum intrusion of 31 inches (left front door panel) (No information on intrusion of left rear door panel.)
