SEMI-ANNUAL PROGRESS REPORT

SHOCK ON ELECTRICAL COMPONENTS IN
TRACK LAYING AND WHEELED VEHICLES

Project 2145

DETROIT ARSENAL, U.S. ARMY
CONTRACT NO. DA-20-089-ORD-36543

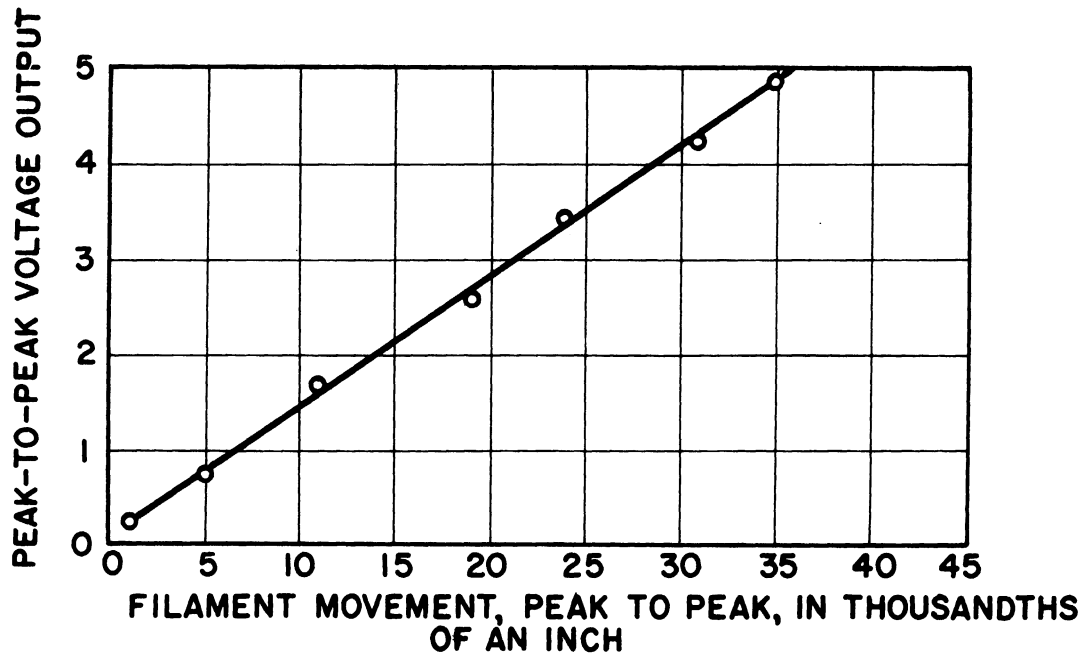
Figure 2 shows the operating circuit. The number of electrons reaching the anode per second will, of course, be a function of the voltage gradient between the anode and the hot filament. This in turn is a function of the separating distance. As the filament vibrates, the variations in current collected by the anode are converted into output-voltage variations which can be observed on an oscilloscope. Figure 3 shows the performance of a typical lamp.

Fig. 3. Calibration Curve for No. 66 Special 2416 Indicator Lamp.

Calibration is accomplished in the following manner:

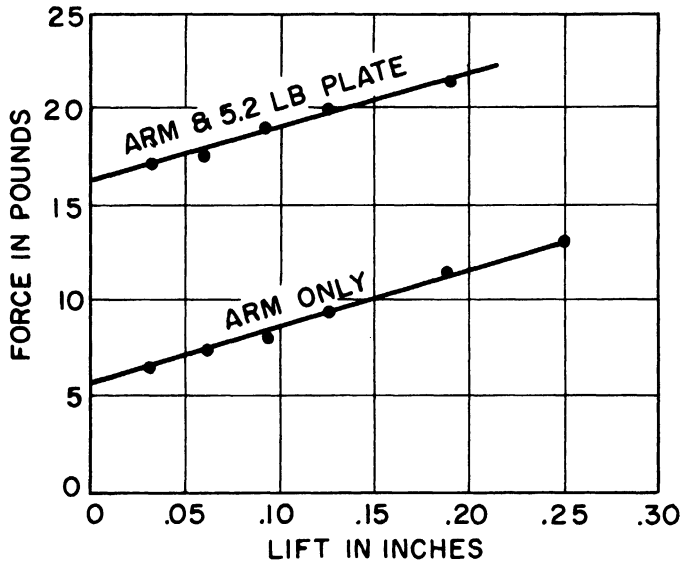
b. New Elastic Hinge 0.050 in.

The amount of force needed to separate the anvils was determined in the same manner as before, using new elastic hinges of two thicknesses. Figure 8b shows the results obtained for an elastic hinge of 0.050 inch thickness, and Figure 8c for the 0.0815 inch hinge.

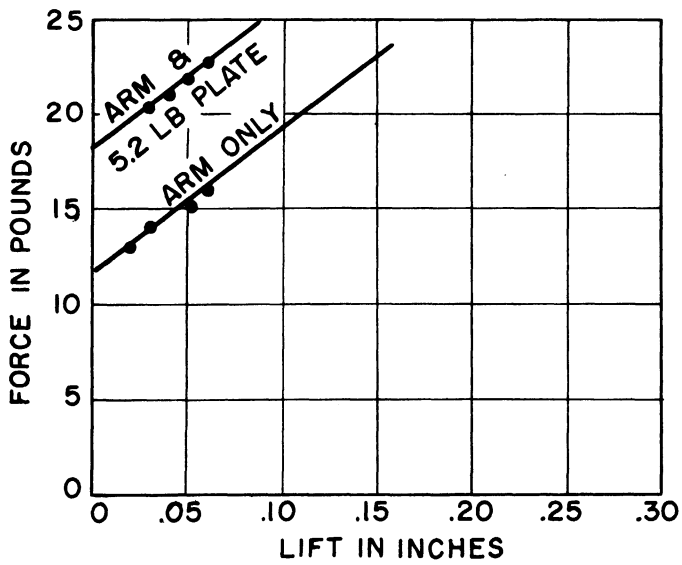
c. New Elastic Hinge 0.081 in.

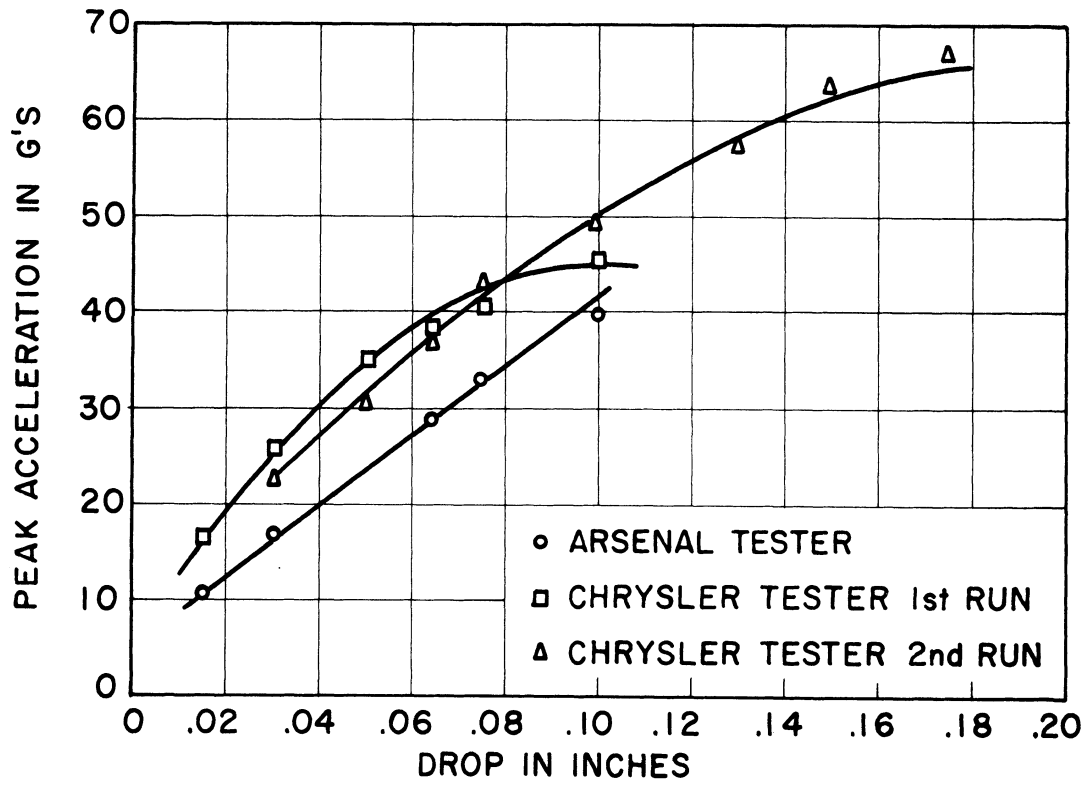
Fig. 10. Comparison of Single Anvil Drops Between the Arsenal Impact Tester and the Chrysler Impact Tester.

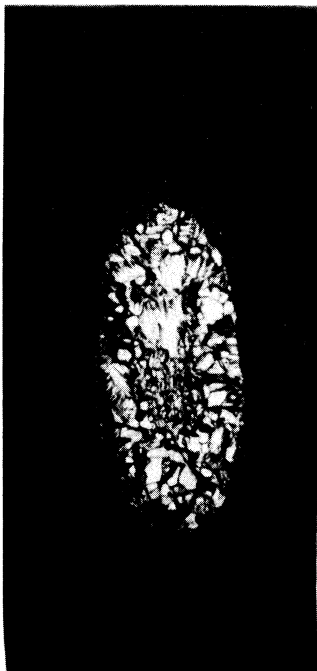
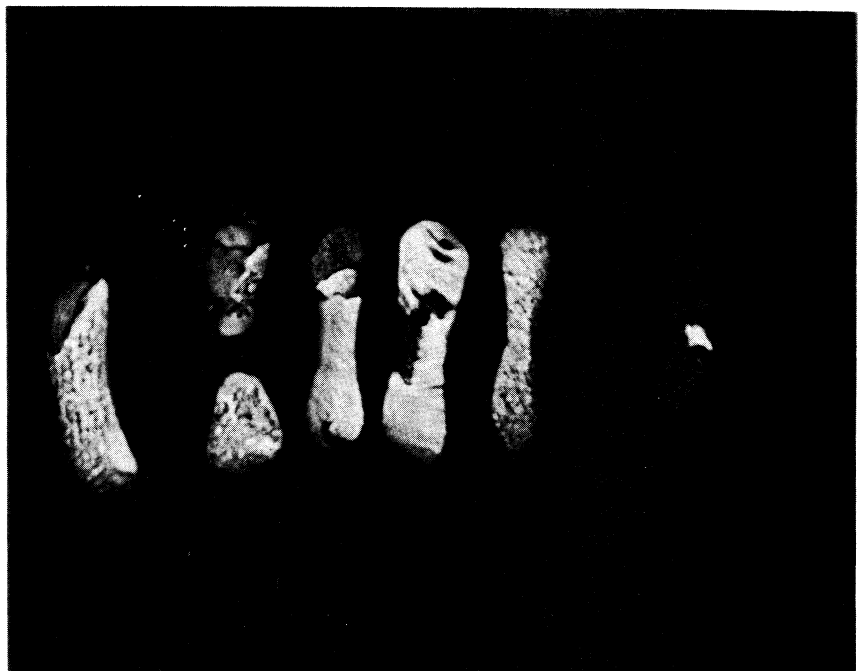
Fig. 24

When a metal reaches the recrystallization temperature, new, unstressed grains start to form which eventually grow and replace the cold-worked structure. This recrystallization temperature is affected by the degree of cold-work, composition (additions), and time. It can vary from 800°C for pure tungsten to over 2000° for tungsten which contains large amounts of alumina and thoria. If a metal is either held at the recrystallization temperature for a long time or heated to higher temperature, some of the small grains will grow at the expense of others (the process of grain growth) and the structure becomes more coarse as in Figure 24c.

Figures 24b and 24c can be termed annealed structures. Unlike most metals, tungsten at room temperature is very brittle in the annealed condition. This means that the structures illustrated by Figures 24b and c, which are considered desirable in most metals become very detrimental in the case of tungsten as far as resistance to fracture is concerned. The fractures that occur are intercrystalline, that is to say, the fractures occur along grain boundaries. This means that a structure that has a grain-boundary path that runs directly through the whole cross-section of the wire will be very susceptible to fracture. A structure that is fine grained has an easy path of fracture (Figure 25a) as does one in which the grains occupy the whole cross-section of the wire (Fig. 25b). A structure similar to that in Figure 25c would be preferable. The cold-worked structure is, of course, much better than any one of the structures above.

a. Cold-worked Structure. (250X)

b. Fine-grained Structure. (250X)

c. Coarse-grained Structure. (250X)

of Figure 24b. Several samples which exhibited cold failures were mounted and polished so that the structure at the fracture could be observed (Figure 28). The metallographic procedure is outlined below.

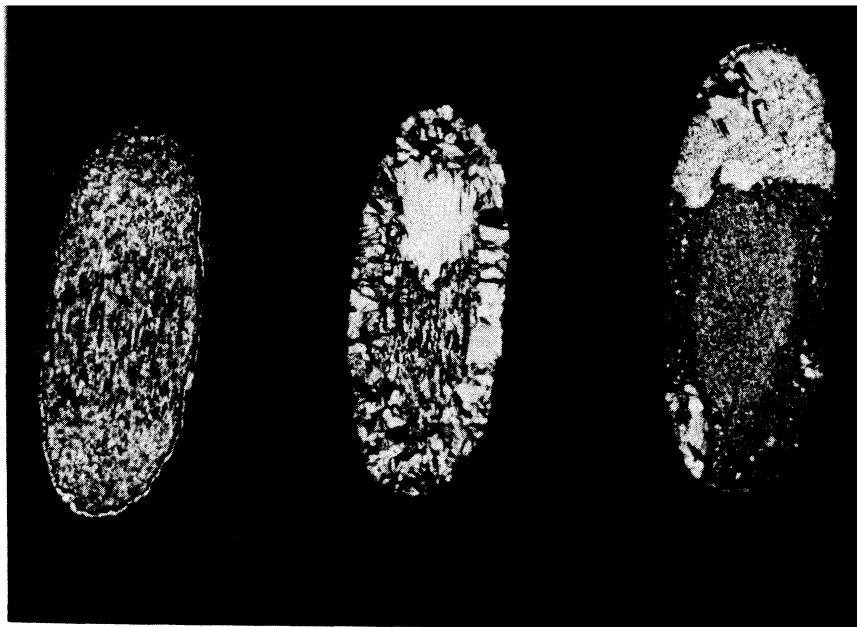
Fig. 27. Three Successive Primary Turns of A Filament after Showing Cold-worked, Fine-grained, and Coarse-grained Structures. (250X)
