Final Report

FEASIBILITY OF THIN-FILM ELECTRON MICROSCOPY FOR STUDY
OF FINE DEFECT STRUCTURE IN STEEL AFTER LOW CYCLE FATIGUE

D. K. Felbeck
Department of Mechanical Engineering
College of Engineering
The University of Michigan

March 1964

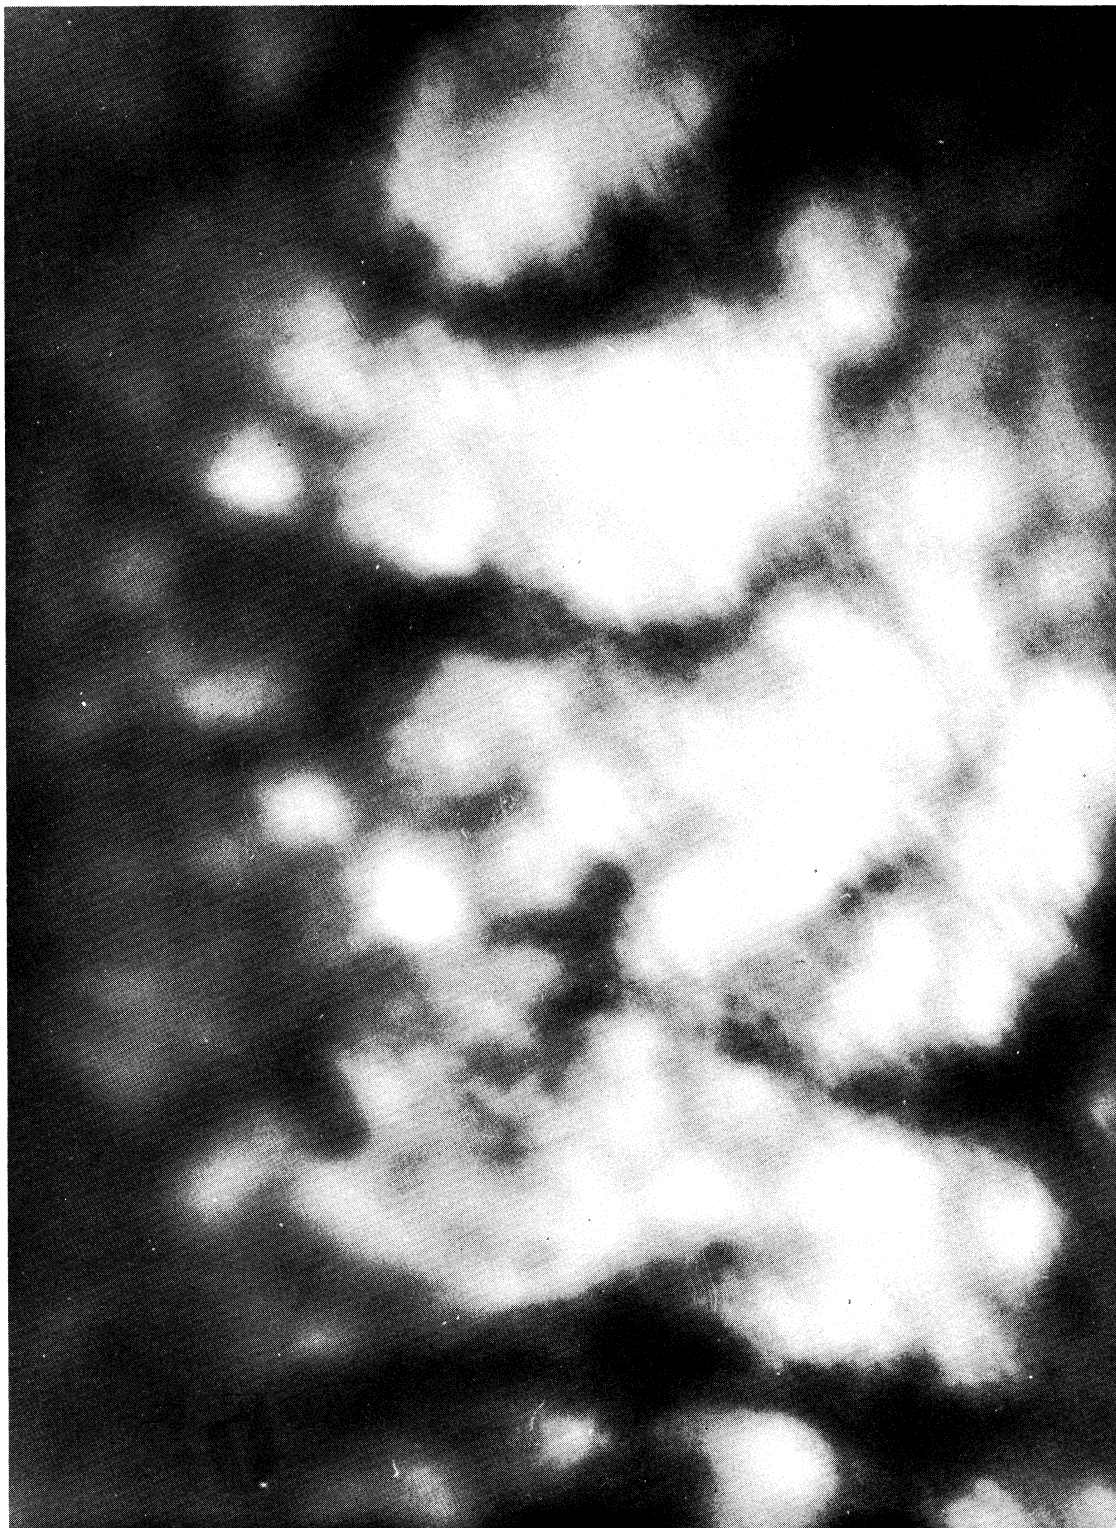
Fig. 2. Specimen RC-21, 0.02 in. from fracture surface. 48,000x.

Figures 2 to 4 show several regions, all from the area close to the fracture region, about 0.02 in. from the fracture surface of specimen RC-21. The aggregation of imperfections into a kind of coarse network is shown in Fig. 2. A very fine, dense network of dislocations has developed in the region of Fig. 3. Figure 4 shows a fine network of dislocations, more dense than in the non-fracture specimen of Fig. 1. In addition, Fig. 4 contains a sub-grain boundary which is apparently the result of localized dislocation tangles of much higher density than in either Fig. 1 or 3.
