TRI-LEVEL ACCIDENT  
INVESTIGATION STUDY

JULY 31, 1973  
FINAL REPORT  
VOLUME I

1. Report No		2. Government Accession No		3. Recipient's Catalog No	
4. Title and Subtitle <b>Tri-Level Accident Investigation Study Volume 1, Final Technical Report</b>				5. Report Date

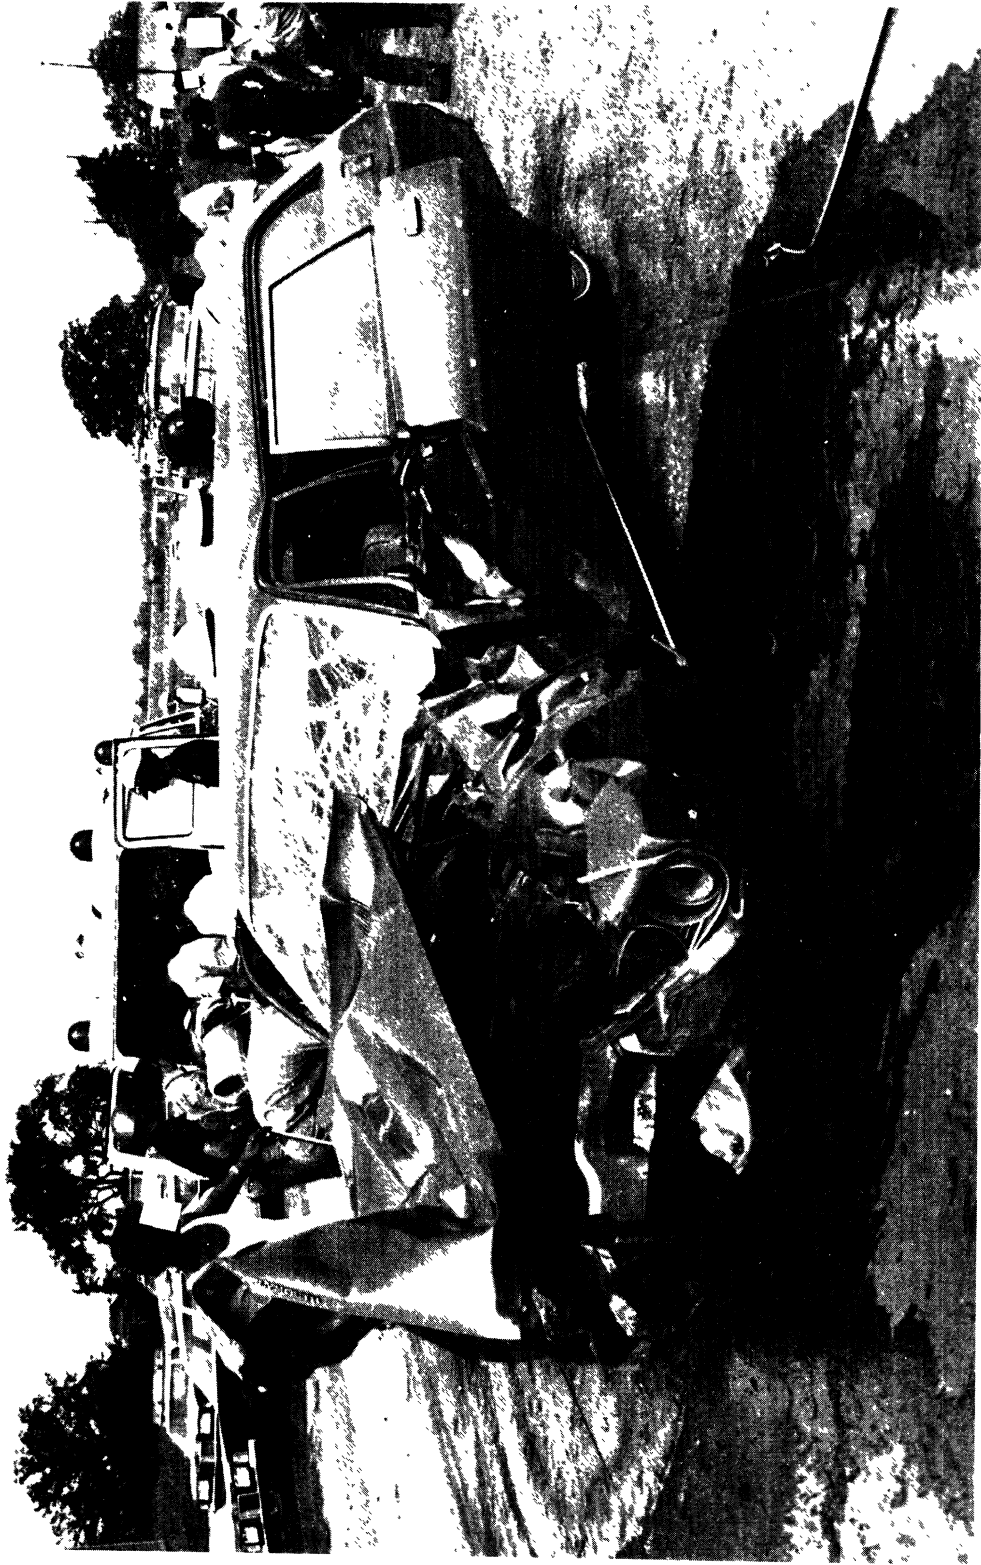
Figure 9.2-1. Absence of median barrier permitted vehicle to cross into on-coming traffic.

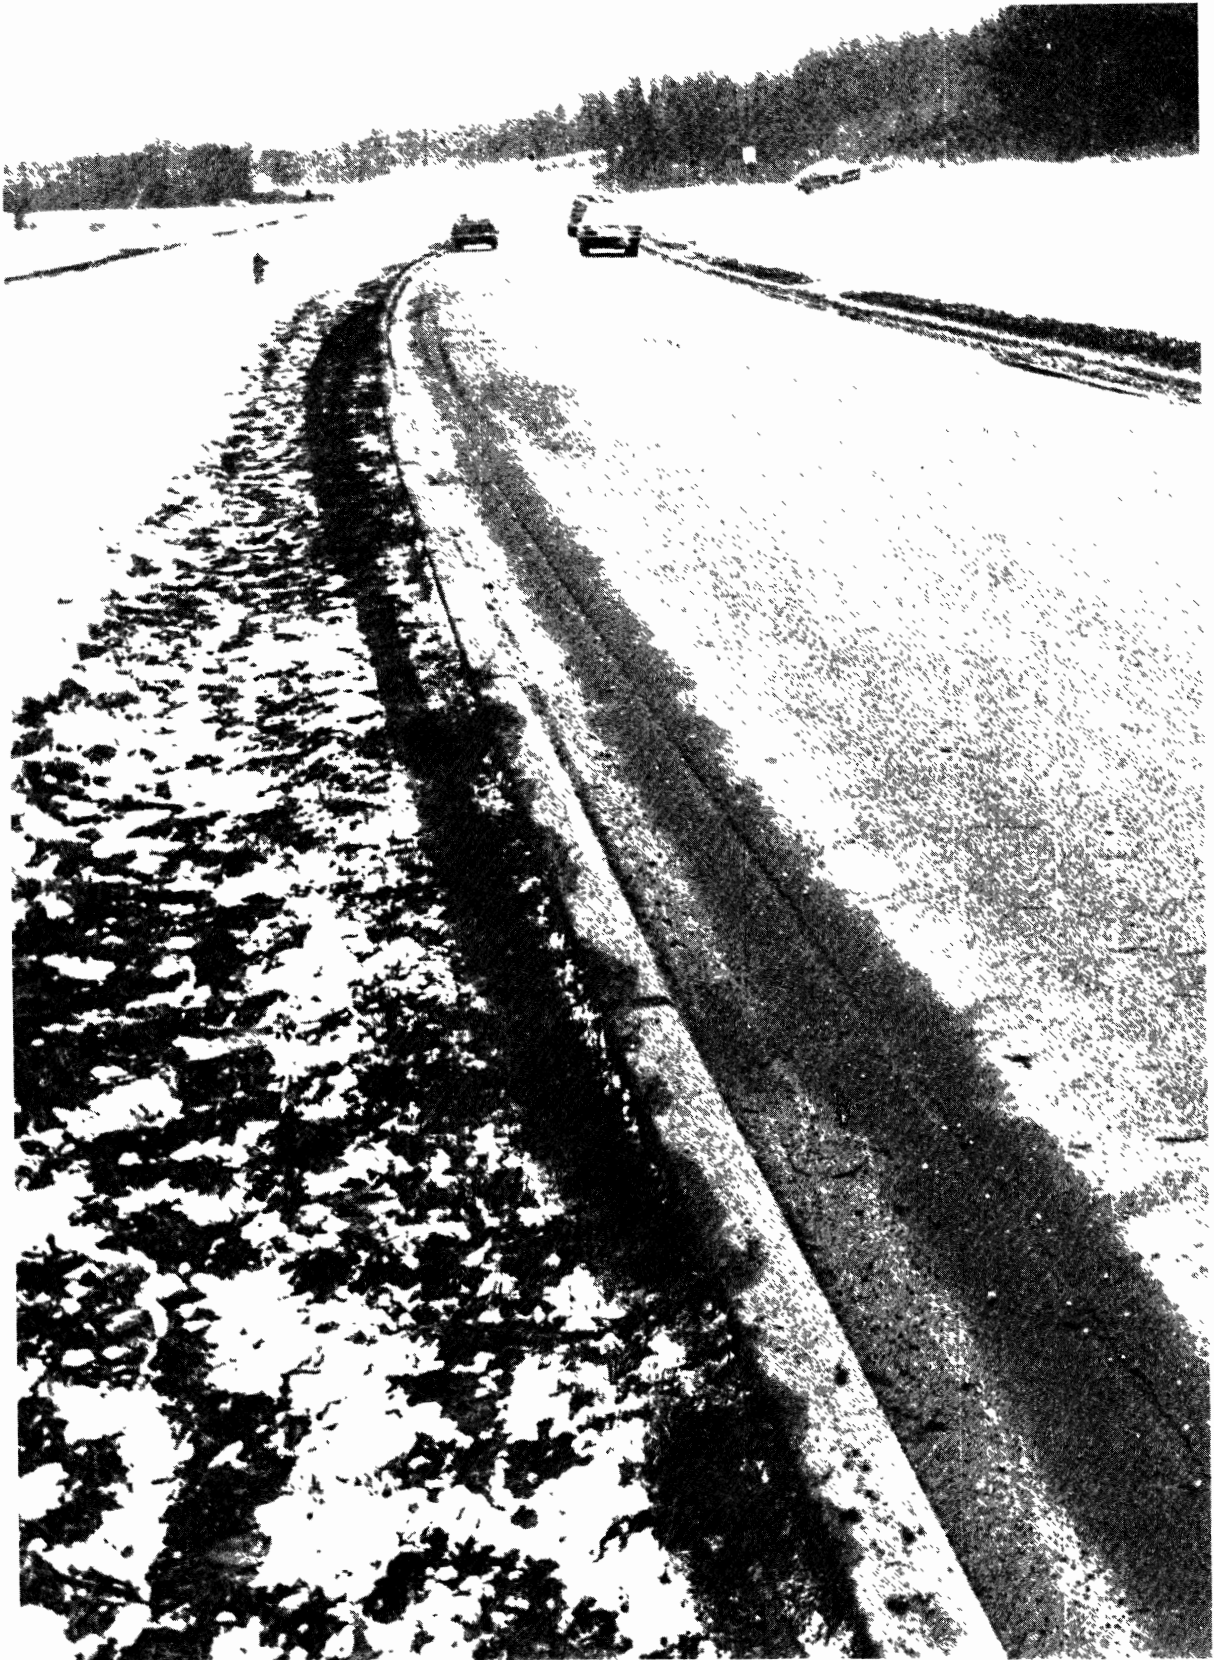
3. A recently constructed urban parkway was built to modern standards. In Case AA344, an out-of-control vehicle left the roadway and decelerated on an appropriately designed upslope that had been cleared of trees to the desirable distance of 30 feet from the roadway. The decelerations experienced were low and the severity was low. Interestingly, an element contributing to the loss of control was the presence of a fire hydrant in the median close to the end of the pavement which the driver was trying to avoid. However, this fire hydrant, unknown to the driver, was of the break-away design.

Figure 9.2-2. Path of Pinto that left roadway of urban parkway. Vehicle is in final resting position on right upslope of bank. (AA 344).

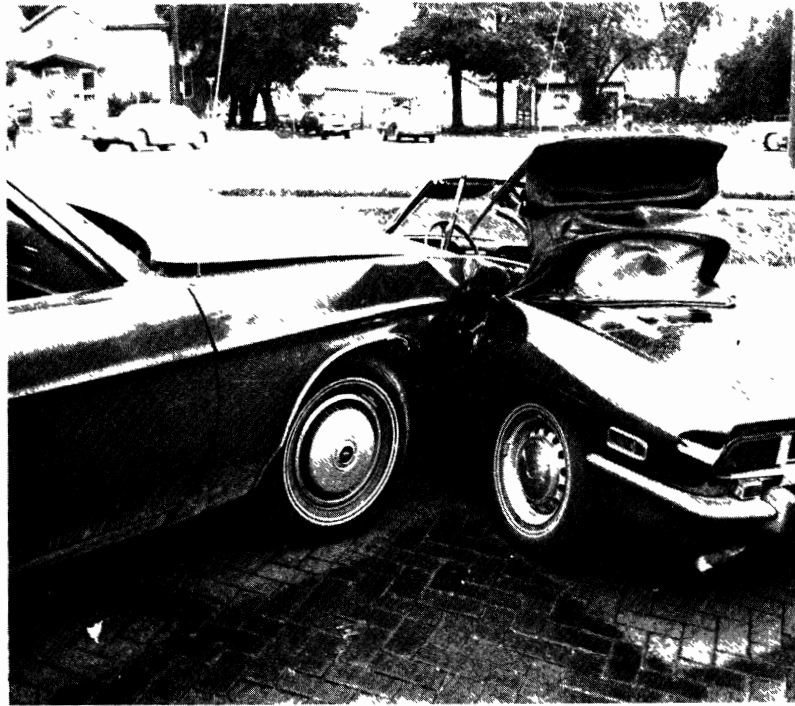
Figure 10.1-1: 1969 Fiat impacted in left side by 1971 Ford station wagon. AA 304.

stressed more to the motoring public." Other illustrations of crashes between dissimilar size vehicles are shown in Figure 10.1-1 and 10.1-2.

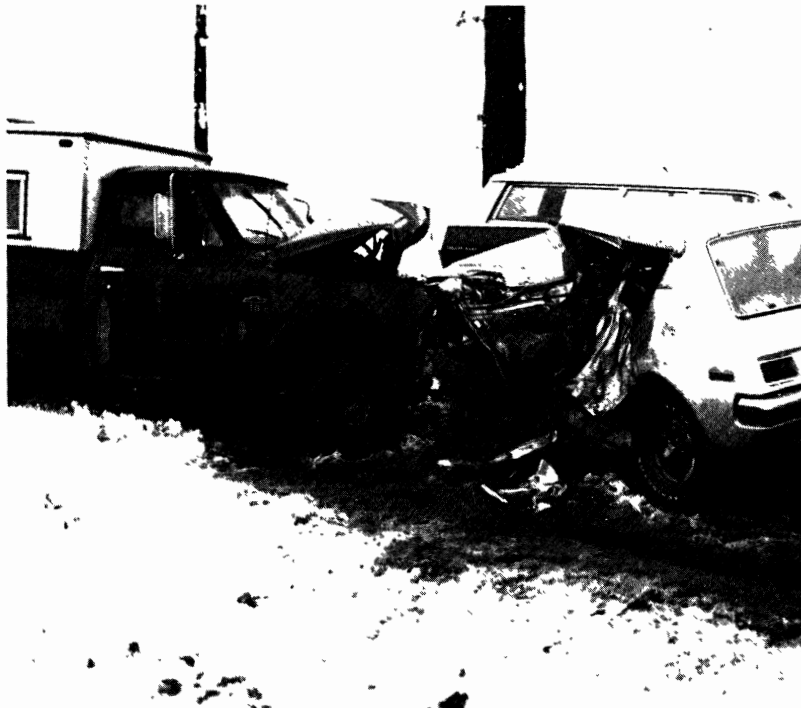
Figure 10.1-2: Gremlin impacted by full-size pickup truck.

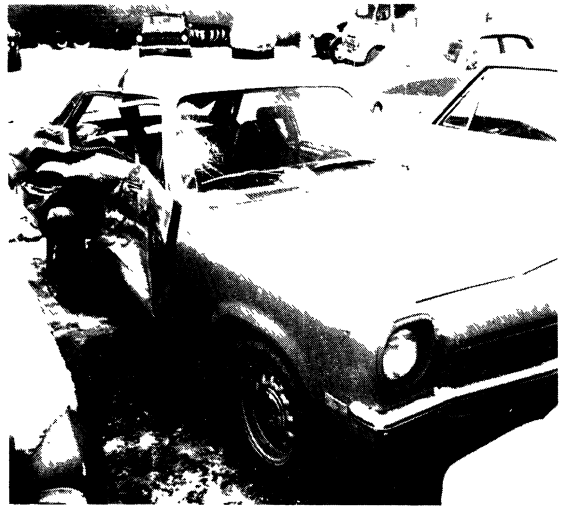
Figure 10.3-2. 1971 Chevrolet Vega

The 1971 sub-compact Chevrolet Vega in Figure 10.3-2 was also equipped with "side guard beams", and was struck broadside at 10.mph impact velocity by a Chevrolet pickup truck. Maximum crush was 13 inches at the B-pillar. The driver and right front passenger, both unrestrained, sustained minor injuries. The right rear unrestrained passenger received a severe concussion from contact with the B pillar (AIS-05, critical, survival uncertain).

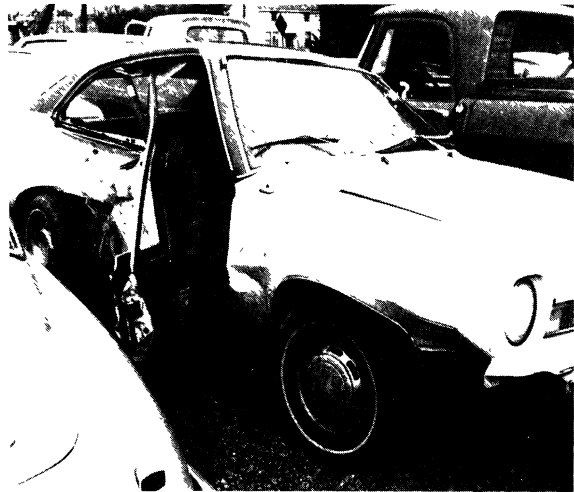
Figure 10.3-3. 1973 Ford Pinto

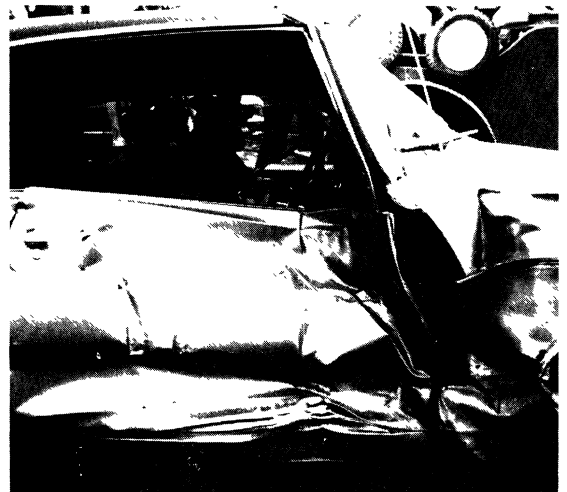
Figure 10.3-4. 1969 Chevrolet Impala

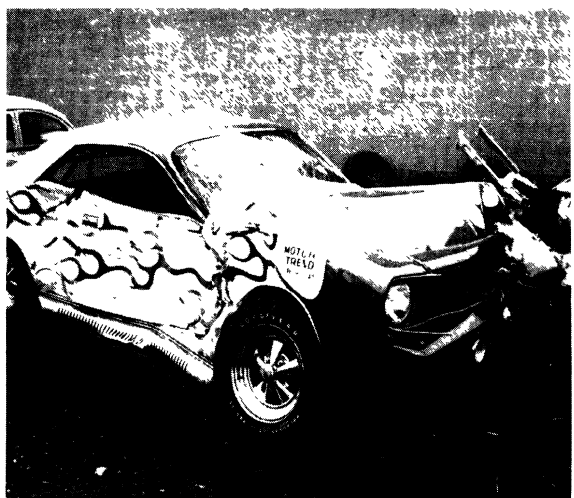
Figure 10 3-5 1970 Plymouth Barracuda

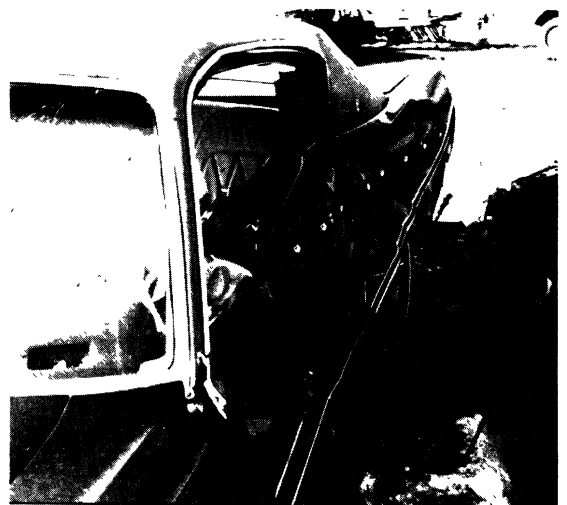
Figure 10 3-6 1972 Plymouth Gran Coupe

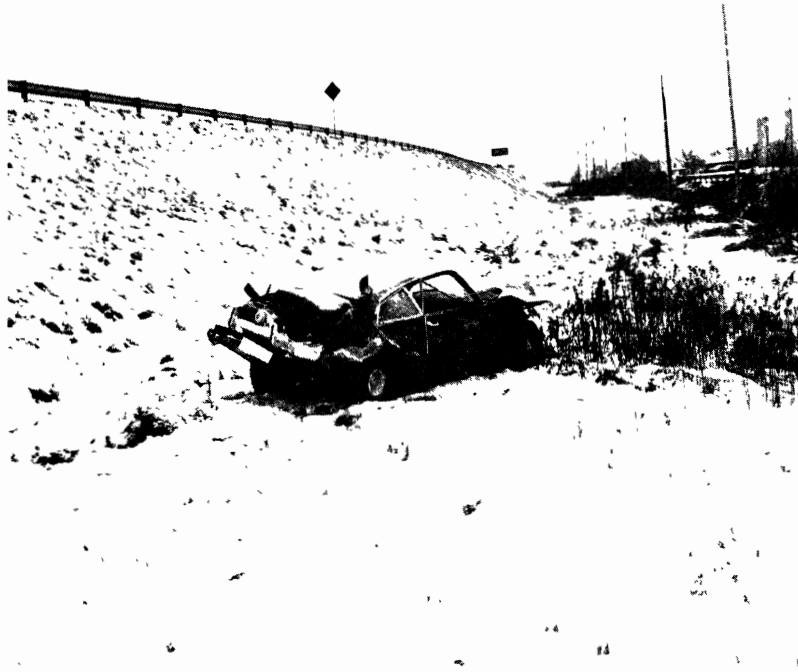
Figure 10.5-1: Final resting position of maverick. (AA 328.)
