T H E U N I V E R S I T Y O F M I C H I G A N  
COLLEGE OF ENGINEERING  
Department of Civil Engineering

Interim Report

EFFECTS OF FOREST CLEAR-CUTTING ON THE STABILITY OF NATURAL SLOPES:  
RESULTS OF FIELD STUDIES

Donald H. Gray

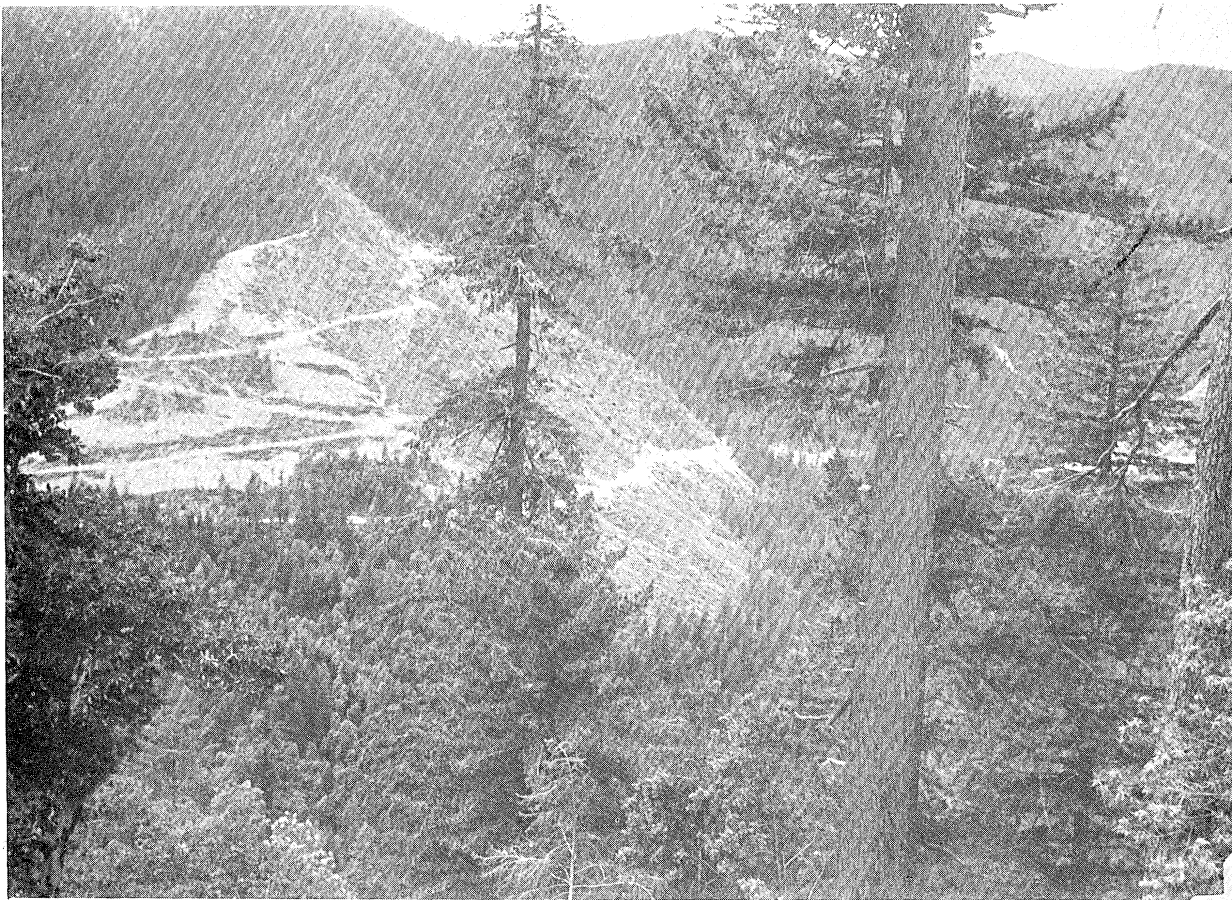
Figure 1. View of clear-cut site, Happy Camp Ranger District, Klamath National Forest.

with deforestation; the two are virtually synonymous when clear-cutting is carried out in mature, even age stands of timber. Evidence of this fact is visible in many clear-cut sites in Washington, Oregon, and California. Figure 1 is a photograph of only one of several clear-cut sites observed by the author—illustrating complete denudation.

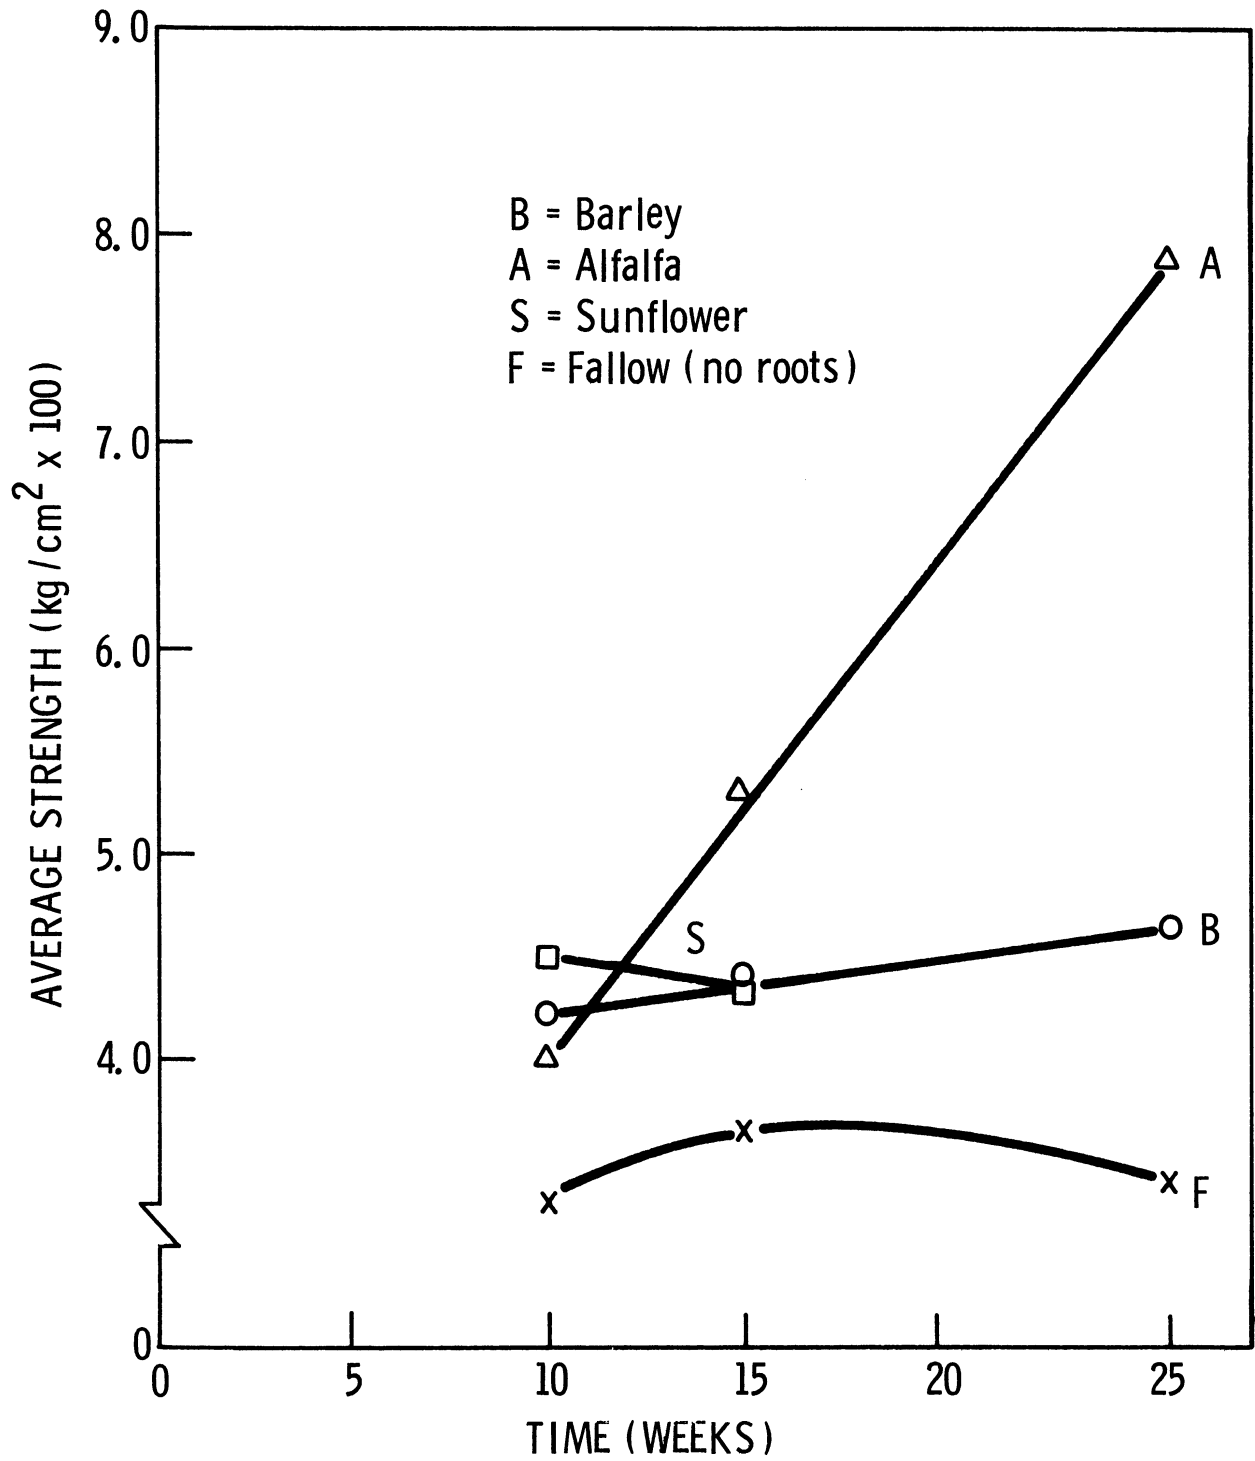
Figure 5. Variation of peak strength with time at 6-inch depth for soil containing roots of various plants (after Manbeian, 1973).

Only the effects of herbaceous plant roots (alfalfa, barley, and sunflower) were investigated. Manbeian's results showed that both peak and residual shear strength were generally increased by as much as 2 to 4 times, respectively, in soil specimens containing roots. Typical results are shown in Table 1 and Figure 5. Strength increases reported by Manbeian in this case

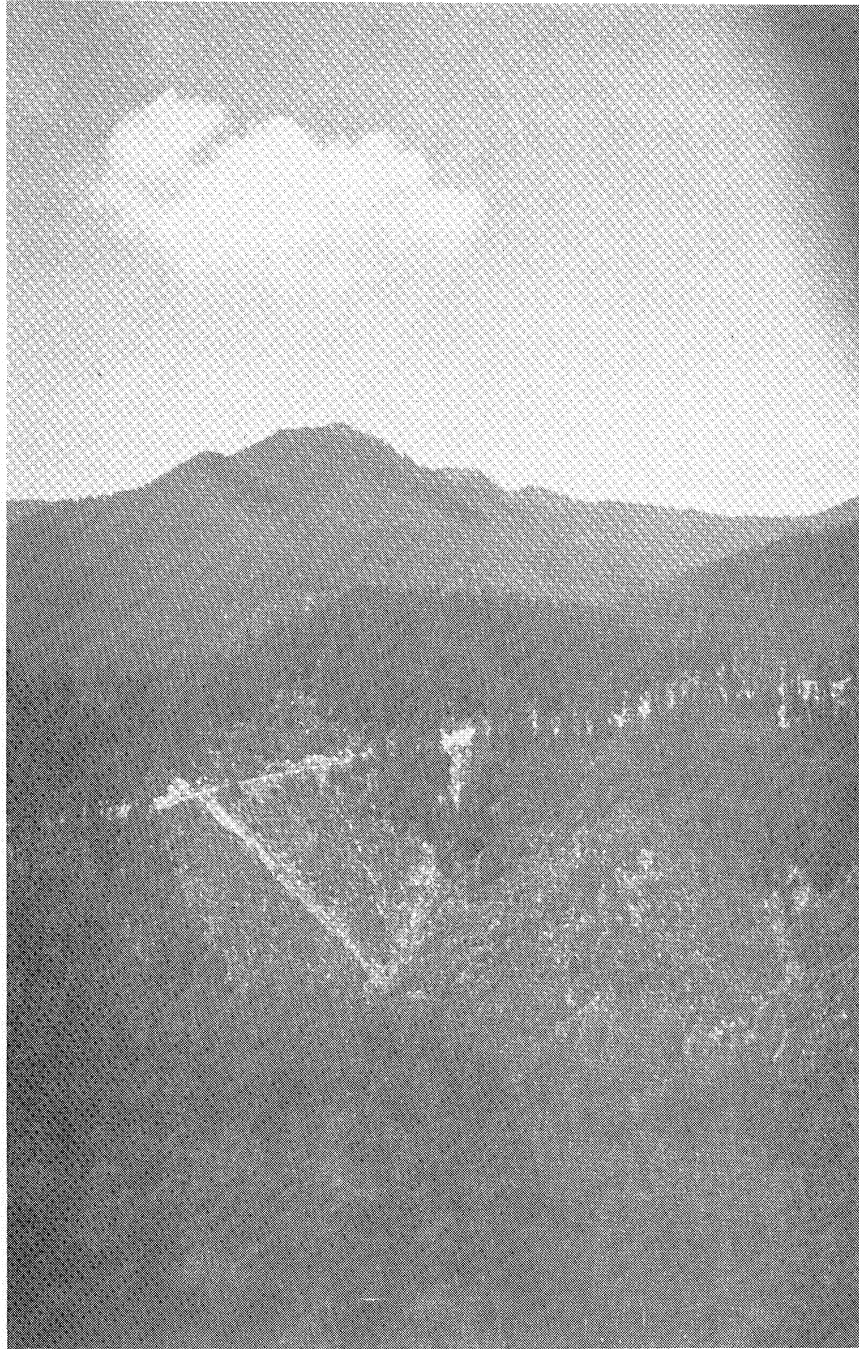
Figure 16. Earth flows in a "logged" and "roaded" slope, H. J. Andrews Experimental Forest.

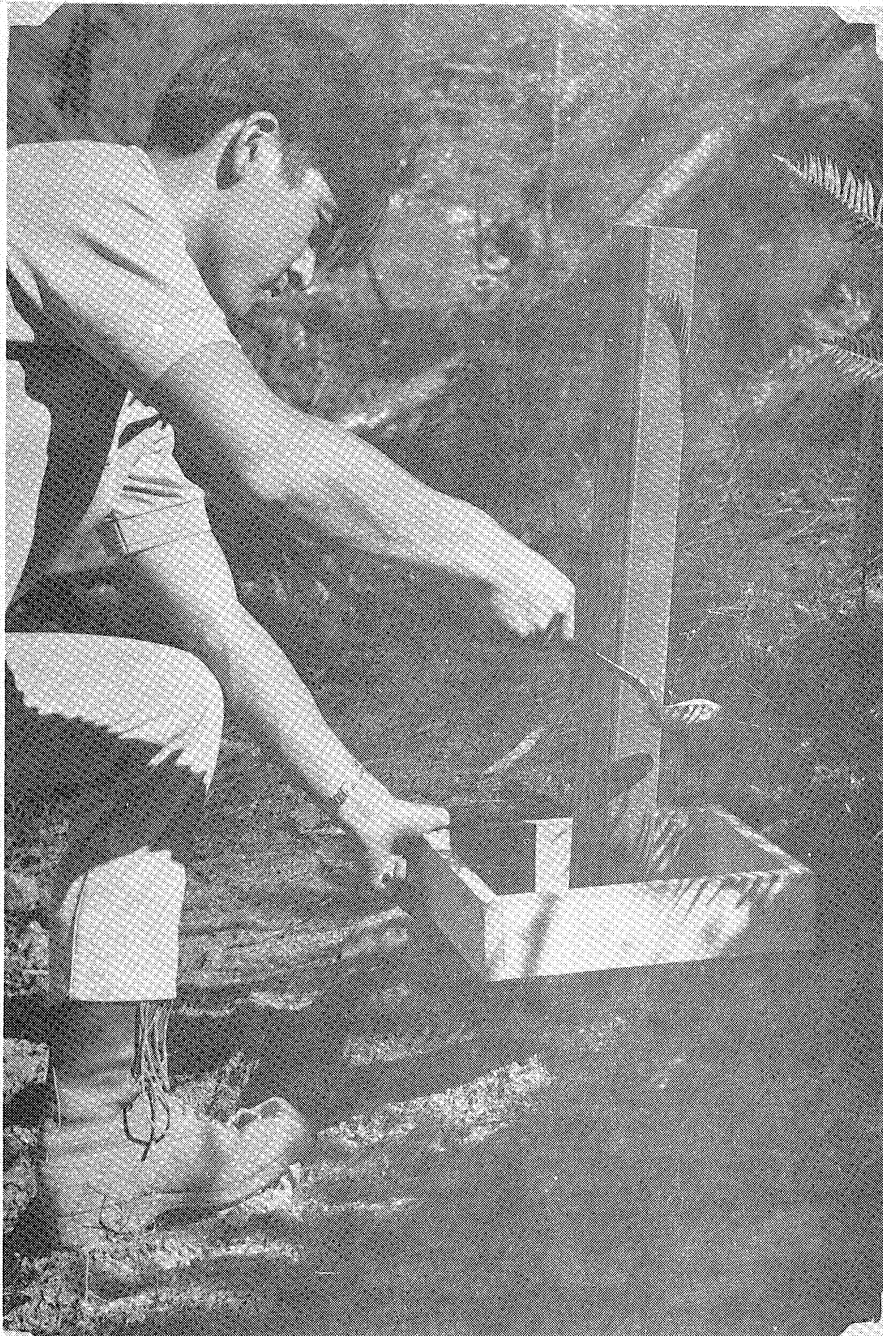
Figure 23. Backfilling around slope indicator casing using the "single grain air dropping" technique.

By using a so-called single grain, air dropping technique it was possible to obtain a backfill with a minimum void ratio (or maximum relative density) which completely occupied the annular space and which could deform, but not compress. This technique of backfilling is one recommended by the manufacturer of the Slope Indicator. It is also a technique of depositing dry sand which has been investigated extensively in the Soil Mechanics Laboratory at The University of Michigan and which has been found consistently and reliably to give minimum void ratios. 'Single grain air dropping' and minimum void ratios can be achieved in the field by raining a uniformly graded, dry sand through a

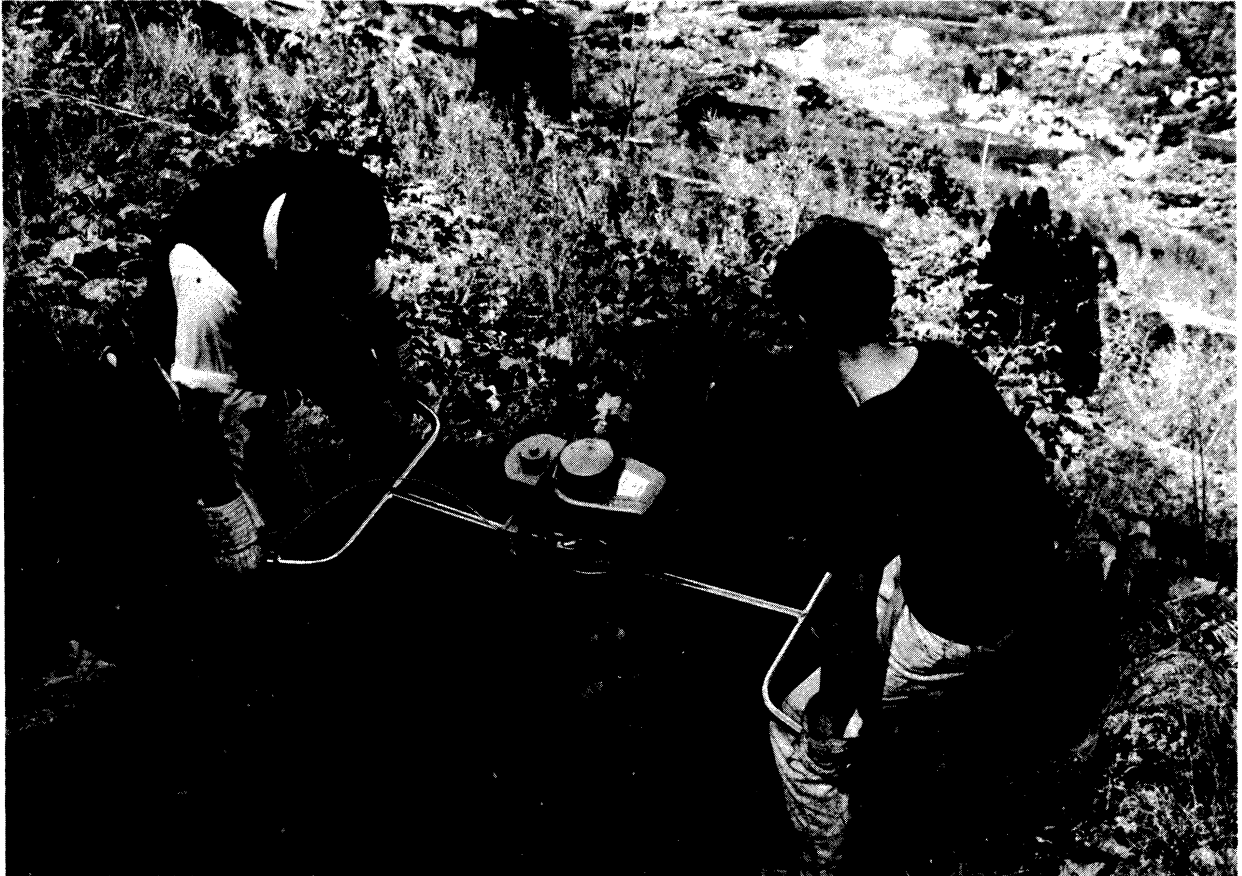
Figure 24. Drilling a hole for a slope indicator tube using a portable, power auger.

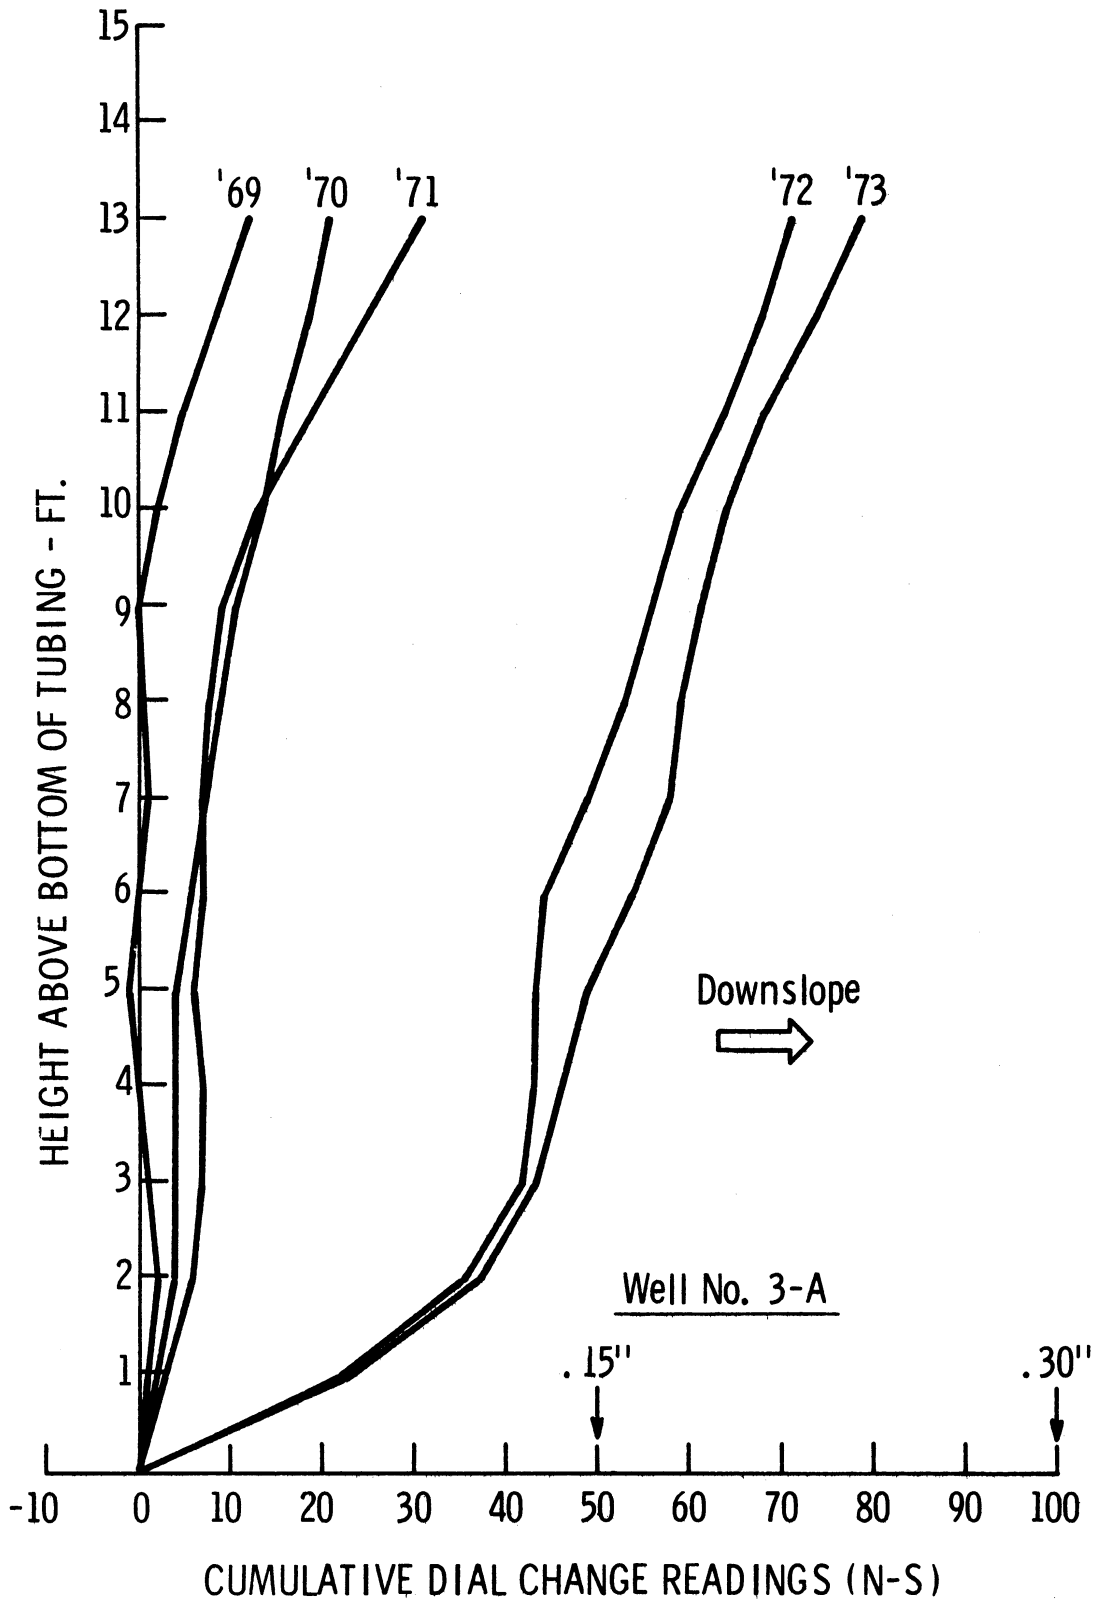
Figure 36. Creep profiles, Watershed No. 1 (clear-cut), H. J. Andrews Experimental Forest.

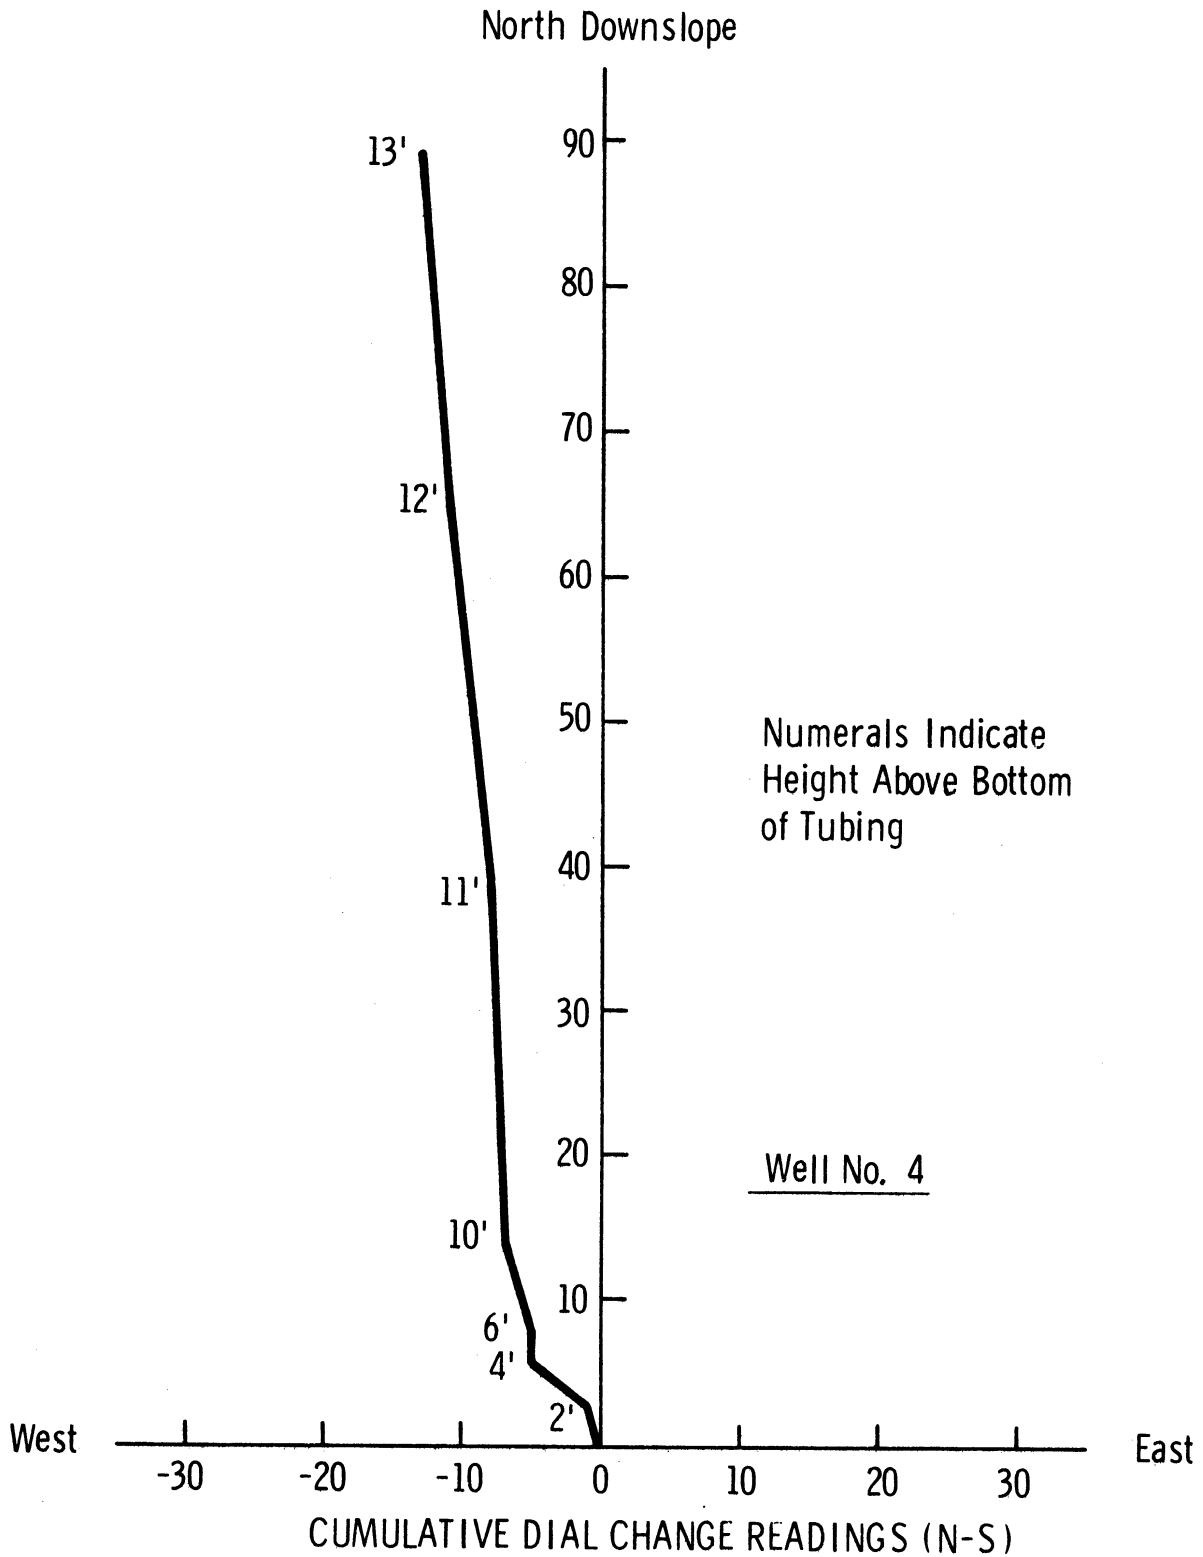
Figure 39. Polar diagram of total creep movement (1973), Watershed No. 10 (forested), H. J. Andrews Experimental Forest.

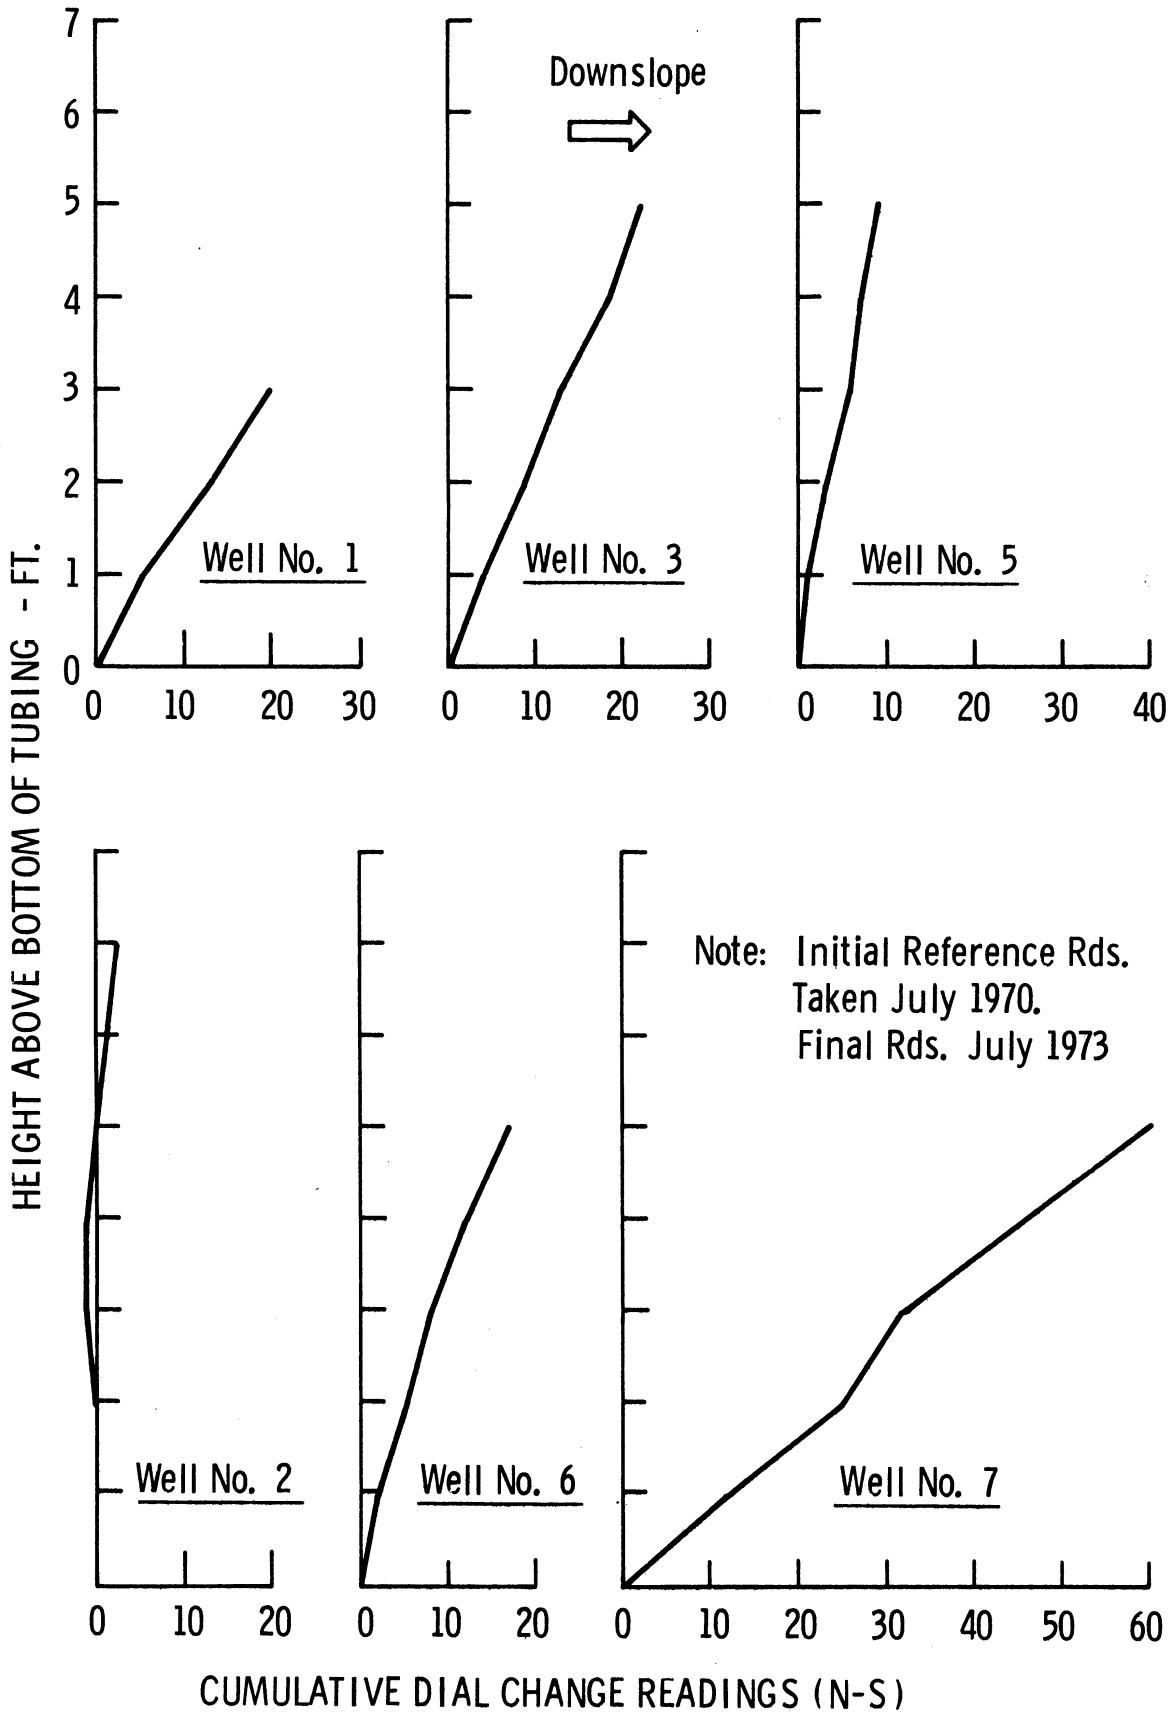
Figure 40. Creep profiles, cutover slope, U. S. Naval Radio Station.

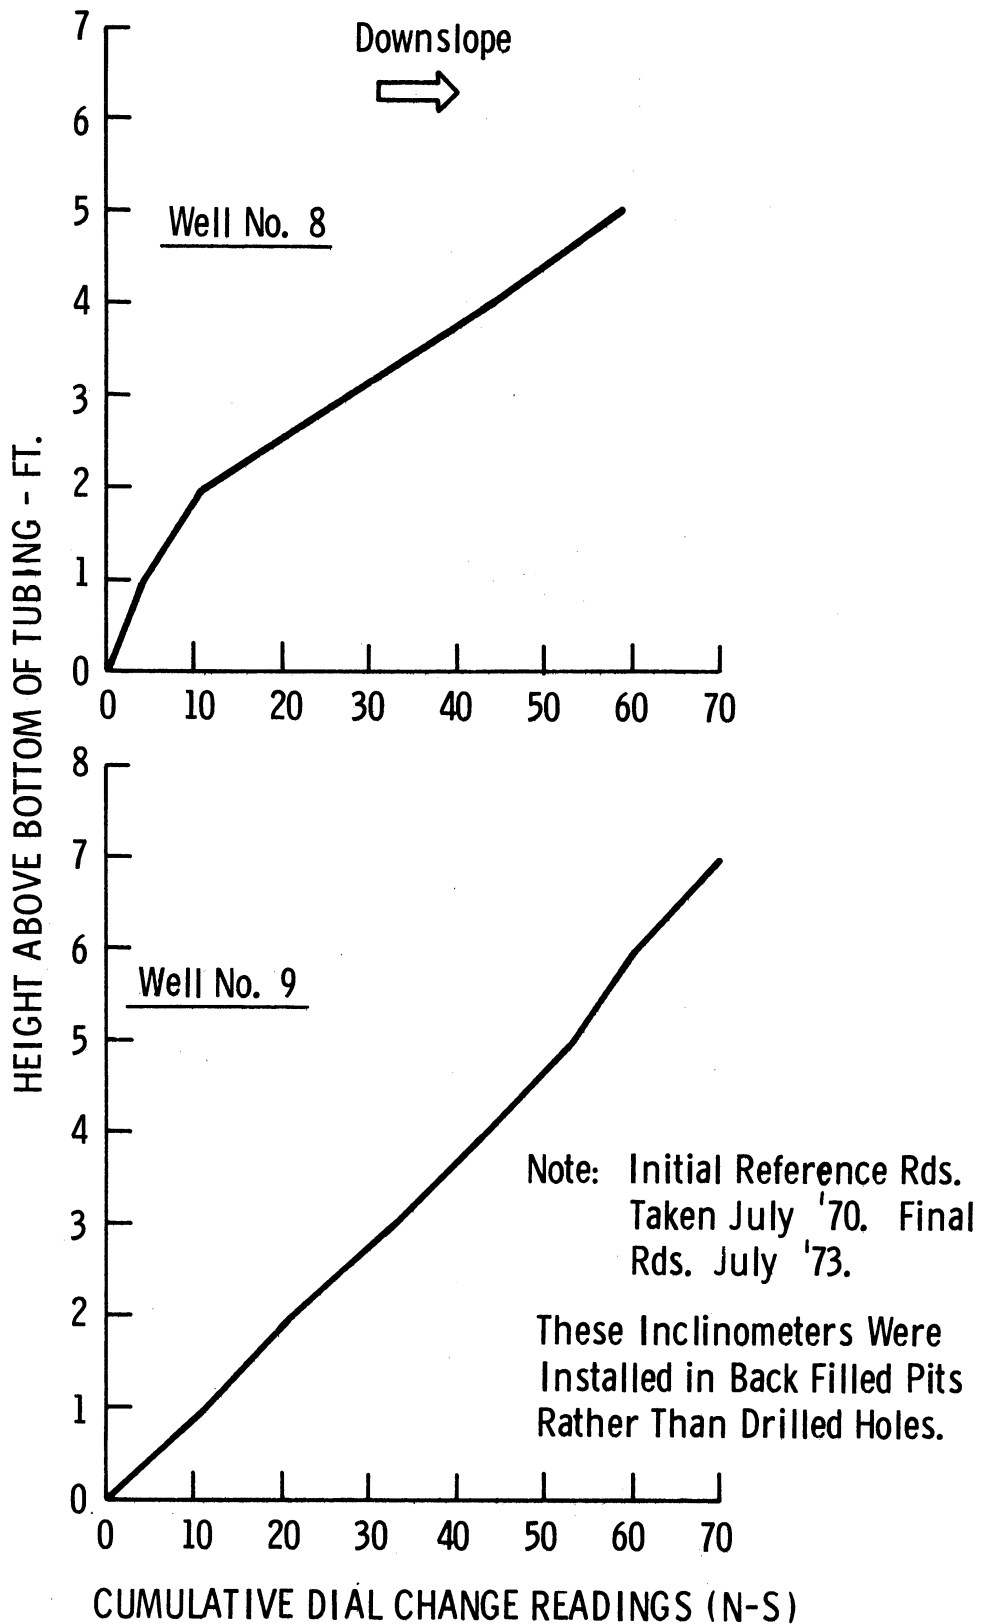
Figure 41. Creep profiles, forested slope,  
U. S. Naval Radio Station.

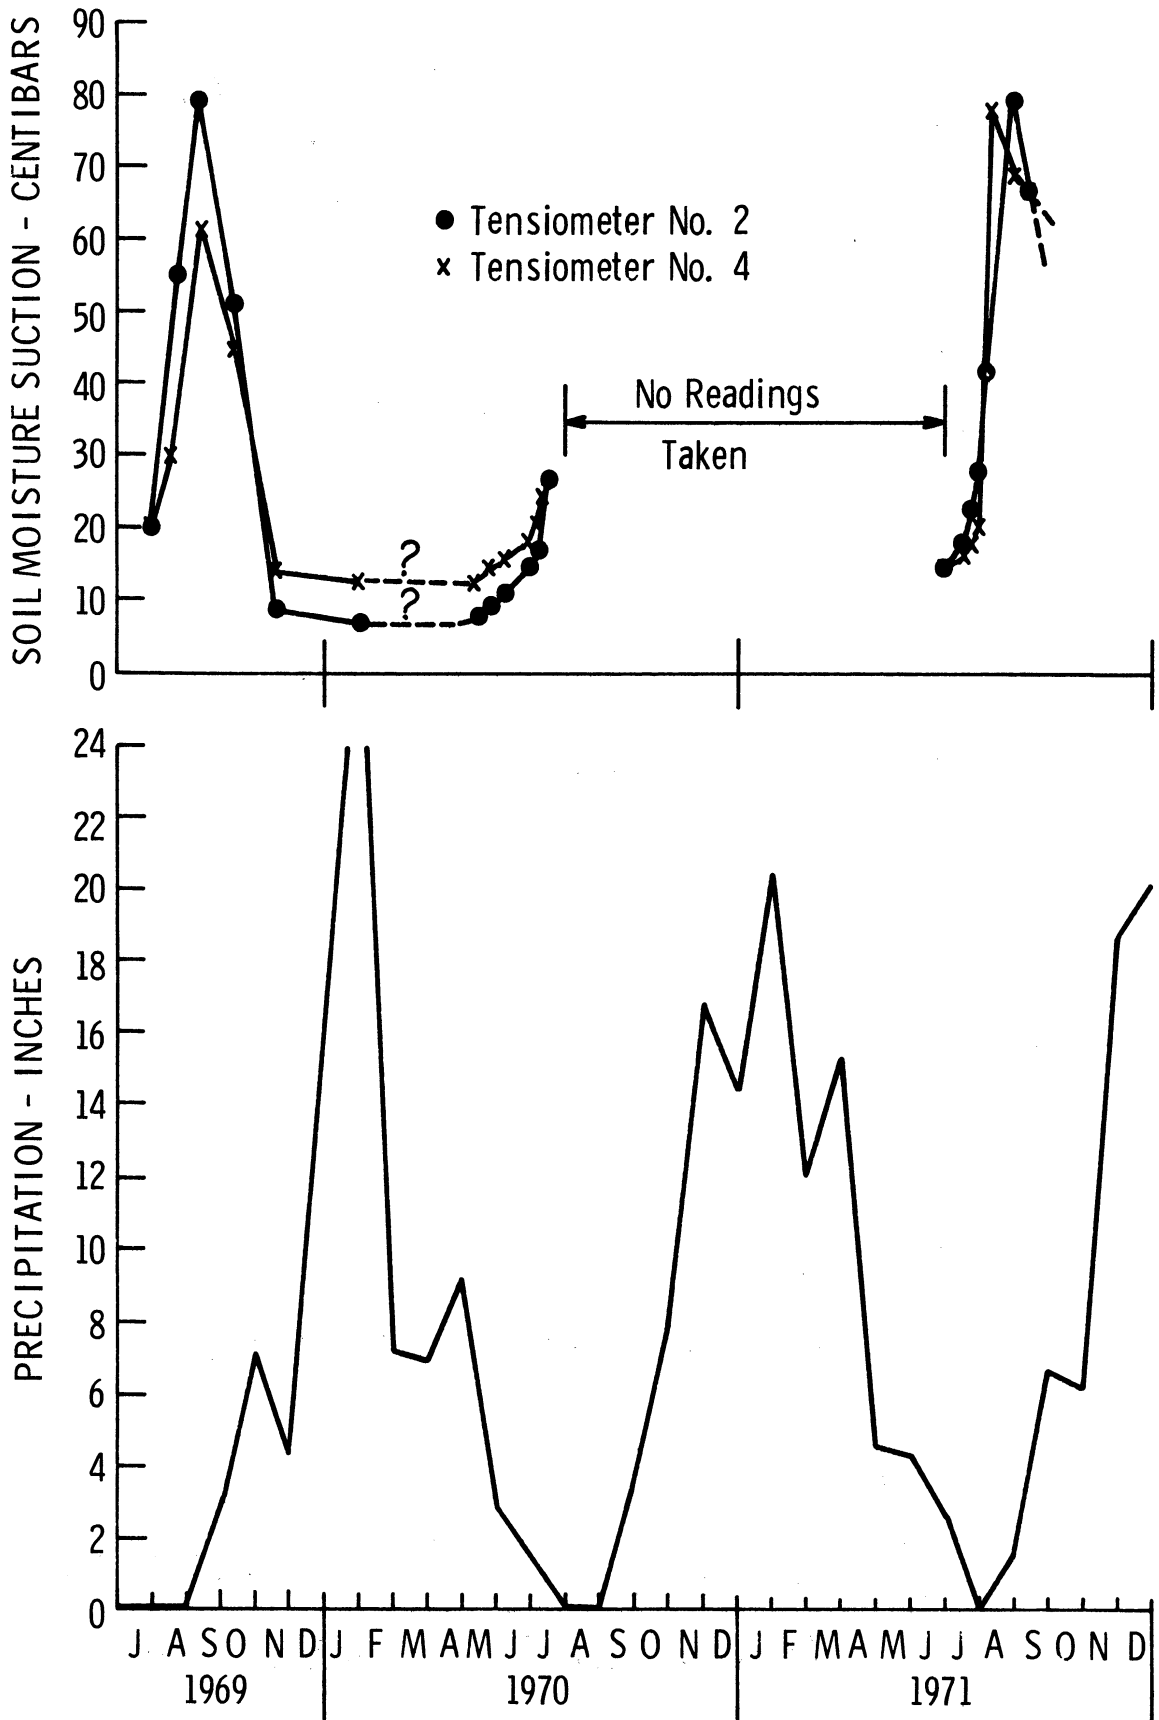
Figure 46. Soil moisture suction and precipitation vs. elapsed time, Watershed No. 10, H. J. Andrews Experimental Forest.
