THE UNIVERSITY OF MICHIGAN
INDUSTRY PROGRAM OF THE COLLEGE OF ENGINEERING

CAVITATION DAMAGE TESTS WITH WATER
IN A CAVITATING VENTURI

April, 1962

IP-562

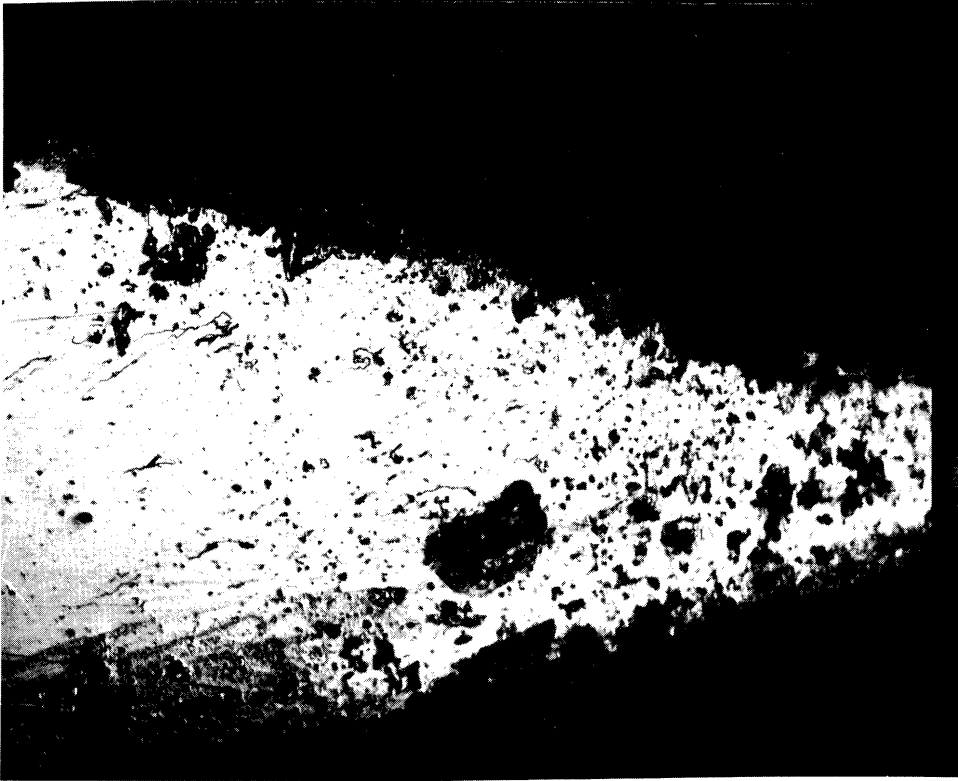
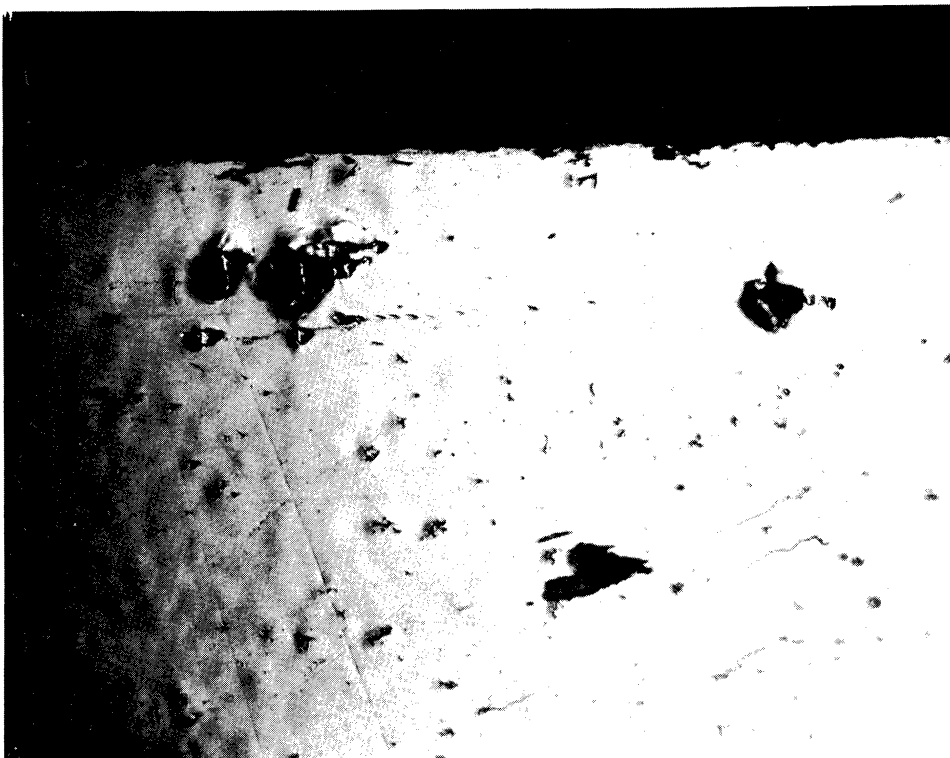
Figure 8. Typical cavitation damage on carbon steel. Carbon steel specimen 1-19, standard cavitation condition, 64.7 ft/sec. Location 1 (upper photo), after 22 hours; Location 2 (lower photo) after 3 hours, (X100).

Figures 8 through 17 show typical damaged regions on stainless steel, carbon steel, and aluminum specimens. It is noted generally that the pits have fairly regular contours so that they can be assigned a

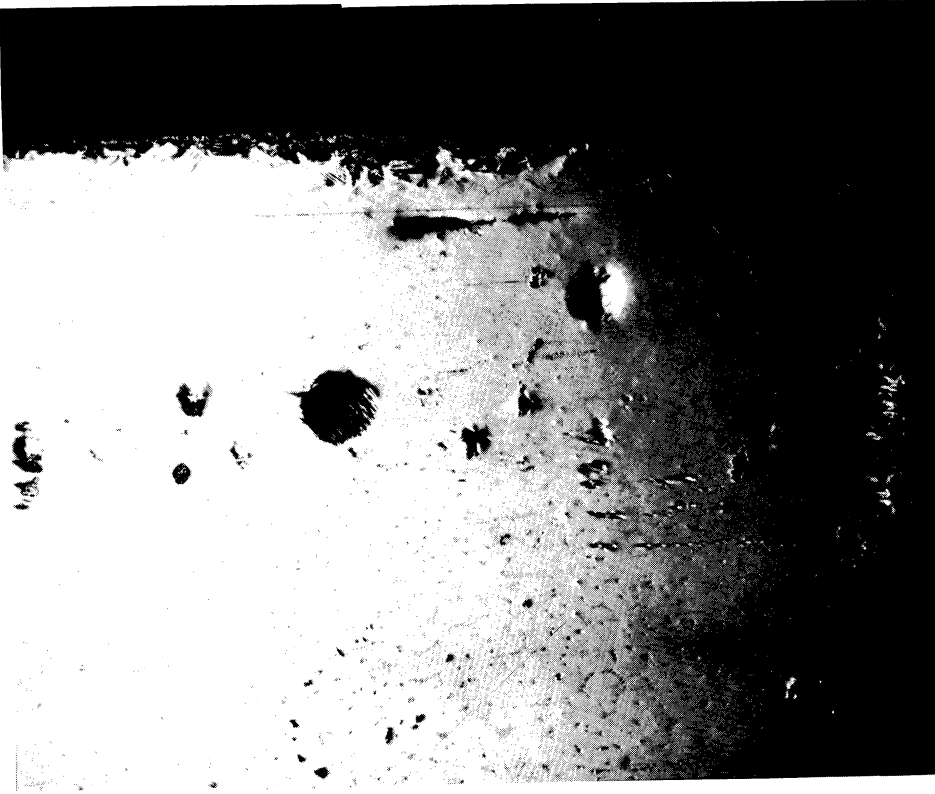
Figure 11. Development of cavitation damage. Two locations on type 302 stainless steel specimen number 3-5, standard cavitation condition, throat velocity = 64.7 ft/sec, after 15 hours, (X100).

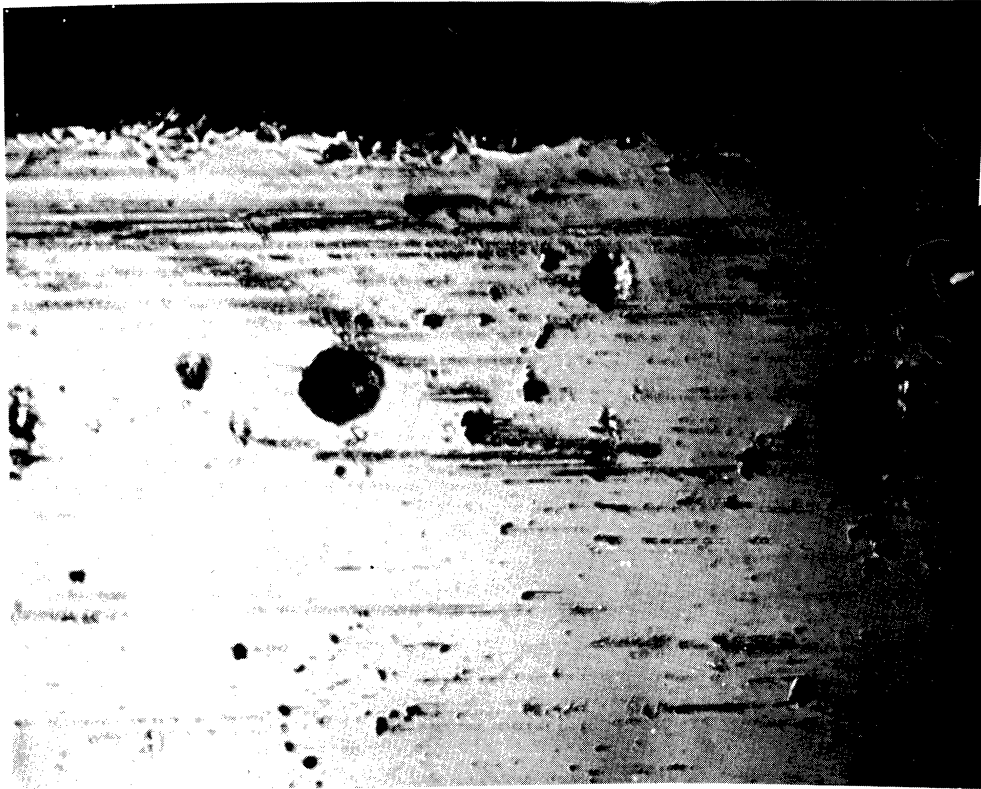
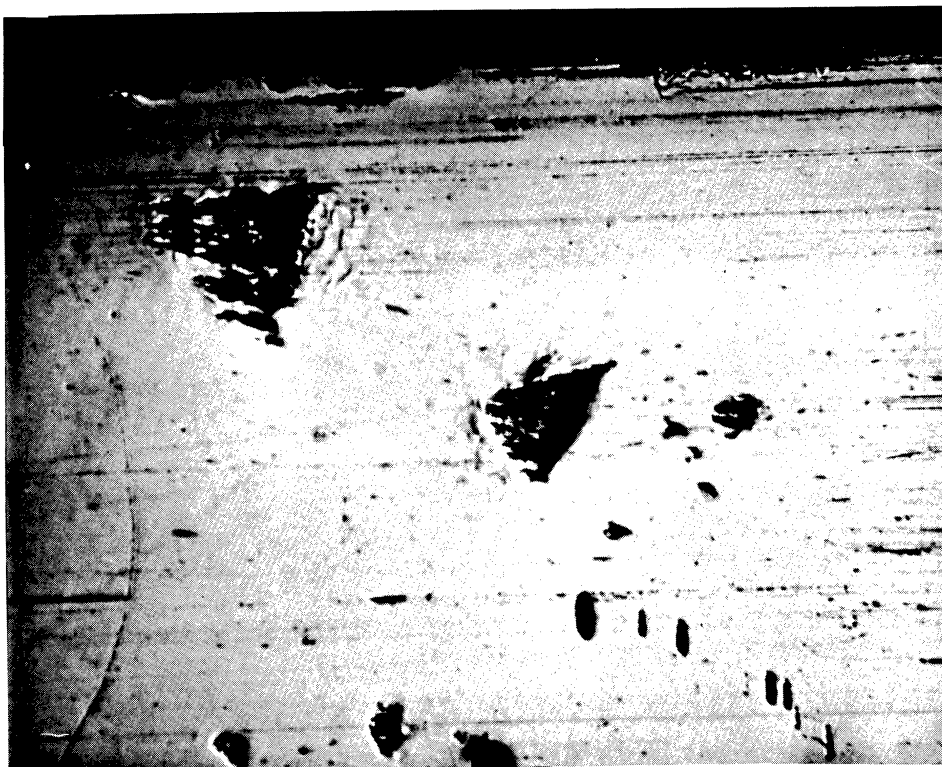
Figure 13. Development of cavitation damage. Two locations on type 302 stainless steel specimen number 3-5, standard cavitation condition, throat velocity = 64.7 ft/sec, after 45 hours, (X100).

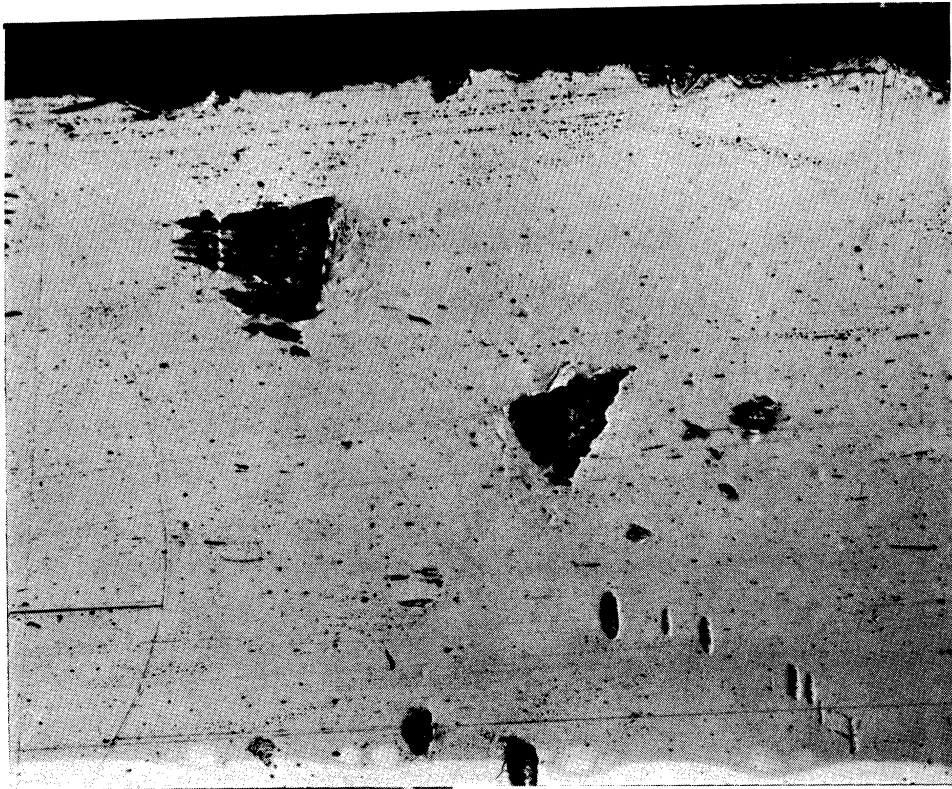
Figure 14. Development of cavitation damage. Two locations on type 302 stainless steel specimen number 3-5, standard cavitation condition, throat velocity = 64.7 ft/sec, after 75 hours, (X100).

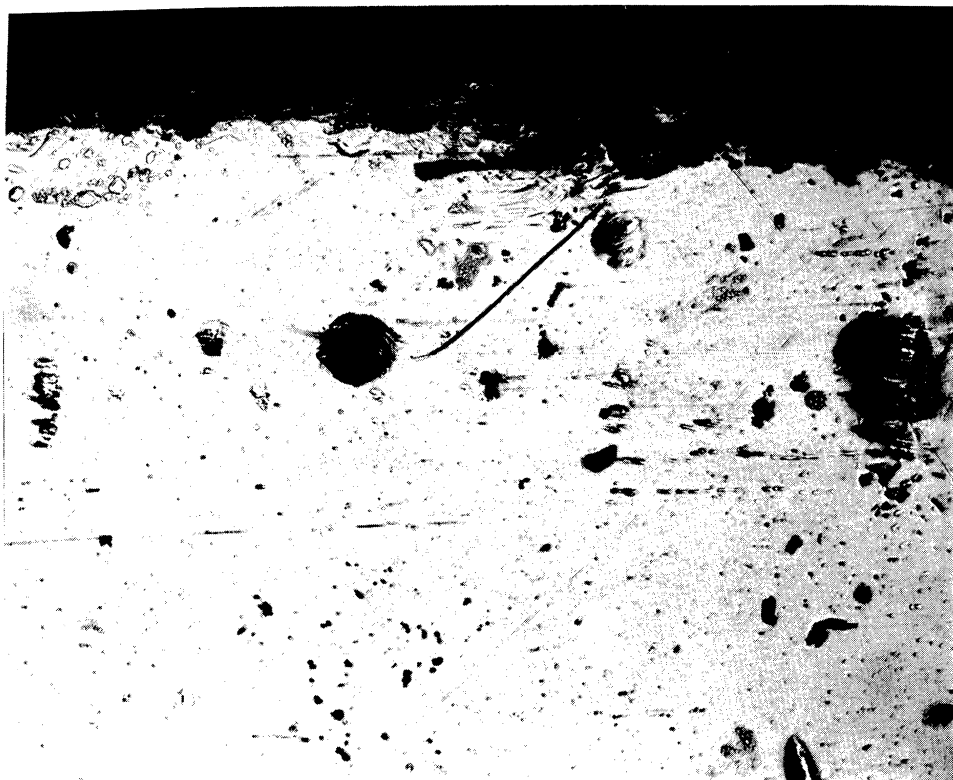
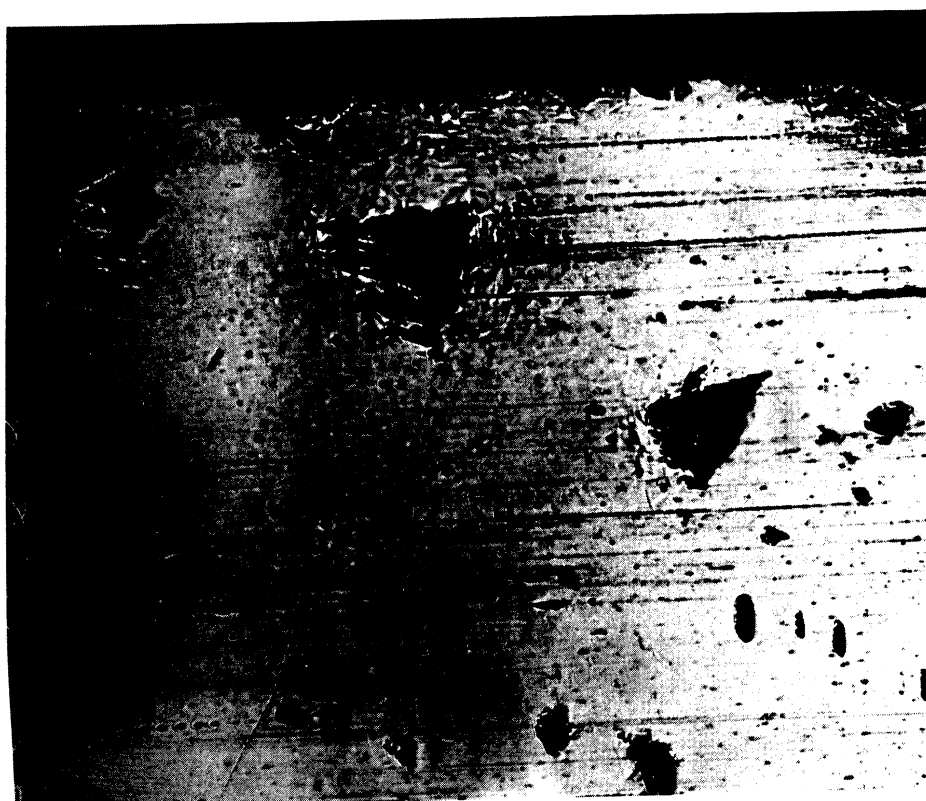
Figure 15. Development of cavitation damage. Two locations on type 302 stainless steel specimen number 3-5 standard cavitation condition, throat velocity = 64.7 ft/sec, after 110 hours, (X100).

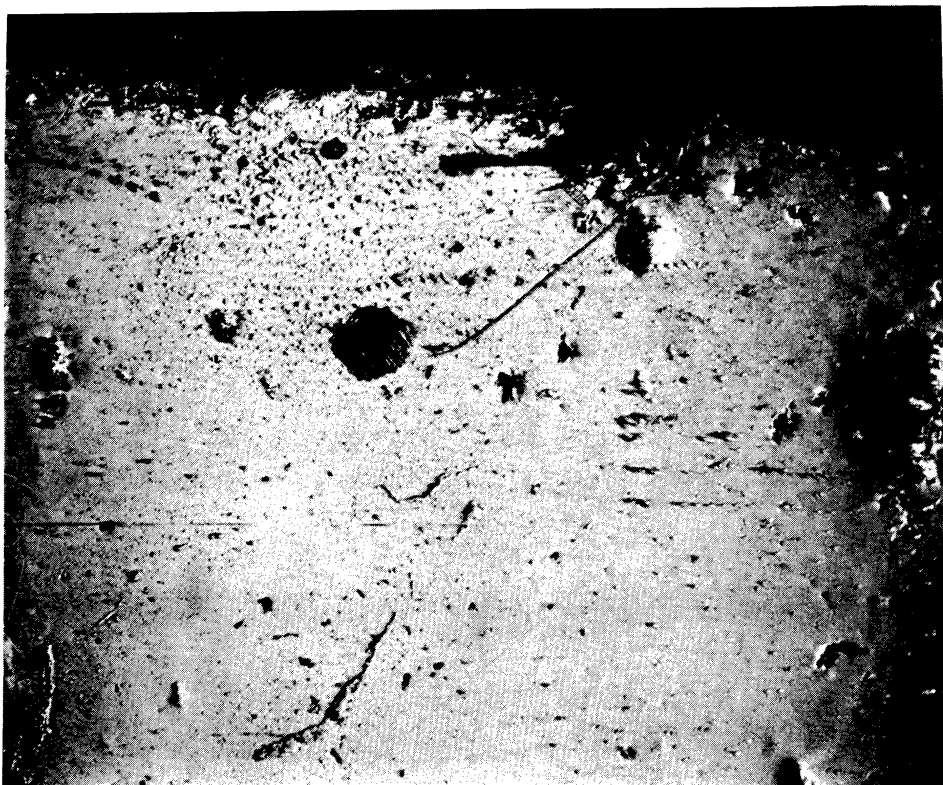
Figure 16. Development of cavitation damage. Two locations on type 302 stainless steel specimen number 3-5, standard cavitation condition, throat velocity = 54.7 ft/sec, after 150 hours, (X100).

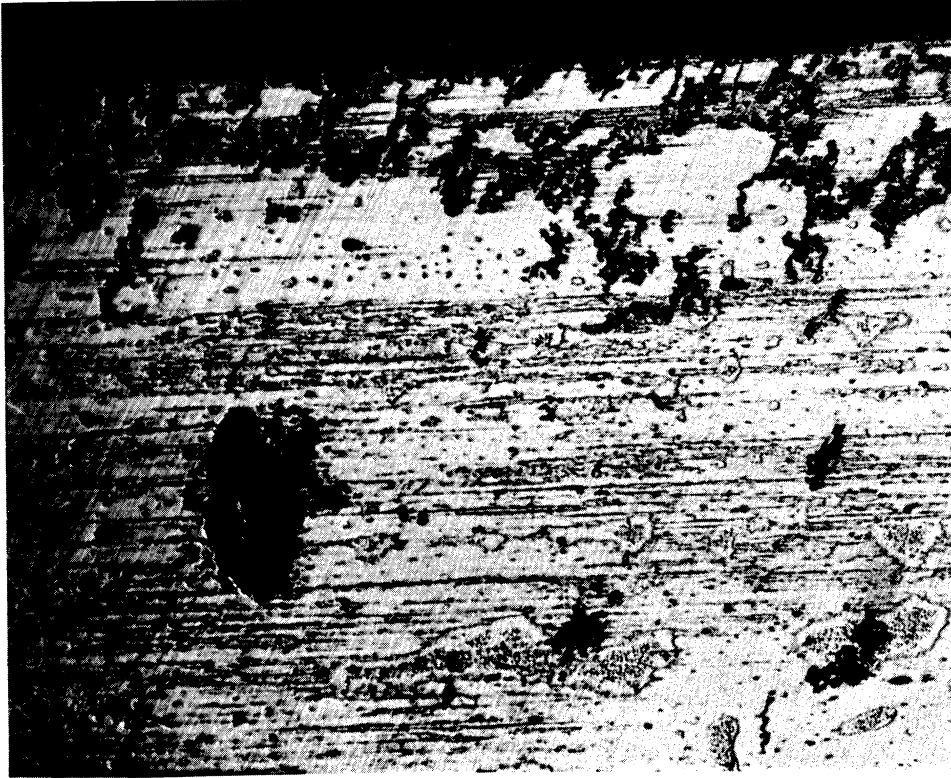
Figure 17. Rust cluster on type 1010 carbon steel specimen. Carbon steel specimen number 1-36, standard cavitation condition, throat velocity = 97.2 ft/sec, after one hour in test section, (X100).

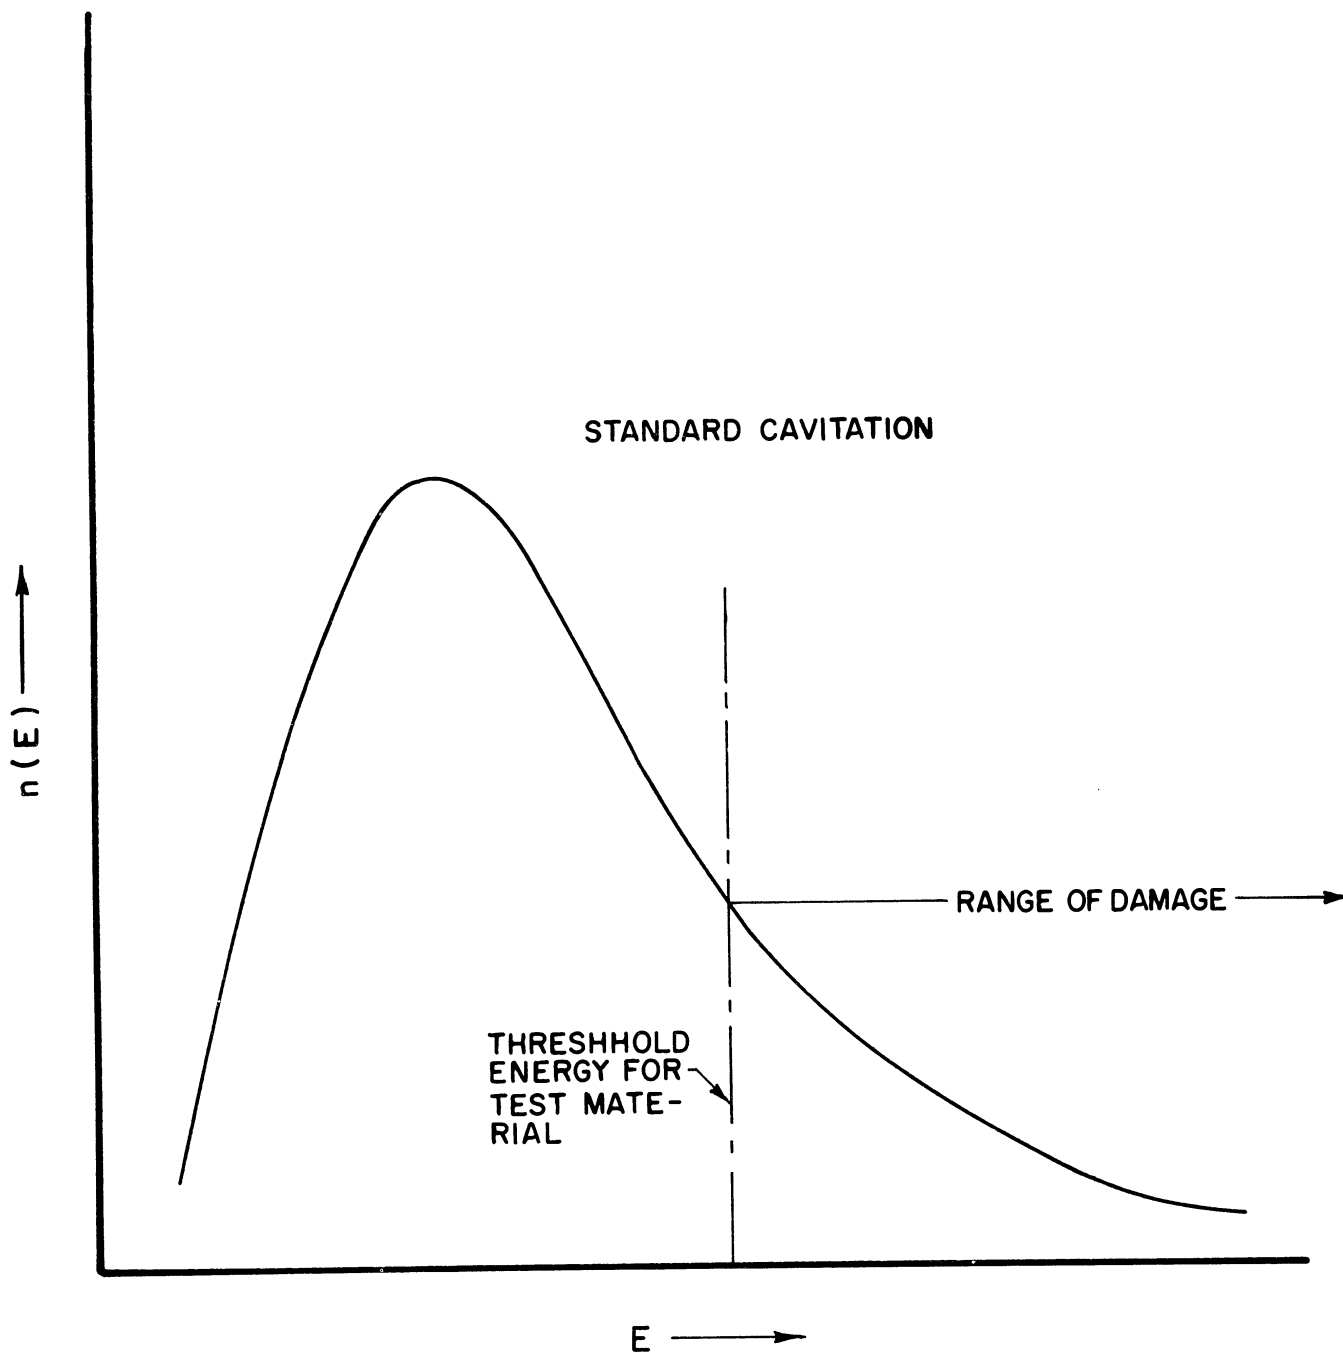
Figure 19. Hypothesized bubble energy spectrum, where $n(E)$ = number of bubbles from those "in vicinity of" damage specimen which deliver an energy quantum, E , to the surface of the specimen; E = energy delivered by an individual bubble to the surface of the specimen.

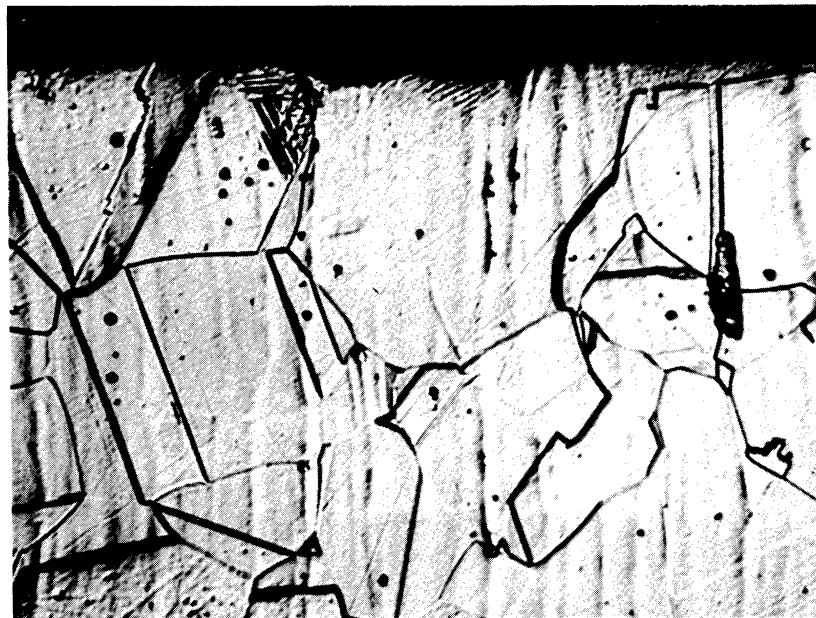
Figure 23. Typical sections through irregular shaped pit showing slip lines. (Magnification 1000X, oil immersion, oblique illumination.) Figure 23-b is the same pit as Figure 23-a, but after additional polishing to show slip bands exist in 3 dimensions.

Slip lines were clearly observed in the immediate vicinity of the pit as shown in Figure 23-a. Slip is not observable in every grain which borders on the region of the pit. This is expected since slip is strongly a function of crystal orientation, and deformation should occur only in those crystals whose lattice structures are properly oriented with respect to the stress field.

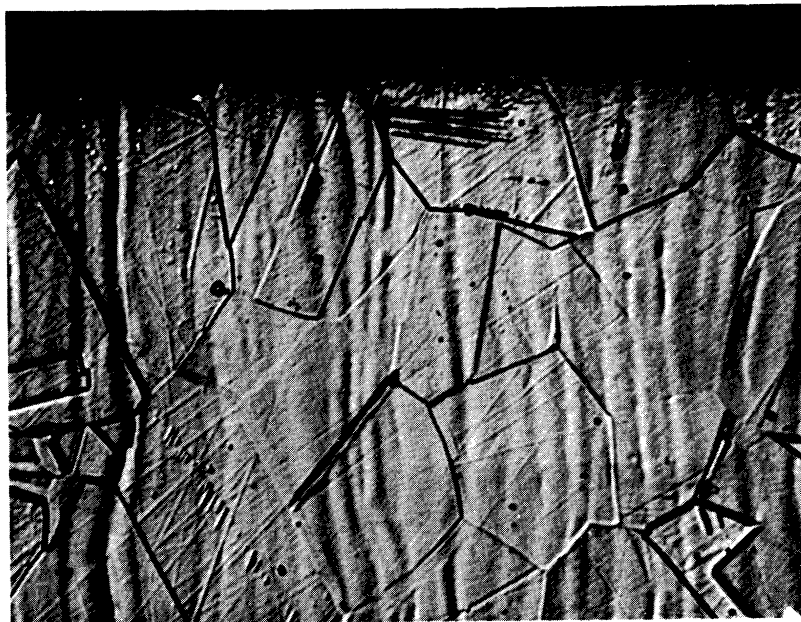
Figure 25. Evidence of crystallographic slip in two different isolated grains away from pits. (Magnification 1000X, oil immersion, a) oblique illumination, b) slightly oblique illumination.)
