THE UNIVERSITY OF MICHIGAN
INDUSTRY PROGRAM OF THE COLLEGE OF ENGINEERING

INITIAL PHASES OF DAMAGE TO TEST SPECIMENS IN A CAVITATING
VENTURI AS AFFECTED BY FLUID AND MATERIAL
PROPERTIES AND CAVITATION REGIME

December, 1963

IP-644

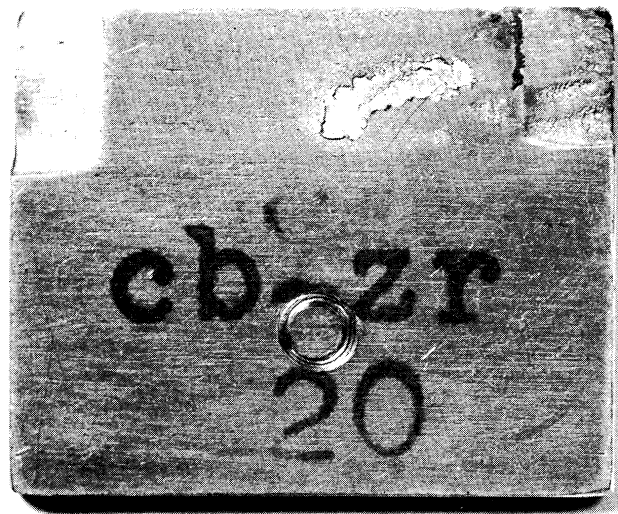
1074

Figure 20. Macrograph of Numbered Side of Sample Number Cb-1Zr 20 After 50 Hours Exposure to "Nose" Cavitation Condition in Mercury at a Throat Velocity of 48 feet/second. Mag. 4X.

Damage of a sort not observed in the tests on the other materials has occurred in tests with mercury on Cb-1 Zr alloy,* in which there was an eventual** macroscopic fatigue-type failure, in which a thin surface layer covering an area of the order of 0.015 square inches peeled-off to a depth of about 2 to 3 mils (Figure 20). Figure 21 is a section through this region showing the continued propagation of cracks at the ends of the region. The microstructure of the material is shown in Figure 22.

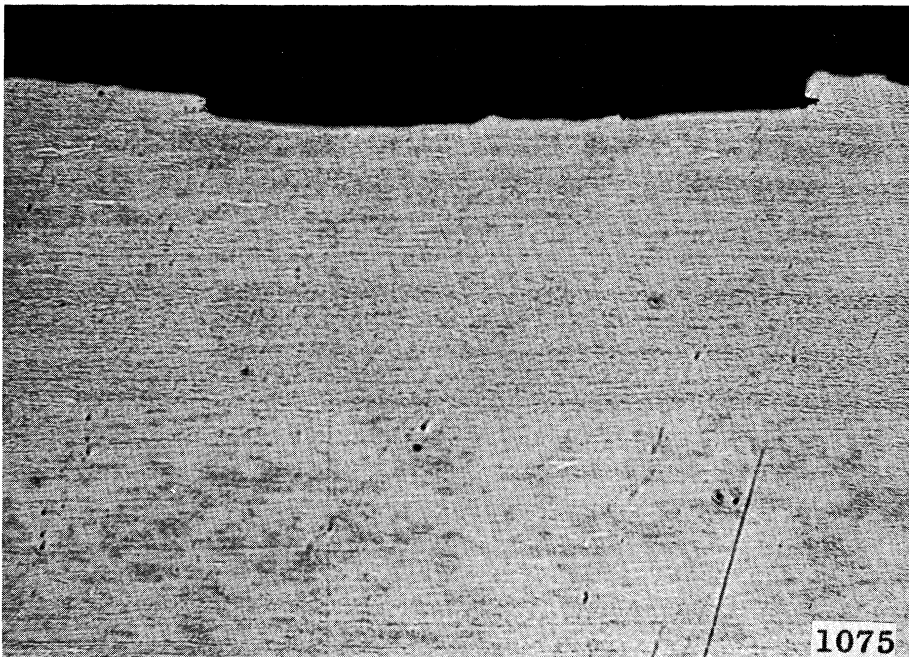
1075

Figure 21. Microsection Through Gross Damage Area on Numbered Side of Sample Number Cb-1Zr 20 as Shown in Figure 58. Etched. Magnification 100X.
