**FINAL REPORT**

**CARGO TANK ROLLOVER FORCE VERIFICATION**

January 2006

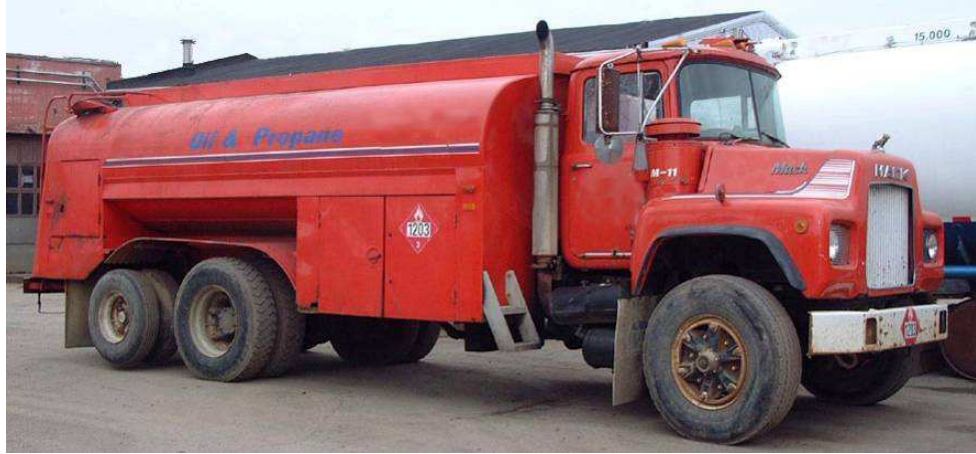
**Figure 1. Single-unit truck**

The single-unit truck was a 1977 U-model Mack-2500 equipped with a tank designed for residential and farm delivery of gasoline, diesel, and heating fuels. It had a steer axle, a drive axle, and an unpowered tag axle. Figure 1 shows the truck as it looked when it was retired from service. A steel roll cage was built around the engine and around the tank to protect the truck so it could be crashed several times. The roll cage is visible in Figure 2, which shows the truck on the tilt table at UMTRI. The fill ports on top of the truck are also visible in the photograph, as are the two rails running the length of the tank, which are typical overturn protection devices for a gasoline cargo tank.

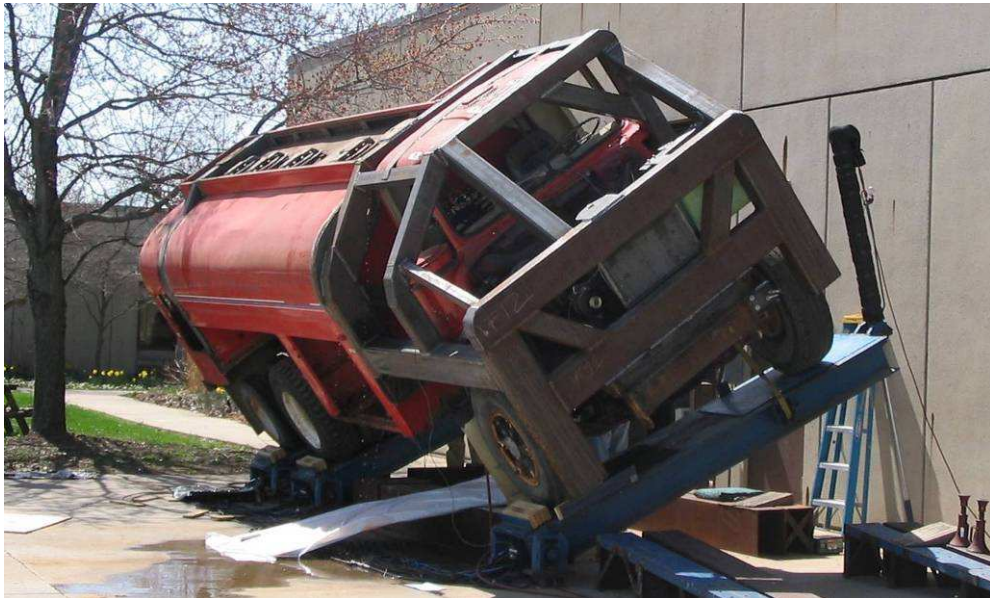
**Figure 2. Single-unit truck on the tilt table**

**The roll cage, the fill ports for the tanks and the rails serving as “rollover protection devices” are visible in the photo.**

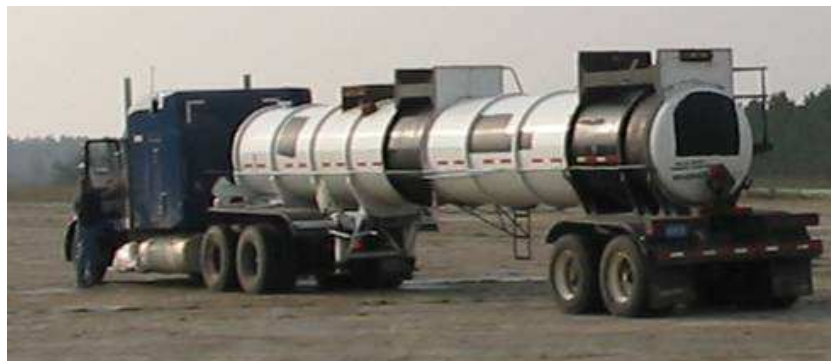
**Figure 4. Tractor semitrailer combination**

The semitrailer (Figure 4) had a tank of circular cross section. It carried muriatic acid during its service years. It was an MC 312 with a steel tank, built by Fruehauf in 1981. The trailer is nearly identical to the one in the Albuquerque crash in the NTSB report. It was filled with water for the test roll, so its test weight was 72,000 lb. The tractor was a Peterbilt 379, model year 2000, with a sleeper cab. Its tandem drive axles had a gross weight rating of 40,000 lb. The combination unit truck was tested on the tilt table, as in Figure 5. Its rollover threshold was 0.40 g. Figure 6 shows the dimensions of the trailer and the location of its center of gravity. As with the single-unit truck, the “reference point” is where the instruments were located and where the position was originally reckoned.

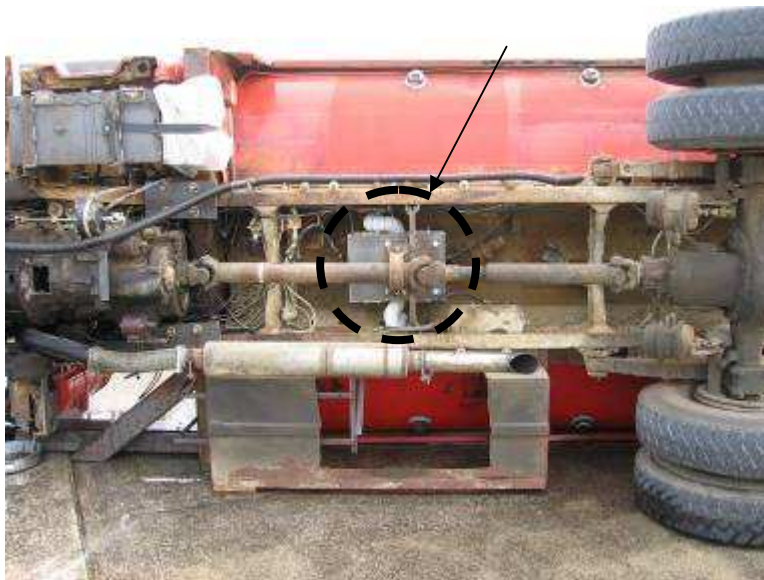
**Figure 7. Inertial guidance unit on the single-unit truck  
It was mounted between the frame rails for protection.**

The instrumentation was carried in a protected location. On the single-unit truck, it was nestled between the frame rails as shown in Figure 7. On the semitrailer, it was under the tank at the landing gear. The motion sensors needed to be affixed to the vehicle essentially rigidly up to the moment of impact, so they would faithfully record the rollover. However, if the instrument had been bolted directly to the frame, it would have suffered excessive shock forces during impact. Accordingly, UMTRI supported the instrument with fragile, but rather rigid, pieces of foam (the pink-colored foam in Figure 8), which would hold the instrument in place during ordinary maneuvers but would break at the moment of the rollover impact. The soft, white foam in the photograph would then cushion the instruments at impact. The broken pink pieces had to be replaced after every roll. This approach worked as planned.

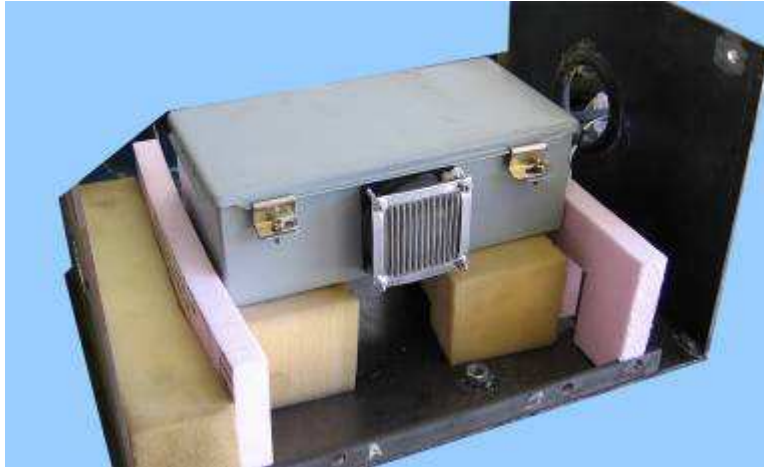
**Figure 8. Support for the inertial navigation system**

**The thin (pink) pieces of foam were rigid but broke away at impact. The thicker (white) pieces of foam cushioned the unit from impact.**

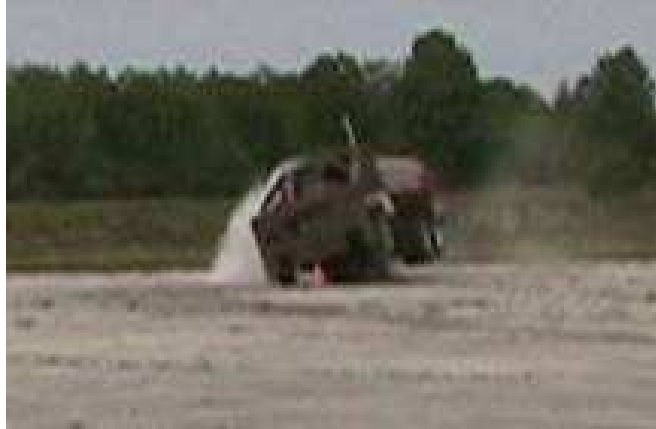
**Figure 13. Single-unit truck in the first rollover**

The next attempt to roll the truck was at 31 mph, 4 mph faster than the first, and the truck did roll over. Figure 13 was taken from one of the video cameras looking nearly down the truck's roll axis as it went over. The cone under the truck marked the predicted rollover point. The model predicted that the center of gravity would be above that point at the moment when the truck's roll angle was 45 degrees, and the truck was actually in the process of going over as it struck the cone.

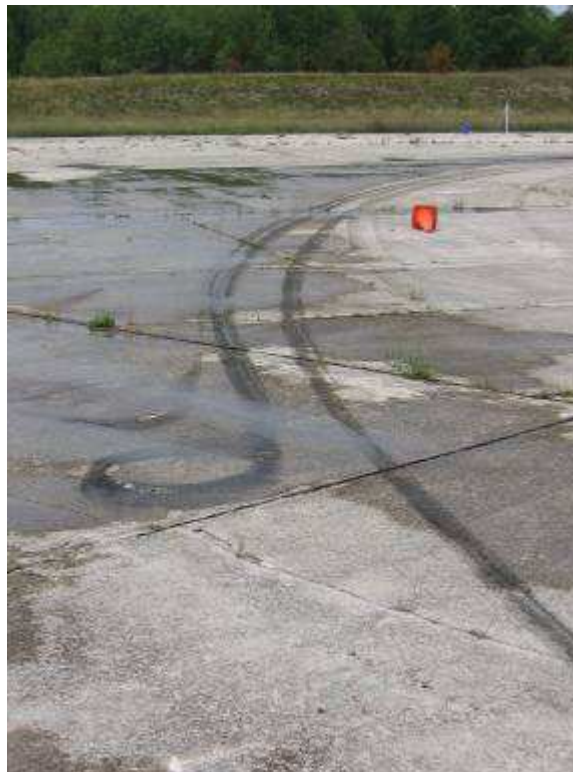
**Figure 14. Skid marks from the first rollover**

This first crash was intended to be the gentlest possible roll, and the skid marks in Figure 14 show that the truck barely flopped over—the circular marks of the rear tires as they struck the pavement are touching the linear skid marks the tires made just before the roll. Contrast these skid marks with those in Figure 15, from the third rollover, the step steer. In a more typical, more severe roll, the truck “flies” through the air for a short distance, so the striking skid mark is a matter of feet from the pre-crash skid line.

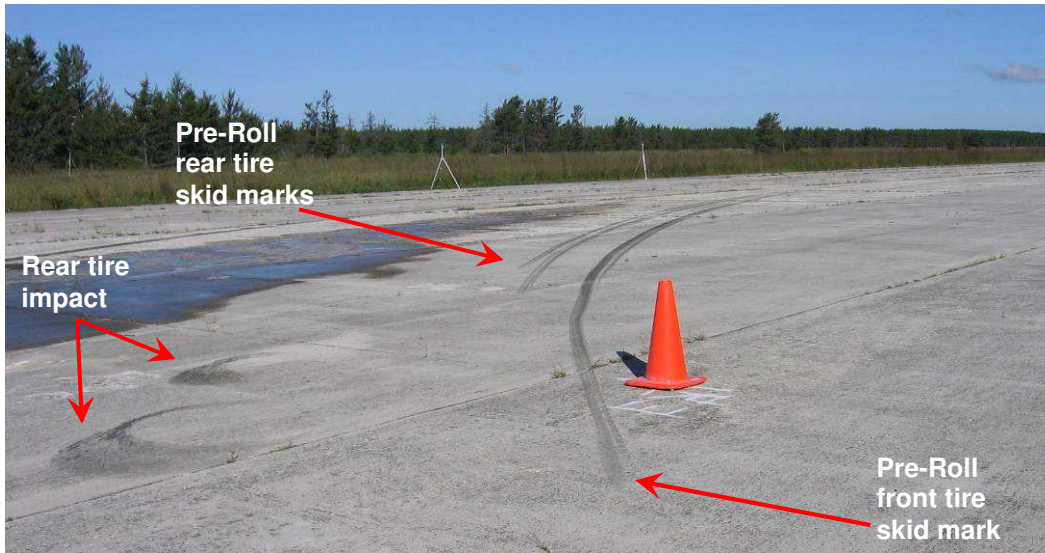
**Figure 15. Skid marks from the third rollover**

During the third rollover, the truck was momentarily airborne, so the linear skid marks end at the point where the tires left the ground. The marks left by the tires at impact are not complete circles because the truck had a roll angle of more than 90 degrees when it struck. The truck continued along its line of travel as it flew, and without the tires holding it in its curve, it also moved outward from the pre-flight curvature. Thus, the tires' impact marks are downrange and outward from the point where they left the pavement. The cone in Figure 15 marks the expected rollover point. The truck was at a steep roll angle when it passed the cone, so the cone was left standing.

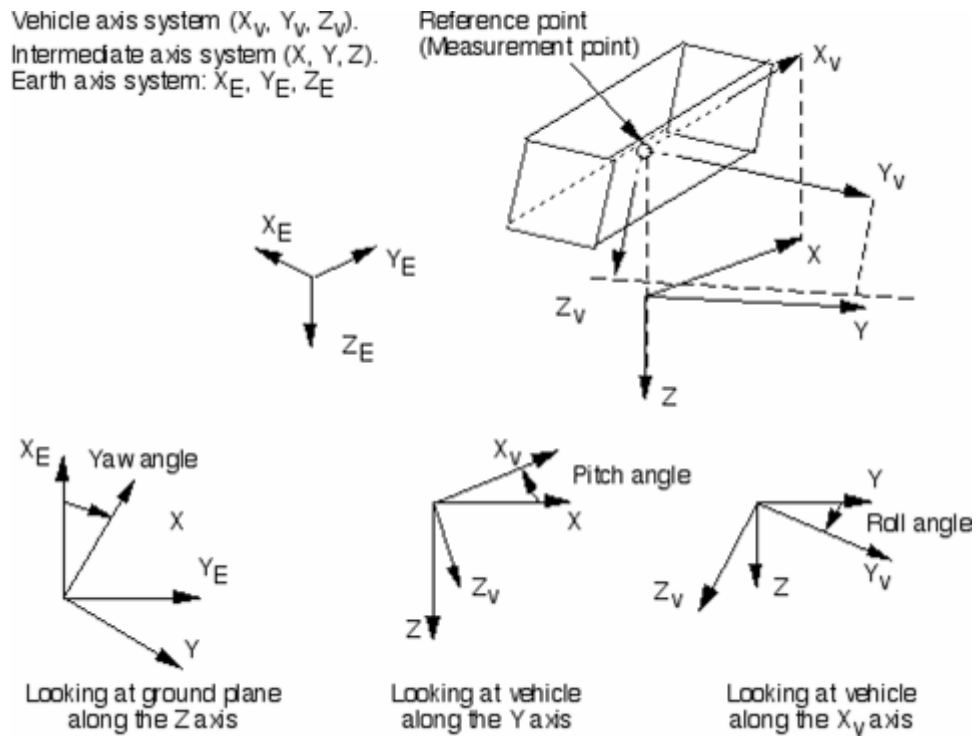
**Figure A-1. Earth, intermediate, and vehicle axis systems and yaw, pitch, and roll angles**

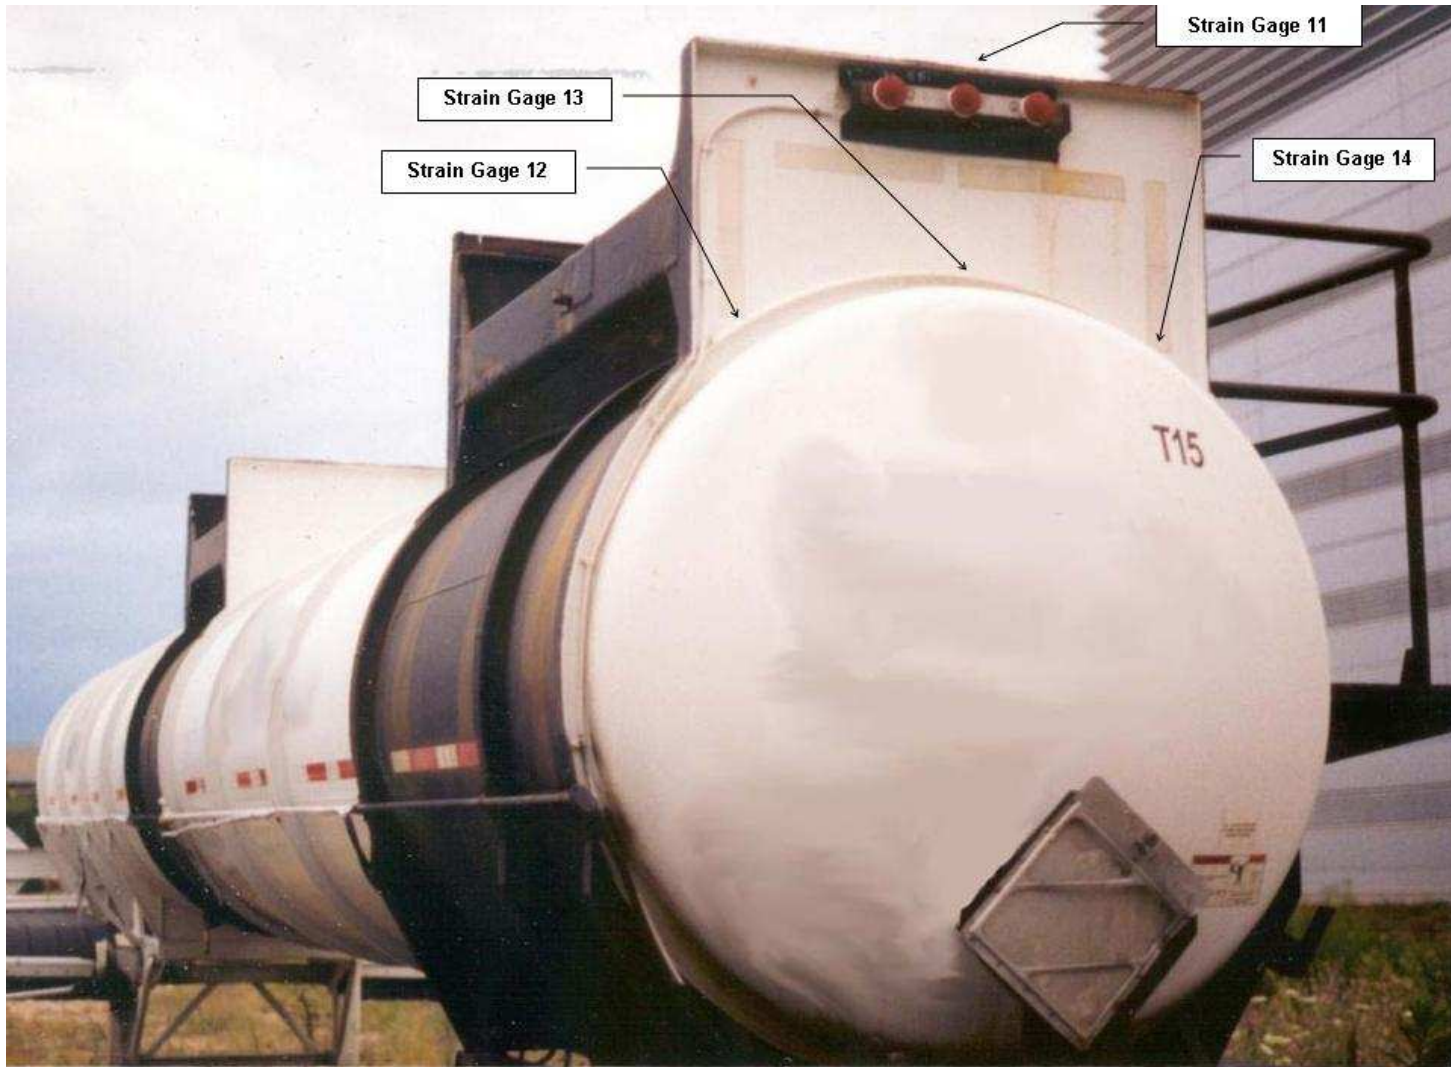
**Figure B-1. Strain gage locations on the rear of the semitrailer**

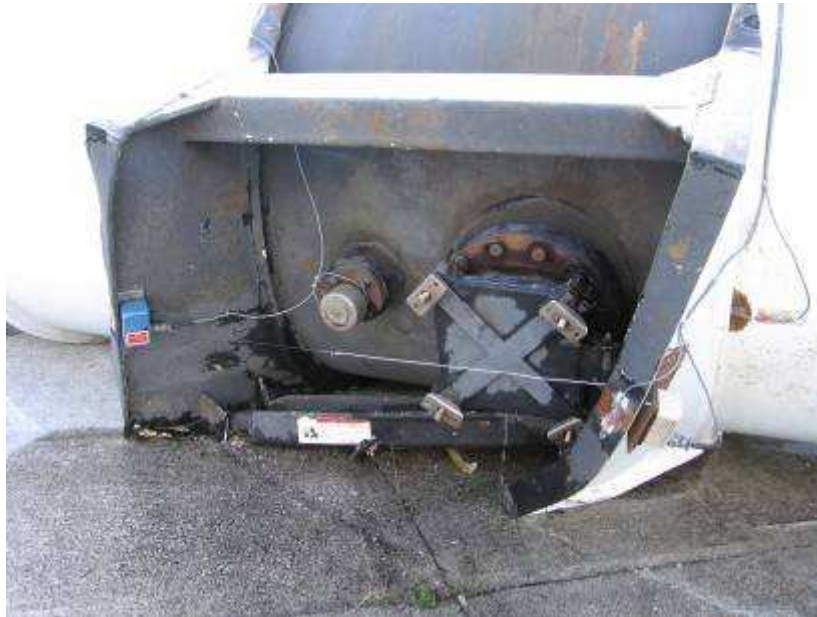
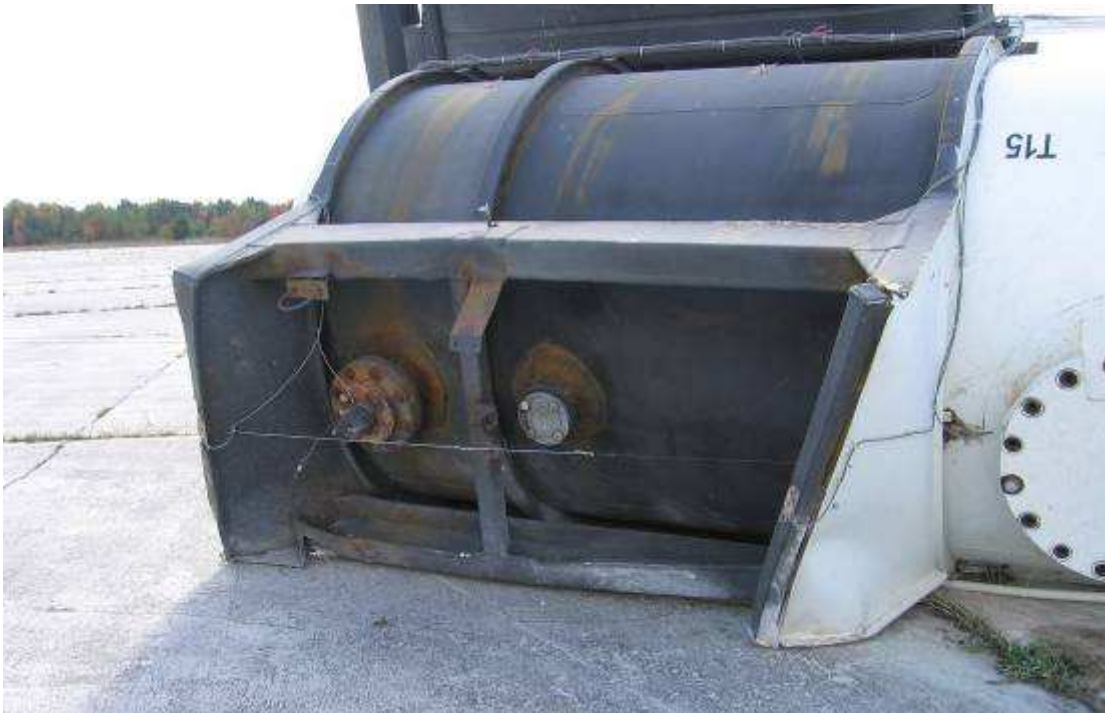
**Figure B-22. Rollover protection devices after the crash**

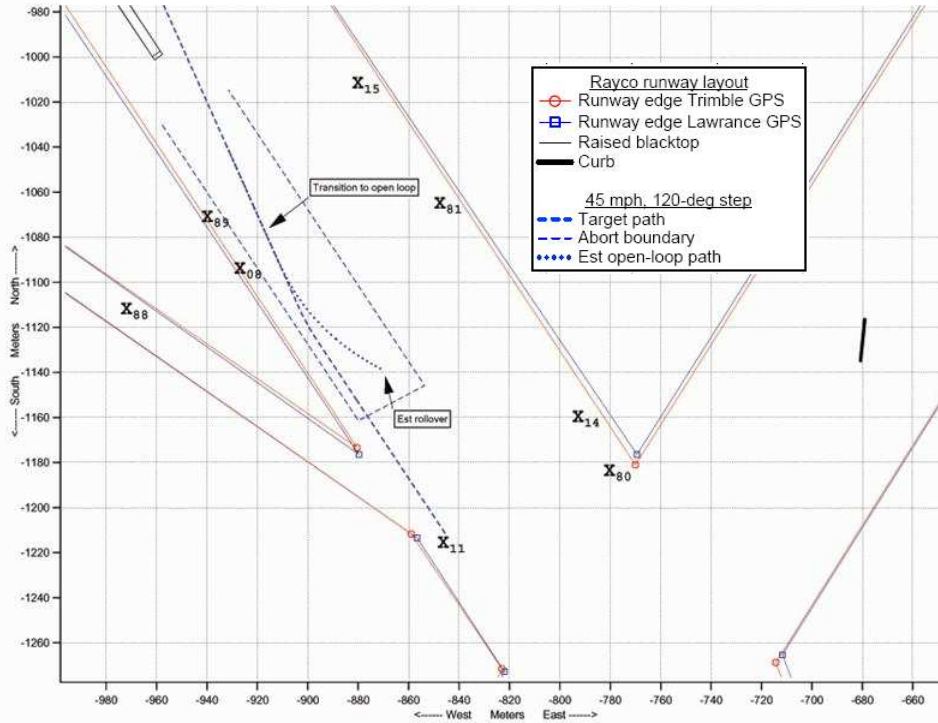
**Figure C-3. Locations of the cameras for Roll No. 3**

Camera 7 was mounted to the truck, under the header.

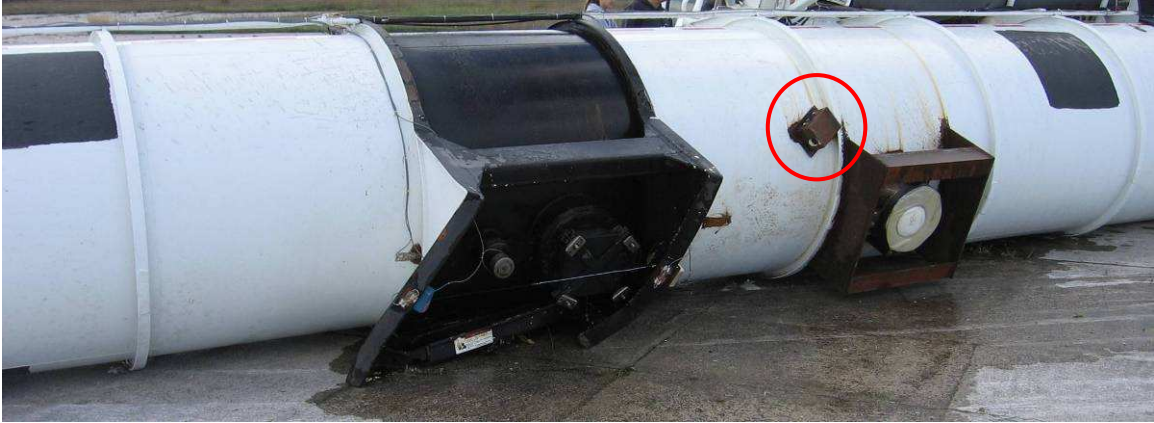
**Figure C-6. The housing for the camera looking at the rollover protection device is in the circle. The GPS antenna is visible below and to the right of the camera.**

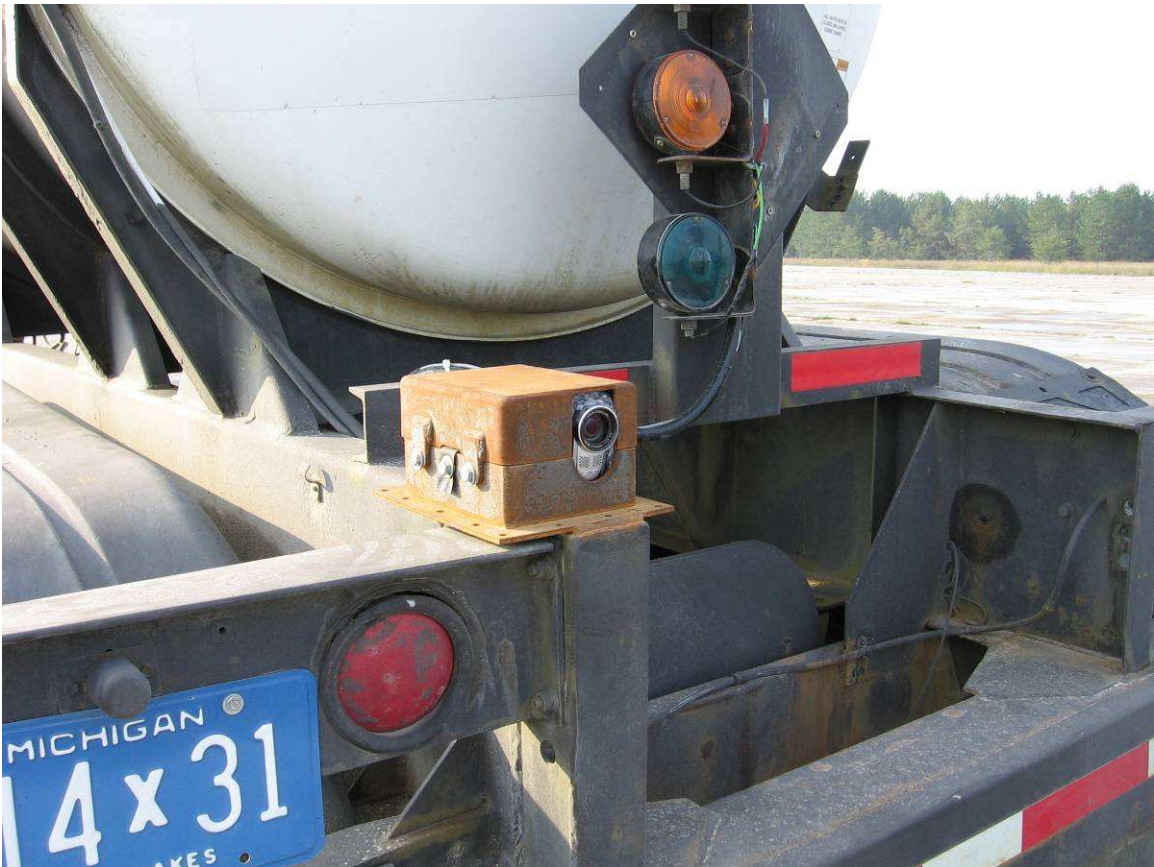
**Figure C-7. The rearward-looking camera on the trailer.**
