## CHAPTER 4

### **Effect of Material Ductility on Restrained Volume Change Induced Cracking and Interfacial Delamination**

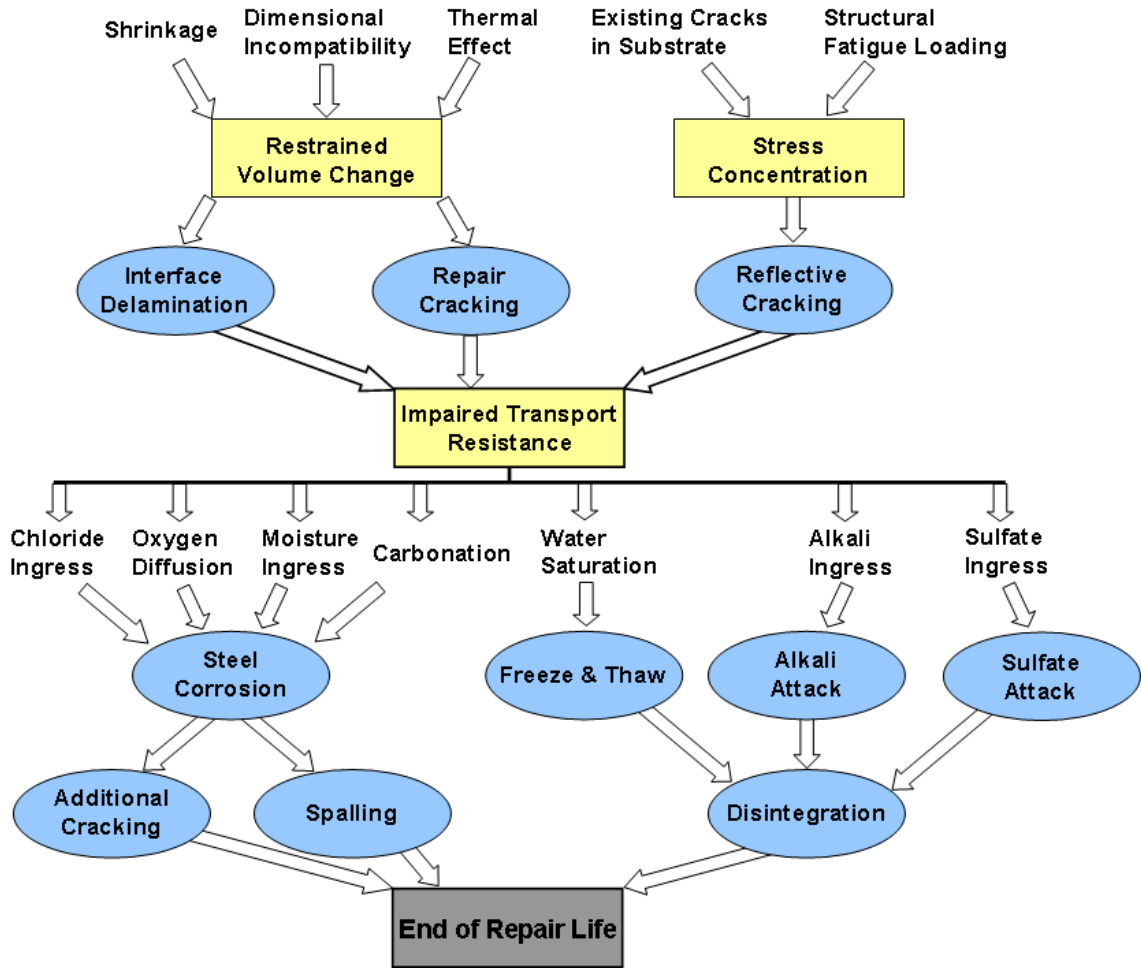
Figure 4.1 – Typical deterioration process of concrete repair.

Concrete repair failure results from a combination of physical, chemical and mechanical processes, as illustrated in Figure 4.1. Generally the repair deterioration process starts with cracking and repair/old interfacial delamination due to restrained volume change such as drying shrinkage or thermal deformation, when there exists a dimensional incompatibility between the repair and existing concrete. Cracking and delamination are insidious causes of many repair durability problems<sup>2,3,4,5</sup>. The presence of cracks dramatically alters the transport properties of the repair material<sup>6,7,8,9,10,11</sup>, facilitates the ingress of aggressive agents into the repaired system, and eventually causes premature deterioration and repair failure such as corrosion and disintegration. Large

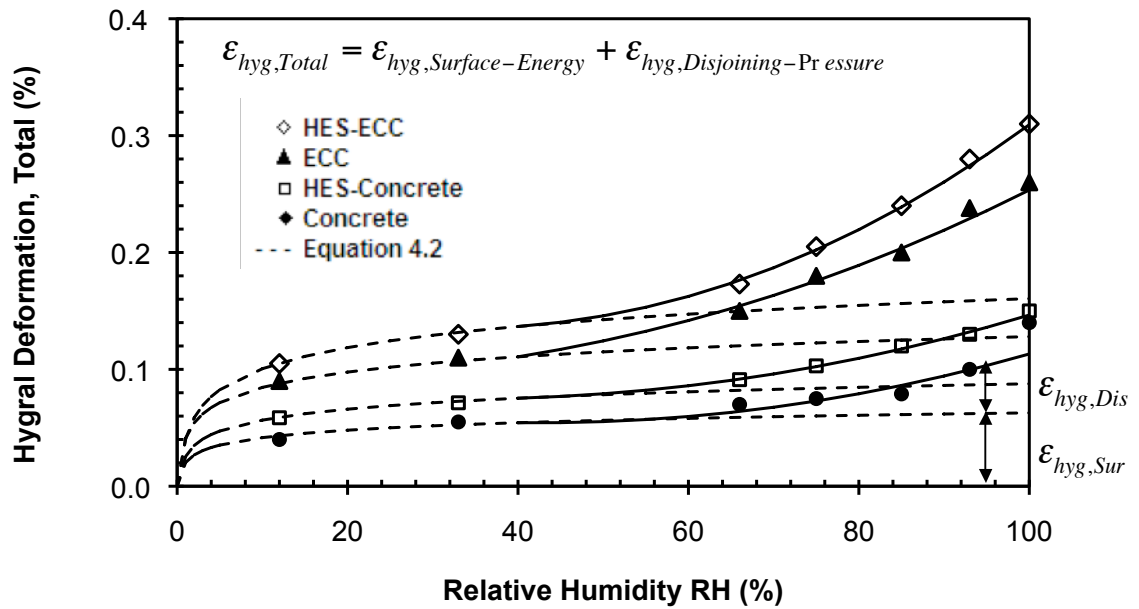
Figure 4.5 – Experimental data and theoretical curves of hygral deformation vs. relative humidity for the investigated materials (data of HES-ECC and HES-Concrete are measured in this study; data of ECC and Concrete are adopted from Weimann and Li, 2003).

Hygral deformation at a given RH can be experimentally measured as the difference between the steady state drying shrinkage value of the dry state, and the steady state drying shrinkage value at the given RH. The total hygral deformation of a cementitious material can be described by the Munich model, which was originally developed for cement paste<sup>45,46</sup>, and later found to also work for concrete<sup>47</sup> and an ordinary ECC (M45)<sup>48</sup>, whose cementitious matrix contains Portland type I cement, ASTM class F fly ash, and fine silica sand. This model assumes that the capillary stress is approximately independent of RH<sup>49,50</sup>. Therefore, the total hygral deformation can be described as the deformation due to a change in surface energy of C-S-H gel particles, plus the deformation due to the disjoining pressure between C-S-H gel surfaces when RH > 40%.

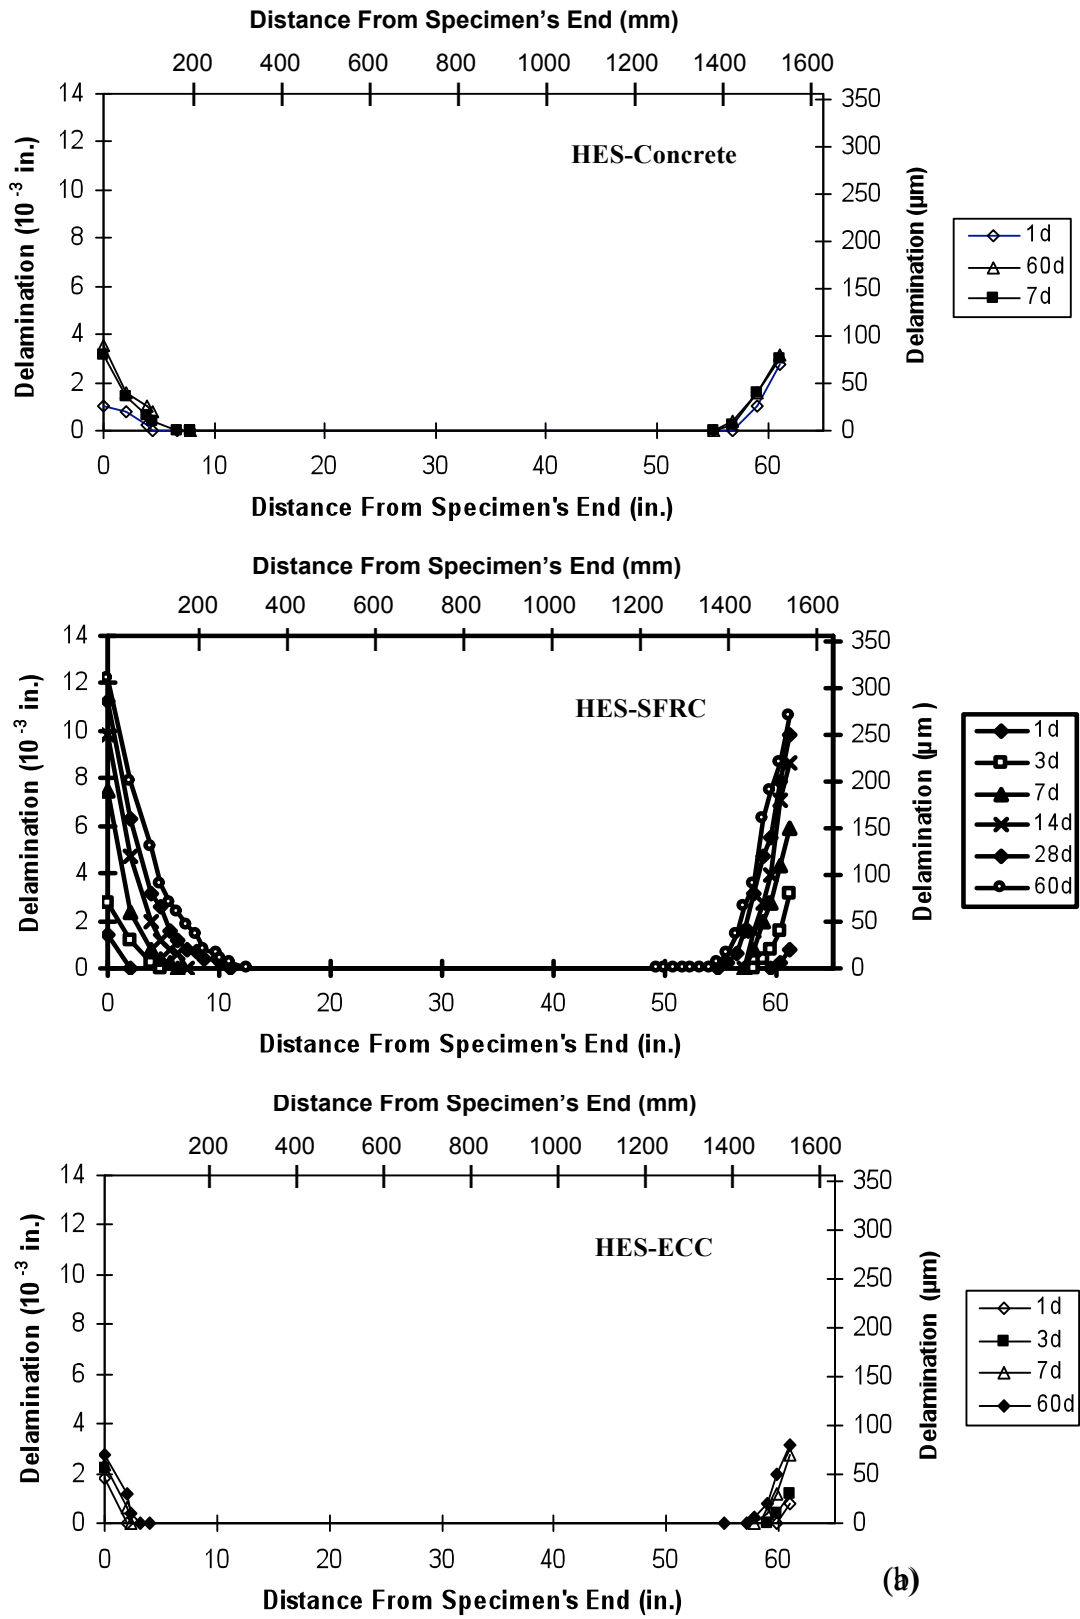
Figure 4.11 – Interface delamination profiles of repaired systems.

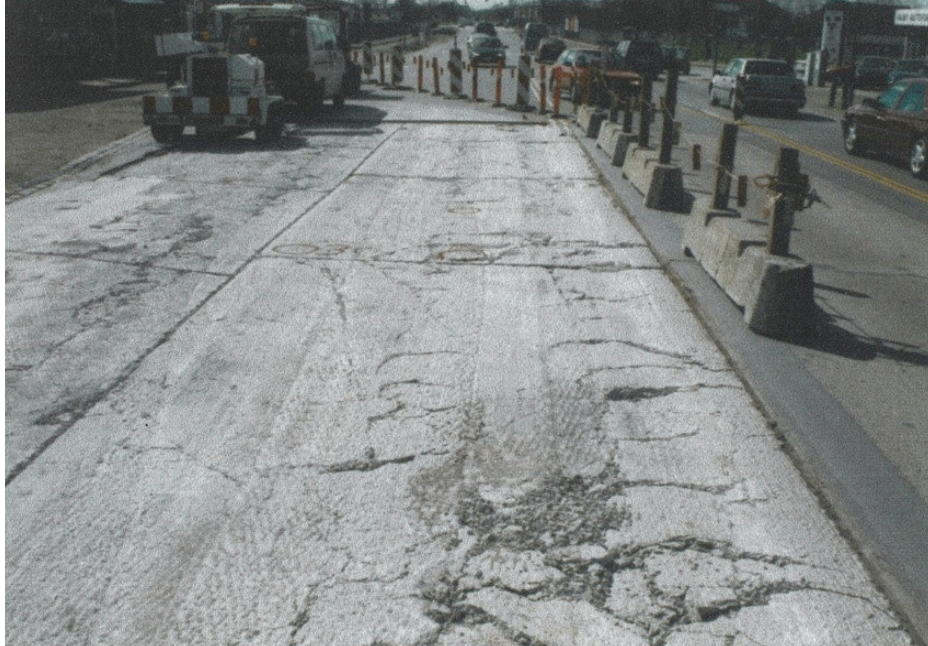
Figure 5.1 – Crack-and-sealed pavement surface.

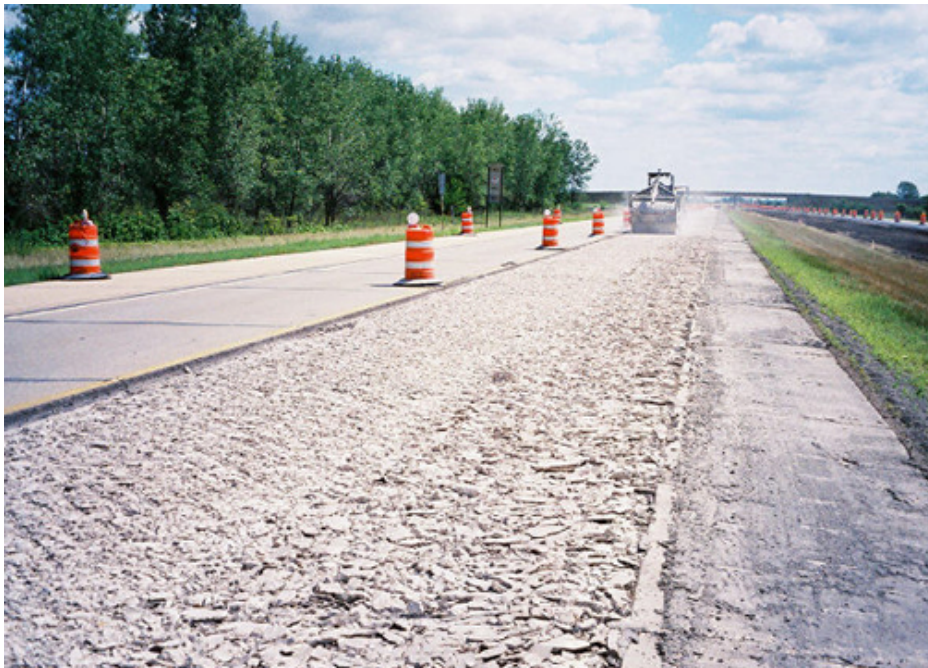
Figure 5.2 – Rubblized pavement surface.

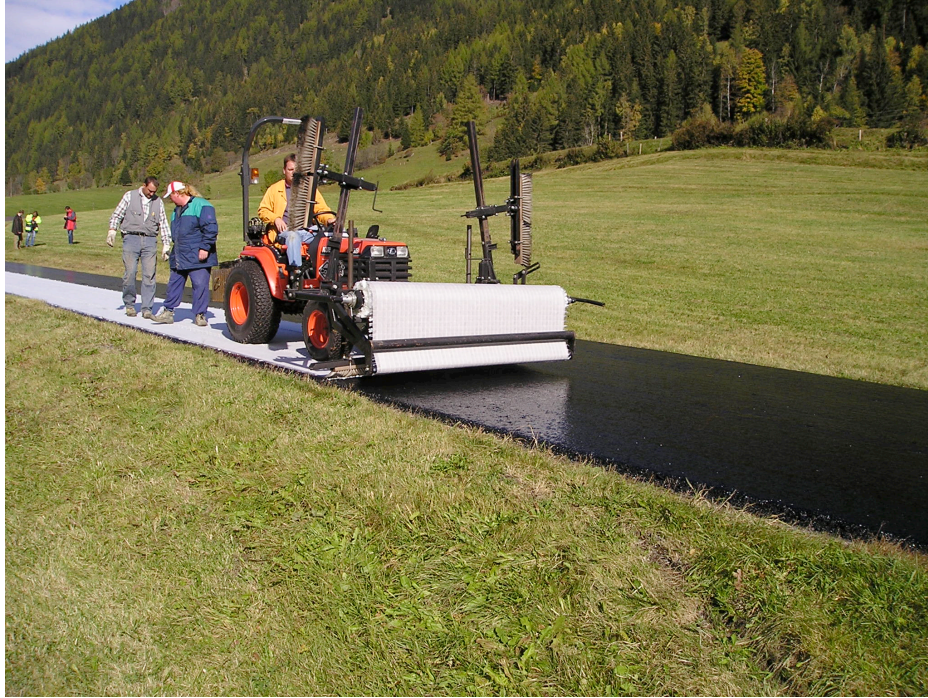
Figure 5.3 – Paving fabric installation.

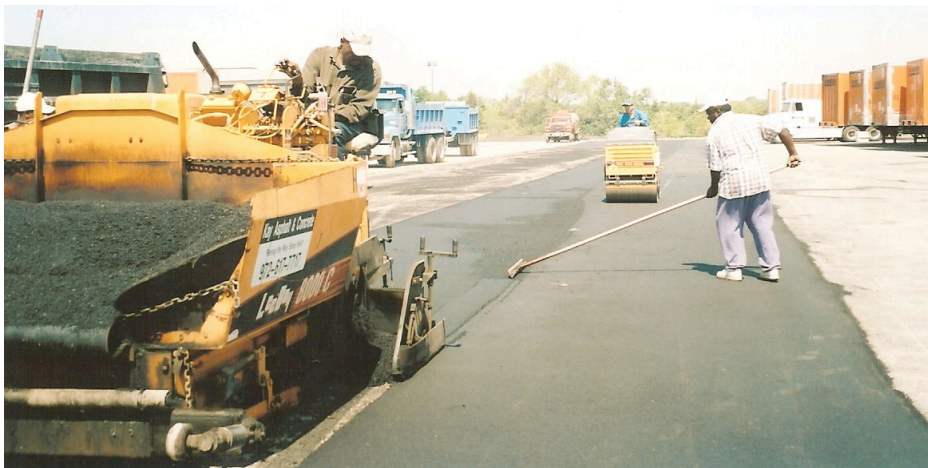
Figure 5.4 – HMA interlayer installation.

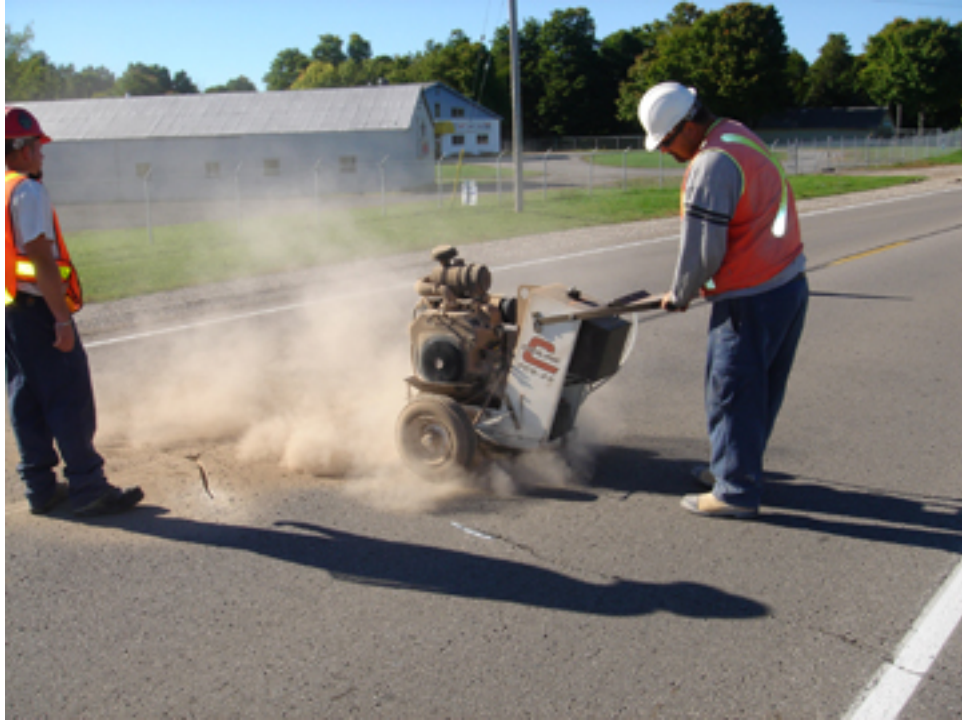
Figure 5.5 – Overlay saw and seal

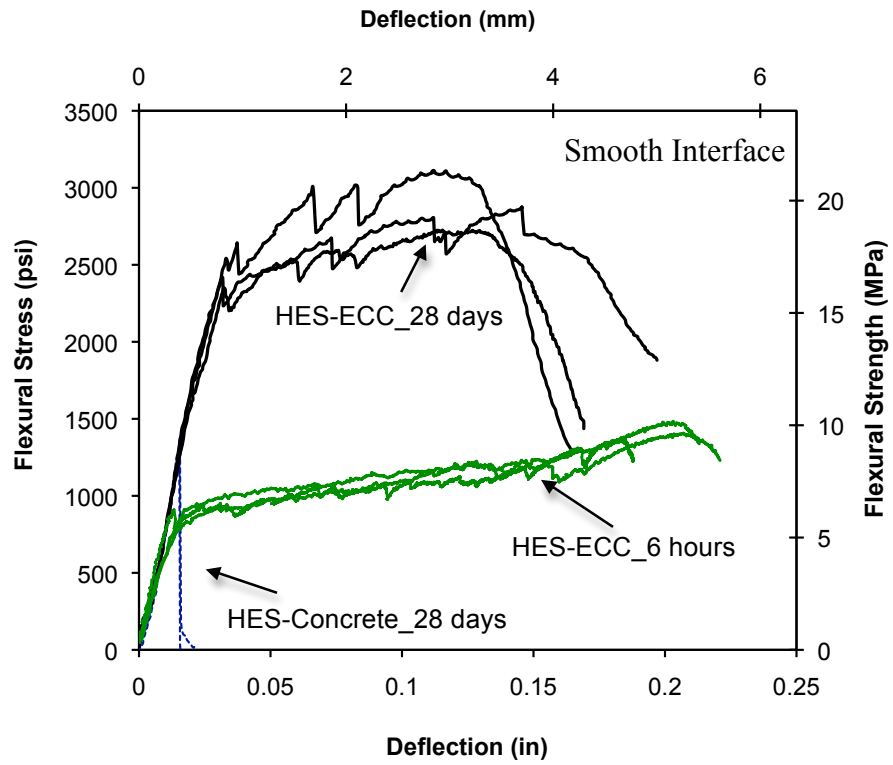
Figure 5.10 – Flexural behavior of HES-ECC and HES-Concrete layered repair system under monotonic loading: (a) smooth interface; (b) rough interface.

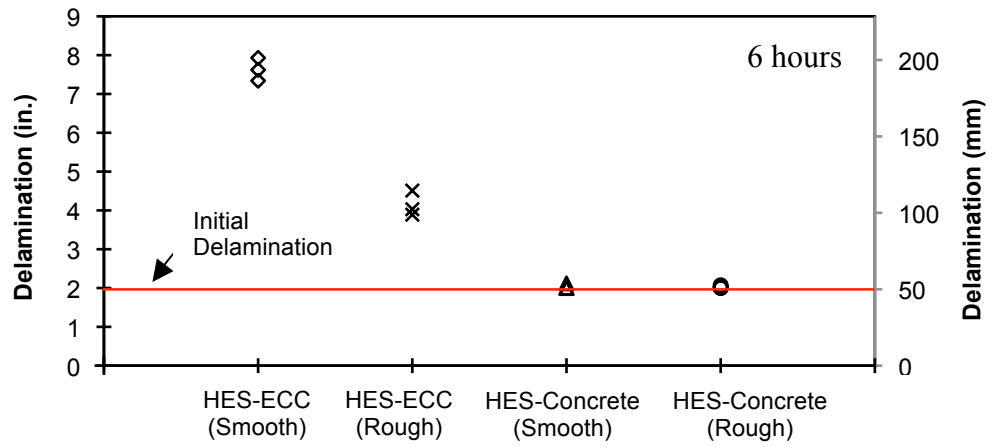
Figure 5.13 – Interfacial delamination upon failure of HES-ECC and HES-Concrete overlay systems under monotonic loading. (a) Overlay age of 6 hours. (b) Overlay age of 28 days.

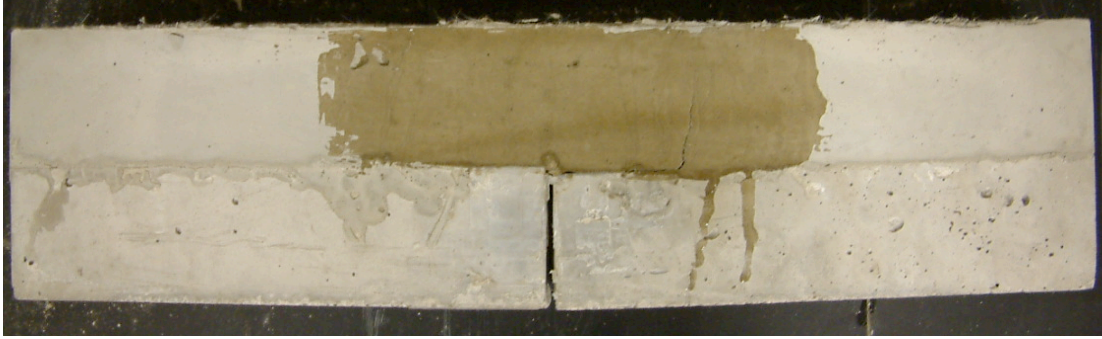
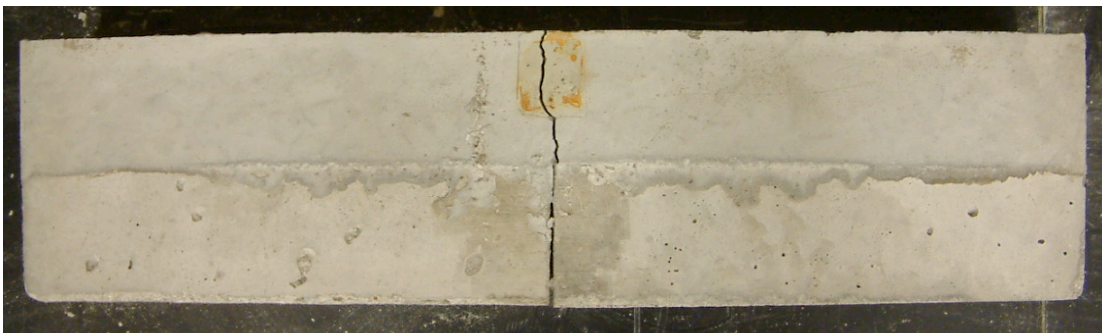
Figure 5.14 – Crack pattern of HES-ECC and HES-Concrete overlay systems at overlay age of 28 days. Epoxy glue was spread over the cracking sections of HES-ECC overlays (a) and (b), to better visually reveal multiple microcracking.

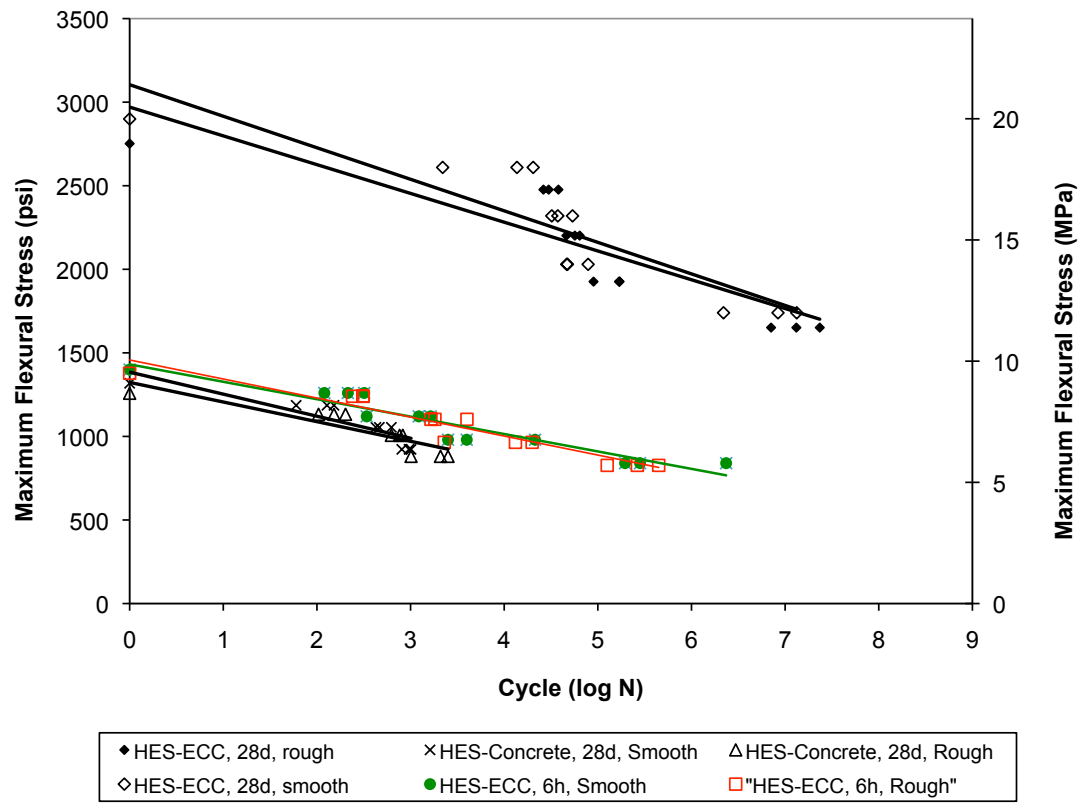
Figure 5.15 – Fatigue stress-fatigue life relation (log) for HES-ECC and HES-Concrete overlay systems.

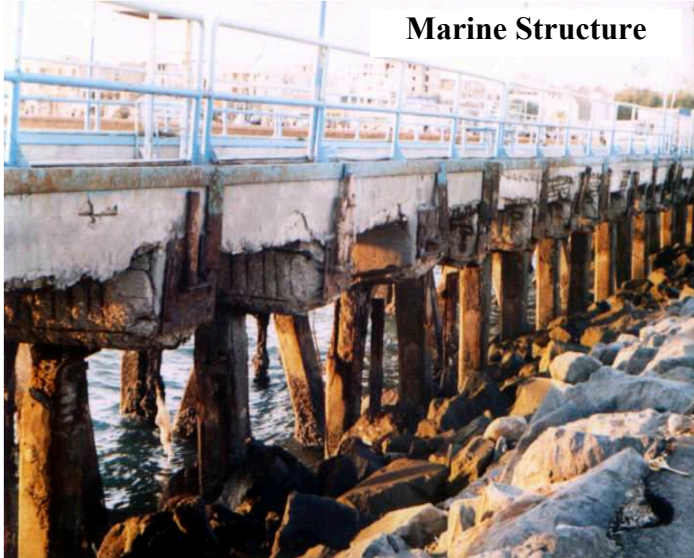
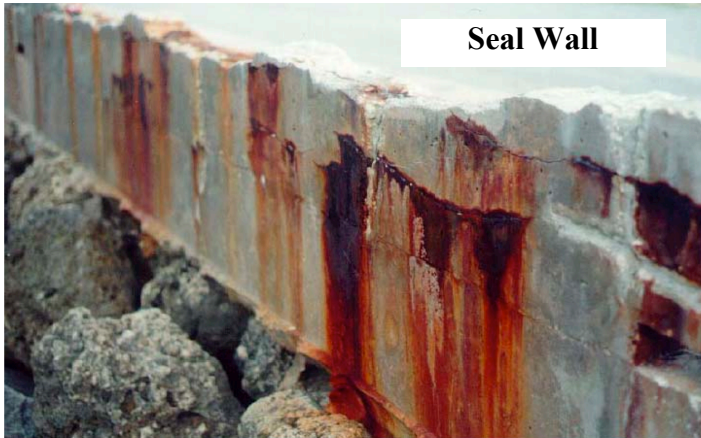
Figure 6.1 – Corrosion in Concrete Structures.

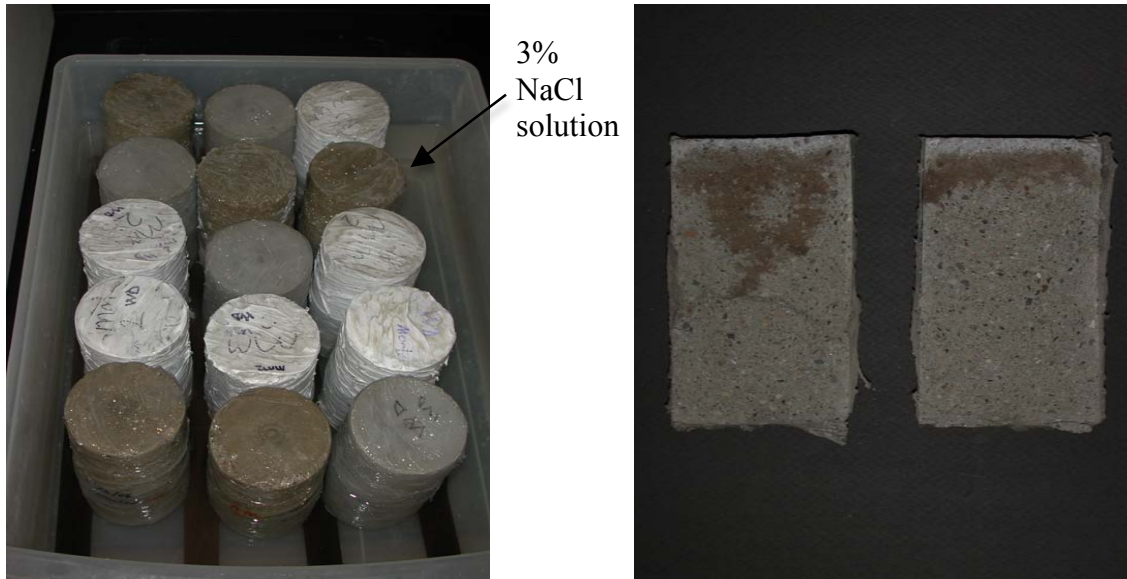
Figure 6.5 – Immersion test. (a) Cylinders were stored under continuous exposure to 3% NaCl solution. (b) One cylinder was taken out, split open, and sprayed with 0.1-N silver nitrate ( $\text{AgNO}_3$ ) solution, to measure the chloride penetration depth.

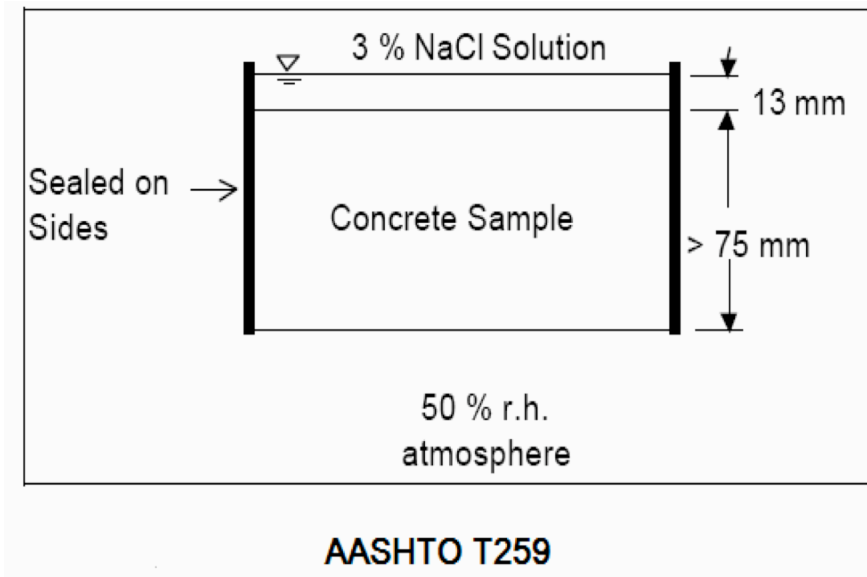
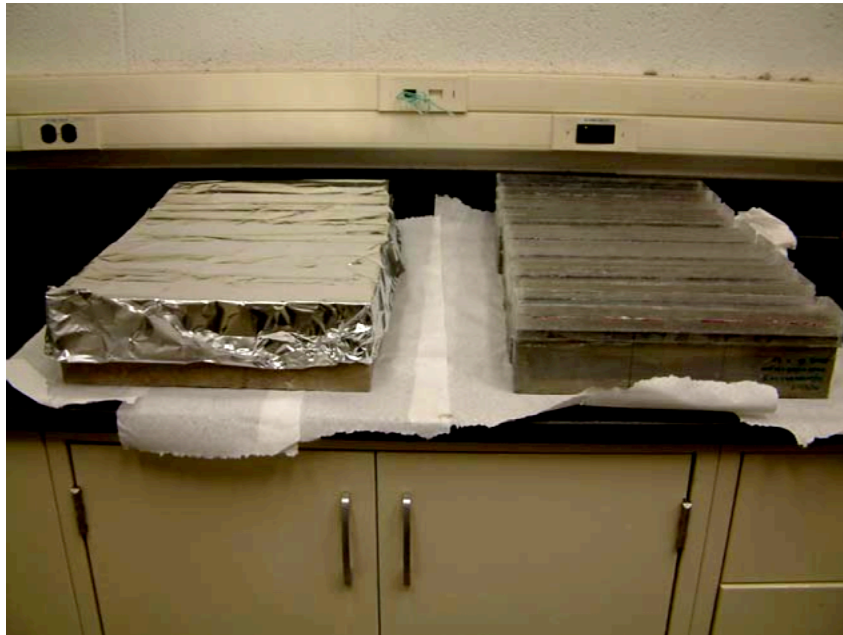
Figure 6.7 – Salt ponding test on uncracked and cracked beam specimens with dimensions of 355.6 mm x 50.8 mm x 76.2 mm (14 in. x 2 in. x 3 in.).

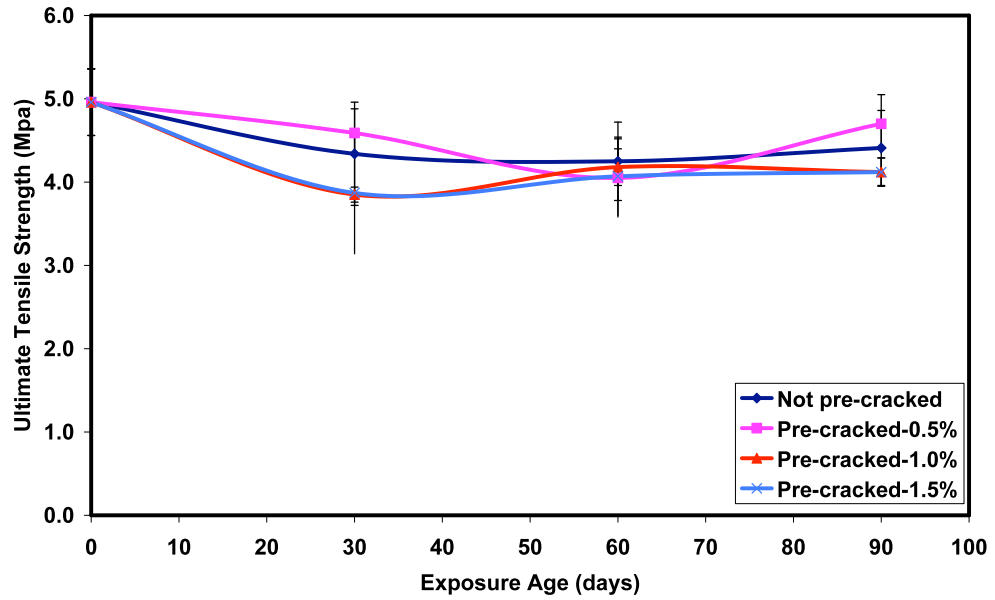
Figure 7.4 – Influence of NaCl exposure time and applied strain level on ECC ultimate tensile strength.

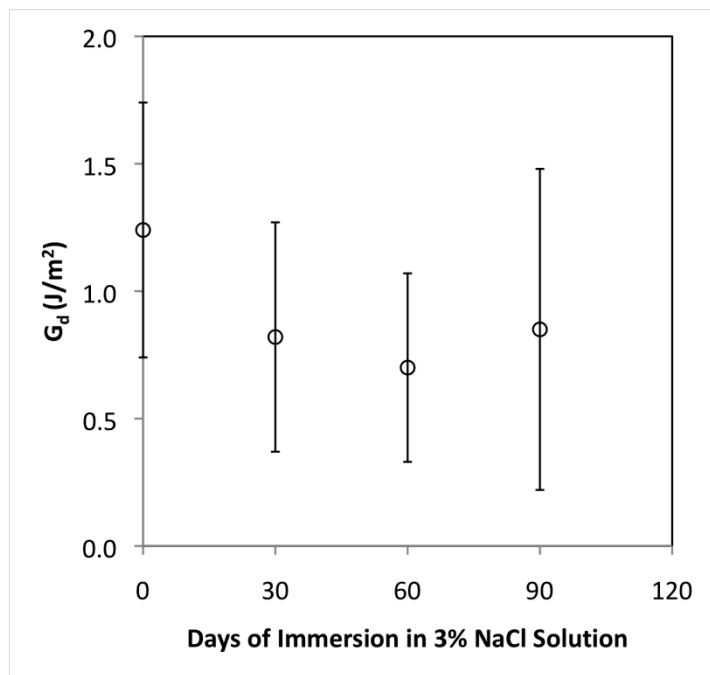
Figure 7.7 – Influence of NaCl solution exposure time on ECC matrix/fiber interfacial chemical bond.
