University of Michigan
Department of Mechanical Engineering
Cavitation and Multiphase Flow Laboratory

Report No. UMICH 014456-45-I

Influence of Cavitation Erosion on Corrosion Fatigue
and Effects of
Resistance to that Influence by the Surface Coatings

June, 1979

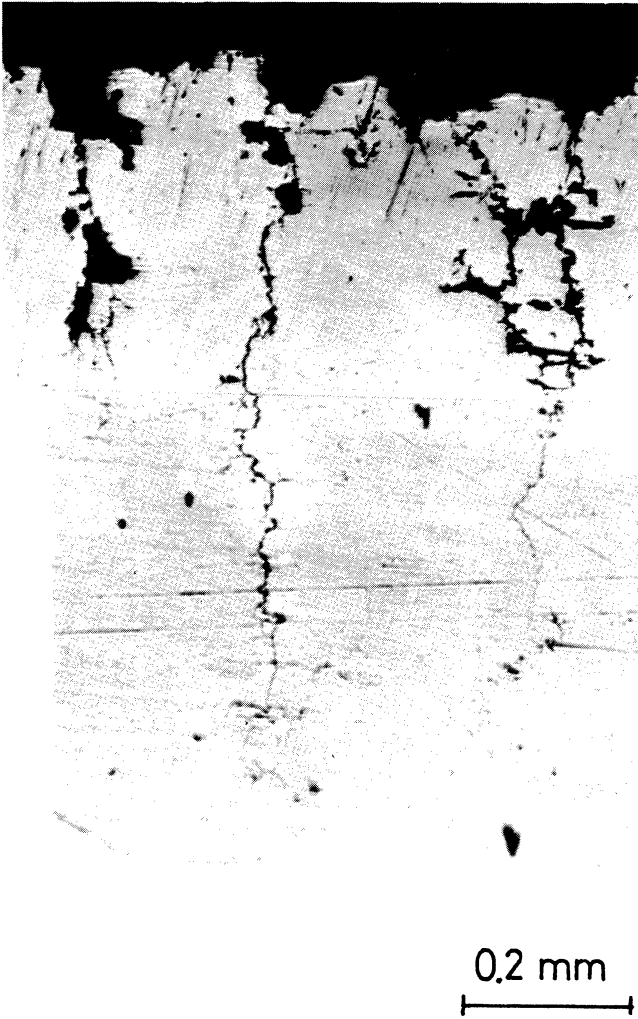
Fig.9 Examples of cracks

(a) Erosion area

(b) Corrosion area

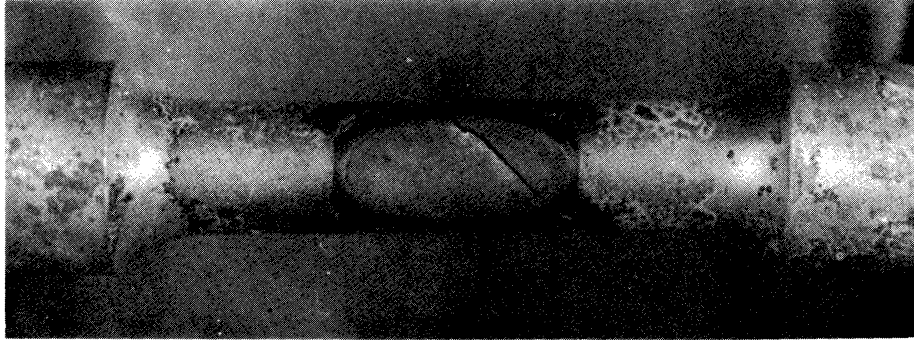
Fig.23 Fracture in erosion fatigue

Zincified S35C test piece,
 $\tau_a=15.0 \text{ Kg/mm}^2$, $h=0.5 \text{ mm}$,
 $N=1.95 \times 10^6$

Tinned S35C test piece,
 $\tau_a=11.0 \text{ Kg/mm}^2$, $h=0.5 \text{ mm}$,
 $N=6.84 \times 10^6$

Some examples of the surfaces of plated test pieces after under cavitation erosion fatigue test runs are shown in Fig. 23. An elliptical area with a major axis of about 16mm is quickly eroded by cavitation and the plating layer is broken down. Moreover, in the zincified test piece, a corrosion resistance area in the form of a ring of 1-2mm width appears around the eroded area, but the surface of the ring area is the base matrix because the zinc layer is dissolved. The zinc layer adjacent to the ring area is also gradually corroded with the increase of the test duration. When the zinc layer is entirely dissolved, the effect of the sacrificial anode is lost and red rust appears on the surface of the matrix. On the tinned test piece, a copper band around the elliptical area appears as the corrosion resistance area. Furthermore, another band of 1-2 mm width around the copper layer is remarkably corroded. Outside this area, the tin layer remains complete and protects the matrix.
