UM - HSRI-77-25

FEMUR IMPACT STUDY

FINAL REPORT
MAY 26, 1977

THE UNIVERSITY OF MICHIGAN
HIGHWAY SAFETY RESEARCH INSTITUTE

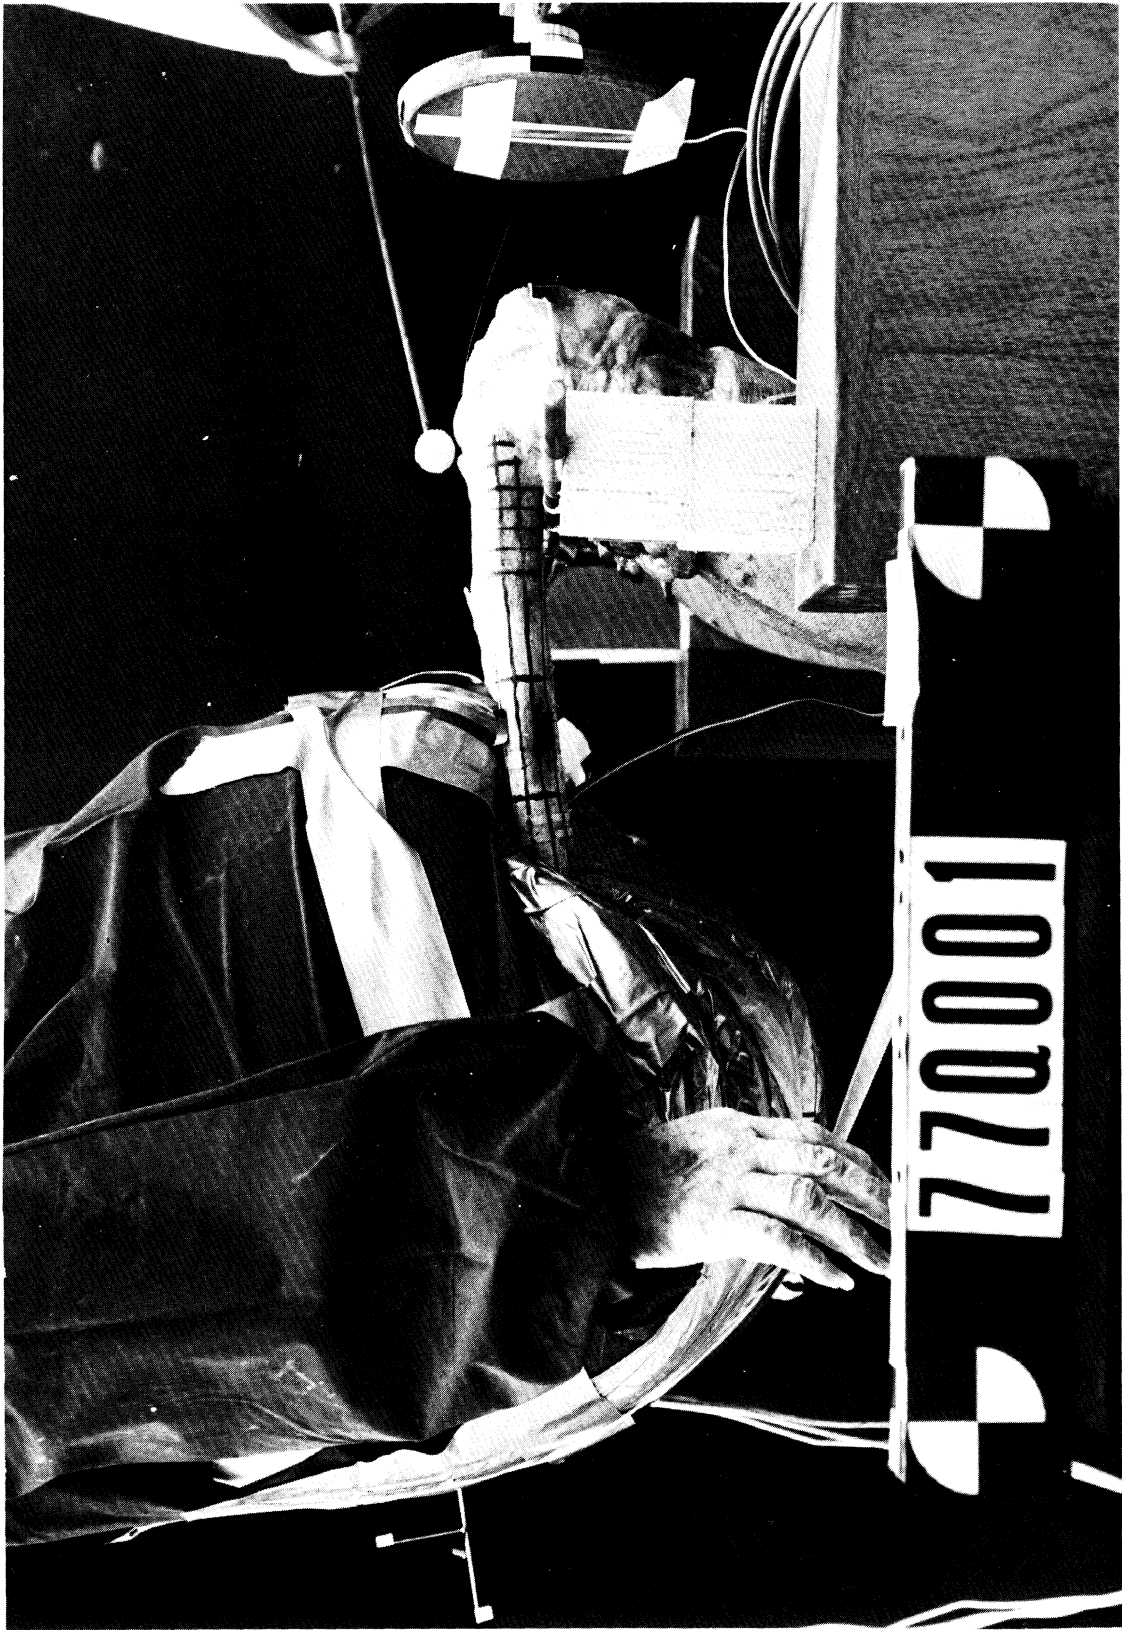
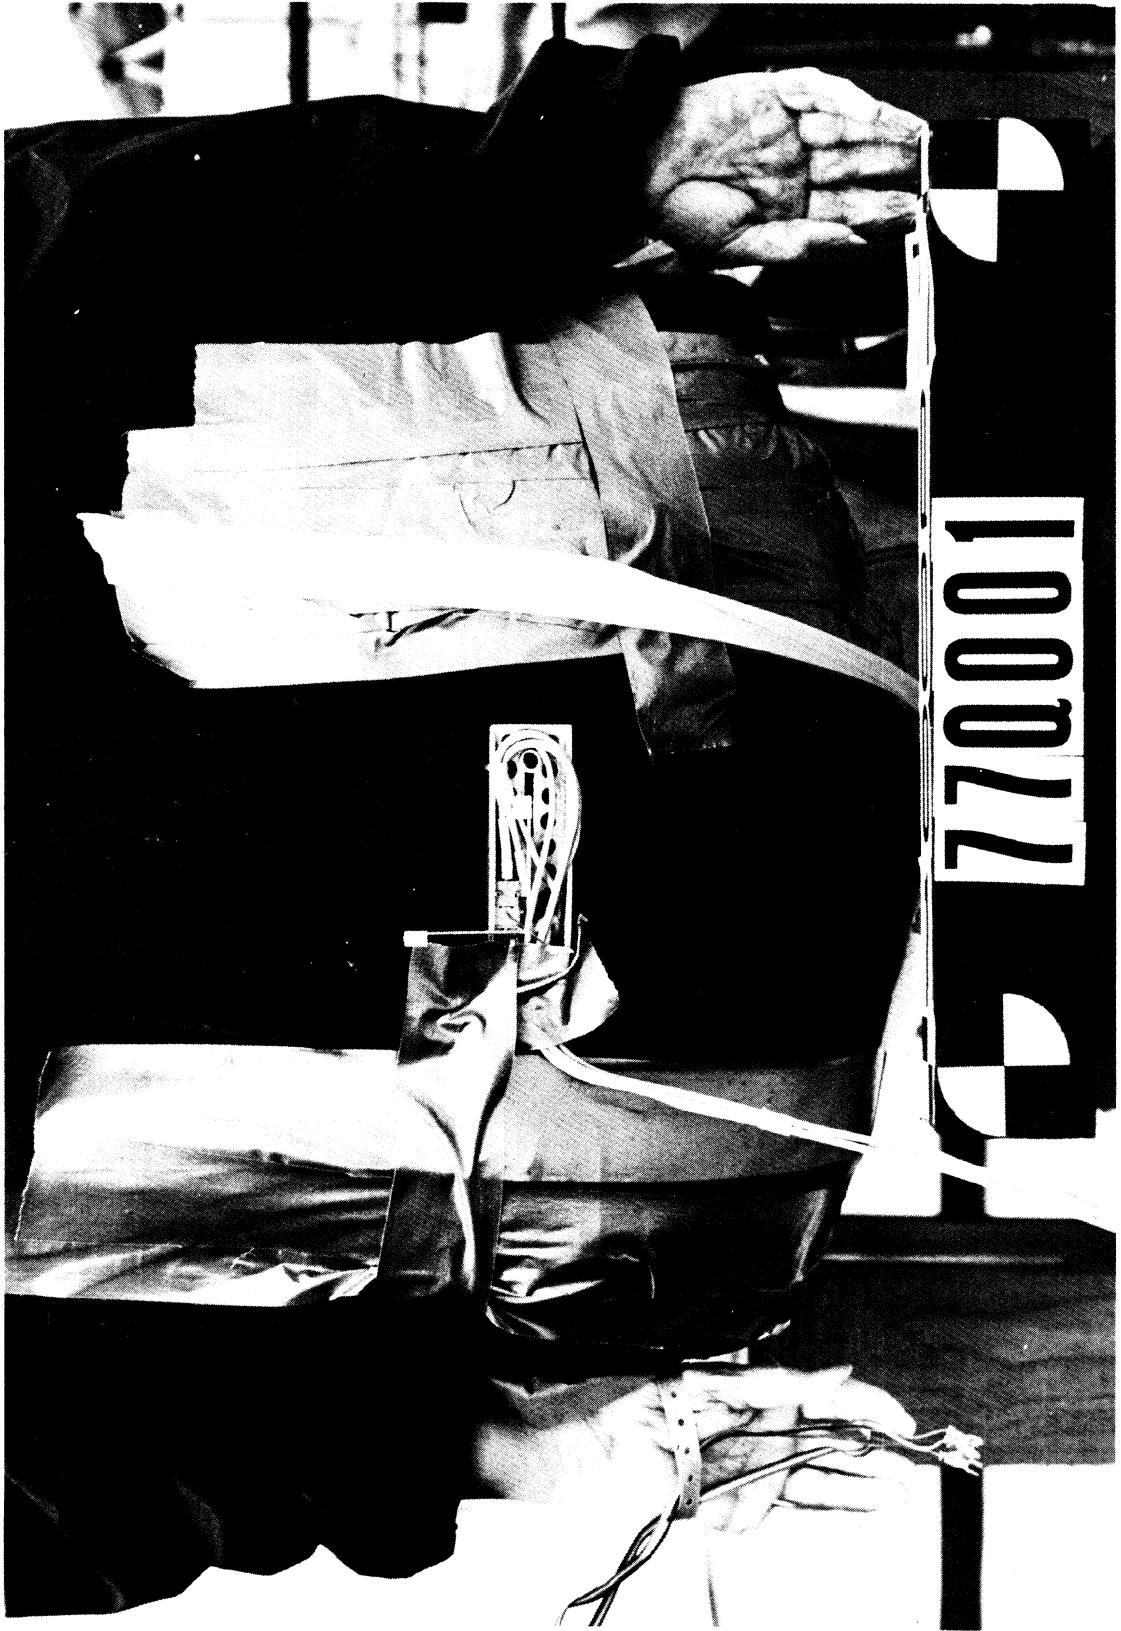
TEST NO. 77Q001 Rt.

TEST DESCRIPTION: This test was conducted as outlined in the text. The
femur was left exposed in the air seven hours with no care taken
to prevent drying.

The midshaft was fractured and the patella was shattered.

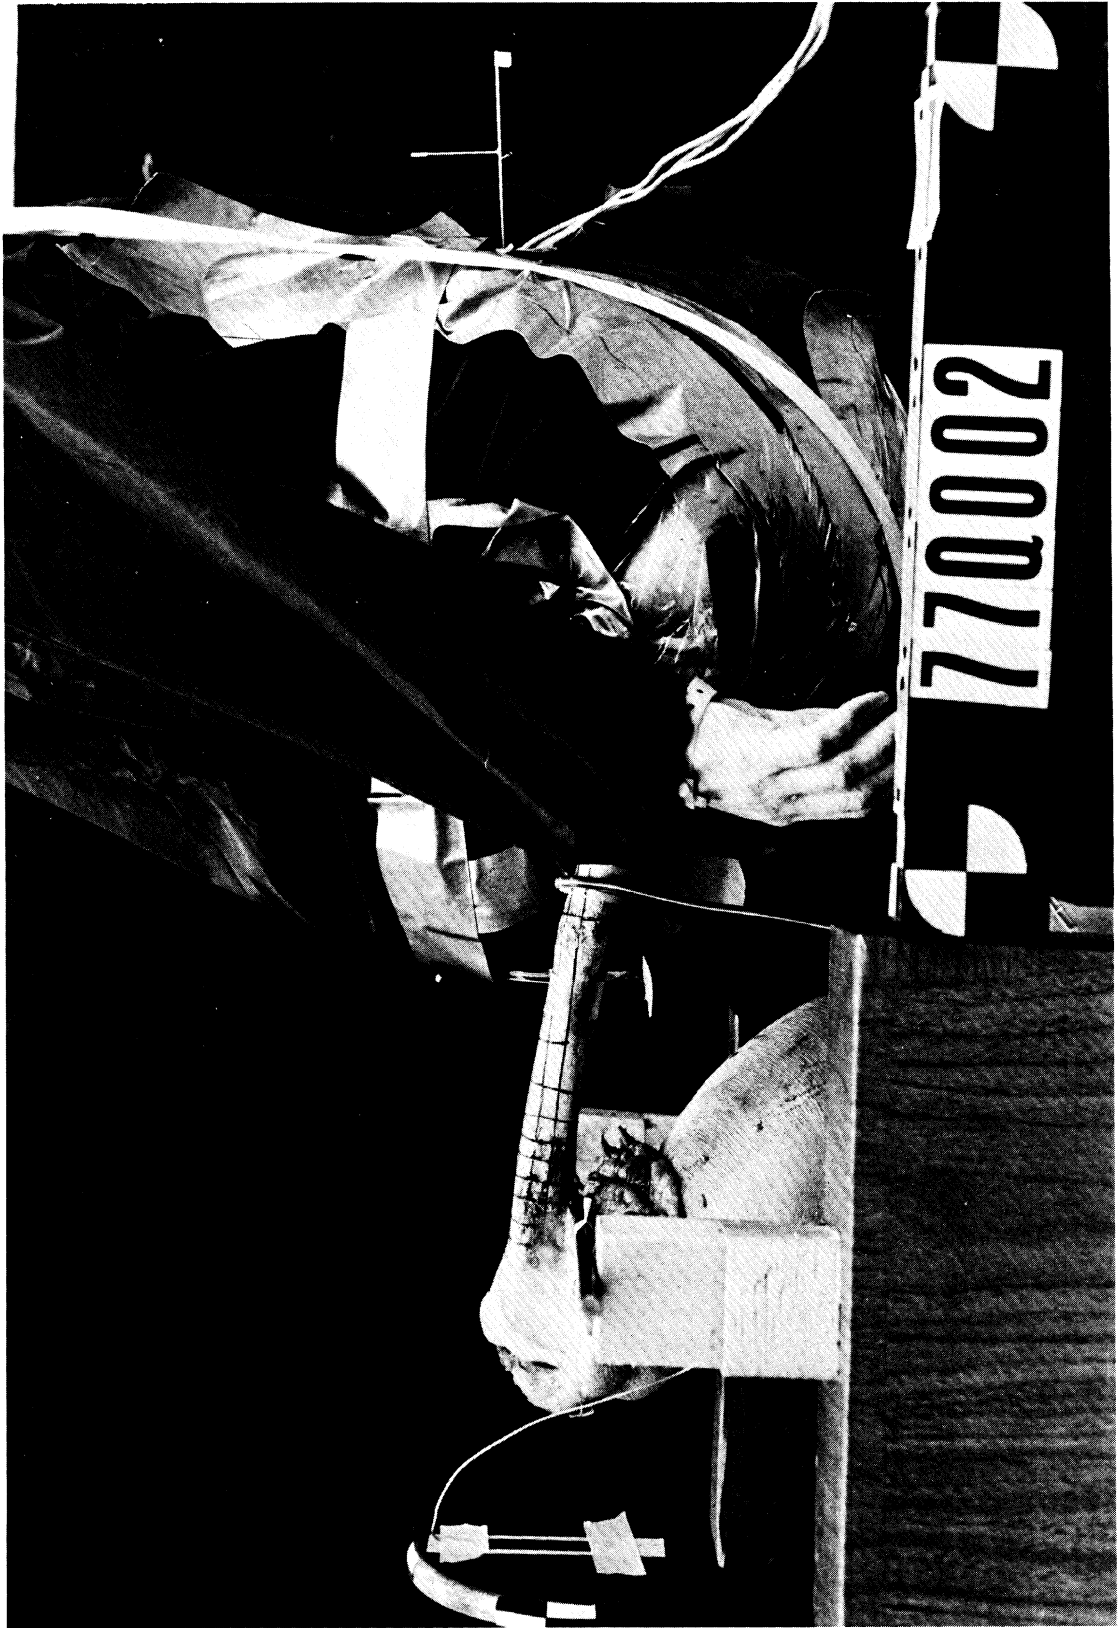
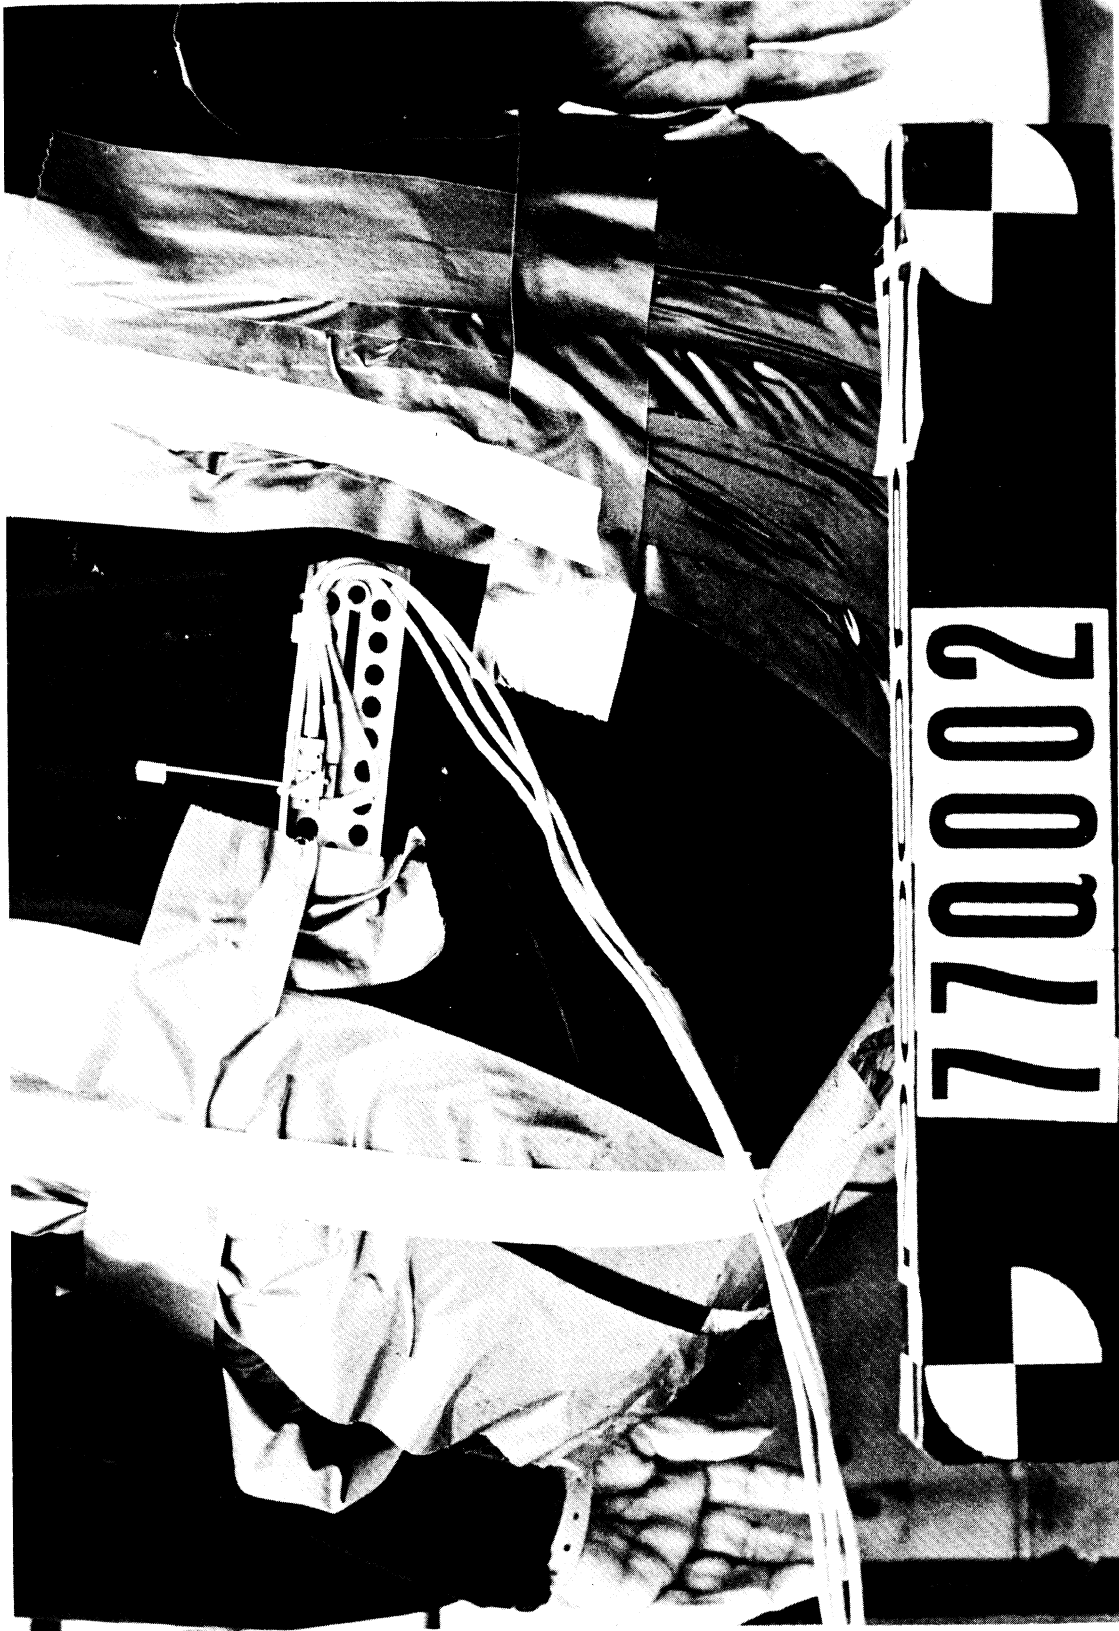
TEST NO. 77Q002 Lt.

TEST DESCRIPTION: Same as 77Q001

The midshaft and patella were fractured.

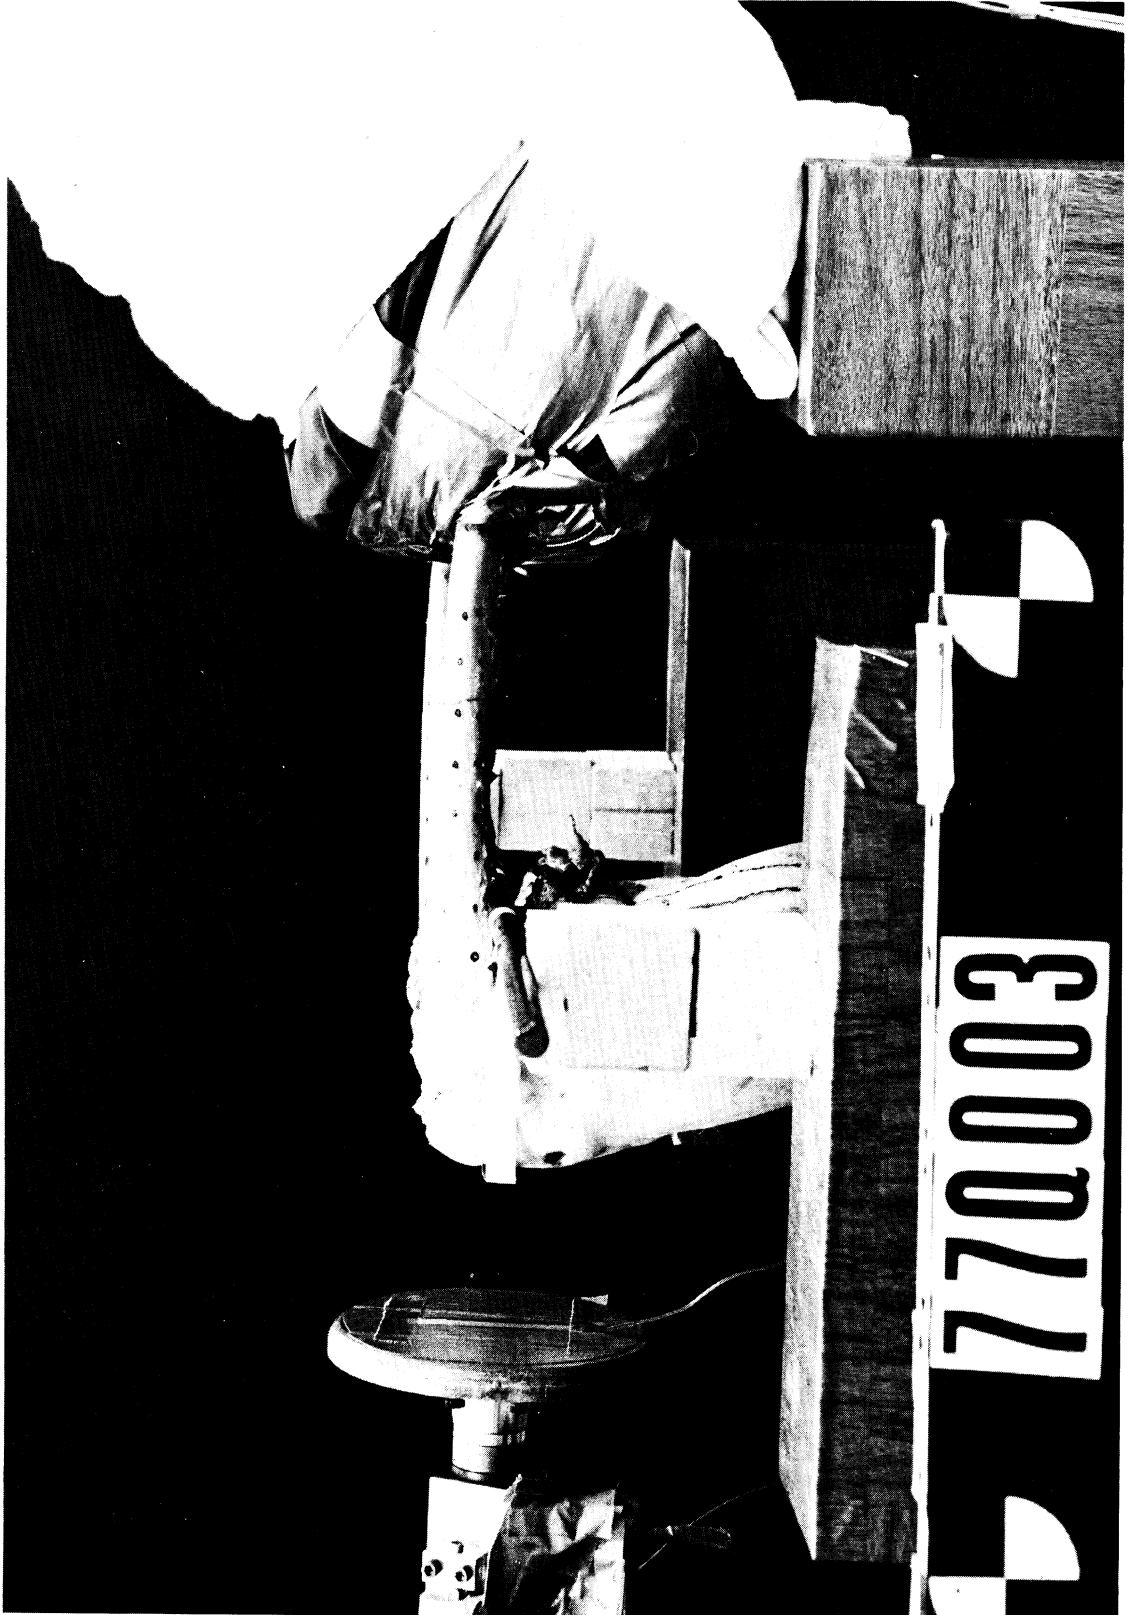
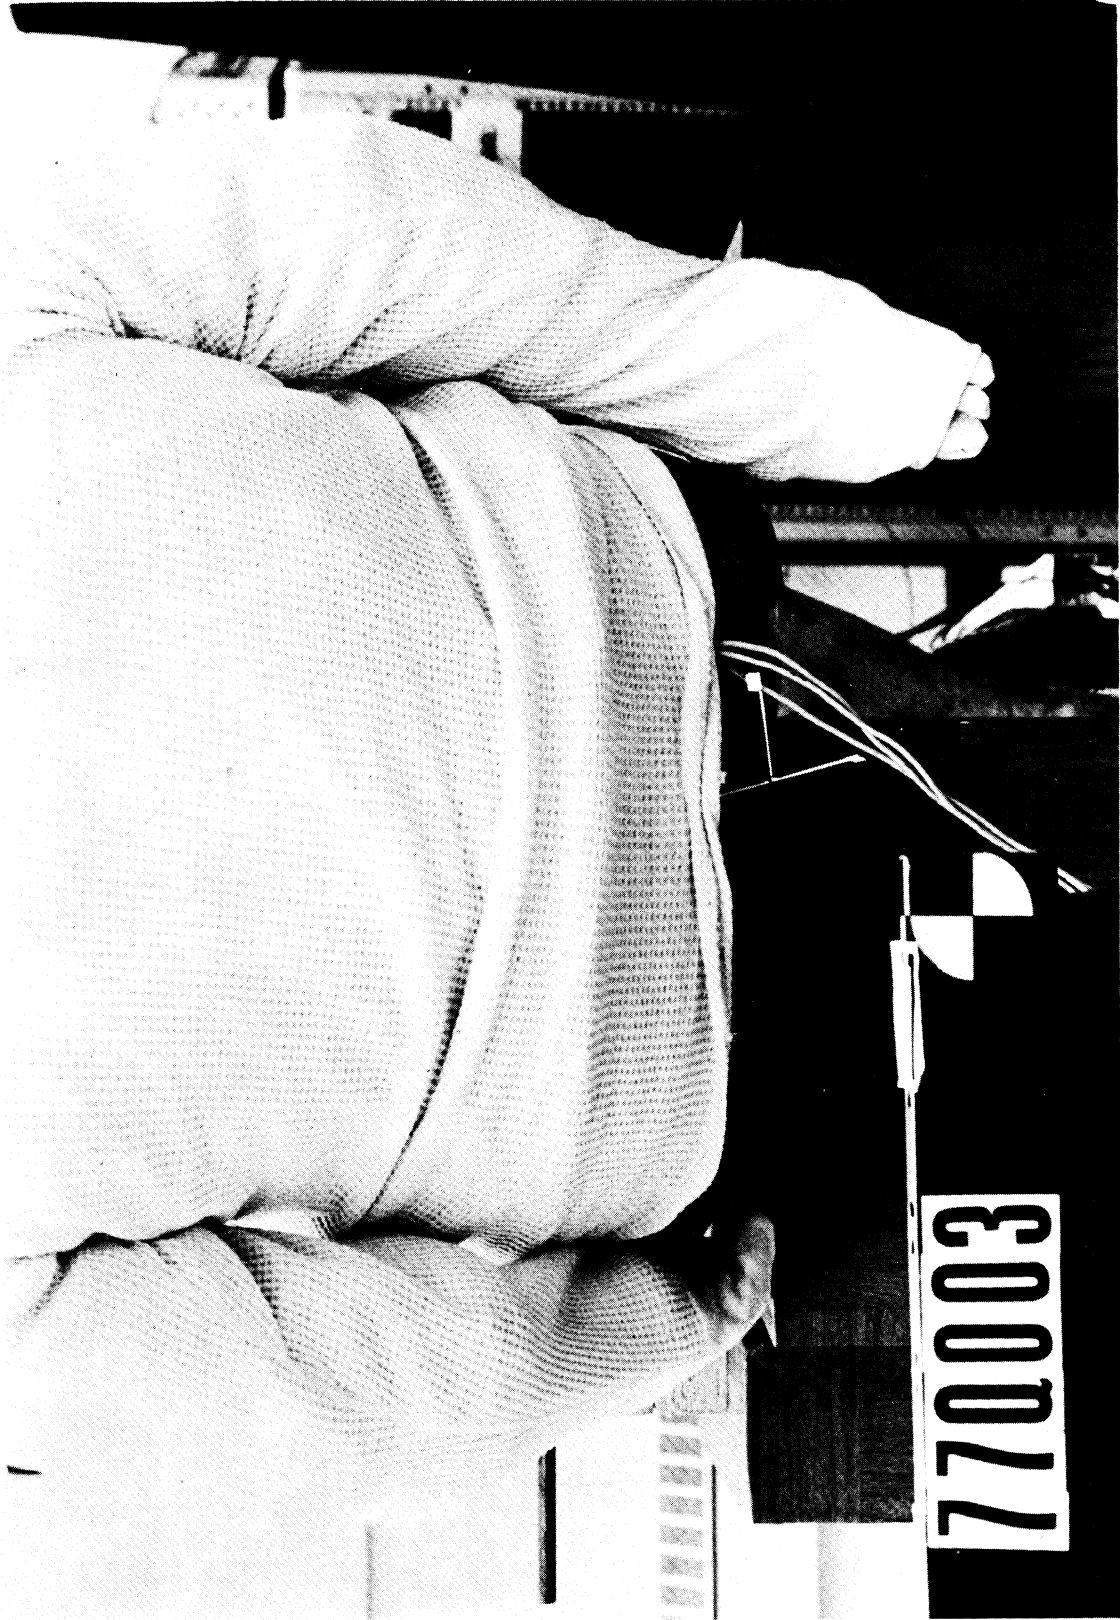
TEST NO. 77Q003 Lt.

TEST DESCRIPTION: No strain gages were used in this test because it was
assumed that the femurs in tests 77Q001 and 77Q002 dried out while
the gages were being put on. The femur was coated with vaseline
as soon as the muscle was removed, so as to prevent drying.

The midshaft and neck of the femur were fractured. The patella
was shattered.

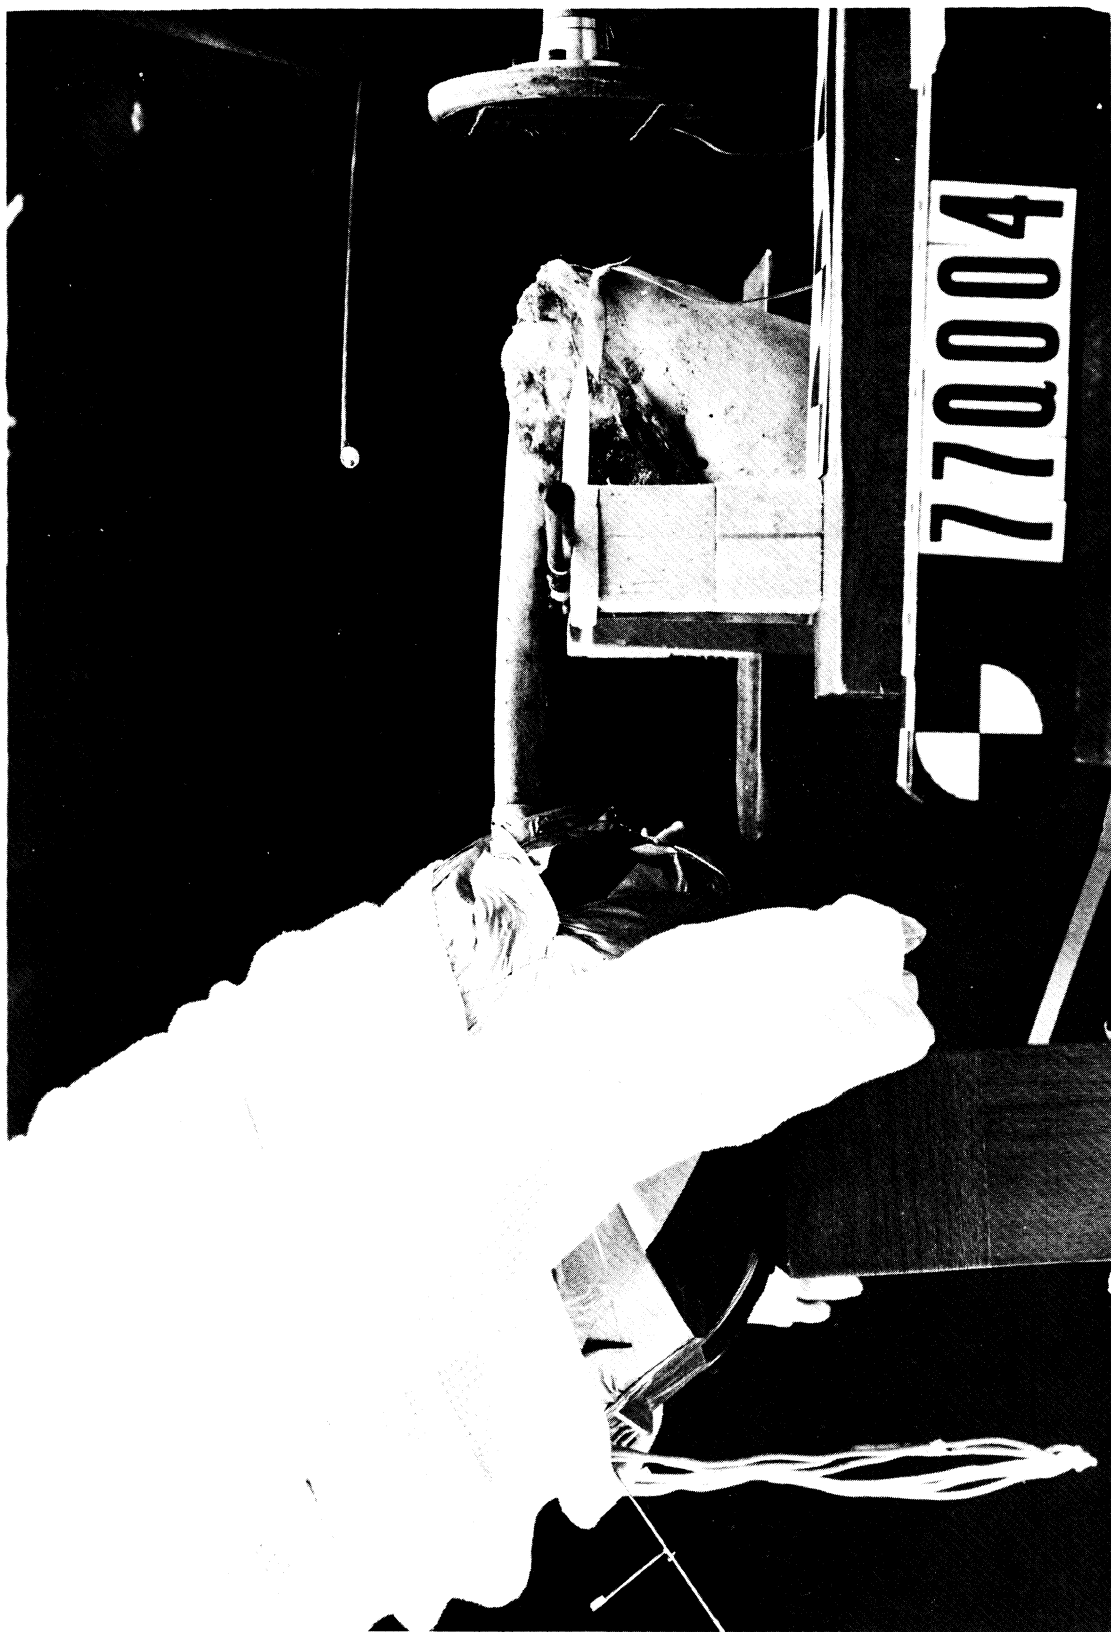
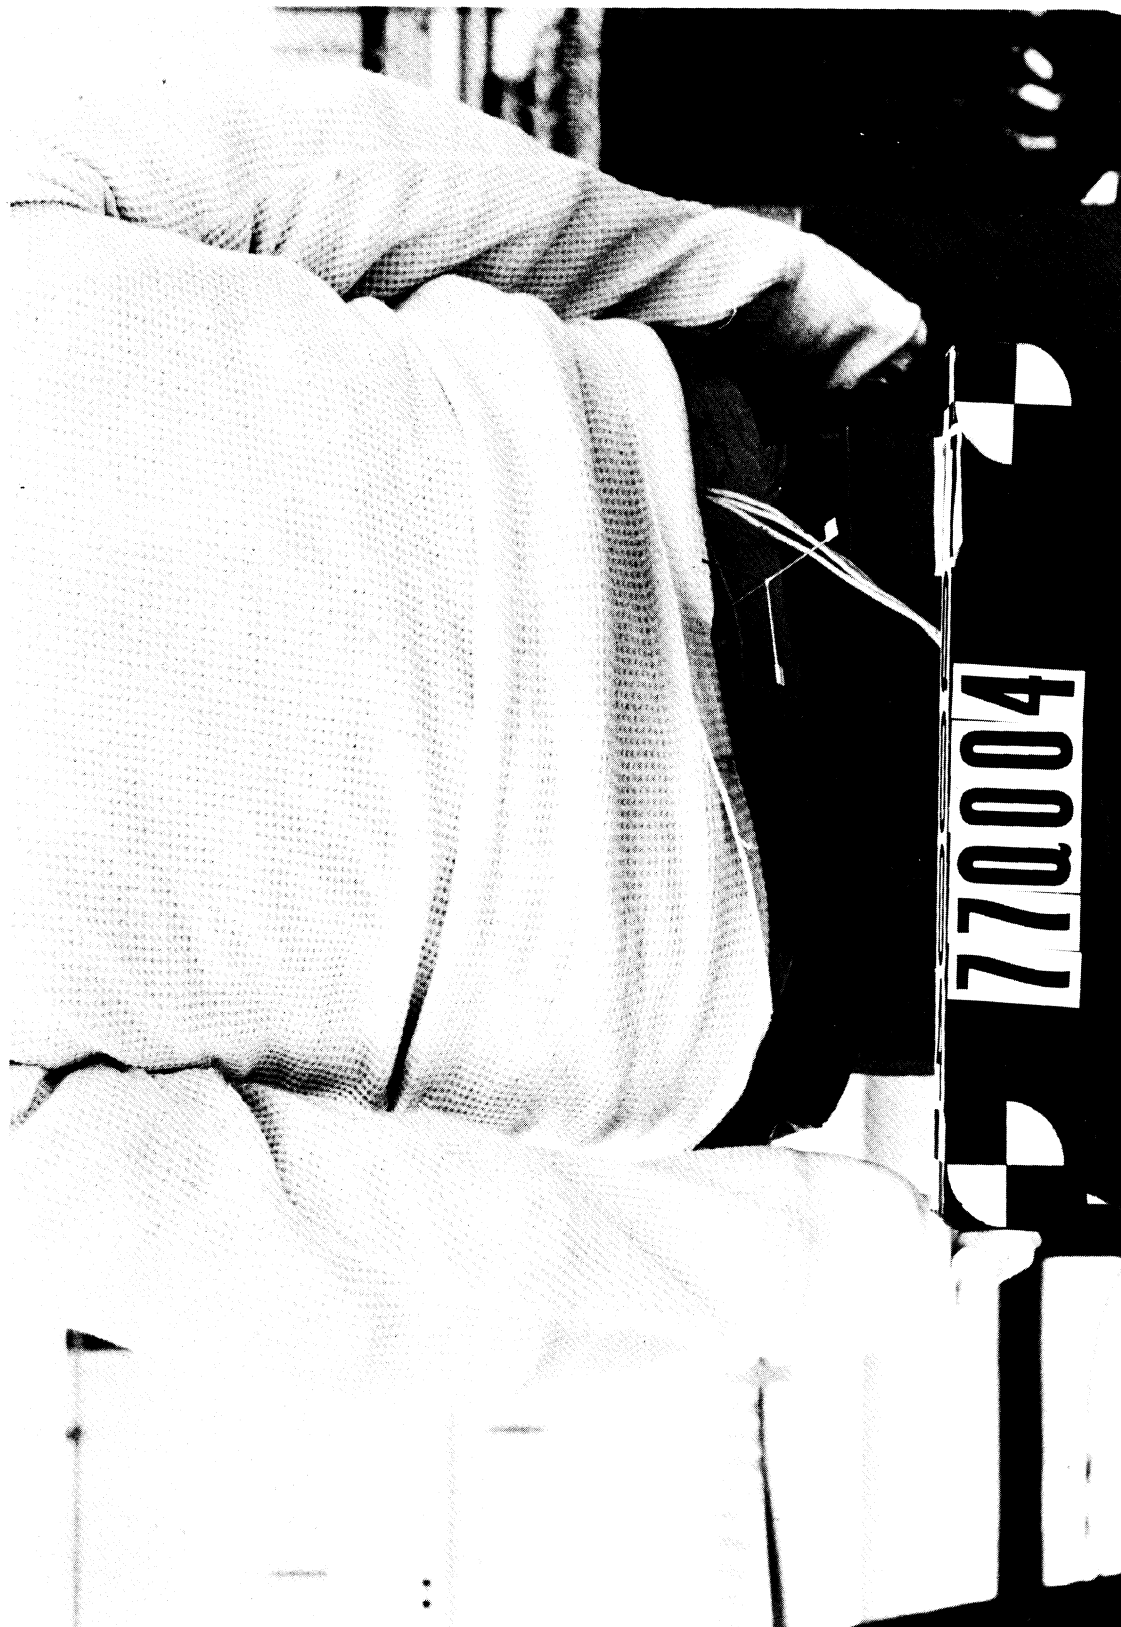
TEST NO. 77Q004 Rt

TEST DESCRIPTION: Same as 77Q003

The midshaft and neck of the femur were fractured. The patella was
shattered.

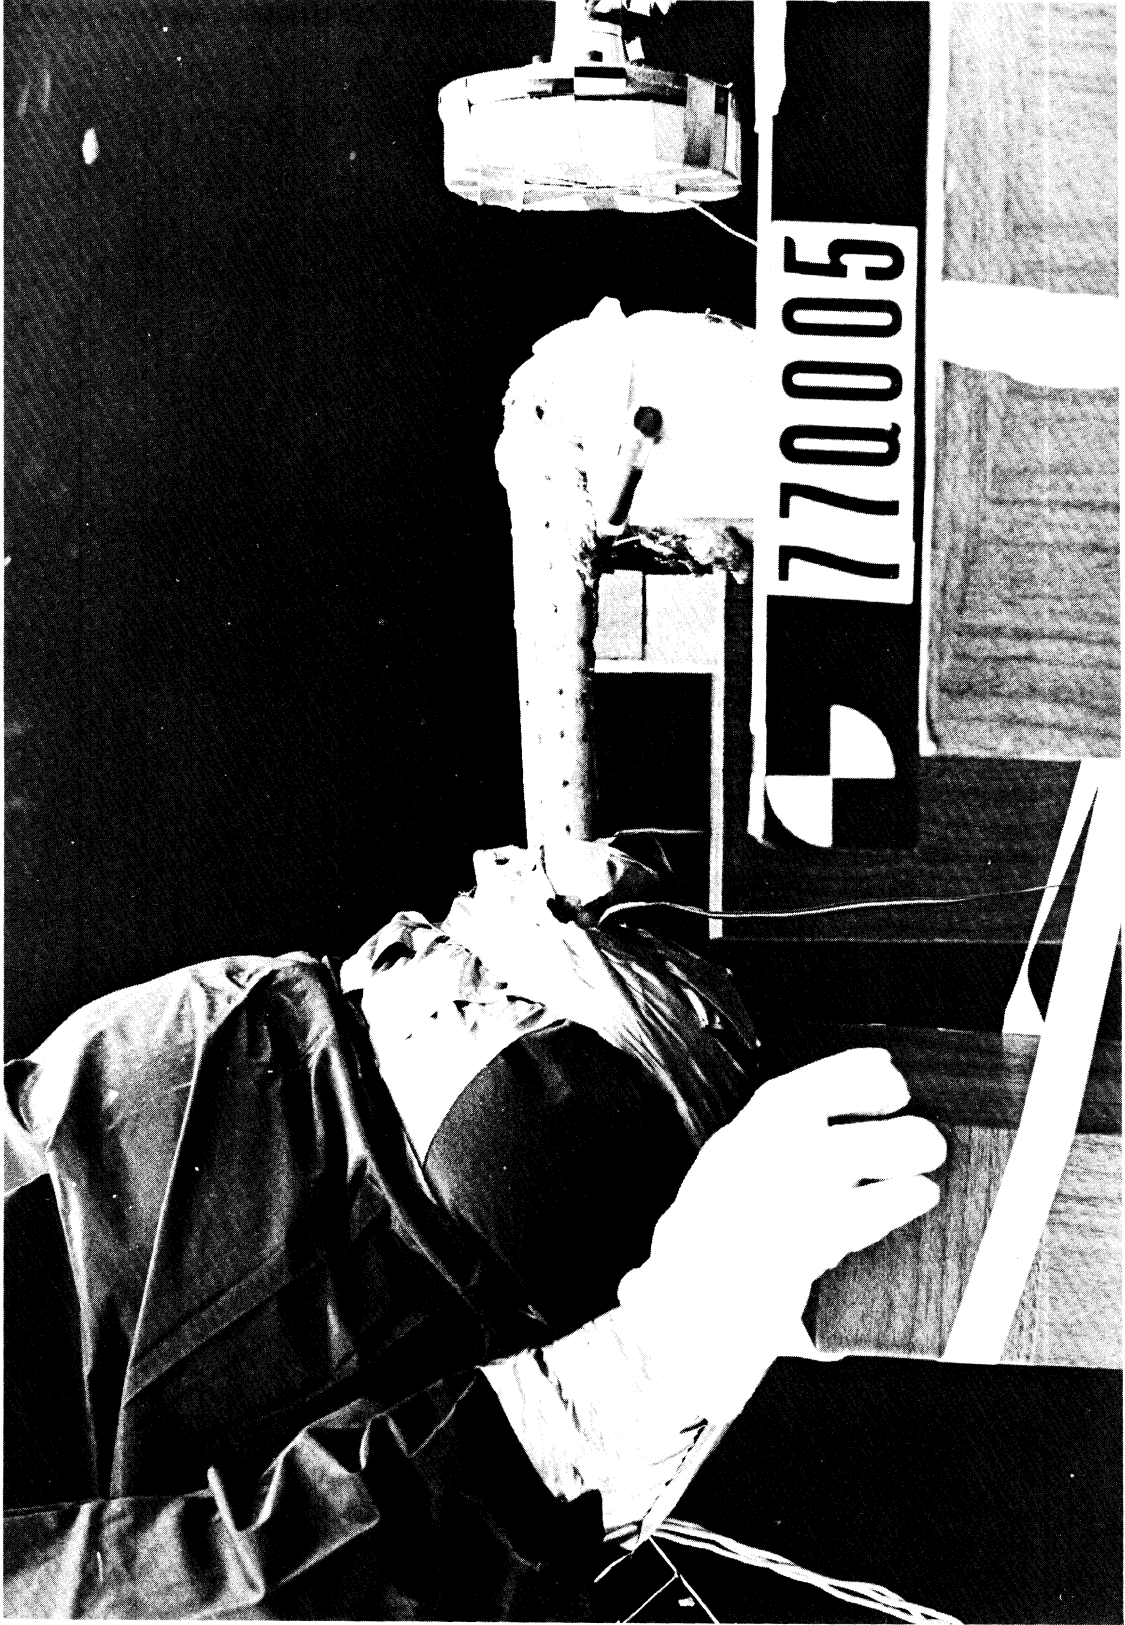
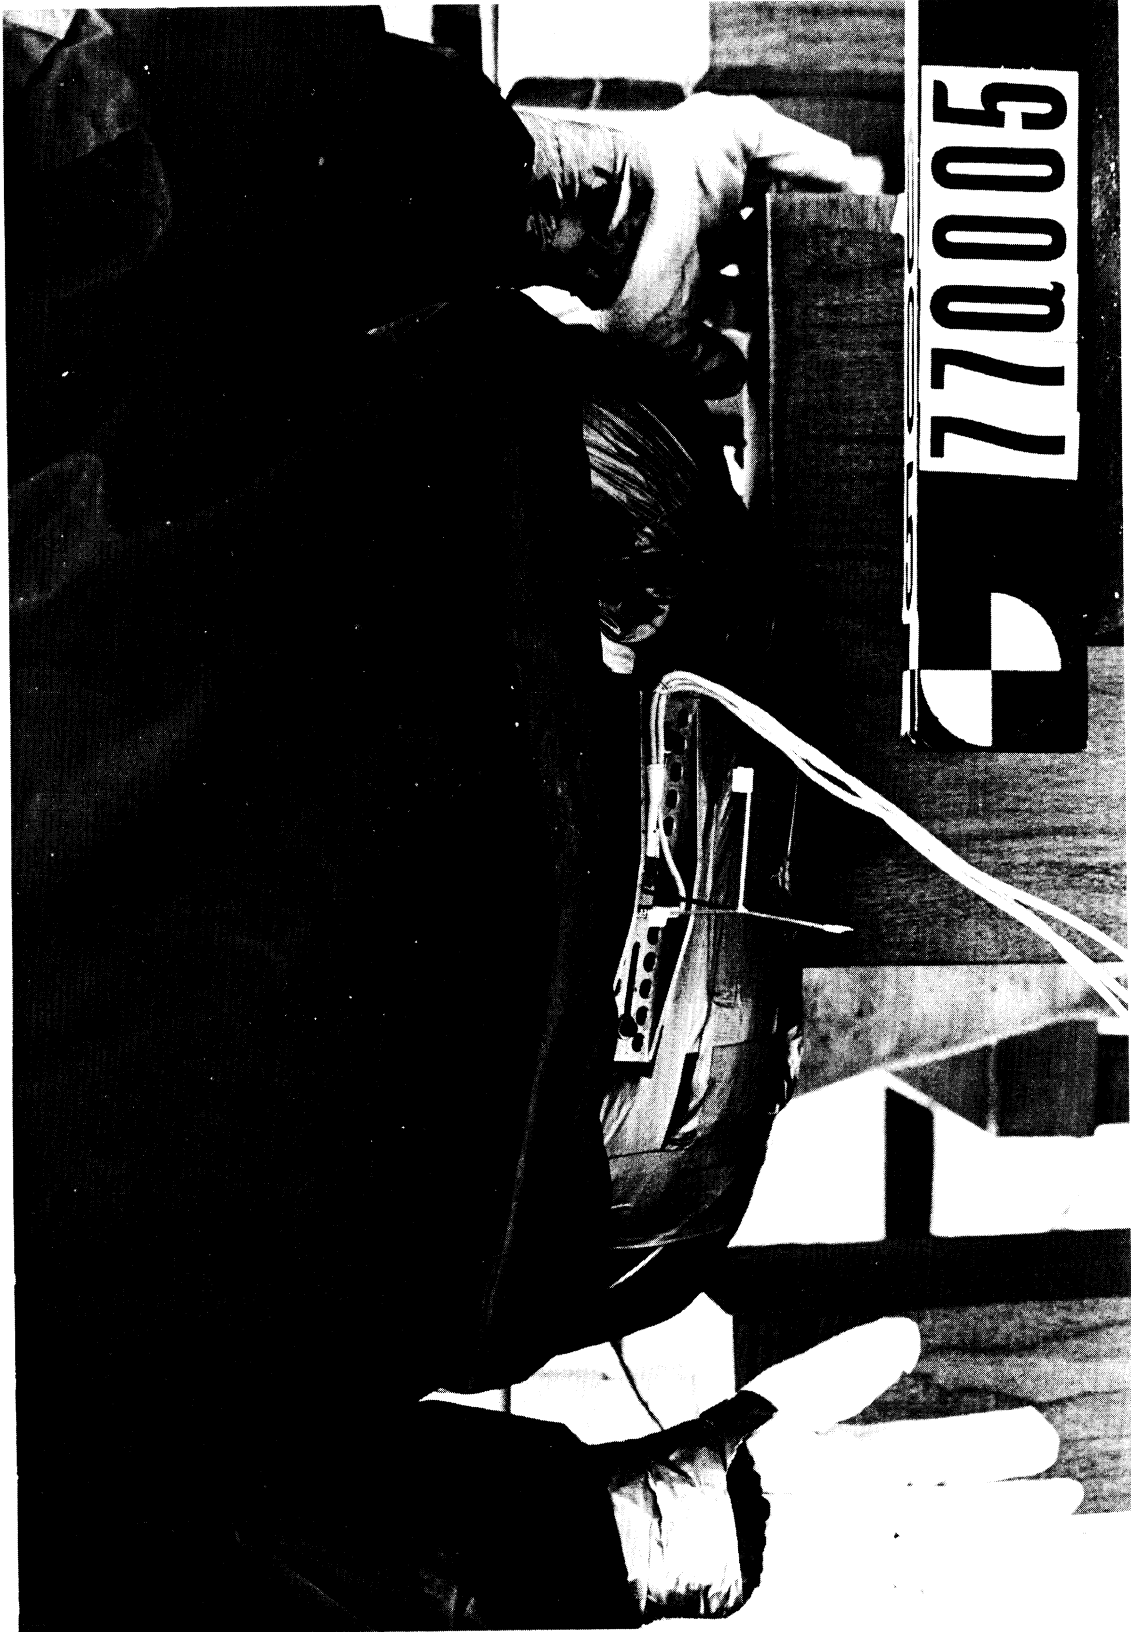
TEST NO. 77Q005 Rt.

TEST DESCRIPTION: This test was conducted as outlined in the text,
but great care was taken to keep the femur from drying out. Vaseline
and wet sponges were used to keep the bone moist.

Comminuted fractures of the condyles were produced. There was no
patella damage.

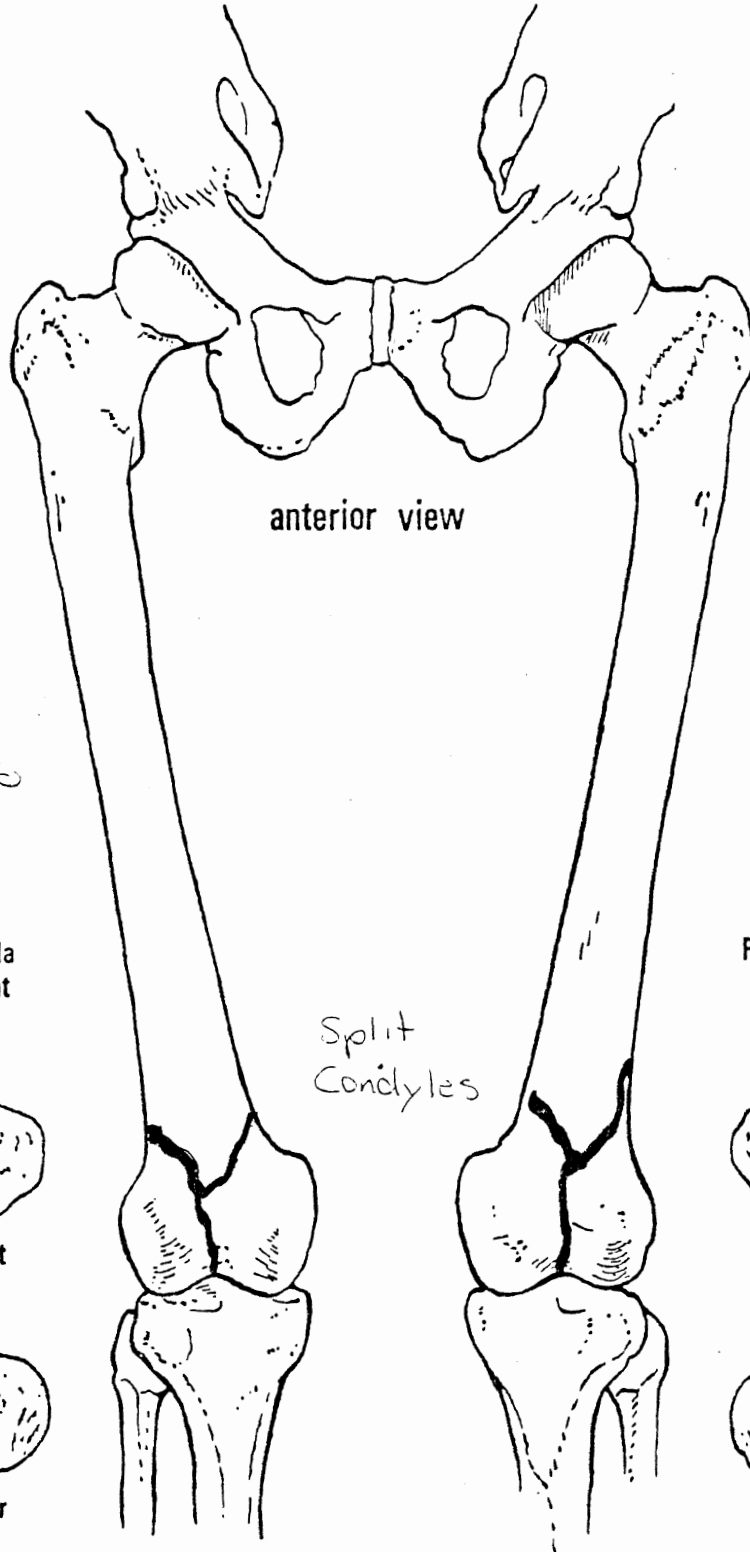
TEST NO. 77Q005-G
CADAVER NO. 20698
DATE 3-17-77

No Damage To
Patellas
