UM - HSRI-77-25

FEMUR IMPACT STUDY

FINAL REPORT
MAY 26, 1977

THE UNIVERSITY OF MICHIGAN
HIGHWAY SAFETY RESEARCH INSTITUTE

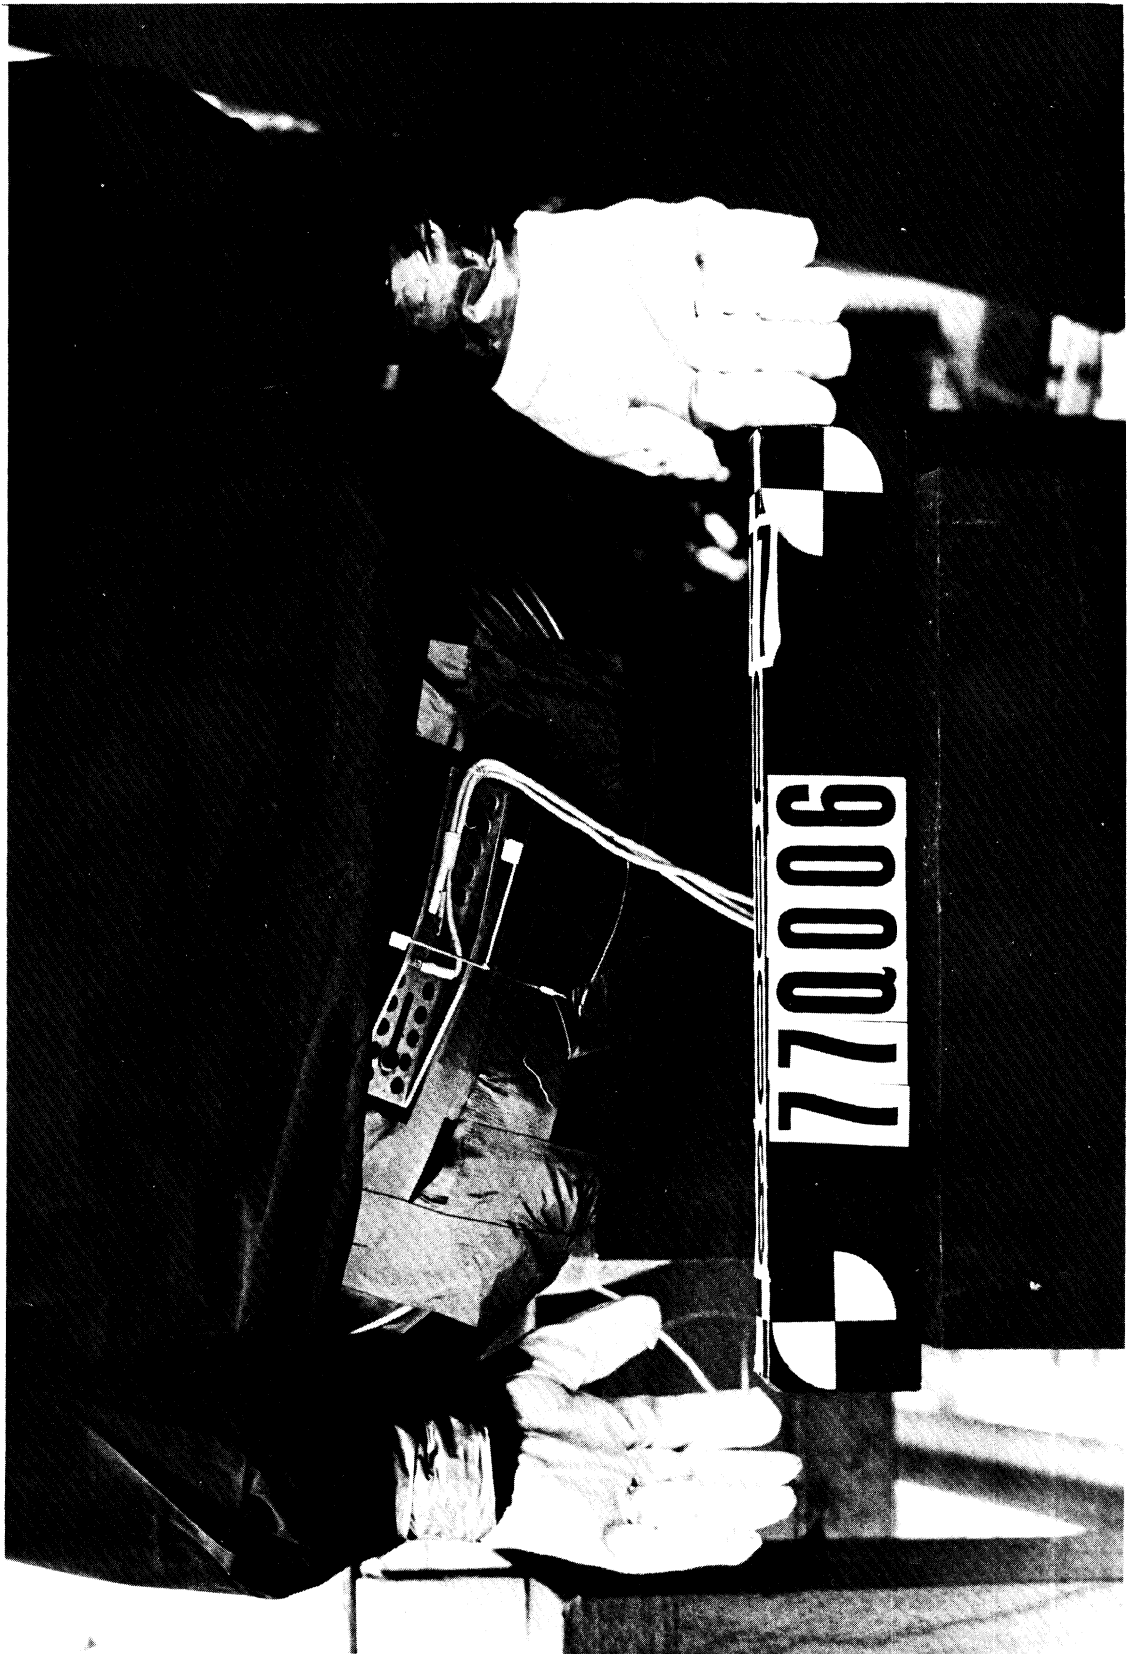
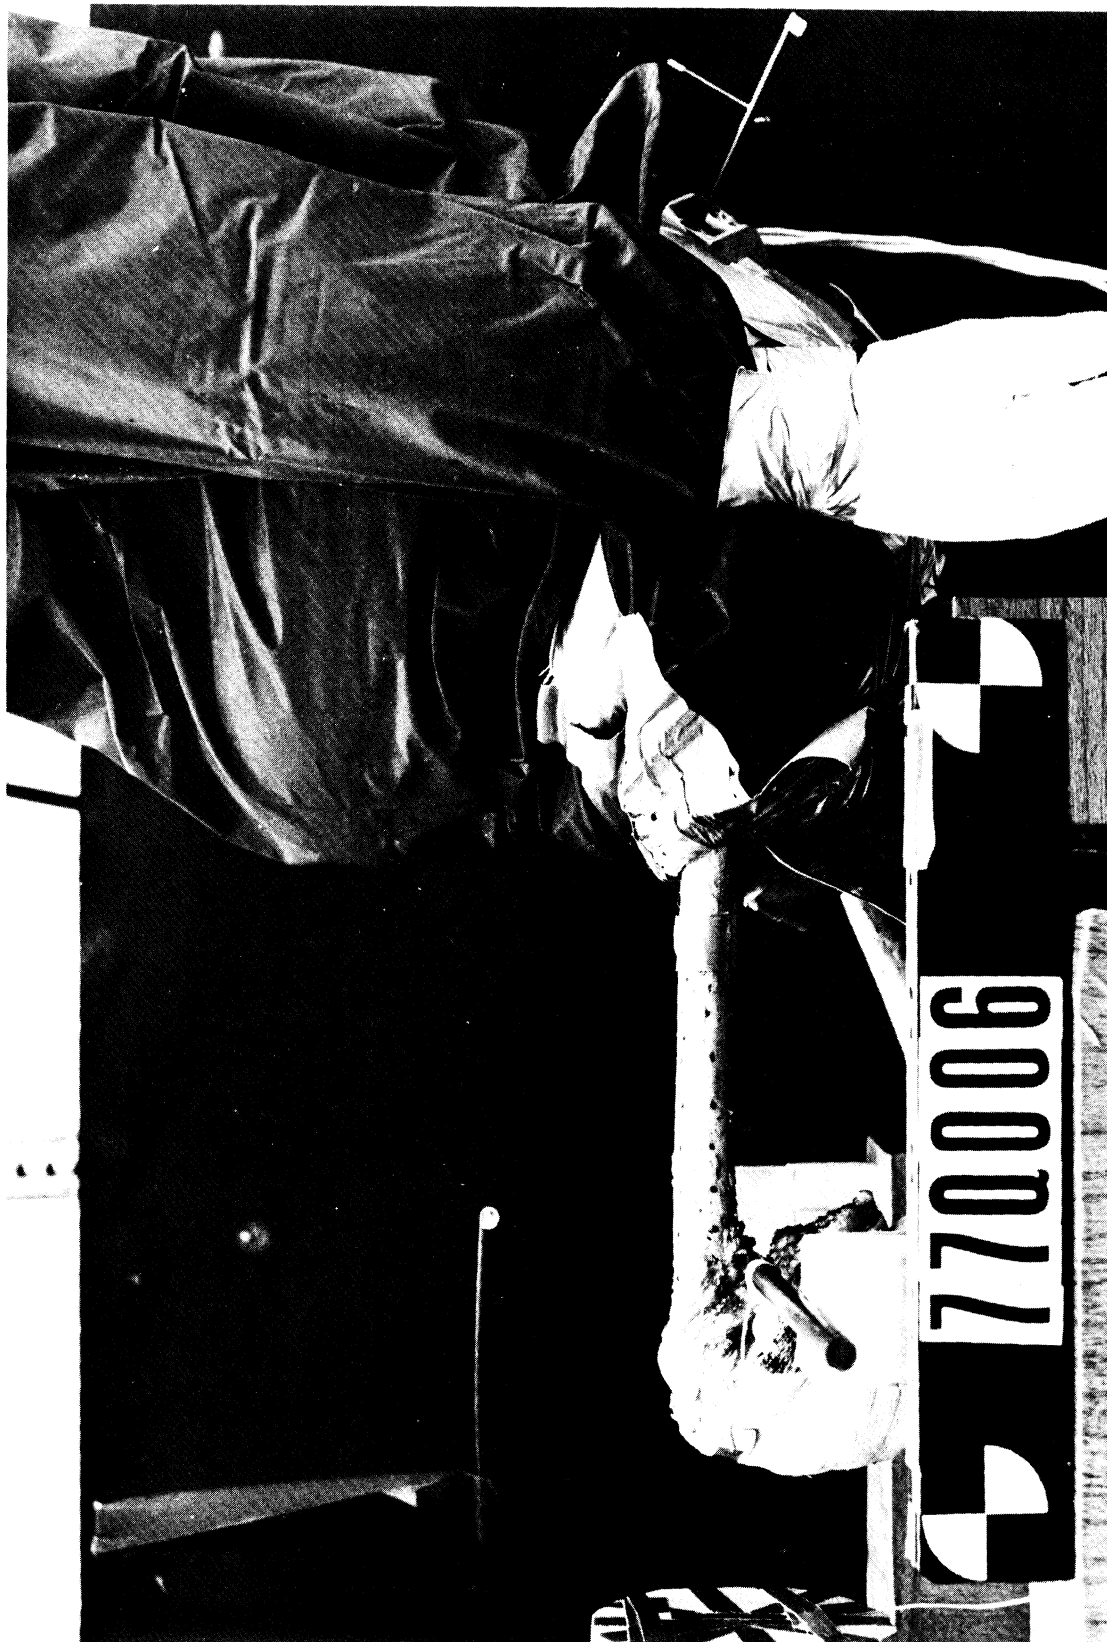
TEST DESCRIPTION: Same as 77Q005

Comminuted fractures of the condyles were produced. There were no
patella damage.

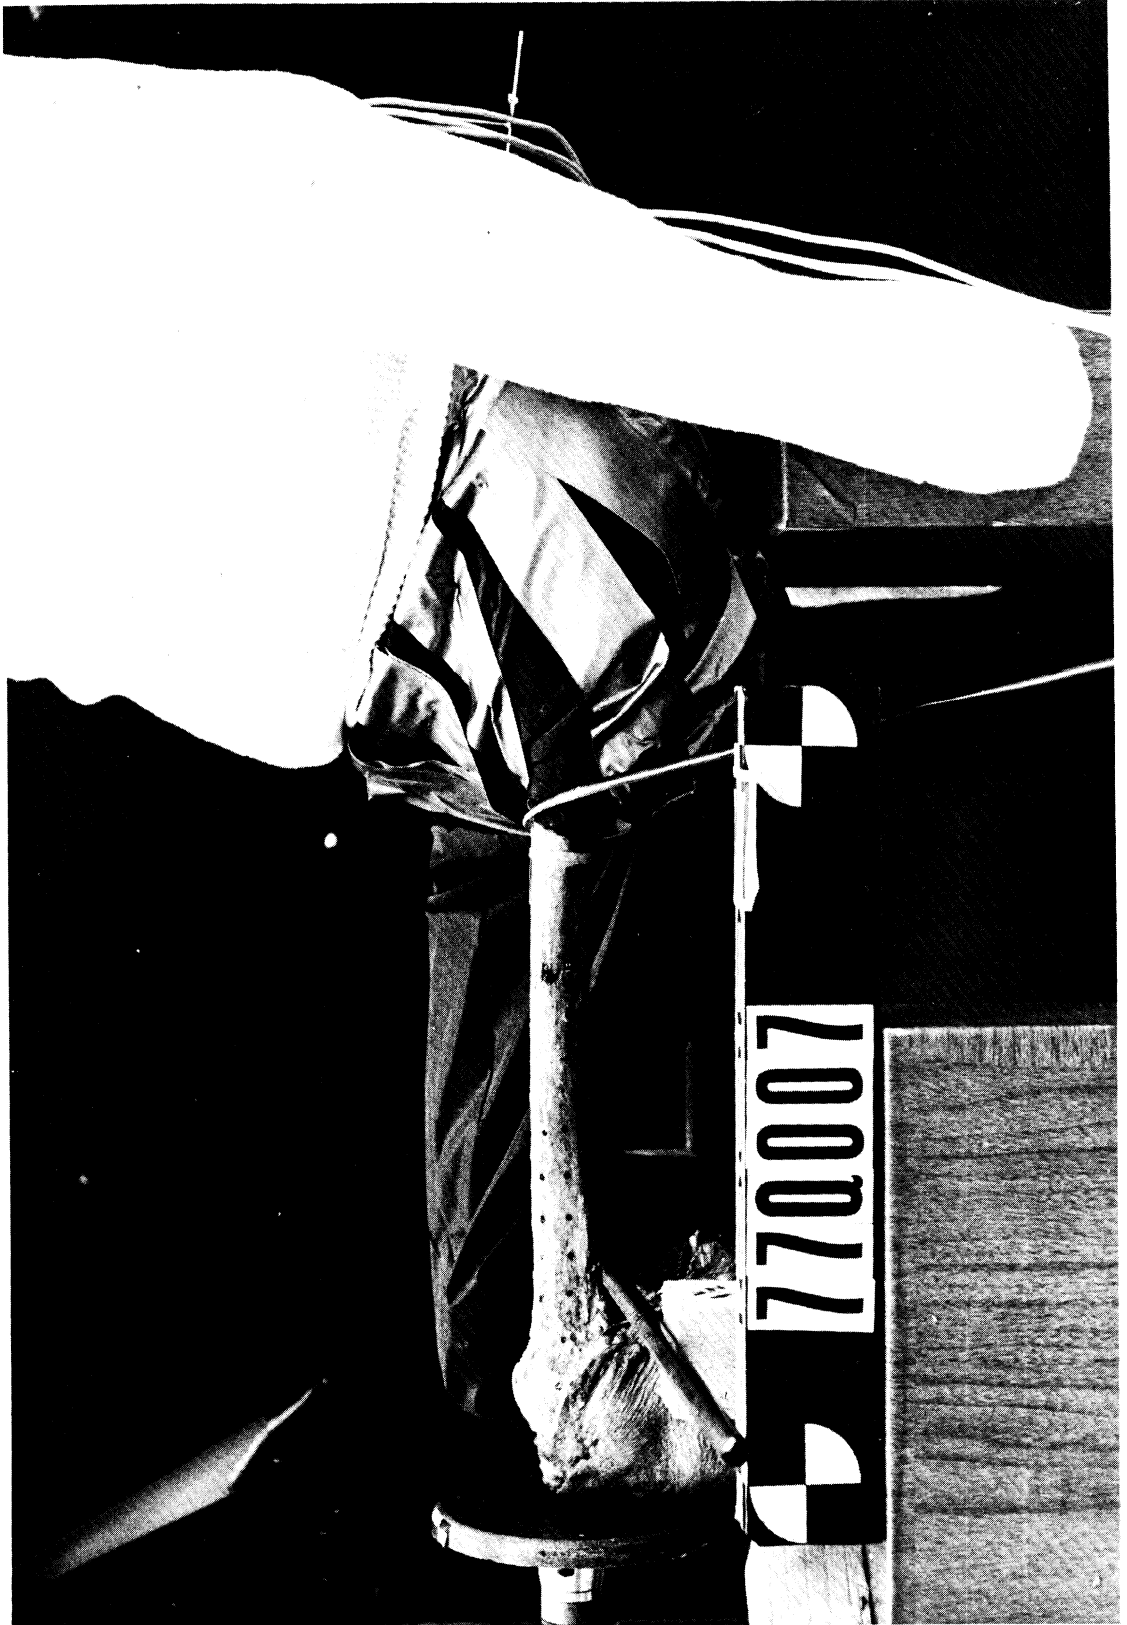
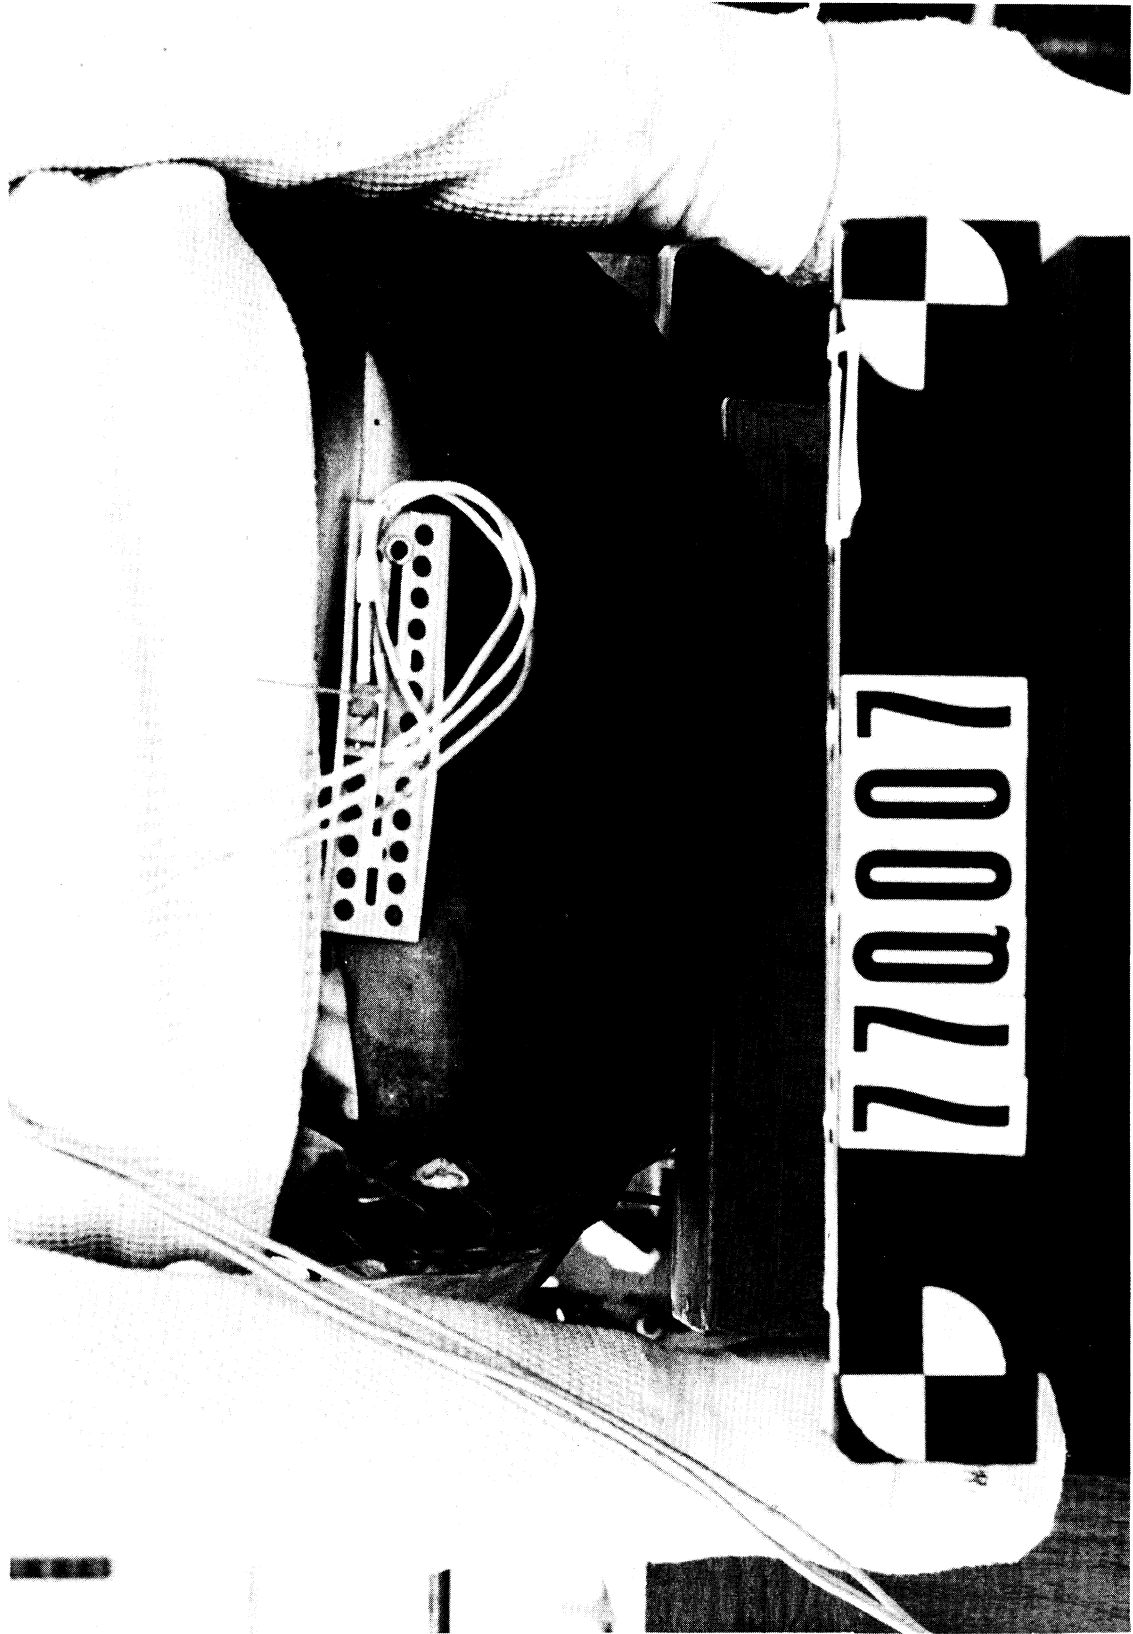
TEST DESCRIPTION: Tests seven and eight were performed to determine the effect of drying, flesh removal, and possible osteoporotic conditions on femur response. Cadaver 20709 was judged to be of good quality for this test. The left leg was prepared as in 77Q005. If it fractured mid-shaft and was shown not to be osteoporotic, then the right leg which had not undergone preparation, was to be tested in the identical manner. If the condyles failed, then the right leg was to be prepared as the left and run in a padded test.

The midshaft was fractured and the patella was shattered.

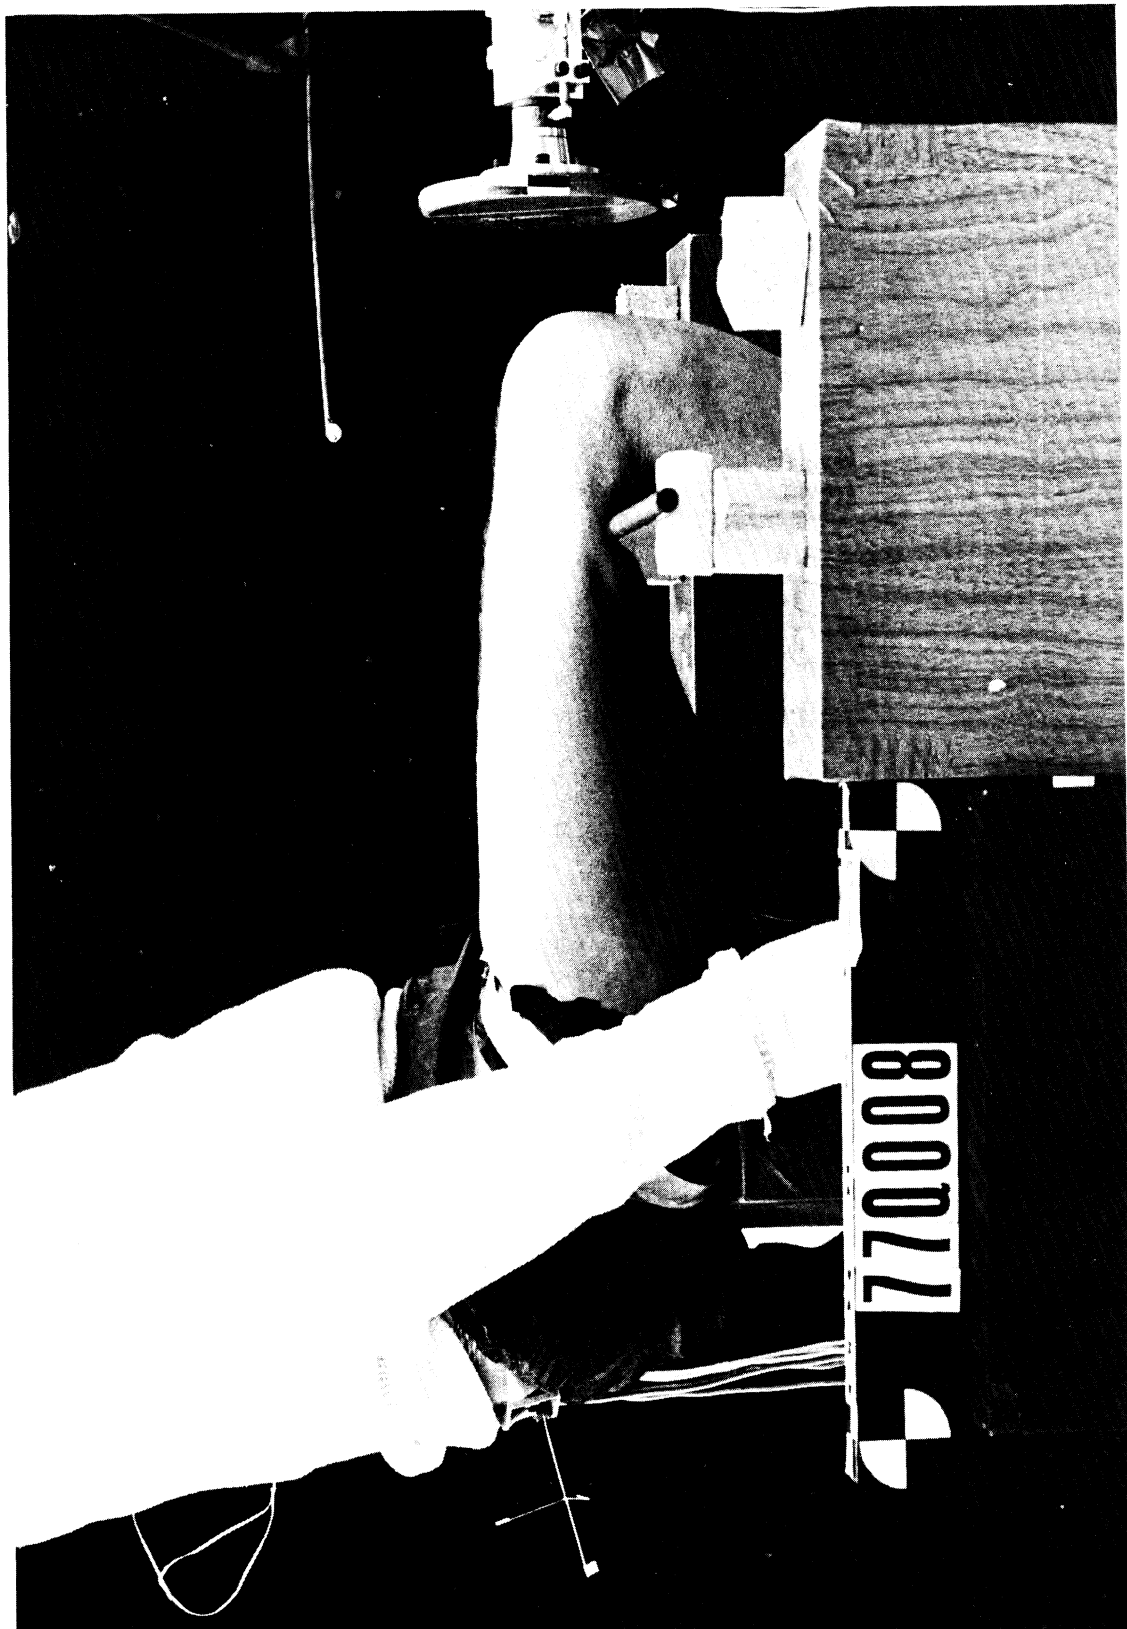
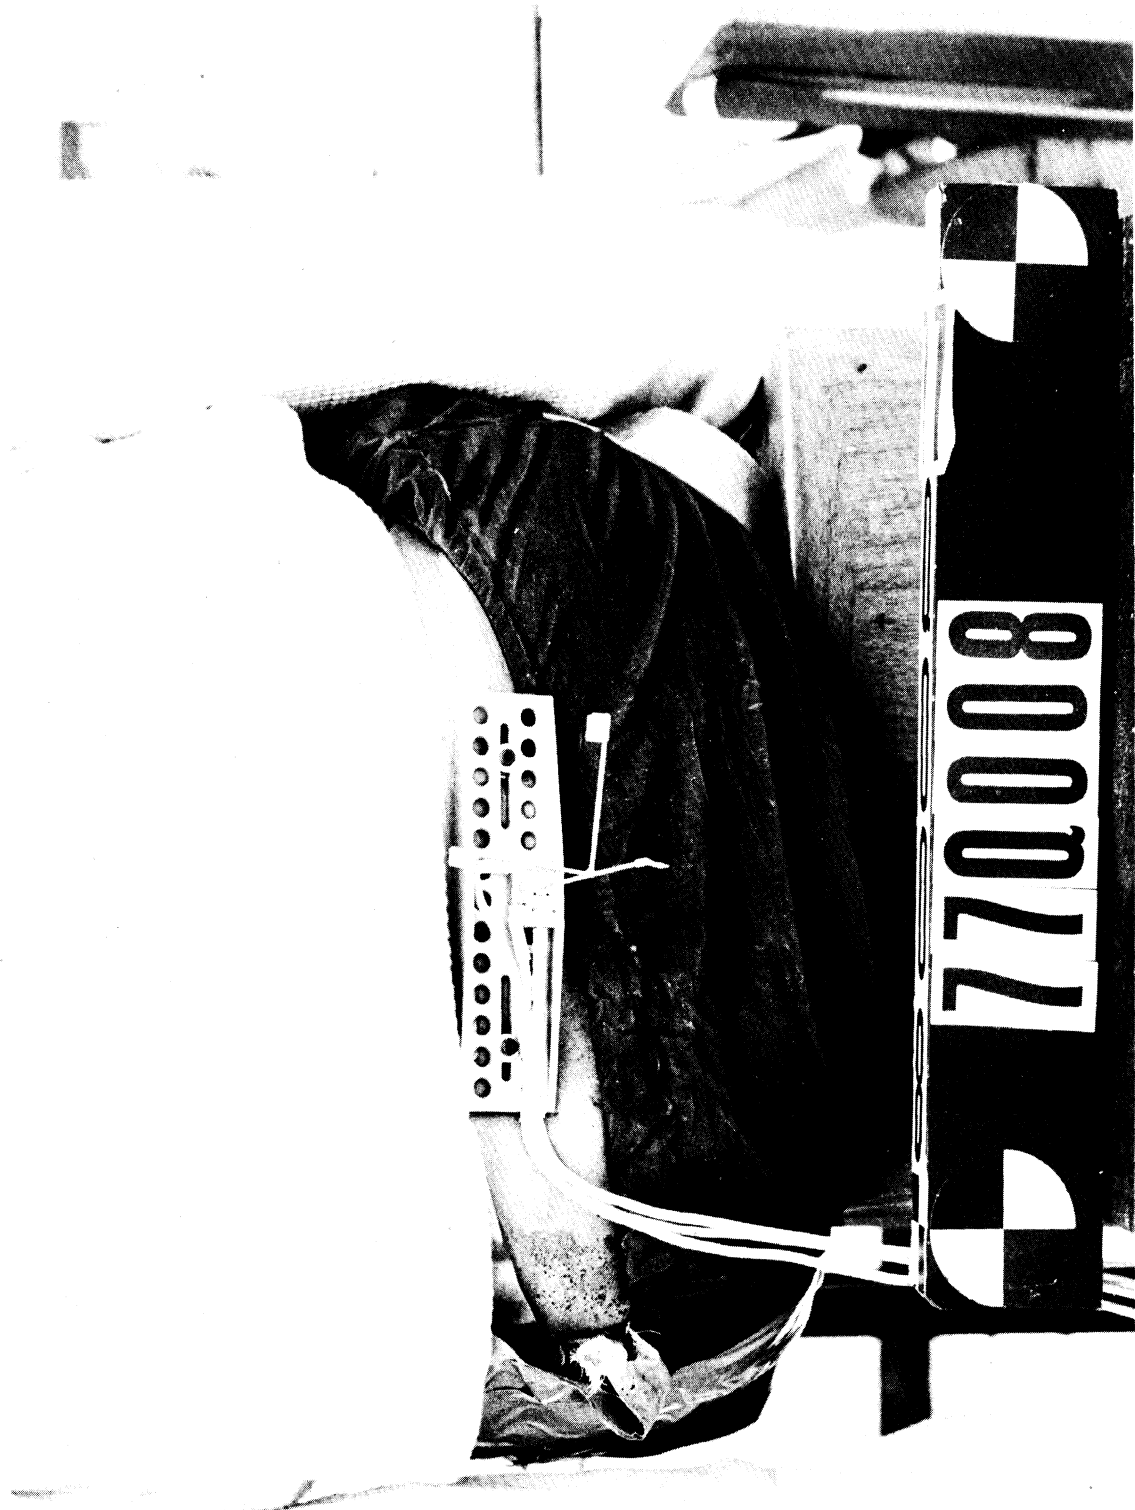
all else remained the same as run 77Q001.

The midshaft was fractured and the patella was shattered.

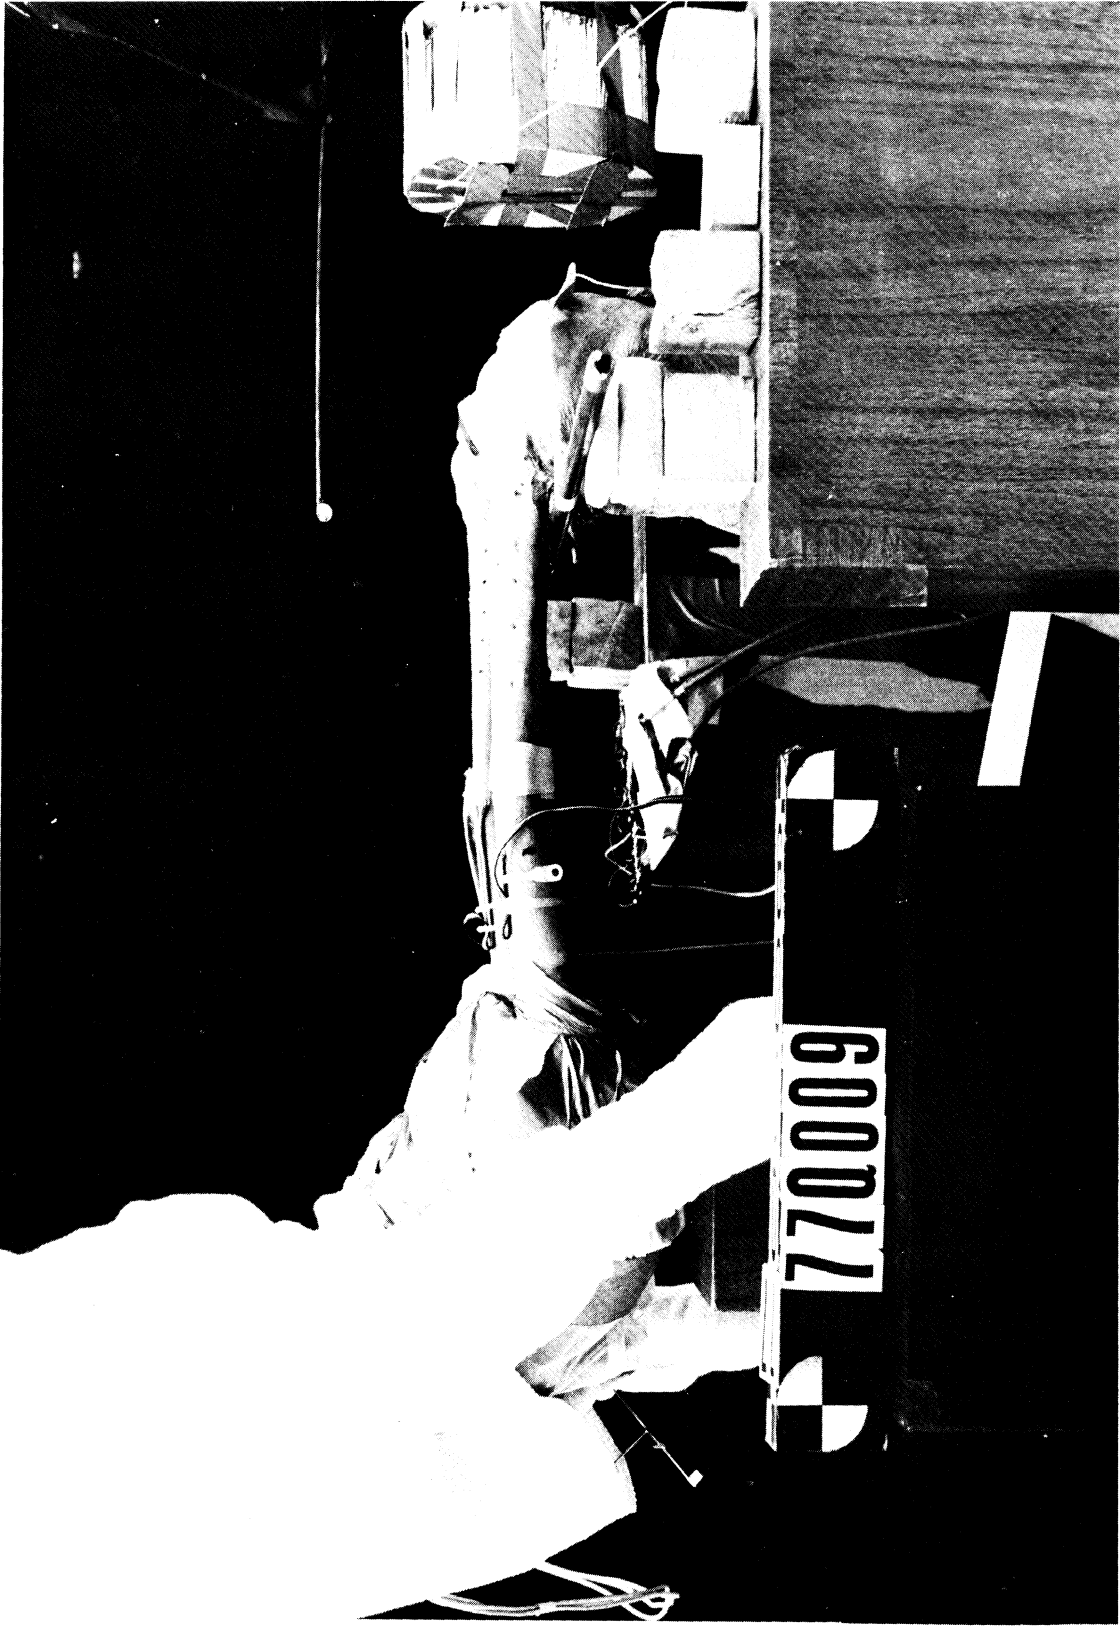
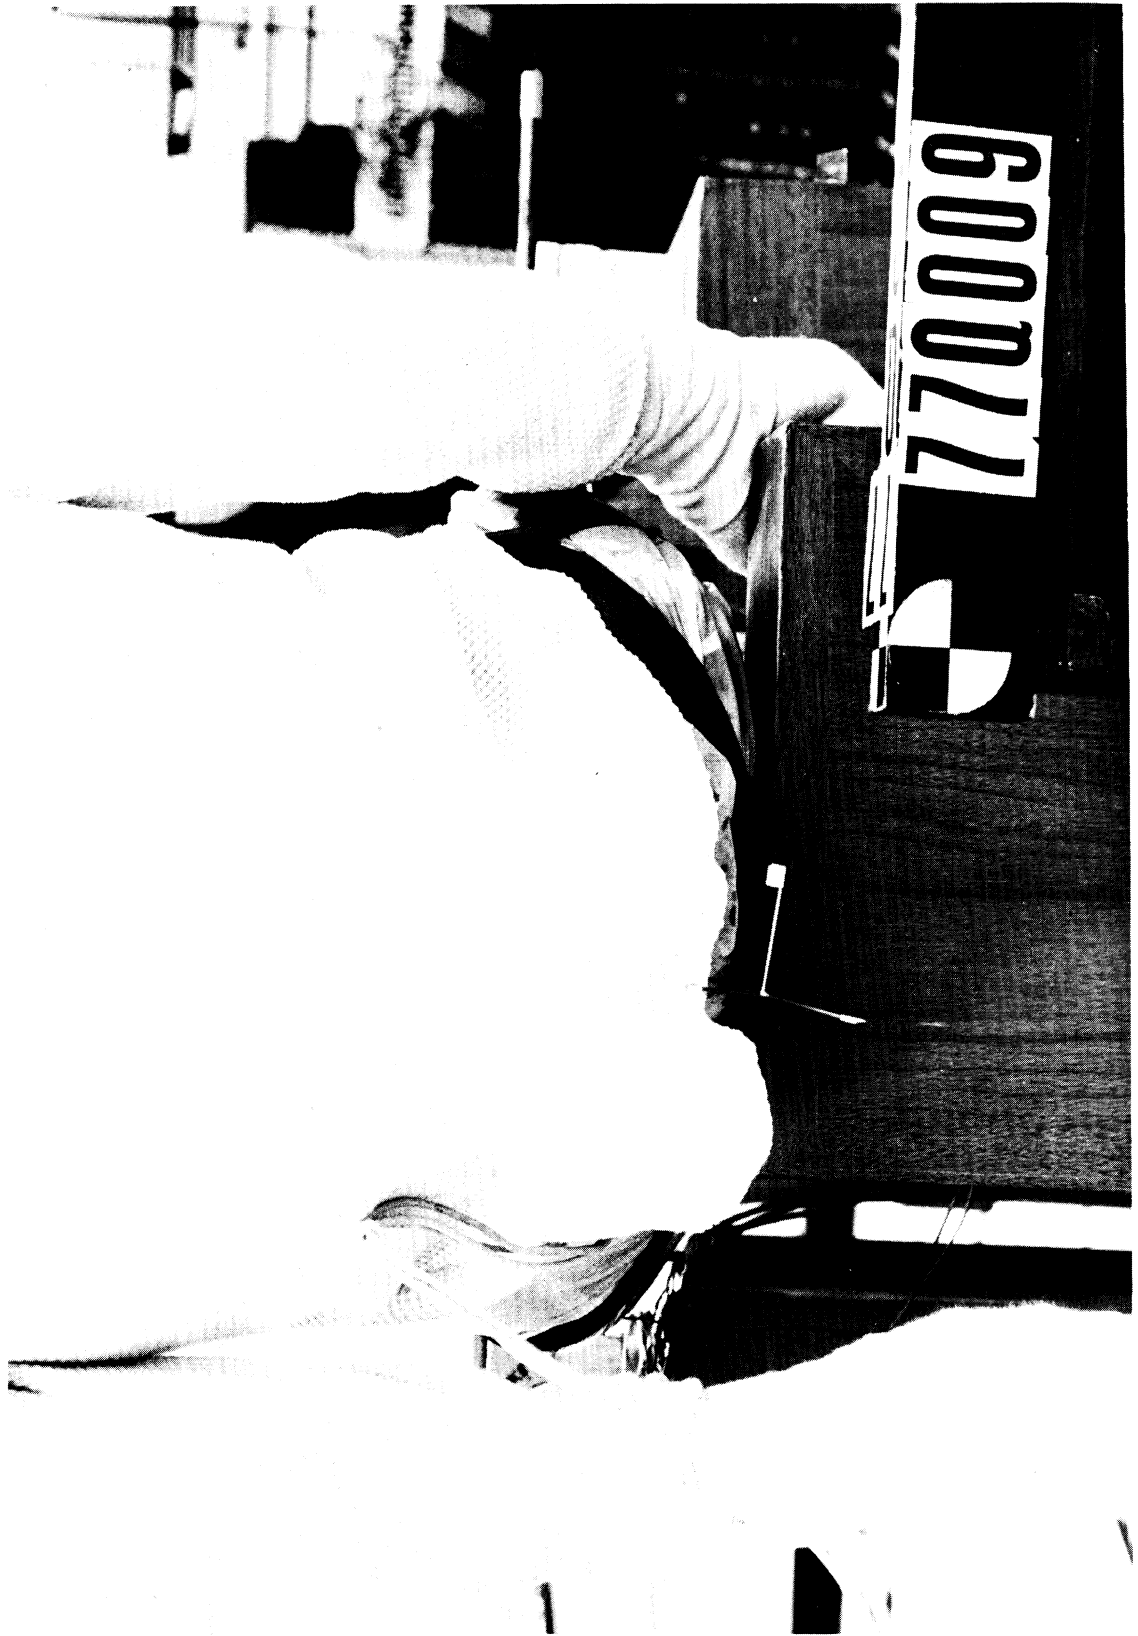
TEST DESCRIPTION: Same as Test 77Q005

There were no injuries.

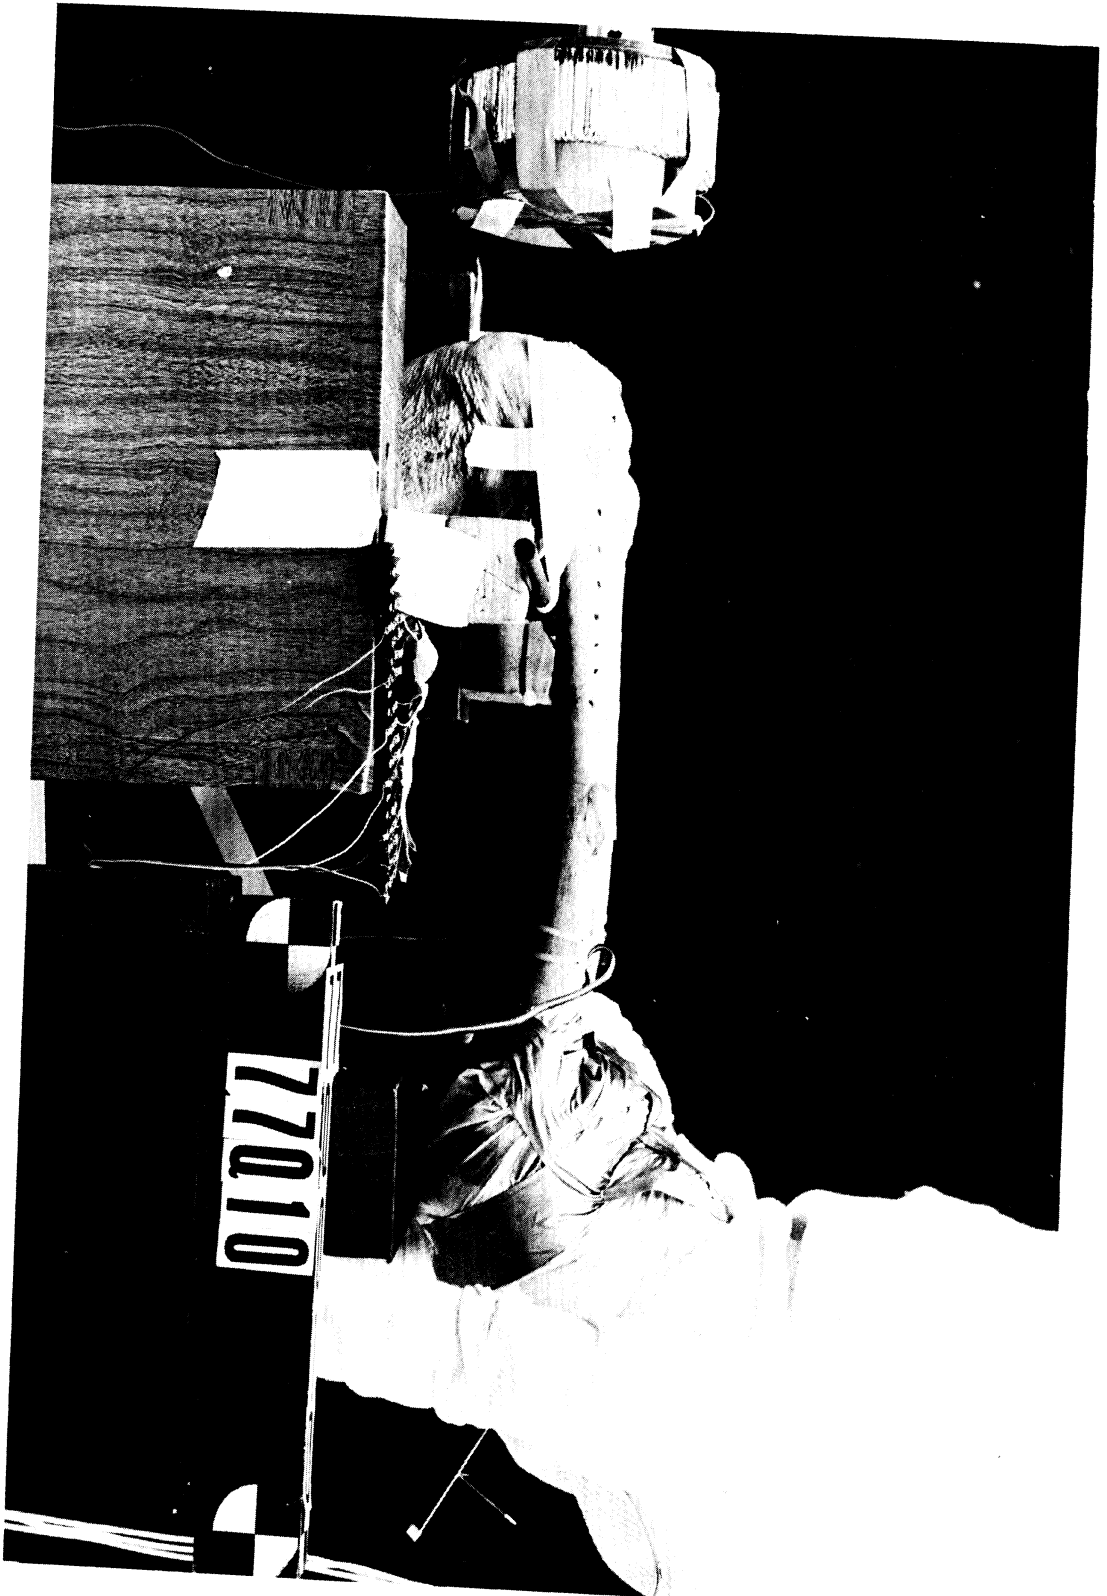
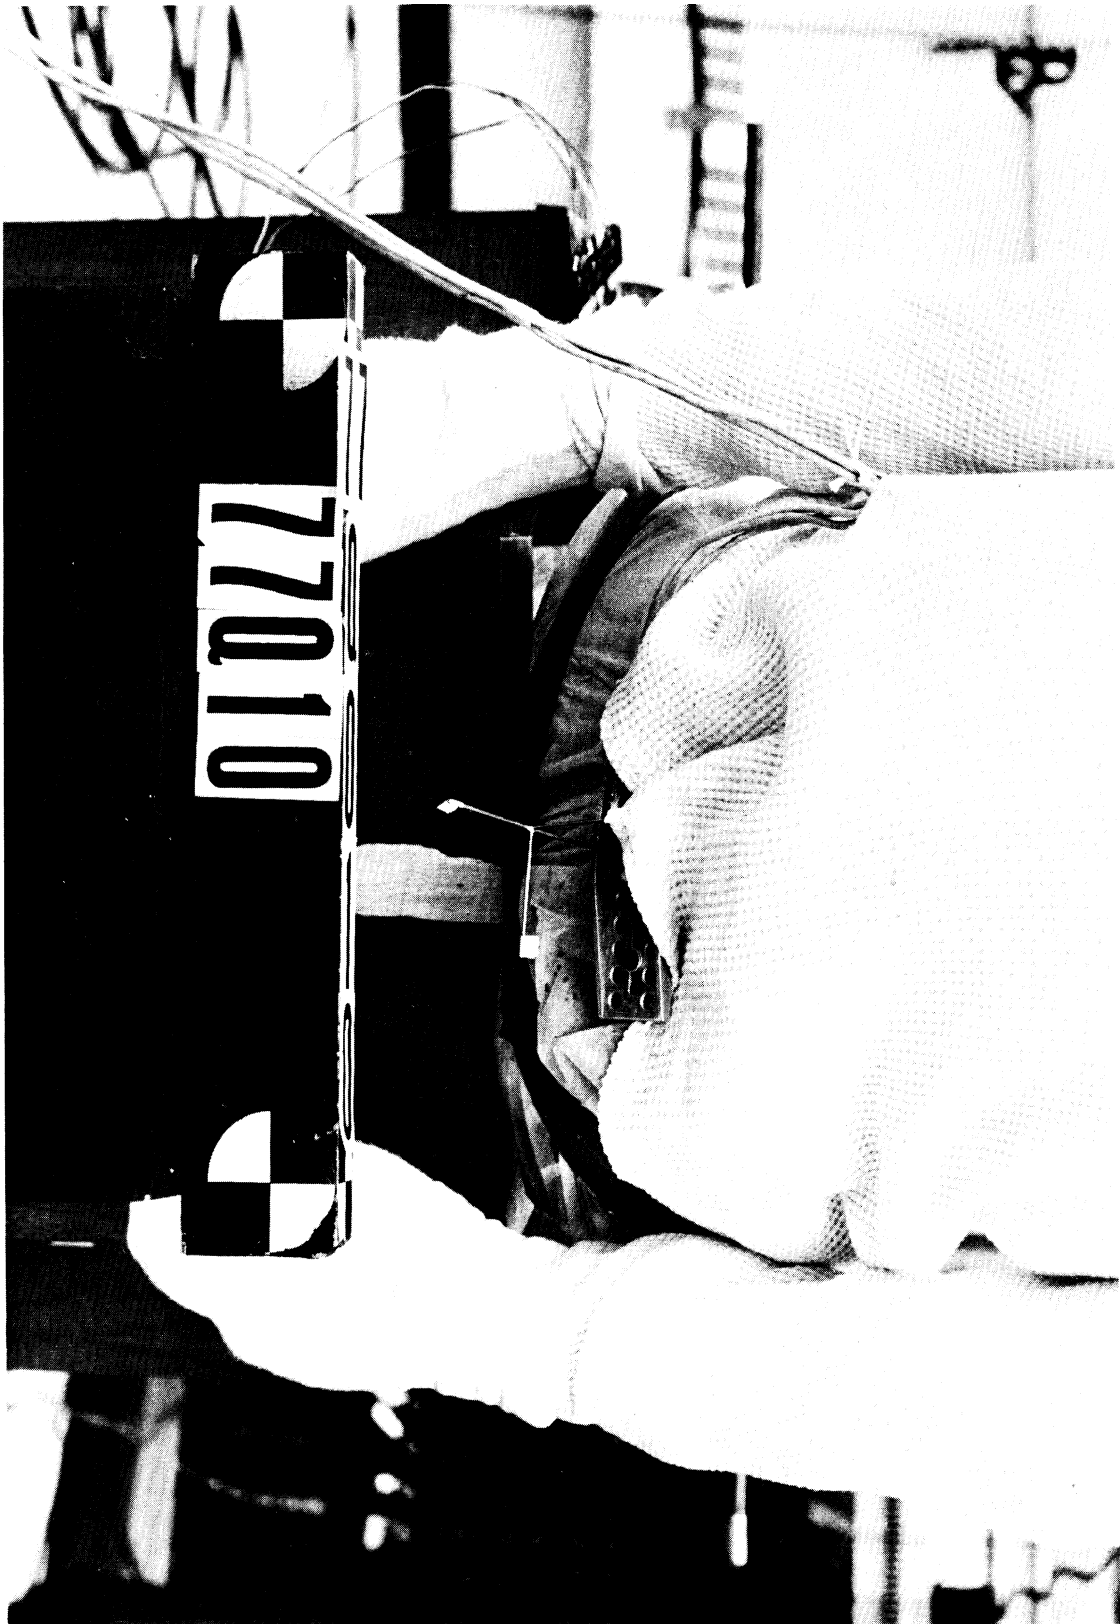
TEST DESCRIPTION: Same as Test 77Q005

There were no injuries.

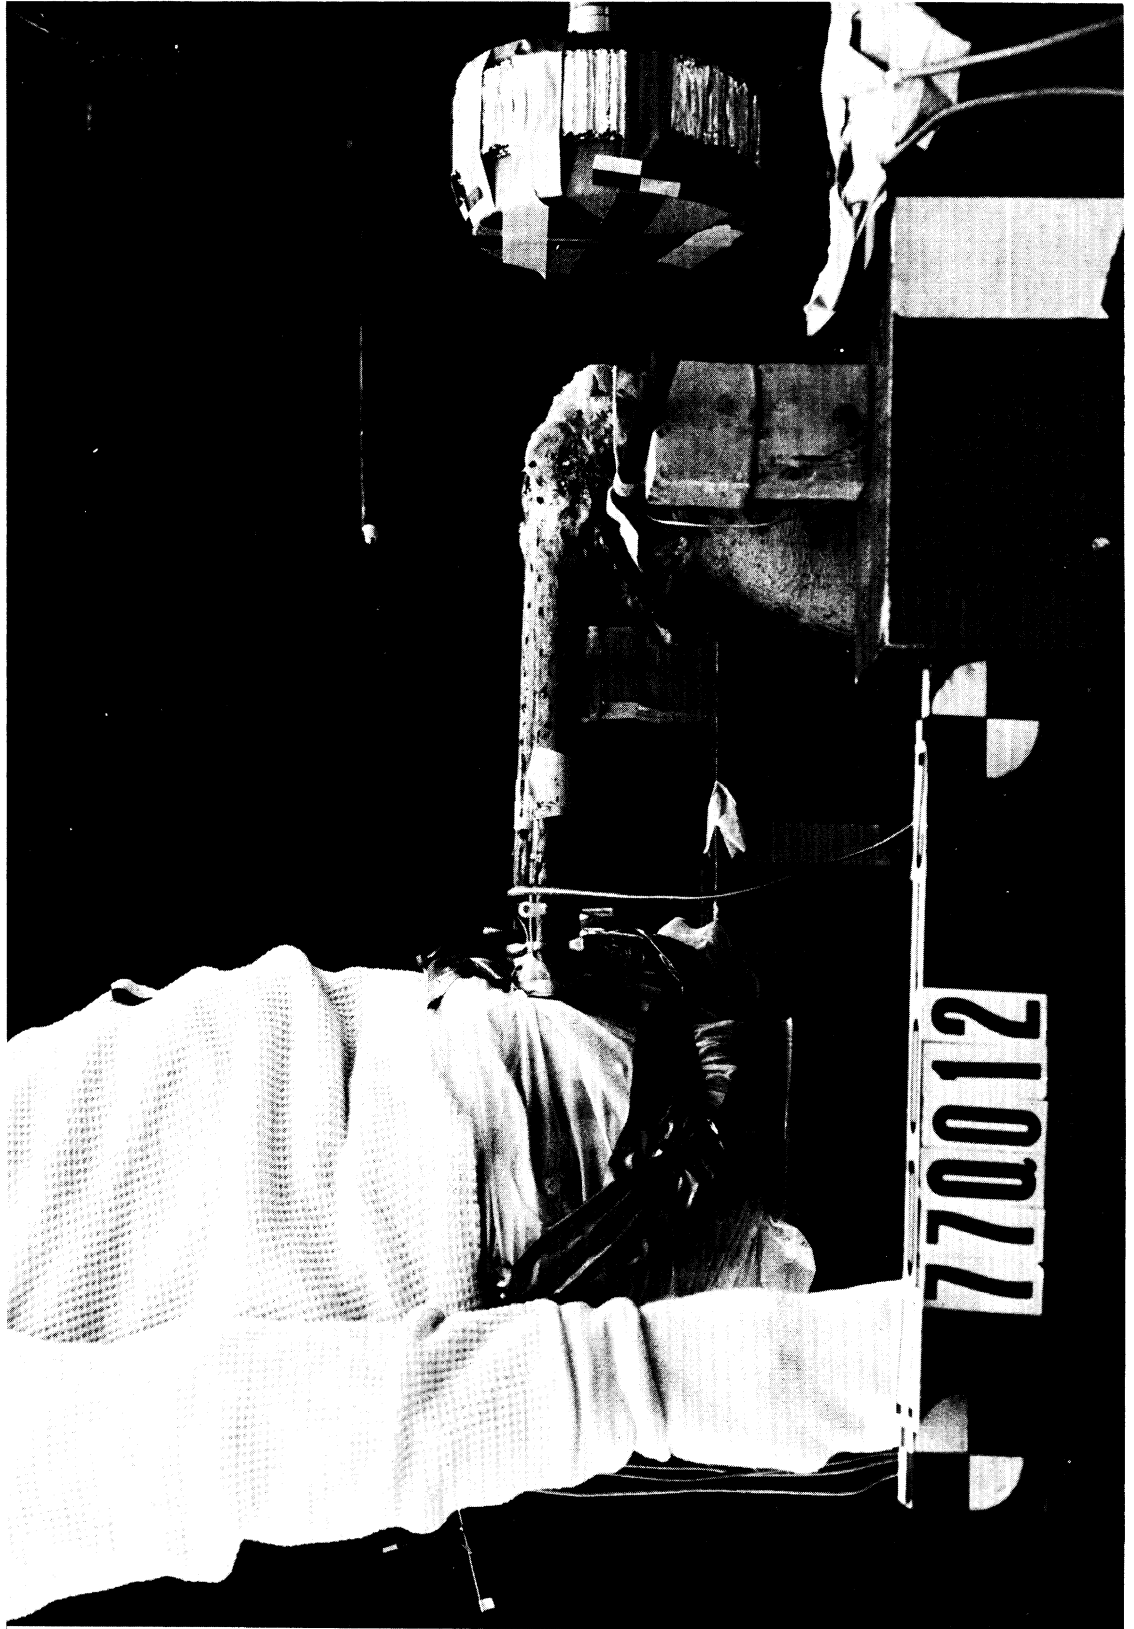
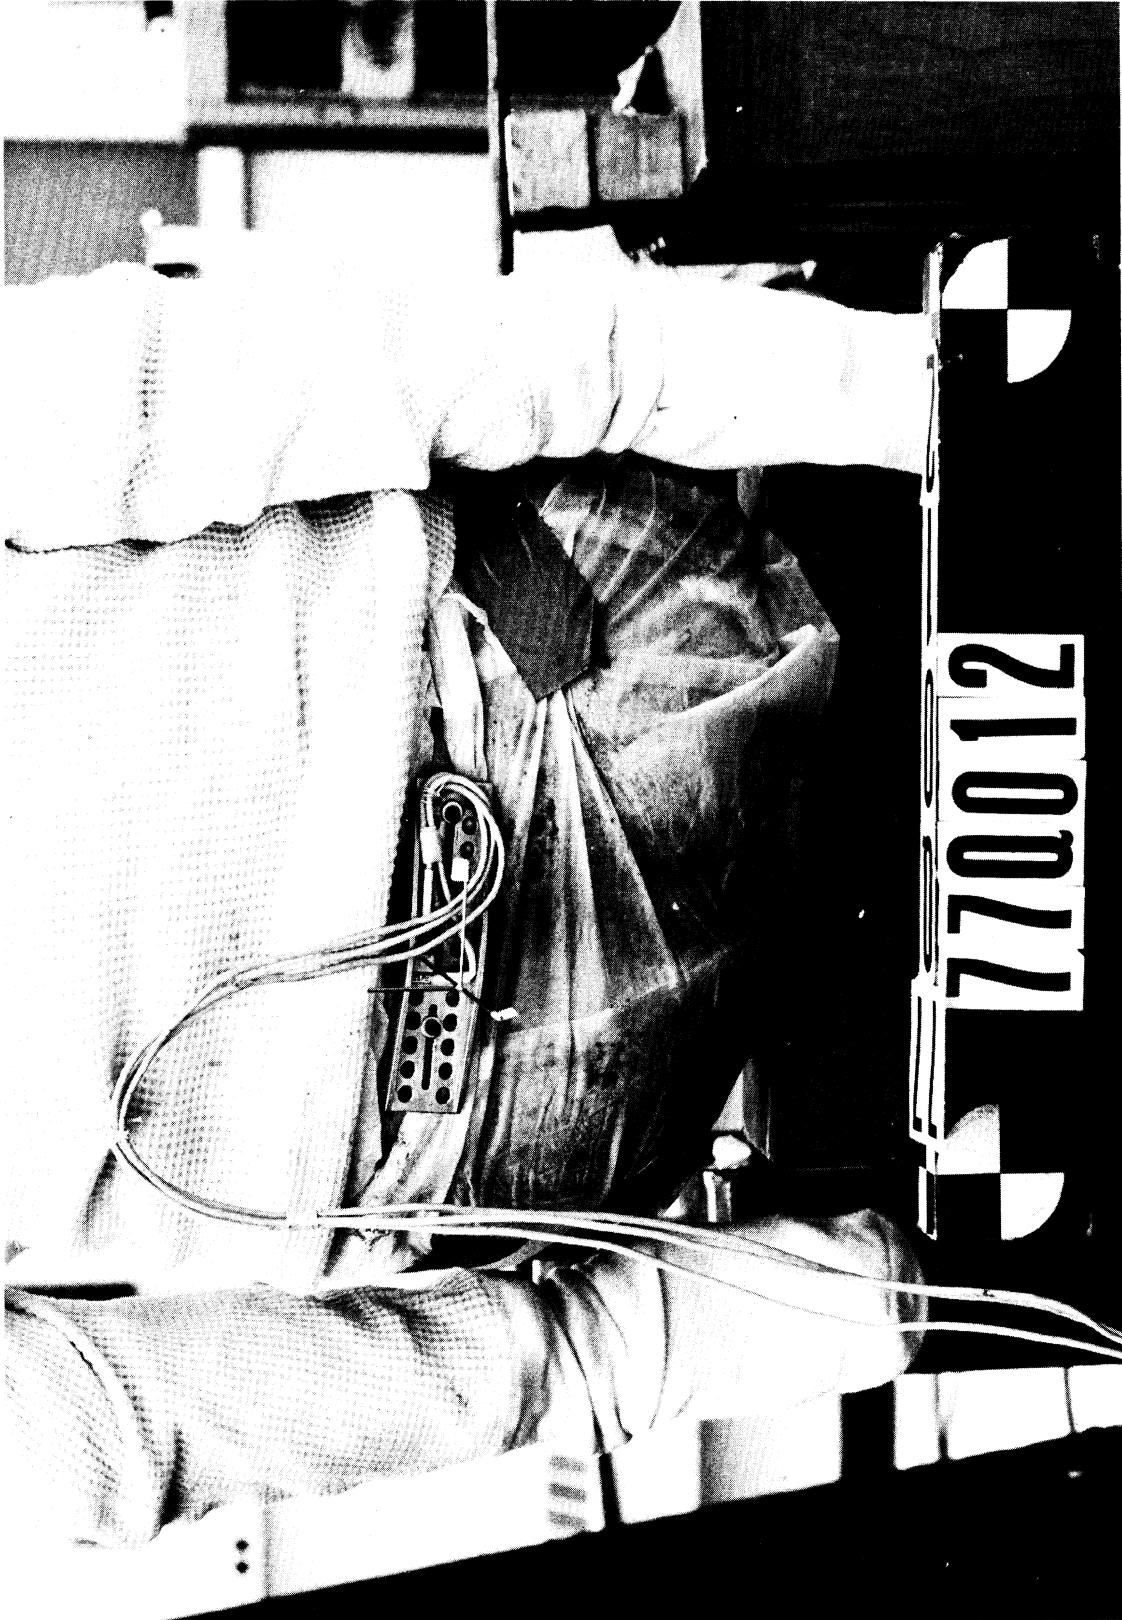
There was a supracondylar fracture, but the patella wasn't damaged.

Apparent osteoporosis.
