UM - HSRI-77-25

FEMUR IMPACT STUDY

FINAL REPORT
MAY 26, 1977

THE UNIVERSITY OF MICHIGAN
HIGHWAY SAFETY RESEARCH INSTITUTE

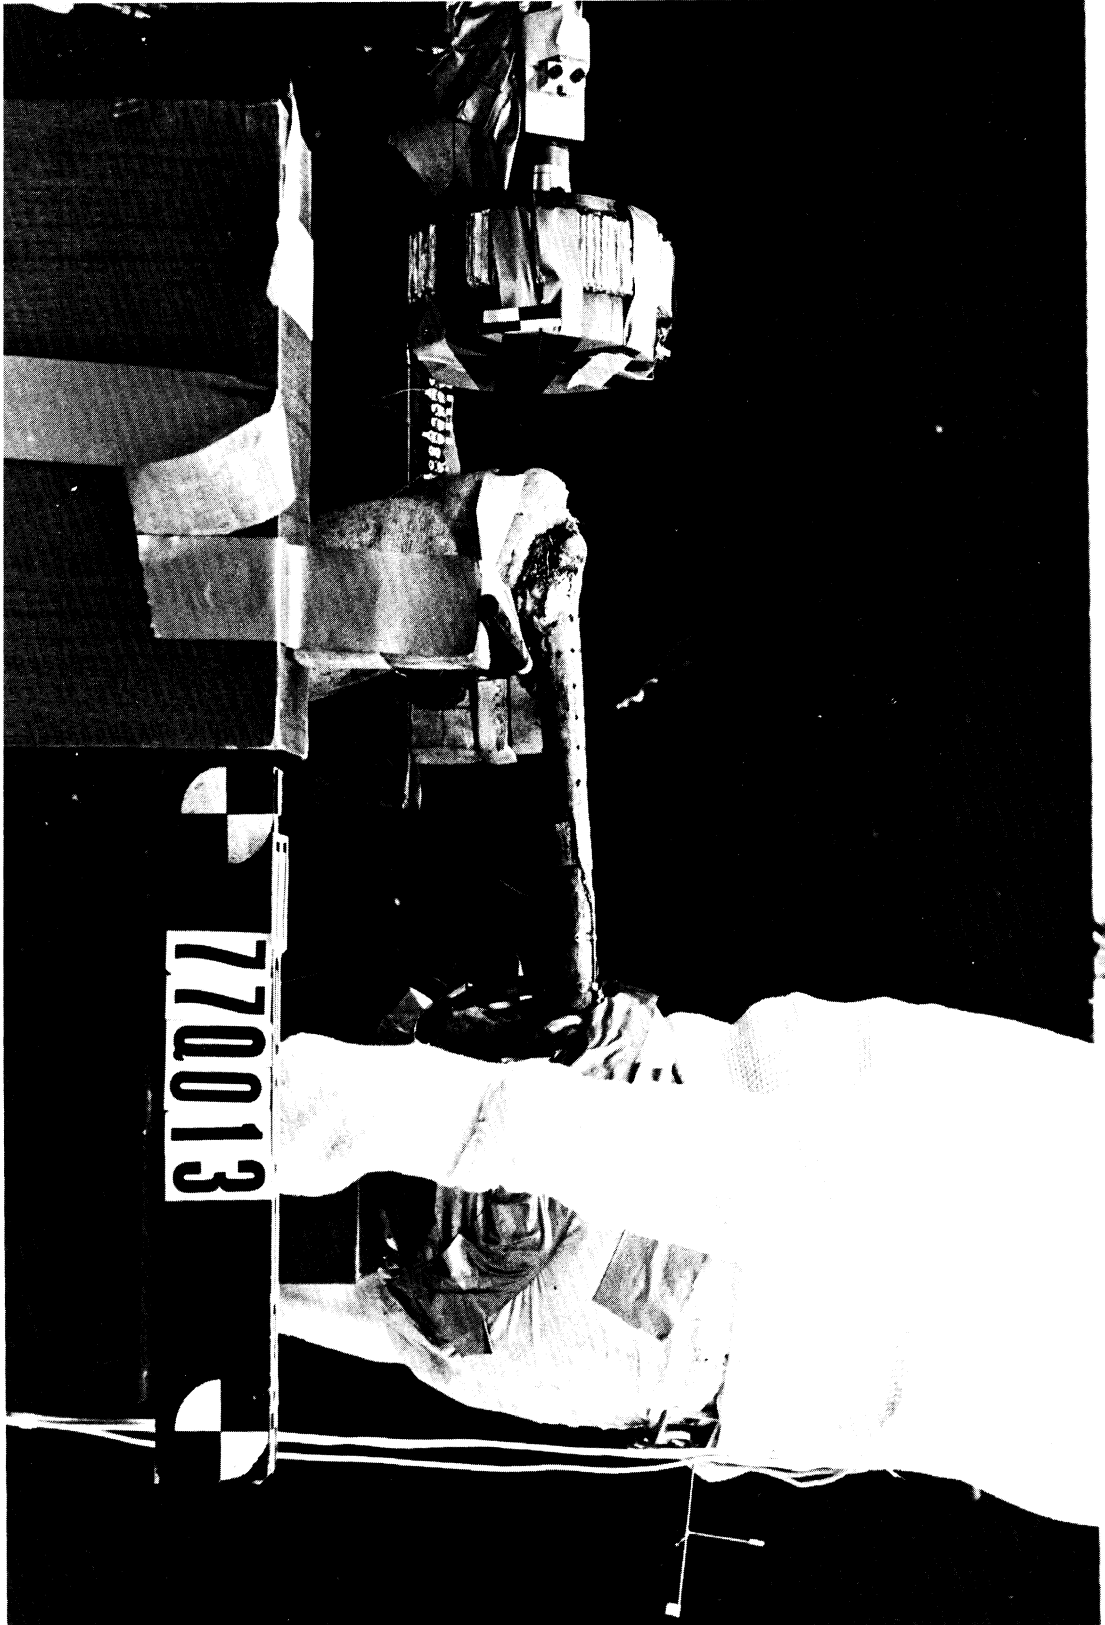
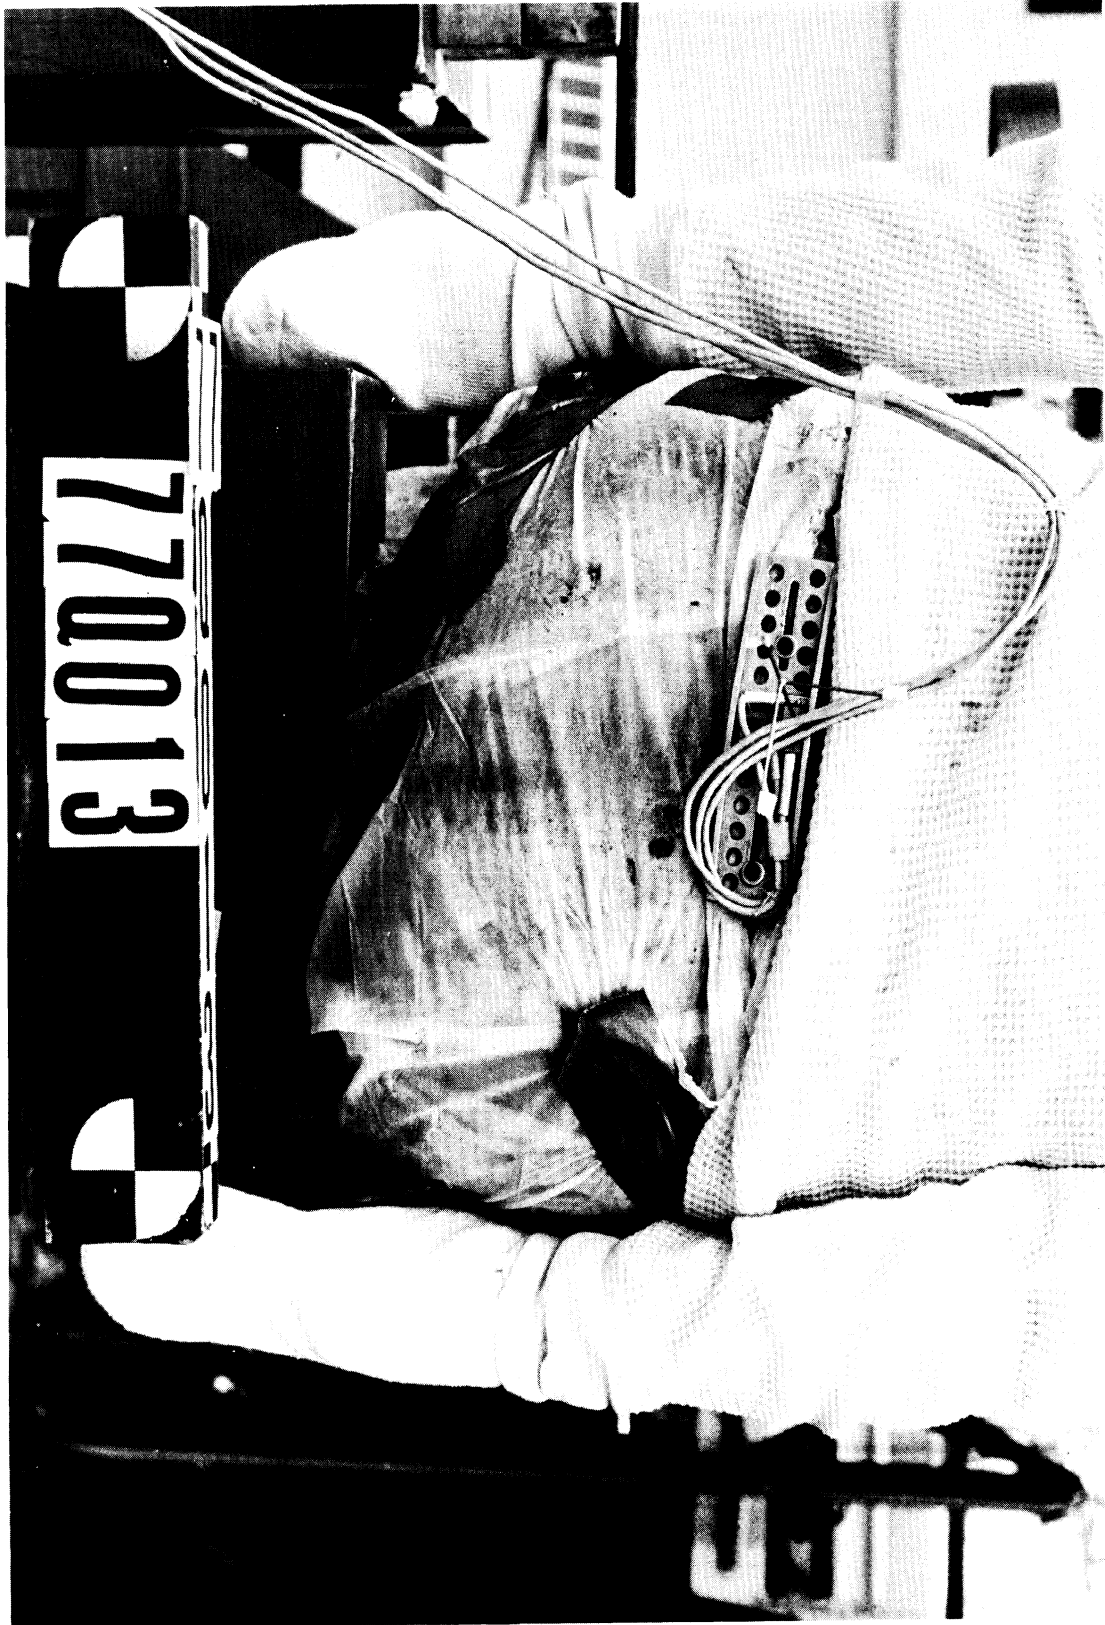
TEST DESCRIPTION: Same as Test 77Q005

The condyles and midshaft were fractured, but the patella wasn't
damaged. Apparent osteoporosis.
