**Fiber Reinforced Concrete Connections  
for Earthquake Resistant Design of  
Precast Reinforced Concrete Structures**

by  
Khaled S. Soubra  
James K. Wight  
Antoine E. Naaman

A Report on Research Sponsored by  
National Science Foundation  
Grant No. CES-86-15419

Report No. UMCE 89-13  
October 1989

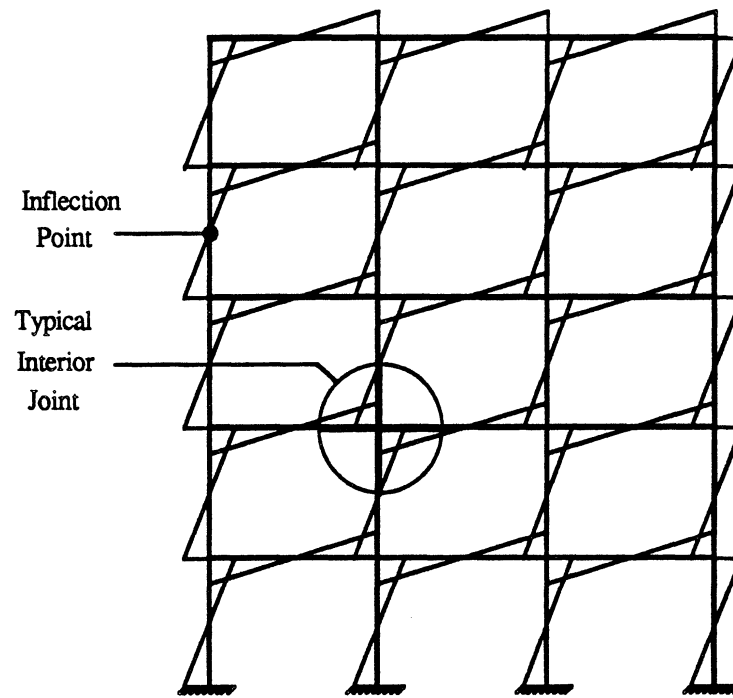
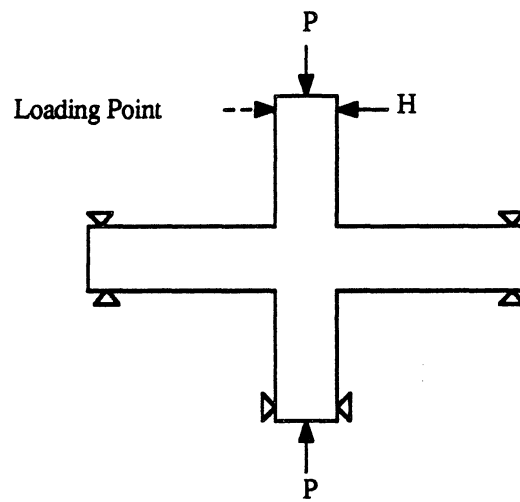
a) Moments due to Earthquake Loading

b) Interior beam-to-column connection

Fig. 1.1- Typical testing setup for beam-to-column connections.

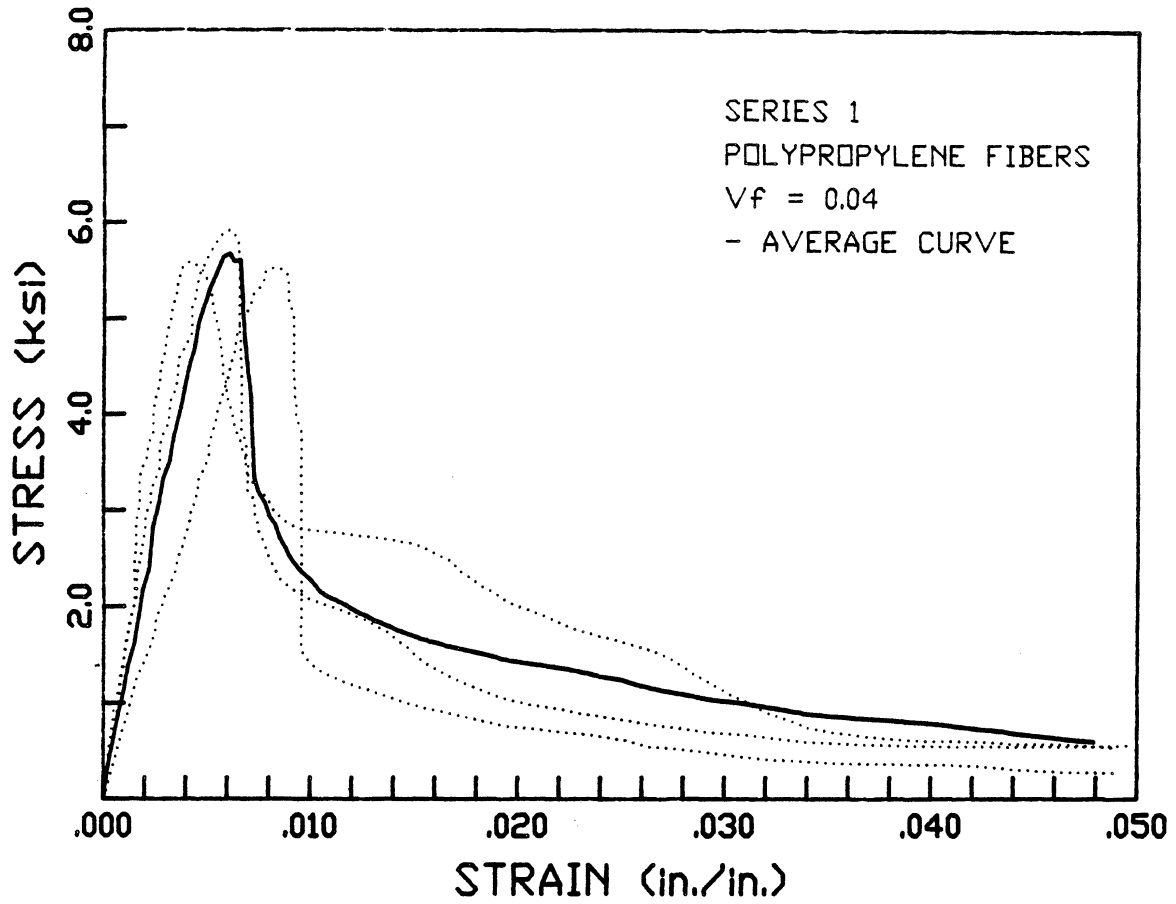
Fig. 3.5- Stress-strain curve for cylinders containing polypropylene plastic fibers.

The stress-strain curve for the specimens containing polypropelene fibers is shown in Fig.3.5. The addition of the fibers increased the average maximum compressive stress to 5670 psi. The compression stiffness was also increased. However, the toughness index was 3.14, the smallest observed among the specimens of the first series. The asymptotic stress at 5% strain was also the smallest at 560 psi.

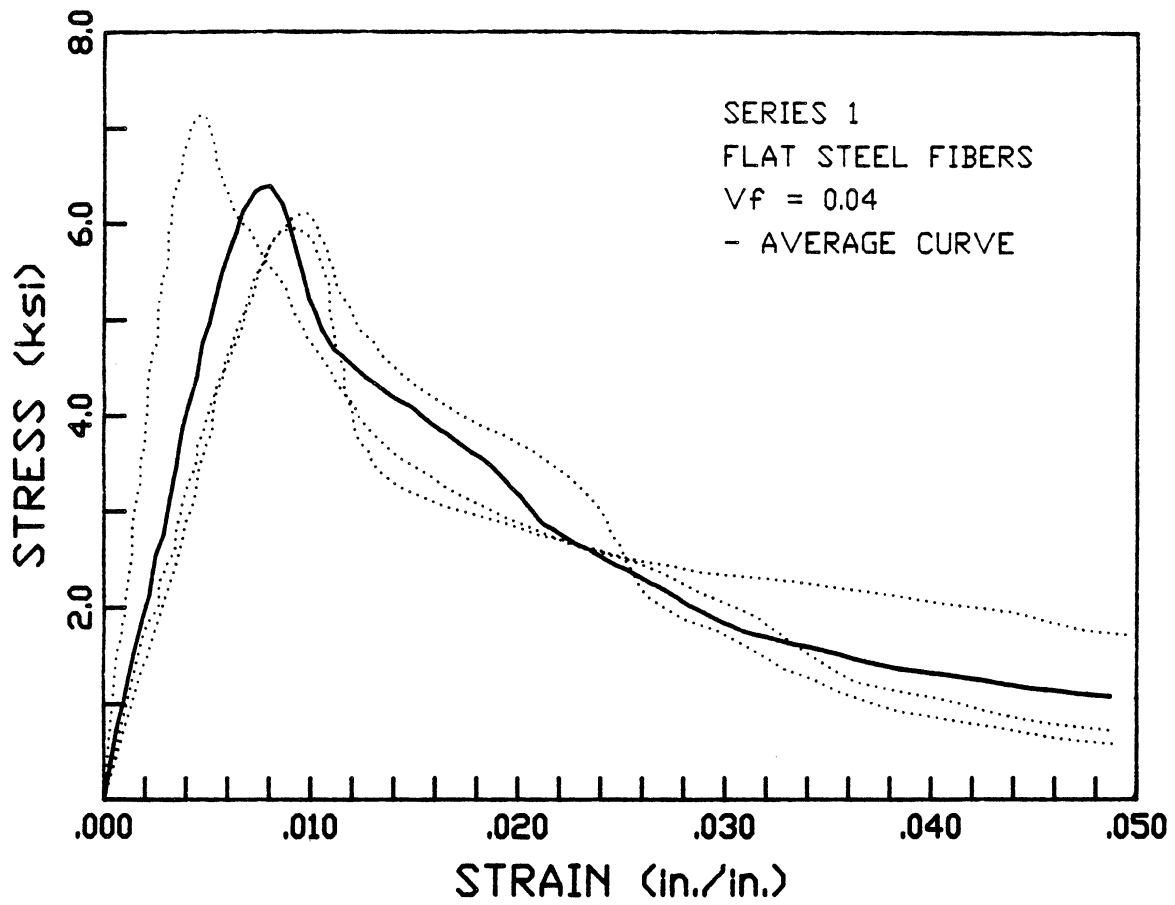
Fig. 3.6- Stress-strain curve for cylinders containing flat steel fibers.

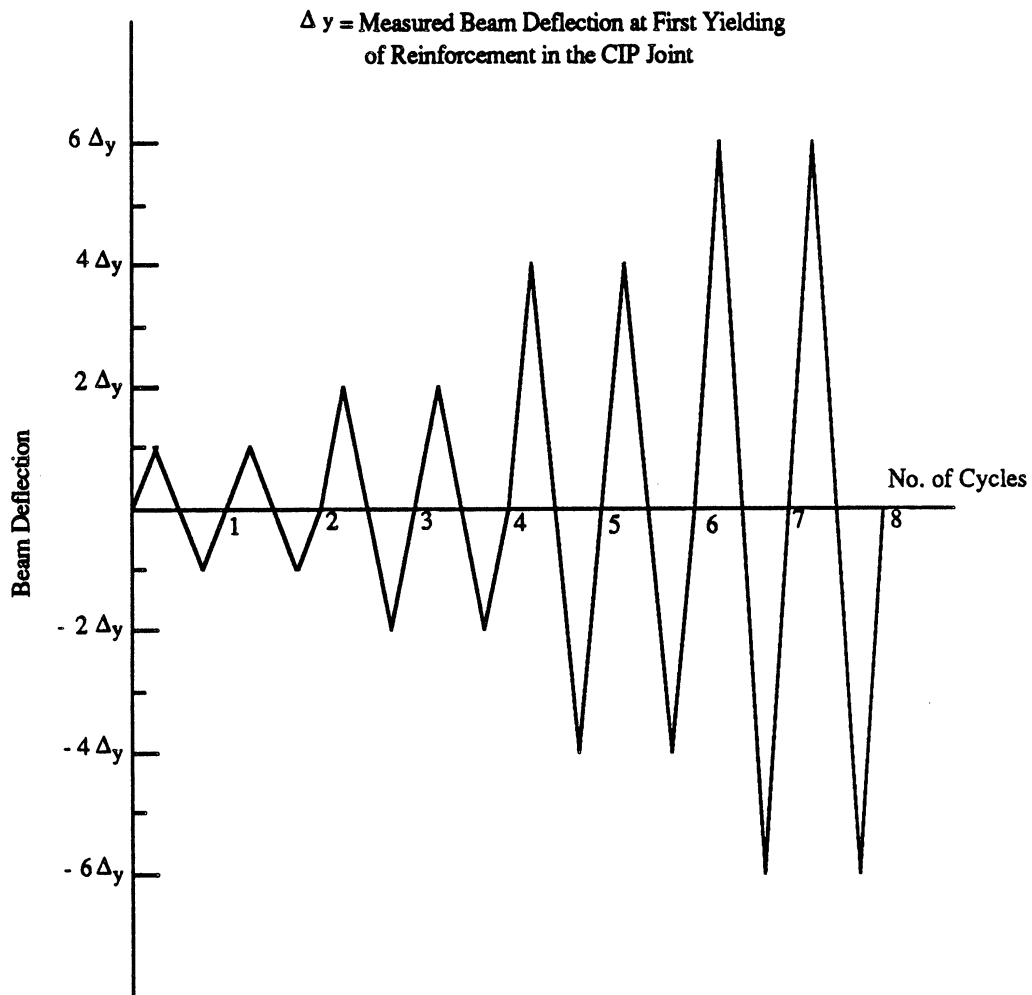
Fig. 4.5- Loading history.

All the tests were controlled by the actuator displacements. The loading history is shown in Fig.4.5. This loading history was used since it was found in previous studies to provide sufficient information on the strength as well as the stiffness degradation of the specimen. The displacement of the specimen at yield served as a guideline in defining the specimen ductility in subsequent cycles.

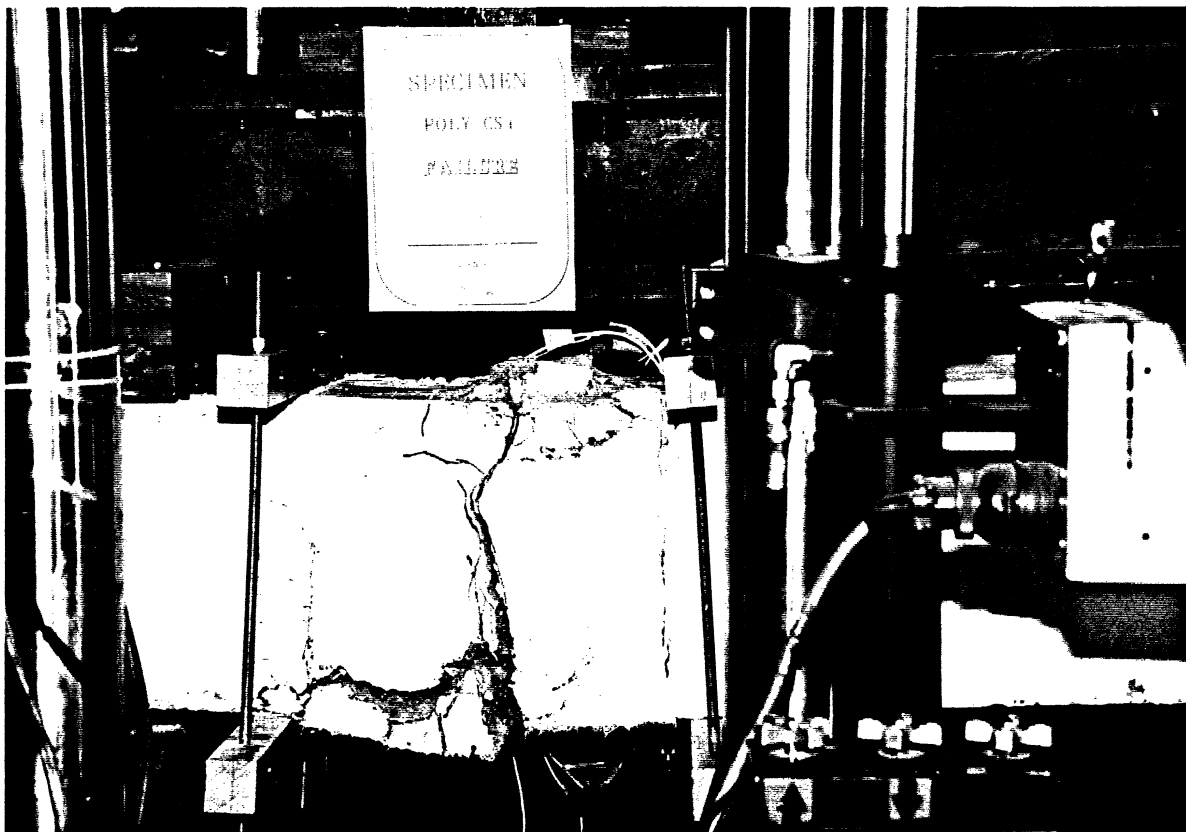
Fig. 4.6- a) Specimen at first cycle.

Fig. 4.6- b) Specimen at failure.

Three flexural cracks appeared in the middle of the joint area during the first cycle. Cracks also appeared at the interfaces. A single crack, located in the middle of the CIP joint, continued to widen as the test progressed, while the rest of the cracks ceased to widen. Shear cracks were also observed in the precast beam parts. Failure occurred in the middle of the CIP joint in the downward loading portion of cycle 8. This failure was due to the tension rupture of one reinforcing bar at a

displacement ductility of 5.8. Fig.4.6 shows the specimen at the first loading cycle and at failure. No slippage of the reinforcing bars occurred.

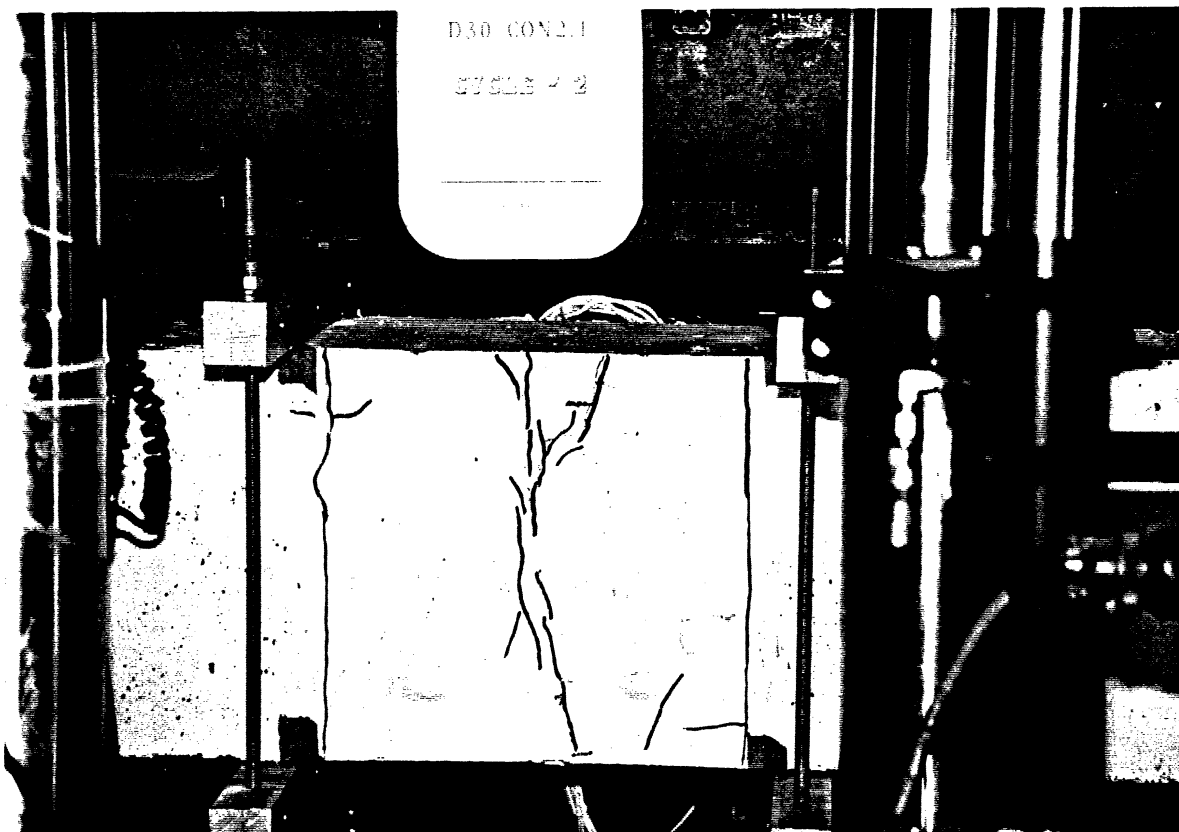
Fig. 4.14- a) Specimen at second cycle.

Fig. 4.14- b) Specimen at failure.

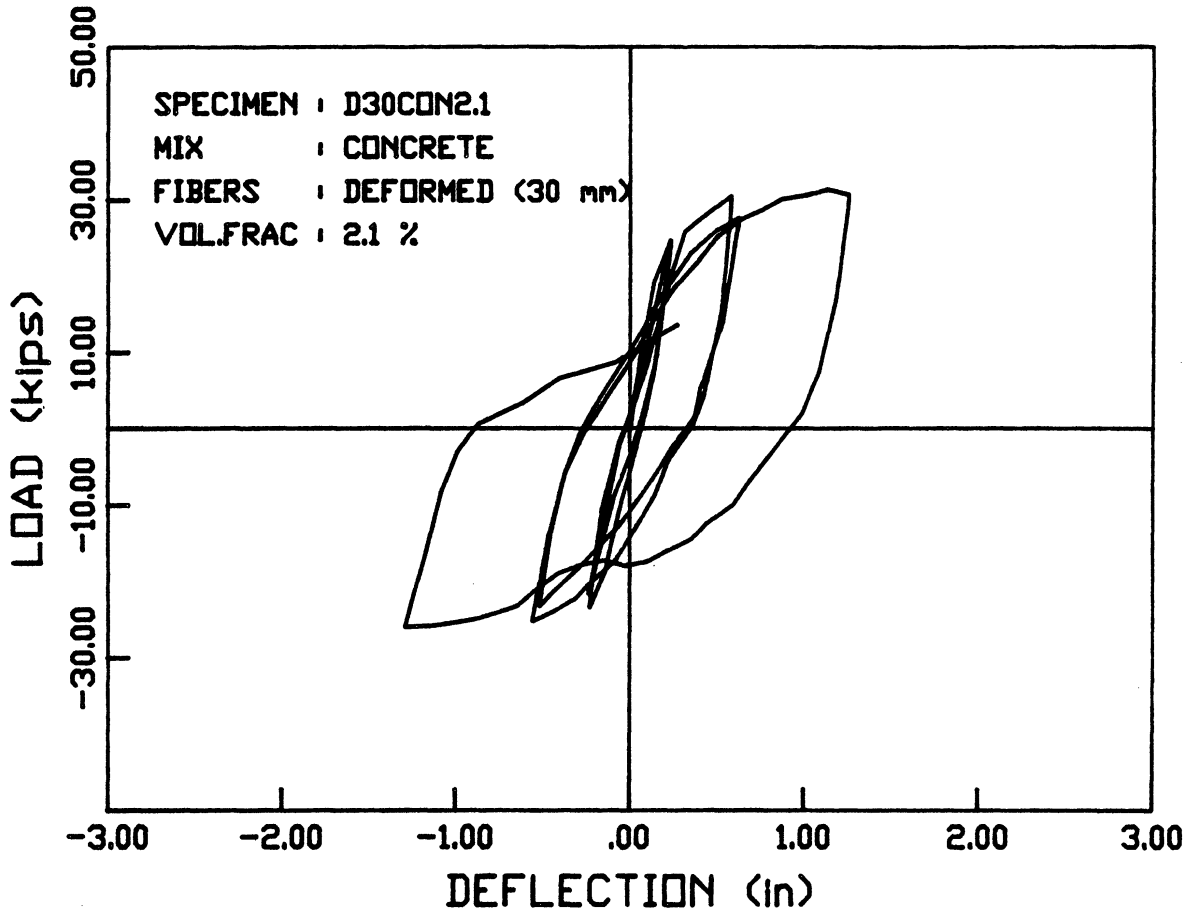
Fig. 4.15- Load vs. deflection curve.

The load vs. displacement curve for this specimen is shown in Fig. 4.15. The load carrying capacity did not decrease in the 5th cycle, despite the decrease in the stiffness. No pinching was observed in the hysteresis loop.

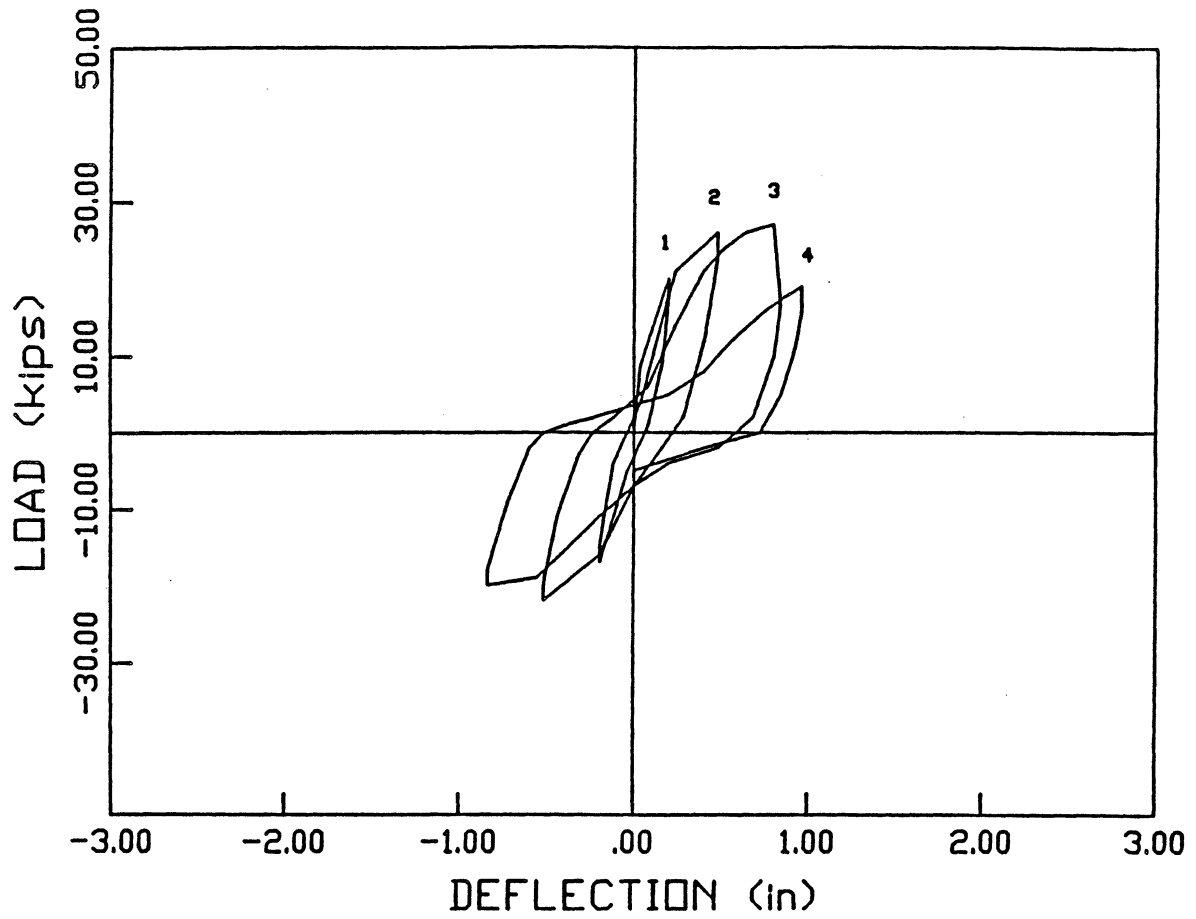
Fig. 5.2- Load vs. deflection curve of control specimen. (2)

The control specimen was tested by Abdou (2) in a previous investigation where slurry infiltrated concrete (SIFCON) was used as the composite in the CIP joint. The specimen had the same reinforcing arrangement of the specimens tested in this investigation. The loading history of the control specimen is shown in Fig. 5.1. The behavior of the specimen was characterized by a localized plastic hinge in the CIP joint. Failure occurred due to the crushing of concrete after reaching the specimen's maximum load carrying capacity. The load vs. deflection curve of the control specimen is shown in Fig. 5.2. Although the loading
