FIVE YEAR PERFORMANCE OF WELDED
WIRE FABRIC IN BITUMINOUS RESURFACING

Egons Tons
Assistant Professor of Transportation Engineering

Alexander J. Bone
Associate Professor of Transportation Engineering

Joint Highway Research Project
Massachusetts Institute of Technology

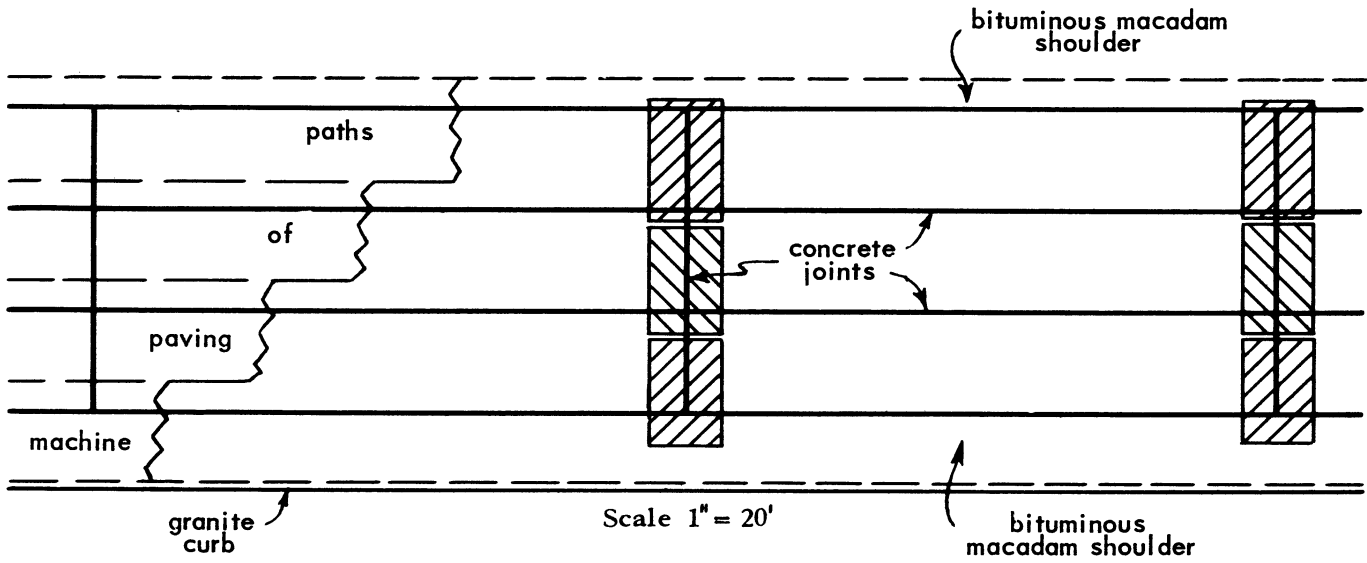
Fig. 2 Placement of fabric on road. Transverse joint reinforcing with sheet fabric.

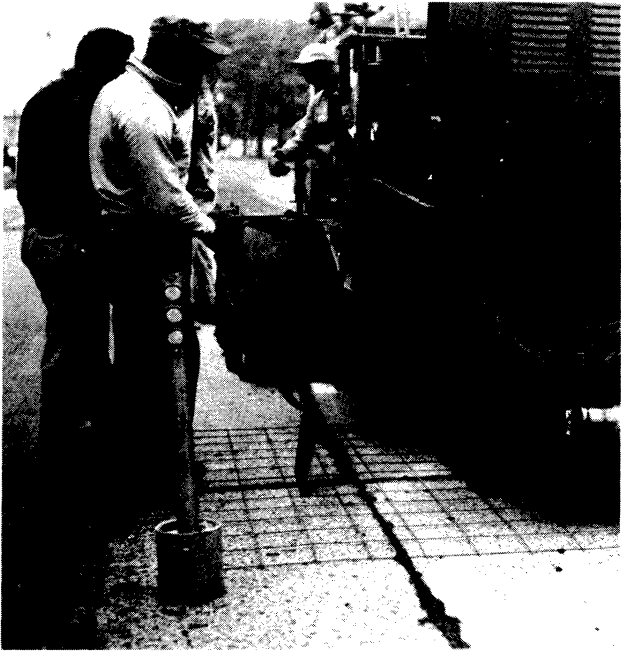
Figure 9. Typical installation of transverse reinforcing over joint.

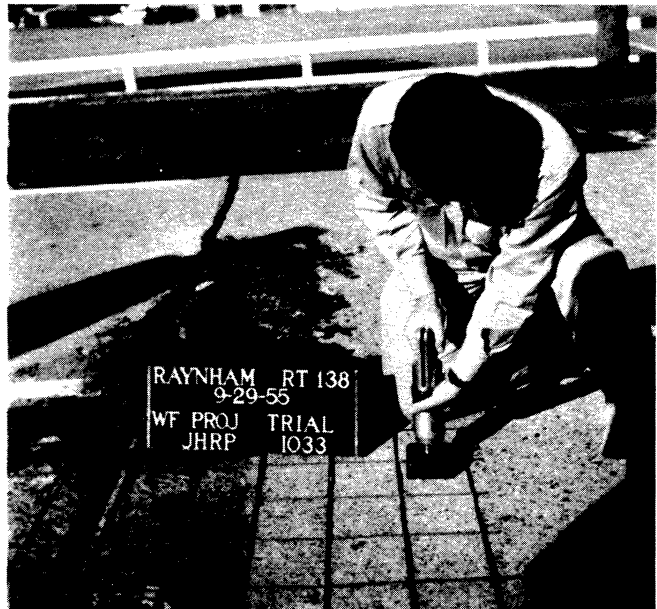
Figure 10. Remington stud driver used to hold down fabric sheets.

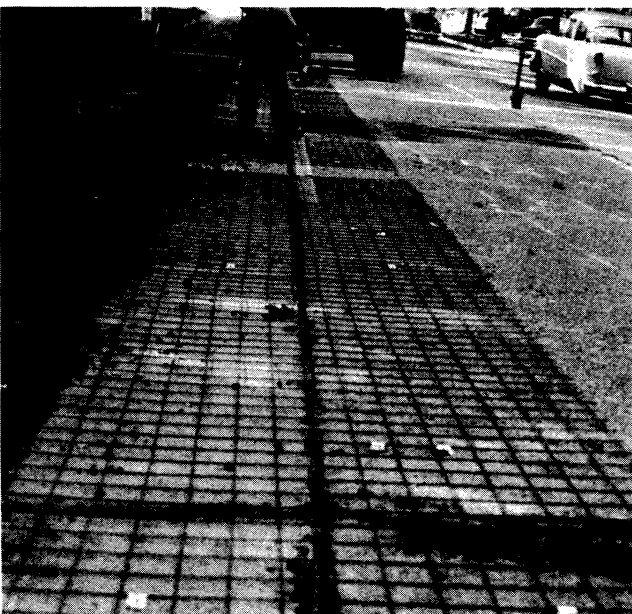
Figure 11. Typical installation of longitudinal reinforcing over joint.

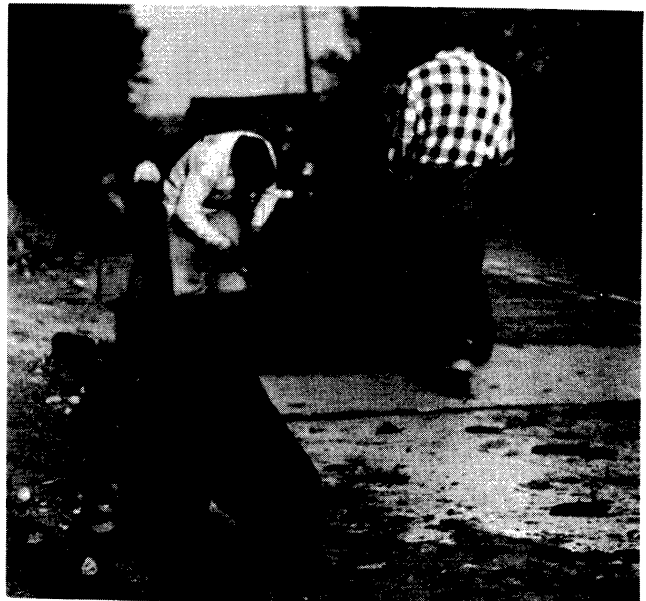
Figure 13. Placing continuous roll reinforcing.

On the Walpole Test Road the rolls were first flattened out to their full length of about 57 feet (see Figure 12 and 13). The ends were overlapped in the middle of the concrete slabs by about 1 1/2 of the transverse wire spacing. However, the curl of the rolls, when opened out, caused the lap to have a tendency to rise up off the concrete. This was remedied by increasing the overlap to 18 inches and fastening both ends of the rolled out fabric together with hog rings. Thus a lane of smooth reinforcement was obtained.

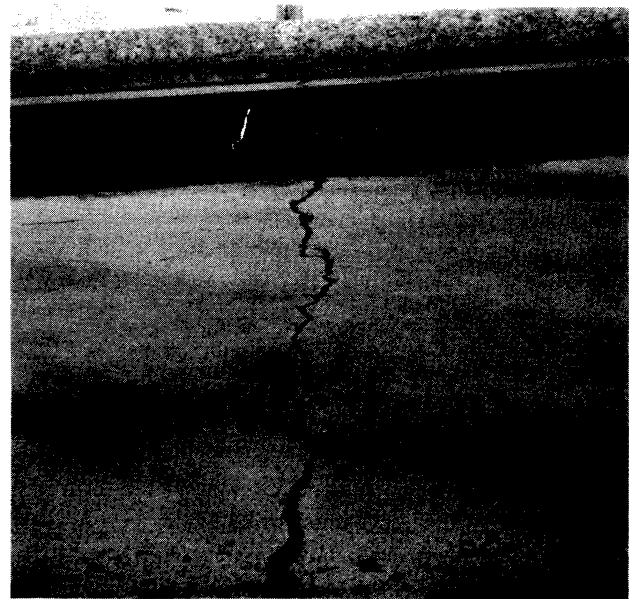
Figure 15 One of the cracks in non-reinforced section.

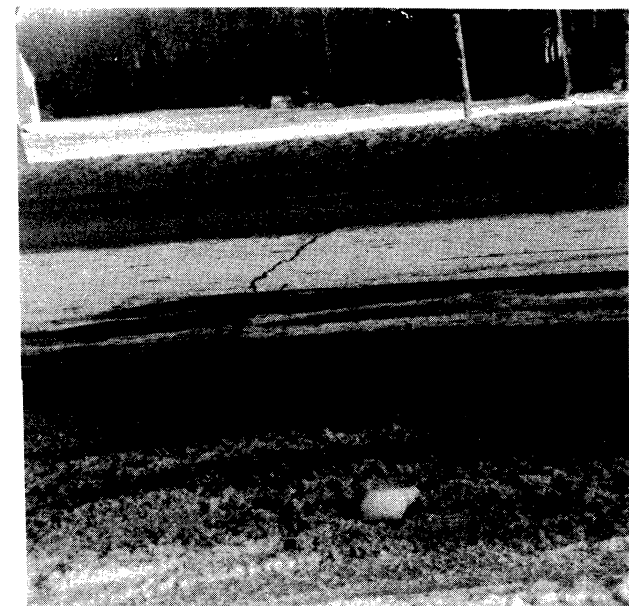
Figure 17 Crack at edge of reinforcement, Raynham.

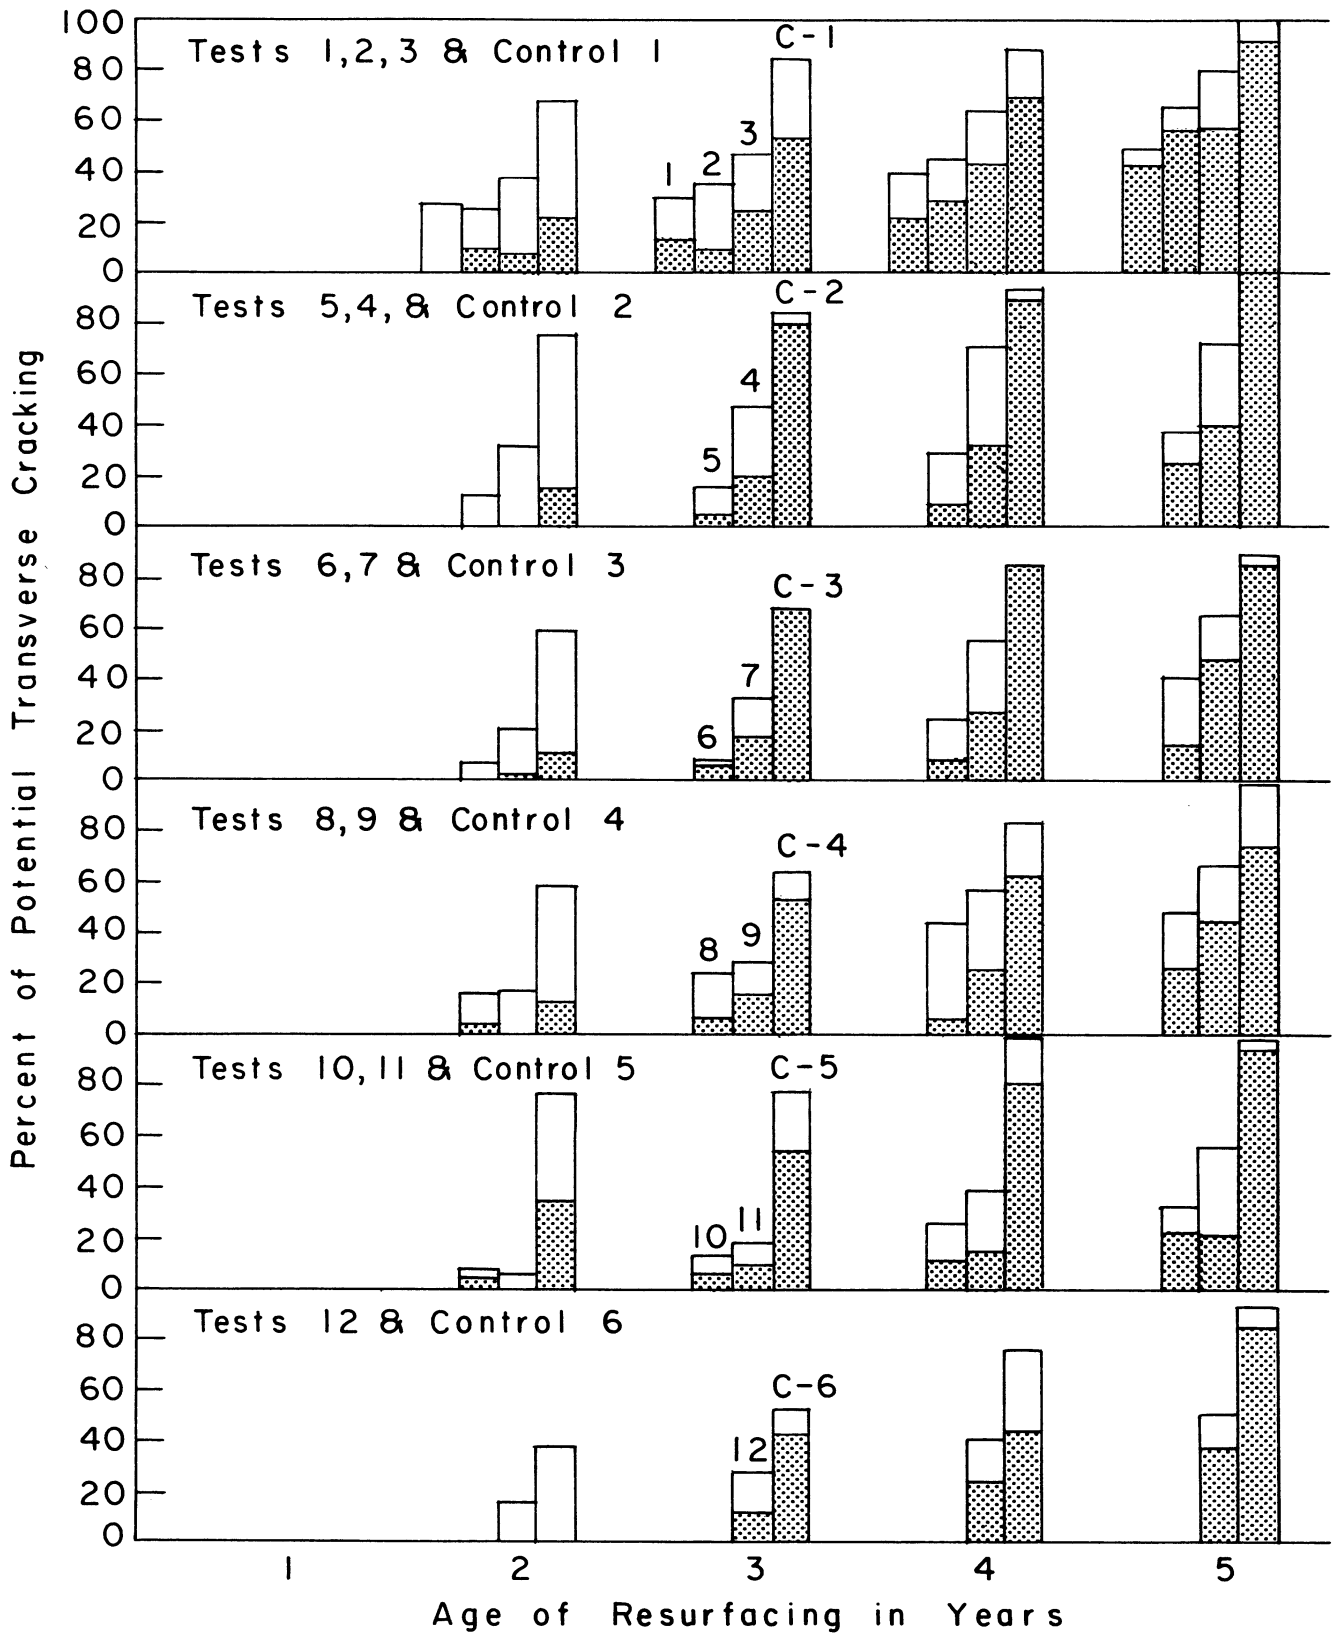
← Cracks 1/8 Inch Wide or Less
 ← Cracks Wider Than 1/8 Inch

Figure 19 Comparison of transverse crack development for the Raynham Test Road using strip reinforcement

The main emphasis in the Raynham test section was placed upon the performance of reinforcement over transverse joints because the strains are relatively higher at these areas as compared to the longitudinal joints. Figure 19 shows that all test sections and controls had cracks after two years of traffic and exposure to weather. In all cases the cracks increased in width and length with time. The most undesirable cracks are the wide ones because they require continued maintenance. Comparing the amount of wide cracks as well as the total cracking in Figure 19 it is apparent that the control sections in all cases had more of both types of cracking than any of the wire reinforced test sections. Thus, it can be said that any of the wire fabric reinforcement over the transverse joints will help in a degree to prevent reflection cracking. The lowest percentage of reflection cracks was found in Test 10 (fabric style - 6 x 6, 8/8) which is about one third of that in a comparable control section. If the percentage of the wide cracks is defined as the most important, Test 6 (fabric style - 3 x 6, 10/10) is the best. In general, Tests 5, 6, 8 and 10 are the best performers with total cracking from about one-half to one-third and wide cracks between one-half to one-sixth of that in the controls.

The percentages of longitudinal cracking between the edge of the slab and the shoulder on each side are given in Figure 19. As can be seen, the relative number of cracks found is small compared to the previously discussed transverse cracking. Even the control sections (except for Control 3) have low cracking index. The reinforcement in the bituminous concrete overlay was extended over already existing bituminous concrete shoulders. Therefore, the amount of settlement so far has been very small which might account for the relatively low cracking indexes. There were a few instances where drainage was placed along the edge of the old pavement prior to resurfacing. The disturbed and then compacted soil and gravel support has settled about 1/4 to 1/2 inch in these locations and edge cracking has taken place. These areas, however, had to be eliminated from the test compilations as they could not be compared with test sections where such disturbances were not present. The high percentage of cracks in Control 3 is not explainable from data available.
