U.S.-JAPAN COOPERATIVE RESEARCH PROGRAM:
CONSTRUCTION OF THE FULL SCALE REINFORCED
CONCRETE TEST STRUCTURE

A Report on Research Sponsored by
National Science Foundation
Grant No. CEE-81-21843

Report UMEE 83R2
Department of Civil Engineering
The University of Michigan
Ann Arbor, MI 48109

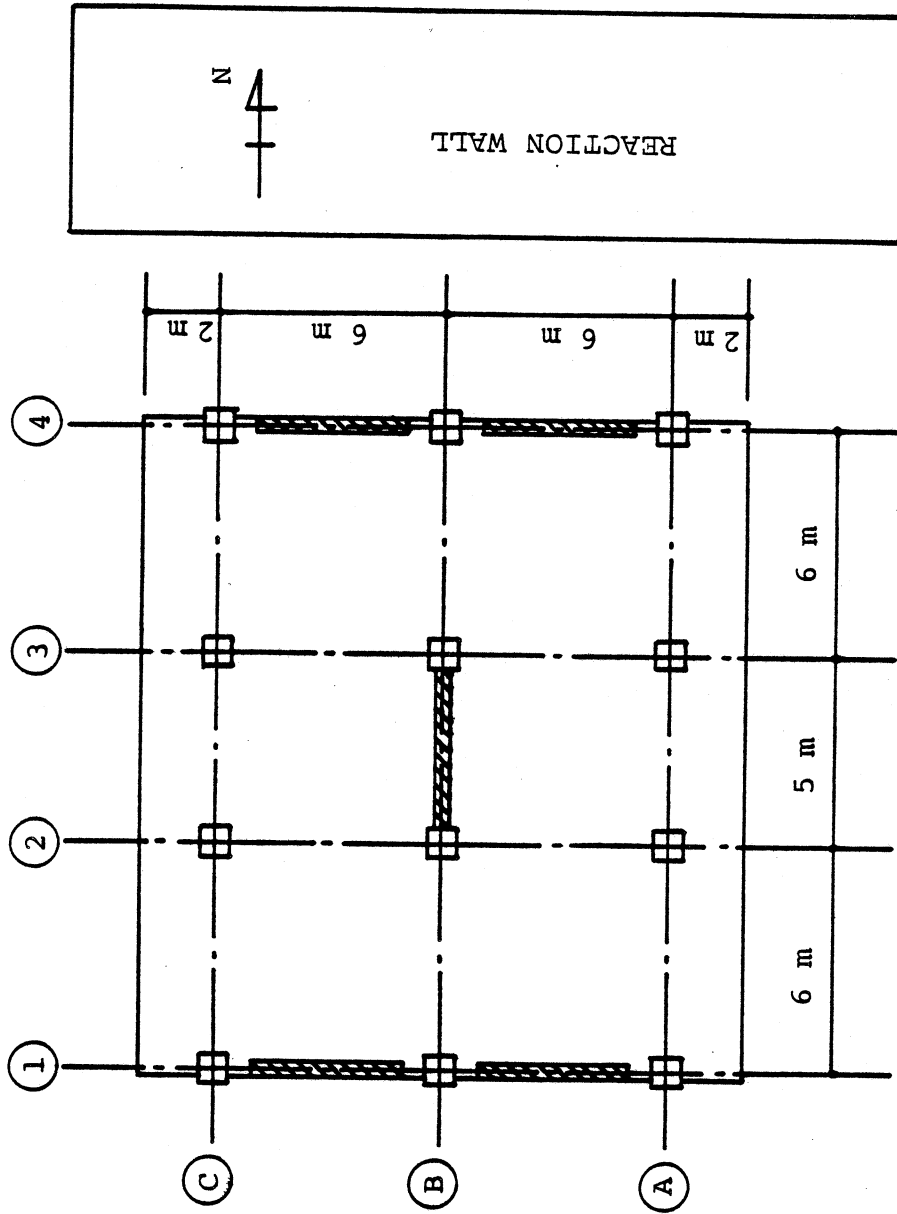
Fig. 1.1.1. General Plan View

The general layout of the building is shown in Figs. 1.1 through 1.3. Figure 1.1 is a general plan view and shows nominal span lengths. The location of the reaction wall is also shown in Fig. 1.1. The test structure consisted of three frames (A,B,C) parallel to the loading direction and four frames (1,2,3,4) perpendicular to the loading direction.

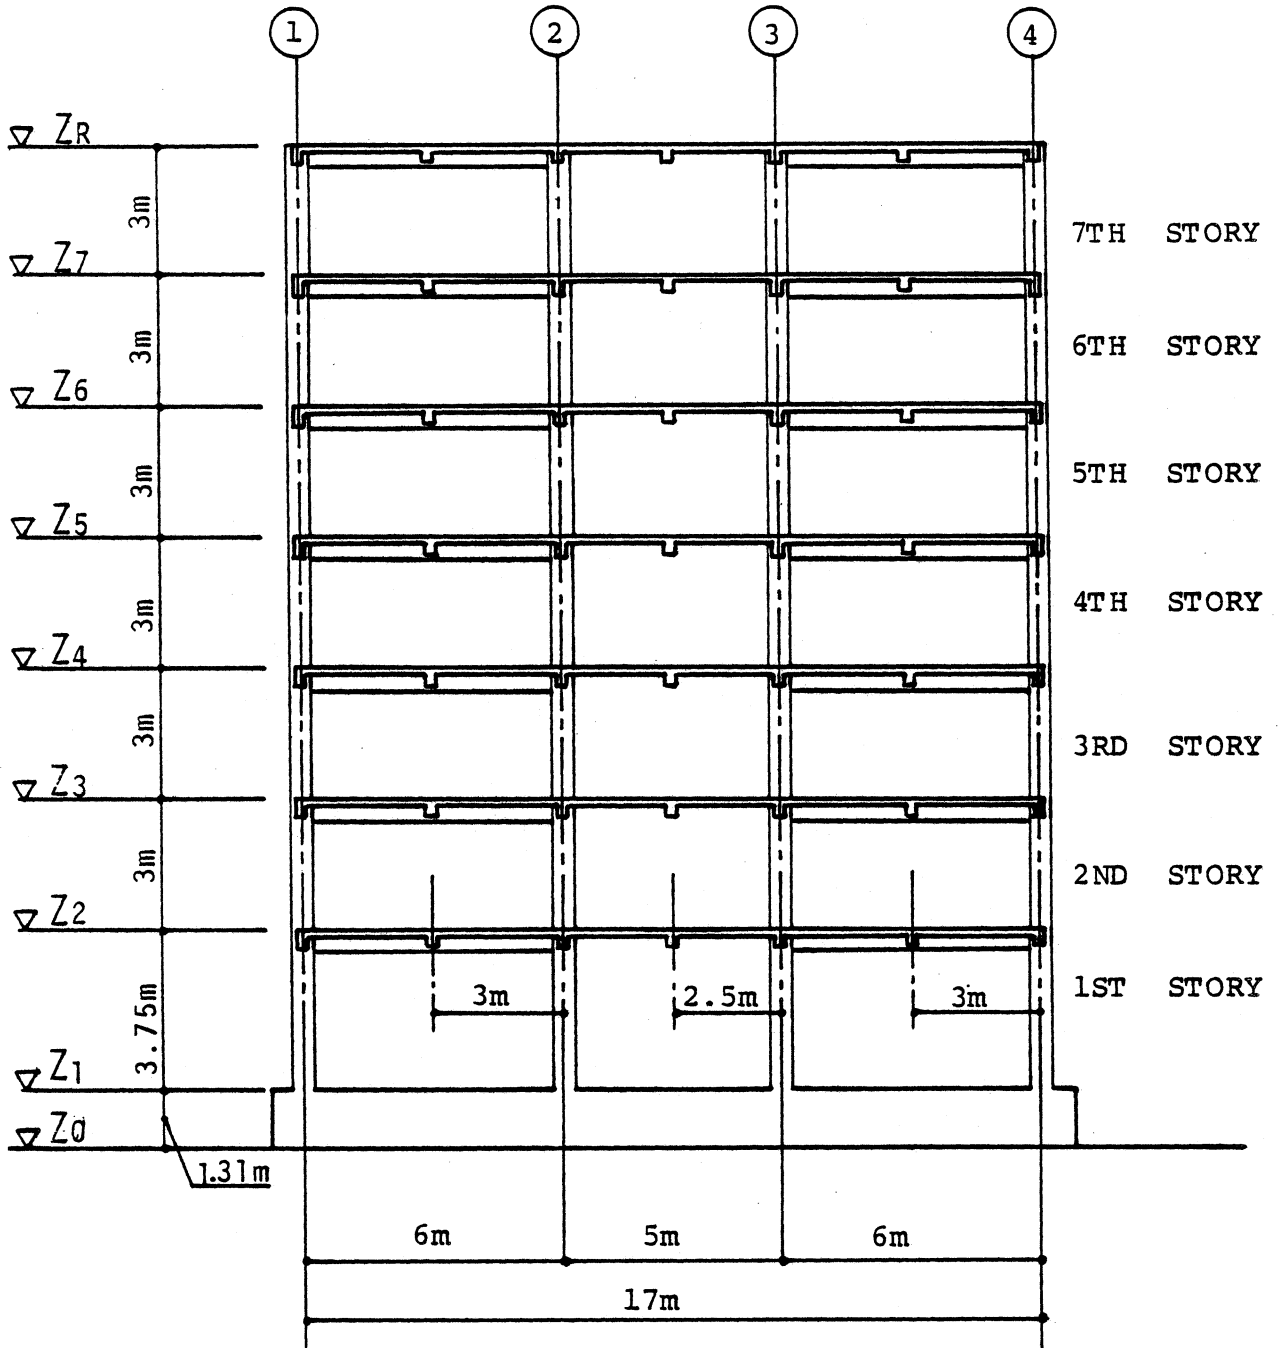
Fig.1.2. Elevation, Frame B

A general elevation of frame B is given in Fig. 1.2. Spans 1-2 and 3-4 are open frames, but span 2-3 is a shear wall with a nominal thickness of twenty centimeters. The girders of spans 1-2 and 3-4 and the longitudinal reinforcement for those girders are not continued through the shear wall.

Figure 1.2 also shows the floor level notation used in this report, starting from level Z0 at the laboratory floor to level ZR at the roof. This notation is not the same as is typically

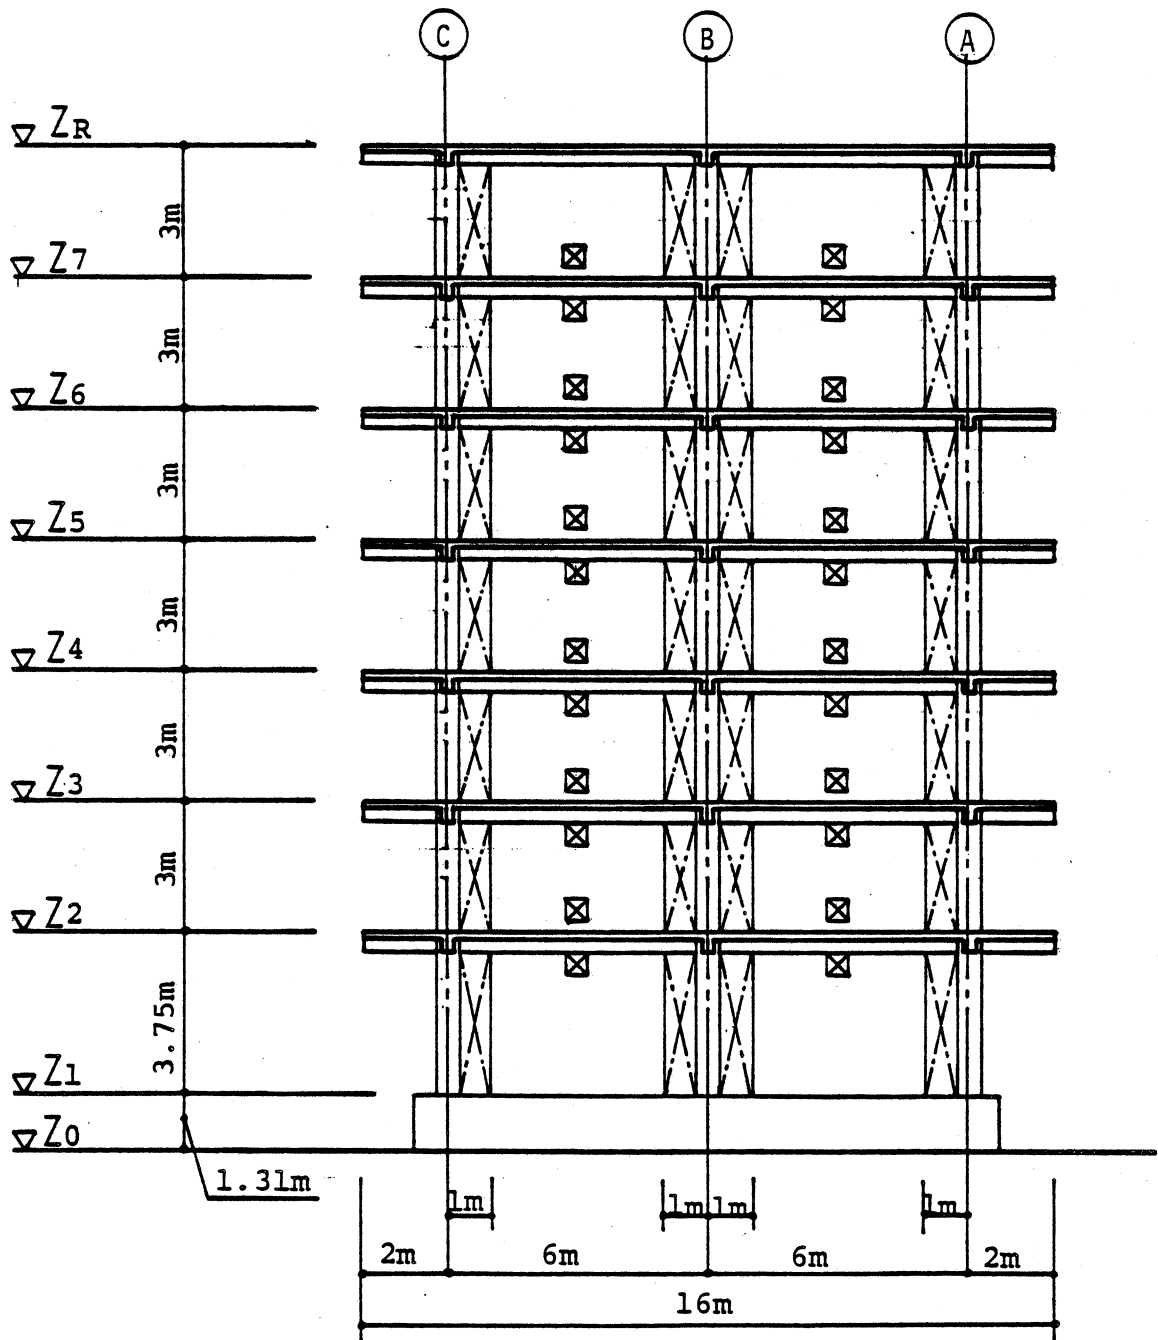
Fig.1.3. Elevation, Frame 4

A general elevation of frame 4 is given in Fig. 1.3. Both spans A-B and B-C have fifteen centimeter thick shear walls, but the walls do not frame into the columns. A one meter gap was provided between the face of the columns and the edge of the wall to permit easy passage of instrumentation beams. In frame 4, pairs of openings (440mm by 500mm) were provided at each floor level to permit the passage of loading beams. Frame 1 is identical to frame 4 except the openings for the loading beams were not required. The walls in frames 1 and 4 are expected to increase the torsional stiffness of the structure and thus insure the structure will move only in the NS direction when loaded. Frames 2 and 3 are pure open frames and have dimensions identical to those given in Fig. 1.3.

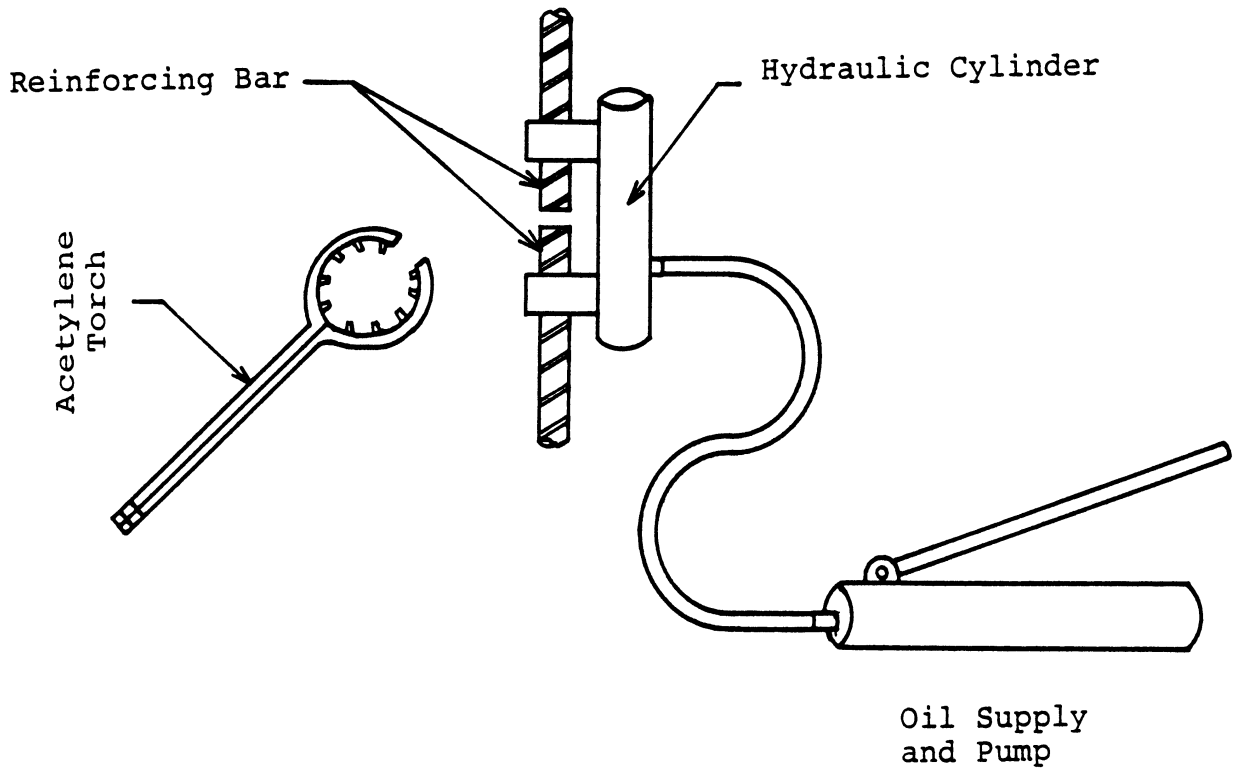
Fig. 2.1. Gas Pressure Welding Process.

Figure 2.1 shows the important items used in this welding method. The ends of the reinforcing bars are cleaned and sanded and then a hydraulic cylinder is used to align the bars. At the start of the process the gap between the bars is to be less than or equal to 3mm. No misalignment or warp is permitted. An acetylene torch, which has a twin semicircular head, is then used to heat the butt zone. The butt zone is defined as a length of bar extending one bar diameter above and below the gap. When the butt zone reaches a red hot condition, the oil pressure in the hydraulic cylinder is increased so the ends of the reinforcing bars are clamped together with a pressure of 300 kg/cm². Heat is applied during the clamping process until a bulge of at least 1.4 times the bar diameter is developed. Heating is then stopped and after the bar had lost its "fire color", the clamping device is removed. Figures 2.2 through 2.5 show the welding equipment, the clamping device applied to a column bar,

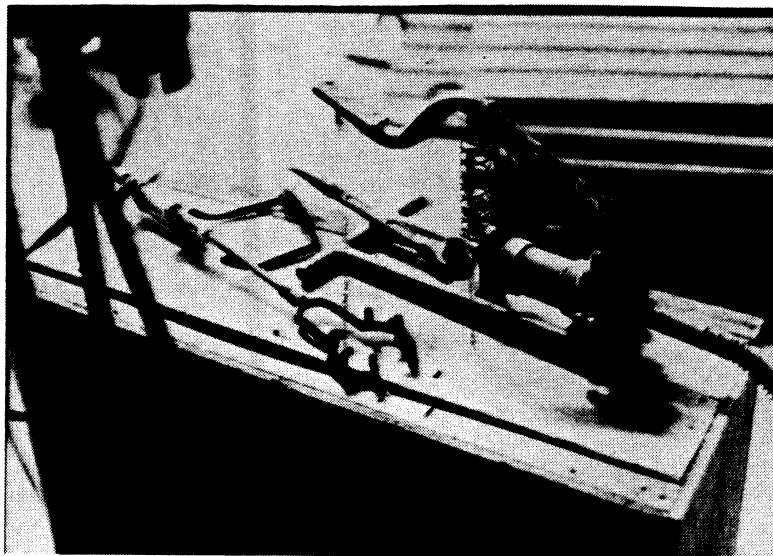
Fig. 2.2. Equipment for Gas Pressure Welding.

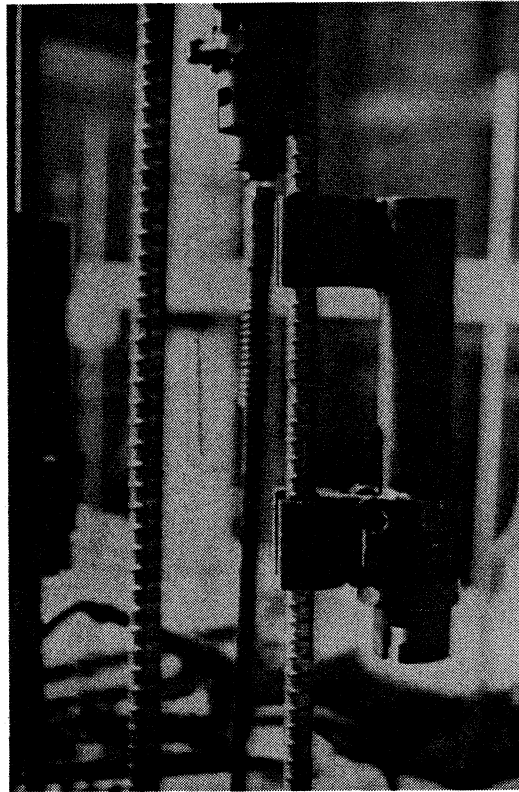
Fig. 2.3. Clamping Device on a Column Bar

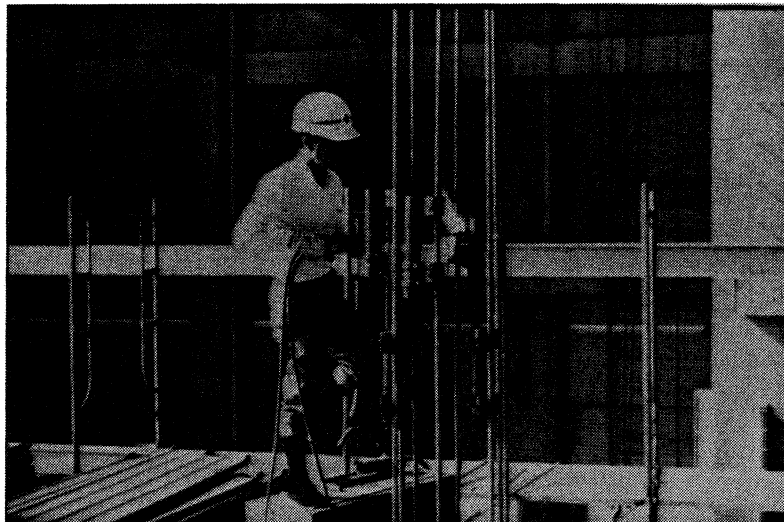
Fig. 2.4. Heating Process

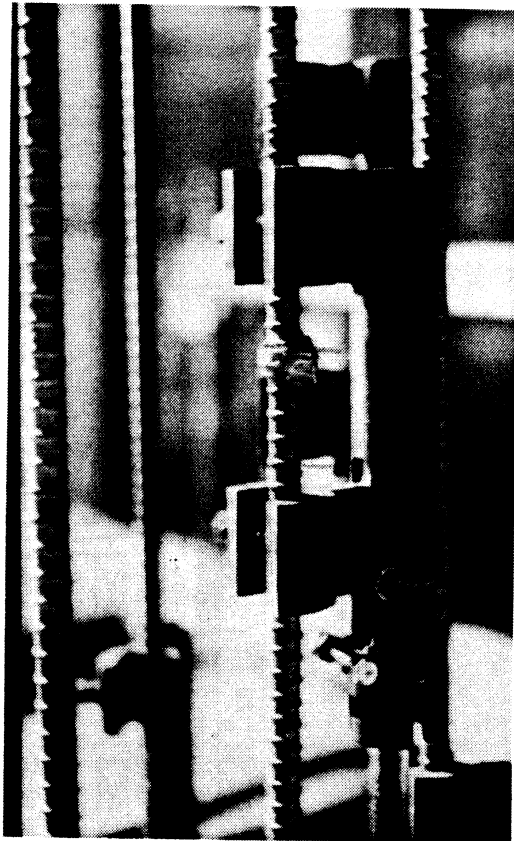
Fig. 2.5. Finished Product

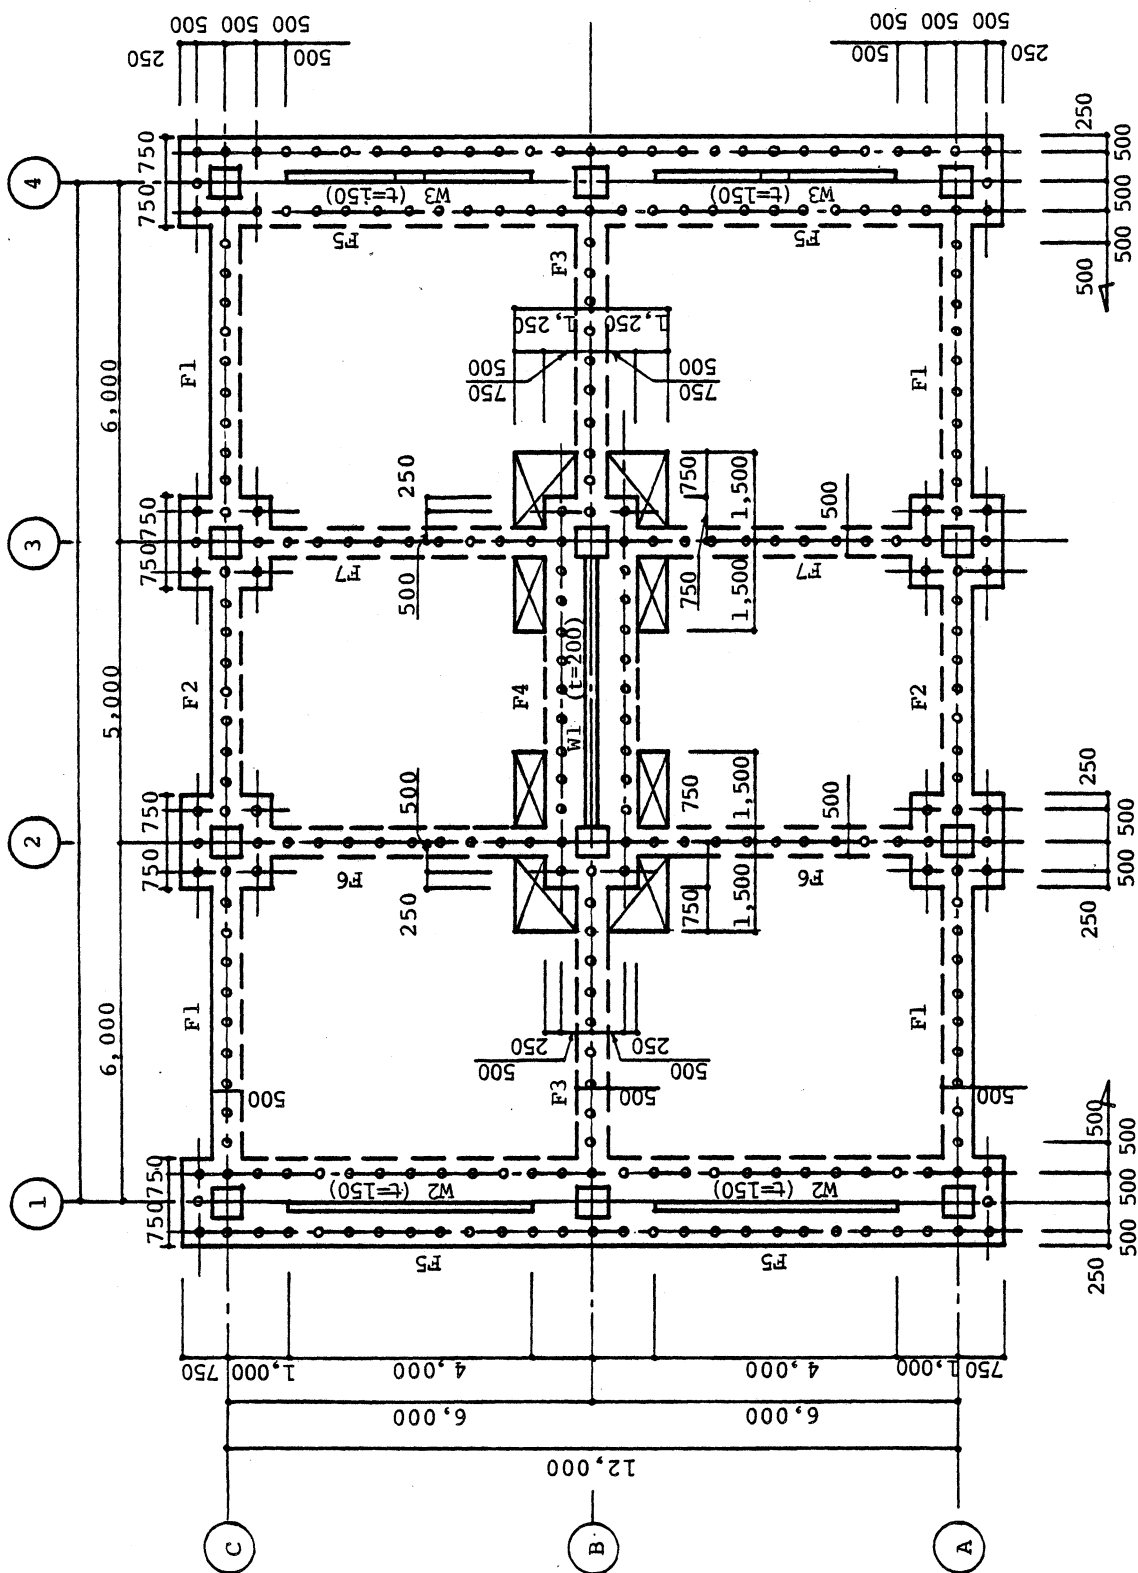
Fig. 3.1 Foundation Plan (Dimensions in mm)

A plan view of the foundation is given in Fig. 3.1. Specified cross section dimensions of the foundation beams are given in Fig. 3.2. The thickness of the slab at the top of the foundation (level Z1) was to be 150mm. The openings in the foundation slab near columns B2 and B3* are for instrumentation. The foundation was post tensioned to the floor with 33 mm diameter post tensioning rods. The rods have a strength of 10t/cm^2 (140 ksi) and were tensioned to a stress of 5.9t/cm^2 (83ksi). Locations of the post tensioning rods are indicated by the open circles in Fig. 3.1.

Columns and wall locations are shown in Fig. 3.1. All of the columns were to be 500mm by 500mm. The wall (W1) parallel to the loading direction was to have a thickness of 200mm. The transverse walls, W2 and W3, in frames 1 and 4 respectively, were to be 150mm thick.

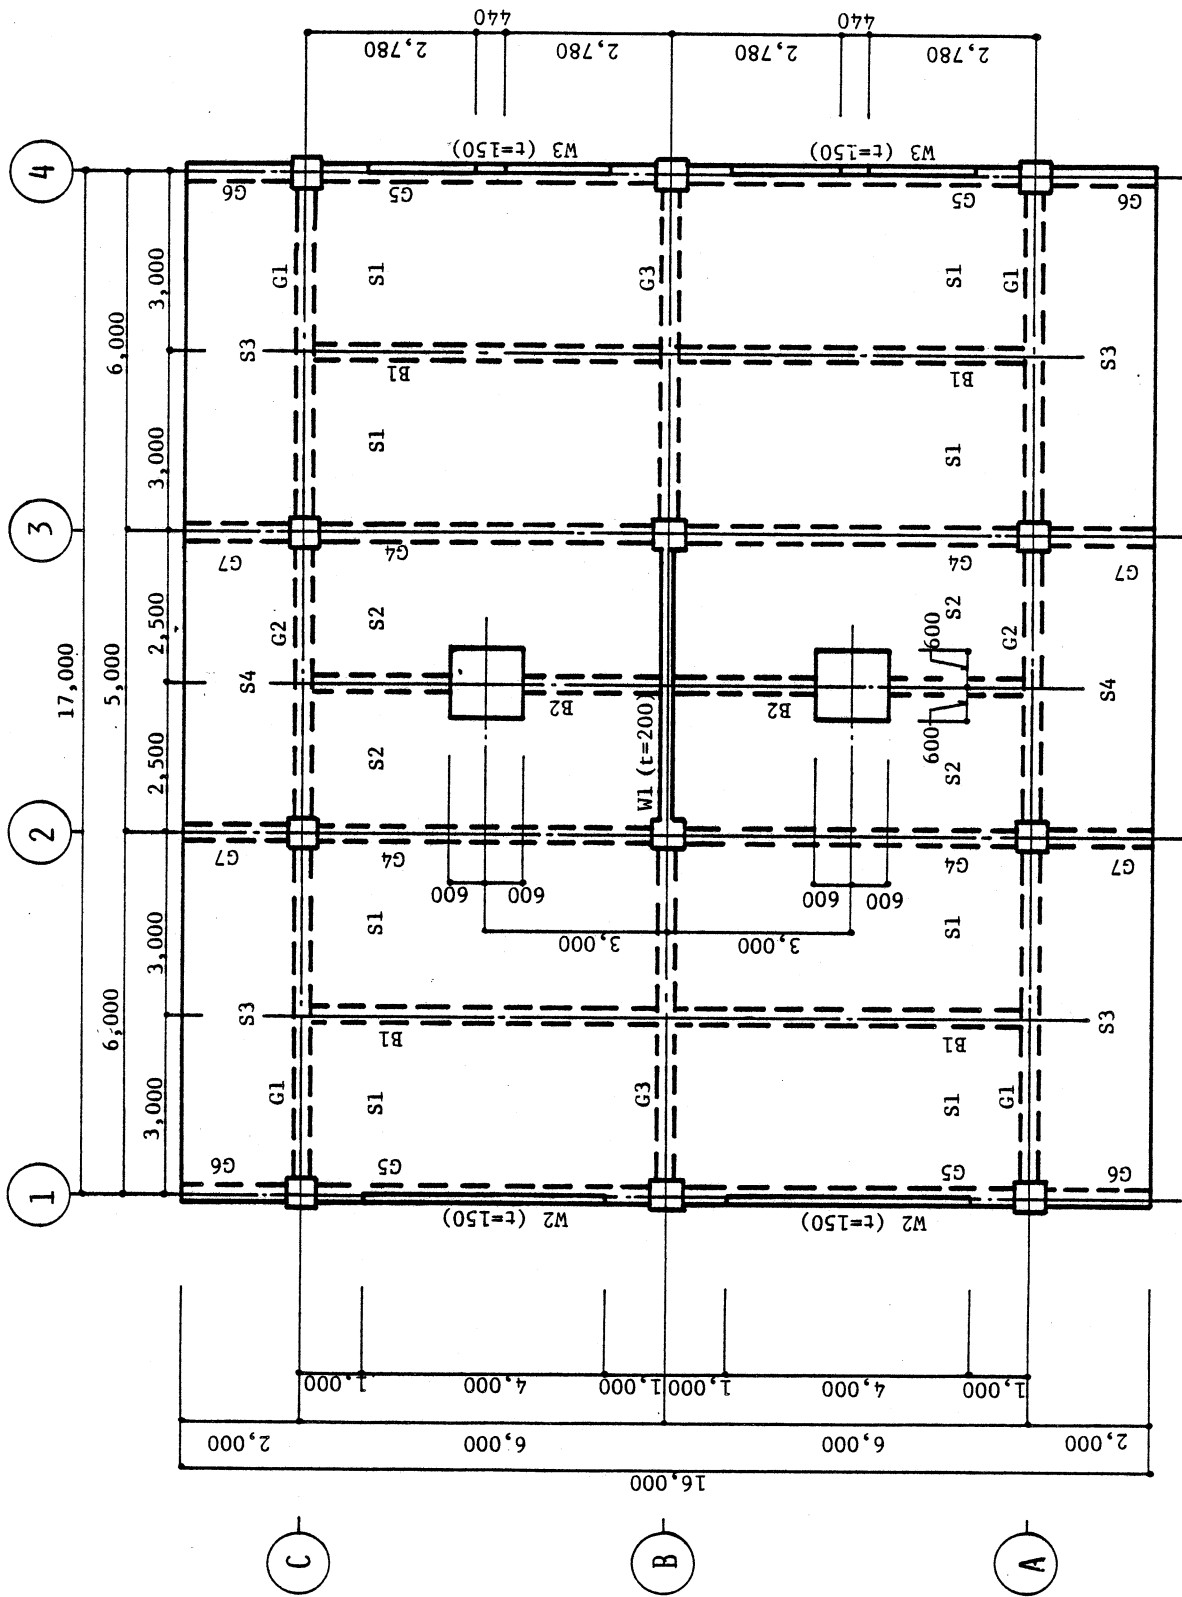
Fig. 3.3. Floor Plan, Levels Z2 through Z7 (Dimensions in mm)

A floor plan for levels Z2 through Z7 is given in Fig. 3.3. Specified cross section dimensions of the beams identified in Fig. 3.3 are given in Fig. 3.4. The floor slab was to be 120mm thick. Load points (1.2m by 1.2m by 880 mm thick) were to be located in the floor slab at the midspan of beams B2. The top of the load point extends 270mm above the top of the floor slab. The bottom of the load points extends 160mm below the bottom of beam B2. A 10mm thick mortar finish was to be applied to the top of the load points before setting the loading beams.

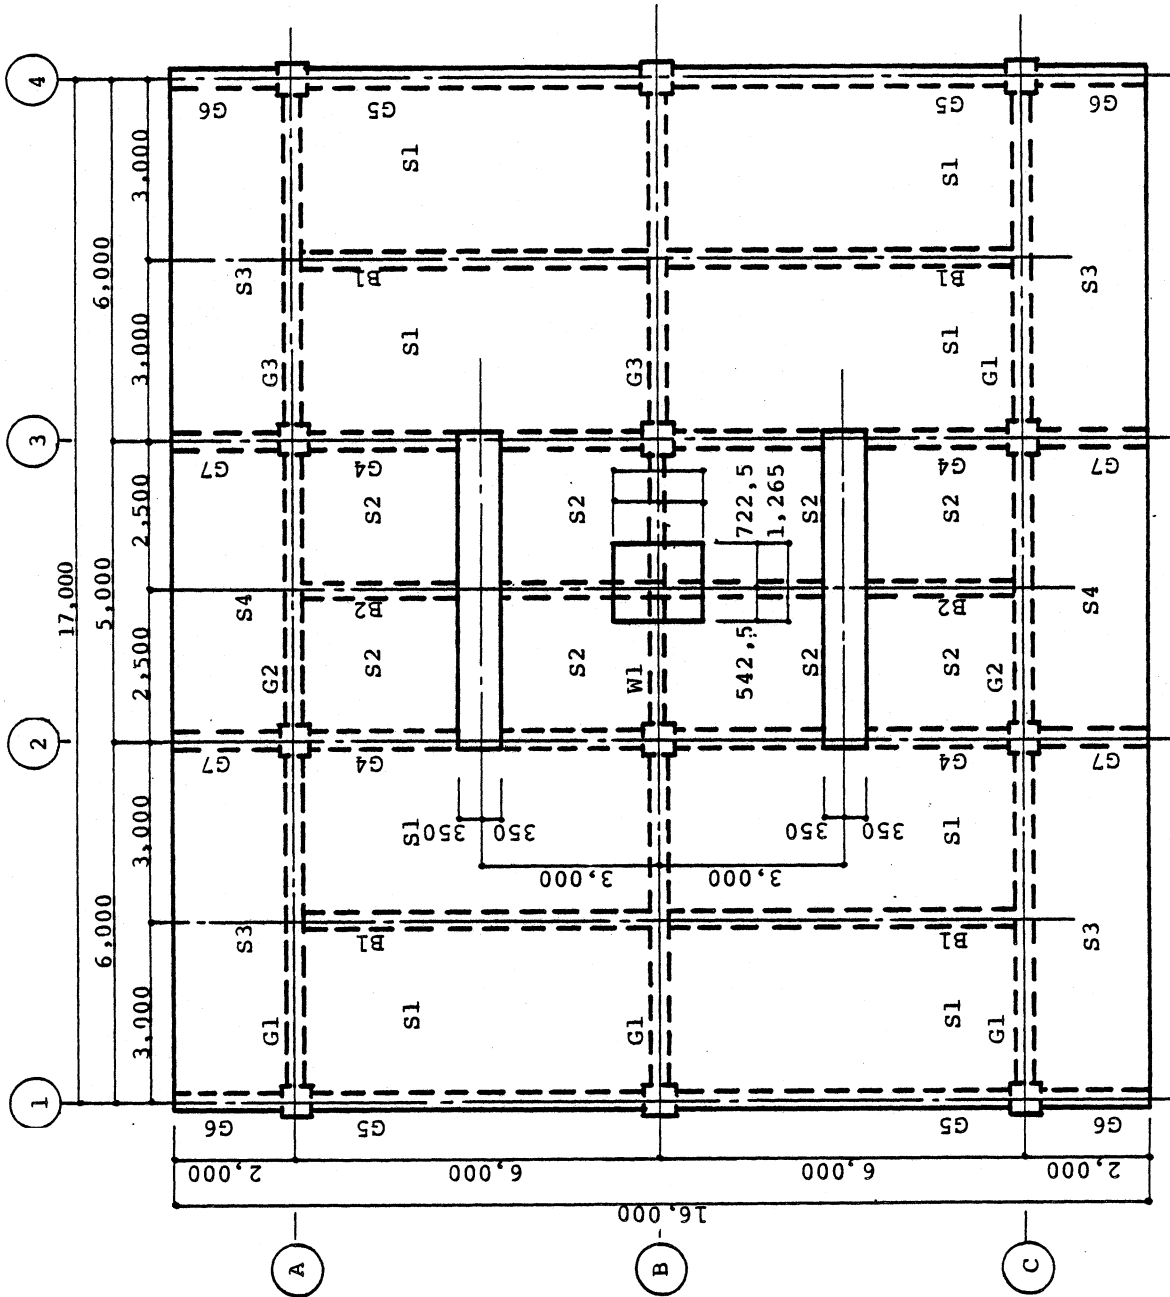
Fig. 3.5. Roof plan, Level ZR (Dimensions in mm)

The roof plan is given in Fig. 3.5. The only difference between the roof plan and the floor plan is the size of the load points. The width of the load points at the roof are 0.7m and they extended from the outside face of beam G4 in frame 2 to the outside face of beam G4 in frame 3. The top of the load points extended 190mm above the top of the roof slab and the bottom was at the same elevation as the bottoms of beams G4 and B2 (total depth of 640mm). A 10mm thick mortar finish was applied to the top of the load points before setting the loading beams.

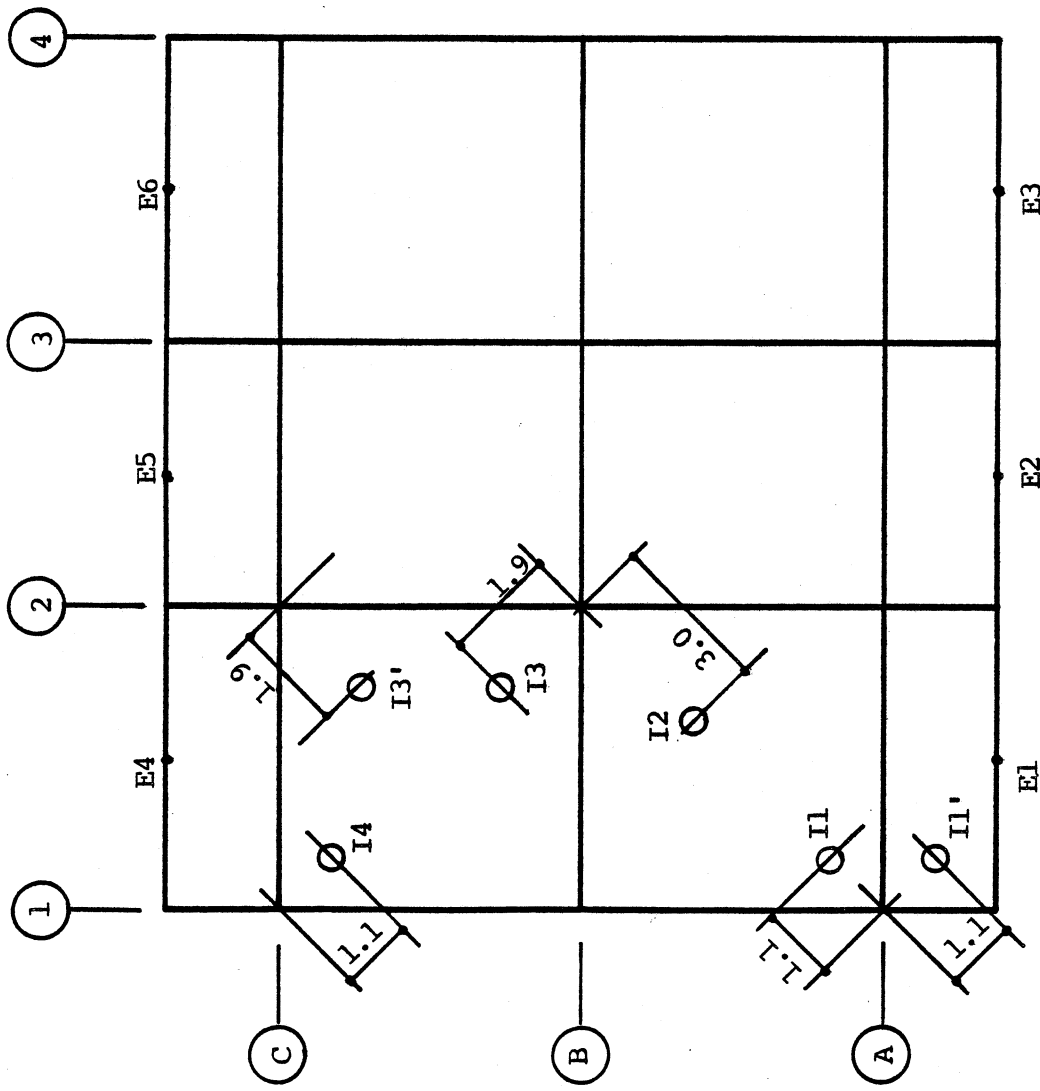
- 1. Internal Hole Dia. = 100 mm
- 2. Holes were located on lines radiating at a 45 degree angle from the column.
- 3. Given dimensions are from column center of the hole.
- 4. Measurement unit is meter.

Fig. 3.9 Locations for Measuring of Slab Thickness.

Measured slab thicknesses are given in Table 3.3 Measurements were taken both internally and at the edge of the slab. Internal measurements were taken at 100mm diameter holes used for construction purposes. The approximate locations of the internal holes are shown in Fig. 3.9. The exact hole locations varied from floor to floor. The edge dimensions are more consistent and accurate than the internal dimensions.

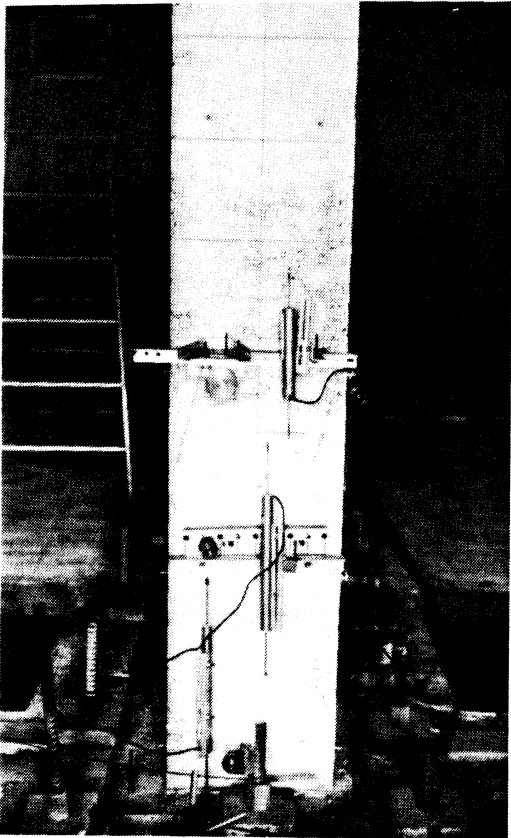
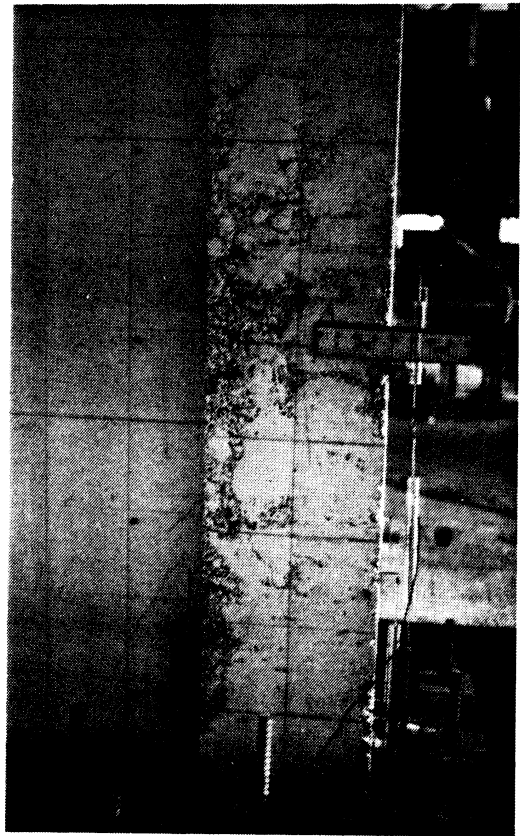
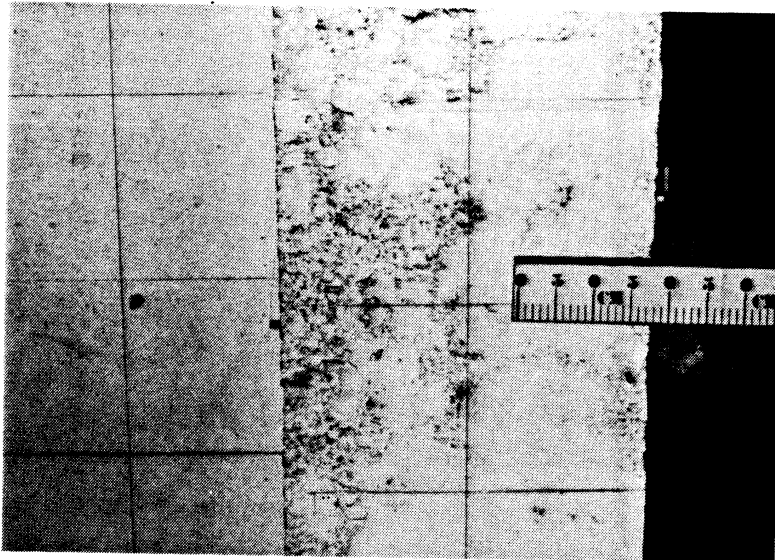
(a) South Face

(b) West Face

(c) West Face

Fig. 3.10. Voids in Column B2

In the first story there were some areas of poorly compacted concrete. While casting concrete for the first story columns and walls, only an internal spud type vibrator was used. In the second through the seventh stories, both the internal vibrators and an external form vibrator were used.

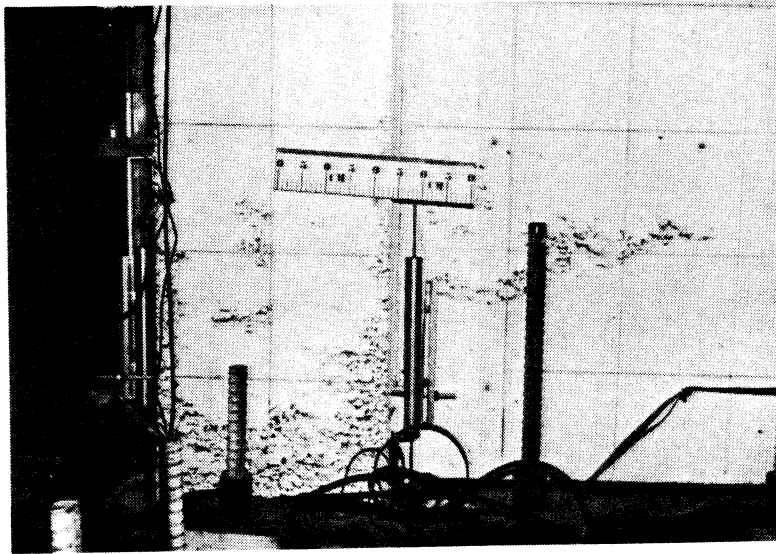
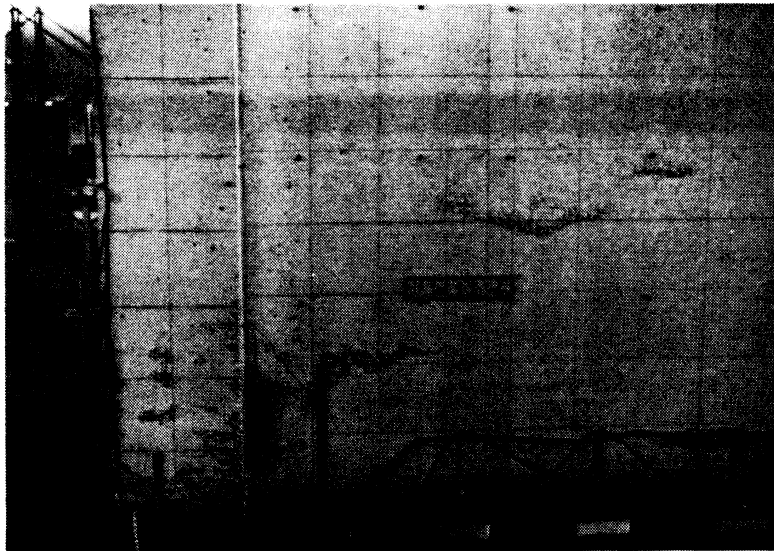
(a) Column B3, West Face

(b) West Side of Wall W1 near Column B3

Fig.3.11. Voids in Column B3 and Wall W1

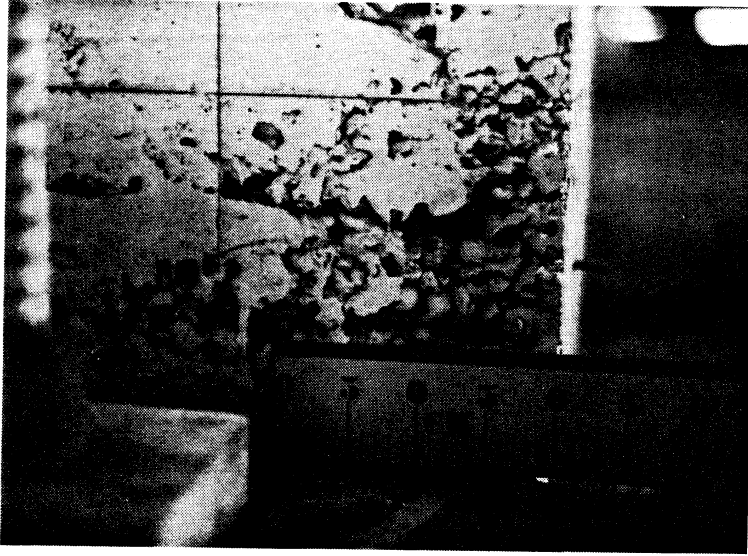
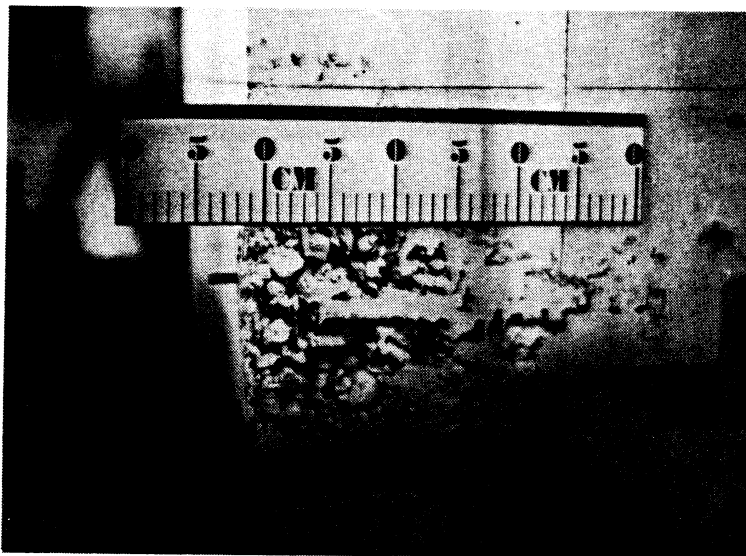
(a) West Face

(b) South Face

Fig. 3.12. Voids at Base of Column C2

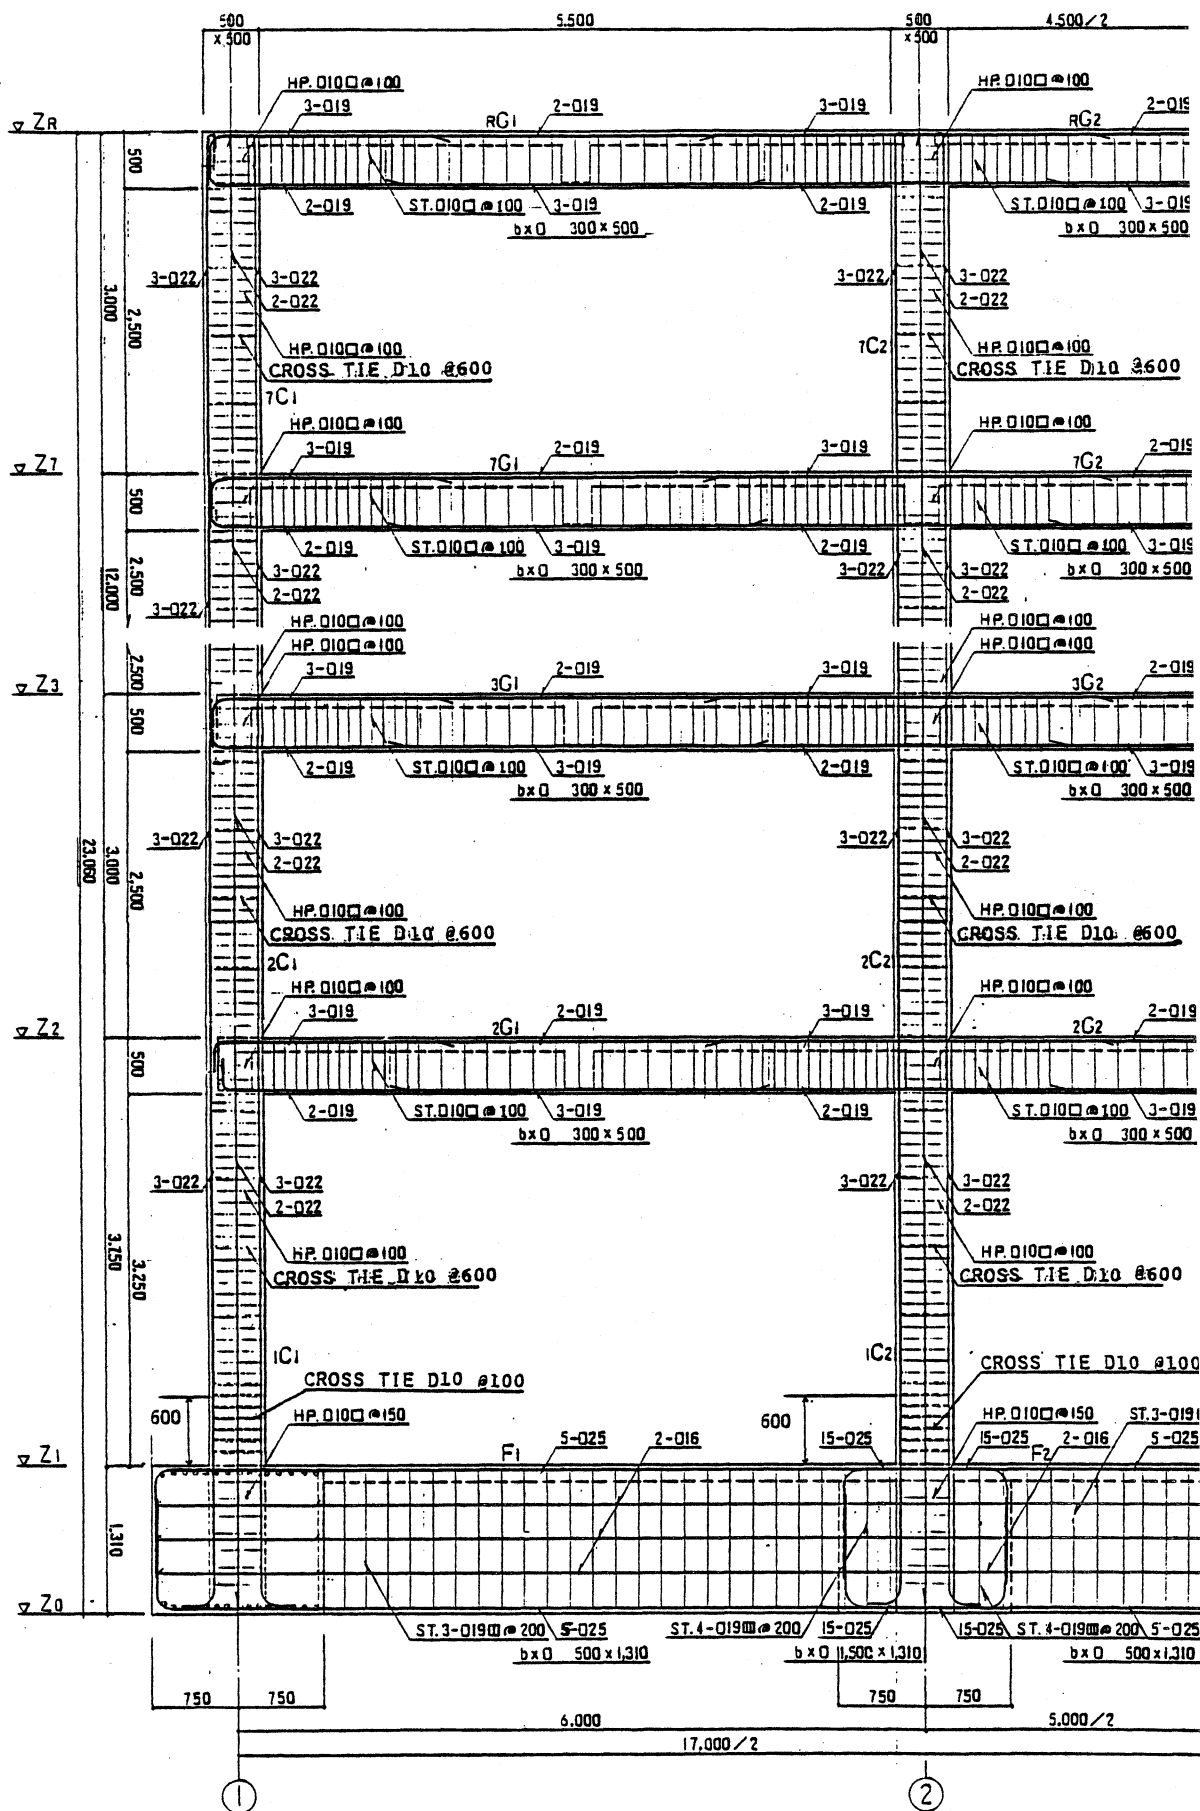
Fig. 4.1. Details of Reinforcing, Frames A and C.

Nominal reinforcement details for all frames in the seven story test structure are given in Figs. 4.1 through 4.6. Cross section reinforcement details for the foundation beams and floor beams for these frames are given in Figs. 3.2 and 3.4 respectively. A typical column cross section is shown in Fig. 4.7. Photographs of a column hoop, a column cross tie and a beam stirrup tie are given in Figs. 4.8, 4.9 and 4.10 respectively.

3. Cross ties were to be provided at a 100mm spacing over the first 0.6m of the columns above the foundation (level Z1). For the remaining portion of the total column height, except at the beam to column joints, cross ties were to be provided at a 0.6m spacing. No cross ties were to be used in the beam to column joints.
4. All of the beam bars terminating at an exterior column were to be anchored with a ninety degree hook. The portion of the beam bar extension beyond the hook was to pass through the mid-height of the beam to column joint and was to be in the same vertical plane as the external edge of the column confined region.
5. All of the column bars were to be terminated at the roof level with a 180 degree hook which extended toward the column centroid.

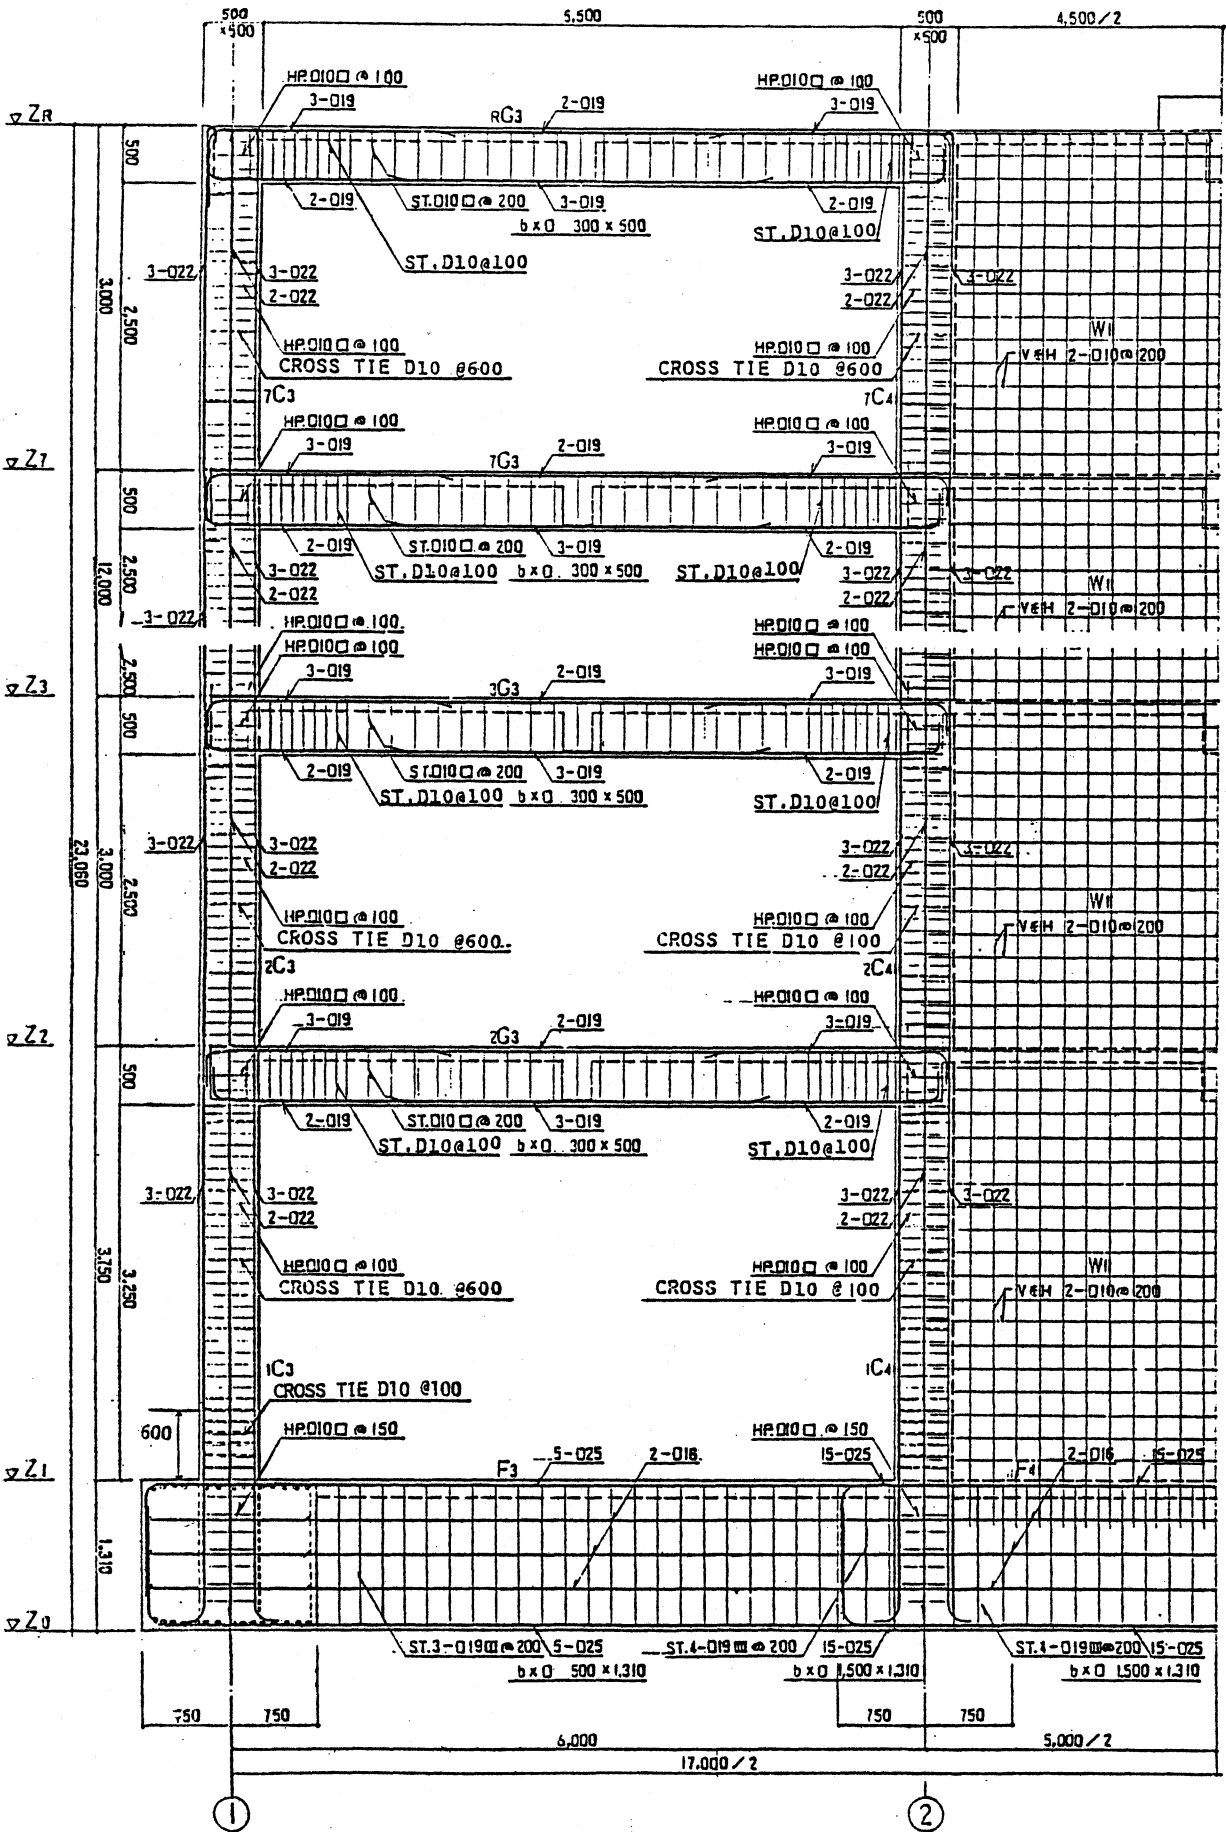
Fig. 4.2. Details of Reinforcing, Frame B.

Reinforcement details for frame B are given in Fig. 4.2. A few important differences between frame B and frames A and C are noted here:

3. The horizontal wall reinforcement was to be anchored by extending the bar straight to the exterior edge of the confined region of the wall boundary columns.
4. The vertical wall reinforcement was to be anchored into the foundation with a straight extension of 0.4m below the top of the foundation.
