U.S.-JAPAN COOPERATIVE RESEARCH PROGRAM:
CONSTRUCTION OF THE FULL SCALE REINFORCED
CONCRETE TEST STRUCTURE

A Report on Research Sponsored by
National Science Foundation
Grant No. CEE-81-21843

Report UMEE 83R2
Department of Civil Engineering
The University of Michigan
Ann Arbor, MI 48109

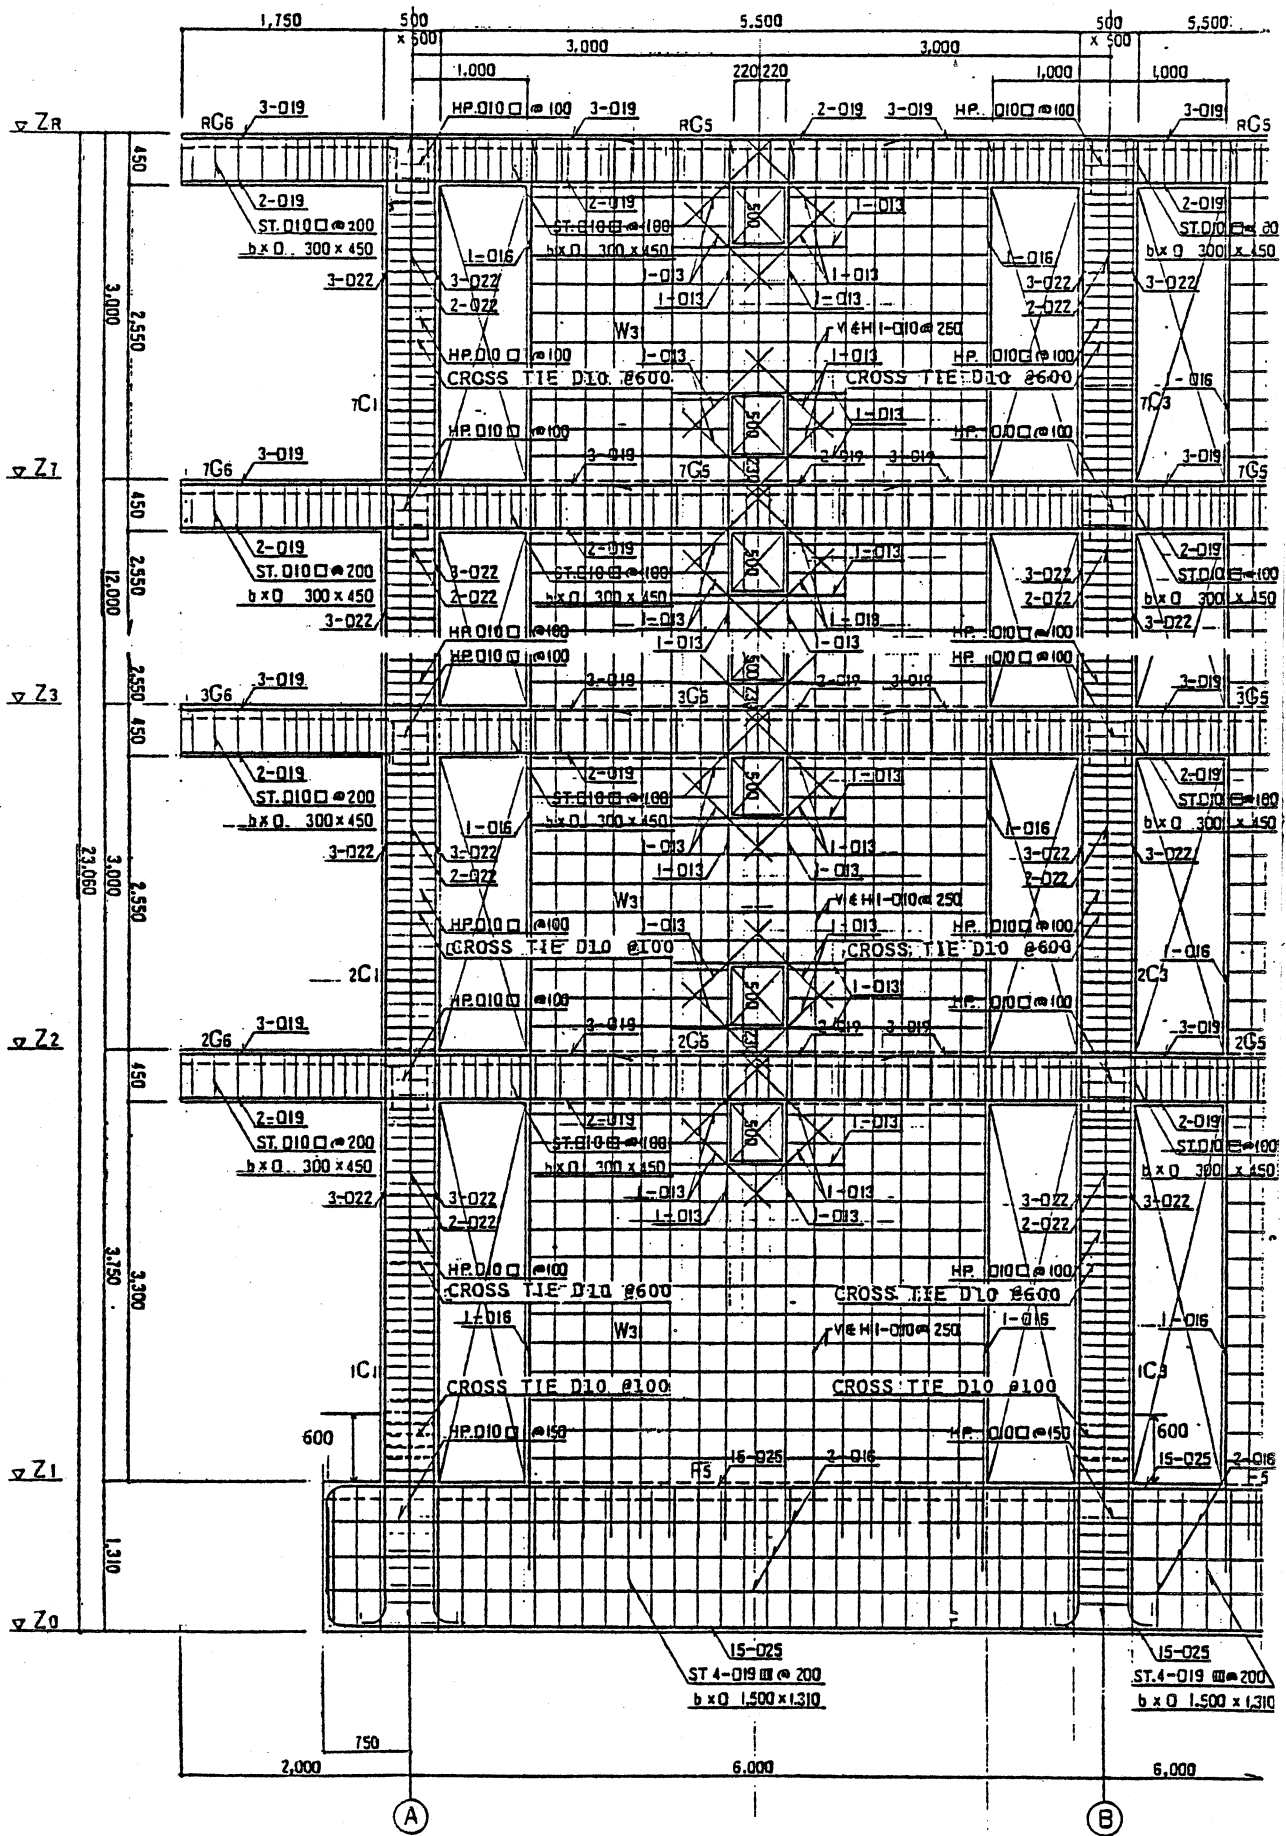
Fig. 4.3. Details of Reinforcing, Frames 1 and 4.

The walls in frames 1 and 4 were identical except for the 440mm by 500mm openings located at the wall centerline, just above and below floor levels Z2 through Z7. These openings and the auxiliary reinforcement around them were only to be present in the wall of frame 4. As discussed previously, these openings were provided to allow the passage of the loading beams. The horizontal wall reinforcement was to be extended straight (no hooks) to a point within 20mm of the edge of the wall. The normal vertical wall reinforcement (D10) was to be anchored into the foundation with a straight extension of 0.4m below the top of the foundation. The D16 bars extending vertically along the wall edge were to be anchored into the foundation with a straight extension of 0.75m.

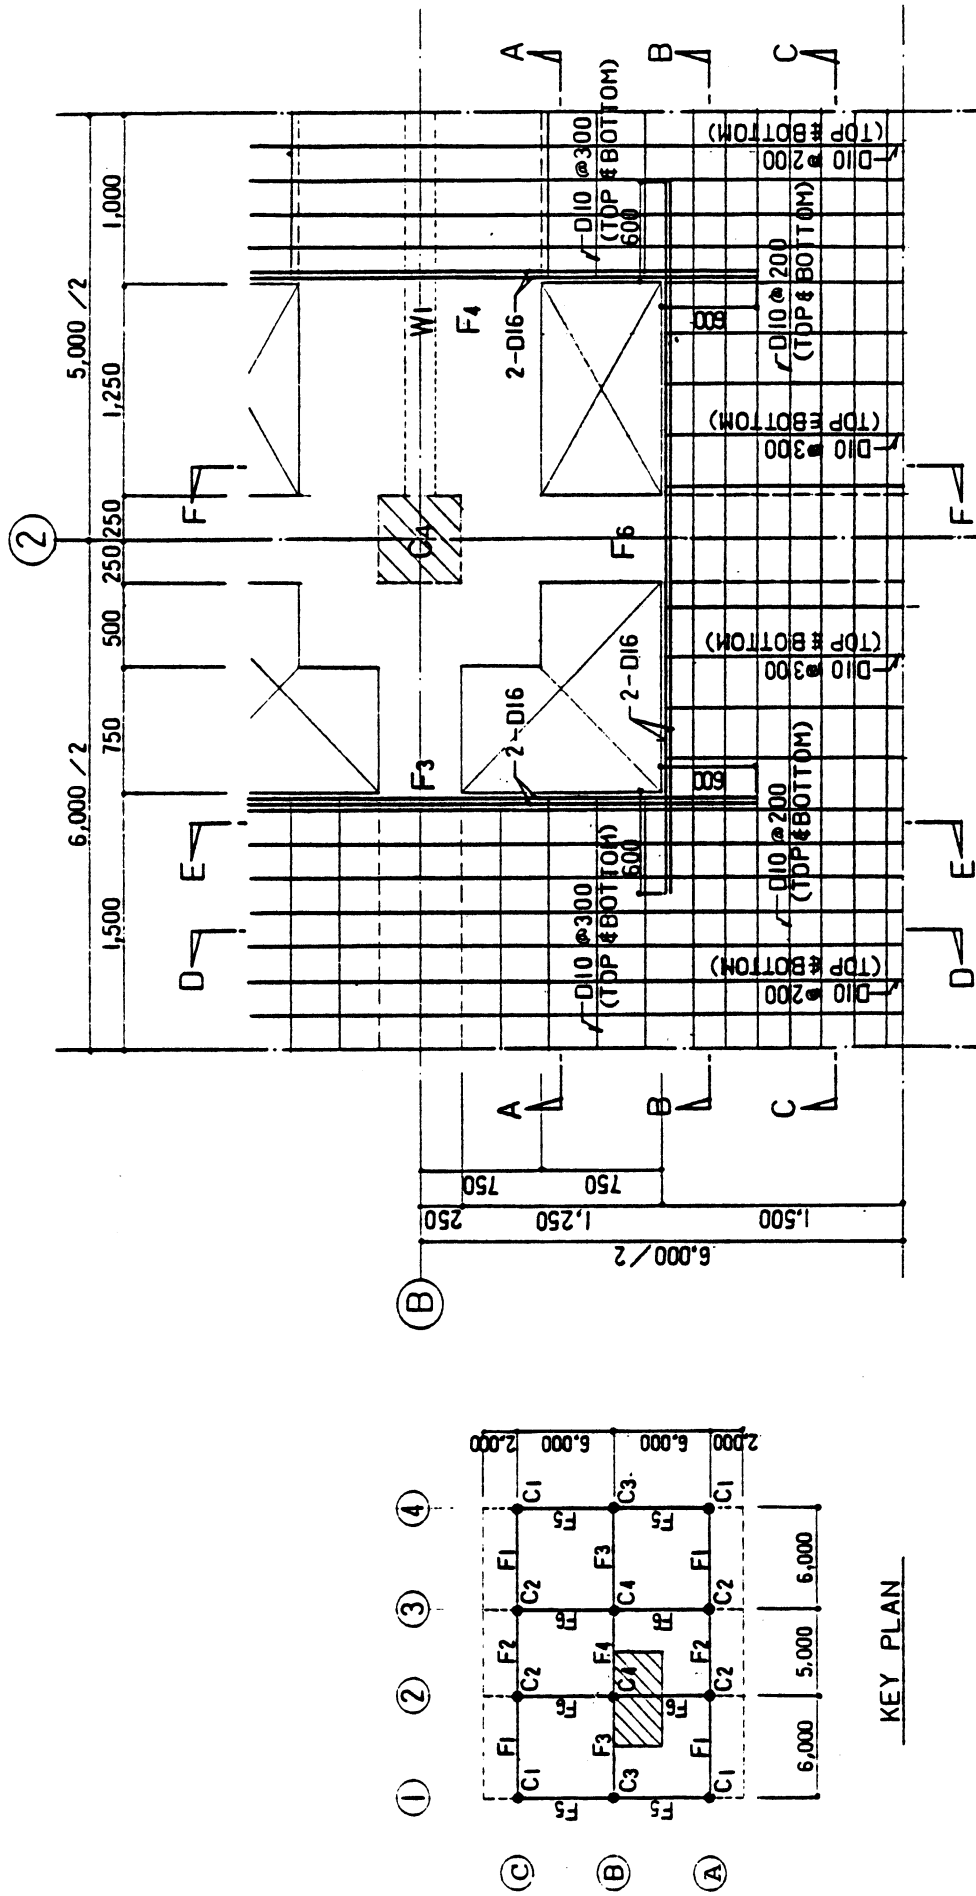
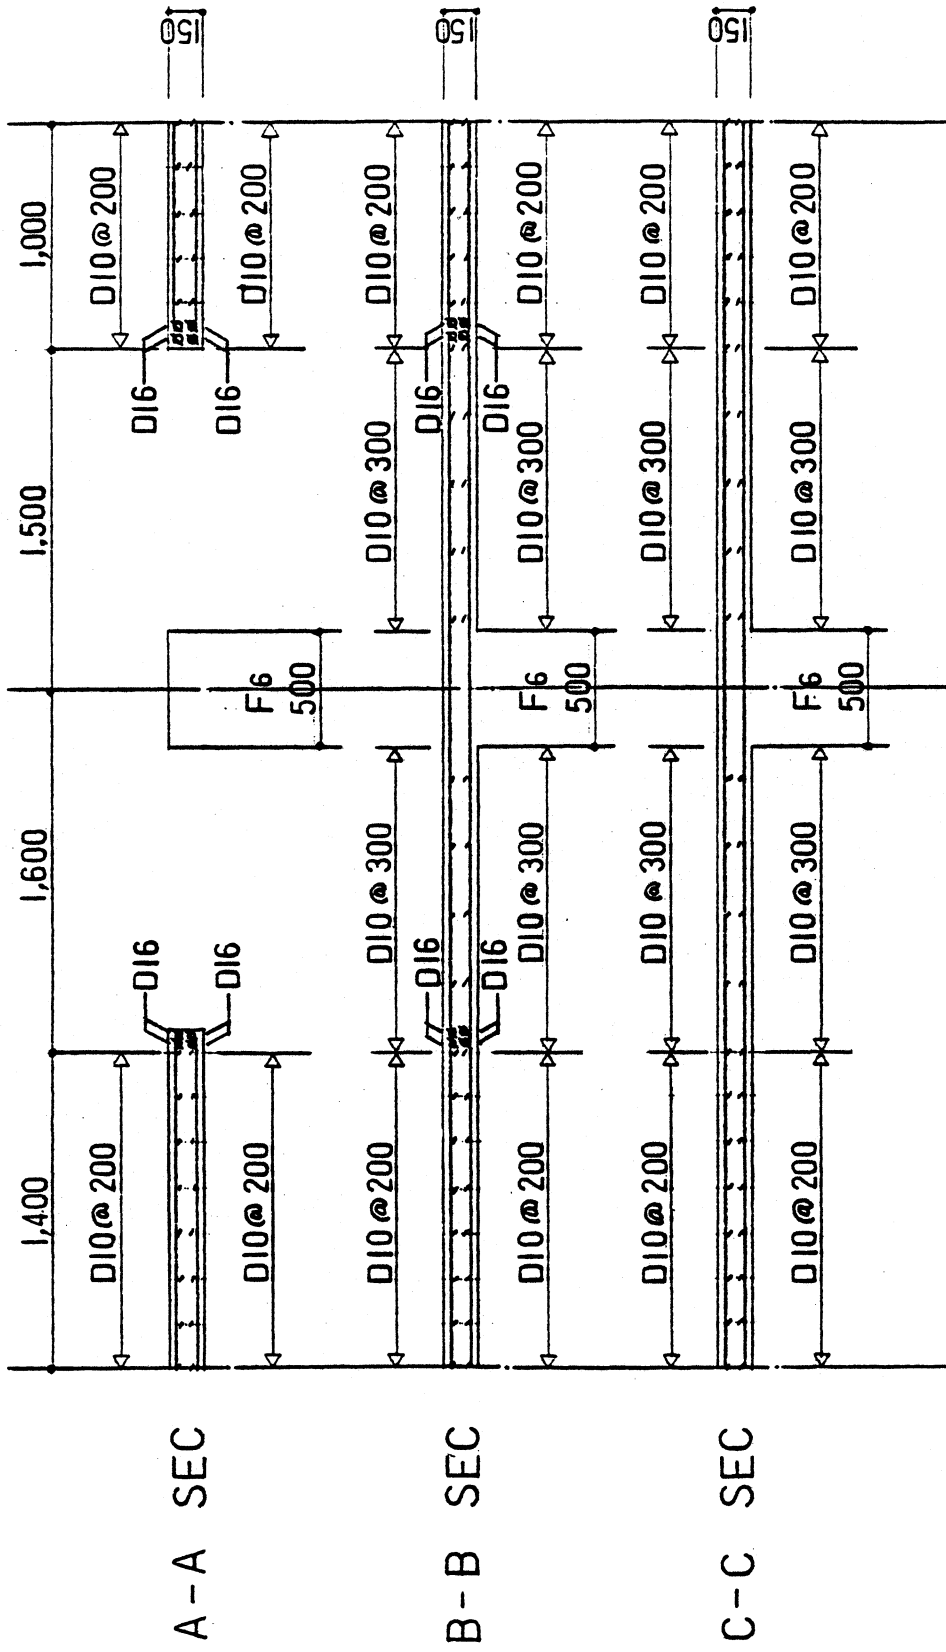
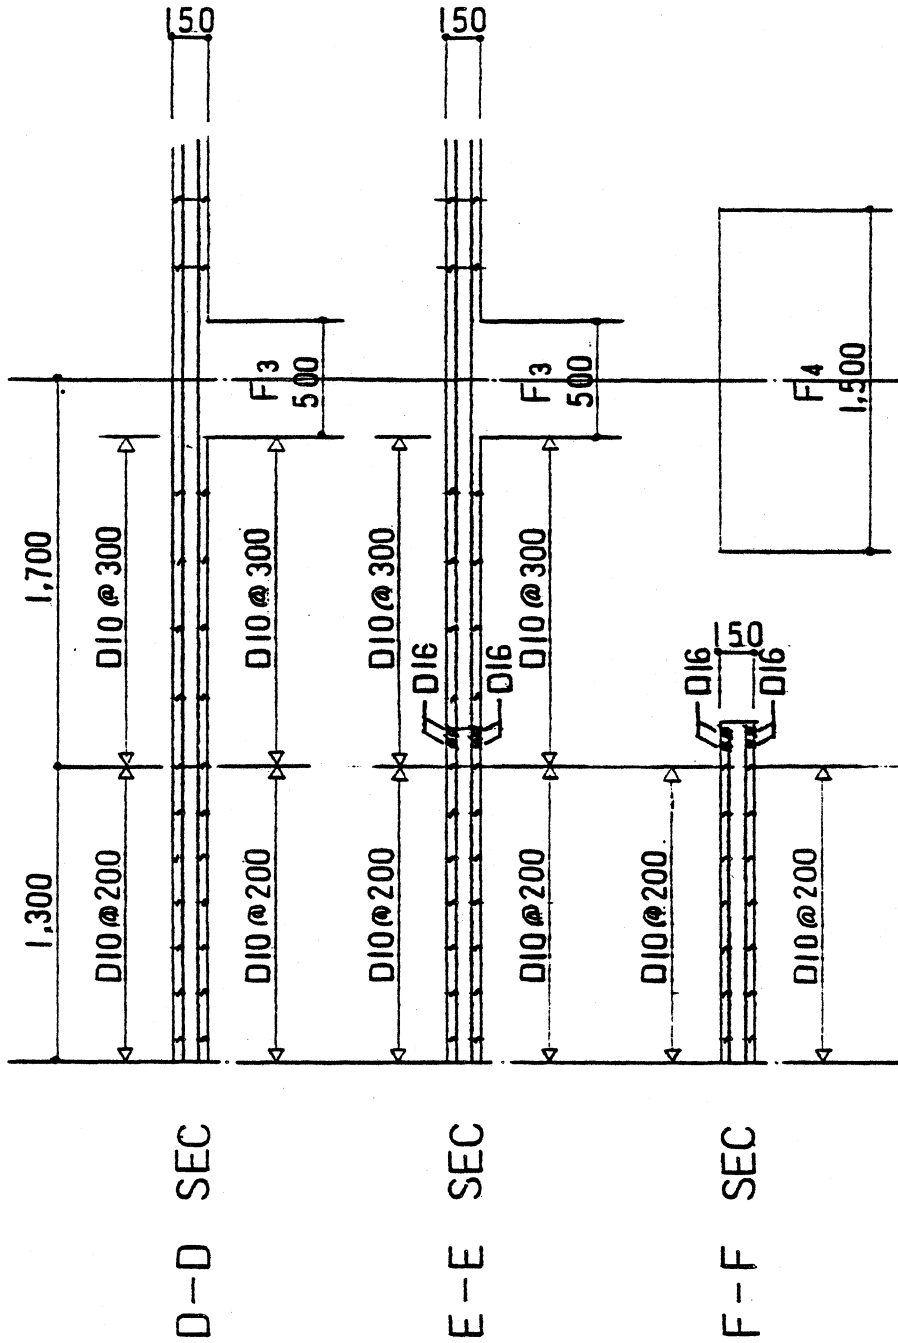
Fig. 4.5. Reinforcement Details for Foundation Slab (level Z1).

Reinforcement details for the foundation slab are shown in Fig. 4.5. Reinforcement details for the floor slabs at levels Z2 through ZR are shown in Fig. 4.6. For all of the slabs, D10 bars were to be used both top and bottom. Different spacings were used in the column strips, middle strips and in the cantilevered portion of the floor slabs. Pairs of D16 bars were to be added around the openings in the foundation slab and extra D13 bars were to be added in the cantilivered portion of the floor slabs (levels Z2 through ZR).

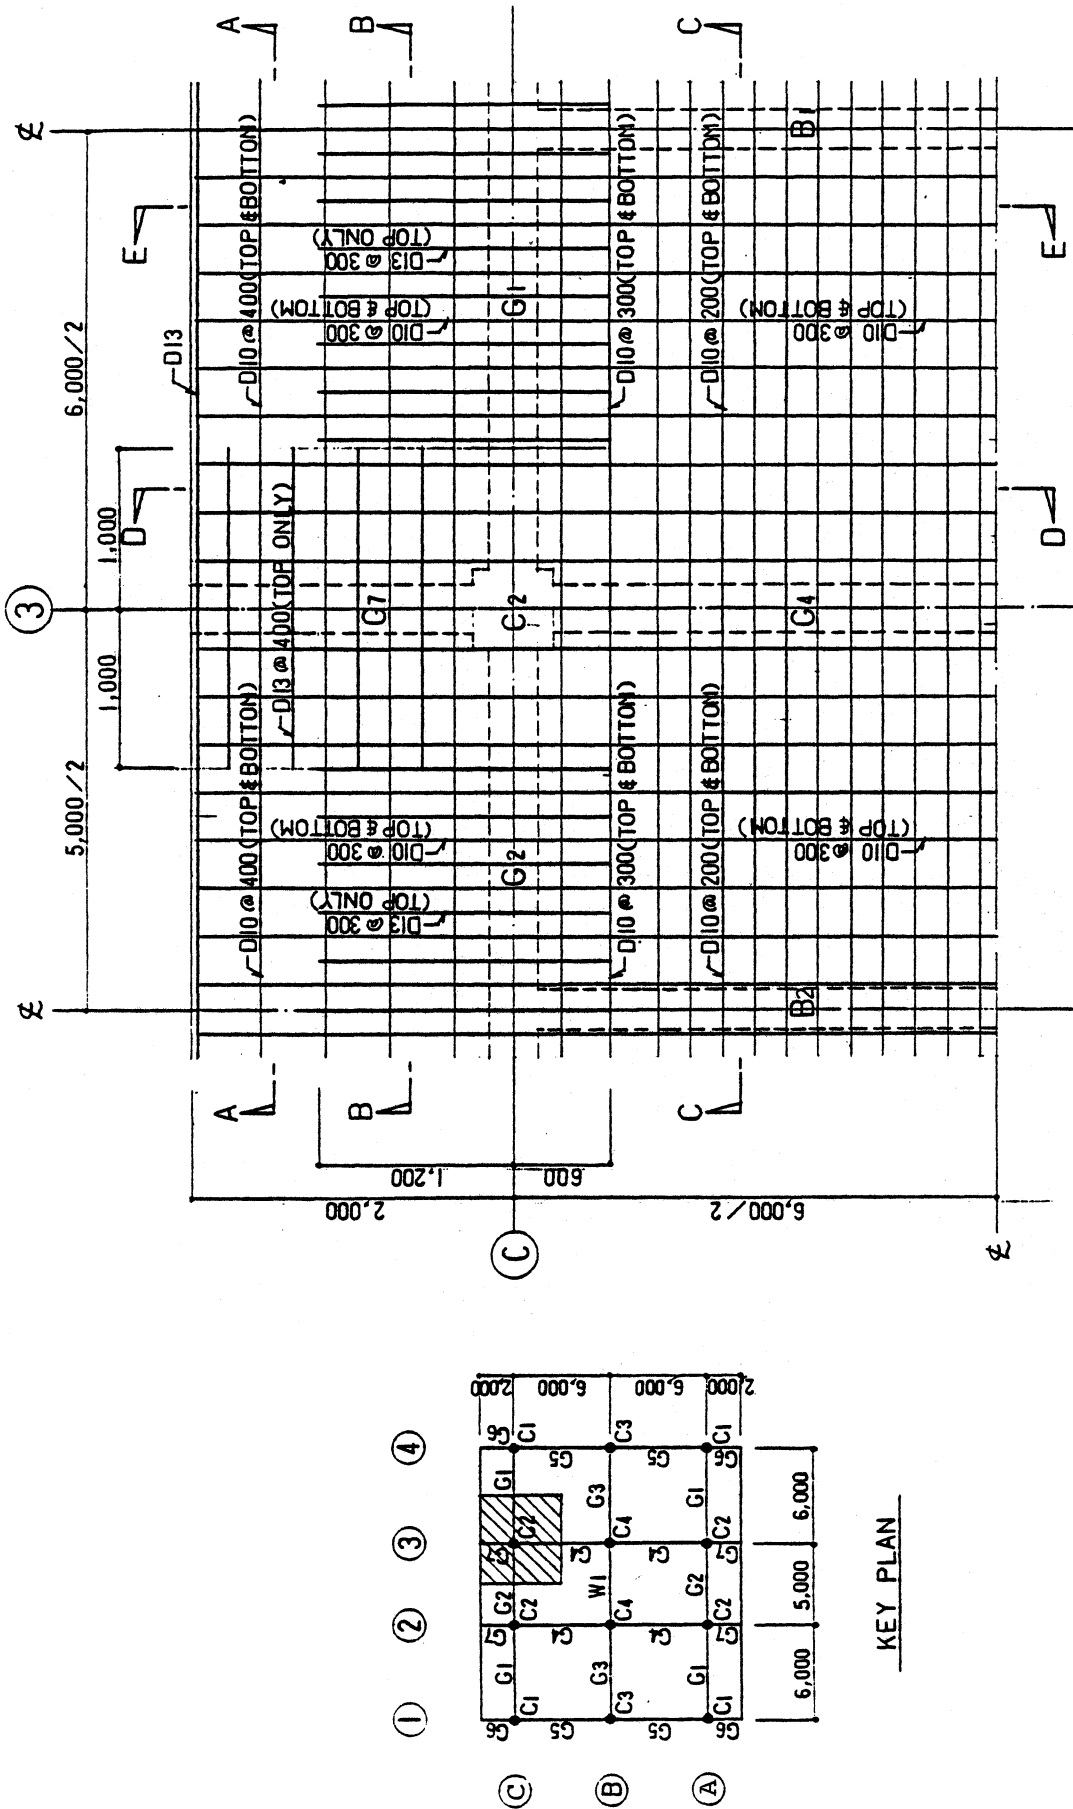
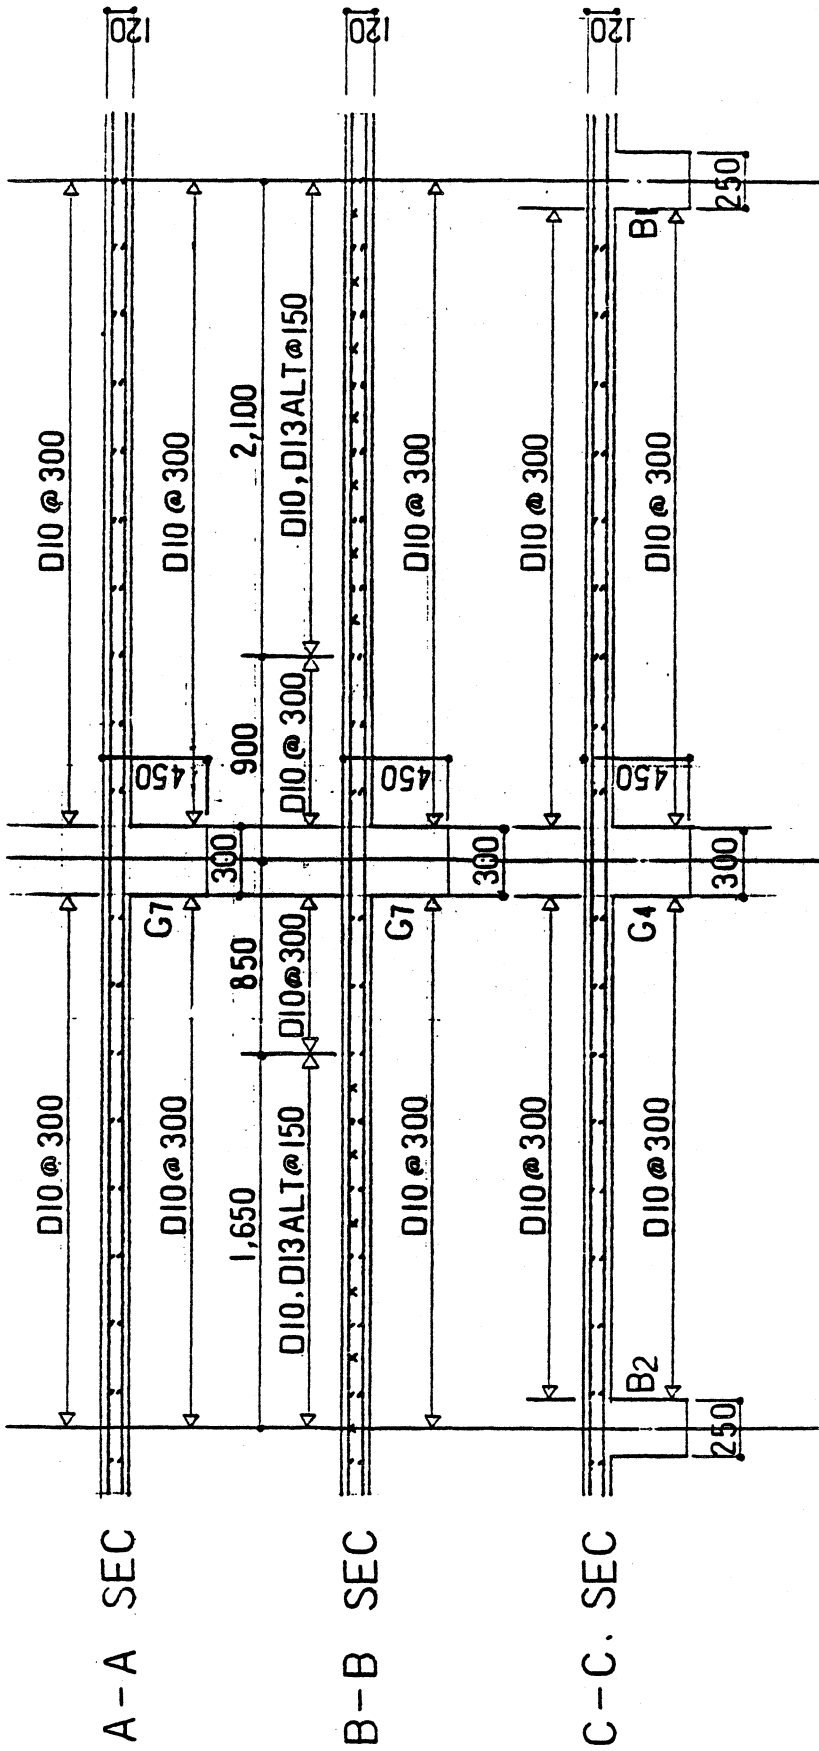
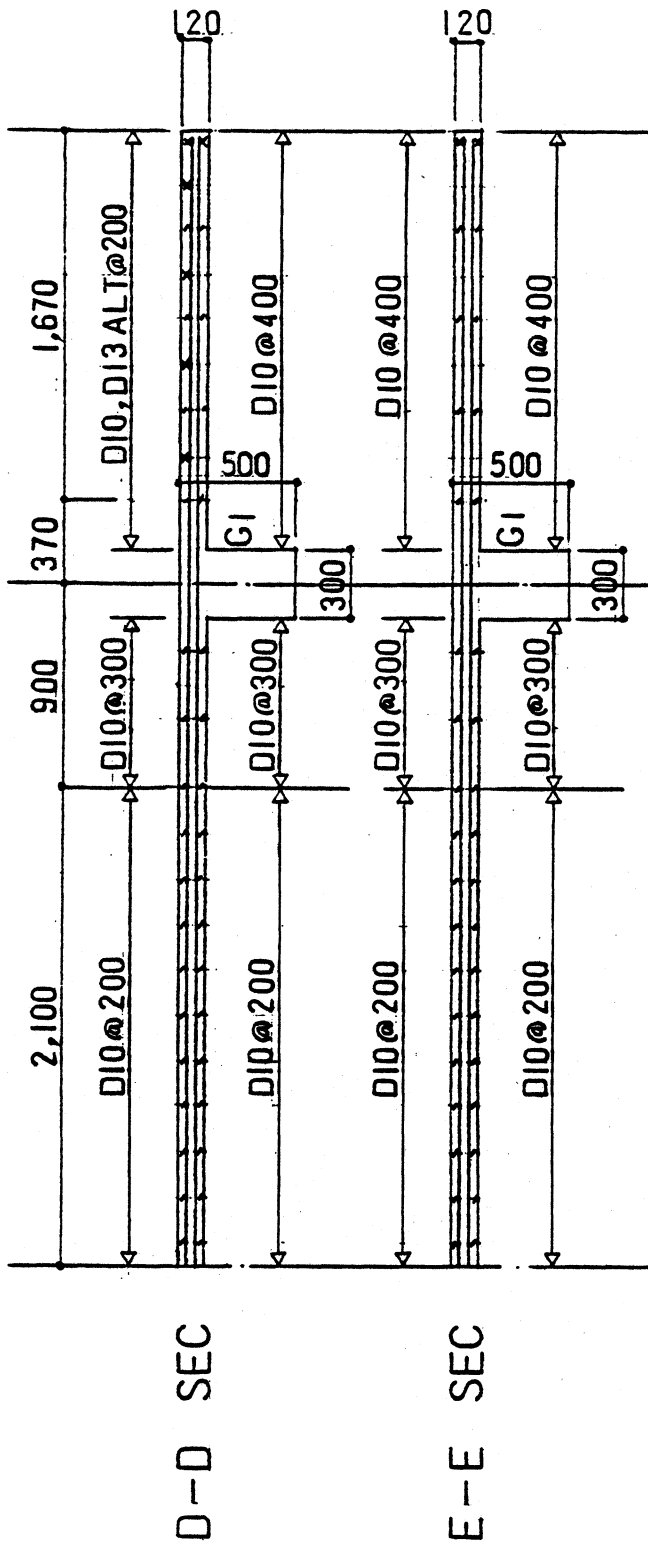
Fig. 4.6. Reinforcement Details, Floor Slab at Levels Z2-ZR.

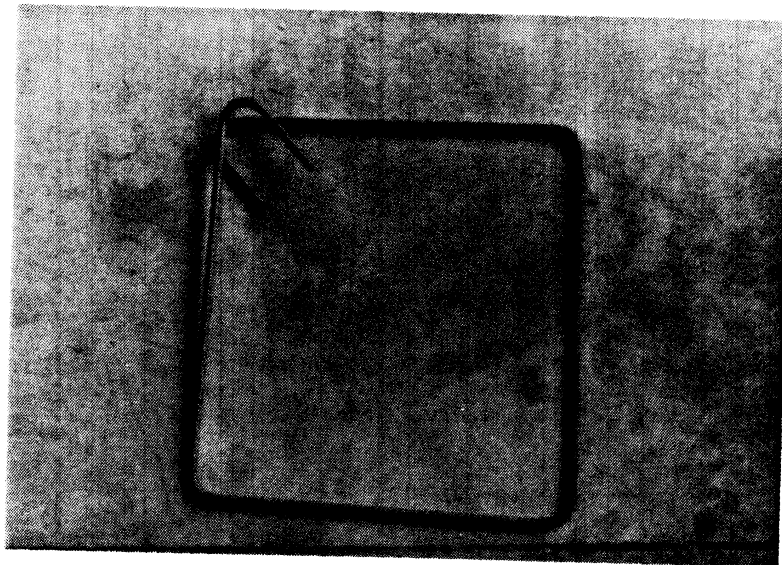
Fig. 4.8. Typical Column Hoop.

Nominal reinforcement details for all frames in the seven story test structure are given in Figs. 4.1 through 4.6. Cross section reinforcement details for the foundation beams and floor beams for these frames are given in Figs. 3.2 and 3.4 respectively. A typical column cross section is shown in Fig. 4.7. Photographs of a column hoop, a column cross tie and a beam stirrup tie are given in Figs. 4.8, 4.9 and 4.10 respectively.

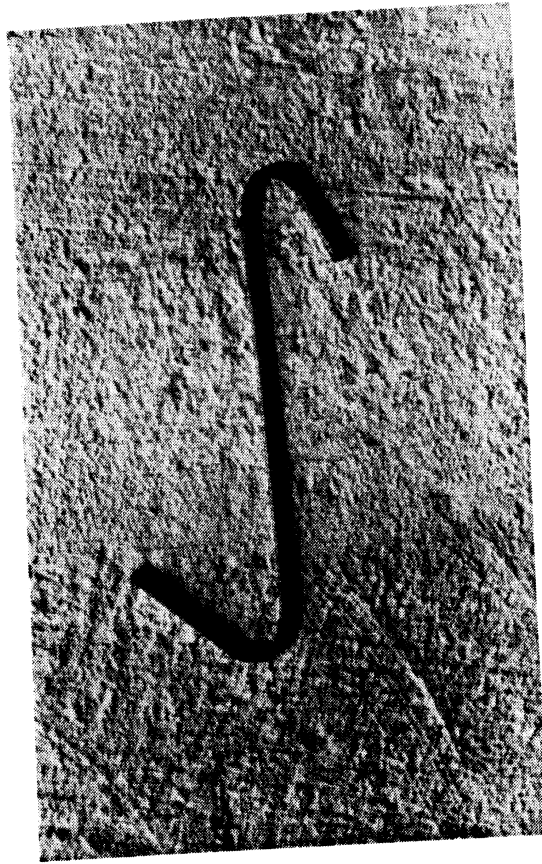
Fig. 4.9. Typical Column Cross-Tie.

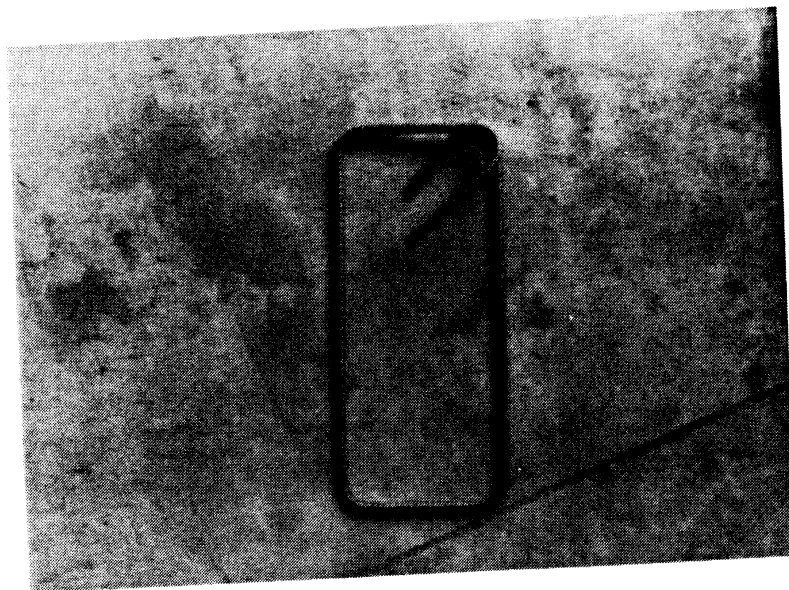
Fig. 4.10. Typical Beam Stirrup-Tie.
