THE UNIVERSITY OF MICHIGAN
COLLEGE OF ENGINEERING
Department of Chemical and Metallurgical Engineering

Progress Report

PREDICTION OF RUPTURE STRENGTHS OF GRADE 11, GRADE 22 AND TYPE 304
STEELS BY SIMULATION OF LONG TIME SERVICE

June 1971

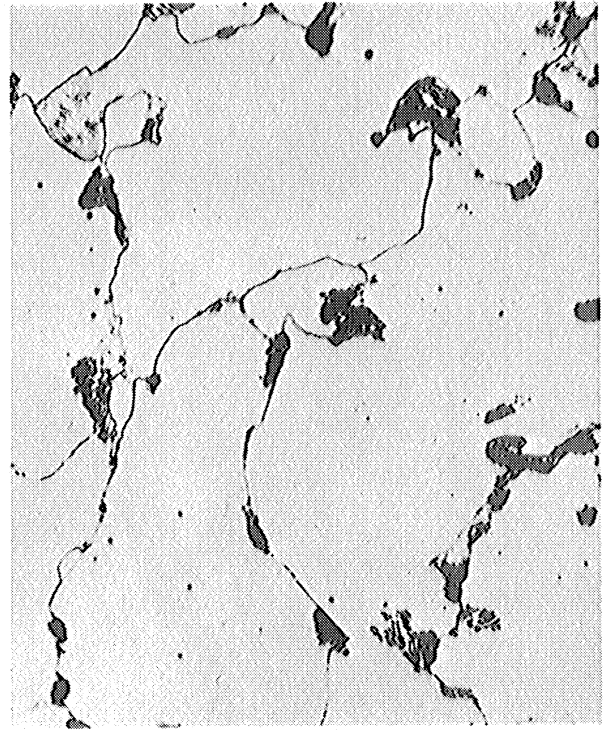
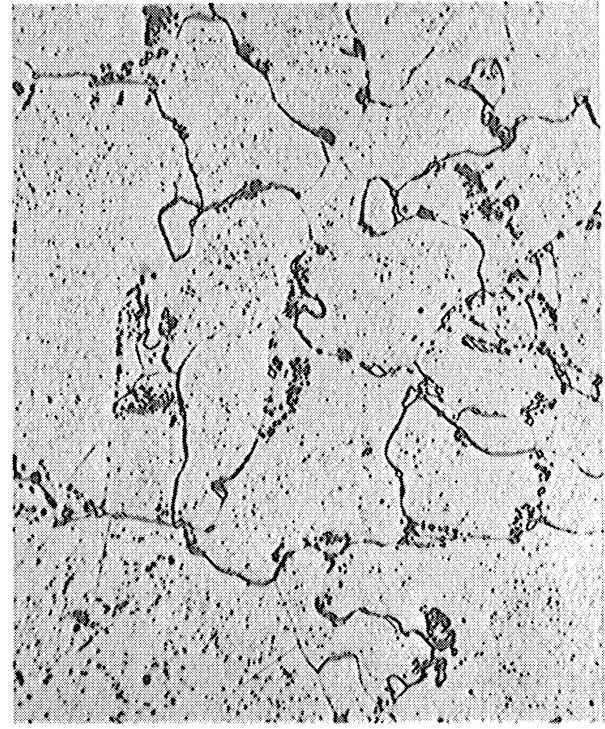
(a) As-Removed from Service

(b) Re-Norm. 1675°F + 20 Hrs. 1200°F

(c) Re-Norm. 1675°F + 88 Hrs. 1200°F

(d) Re-Norm. 1675°F + 300 Hrs. 1200°F

Figure 4: Microstructures of P11 Pipe X1,000.

The as-removed from service microstructure (Fig. 4a) showed extensive spheroidization of carbides. There was also precipitation within the grains. Simulated service by exposure for 20 hours at 1200°F after normalizing from 1675°F did not appreciably spheroidize the carbides (Fig. 4b). Considerable spheroidization occurred during 88 and 300 hours at 1200°F (Figs. 4c,d), but was not as complete as in the material from service. Also there was less precipitation within the grains. A stress of 7800 psi had no readily apparent effect on the microstructures.

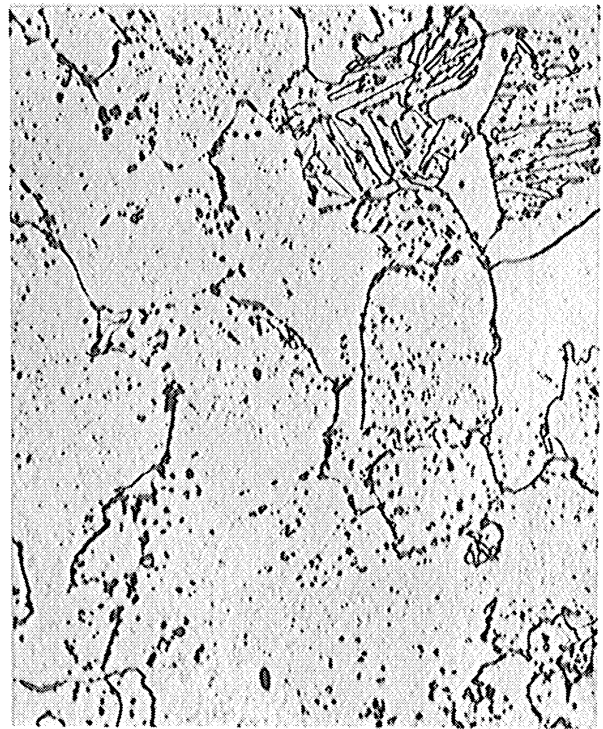
(a) As Produced

(b) Simulated 10,000 Hrs. at 1100°F

(c) Simulated 100,000 Hrs. at 1100°F

(d) 7014 Hour Test at 1100°F

Figure 10: Microstructures of Grade 22, Tube A. X1,000

- (1) Thermal exposure had the greatest influence on the materials (tubes A and B) which exhibited the highest short time strengths (Figs. 10,11). The marked microstructural changes were accompanied by considerable losses in short time rupture strength (Figs. 9a,b). Also, the rupture curves at 1000°F for these thermally unstable materials exhibited increases in steepness.

- (3) With increasing exposure (simulated service or test) the microstructures and rupture strengths became similar (Figs. 10 through 13). As discussed for the P11 material, the results indicate that heat treatment variation can be used to produce widely different strengths at low but not at high parameter values. The extent or generality of this observation requires further checking.

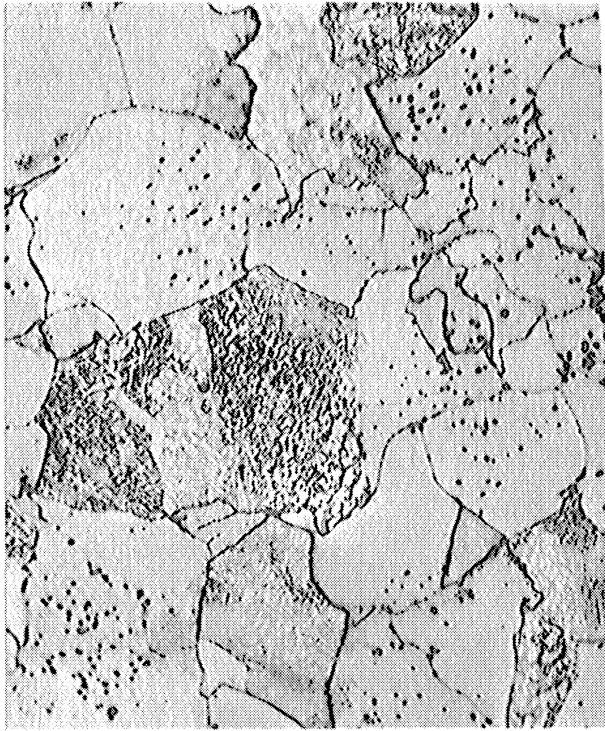
(a) As Produced

(b) Simulated 10,000 Hrs. at 1100°F

(c) Simulated 100,000 Hrs. at 1100°F

(d) 8475 Hour Test at 1100°F

Figure 11: Microstructures of Grade 22, Tube B. X1,000

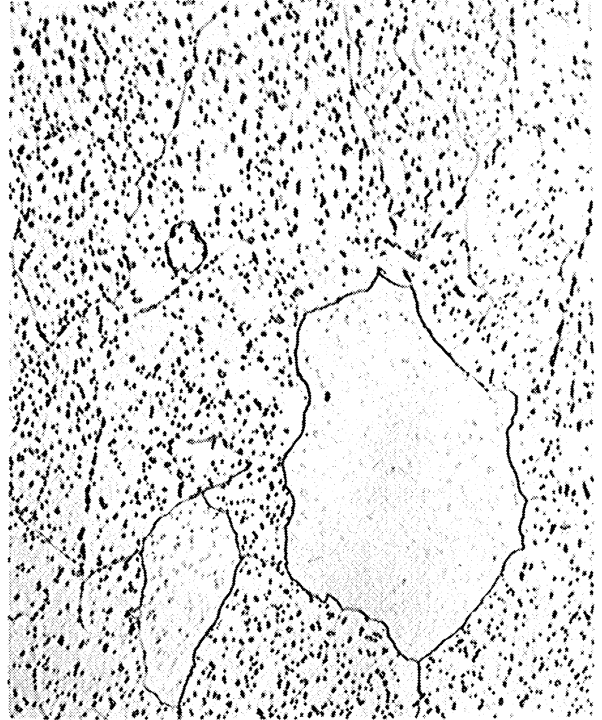
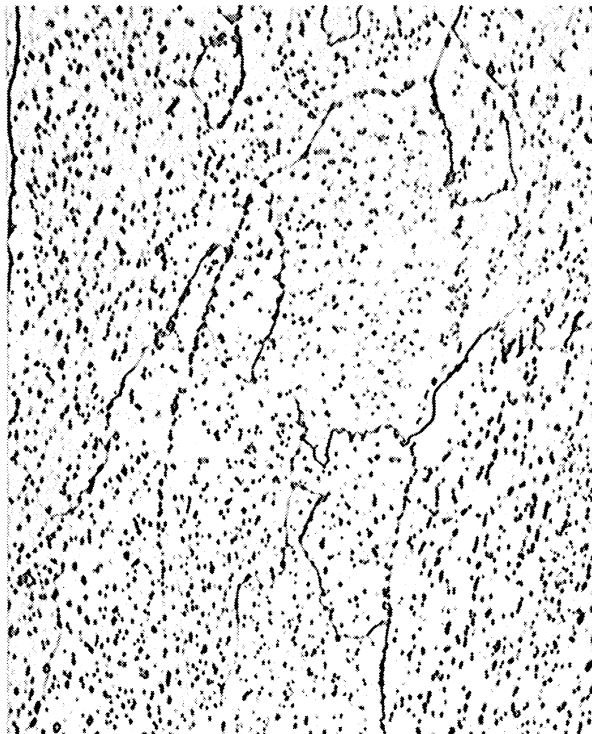
(a) As Produced

(b) Simulated 10,000 Hrs. at 1100°F

(c) Simulated 100,000 Hrs. at 1100°F

(d) 5871 Hour Test at 1100°F

Figure 13: Microstructures of Grade 22, Tube D. X 1,000

- (2) For the lower strength materials (tubes C and D) little microstructural change occurred due to the simulated service exposures (Figs. 12,13). Correspondingly the rupture curves did not exhibit marked instabilities and the exposure had little influence on rupture strength (Figs. 9c,d).

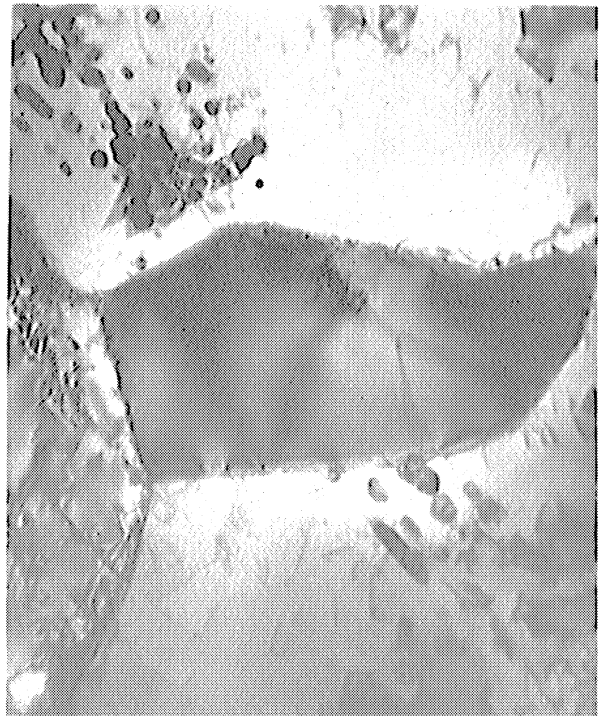
Figure 17: Transmission Electron Micrographs of Type 304 Steel, Cold Reduced 40 Percent and Exposed 100 Hours at 1350°F. X 20,000
