THE UNIVERSITY OF MICHIGAN
COLLEGE OF ENGINEERING
Department of Naval Architecture and Marine Engineering

Final Report

EXPERIMENTAL INVESTIGATION OF GREEN SEA LOADINGS ON DECKHOUSE GEOMETRY
FOR A DESTROYER-TYPE MODEL

ORA Project 08193

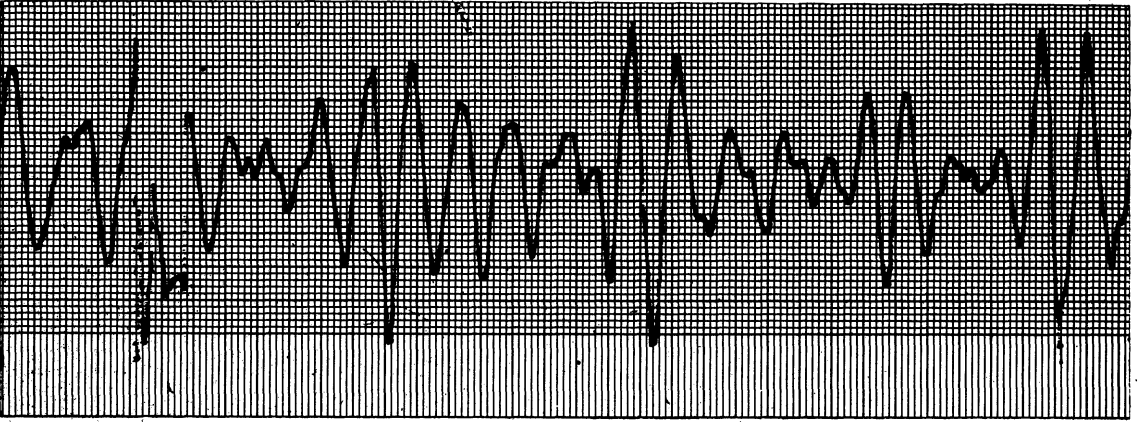
Figure 4. Additional Wave Records Taken During Various Runs in Towing Tank

(Scales are the same as indicated for Figure 3, and the chart speeds for the top three records are again 5 millimeters per second. This bottom record was obtained with a chart speed of 1 millimeter per second. The top record indicates about as regular a wave as could be generated with a height well above 12 inches. The other records illustrate how irregular the higher waves could be, the bottom record indicating a maximum height of 20 inches adjacent to heights as small as 3 inches.)

Figures 3 and 4 show typical wave records obtained during some of the runs. It is known which wave records were taken at the same time all of the pressure traces were and even which go along with the motion picture film frames used in this report. But the wave records were at a single location along the tank and only short lengths of the charts are included in Figures 3 and 4.
