# Water Resource Management at the Mpala Conservancy (Laikipia District, Kenya)

A project submitted in partial fulfillment  
of the requirement for  
the degree of Master of Science  
(Natural Resources and Environment)  
at the University of Michigan  
July 2012

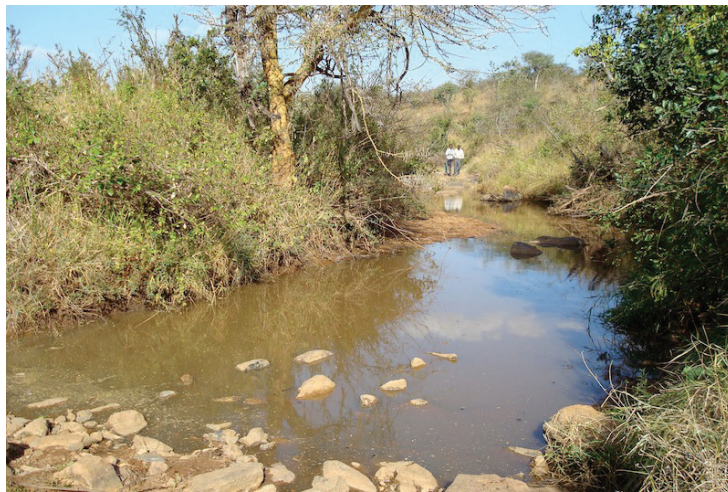
Figure 8: Picture of reservoir created by 'lost' borehole water

higher than what would be expected under normal operating conditions. In February 2012, after repairing one of the leaks, elephants tore up the line and a lot of water was lost (Figure 8). This event is noticeable in the monthly balance table (Table 15) as losses were much higher in February 2012 than in the previous months. When this month is excluded and potential apparent losses are considered, water loss in this system was between 13.8% (444 m<sup>3</sup>) and 17.4% (559 m<sup>3</sup>) (Table 20; Figure 9).

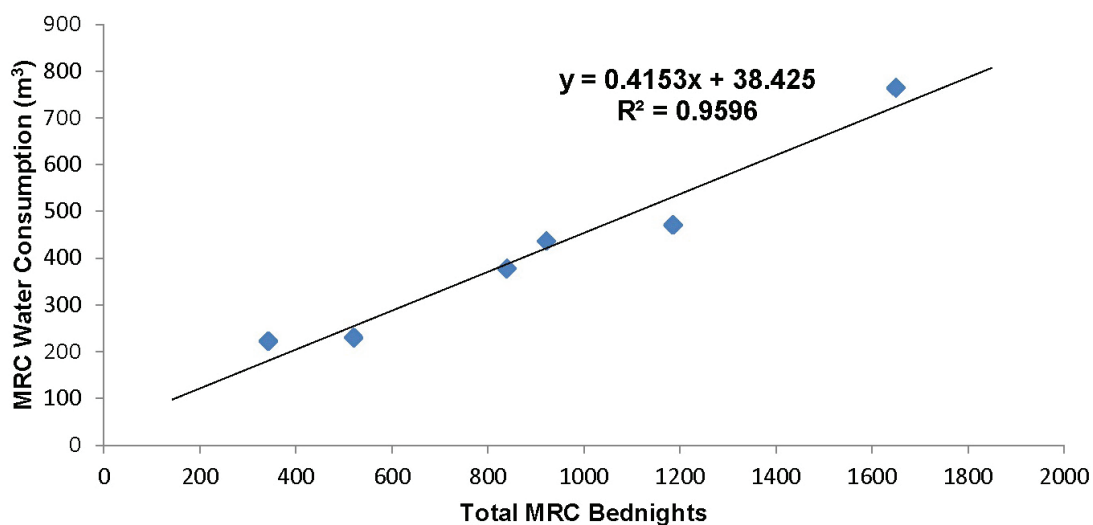
Figure 11: Monthly MRC bednights vs monthly MRC water consumption

Regression analyses were conducted to understand total water requirements at MRC (excluding the Village), water use at the bathrooms, and the relationship between kitchen water use and bednights. The regression analysis showed that bednight data is a strong predictor of water consumption at MRC (Figure 11); additional results from this analysis can be found in Appendix 9, including regression analysis excluding January '12 (Appendix 10), and regression analysis of average population versus water consumption can be found in Appendix 11.

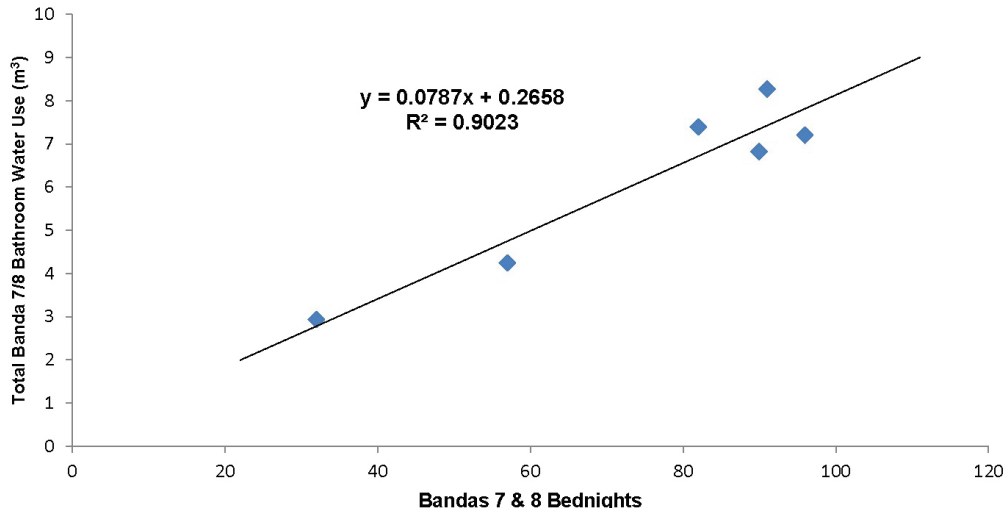
Figure 13: Banda 7/8 bathroom, monthly bednights vs monthly water use

these guests use Princeton Dorm shower facilities and the Banda 7/8 Bathroom for hand washing and toilet use. Using 60 bednights, per capita water demand at Banda 7/8 Bathroom is 80 liters/capita/day and 330 liters/capita/day at the Princeton Dorm. This gives further support to the postulation that guests staying at locations other than the Princeton Dorm are using the Princeton Dorm facilities.

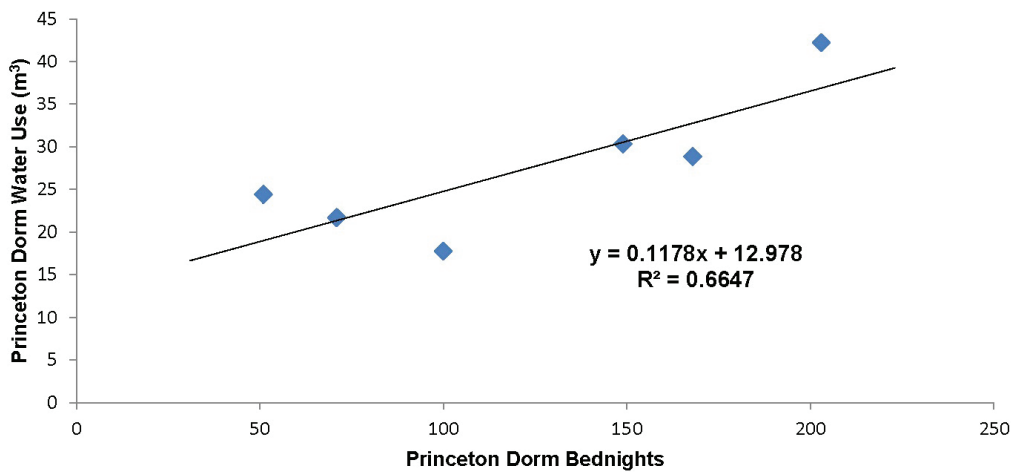
Figure 14: Princeton Dorm, monthly bednights vs monthly water use

As mentioned previously and seen in Figure 13, the correlation between bednights and water use at Princeton Dorm is not as strong as expected (coefficient of determination is 0.66). This is a probable indicator that guests staying at places other than Princeton Dorm are using the facilities, which could impact the results described above regarding the Banda 7/8 Bathroom;

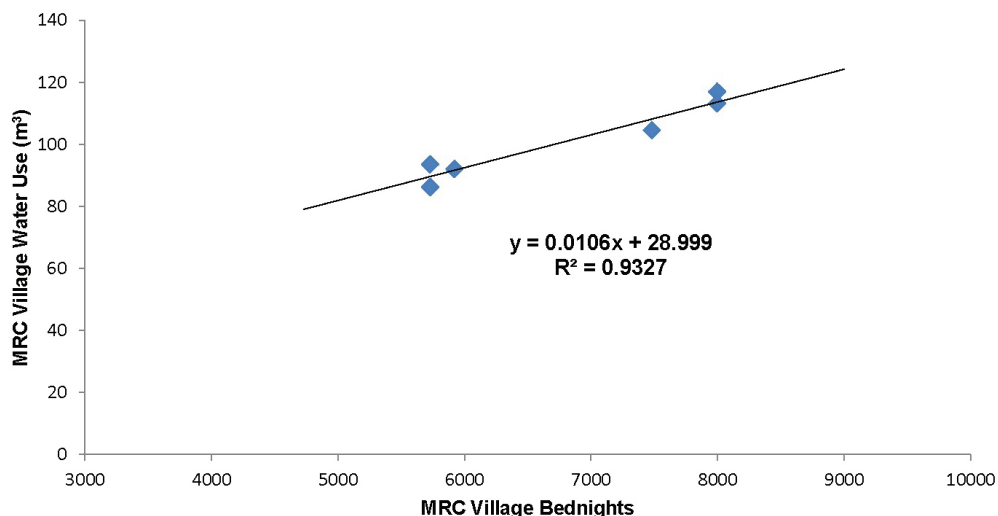
Figure 15: MRC Village , monthly bednights vs monthly water use

To develop a complete understanding of MRC's water demand, water use at the Village must be accounted for as well. Population was estimated at 191 people when children are in school and 258 when children are not in school (Kinnaid, 2010b). Estimates of whether children were back from school or not were determined based on meter readings and monthly water use values. The population was estimated to be 191 people for September, October, and November, and 258 people in December, January, and February. Population was converted to bednights, which showed strong correlation with water use ( $r = 0.9658$ ). Regression analysis showed bednights was significant in predicting Village water use ( $p = .001$ , Figure 15, Appendix 18).

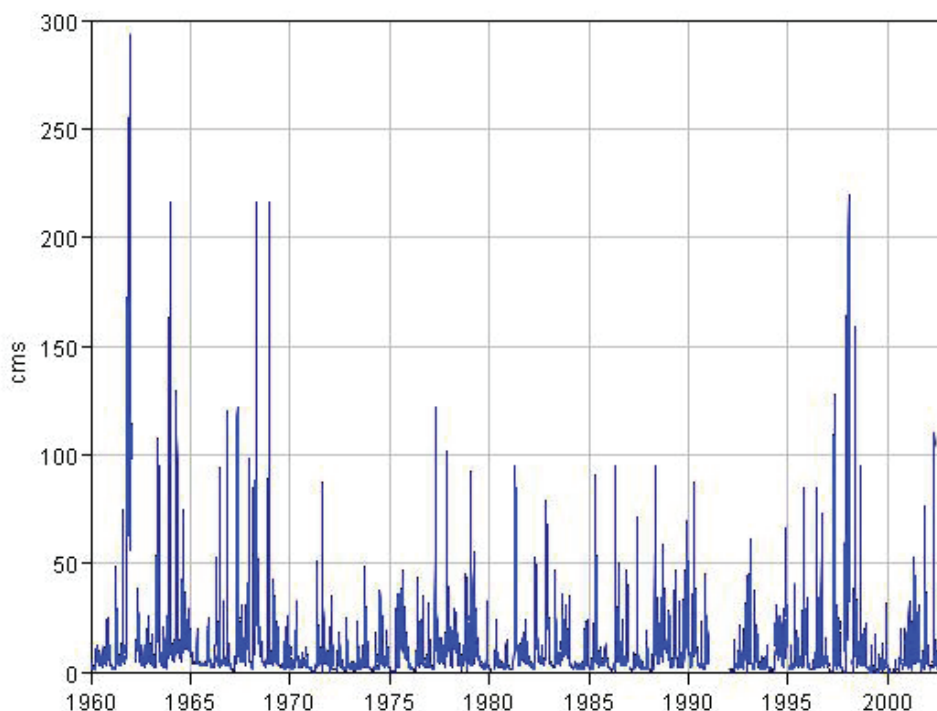
Figure 22a: 42-year hydrograph of the Ewaso Nyiro River

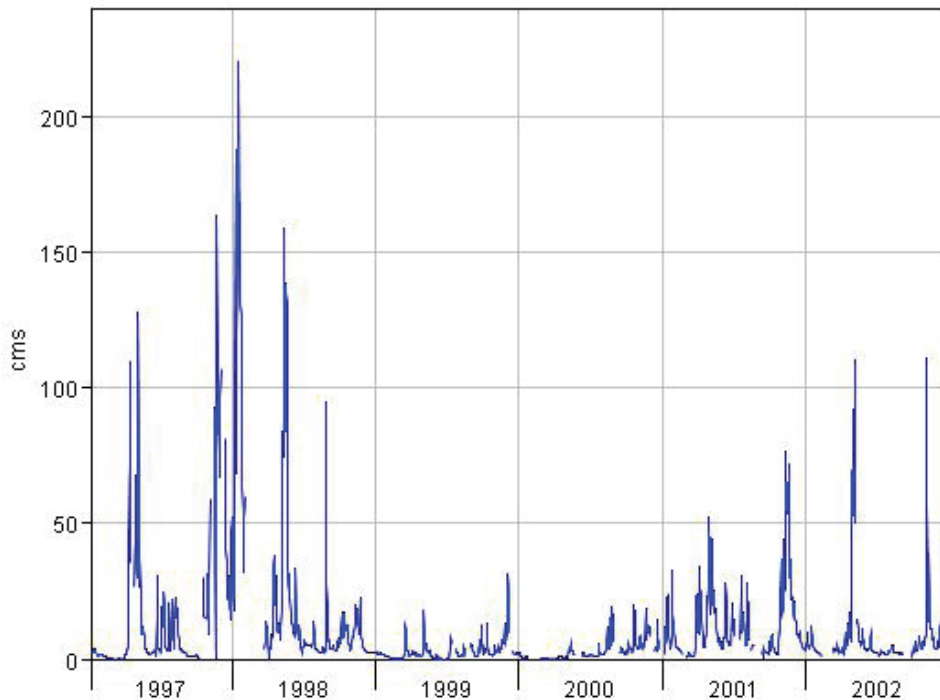
Figure 22b: 6-year hydrograph of the Ewaso Nyiro River

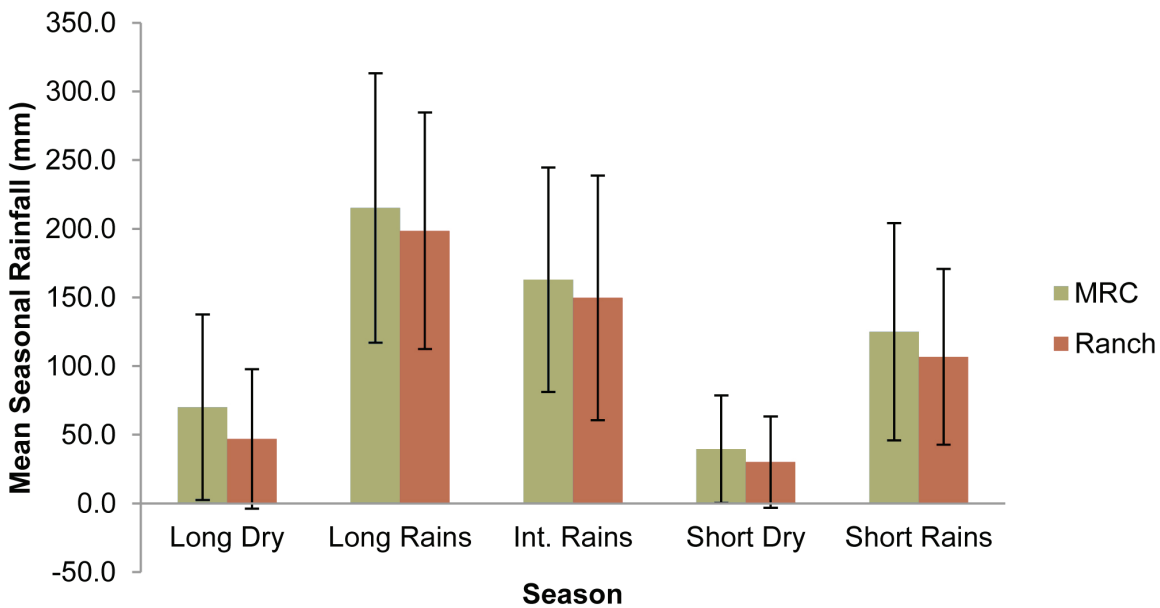
Figure 26: Mean seasonal rainfall at MRC and the Ranch. Significant standard deviation (shown by black bars) indicates that rainfall varies greatly from year to year. If years did not vary the standard deviation would be very small.

Rainfall varies from year-to-year (Figure 26; Table 35), and when planning for future water availability using the historical record, it is important to select a period recent enough to represent the current environment, yet also long enough to capture both high and low rainfall extremes. Within the Laikipia District, extreme rainfall years are designated as those in which the entire district receives a total annual rainfall greater than 750 mm or less than 500 mm (Berger, 1989). During the 13-year (1999-2011) rainfall record period at the Mpala Research Centre and Mpala Ranch, a number of extreme rainfall years (both high and low) were observed. Extremely high rainfall was observed in 2010 with 1,000 mm (MRC), while extremely low rainfall was observed in 2000 with only 187 mm (Ranch). Year-to-year rainfall patterns are at least partially controlled by El Niño and La Niña events, resulting in abnormally wet (El Niño) or dry (La Niña) conditions every 3-6 years (Franz, 2007).

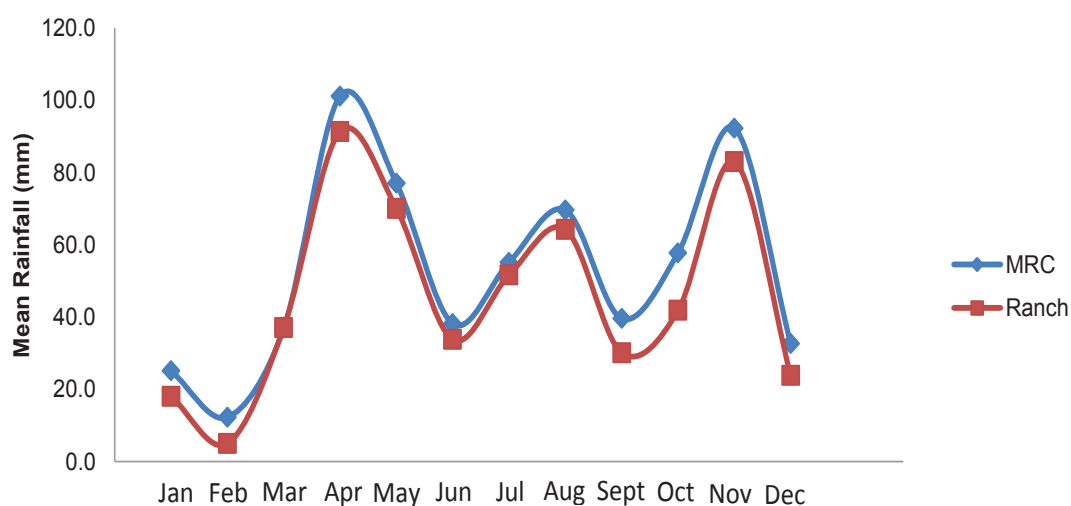
Figure 27: Distinct seasonal rainfall variation

Although there is little statistical variation between the observed rainfall during the long dry and long rainy seasons ( $p > 0.05$ ), that does not mean that the differences which are seen are not meaningful. Because there is such great fluctuation in the amount of rainfall observed year-to-year, variation could in fact simply be masking even more important differences seasonally. The distinct seasonal rainfall variation Mpala observes is well illustrated in Figures 27 and 28.

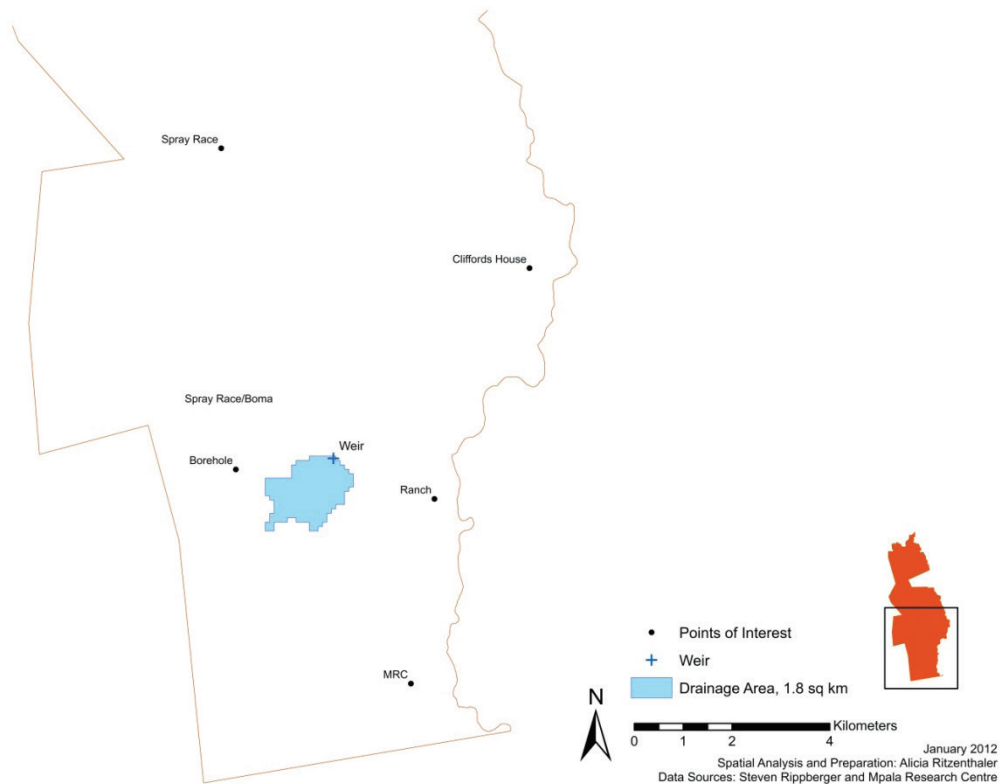
Figure 32: Drainage area and weir

Storage Volume	
	Designed	Measured
<b>Weir 1</b>	2575	1378
<b>Weir 2</b>	1866	1158
<b>Weir 3</b>	2500	1392
<b>Weir 4</b>	2500	2215
<b>Weir 5</b>	5225	4918

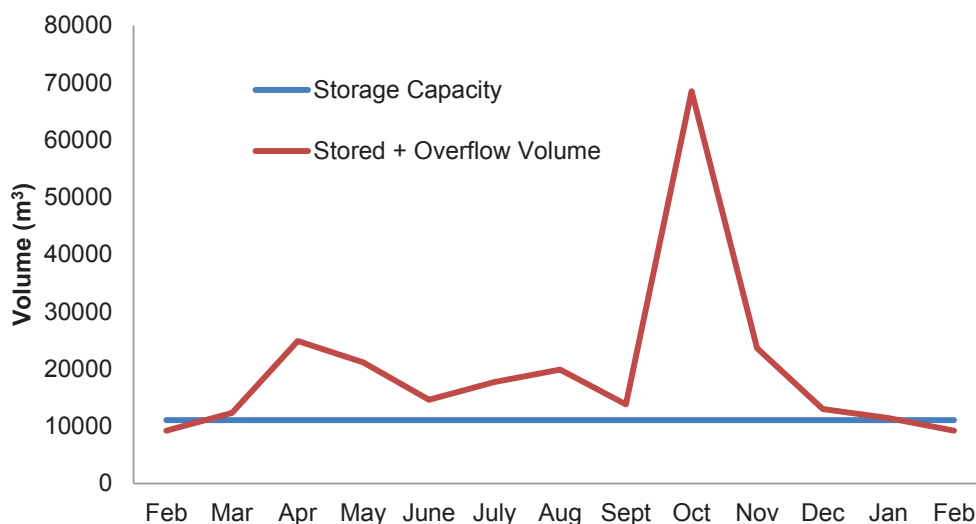
Figure 33: One year cumulative weir storage volume under average rainfall conditions.

$$\text{Stored Volume} = \text{Previous months end volume} + \text{input} - \text{evaporation} - \text{demand}$$

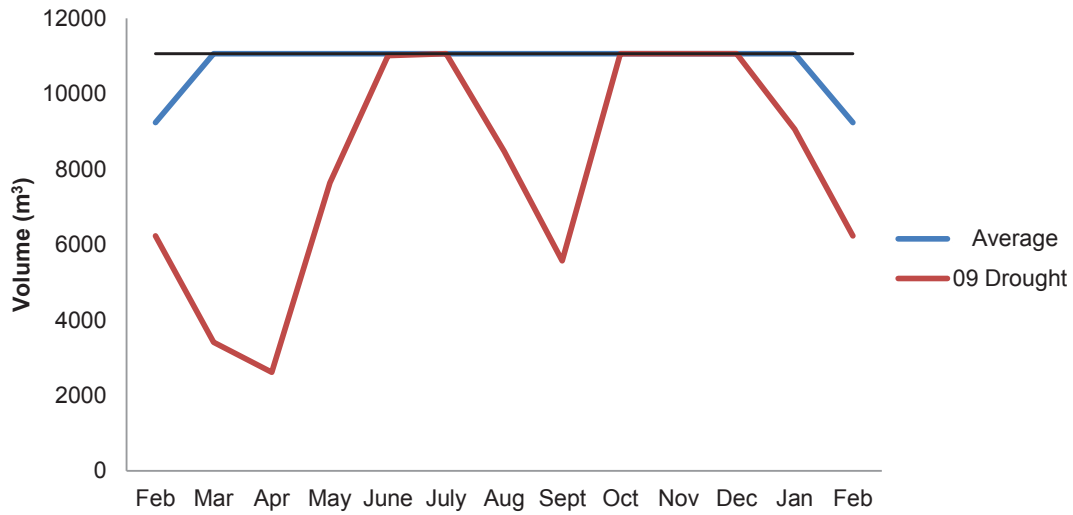
Figure 34: Comparison of water storage volume in the Nanja weirs under the 2009 drought scenario vs the average rainfall scenario. Black line indicates the weir capacity.

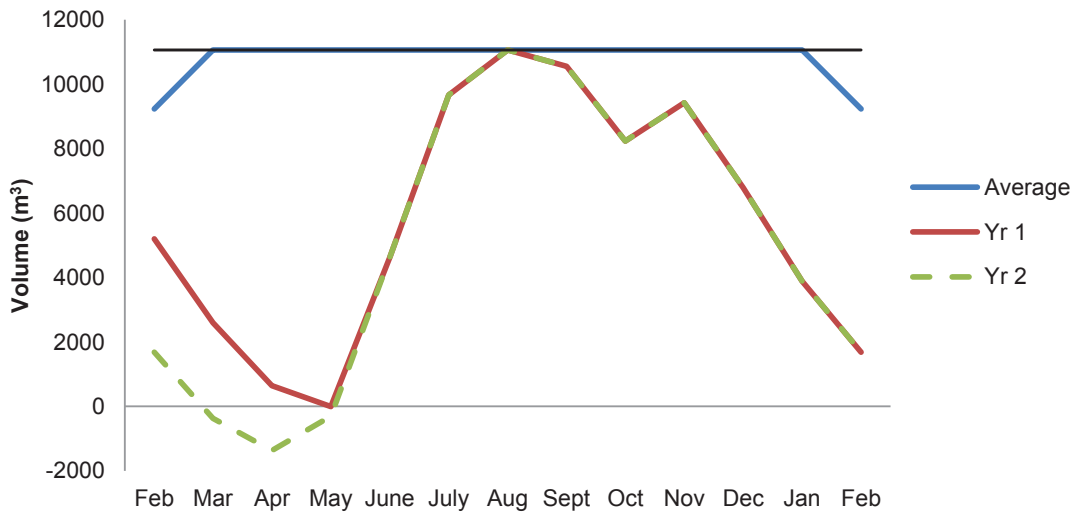
Figure 35: Quantity of water stored in the Nanja weirs after one and two consecutive years of the 2000 drought scenario. Black line indicates the weir capacity.

consecutive year of 2000 pattern of drought (Figure 35). Because this scenario experiences no overflow after the start of the drought, an alternative water source would be required under these extreme conditions.

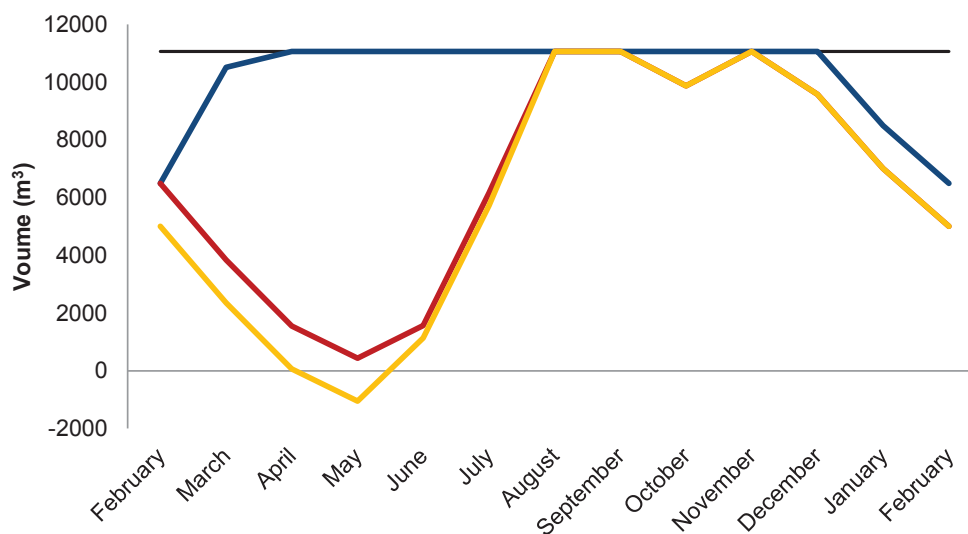
Figure 36: Total volume stored in weirs assuming no evaporation, 200% bednights, & 133% village population. Black line indicates the weir capacity, blue line indicates volume assuming average rainfall, red line indicates volume during 2000 replicated drought, and yellow line indicates volume and deficit during a 2nd consecutive 2000 replicated drought.

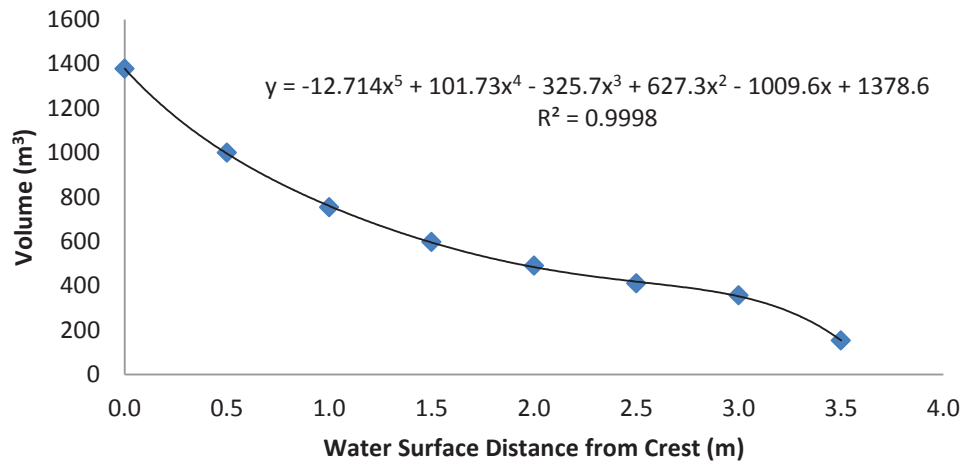
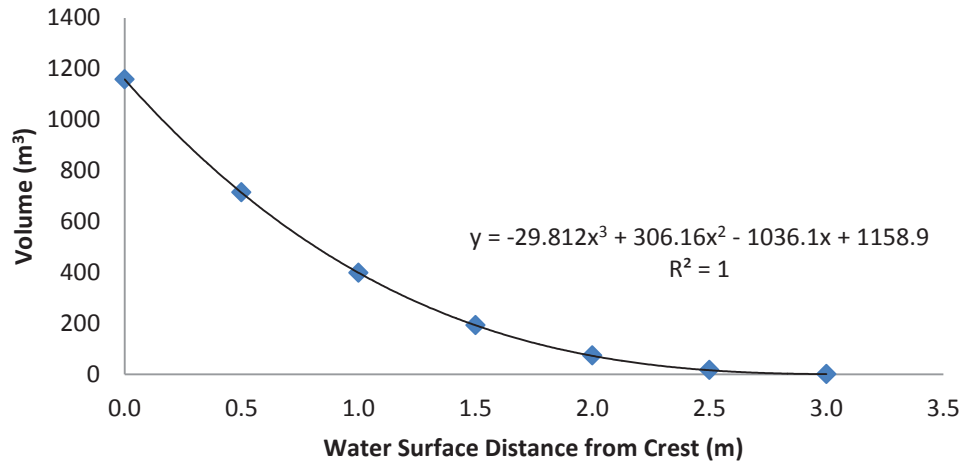
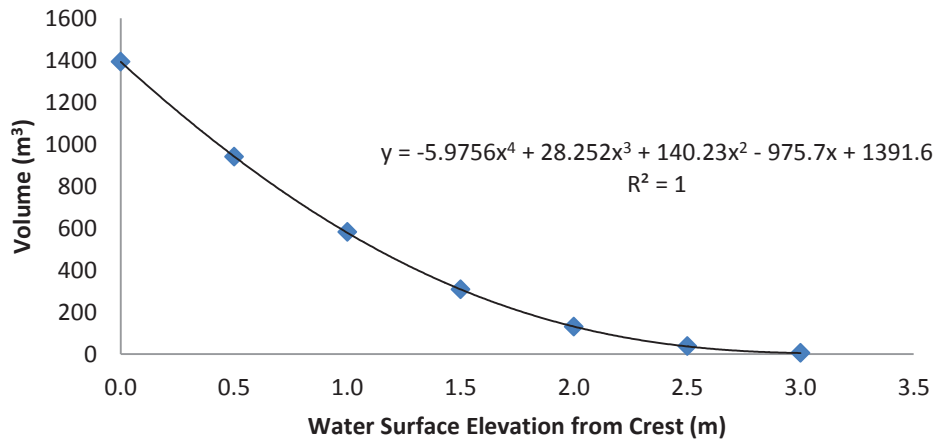
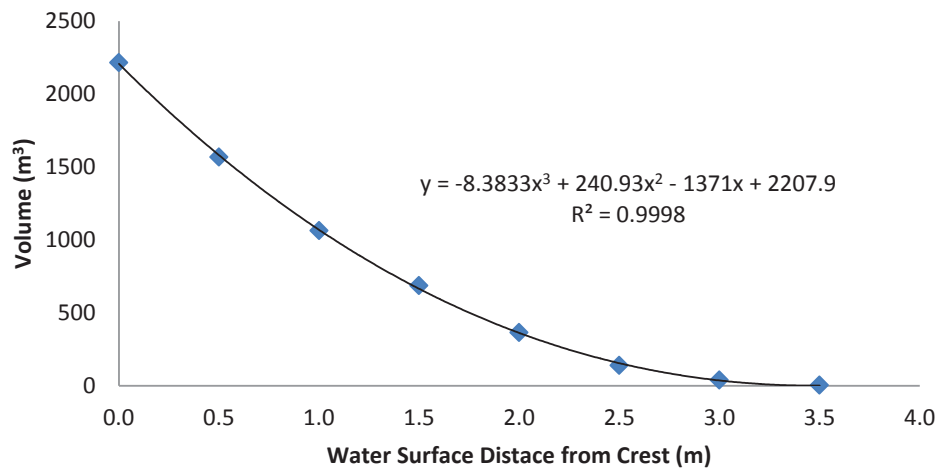
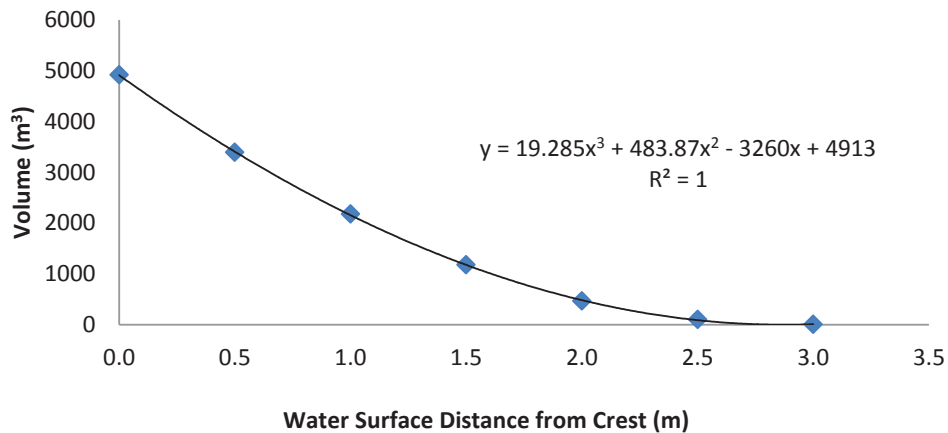
Figure 37: Graphical illustration of the relationship between water surface elevation and weir volume. The best fit line shown (in black) visually represents the curve-fitted polynomial equations which can be used as a management tool.

Figure 37 (continued): Graphical illustration of the relationship between water surface elevation and weir volume. The best fit line shown (in black) visually represents the curve-fitted polynomial equations which can be used as a management tool.

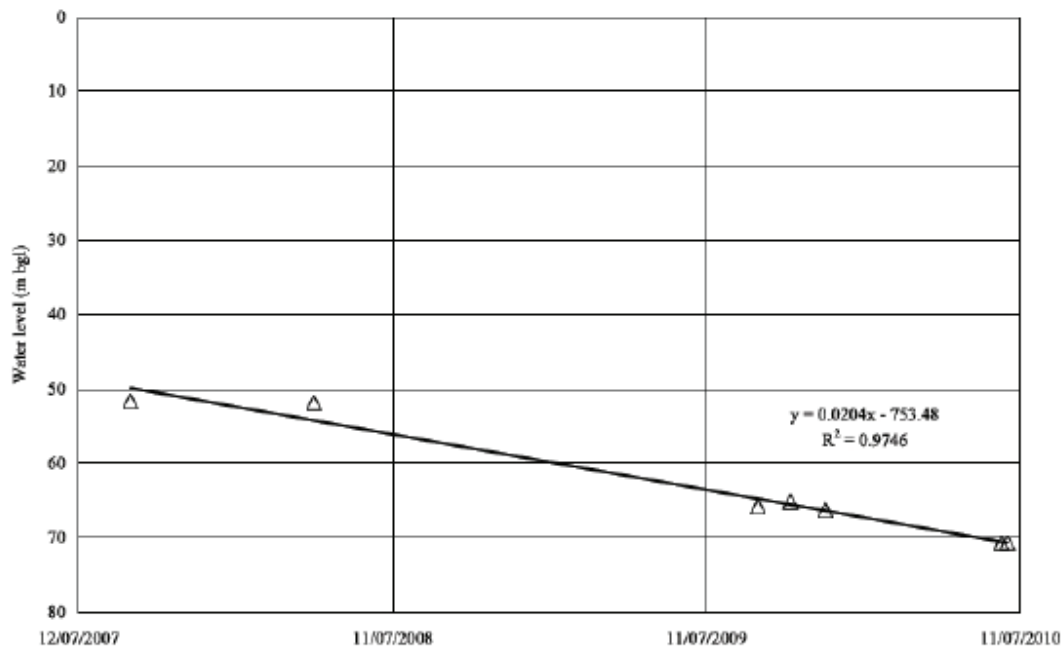
Figure 38: Water level decline in the Miocene aquifer which the Mpala borehole provides water from (Aquasearch Ltd., 2010).

The Mpala property sits on the Miocene aquifer system and while infrastructure is in place to provide both the MRC and the Ranch with groundwater pumped from the borehole, the water is currently used primarily at the MRC. Unfortunately the availability of water from this source is finite, and the aquifer is being depleted at a rate of 0.56m/month or 6.8m/year (Figure 38) (Aquasearch Ltd., 2010). The aquifer, containing ‘fossil water’ from 4,000-10,000 years ago during the African Humid Period, receives only small amounts of modern recharge (Aquasearch Ltd., 2010). Based on our analysis and communication with Mpala staff we conclude that Mpala’s reliance on the borehole is no longer necessary or sustainable, except in extreme situations.

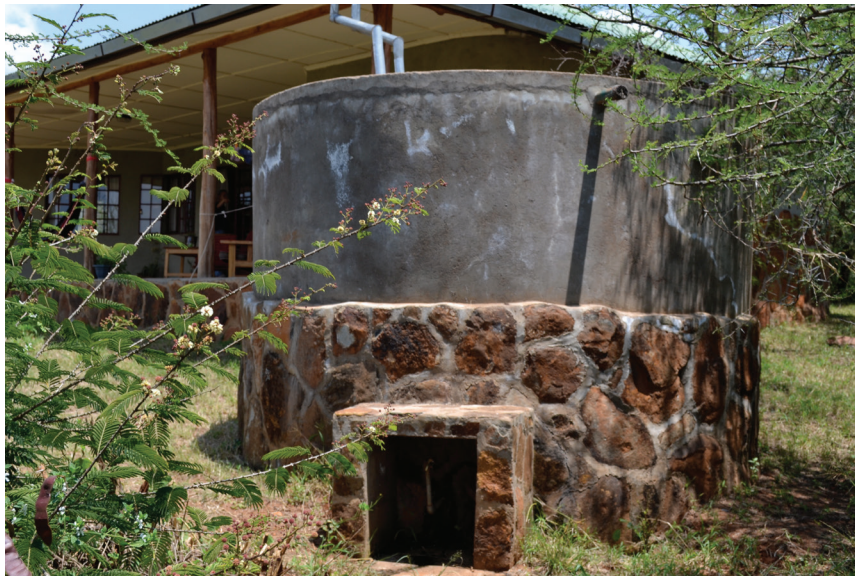
*Figure 40: Grevy rainwater harvesting tank*

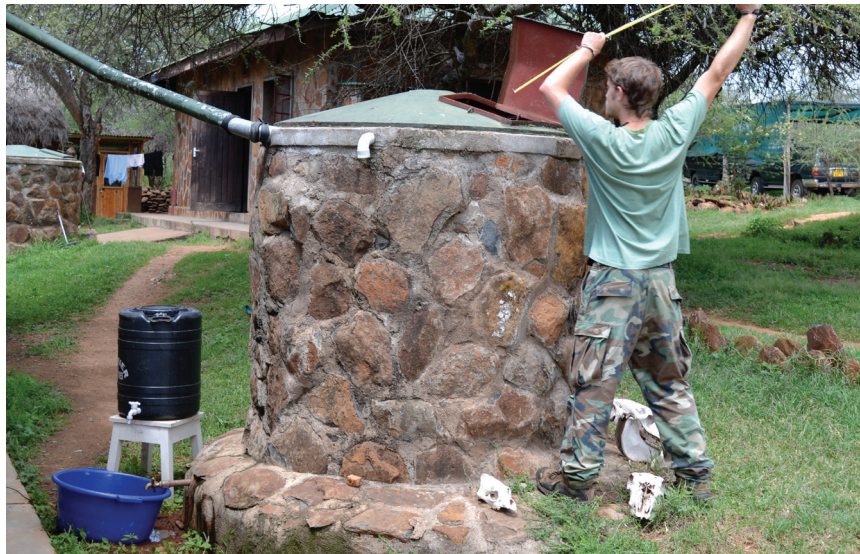
Figure 41: Kitchen rainwater harvesting tank

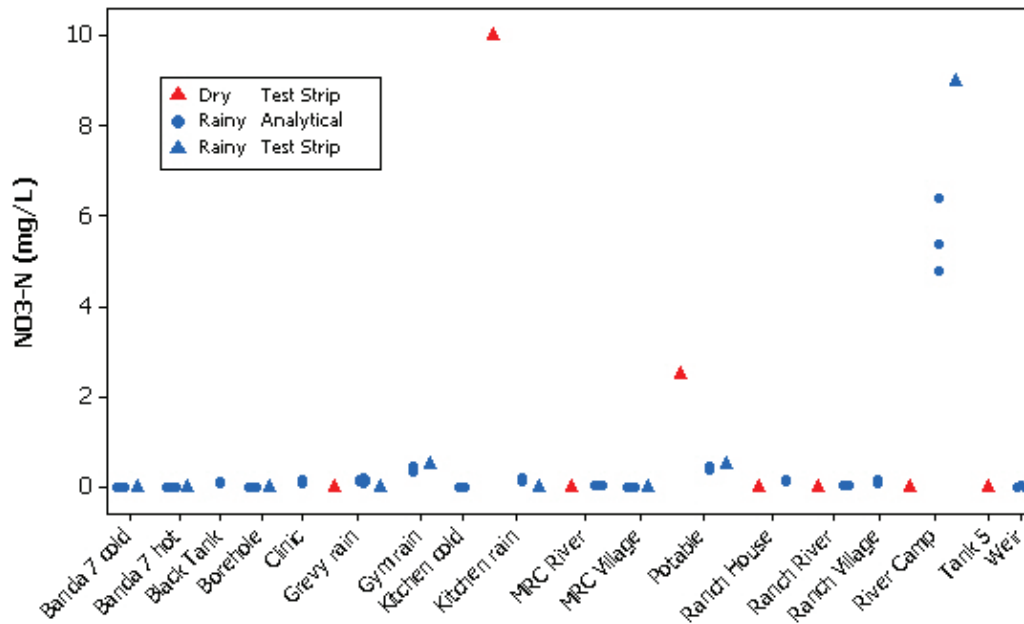
Figure 48: Nitrate results

Figure 48 shows the nitrate test strip results for both sampling events and the

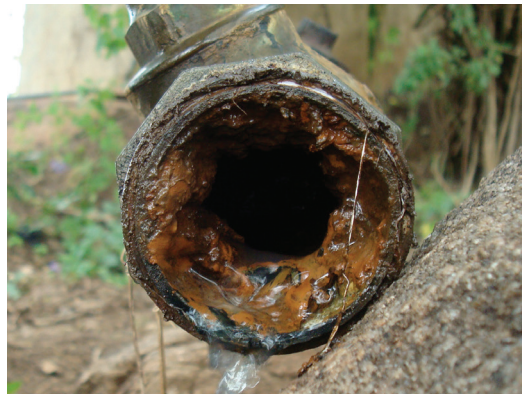
Bacterial colonization of piping systems is sometimes the result of pipe corrosion. Pipe corrosion is a problem that can have serious adverse effects on a distribution system, including leaching of heavy metals (copper, cadmium, lead, chromium, and nickel), bacterial growth, plugging of pipes, increased turbidity, and water loss (Shams El Din, 2009; Lehtola et al., 2004; Zacheus et al., 2001; Moore, 1977). Corrosion can be caused or inhibited by a number of different factors including dissolved ions, hardness, alkalinity, pH, and dissolved oxygen. At Mpala, the borehole water has high chloride (250 mg/L) and fluoride (24 mg/L) concentrations, which can increase corrosion by preventing formation of protective layers (Aquasearch Ltd., 2010; Sander et al., 1996). Langelier and Aggressiveness Indices were calculated using data obtained from the dry season, and all water samples were determined to be nonaggressive, meaning it is unlikely to cause corrosion. Even though these samples are considered nonaggressive, it is clear from visual inspection of the pipe interior that some reactions are taking place and deteriorating the integrity of the piping system (Figure 57). This particular pipe had a slimy film on the inside, which was likely a biologically active layer.

Figure 57: Photograph of a pipe interior at Mpala

The aging nature of Mpala's distribution system increases the likelihood that the interior of pipes will become damaged and obstructed. Corroded, damaged, or obstructed pipes need to be taken into consideration when evaluating water treatment options, because if water is to be treated and disinfected prior to distribution, significant amounts of clean water can be lost from pipes. Furthermore, pipes can harbor bacteria, and these colonies can recontaminate the previously treated water.

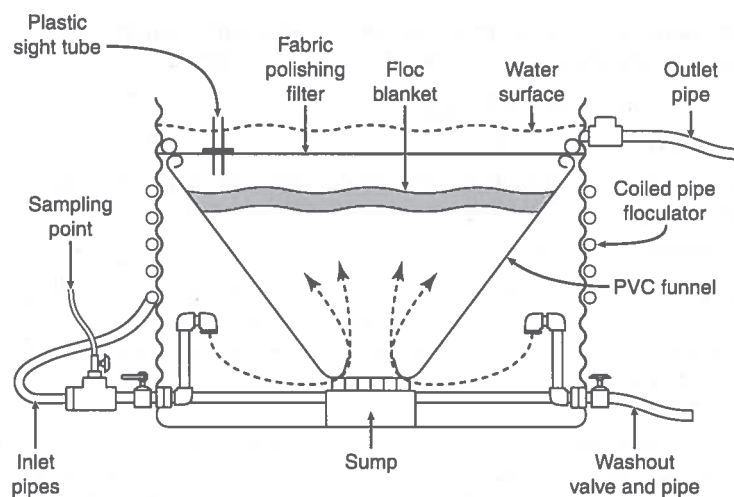
Figure 59: Upflow clarifier used during flocculation (Davis & Lambert, 2002)

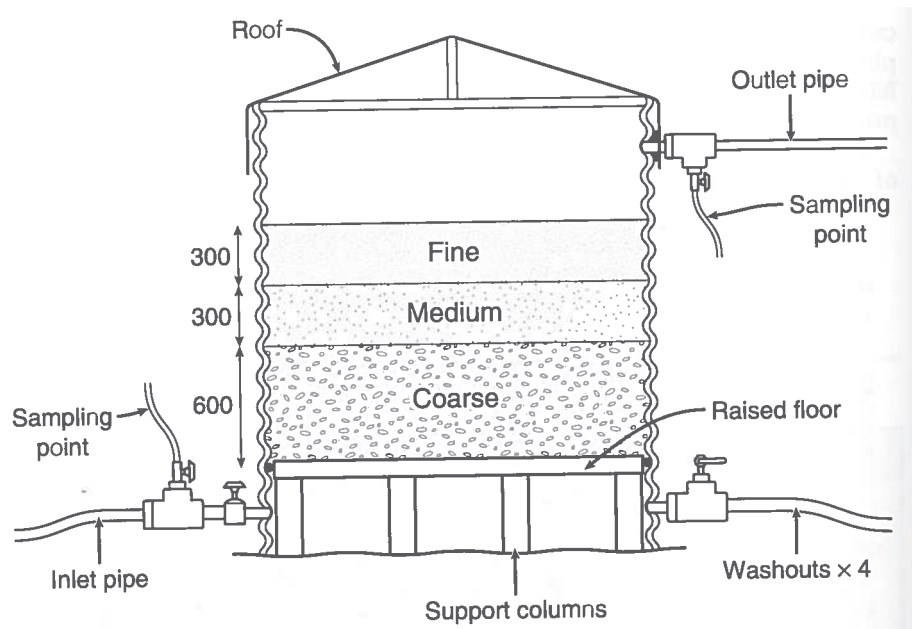
Figure 60: A vertical upflow roughing filter (Davis & Lambert, 2002)

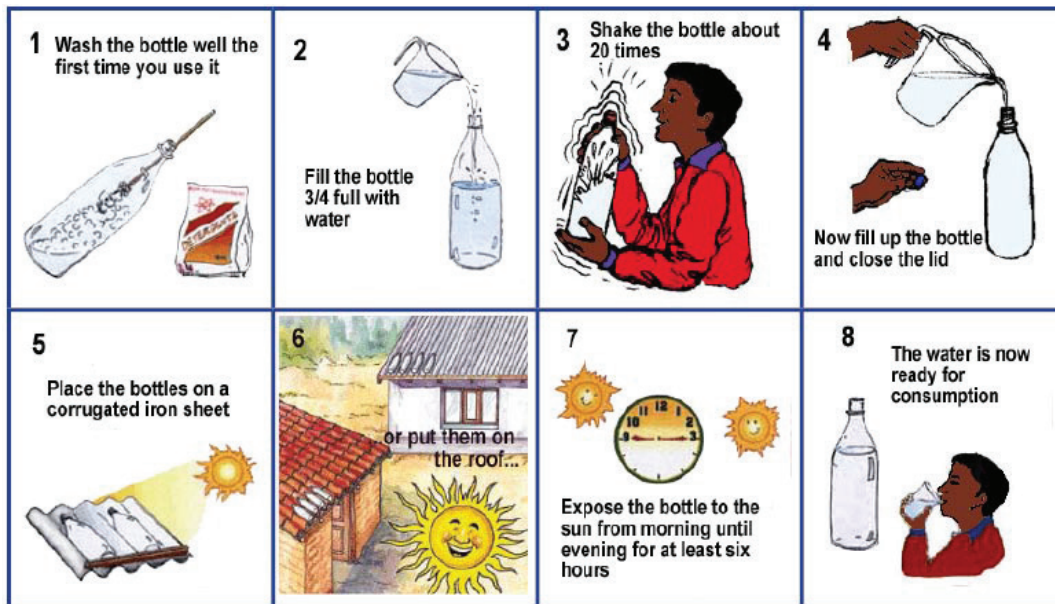
Figure 61: Disinfection using a clear, unscratched plastic or glass bottle (Meierhofer, 2006)

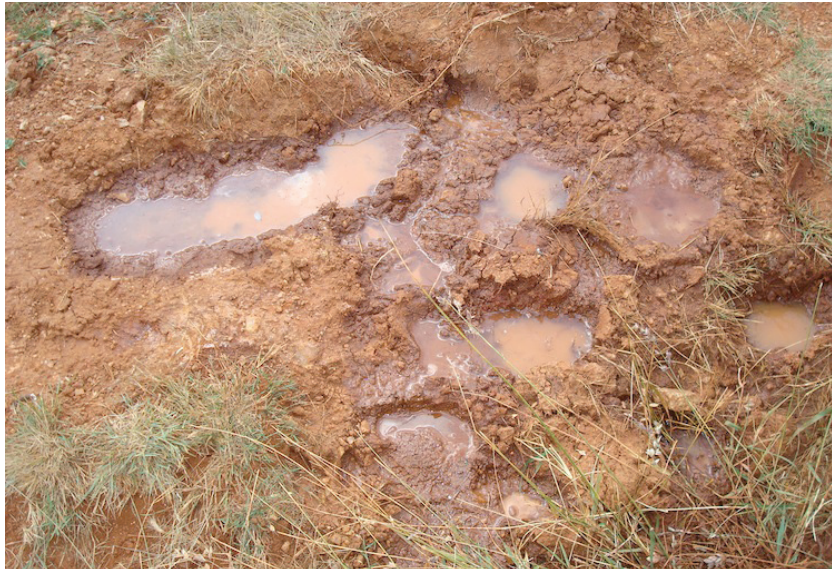
Figure 62: Picture of borehole water coming to surface from an existing leak

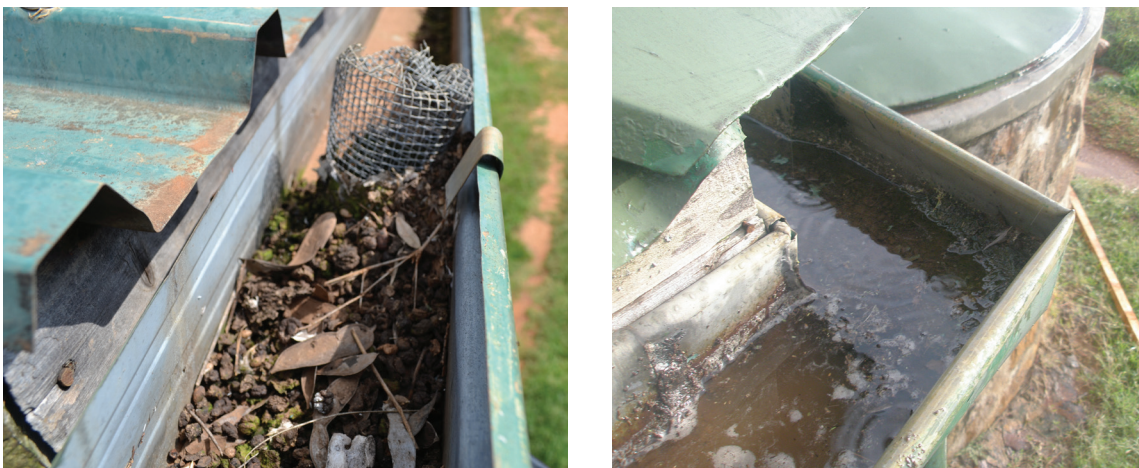
*Figure 63: Poorly maintained gutters at MRC, August 2011*

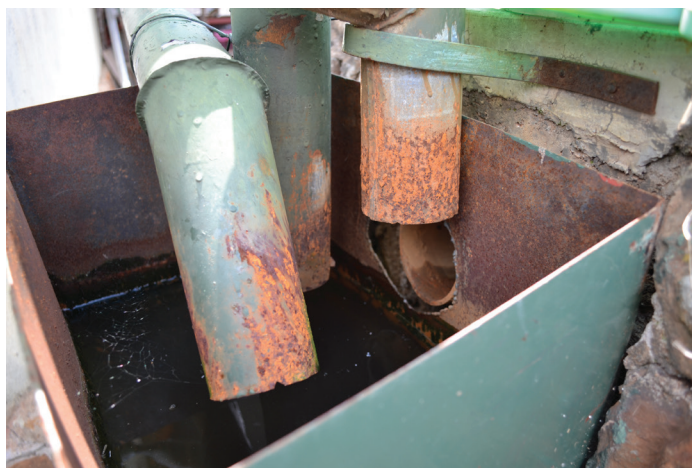
*Figure 64: Disconnected storage infrastructure at McCormack Lab, August 2011*

At MRC, where existing rainwater storage capacity is just over 7% of total capture potential, expansion of rainwater storage could greatly increase the availability of this resource. Due to the high capital cost of increasing rainwater storage capacity, and because the Nanja weirs are expected to meet Mpala's demand, it is recommended that Mpala focus their effort on maintaining their current rainwater harvesting infrastructure rather than expanding it. For gutters to properly channel water into a storage tank they must be clear of debris. Partially or completely blocked gutters do not allow water to flow unimpeded, which can result in overflow and loss of water (Figure 63). Improper connections between rooftop and storage infrastructure also illustrate the need for improved maintenance practices (Figure 64). When rooftop and storage infrastructure are disconnected, water that is captured and could be stored is lost. Between September 2011 and February 2012, some of this infrastructure was improved significantly, most notably the infrastructure at the McCormack Lab, shown in Figure 65. To maximize efficiency of rainwater infrastructure, regular inspection and maintenance must be carried out.

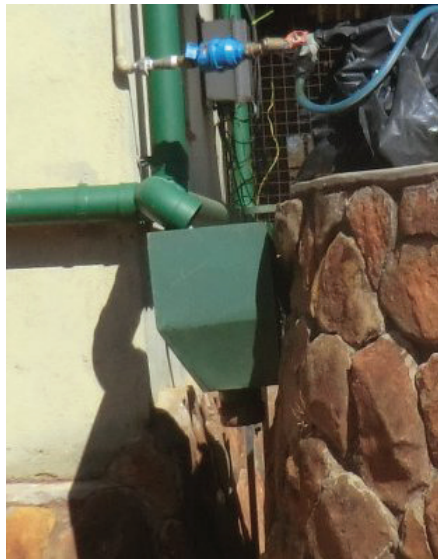
*Figure 65: Repaired rainwater harvesting system at McCormack Lab, March 2012*
