**Interim Report to the Michigan  
State Legislature and Steering  
Committee**

**16-ft Wide Mobile Home Study**

**The University of Michigan  
Transportation Research Institute**

Report No. UMTRI-91-49

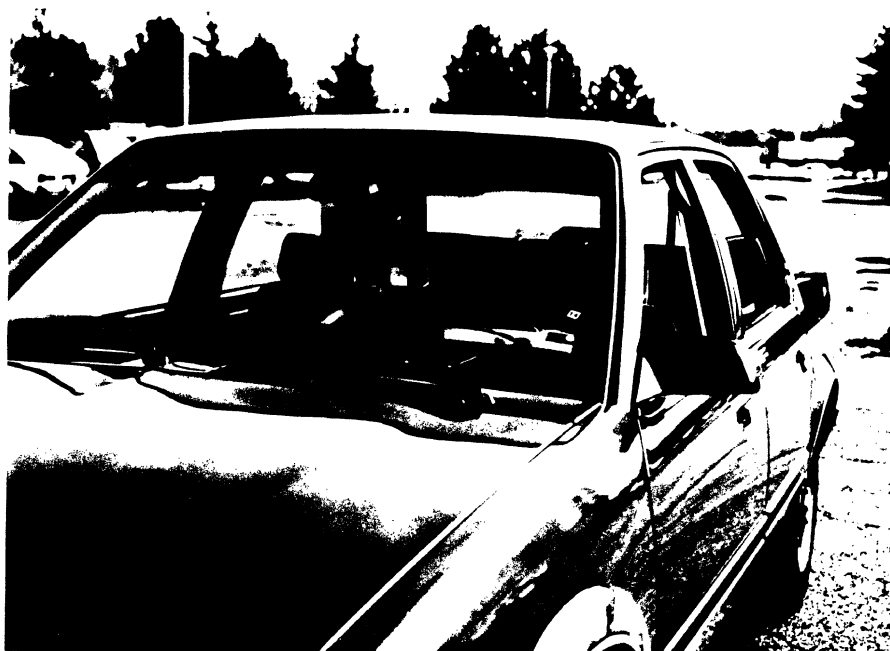
**Figure 3-1. Observation Vehicle.**

Two identically configured vehicles were used for the observations (Figure 3-1). Each data collection trip began with the observation vehicle traveling to the rest area on northbound I-69 located north of the Michigan-Indiana border, immediately south of I-94. Observers waited at this rest area until a tractor/home unit of appropriate size (i.e., 14-foot or 16-foot wide) was seen approaching from the south. Once the tractor/home unit was observed approaching, the observation vehicle positioned itself behind the escort vehicle that followed behind the tractor/home unit. At this time the observers started the video camera recording unit and completed the background data collection sections of the Route Log Sheet (see Appendix 1) and the Log Sheet for Vehicle Passing (see Appendix 2).

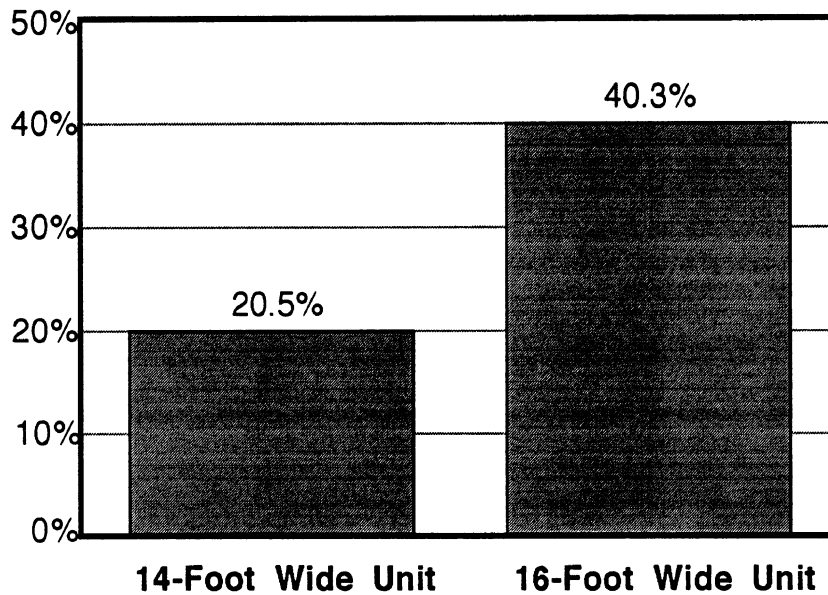
**Figure 3-7. Tractor-Home Encroachment  
Proportion of Time Encroaching in Passing Lane  
(Multi-Lane Divided Highways)**

each passing event, while 14-foot units were observed encroaching an average of only 20.5% of the time for each passing event (see Figure 3-7). In other words, 16-foot wide units encroached into the passing lane during passing events twice as much as did 14-foot units.

There was a good deal of variation, however, between the encroachment behavior of individual tractor/home units. That is, some tractor/home drivers encroached into the passing lane significantly less than other drivers. The range of average encroachment (over an entire delivery trip when adjoining traffic was present) for 16-foot units was from a low of 3.4% to a high of 60.9%. The range of average encroachment (over an entire delivery trip) for 14-foot units was from a low of 2.3% to a high of 54.3%.

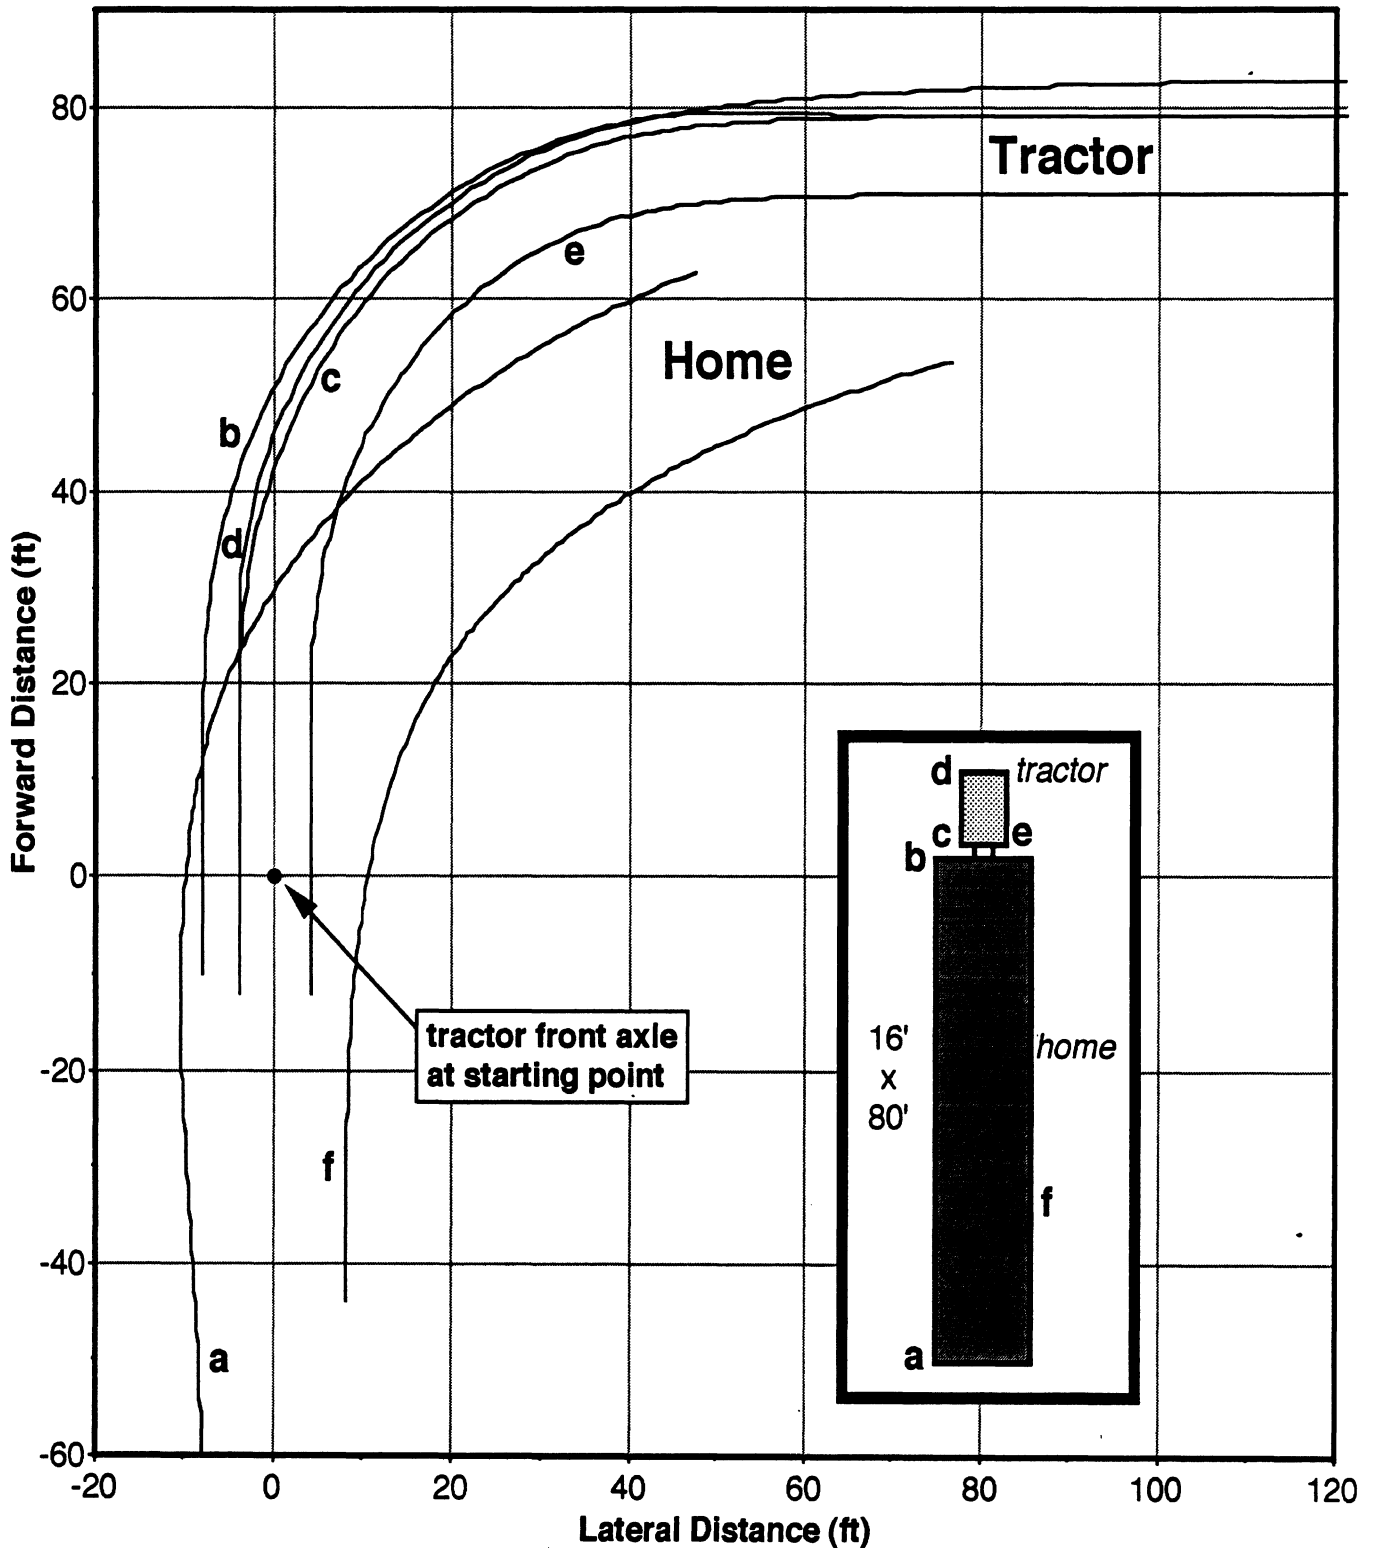
**Figure 4-3. Trajectories of Various Points on a Tractor & Mobile Home Combination Vehicle as it Moves Along a 50-ft Radius Right-Hand Turn.**

To better visualize and dissect how different parts of a mobile home and tractor combination move as they progress through a turn, a somewhat more detailed diagram of the turning process is seen in Figure 4-3. In this figure, the trajectories of six distinct points (a, b, c, d, e, and f) on the combination vehicle are traced out on a grid as the vehicle moves through a right-hand turn. The maneuver is precisely the same as that seen in Figures 4-1 and 4-2. However, Figure 4-3 is less descriptive and more quantitative. In fact, the outermost portions of curves a, b, and f actually define the banana-shaped swept path described in Figures 4-1 and 4-2. Diagrams like Figure 4-3 are being used in the

| <b>a: Outside Rear Corner of Home</b> | <b>e: Inside Rear End of Tractor</b> |
| <b>b: Outside Front Corner of Home</b> | <b>f: Inside Rear Tire(s) of Home</b> |
| <b>c: Outside Rear End of Tractor</b> | |
| <b>d: Outside Front Corner of Tractor</b> | |

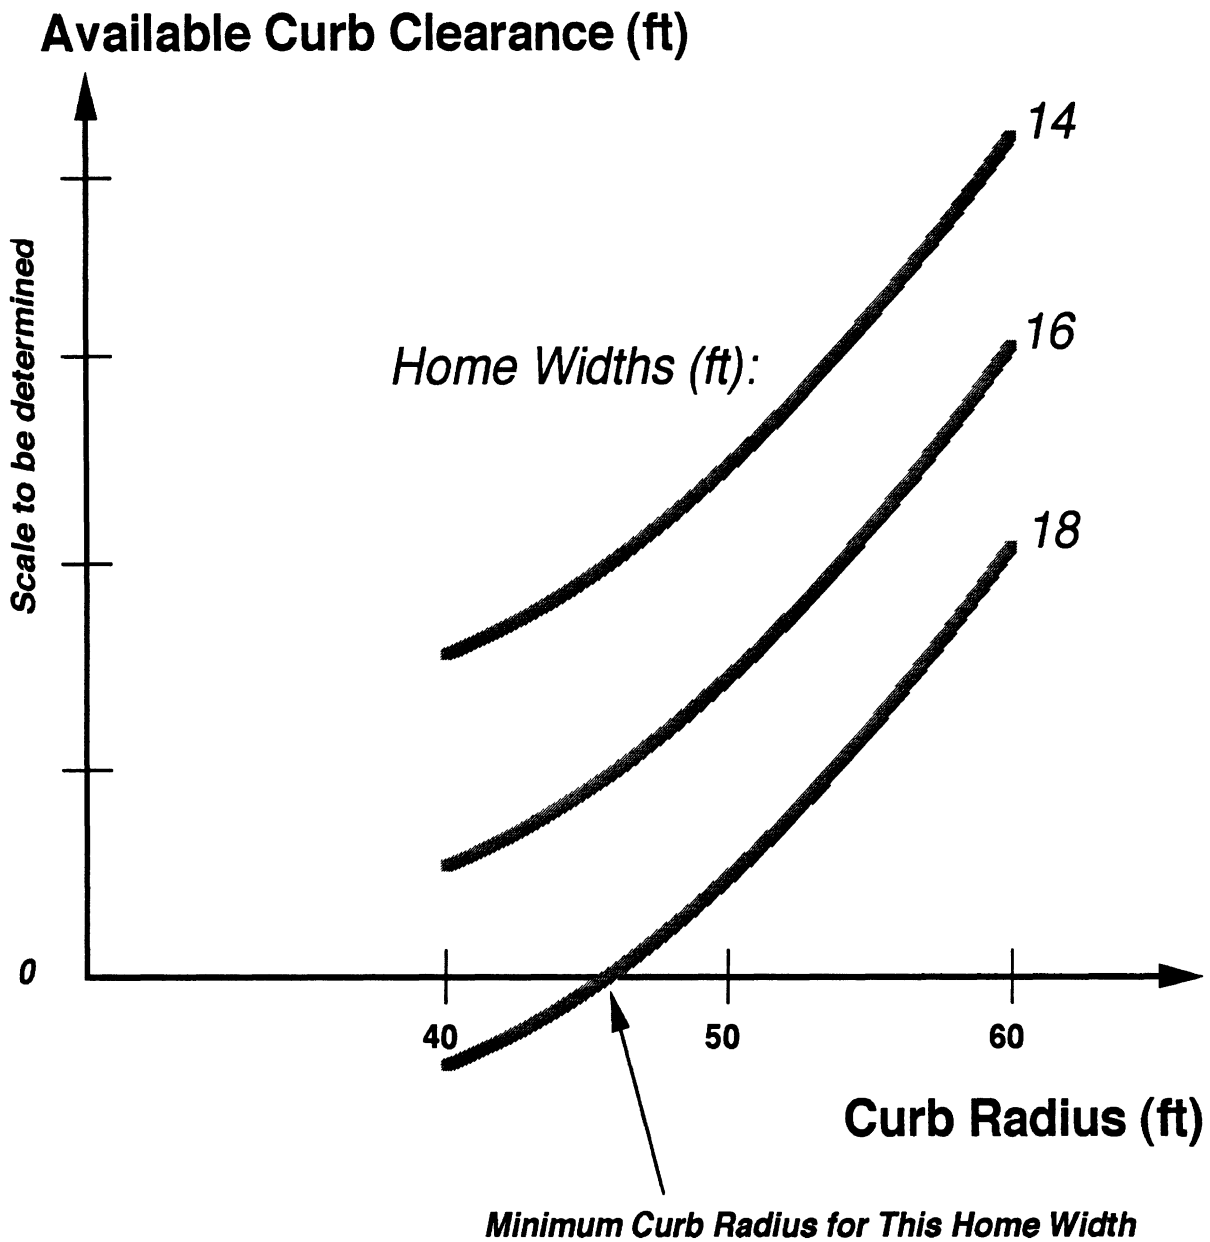
**Figure 4-5. Type of Analysis Still to be Conducted in Remainder of Intersection Study**

The above discussion and results have described findings to date related to low-speed turning at intersections. In the remaining months of the project, additional analyses will be conducted for low speed turning scenarios and potential impact of wider homes on highway and intersection geometry. For example, analyses of curb radii at intersections will be conducted to evaluate adequate curb clearances for mobile homes of various widths. In Figure 4-5, an example analysis is seen which outlines how increased home width will affect the amount of available curb clearance for intersections having different curb radii. Depending upon the intersection geometry, the turning radius of the towing tractor, and the size of the home unit, curb clearances will diminish for increased home width and for

- 50-ft Tractor Turn Radius
- 12-ft Lanes
- 8-ft Shoulders
