Report No. UMCEE 92-31

# **Field Investigation of Damage to Islamic Monuments Caused by the Egyptian Earthquake of October 12, 1992**

December 1992

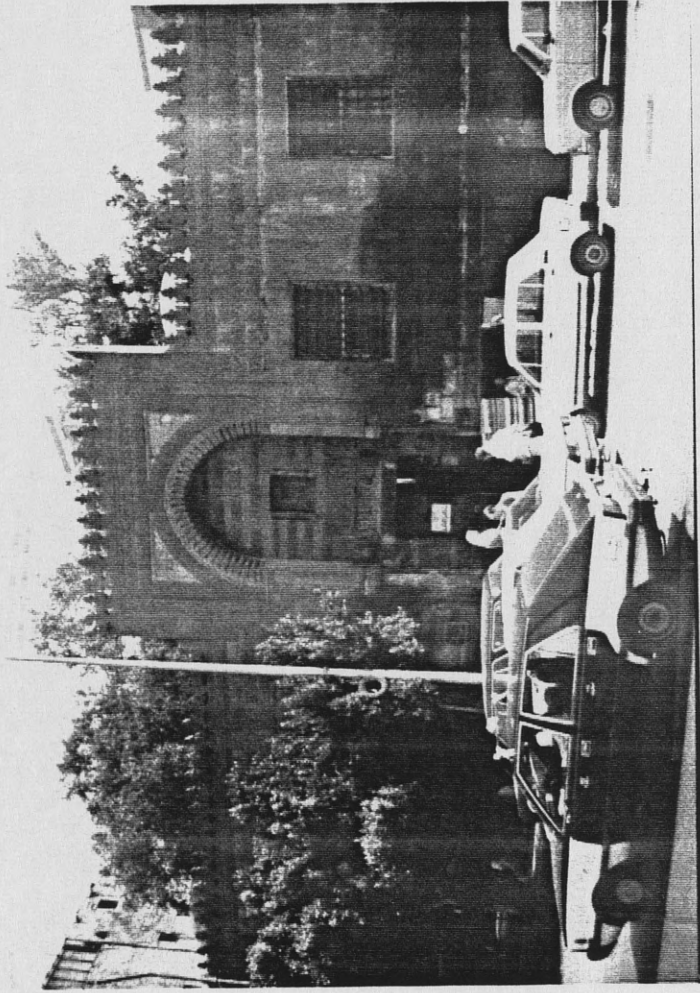
This structure was apparently a sort of convent where the Dervishes came for temporary retreat from the outside world. It is about 250 years old. In the present, it serves as a preschool. It is a one story high square structure with an open interior courtyard and garden (Fig. 19). Rooms are aligned along the periphery of the square. They all open on the inside to a covered corridor surrounding the courtyard. The roof structure is made of a series of masonry domes and arches. Several wide cracks were observed on the inside of the domes and in some rooms the mortar covering on the inside of the brick dome had spalled off and fallen (Fig. 20). Several cracks in the walls, domes and arches probably existed prior to the earthquake, but were amplified by it (Fig. 21). Most of the cracks could be structurally repaired and patched, restoring the structure to at least its pre-earthquake condition.

Fig. 19 Front of Sultan Mahmoud Takkayan Preschool
