DYNAMIC TESTING OF RESTRAINT  
SYSTEMS AND TIE-DOWNS FOR USE  
WITH VEHICLE OCCUPANTS SEATED IN  
POWERED WHEELCHAIRS

FINAL REPORT

Lawrence W. Schneider  
The Highway Safety Research Institute  
The University of Michigan  
Ann Arbor, Michigan 48109

April 1981

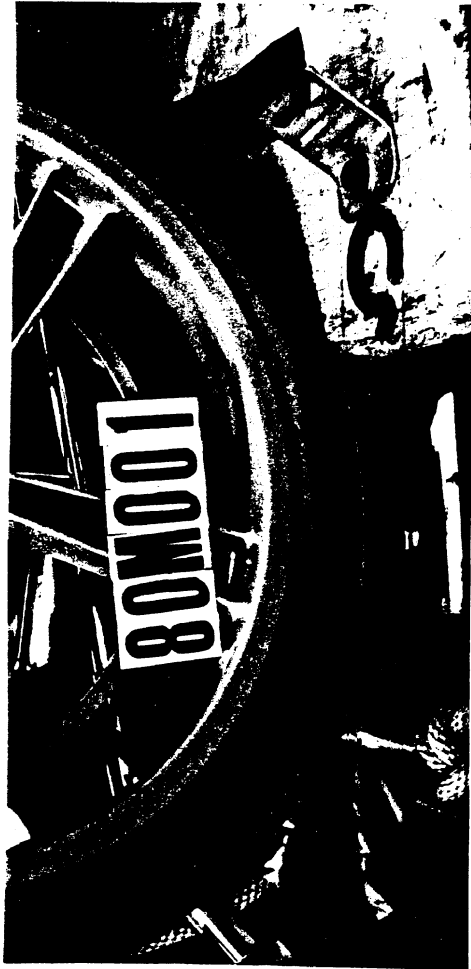
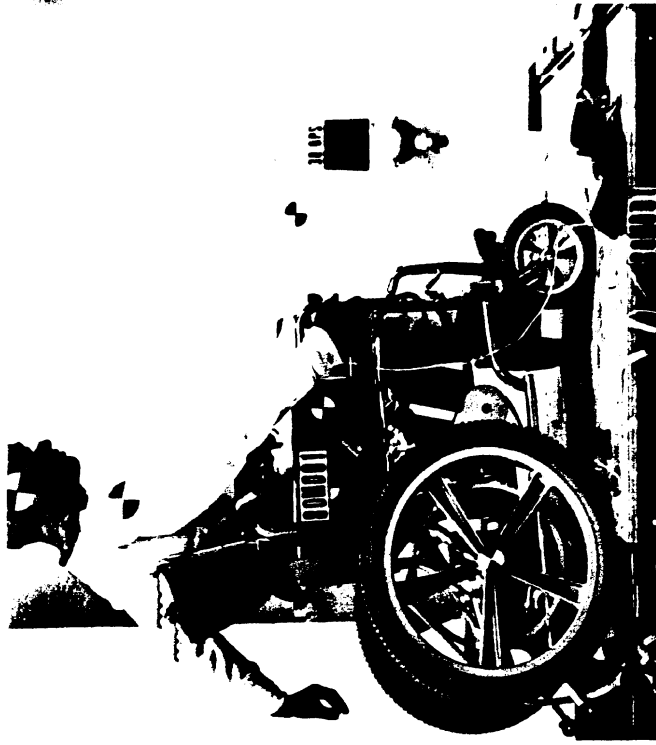
Post-Impact Photos for Test 80M001

Prior to impact the chair moved backward on the sled due to the sled acceleration (approx. .5 G), producing slack in the lap belt. The ring of the right lift ring assembly broke at the sharp bend on impact, releasing the lap belt and allowing the wheelchair to move unrestrained into the padded front of the sled. The velcro fastening on the chest belt did not hold. The chair sustained little or no damage.

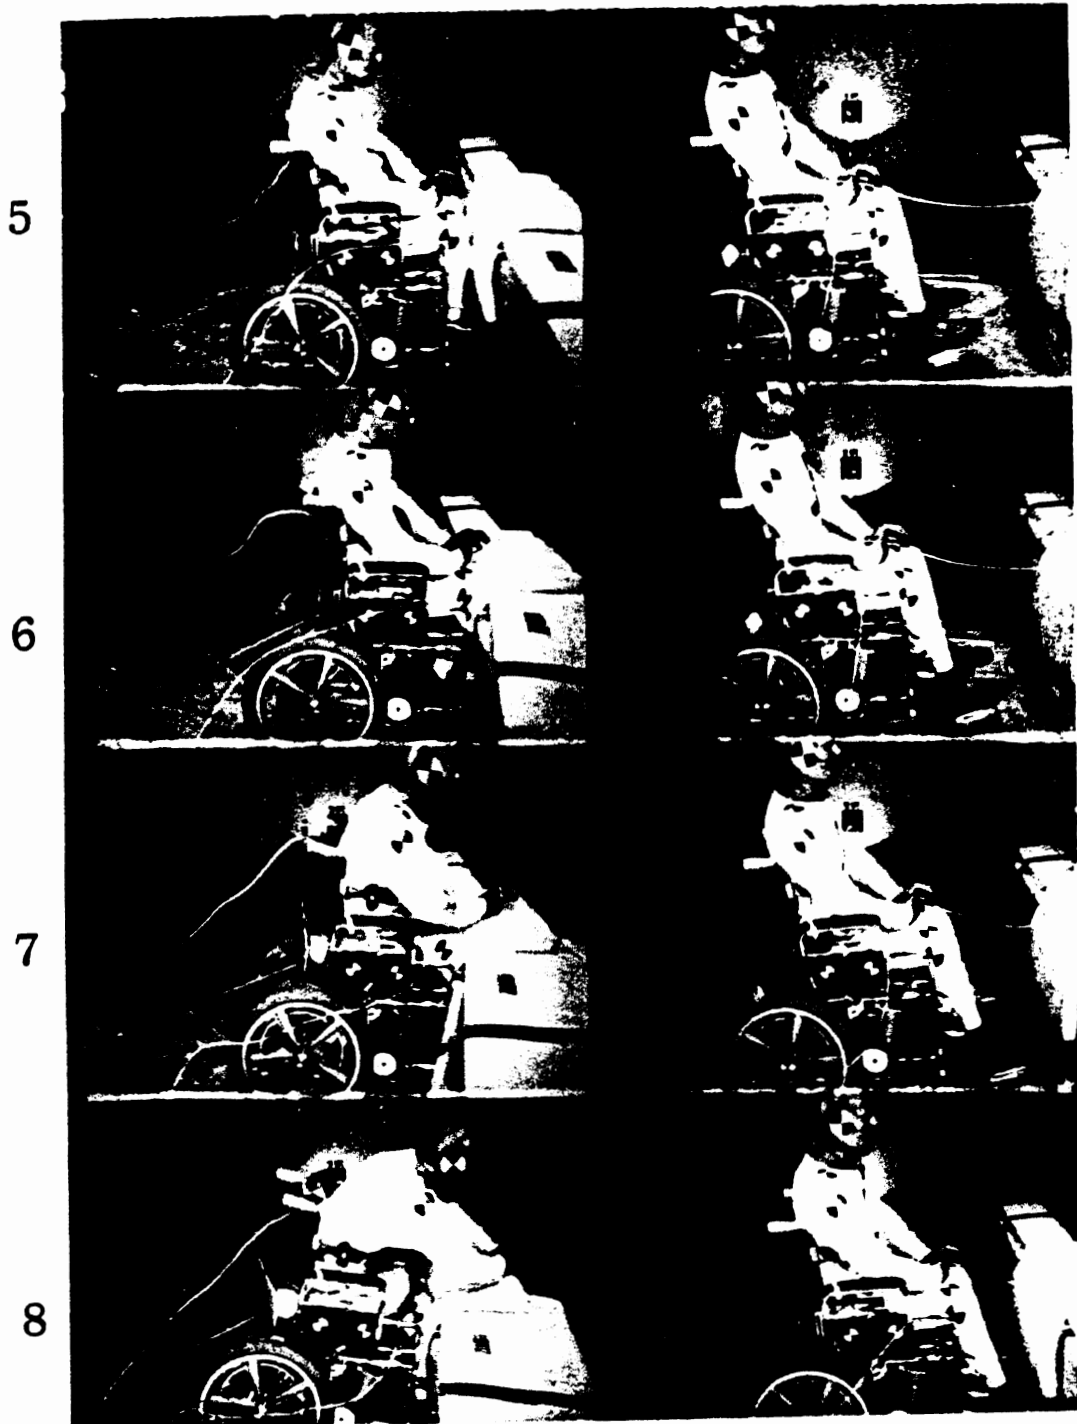
Time Sequence Photos for Test 80M002

The chair did not move on sled acceleration and the lap belt remained taut until impact. Upon impact the ring of the left ring assembly broke at the sharp bend, releasing the chair and dummy, which moved forward and impacted with the padded front of the sled. The velcro belt released, allowing the dummy's torso to flex forward. The chair back upholstery was torn loose on dummy rebound. The chair sustained little or no damage to the frame.

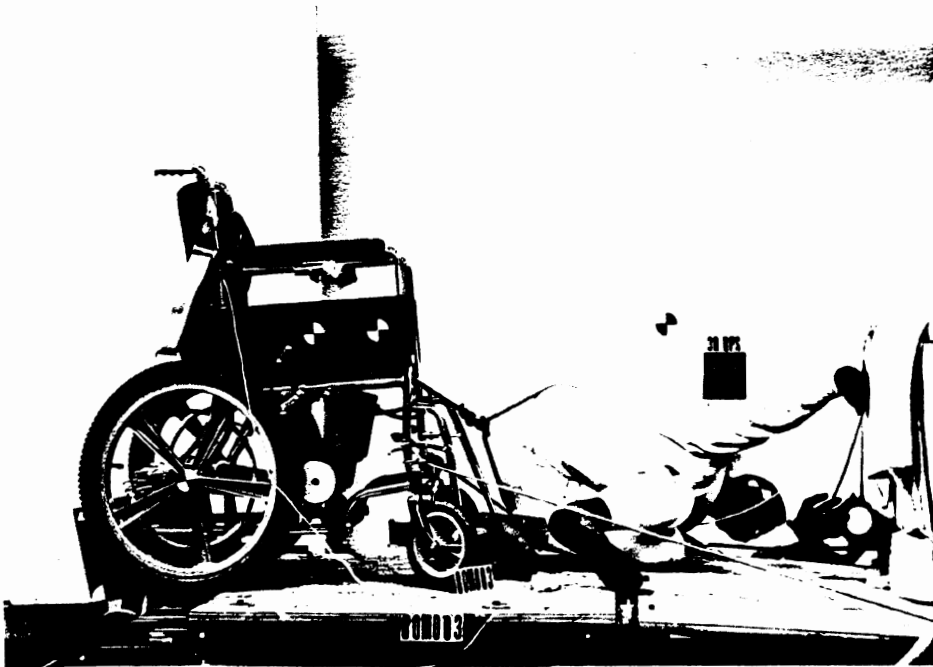
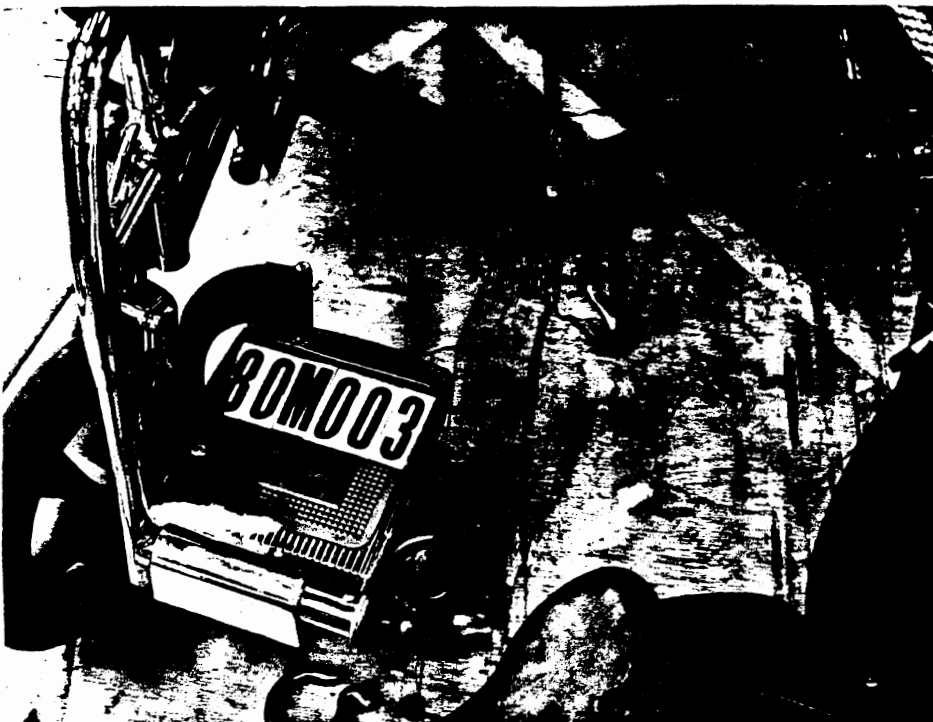
Post-Test Photos for Test 80M003

The ring of the lift ring assembly broke at the sharp bend, releasing the wheelchair to move forward into the padded front of the sled. The T-bar and hook bolt bent significantly and the velcro belt came loose, allowing the dummy to fall to the floor.

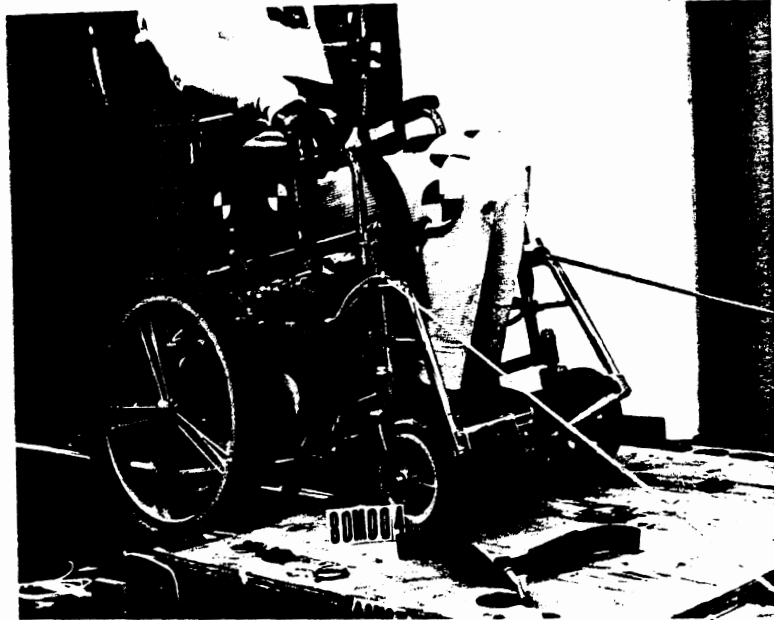
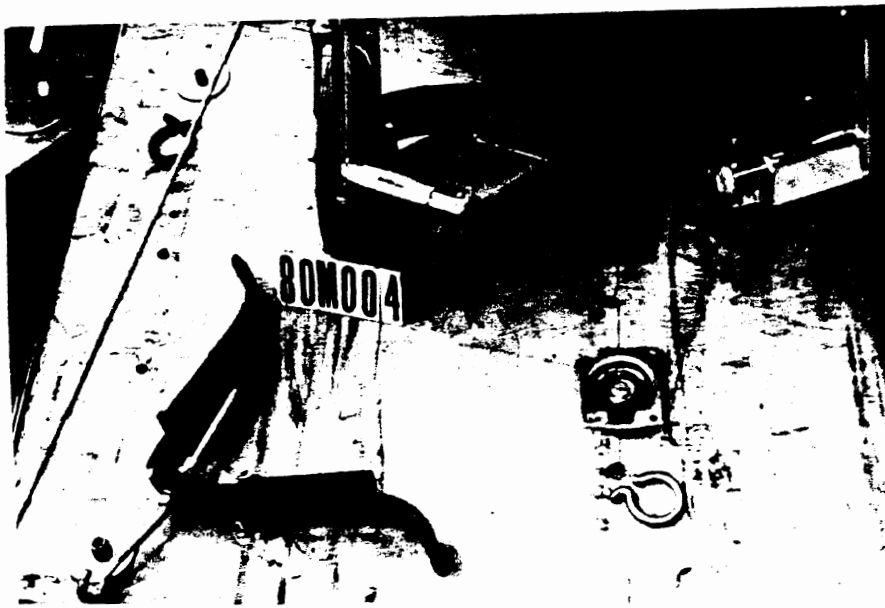
Post-Test Photos for Test 80M004

The rings from the lift ring assemblies securing the T-bar and one side of the lap belt broke at the sharp bends, allowing the wheelchair to move into the padded front of the sled. The T-bar itself bent and fractured, and the lap belt also unbuckled. Although the velcro on the chest belt held, the stitching tore out, allowing the belt "D" ring to slide through the double webbing and produce significant belt slack.

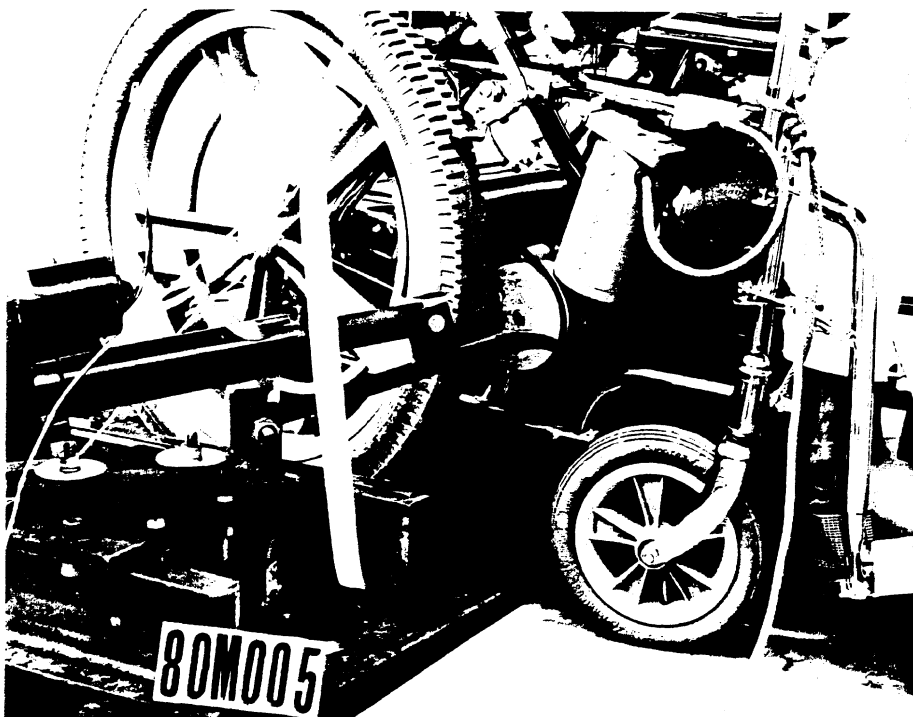
Post-Impact Photos for Test 80M005

There was no significant restraint of the chair by the power lock-down. The lock-down arm slid off the frame with little apparent effect on wheelchair movement. When the arm did interact with the chair frame at the cross-bars, the power lock-down rotated out of the way as the chair moved forward. The chair moved into the padded front of the sled with little or no turning, so that the dummy's knees absorbed most of the energy. During the test the lap belt stayed secure and the dummy remained in the chair. The chair sustained little damage other than bending of the motor brackets.

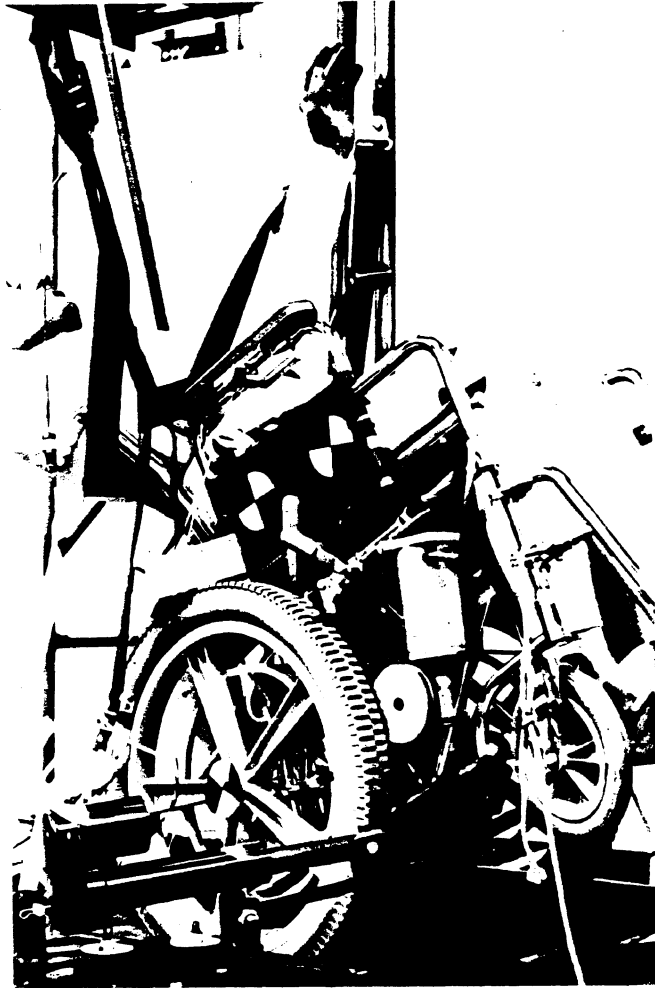
Post-Test Photo for Test 80M006

The power lock-down did not secure the chair, which became restrained by the passive belt system through loading on the dummy. The lower part of the chair, being unrestrained, moved forward, causing the dummy and chair to tilt backwards. A tether rope caught on a sled bolt, preventing the chair from flipping to the floor. The lap belt stayed secure. High forces in the floor-to-roof belt caused the steel structure used to simulate the vehicle roof anchor point to collapse.

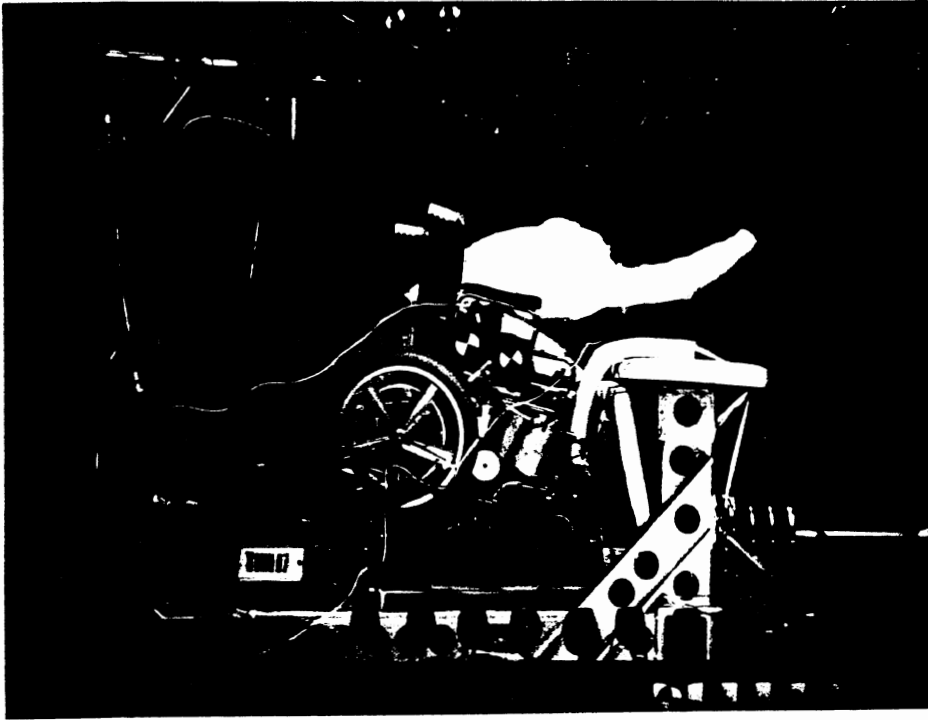
Stop Action During Impact Test 80M007

The power lock-down did not restrain the chair. The chair and dummy moved forward into the passive belt system, causing the stitching around the metal ring in the floor-mounted belt to break, releasing the chair to move out of the power pan and into the front of the sled. The chair sustained little damage.

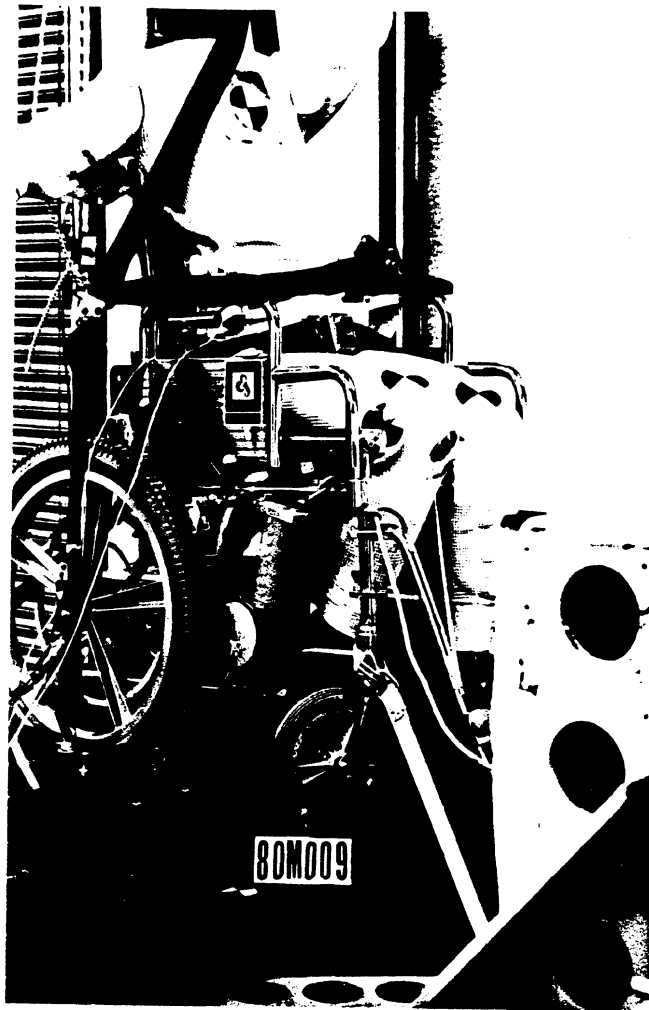
Post-Impact Photo for Test 80M009

The Aeroquip straps provided good restraint of the wheelchair, and the chair moved only a couple of inches due to stretching of the straps. There was no apparent damage to the chair frame and the passive belt system with lap belt to chair provided good upper and lower torso restraint for the dummy.

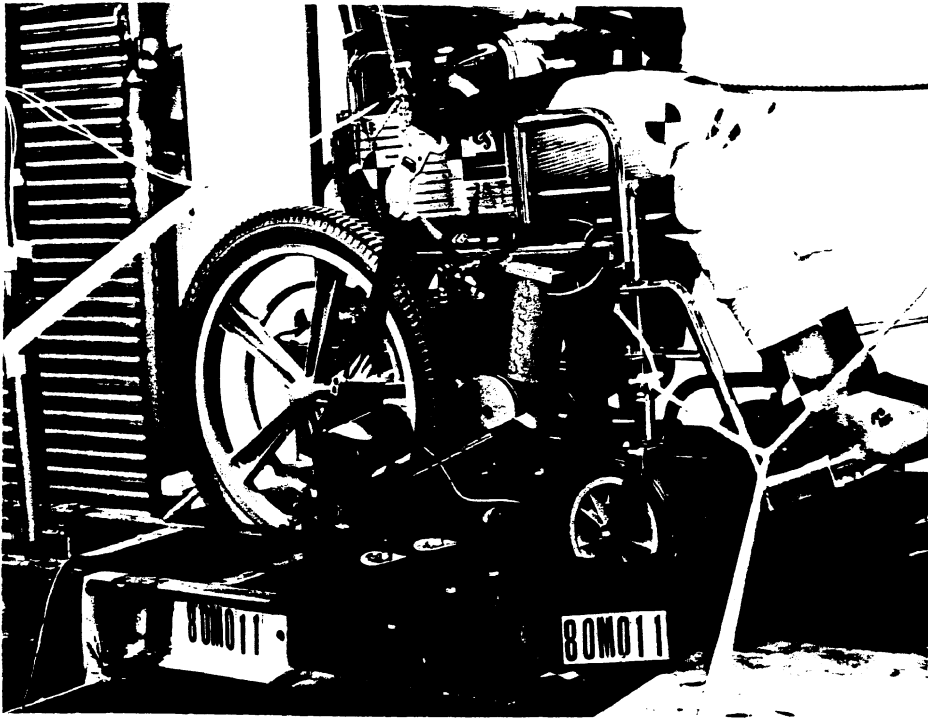
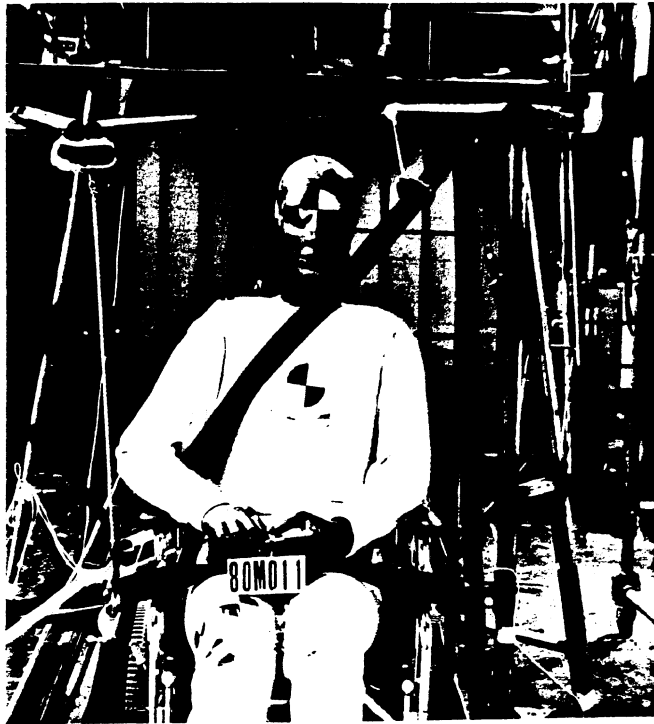
Set-Up Photos for Test 80M011

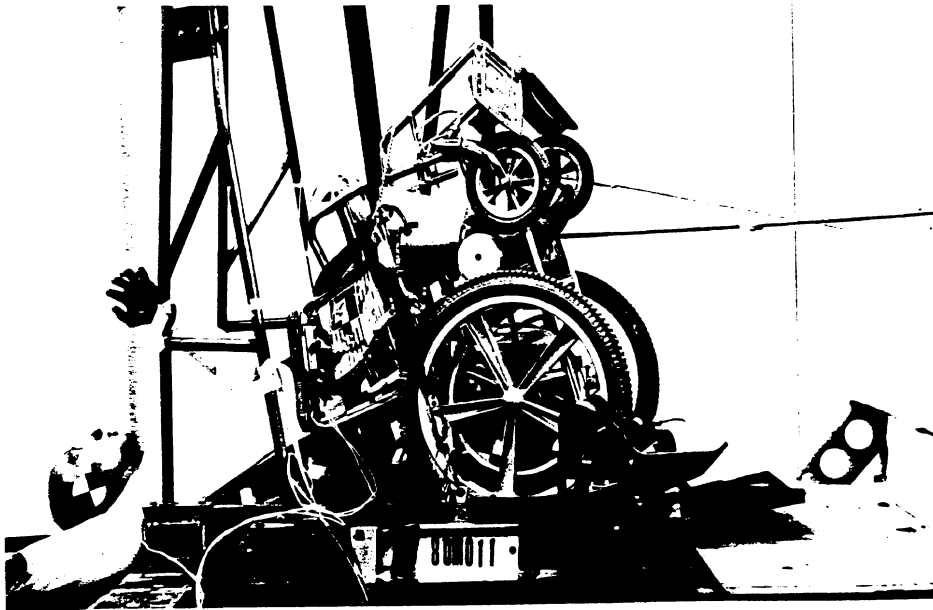
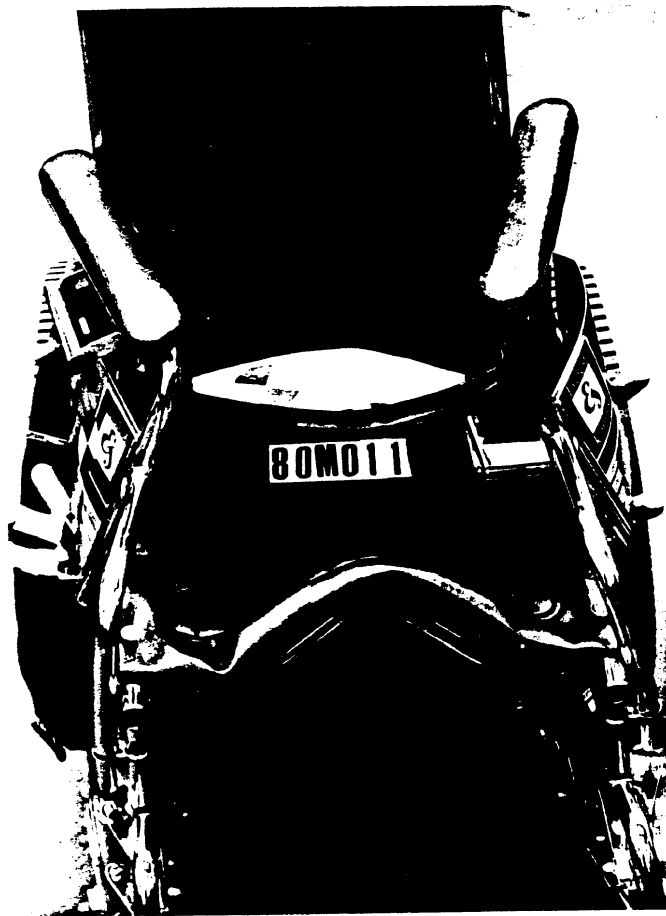
Post-Impact Photos for Test 80M011

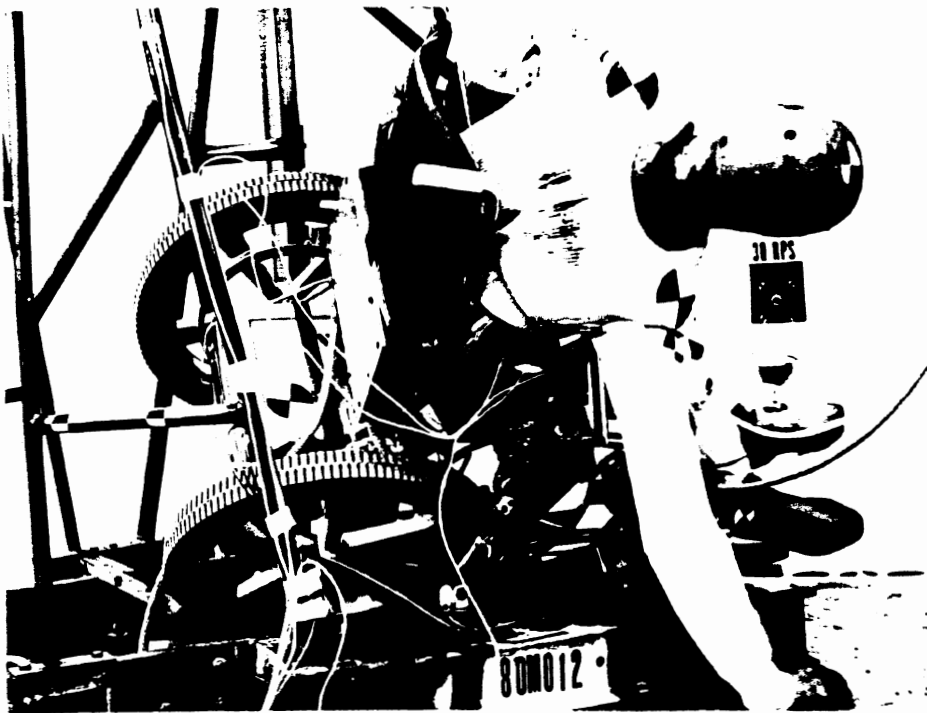
Post-Impact Photos for Test 80M012

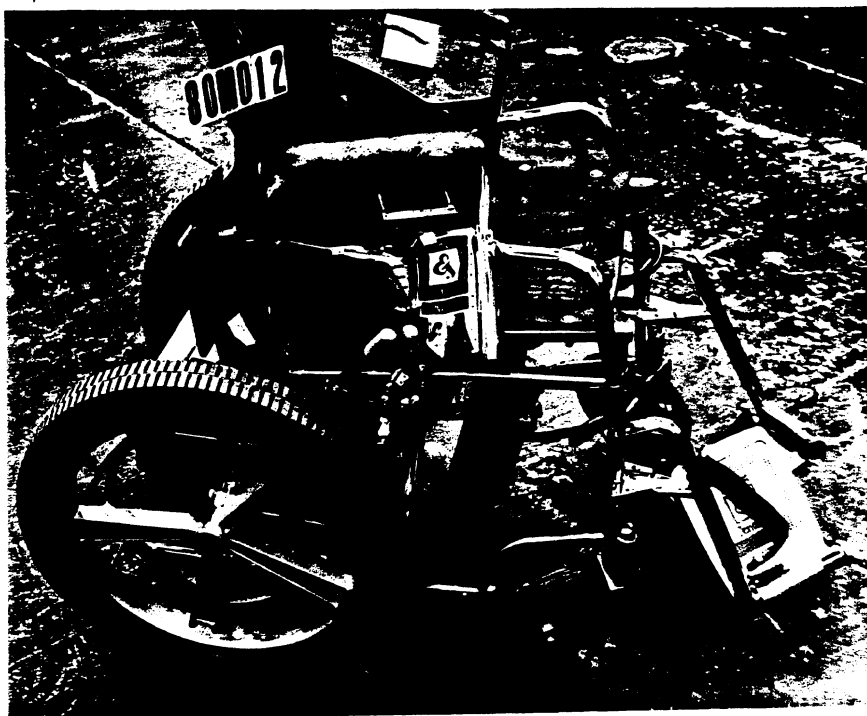
Post-Impact Photos for Test 80M012

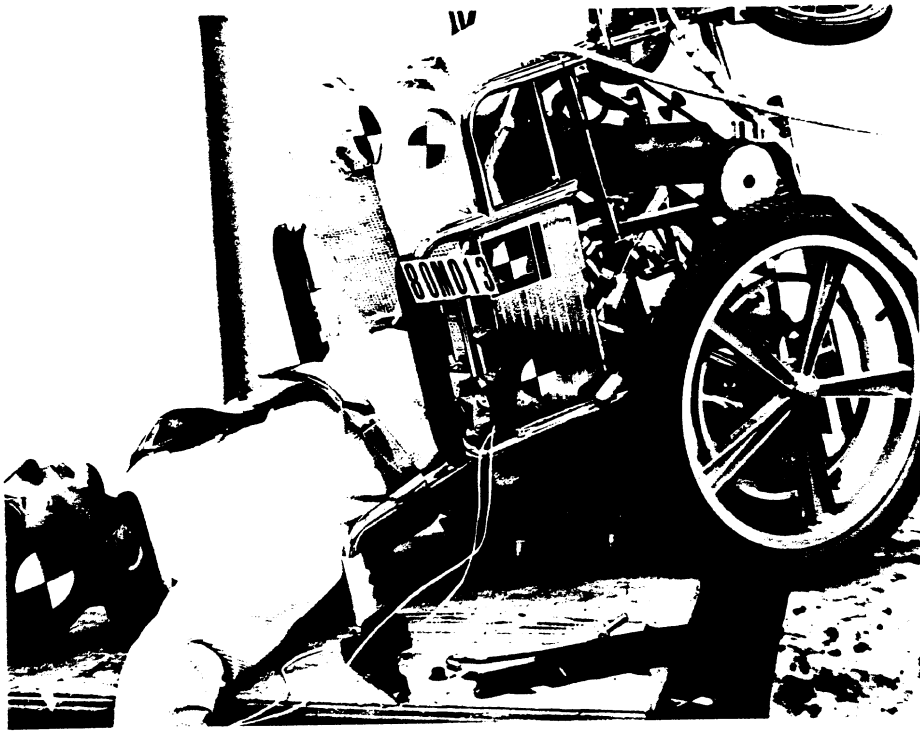
Post-Impact Photo for Test 80M013

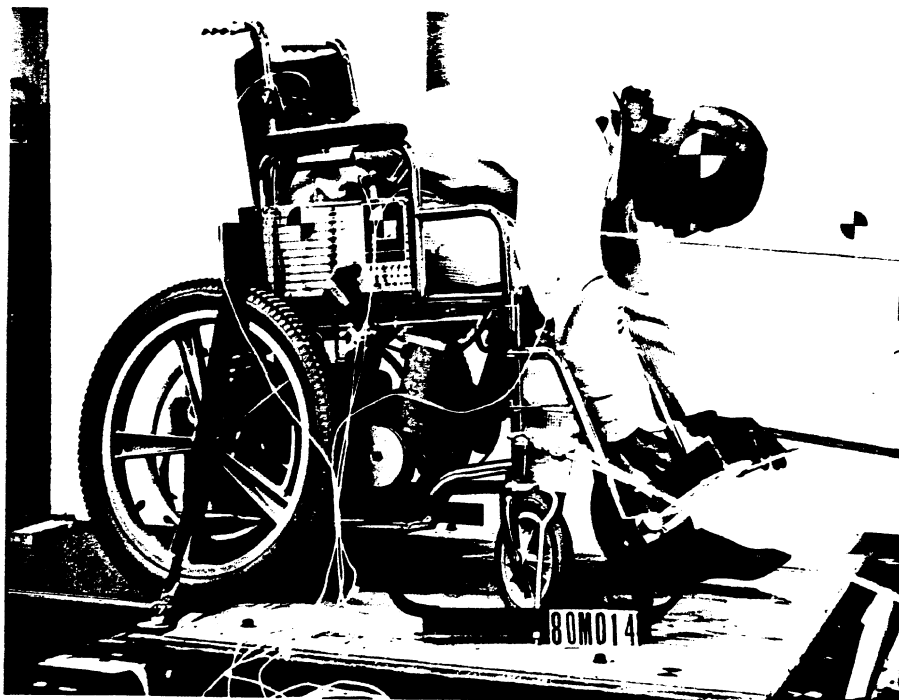
Post-Impact Photo for Test 80M014

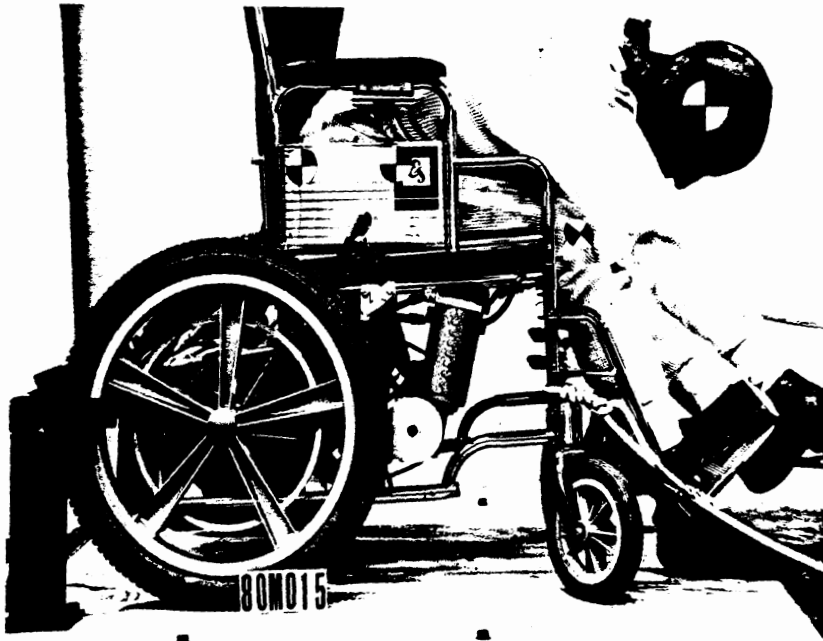
Post-Impact Photo for Test 80M015

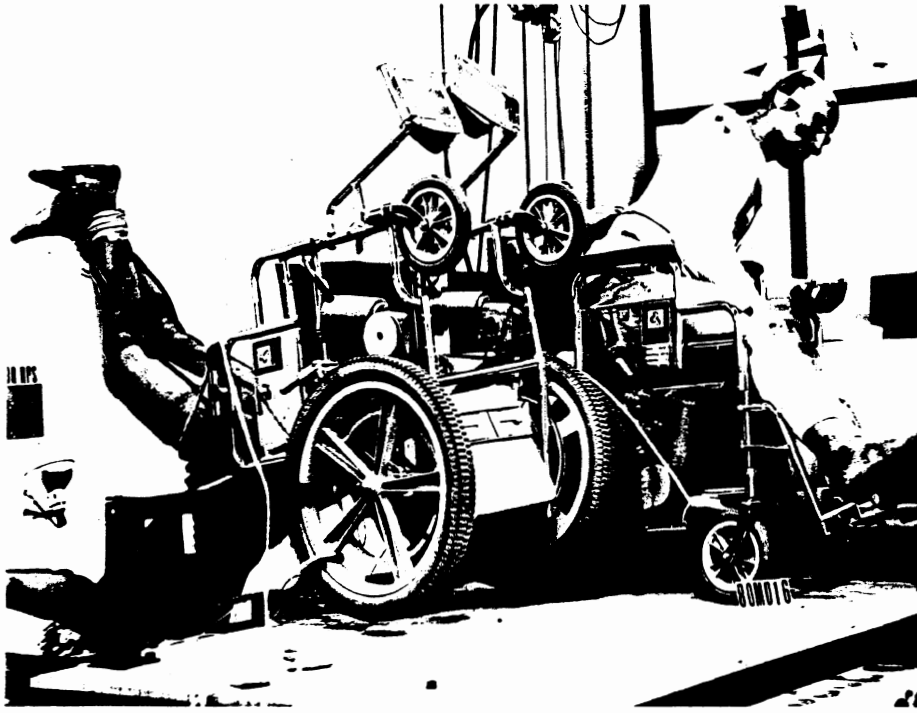
The rim pin fixtures of the stanchion slid along the bar to the front of the stanchion bar. The front chair impacted into the padded front of the sled, fracturing the left magnesium wheel rim and badly bending the chair. The rear chair impacted into the front chair and then flipped backward over the stanchion, with the dummy ending upside down and hanging off the side of the sled. Both lap belts held the dummies in the chairs.

Post-Impact Photos for Test 80M016

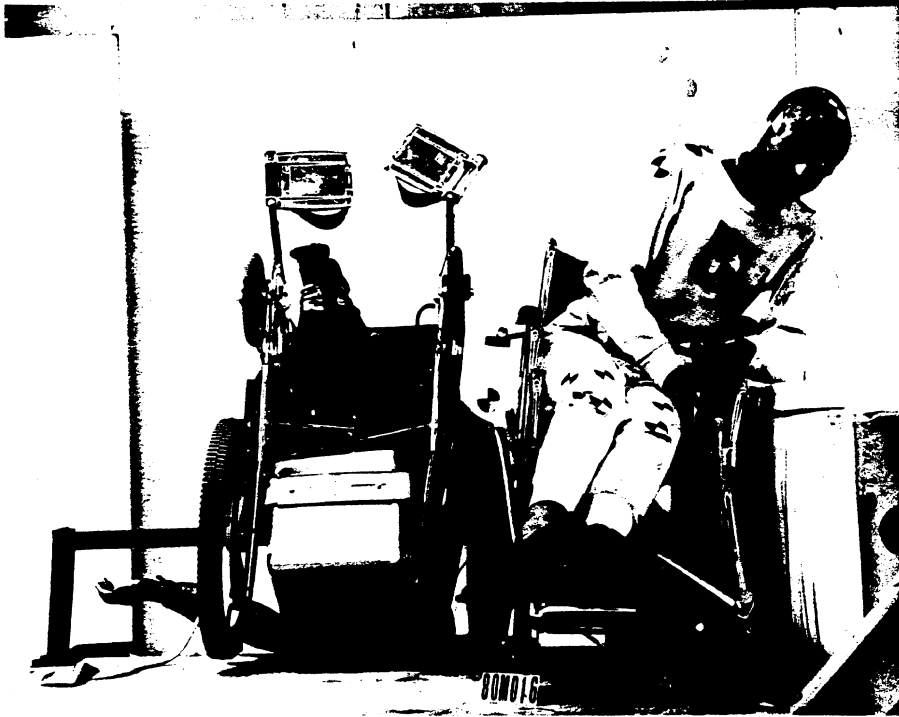
Post Impact Photos for Test 80M016

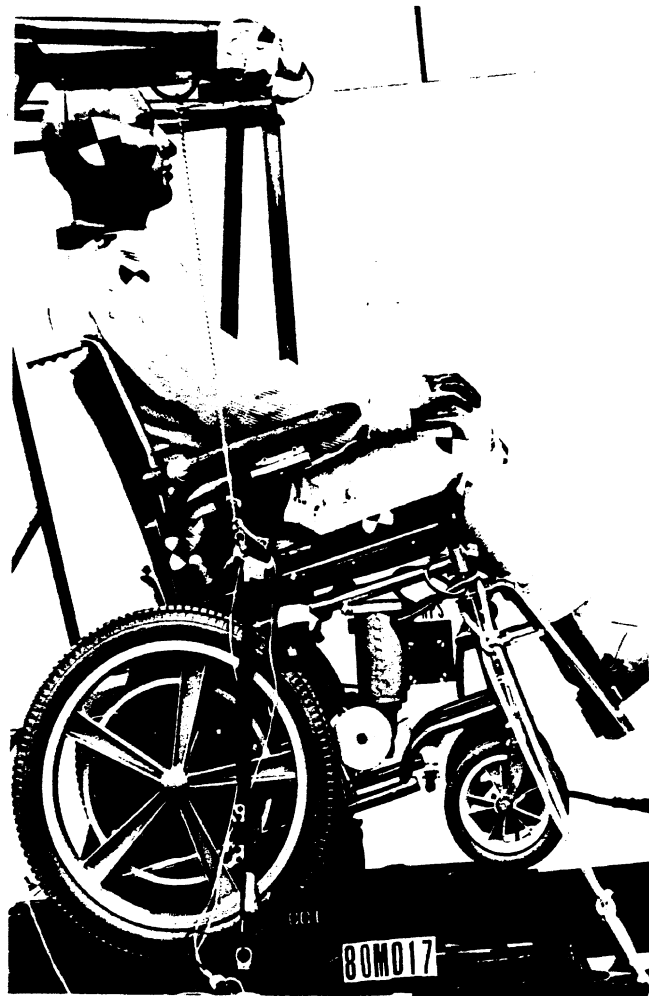
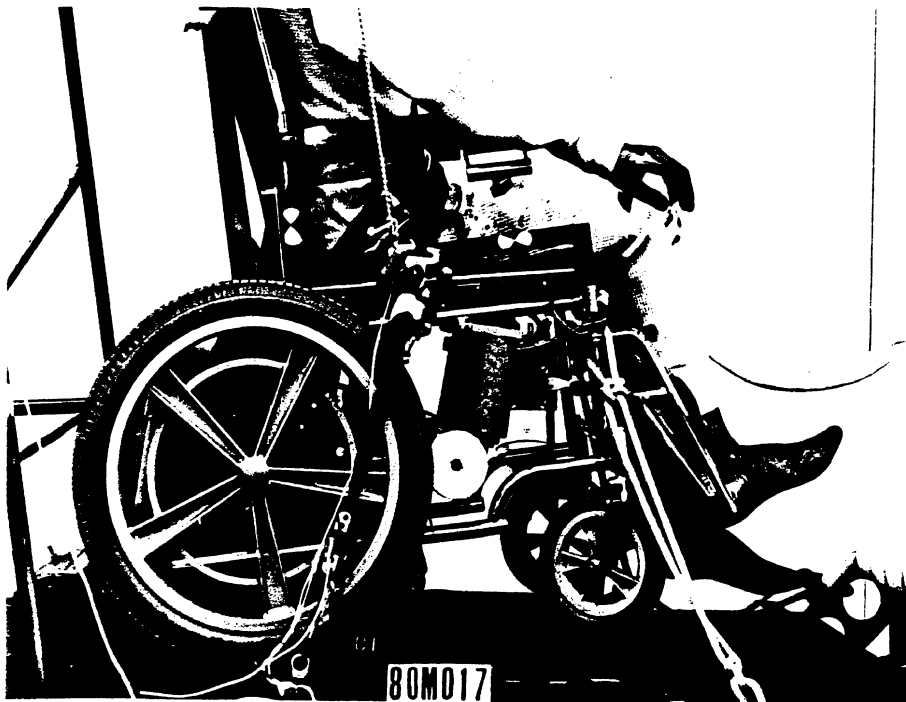
Post-Impact Photos for Test 80M017

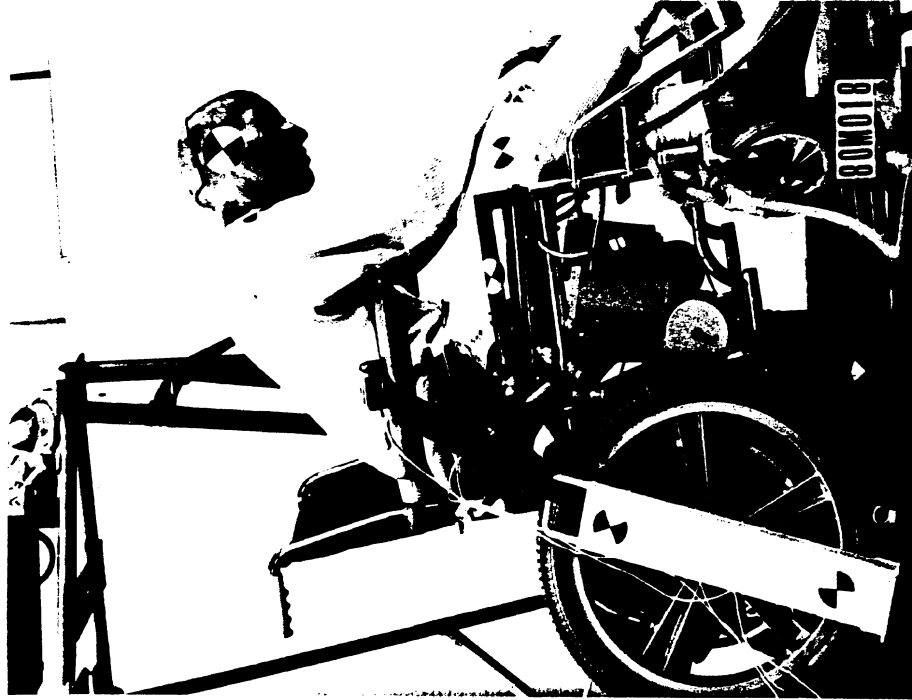
Post-Impact Photos for Test 80M018

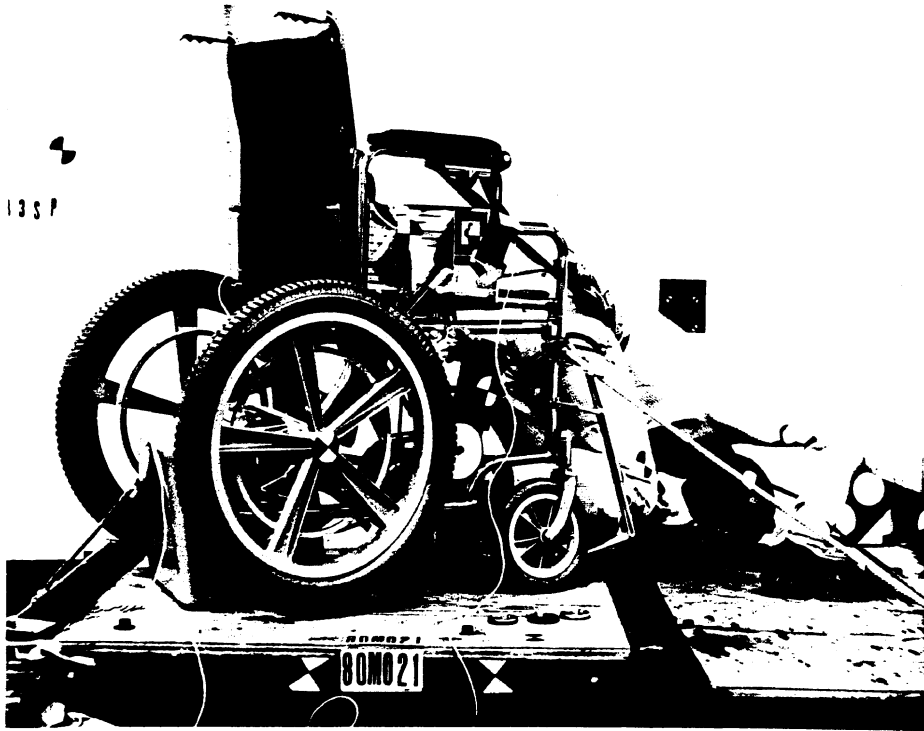
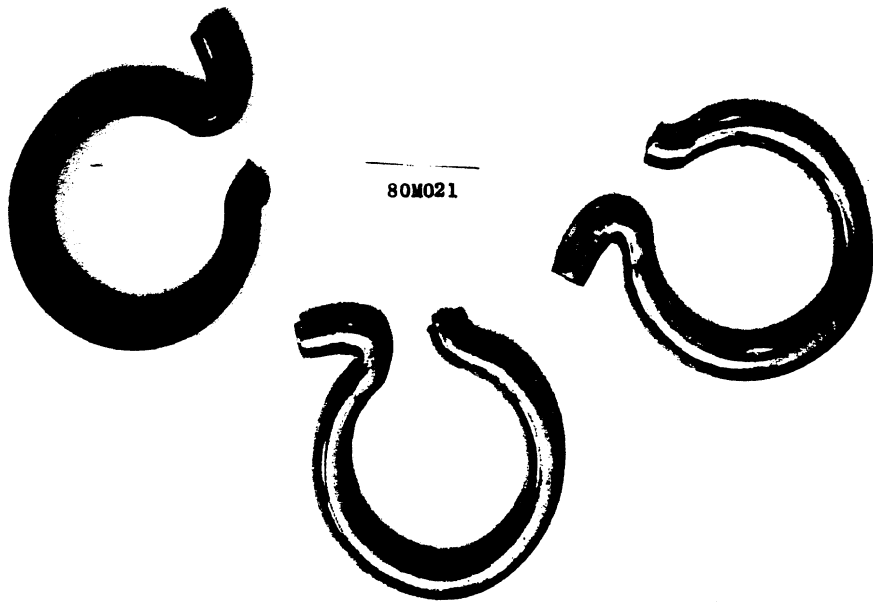
Post-Impact Photos for Test 80M021

All three of the lift rings broke at the sharp bend, completely releasing the chair and dummy to impact into the padded front of the sled. After impact the dummy fell to the floor unrestrained. The wheelchair sustained little or no damage.

The lift-ring assemblies currently in use for anchoring lap belts and T-bar bolts were simply not intended for forces generated by a 110 pound wheelchair in any kind of crash. These are "off-the-shelf" trap door rings which can be purchased in most any hardware store. The weak point is clearly the sharp bend in the ring, which appears to have been cold formed from a piece of standard rod. Replacement of these ring assemblies by heavy duty eye bolts or some other strengthened hardware is essential for effective wheelchair restraint.

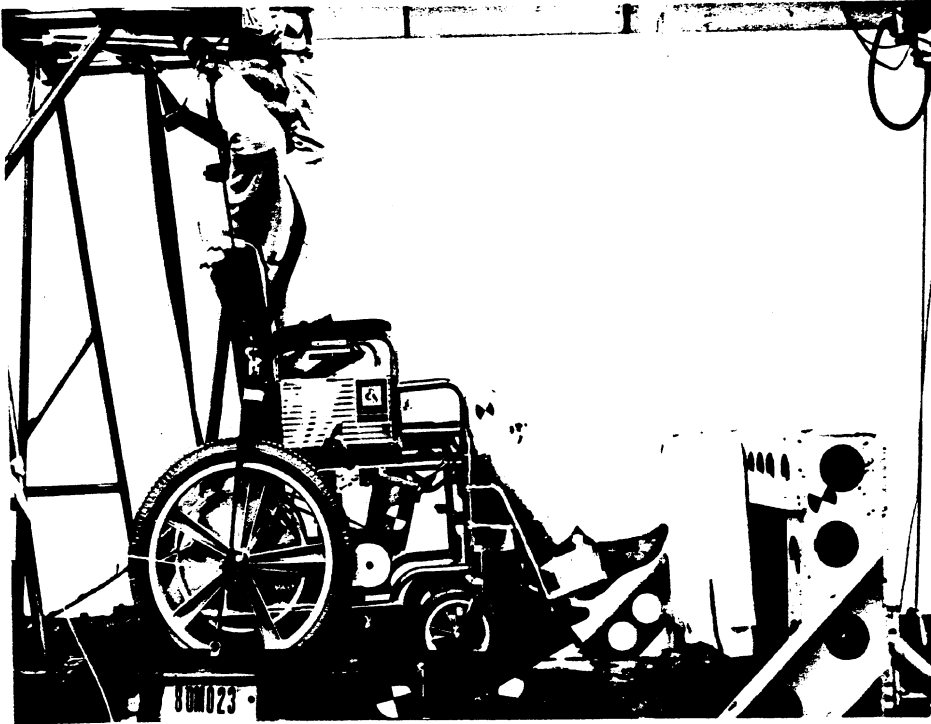
Post-Impact Photos of Test 80M023

The tie-down and occupant restraint systems provided excellent restraint for the wheelchair and dummy, respectively. The lap portion of the Bud passive belt would have placed forces on the abdomen of an occupant, however. The wheelchair sustained little or no damage.

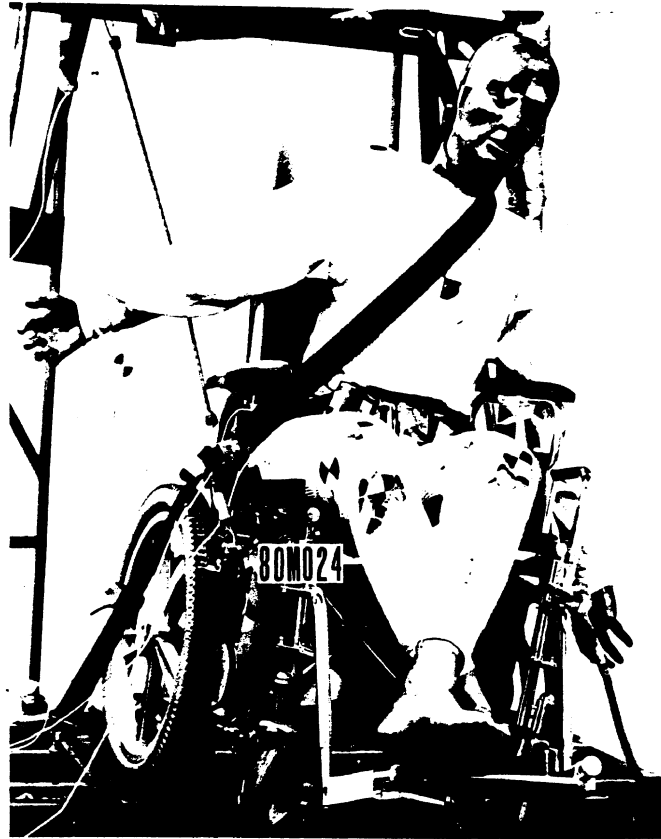
Post-Impact Photos for Test 80M024

The CCI power pan retrofit tie-down system provided excellent wheelchair securement, and the chair sustained only minor damage due to the asymmetric forces. The dummy was well restrained, but the shoulder belt pressed into the dummy's neck due to the angle of impact.

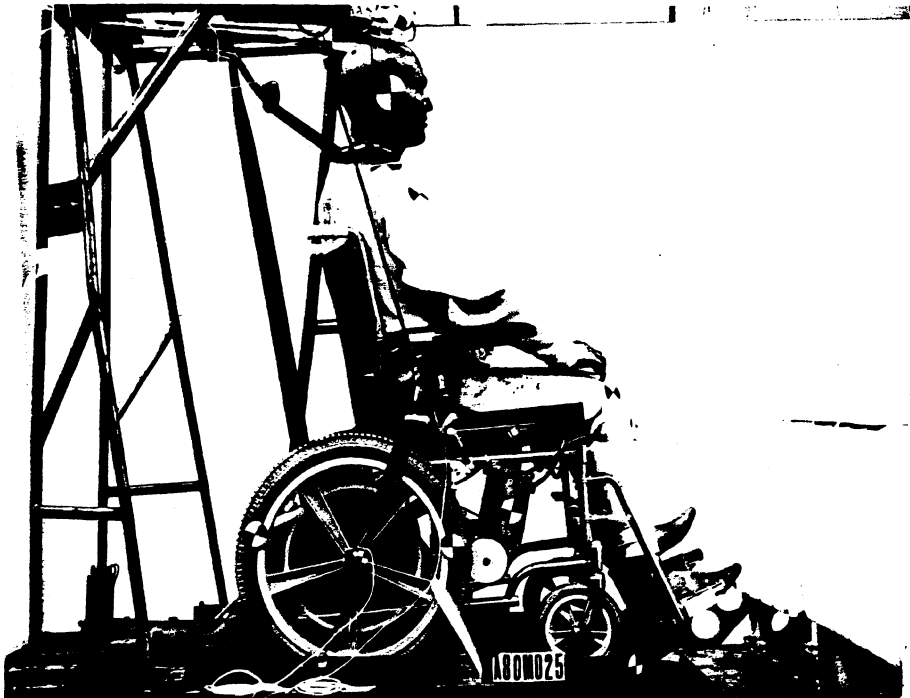
Post-Impact Photo for Test 80M025

The wheelchair tie-down and belt systems provided excellent restraint for the wheelchair and dummy, respectively. The wheelchair sustained little or no damage.

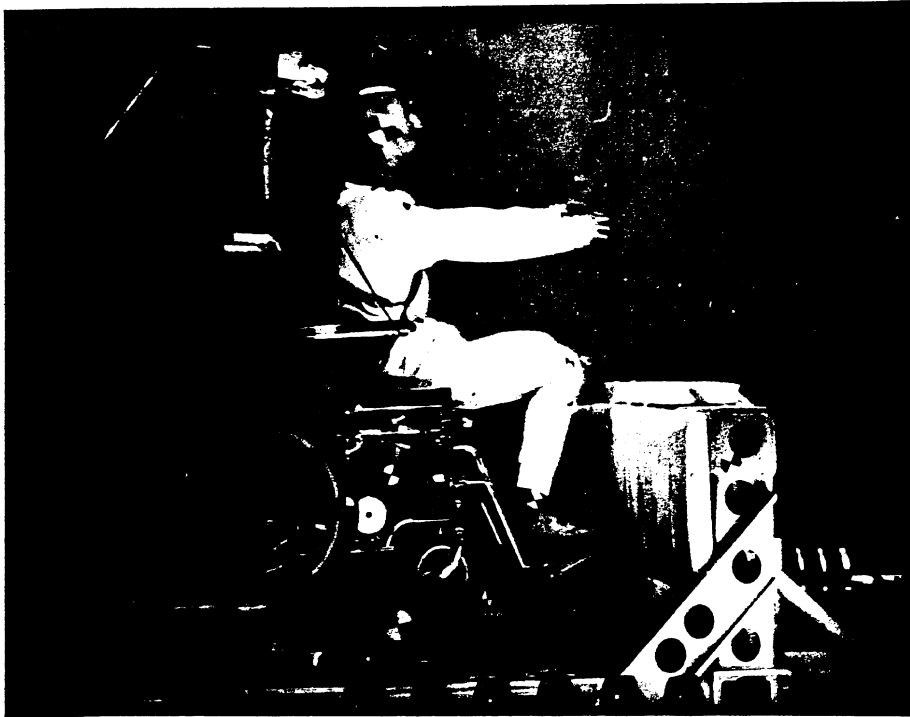
Action Photo of Test 80M026

The wheelchair was secured well by the CCI tie-down system, but a knot in the floor belt broke loose at the metal ring, allowing considerable forward translation of the dummy. The chair sustained little or no damage.

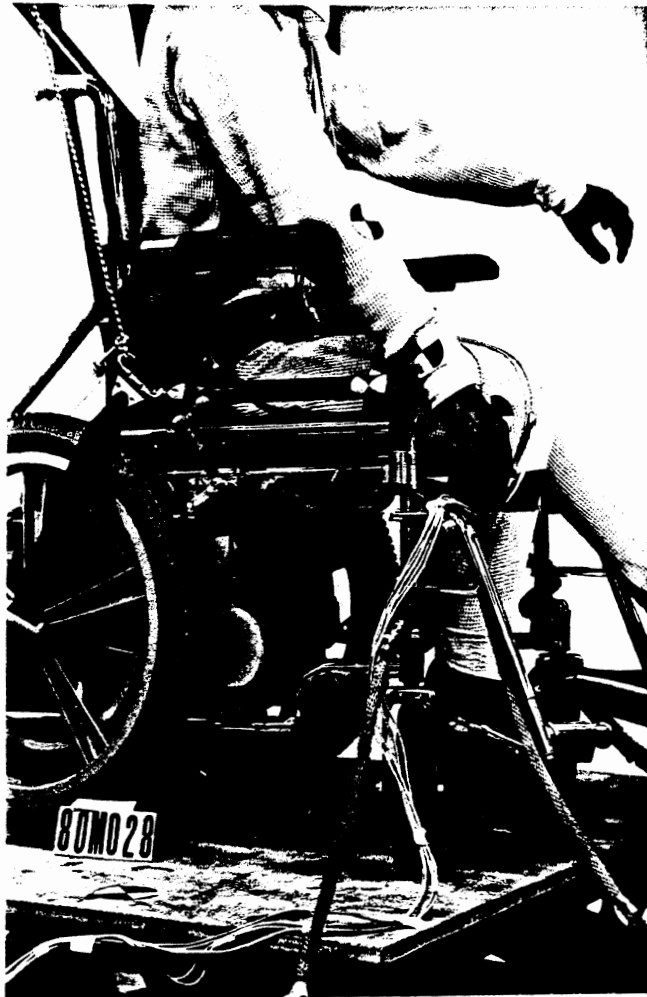
Post Impact Photo of Test 80M028

The wheelchair and dummy were effectively restrained by the CCI tie-down and belt systems respectively. There was little or no damage to the wheelchair.
