DYNAMIC TESTING OF RESTRAINT  
SYSTEMS AND TIE-DOWNS FOR USE  
WITH VEHICLE OCCUPANTS SEATED IN  
POWERED WHEELCHAIRS

FINAL REPORT

Lawrence W. Schneider  
The Highway Safety Research Institute  
The University of Michigan  
Ann Arbor, Michigan 48109

April 1981

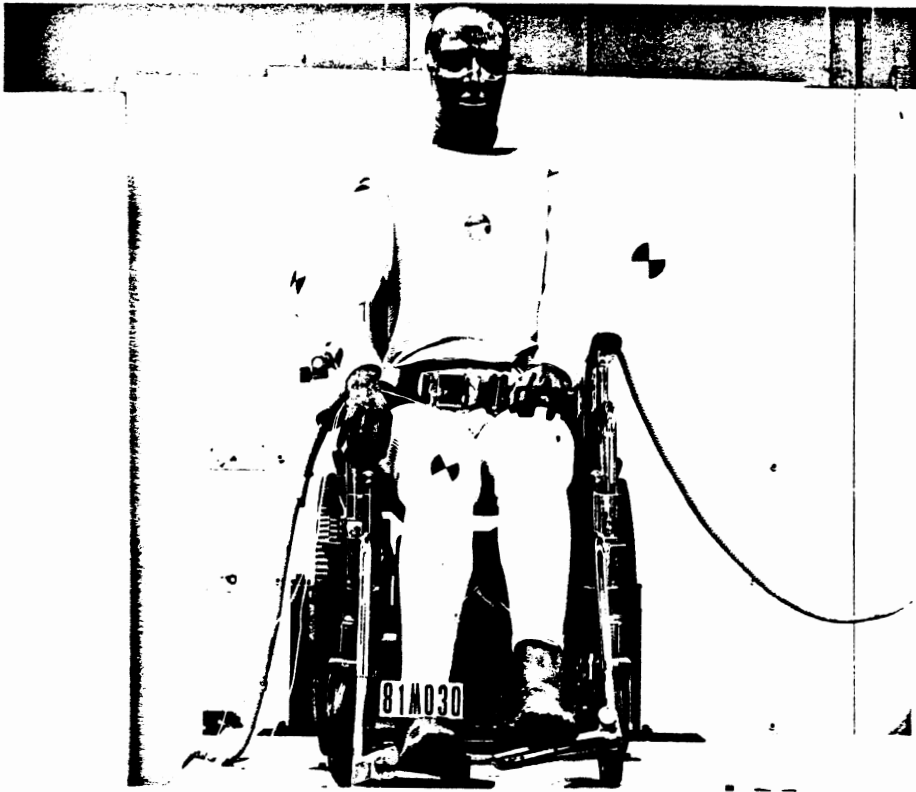
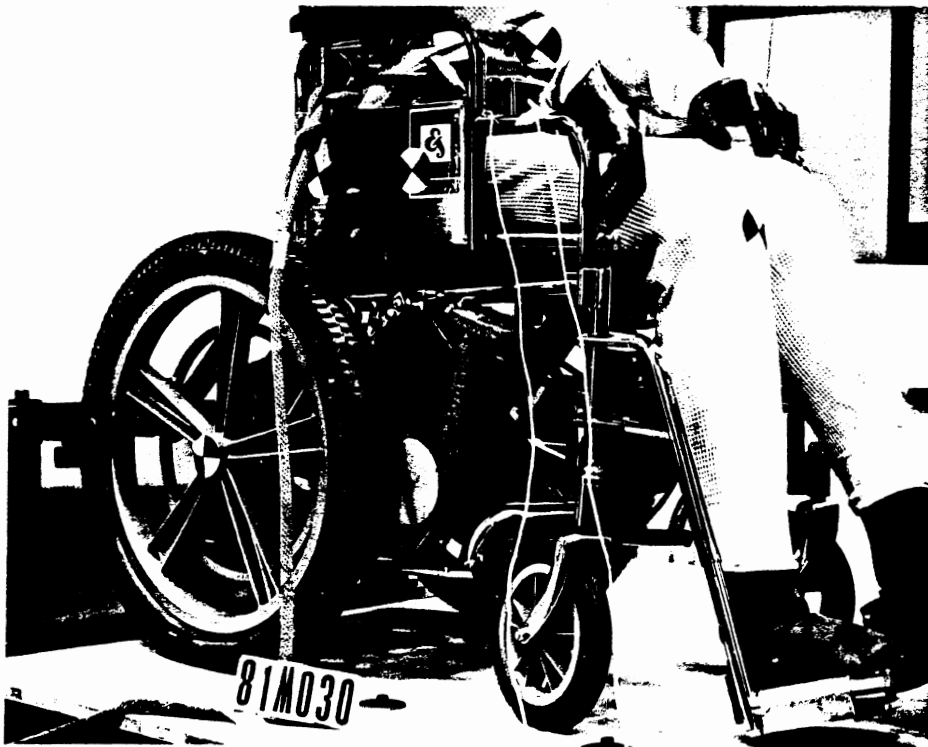
Set-up Photos for Test 80M030

The chair and dummy torqued and twisted sideways toward the front of the sled. The right magnesium rim of the chair broke apart and the chair sustained significant damage. The dummy's left side impacted into the left chair arm, causing significant bending of the chair frame.
