UMTRI-83-3

Biomechanical Accident
Investigation Methodology

Final Report
February 1983

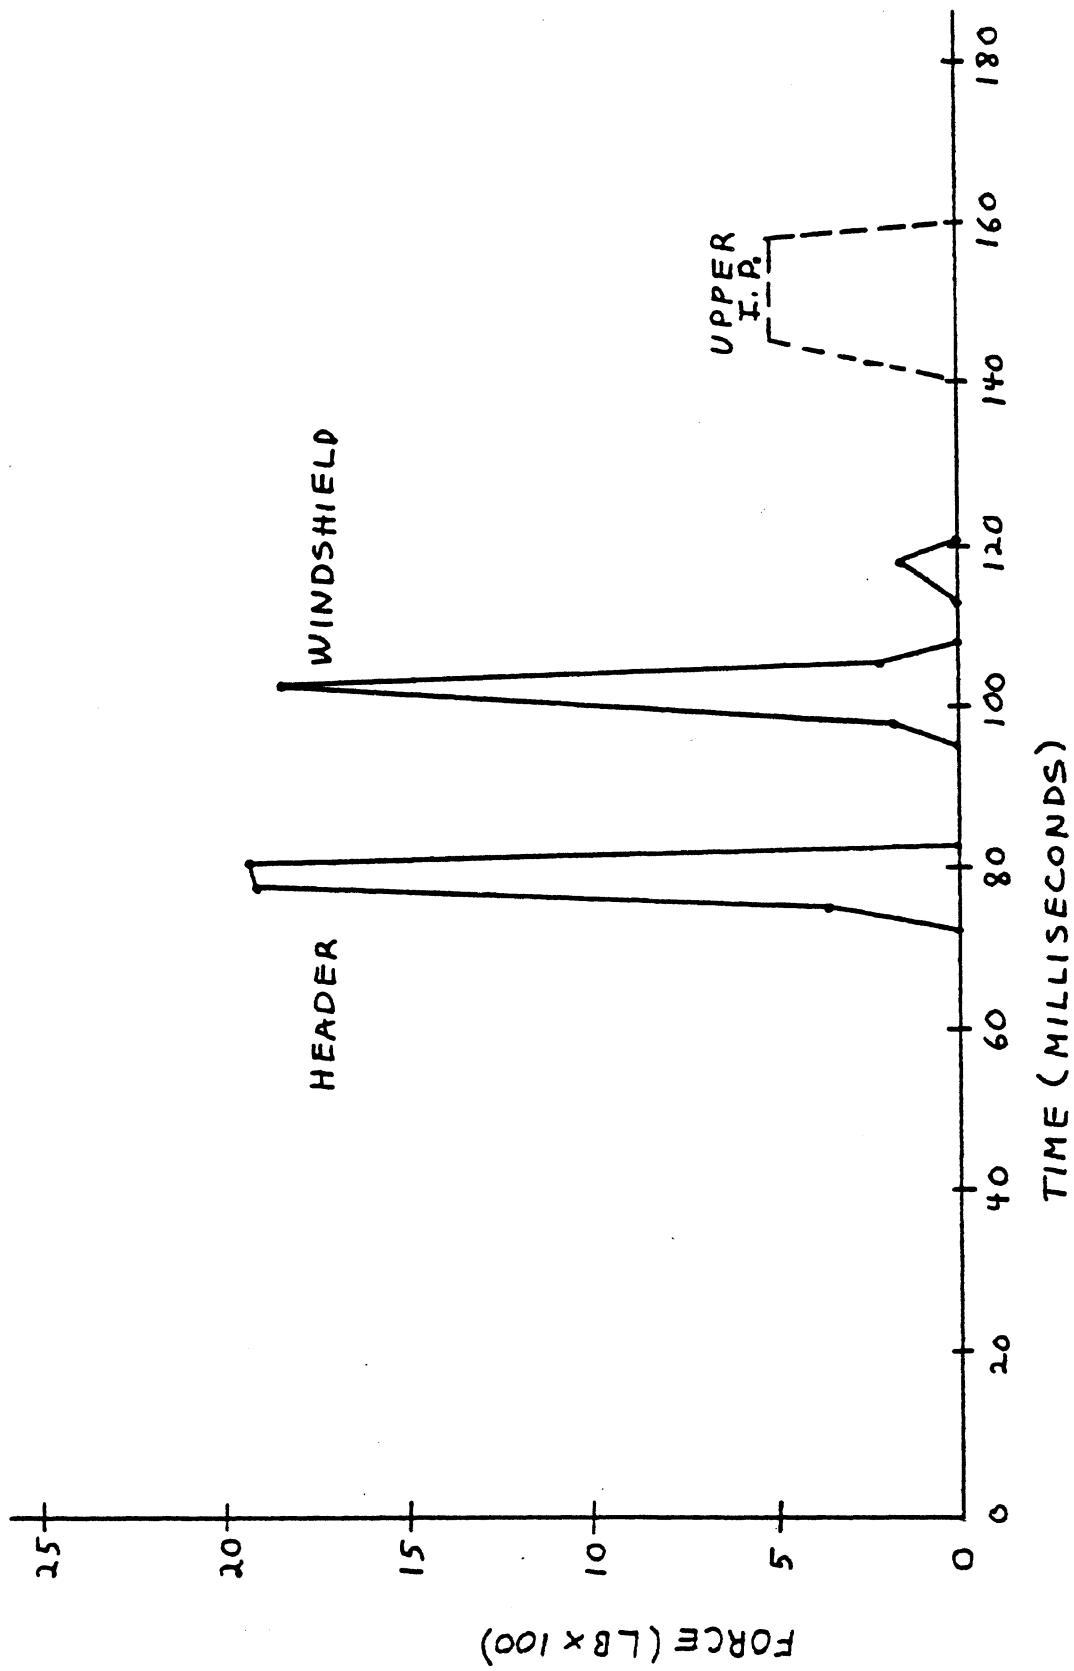
Figure 12. Force on Head Due to Interior Contacts (Case No. 9).

Figures 12-15 show some of the dynamic output results produced by the simulation. Figure 12 shows the sequence of interactions between the head and, successively, the header, windshield, and upper instrument panel. Figure 13 shows the chest and abdomen interactions with the steering wheel/column. Interaction between the lower part of the steering wheel rim and the abdomen leads the chest/column contact by about 10 milliseconds. Substantial normal forces are generated on both the femur (at the knee) and the tibia (just below the knee) during their contact with the lower instrument panel as shown in Figure 14. Because of the two-dimensional nature of the MVMA-2D occupant motion simulation, the numbers shown represent the sum of the loadings to both legs. Vehicle/occupant interactions observed as actual contact points in the crashed vehicle indicate that this assumption is reasonable. Head and chest accelerations are shown in Figure 15.

This large, 35 year old male sustained significant head impacts against the header and windshield. The force levels of 1800-1900 lbs. associated with these impacts would not be expected to cause frontal bone skull fractures although they approach the lower limits of frontal fracture tolerance for flat impact surfaces. Similarly, the head accelerations associated with these two impacts are moderately severe (peaks near 120 G's). Additional head acceleration peaks around 80 G's are also present, and the entire head acceleration-time history (Figure 15) is characterized by significant time durations as well as acceleration magnitudes. This subject was concussed for 2-3 minutes.

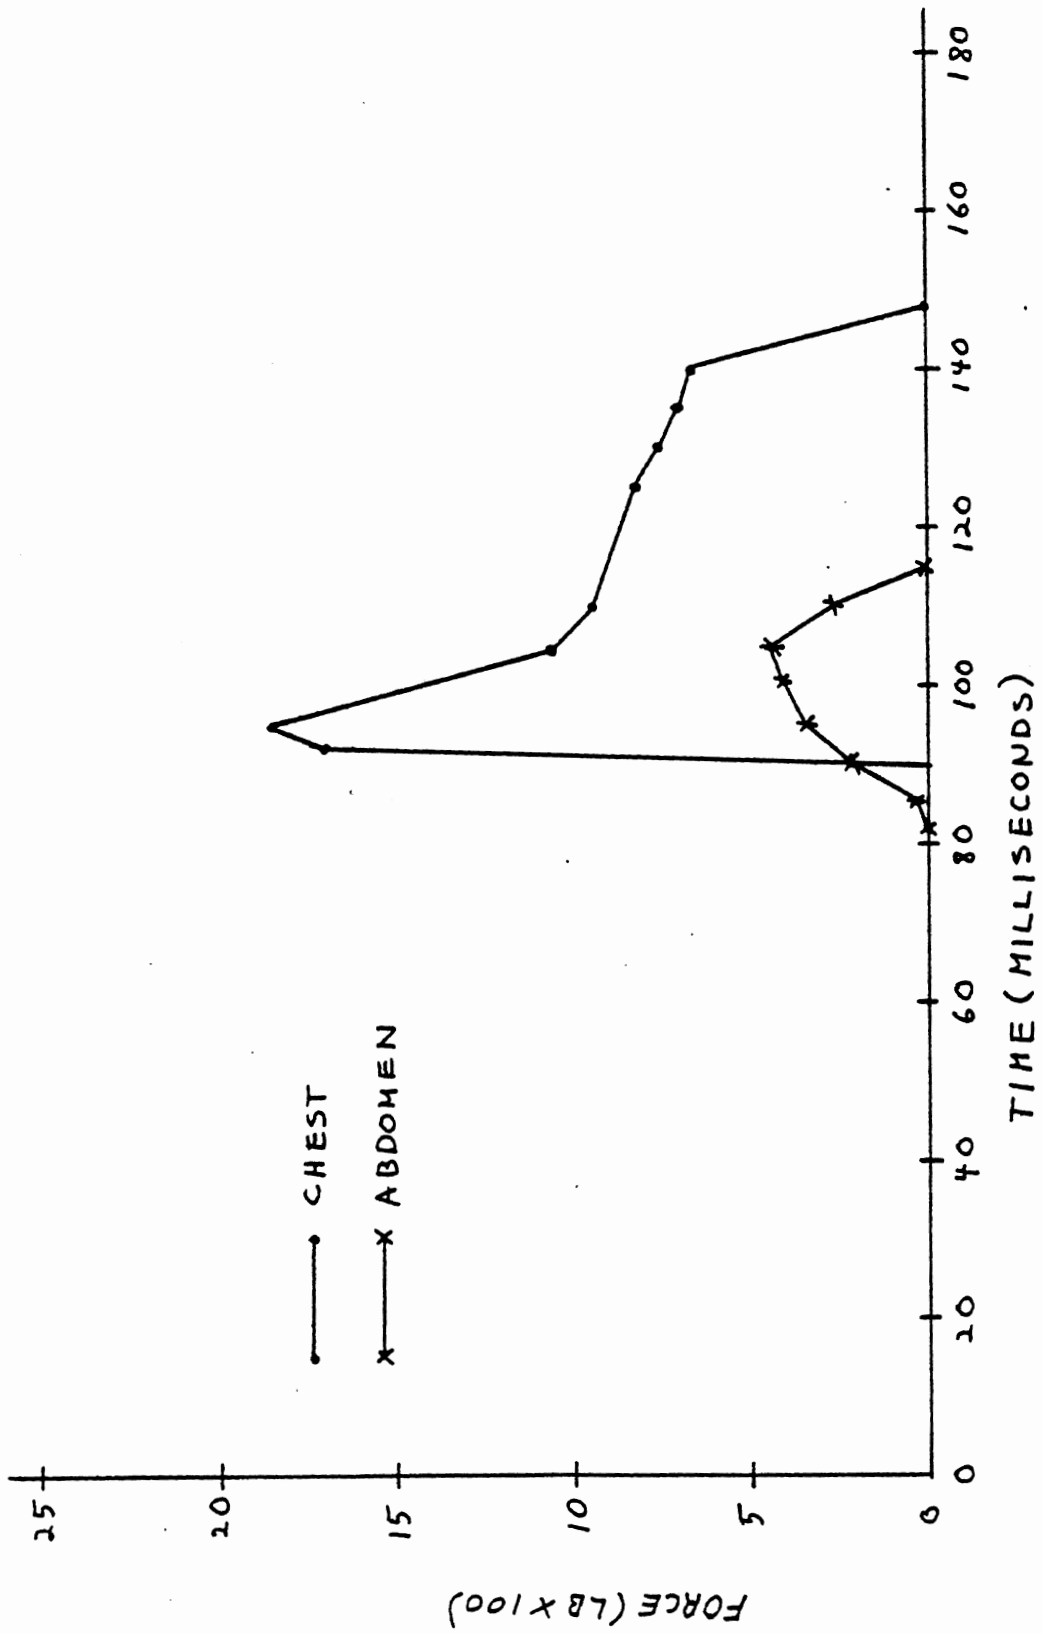
Figure 13. Force on Chest and Abdomen from Steering Wheel (Case No. 9).

The size and position of the subject and the vehicle interior geometry combined to produce a uniform contact of the chest squarely with the steering wheel. Although uniform, the loading was severe enough to fracture the sternum. The predicted load peak was approximately 2000 lbs. which is similar in magnitude to those produced by experimental studies on chest impact with cadavers. The chest accelerations associated with the impact were less than 50 G.

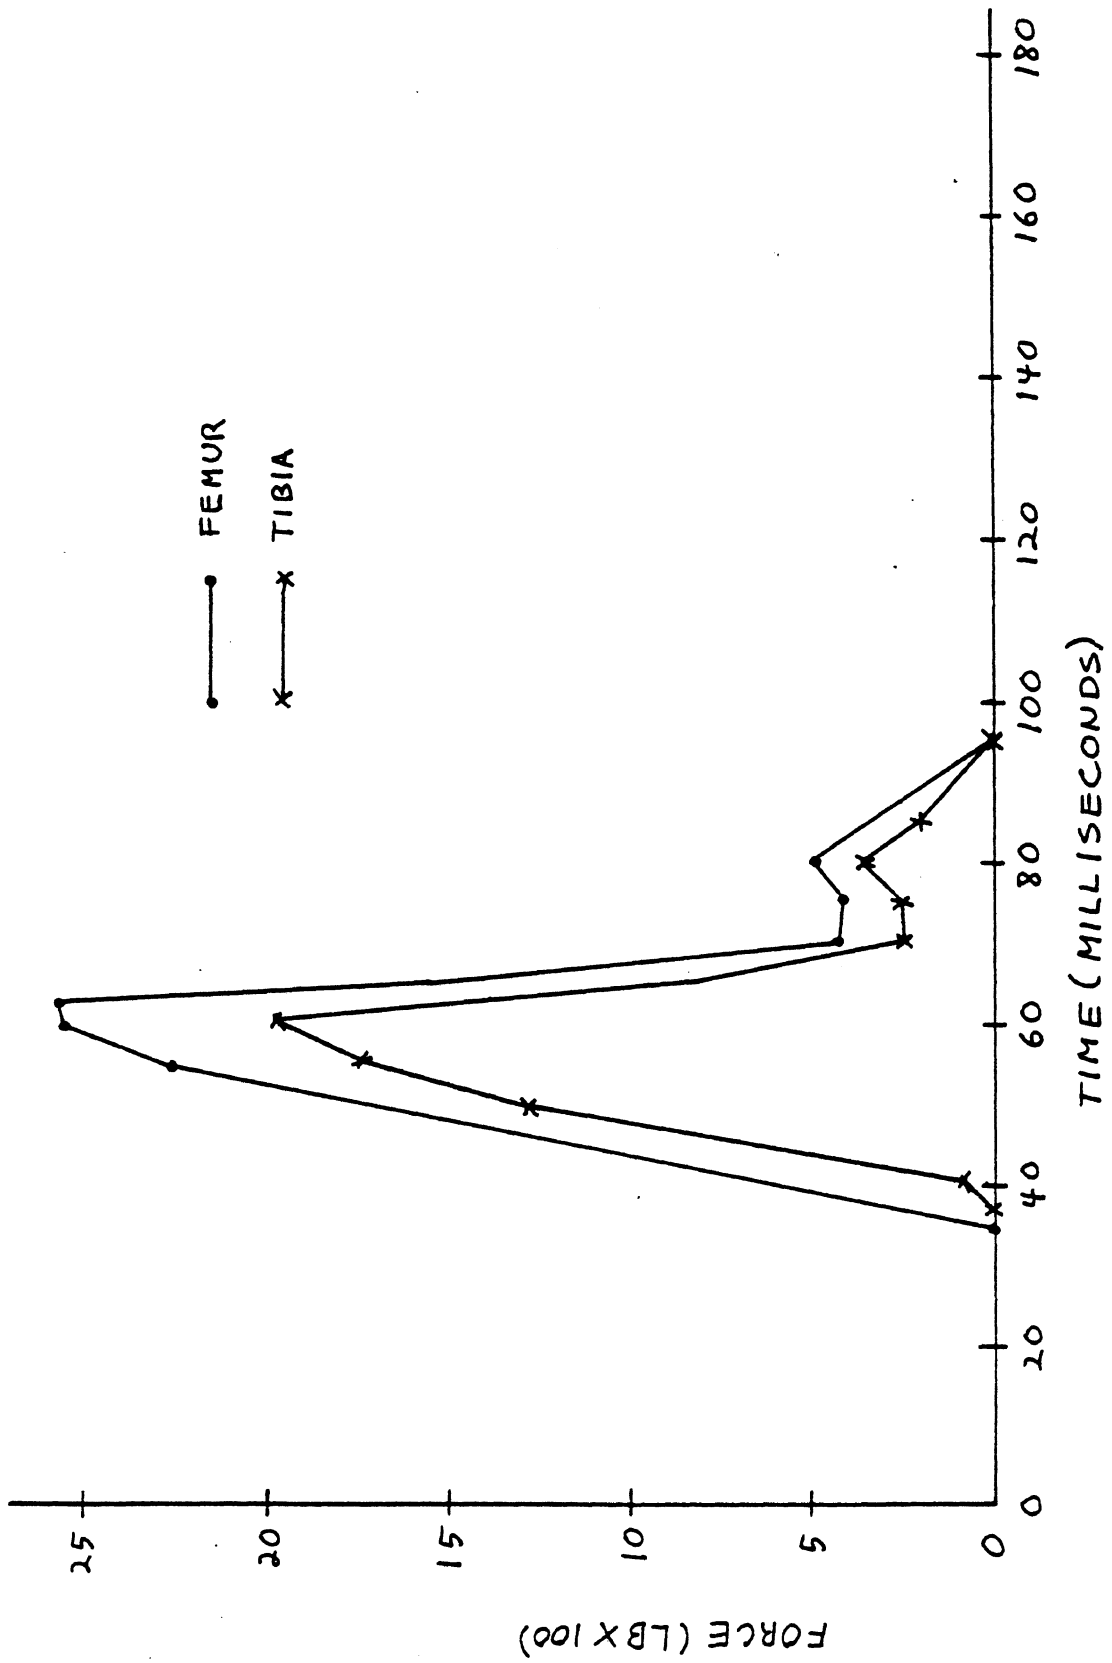
Figure 14. Force on Knee and Tibia from Instrument Panel (Case No. 9).

The contact of the subject's legs with the instrument panel produced an average force of 1300 lbs. in each femur and 1000 lbs. into each lower leg. This resulted in a total femur load of approximately 2300 lbs. in each leg as the lower leg force would be transmitted by shear to the upper leg. The lower leg load was close to tolerable values for knee joint ligamentous damage in cadavers. The subject was tall and had robust legs. Neither the average lower leg loads of 1000 lbs. nor the total femur loads of 2300 lbs. were likely near the tolerance of this subject.

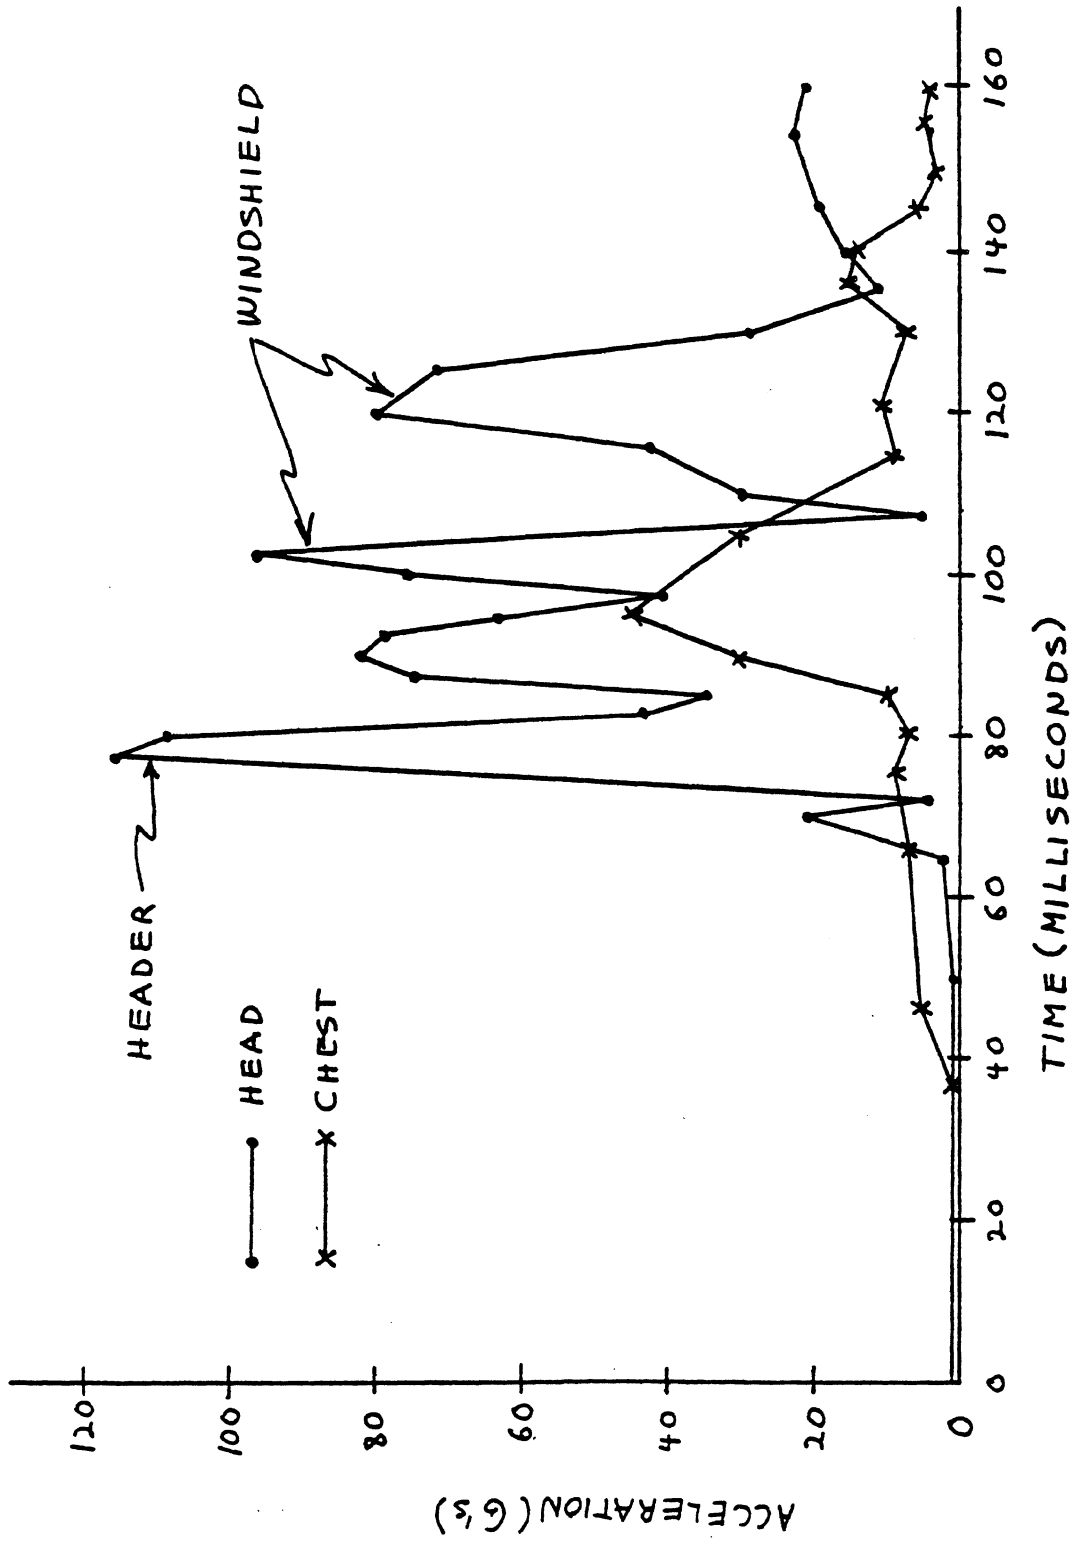
Figure 15. Head and Chest Accelerations (Case No. 9).

For the most part the peaks correspond with the peak force loadings shown in the previous figures.

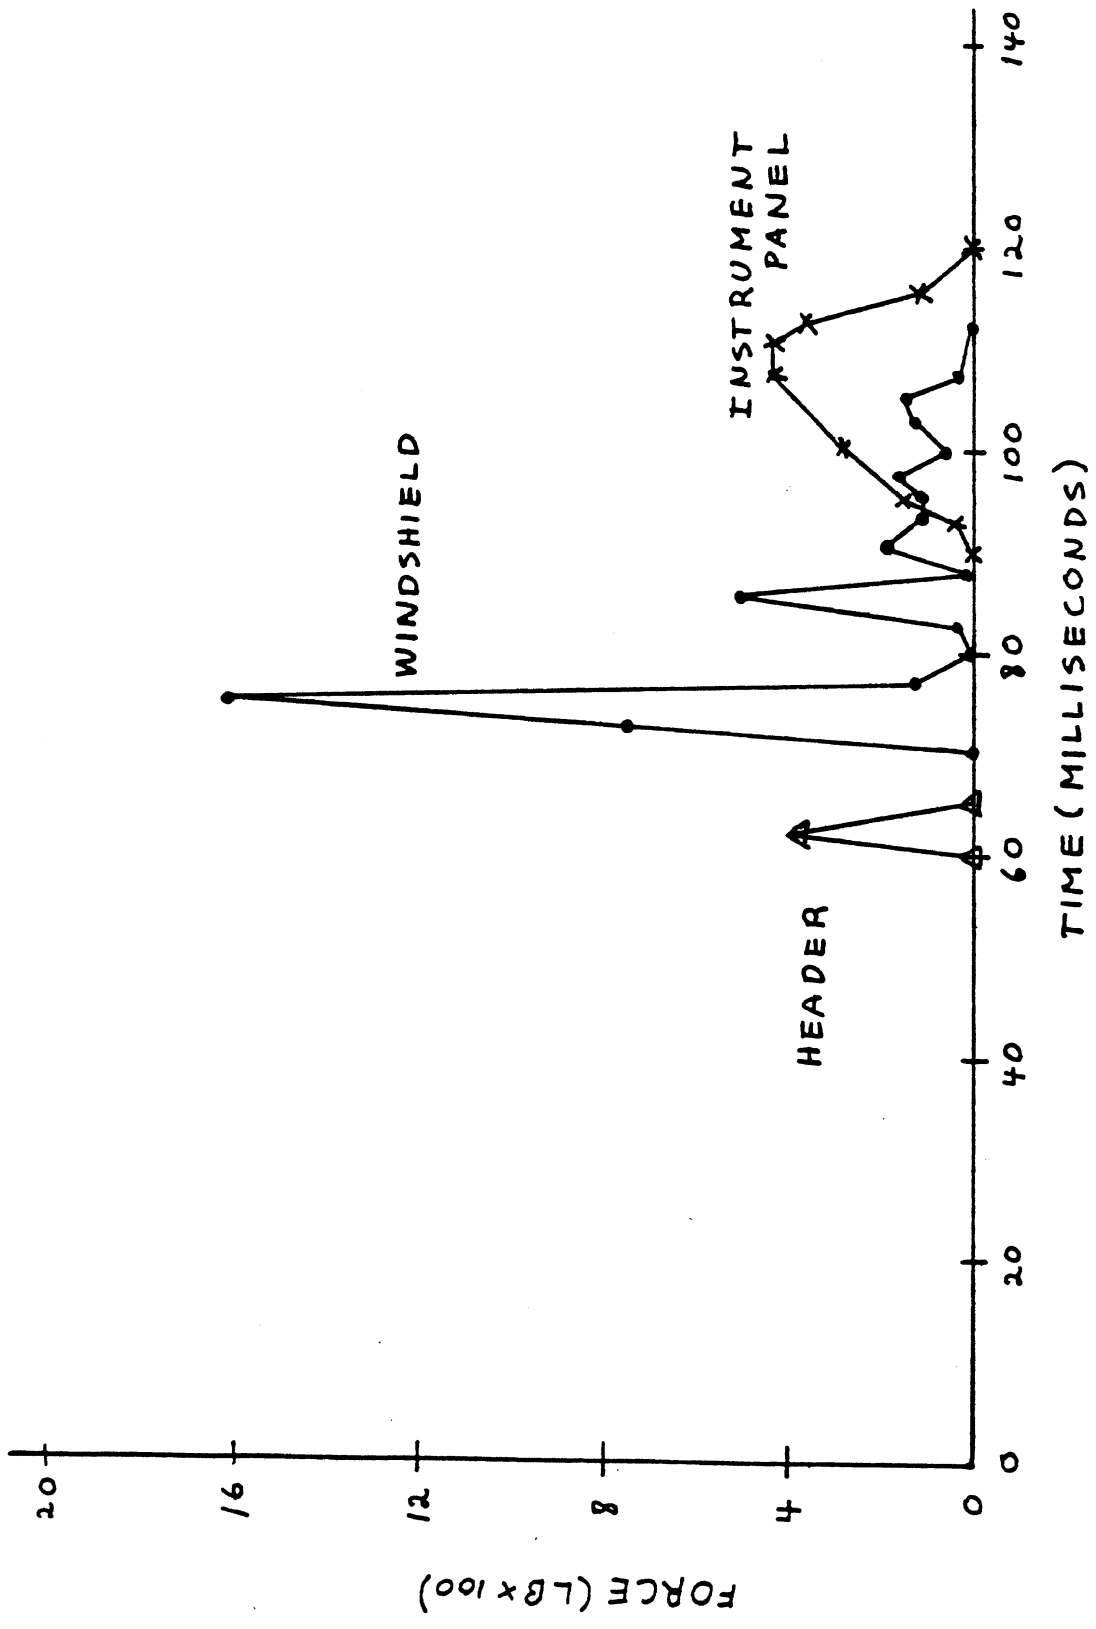
Figure 24. Force on Head due to Interior Contacts (Case No. 10).

Figures 24-27 show some of the dynamic output results produced by the simulation. Figure 24 shows the predicted force loadings applied to the head. The three primary interactions are with the header, windshield, and instrument panel. Interactions of the chest and abdomen with the steering

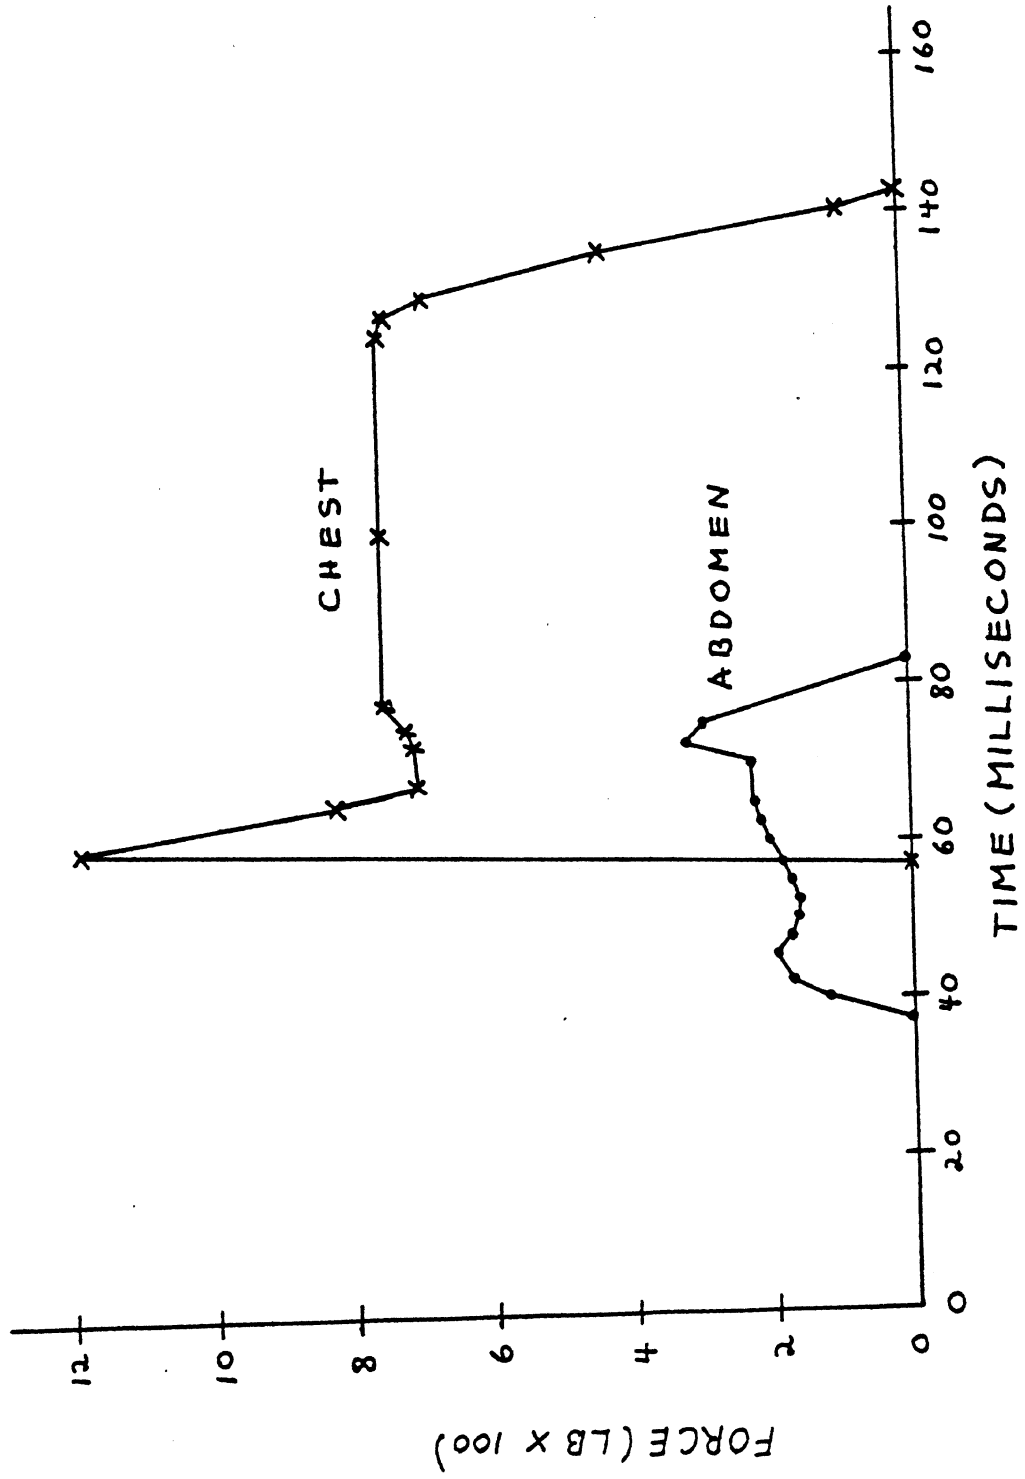
Figure 25. Force on Chest and Abdomen from Steering Wheel (Case No. 10).

wheel/column are shown in Figure 25. The abdomen is in contact for approximately 20 ms before the rib cage becomes substantially involved in the dynamics. The tibia and femur loads shown in Figure 26 show the considerable force which was likely transmitted to the acetabulum. Figure 27 shows head and chest accelerations which are, as happened in Case No. 9, well correlated with the phasing of the loadings shown in the previous figures. It should be noted that the G-loading to the head due to the header contact is relatively low. This is a case where small changes in input data could dramatically change the simulation. If the occupant sat 1/2 inch lower, the contact would not occur. If he were 1/2 inch higher, the size of the force spike would likely be larger than that for the windshield. The effect of vehicle pitch during the tree impact was not investigated due to the limited nature of the project and could also be a major factor in the relative position of the head with respect to the vehicle in the timing of this important contact.

The contact of the subject's chest with the steering wheel was not as uniform or aligned as in Case 9 due to configurational differences in the vehicle interior and the subject positioning. A peak chest load of 1200 lbs. was produced. The fractures of the 8th and 9th ribs on the left side may have been due to the interaction of the bottom half of the steering wheel as shown in Figure 21. The age of the subject may also have had an influence on the production of skeletal damage at the lower load of 1200 lbs. Despite the lower load, the peak chest accelerations were slightly higher (55 G) than in Case 9.

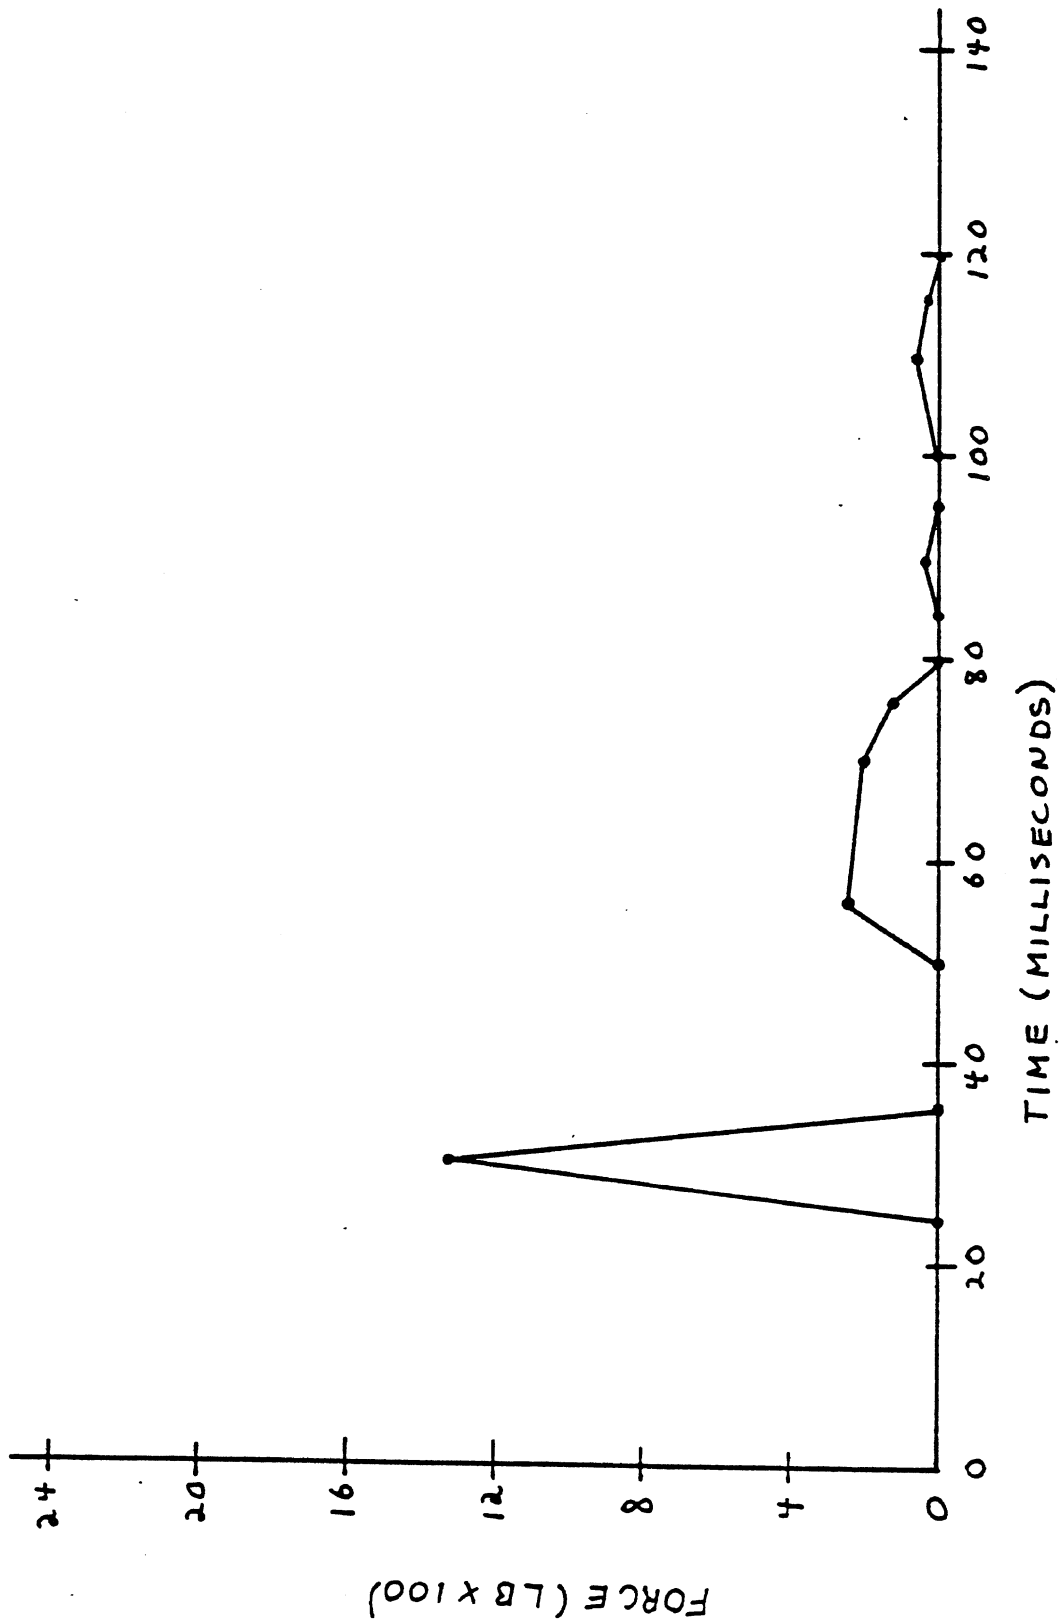
Figure 36. Force on Forearm from Steering Wheel (Case No. 13).

Figures 36-39 show some of the dynamic output results produced by the simulations. Interactions between the forearm and the steering wheel are shown in Figure 36. Although the magnitude of the initial spike is probably unrealistic from a human response point of view, the ability to feed force and energy into the body through this part in the linkage in a relatively continuous manner has been demonstrated. Refinement of the force-deflection curve for the steering column, which was used for this simulation, to reflect a softer material property for wheel rim deformation, would probably solve much of the problem. Similarly, the properties of elbow and shoulder joints could be refined, to include muscle tension effects and the mobility of the shoulder girdle. No well-researched data have been developed to this point in time for definition of shoulder girdle mobility. Figure 37 shows the major restraint effect on the chest due to the upper torso belt. Figure 38 shows the forces on the tibia due to contact with the bolster. This force is transmitted into the knee joints as a shear force. Within the limited scope of this project it was not possible to explore the intrusion of the knee bolster into the occupant compartment. This intrusion could have had a marked effect on the results. Figure 39 is a plot of head and chest accelerations. The peak head accelerations follow the peak chest accelerations which appear to be directly related to the application of the belt forces. This phasing relation is related to the pitching down of the head with respect to the upper torso. No evidence of contact of the head with the vehicle is evident.

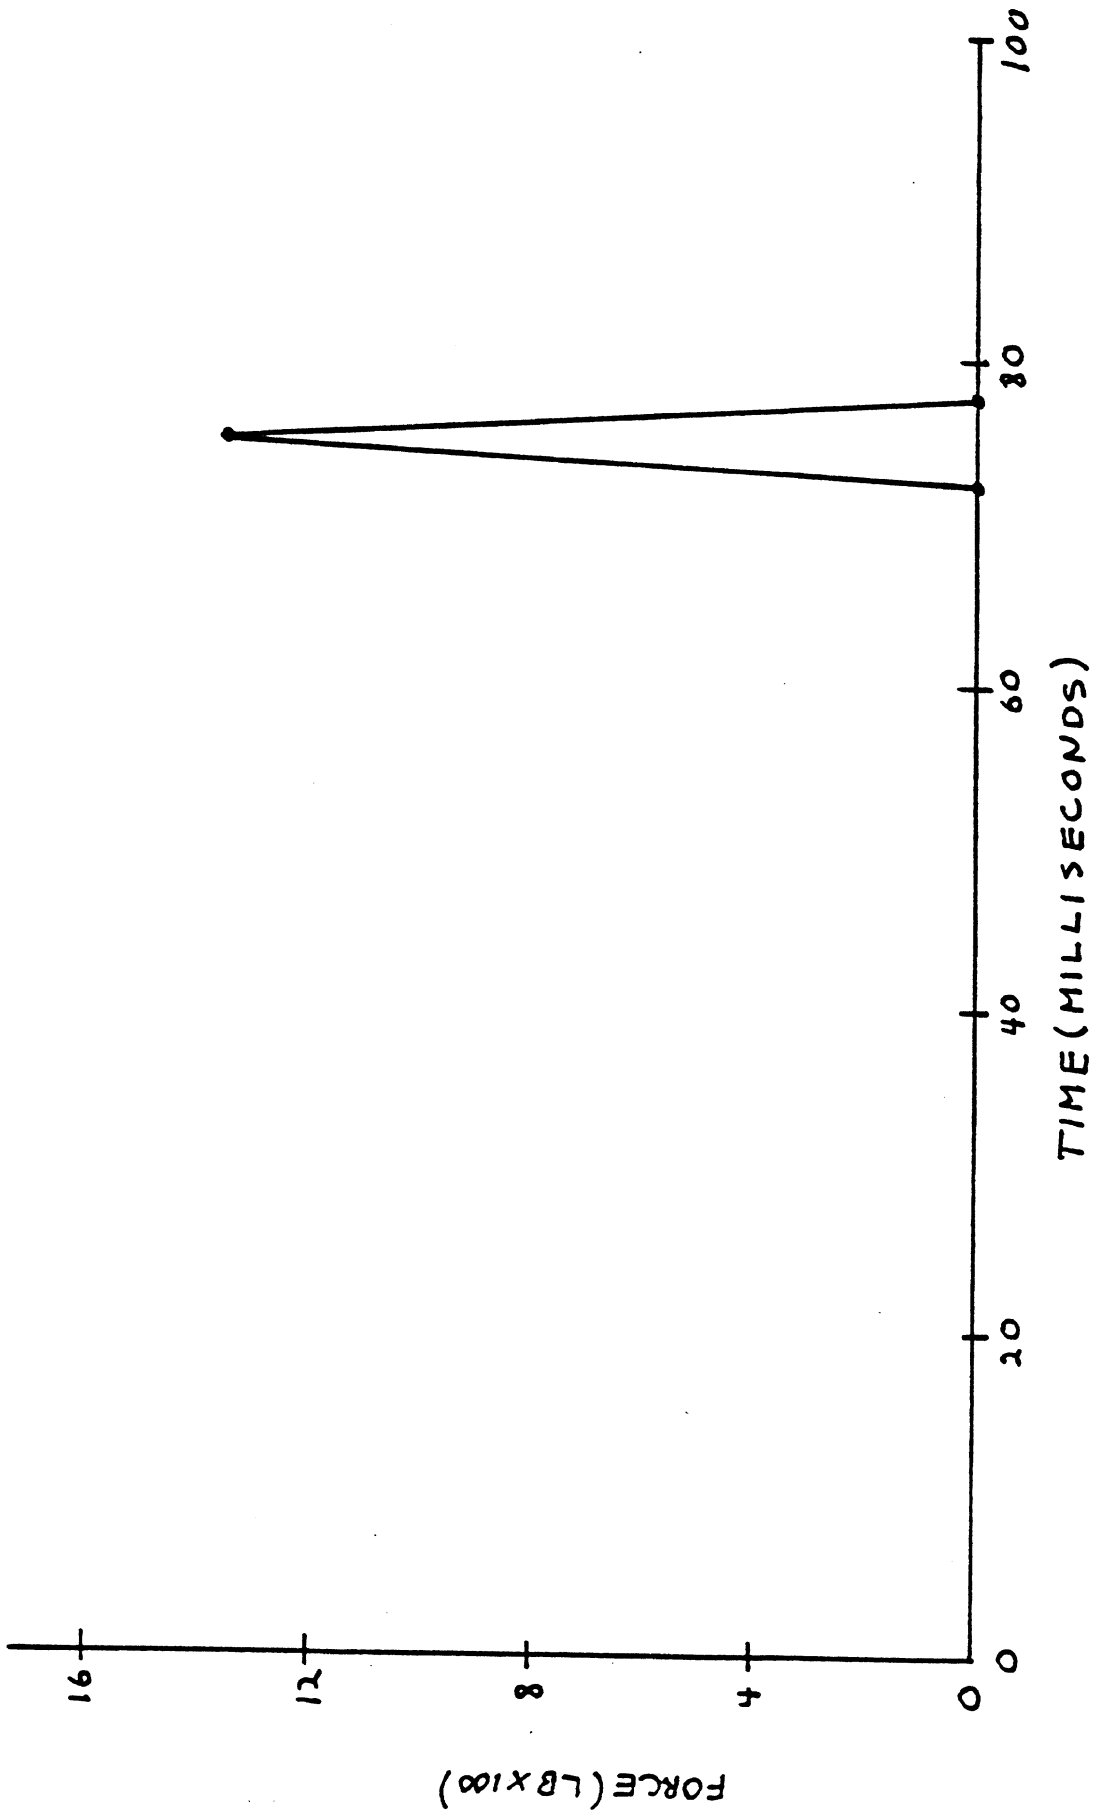
Figure 48. Force on Head from Window (Case No. 14)

Figures 48-54 show some of the dynamic output results produced by the simulations. Figure 48 shows the force on the head produced during the window contact. The restraining effect of the belt forces is shown in Figure 49. The effect of the belts is to prevent the lower torso and extremities from completely riding over the transmission housing. The arm/shoulder interaction with the door is shown in Figure 50. Computer exercises using either more or less intrusion of the door resulted in higher or lower to no force of interaction. Figure 51 documents the interaction of the thighs and upper legs at the hip with the transmission housing. The location of the 3-point belt stalk by the housing and the minor injury suffered by the driver most likely resulted from this interaction. The interaction between the leg and shift lever is shown in Figure 52. It also occurs early in the dynamic event. Figures 53 and 54 show the lateral and vertical accelerations experienced by the dynamic linkage. In many cases the peaks correlate well with observed kinematic or dynamic events. Chest accelerations shift from lateral (40-60 milliseconds) to vertical (60-80 milliseconds) as the belt system and shift housing causes the torso to pitch toward the side. A clean spike shows up in the head lateral acceleration which correlates well with the interaction with the window. Head vertical accelerations appear to be larger than would be expected for a human. This could probably be corrected by including better data (if it

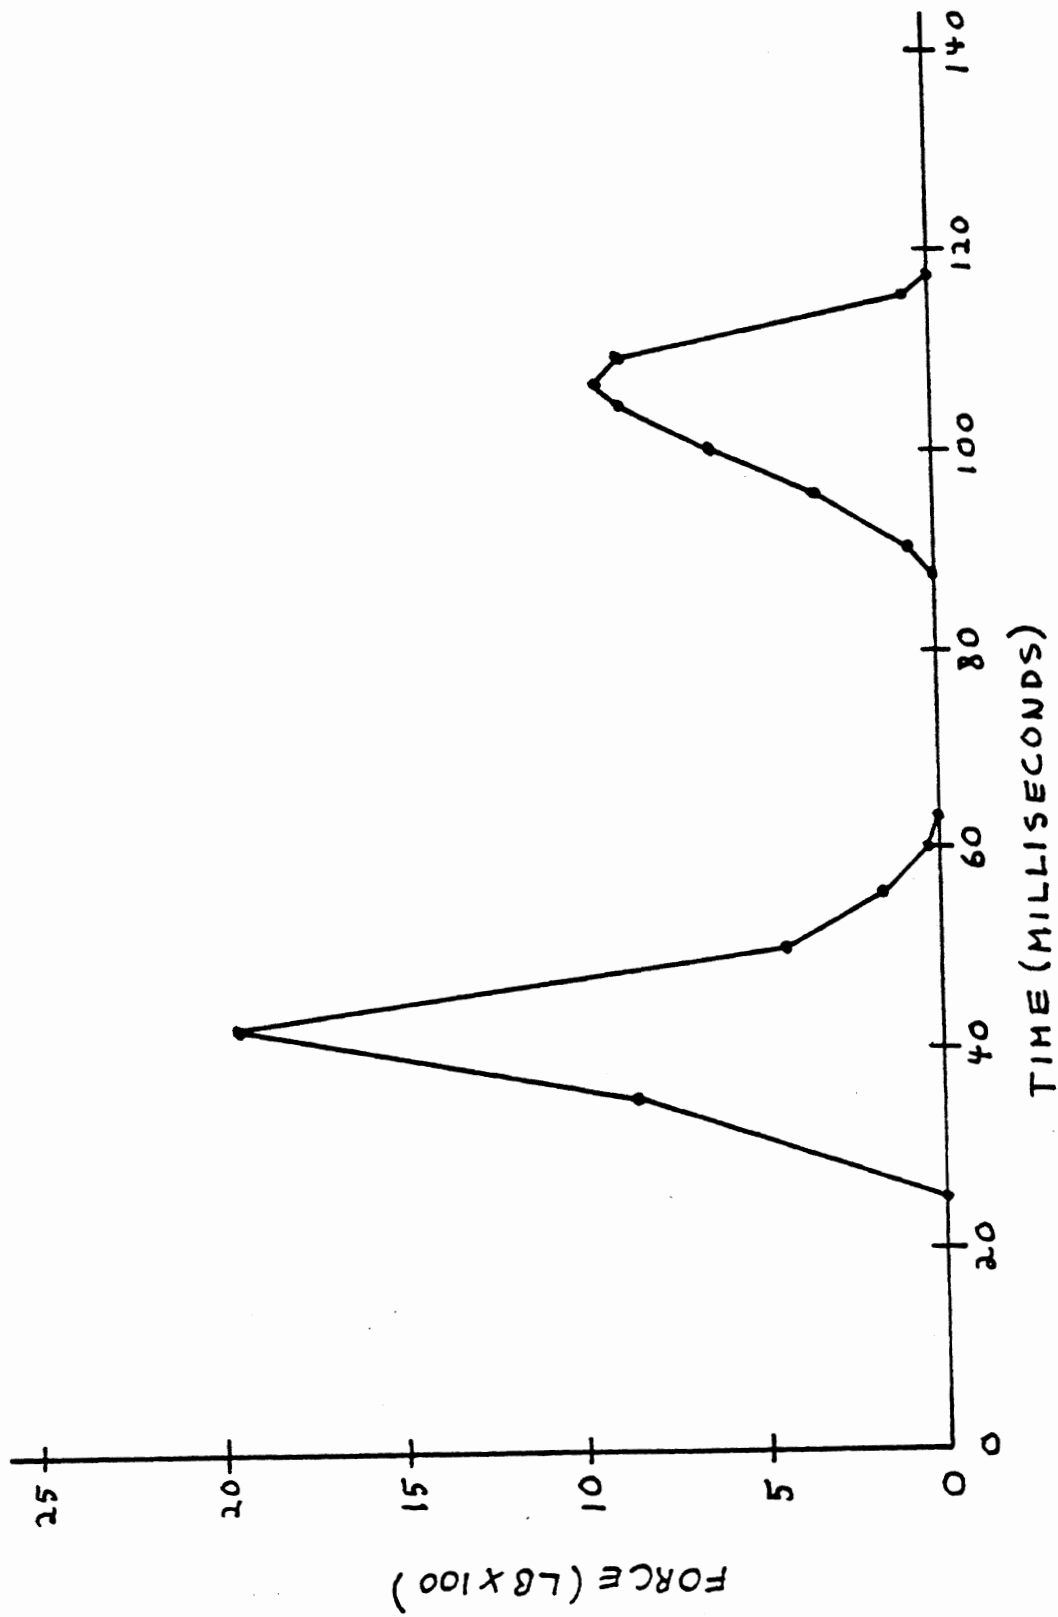
Figure 51. Force on Right Upper Leg from Transmission Housing (Case No. 14)

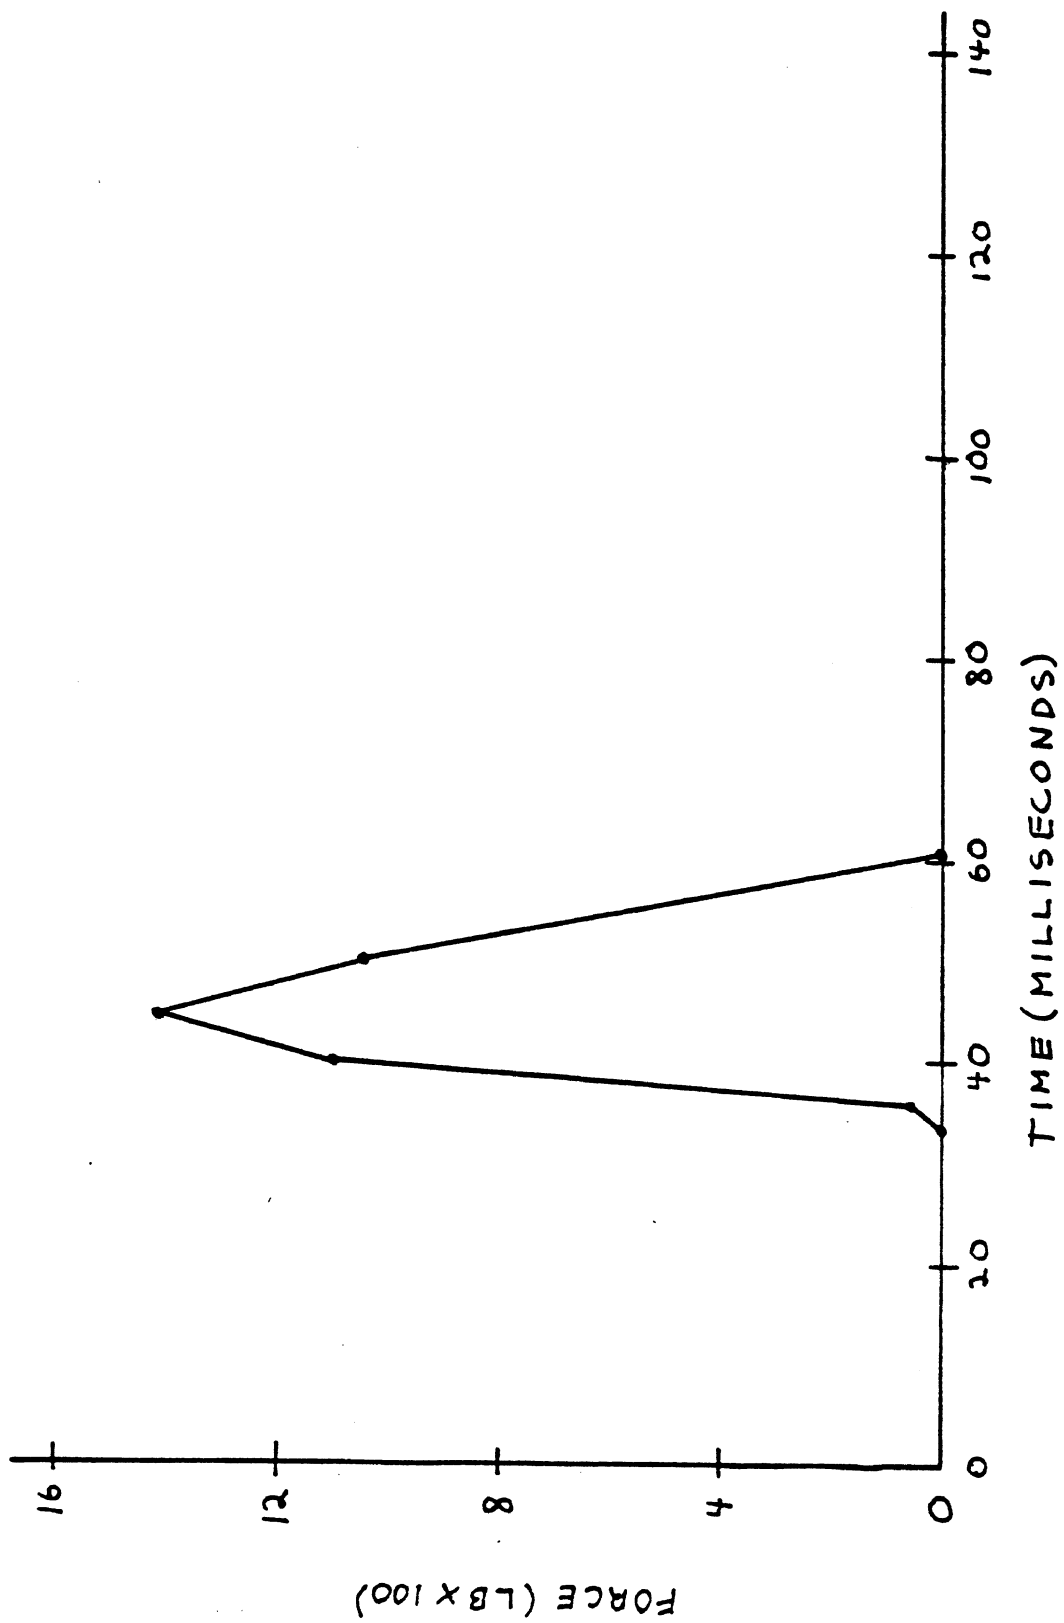
Figure 52. Force on Leg due to Shift Lever (Case No. 14).

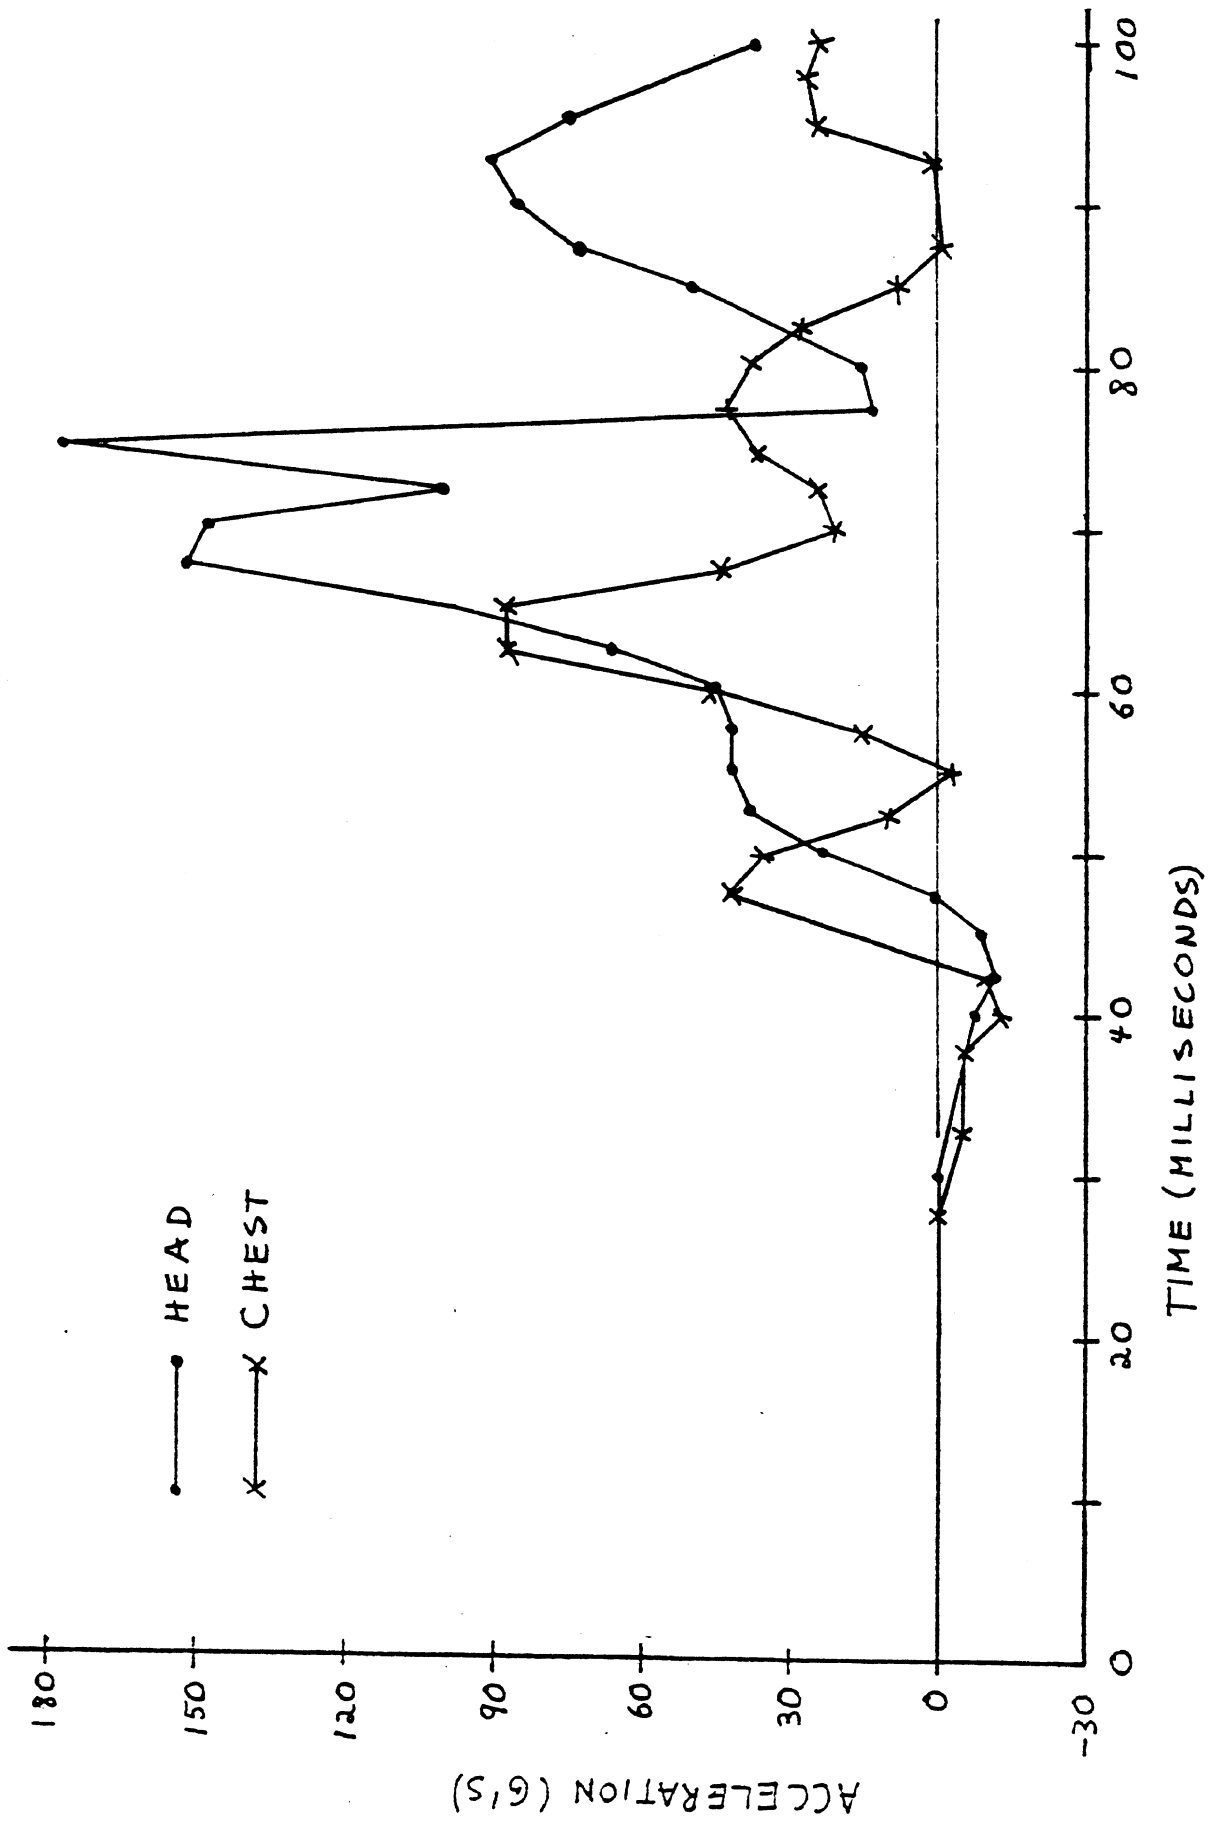
Figure 53. Head and Chest Vertical Accelerations (Case No. 14).
