UMTRI-83-3

Biomechanical Accident
Investigation Methodology

Final Report
February 1983

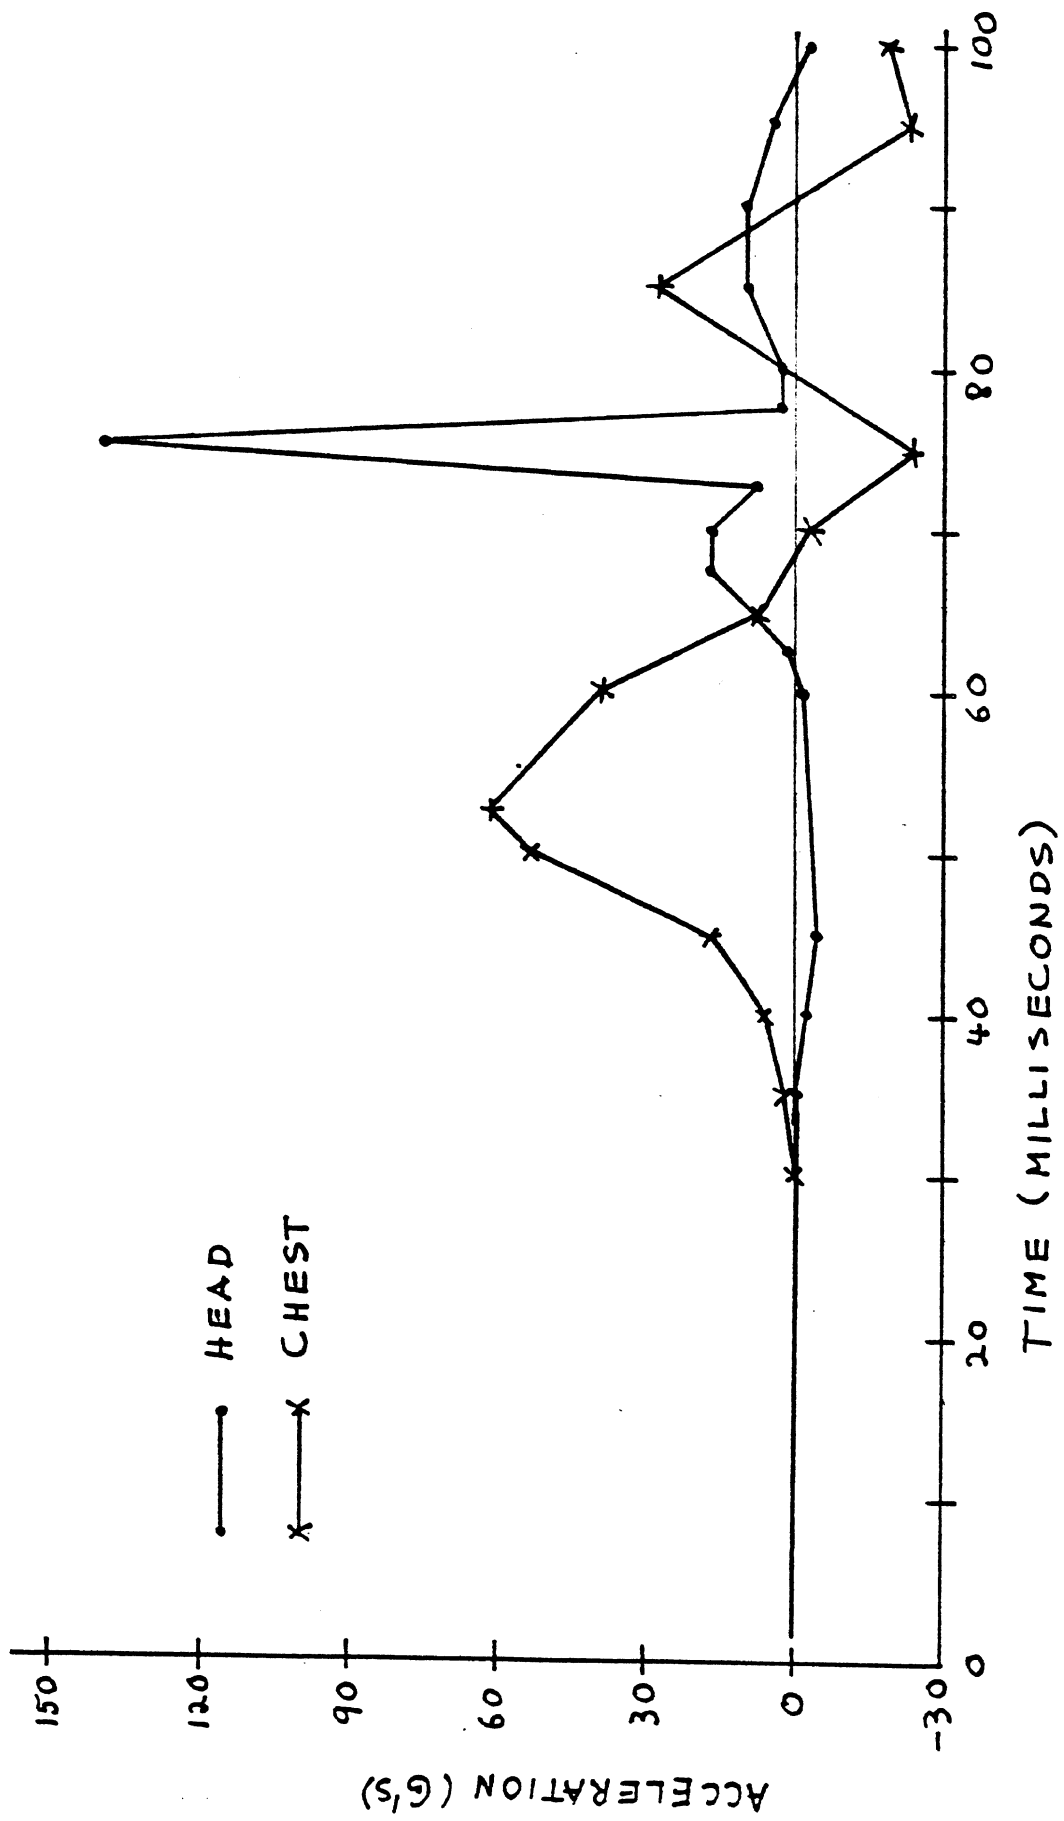
Figure 54. Head and Chest Lateral Accelerations (Case No. 14).
