AIAA-2004-34309

An Evaluation of the Discharge Chamber of the 30,000 Hr Life Test of the Deep Space 1 Flight Spare Ion Engine

This paper summarizes the results of a post-test evaluation of the discharge chamber of an extended life test of the DS1 spare flight ion thruster (FT2). In particular, results are presented on the discharge chamber magnetic field measurements, films and film deposits, and the high voltage main isolator.

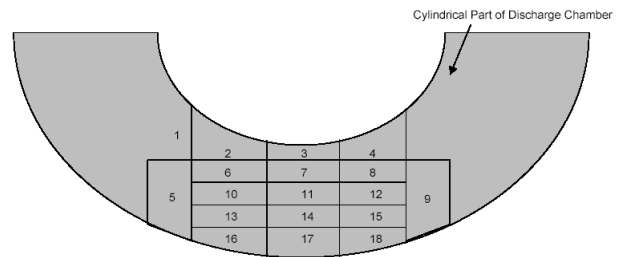
Figure 7. Zones in the discharge chamber for flake collection.

Post-test inspection of the discharge chamber following the ELT revealed the presence of numerous small flakes on the surface of the sputter containment mesh. The flakes were located at the bottom of the discharge chamber in an arc between approximately the 4:00 to 8:00 o'clock positions, viewed from the grid end of the thruster. The flakes were then swept into 18 separate piles using fine brushes and collected separately so that data on flake type could be correlated to collection location. Flakes that could not be collected via brushes were collected using Teflon tape. A diagram showing where flakes were collected is shown in Figure 7.

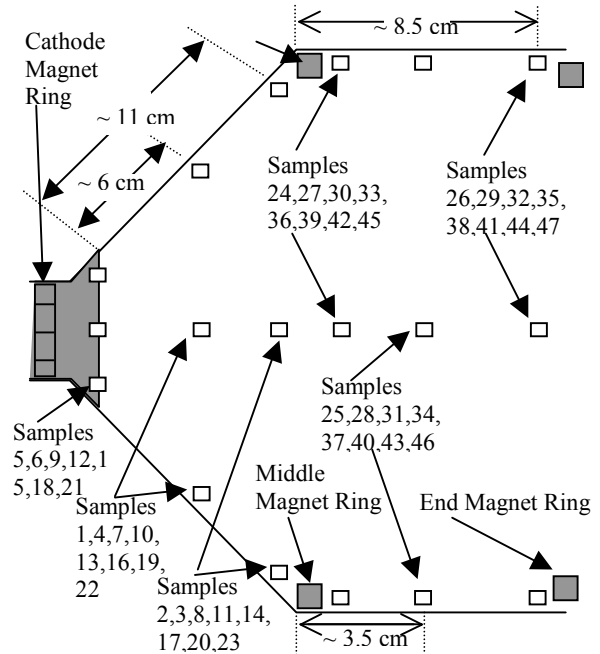
Figure 11. Diagram of sample locations from the discharge chamber of the ELT thruster.

Samples of the mesh (approximately 1cm² in size) from different azimuthal and axial locations inside the engine’s discharge chamber, still bonded to the underlying steel shell, were laser-cut or mechanically removed from the thruster using a cutting tool. A diagram of sample removal locations is shown in Figure 11.

thickness and composition as a function of distance from the screen grid electrode. SEM analysis indicates the deposits are 5 microns thick near the cathode (samples 9 and 12) and 10 microns thick near the screen grid (samples 38 and 41). A list of sample locations and film thicknesses for a row of holes (Figure 12) is shown in Table 2.
