PROFILE ANALYSIS OF THE LTPP SPS-6 SITE IN ARIZONA

1. Report No. UMTRI-2010-17		2. Government Accession No.		3. Recipient's Catalog No.	
4. Title and Subtitle Profile Analysis of the LTPP SPS-6 Site in Arizona				5. Report Date July 2010

14. Sponsoring Agency Code	
15. Supplementary Notes					
16. Abstract <p>This report characterizes the longitudinal profiles of five pavement sections within the Arizona Specific Pavement Studies 6 project throughout their service life. This project was built and monitored as part of the Long-Term Pavement Performance Study. Road profile measurements were collected on this site about once per year since the fall after it was opened to traffic. This study analyzed the profiles in detail by calculating their roughness values, examining the spatial distribution of roughness within them, viewing them with post-processing filters, and examining their spectral properties. These analyses provided details about the roughness characteristics of the road and provided a basis for quantifying and explaining the changes in roughness with time, relating post-rehabilitation roughness with rehabilitation type, surface preparation, and profile properties, as well

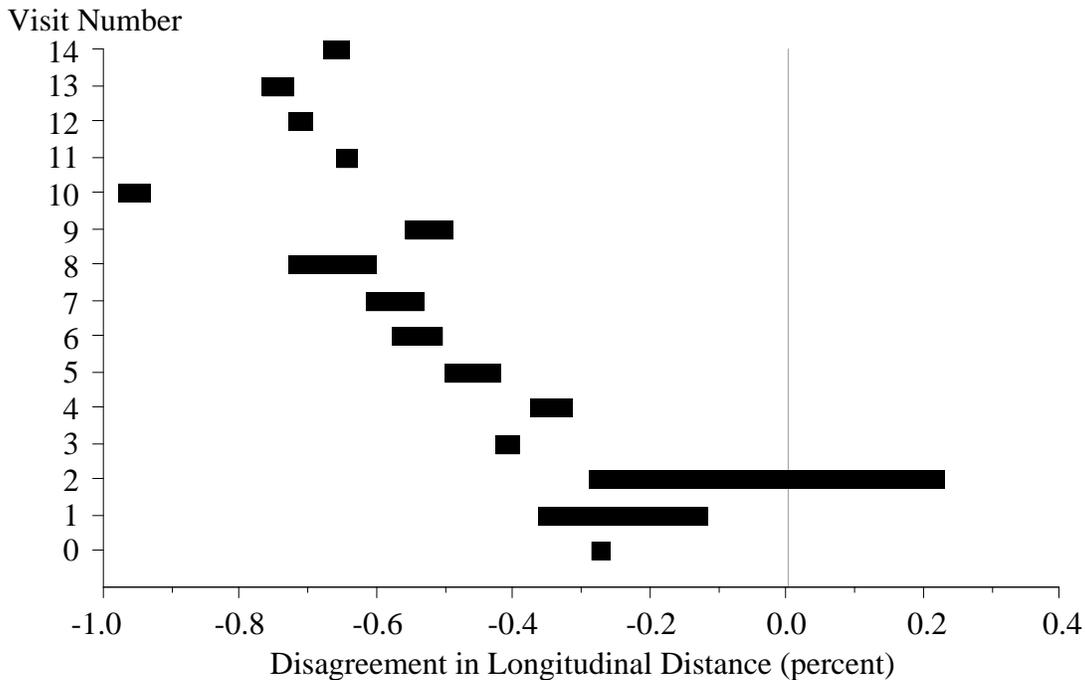
Figure 1. Consistency in longitudinal distance, leading sections.

Figure 1 shows the disagreement in longitudinal distance measurement for each visit of the leading group of sections, using the event markers from repeat 1 of visit 02 as a reference. The leading group terminates at the end of section 0601 for visits 00 through 04, and at the end of section 0603 for the other visits. In the figure, a range of disagreement for each visit exists because up to nine repeat profile measurements were made. The variation between repeat measurements from the same visit appears as the width of each bar in the figure. Since the longitudinal distance measurement was based

on the rotation of a drive wheel, the variations were most likely caused by variations in speed, lateral wander, and tire inflation pressure. (3) If tire inflation pressure were the dominant cause, the disagreement would grow more negative (or less positive) with each successive repeat measurement as the tire heated up. This is because the tire rolling radius would increase, and the profiler would register less wheel rotation for the same travel distance. This appeared to be the case for visits 08 through 13. However, the effect was weak, which indicates that the tires were warmed up to some extent before the measurements began. The only visit that exhibited a level of disagreement between repeat measurements that may interfere with the analyses described in this report was 02.

The variation between visits in Figure 1 is caused by differences in distance measurement instrument calibration. The longitudinal distance measured by a profiler is not true horizontal distance. It always includes some additional component because the profiler must travel up and down the undulations in the road. Calibrating the profiler to true horizontal distance can minimize this component. However, if a profiler operates on a road with grade changes and roughness that are not similar to the site used for longitudinal distance measurement calibration, some error will exist. Tire inflation pressure must also be close to the level that existed during calibration for consistent results.

measurement. (3) With the exception of visit 02, longitudinal distance was measured with enough consistency to avoid bias in the IRI values above 1 percent.

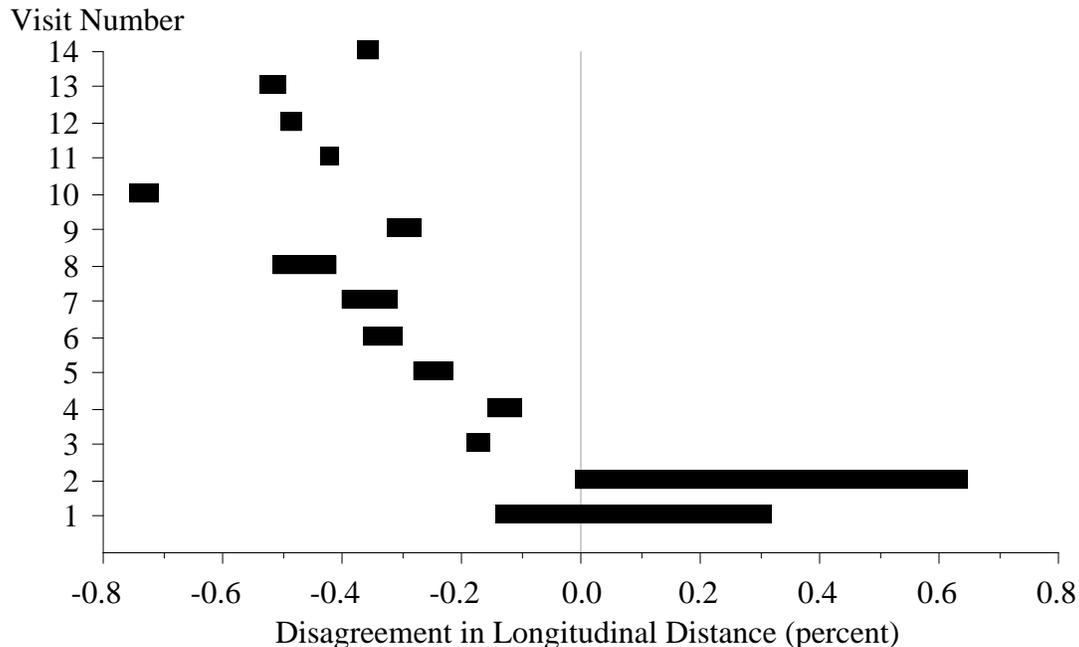
Figure 2. Consistency in longitudinal distance, trailing sections.

Figure 2 shows the disagreement in longitudinal distance measurement for the trailing group of sections (0664 through 0669). Overall, the disagreement is similar to that observed for the leading group, with the exception that earlier visits were less repeatable.

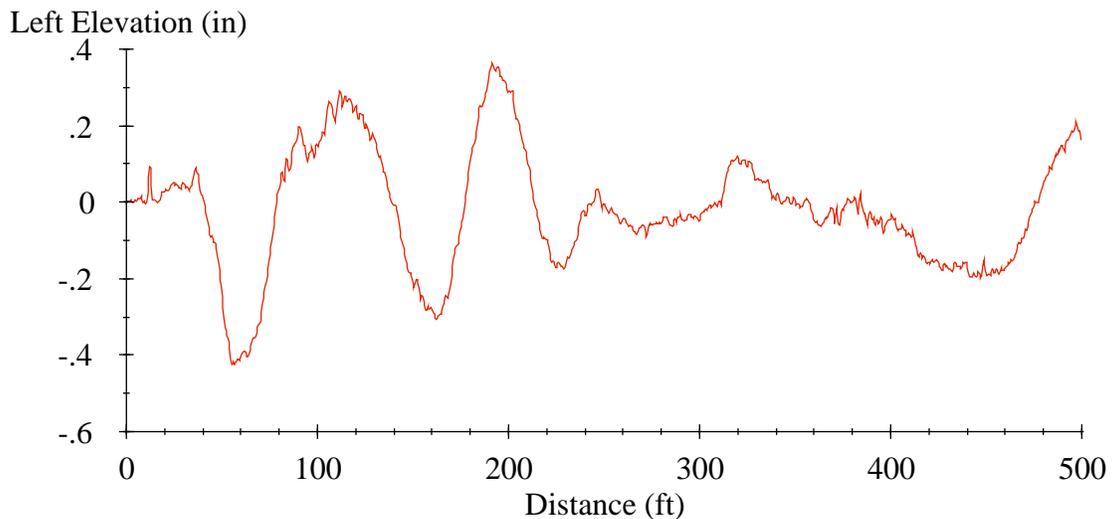
Figure 26. Elevation profile of section 0660 in September 1991.

The profile featured in Figure 25 was measured shortly after rehabilitation, and it represents the status of the section just after rehabilitation. The construction process itself caused the roughness in the first half of the section. Figure 26 shows the elevation profile that corresponds to Figure 25 after application of an anti-smoothing moving average filter with a base length of 100 ft. The figure shows that some very long duration features cause the roughness. The “long dip” running 30 to 90 ft from the start of the section deteriorated over time, and eventually became so rough by growing in depth that a skin patch was placed over it.
