**EVALUATION OF GREAT LAKES
SHORE PROTECTION STRUCTURES**

Report UMCEE 88-8

**THE UNIVERSITY OF MICHIGAN
DEPARTMENT OF CIVIL ENGINEERING
ANN ARBOR, MICHIGAN**

**Michigan Department of Natural Resources
Coastal Management Program
Land and Water Division**

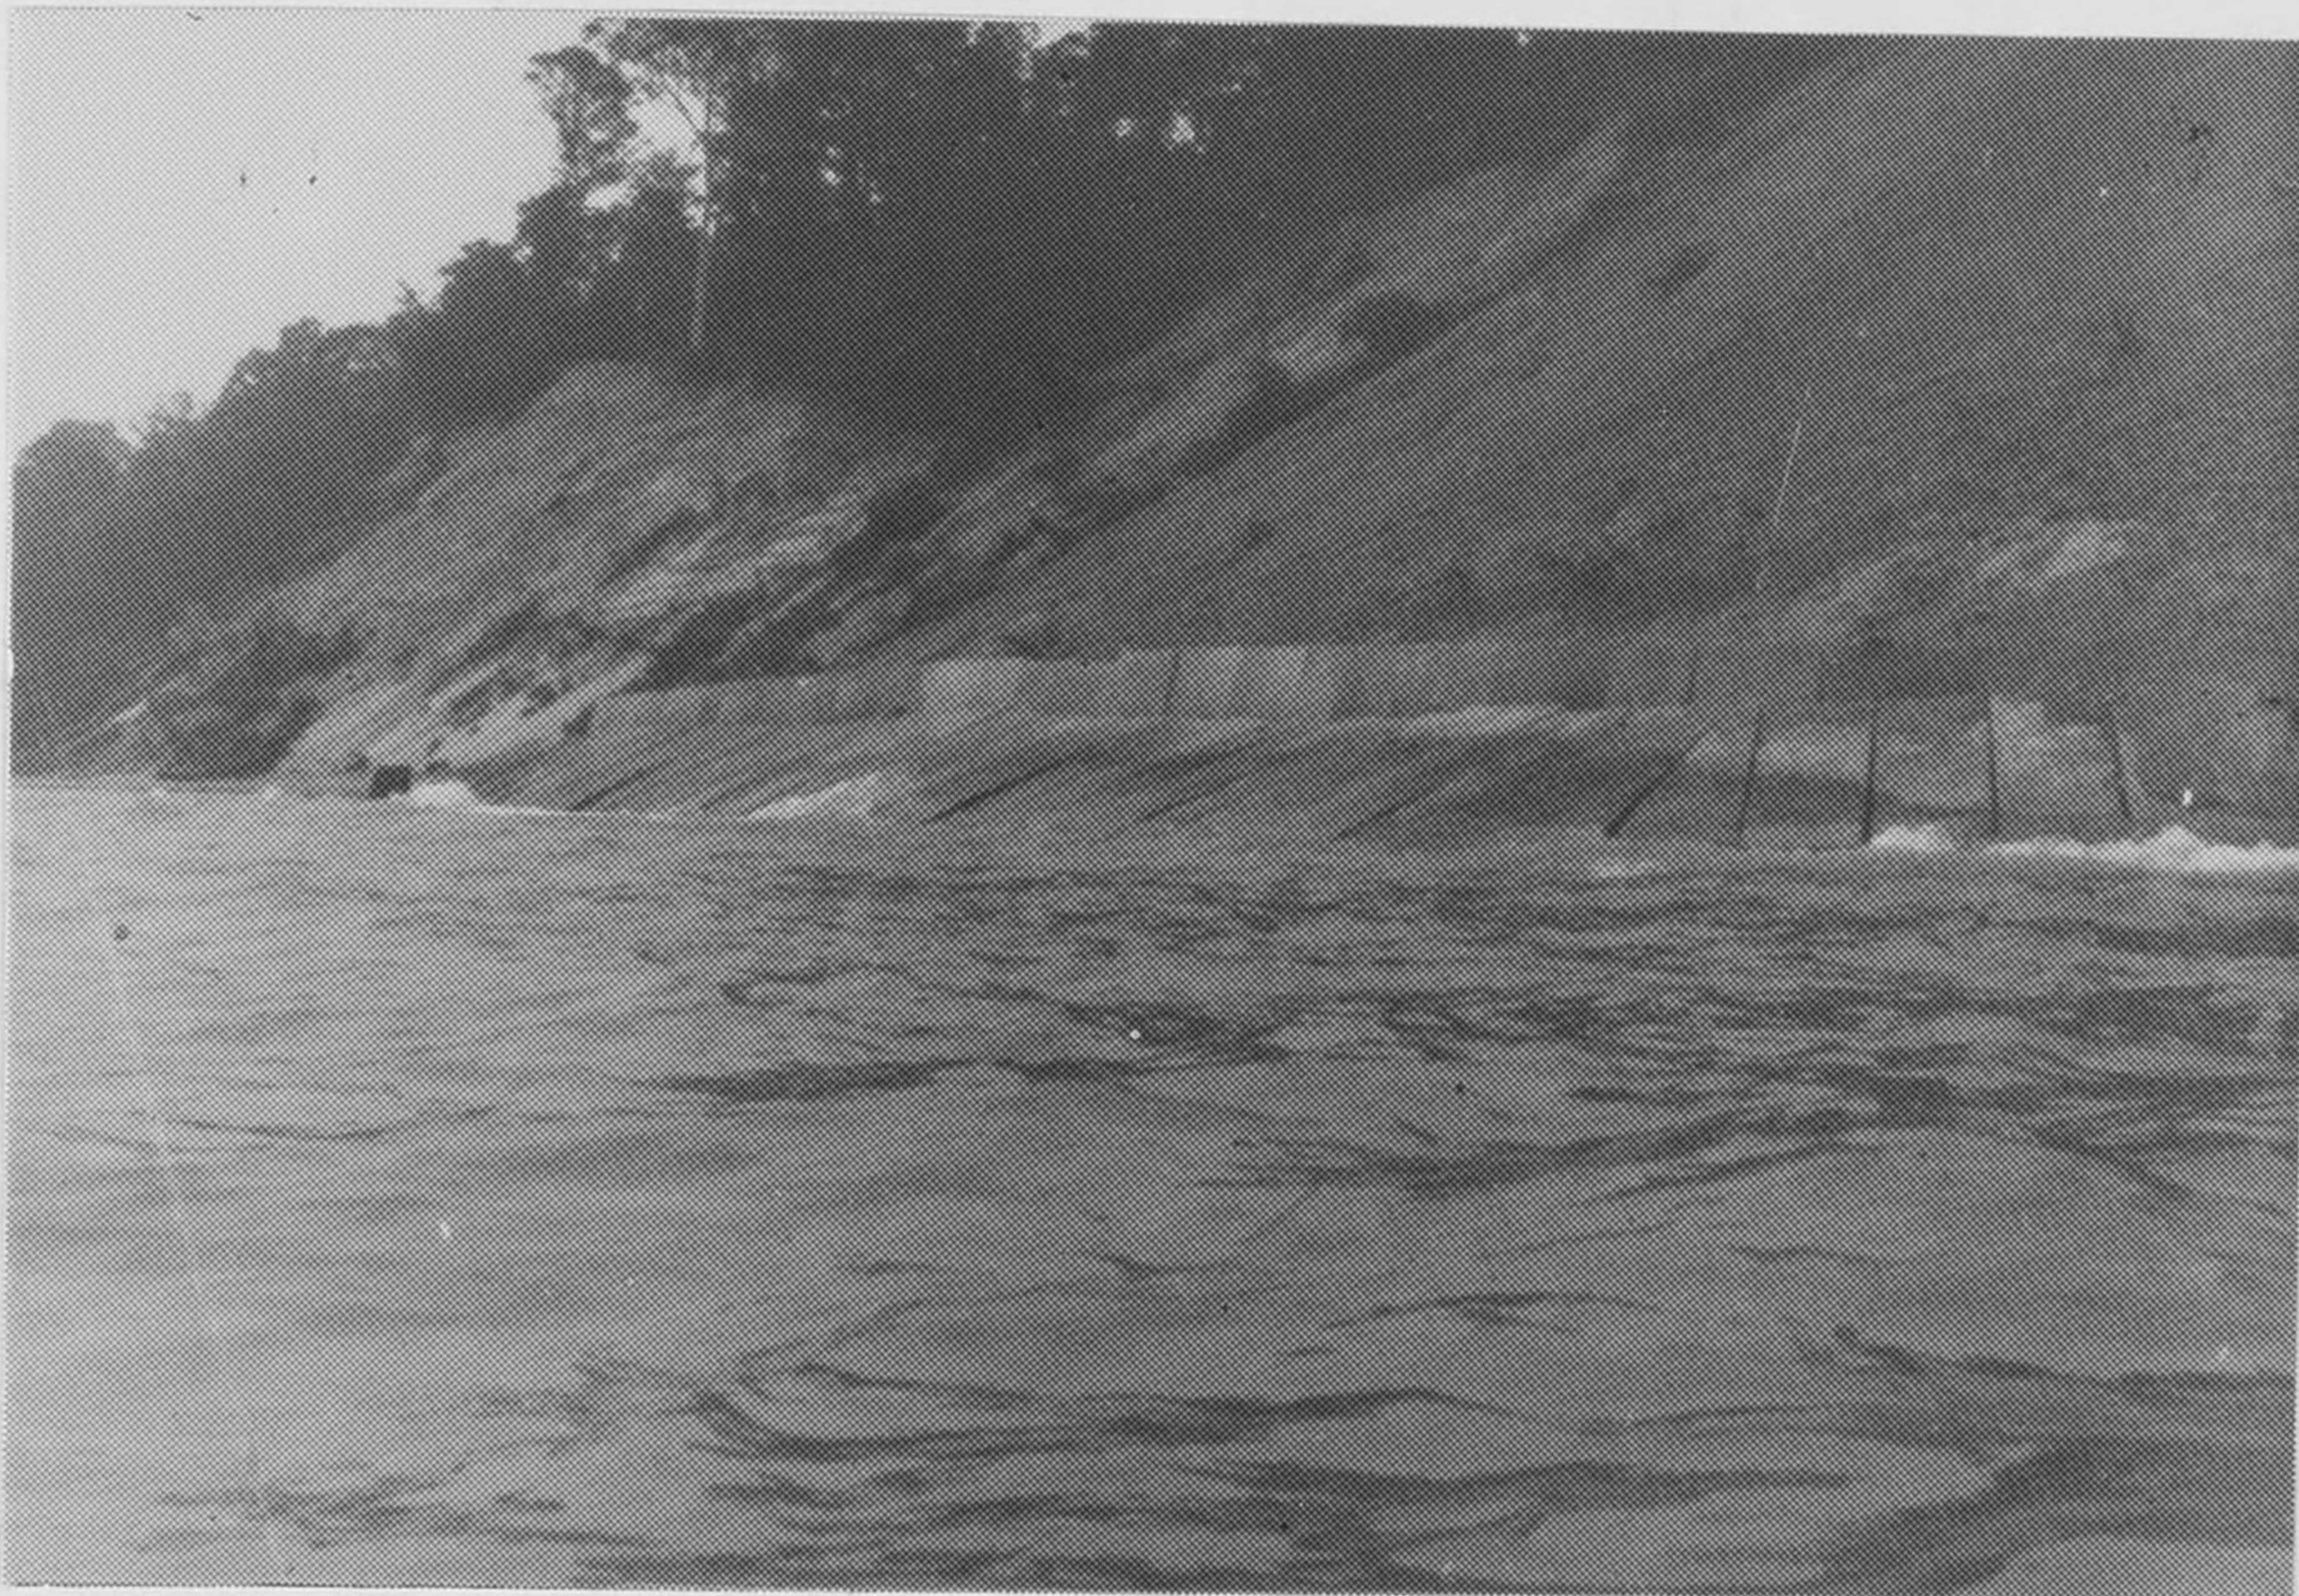
Figure B7. Site C: View of modular units looking from offshore onto the structure.

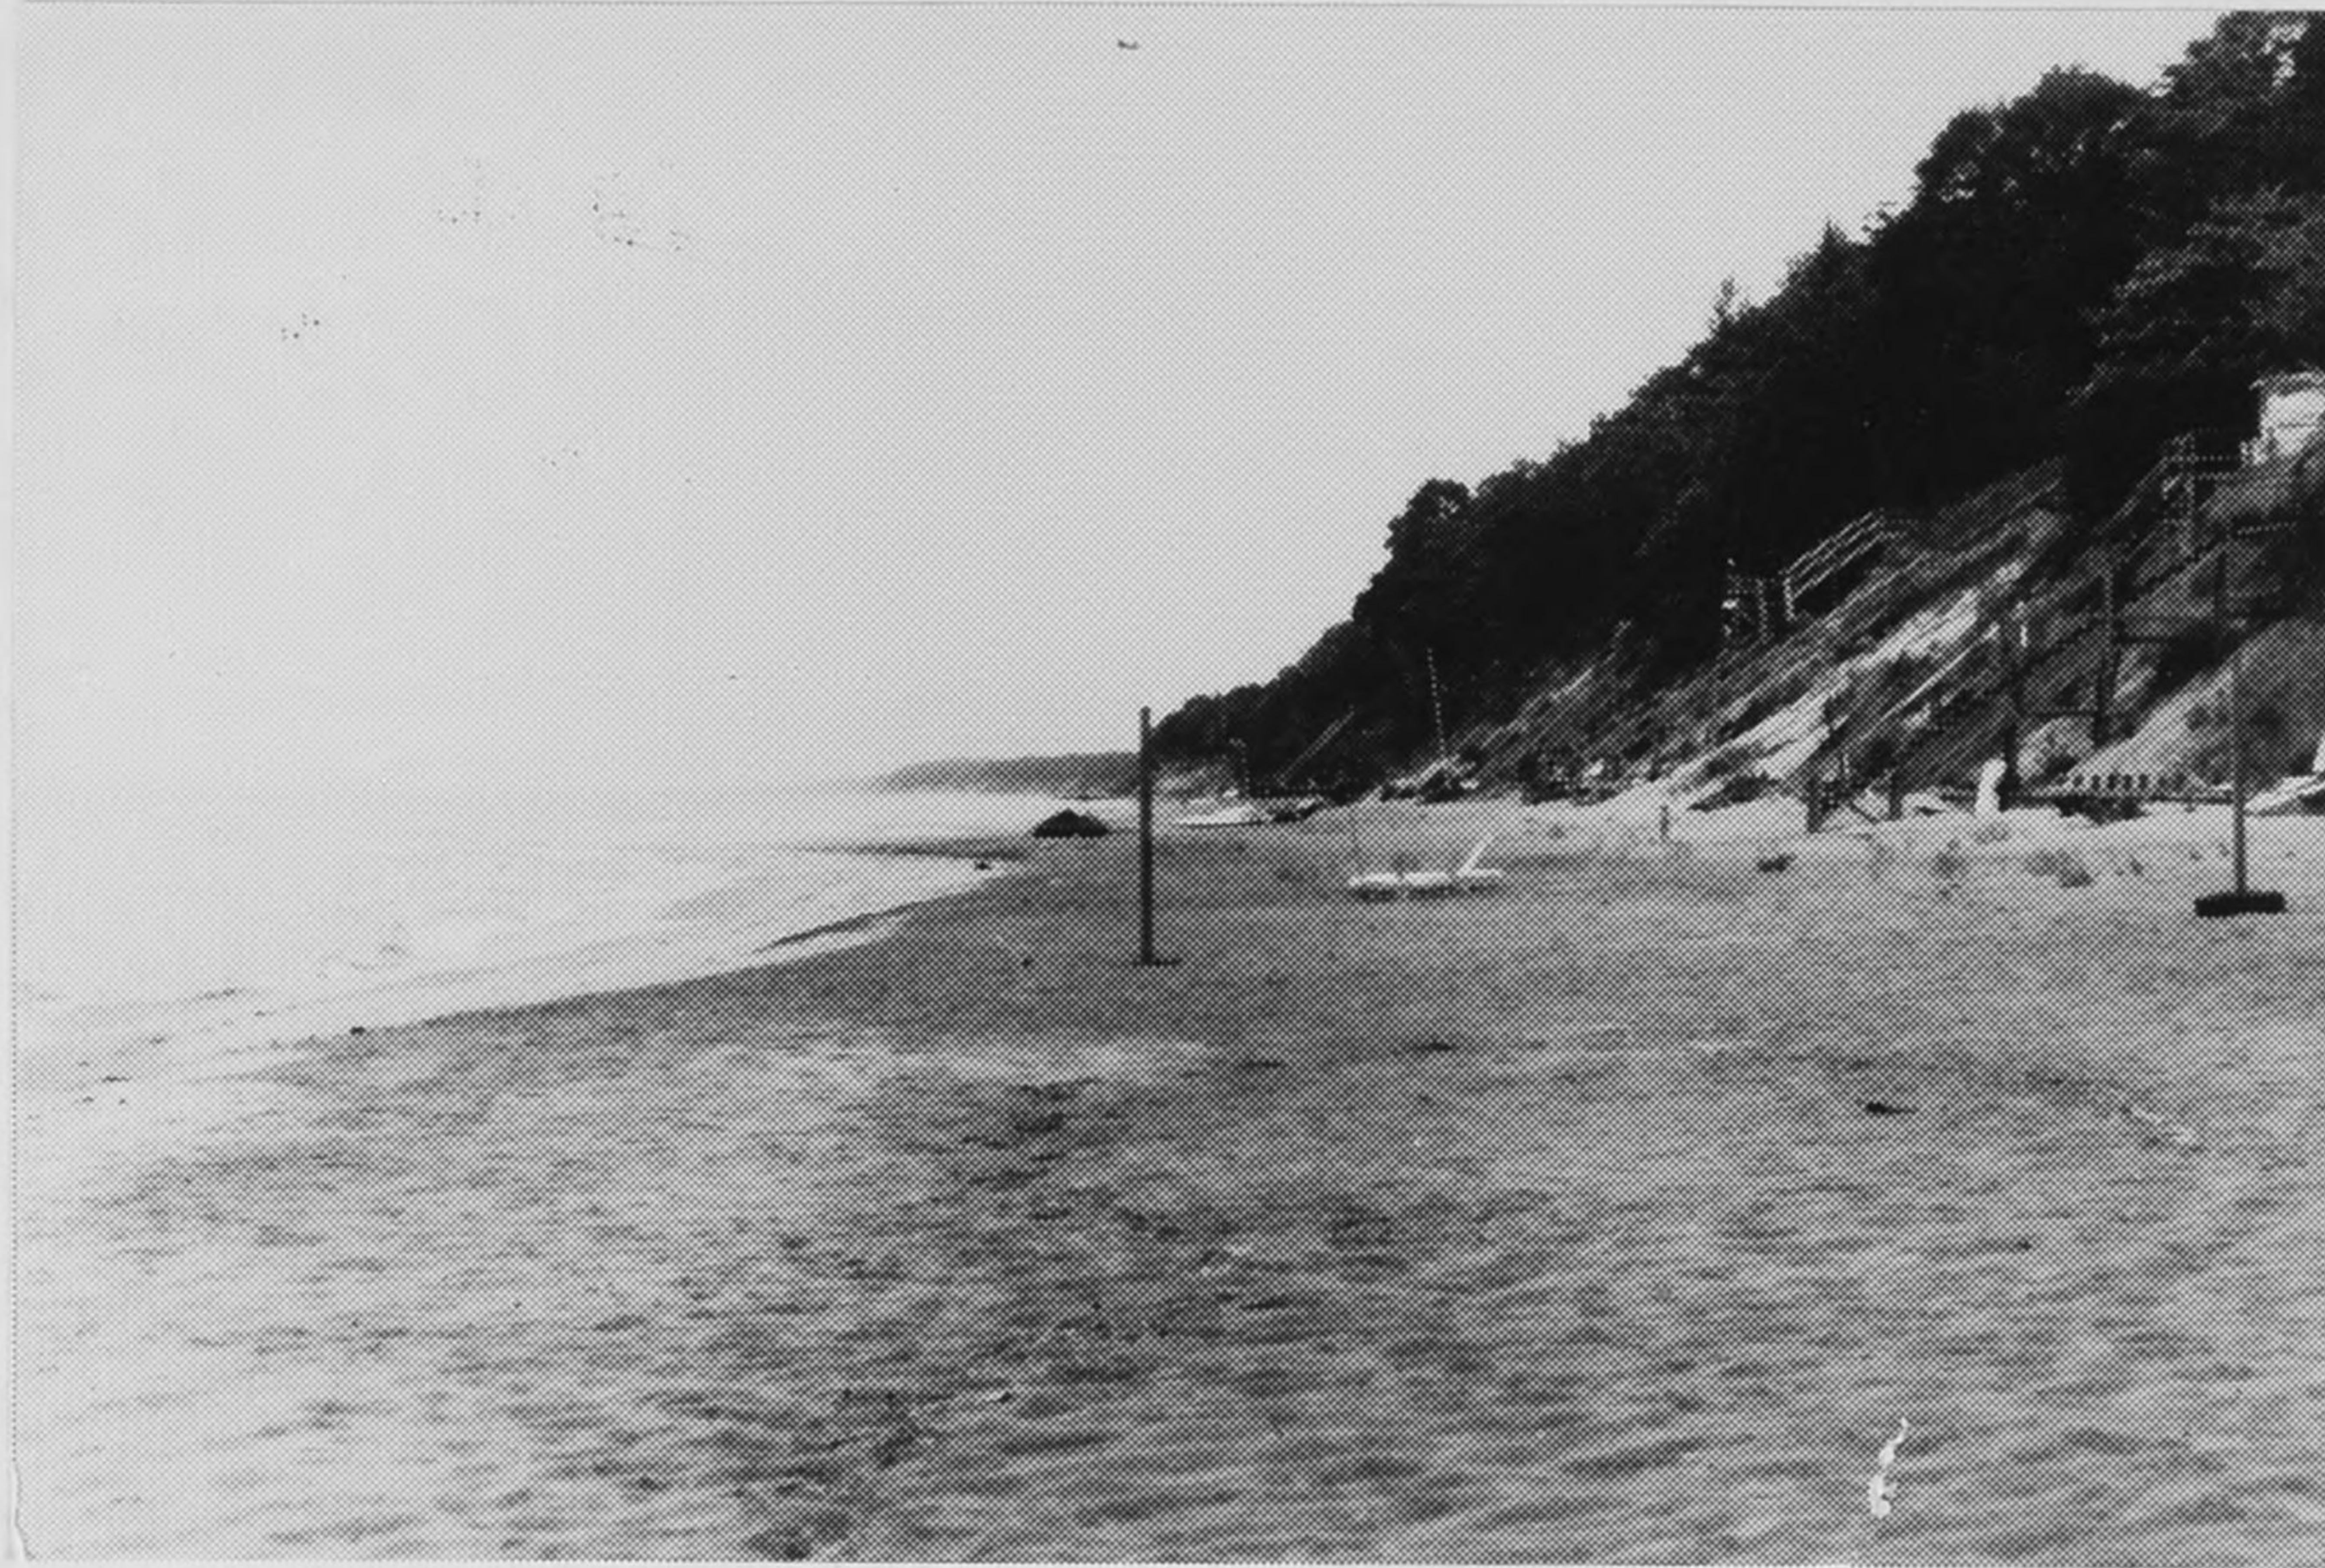
Figure B12. Site E: Looking to the north from southern edge of site. Shoreline is more visible in this photograph. Top of retaining wall is barely visible at right center of photo.

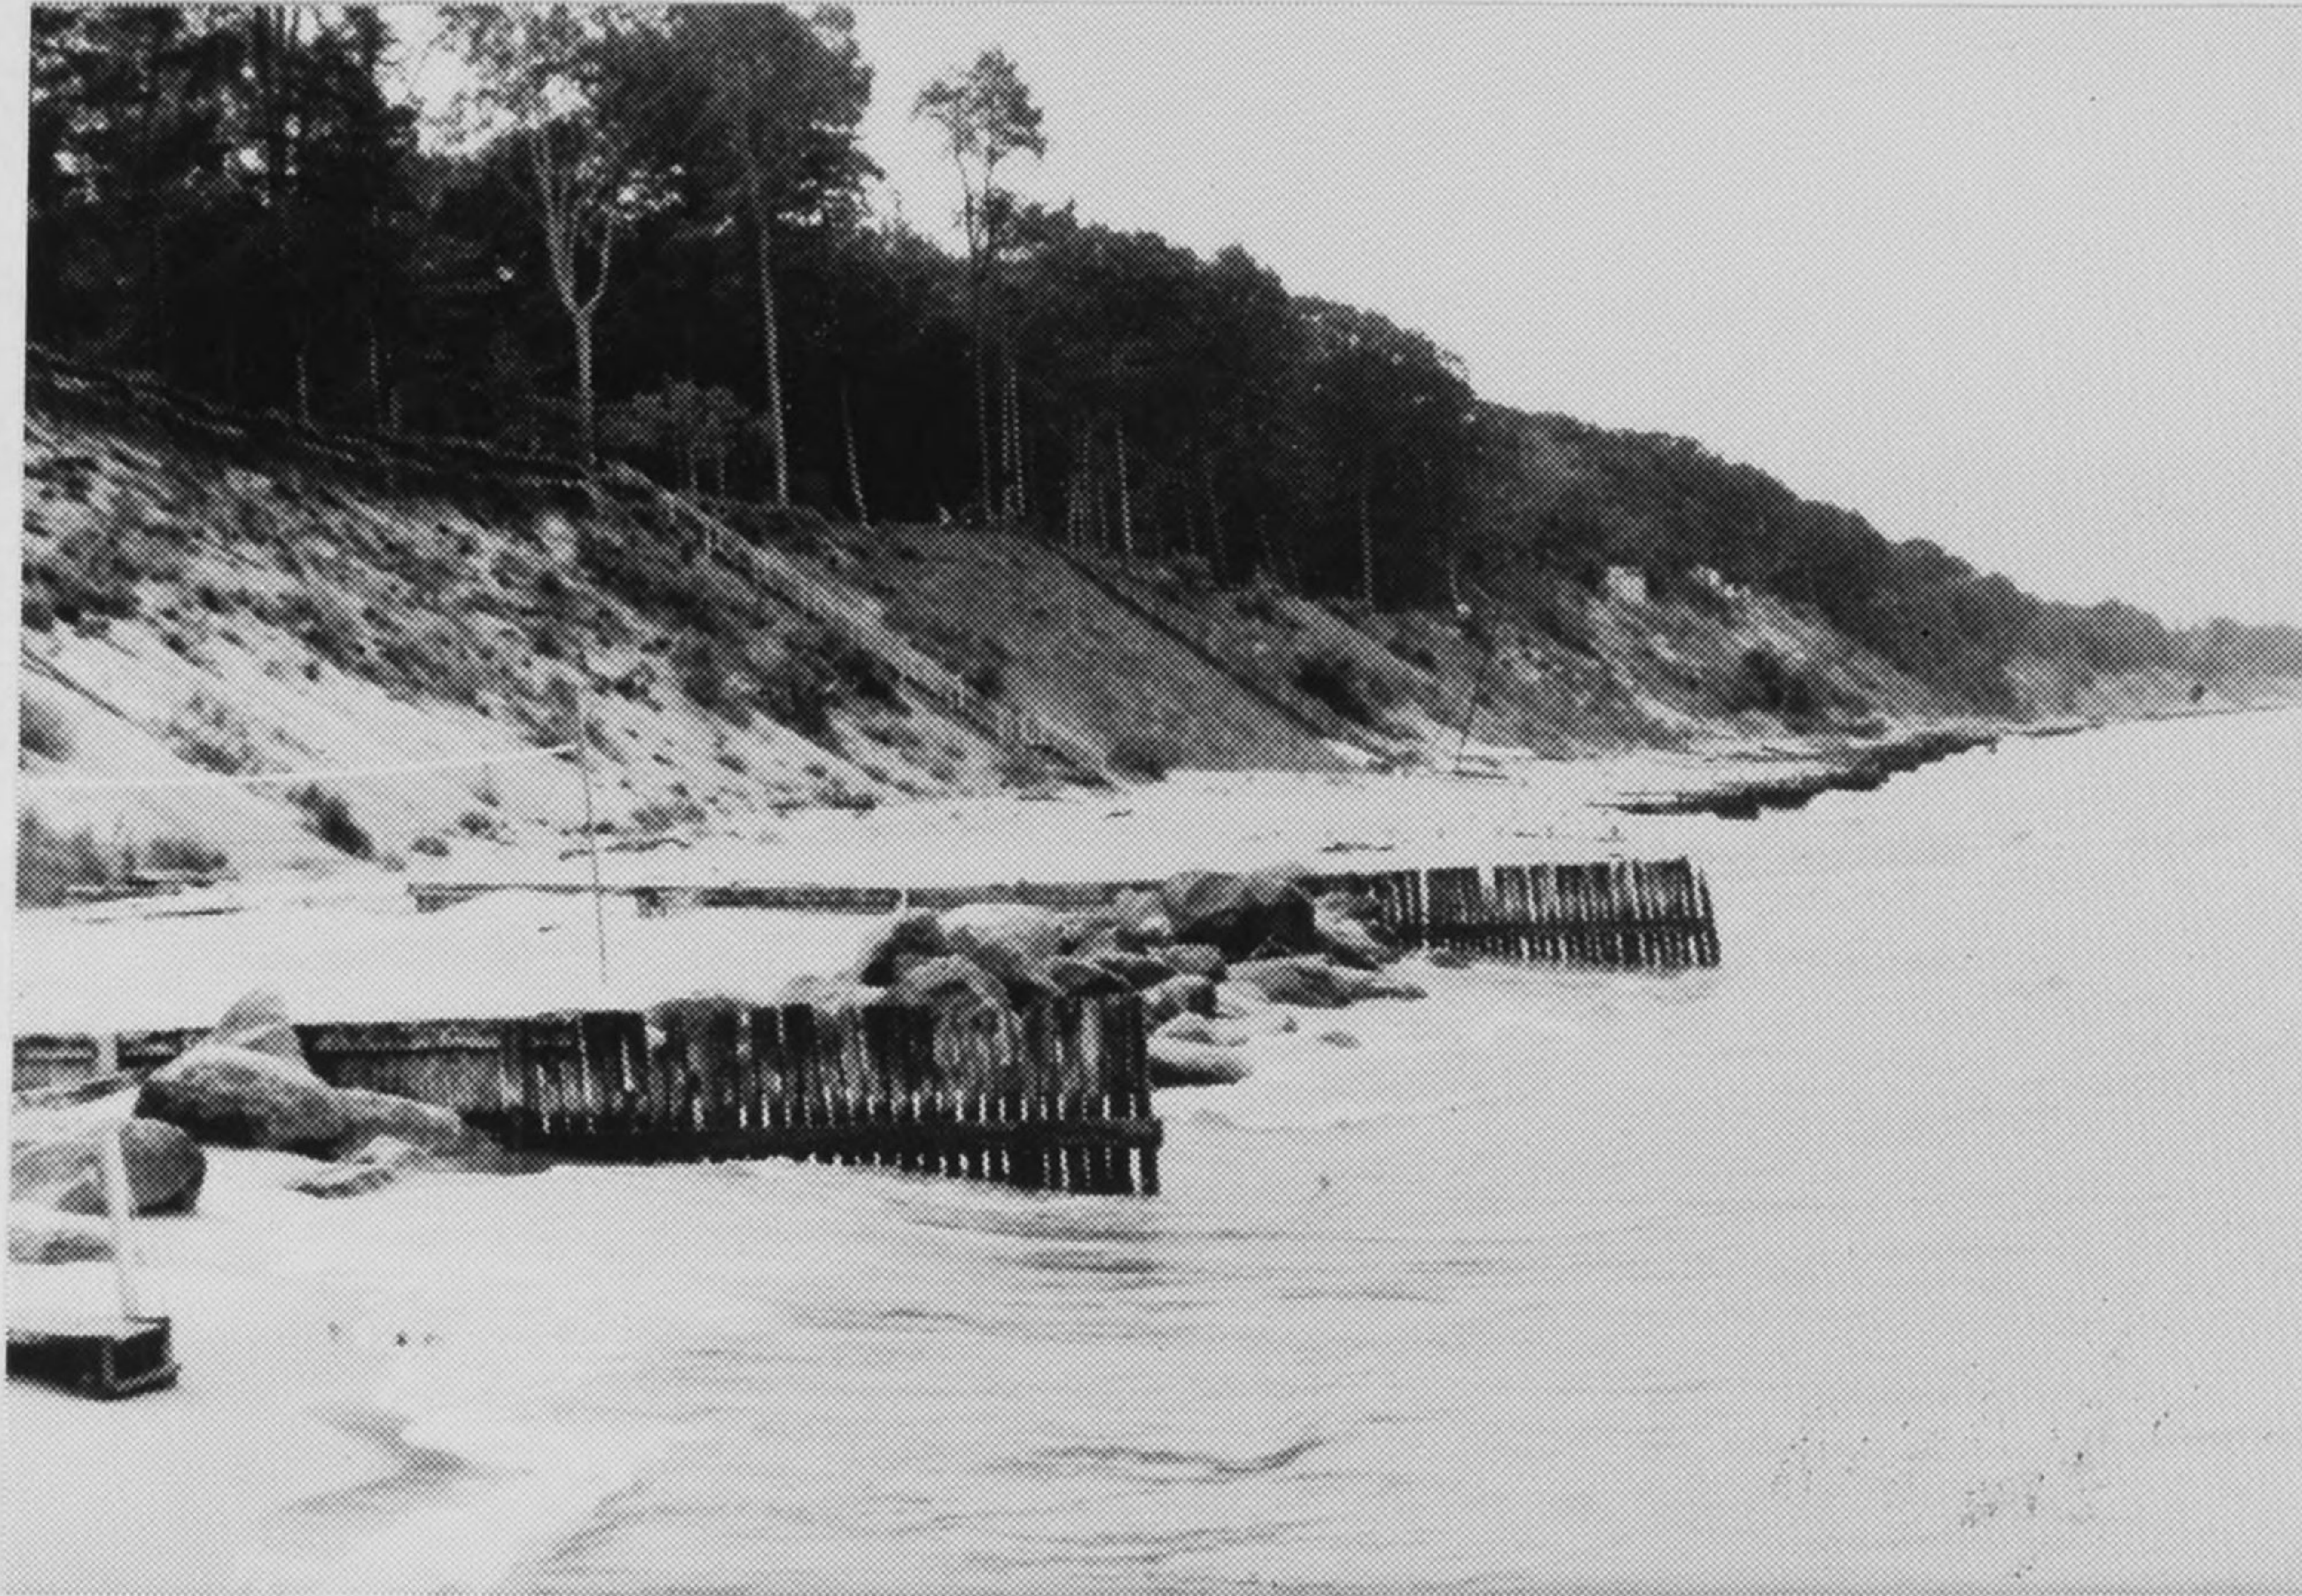
Figure B14. Site F: Looking south towards site from two properties to the north. Top of buried groin is immediately behind stone filled groin compartment in foreground.

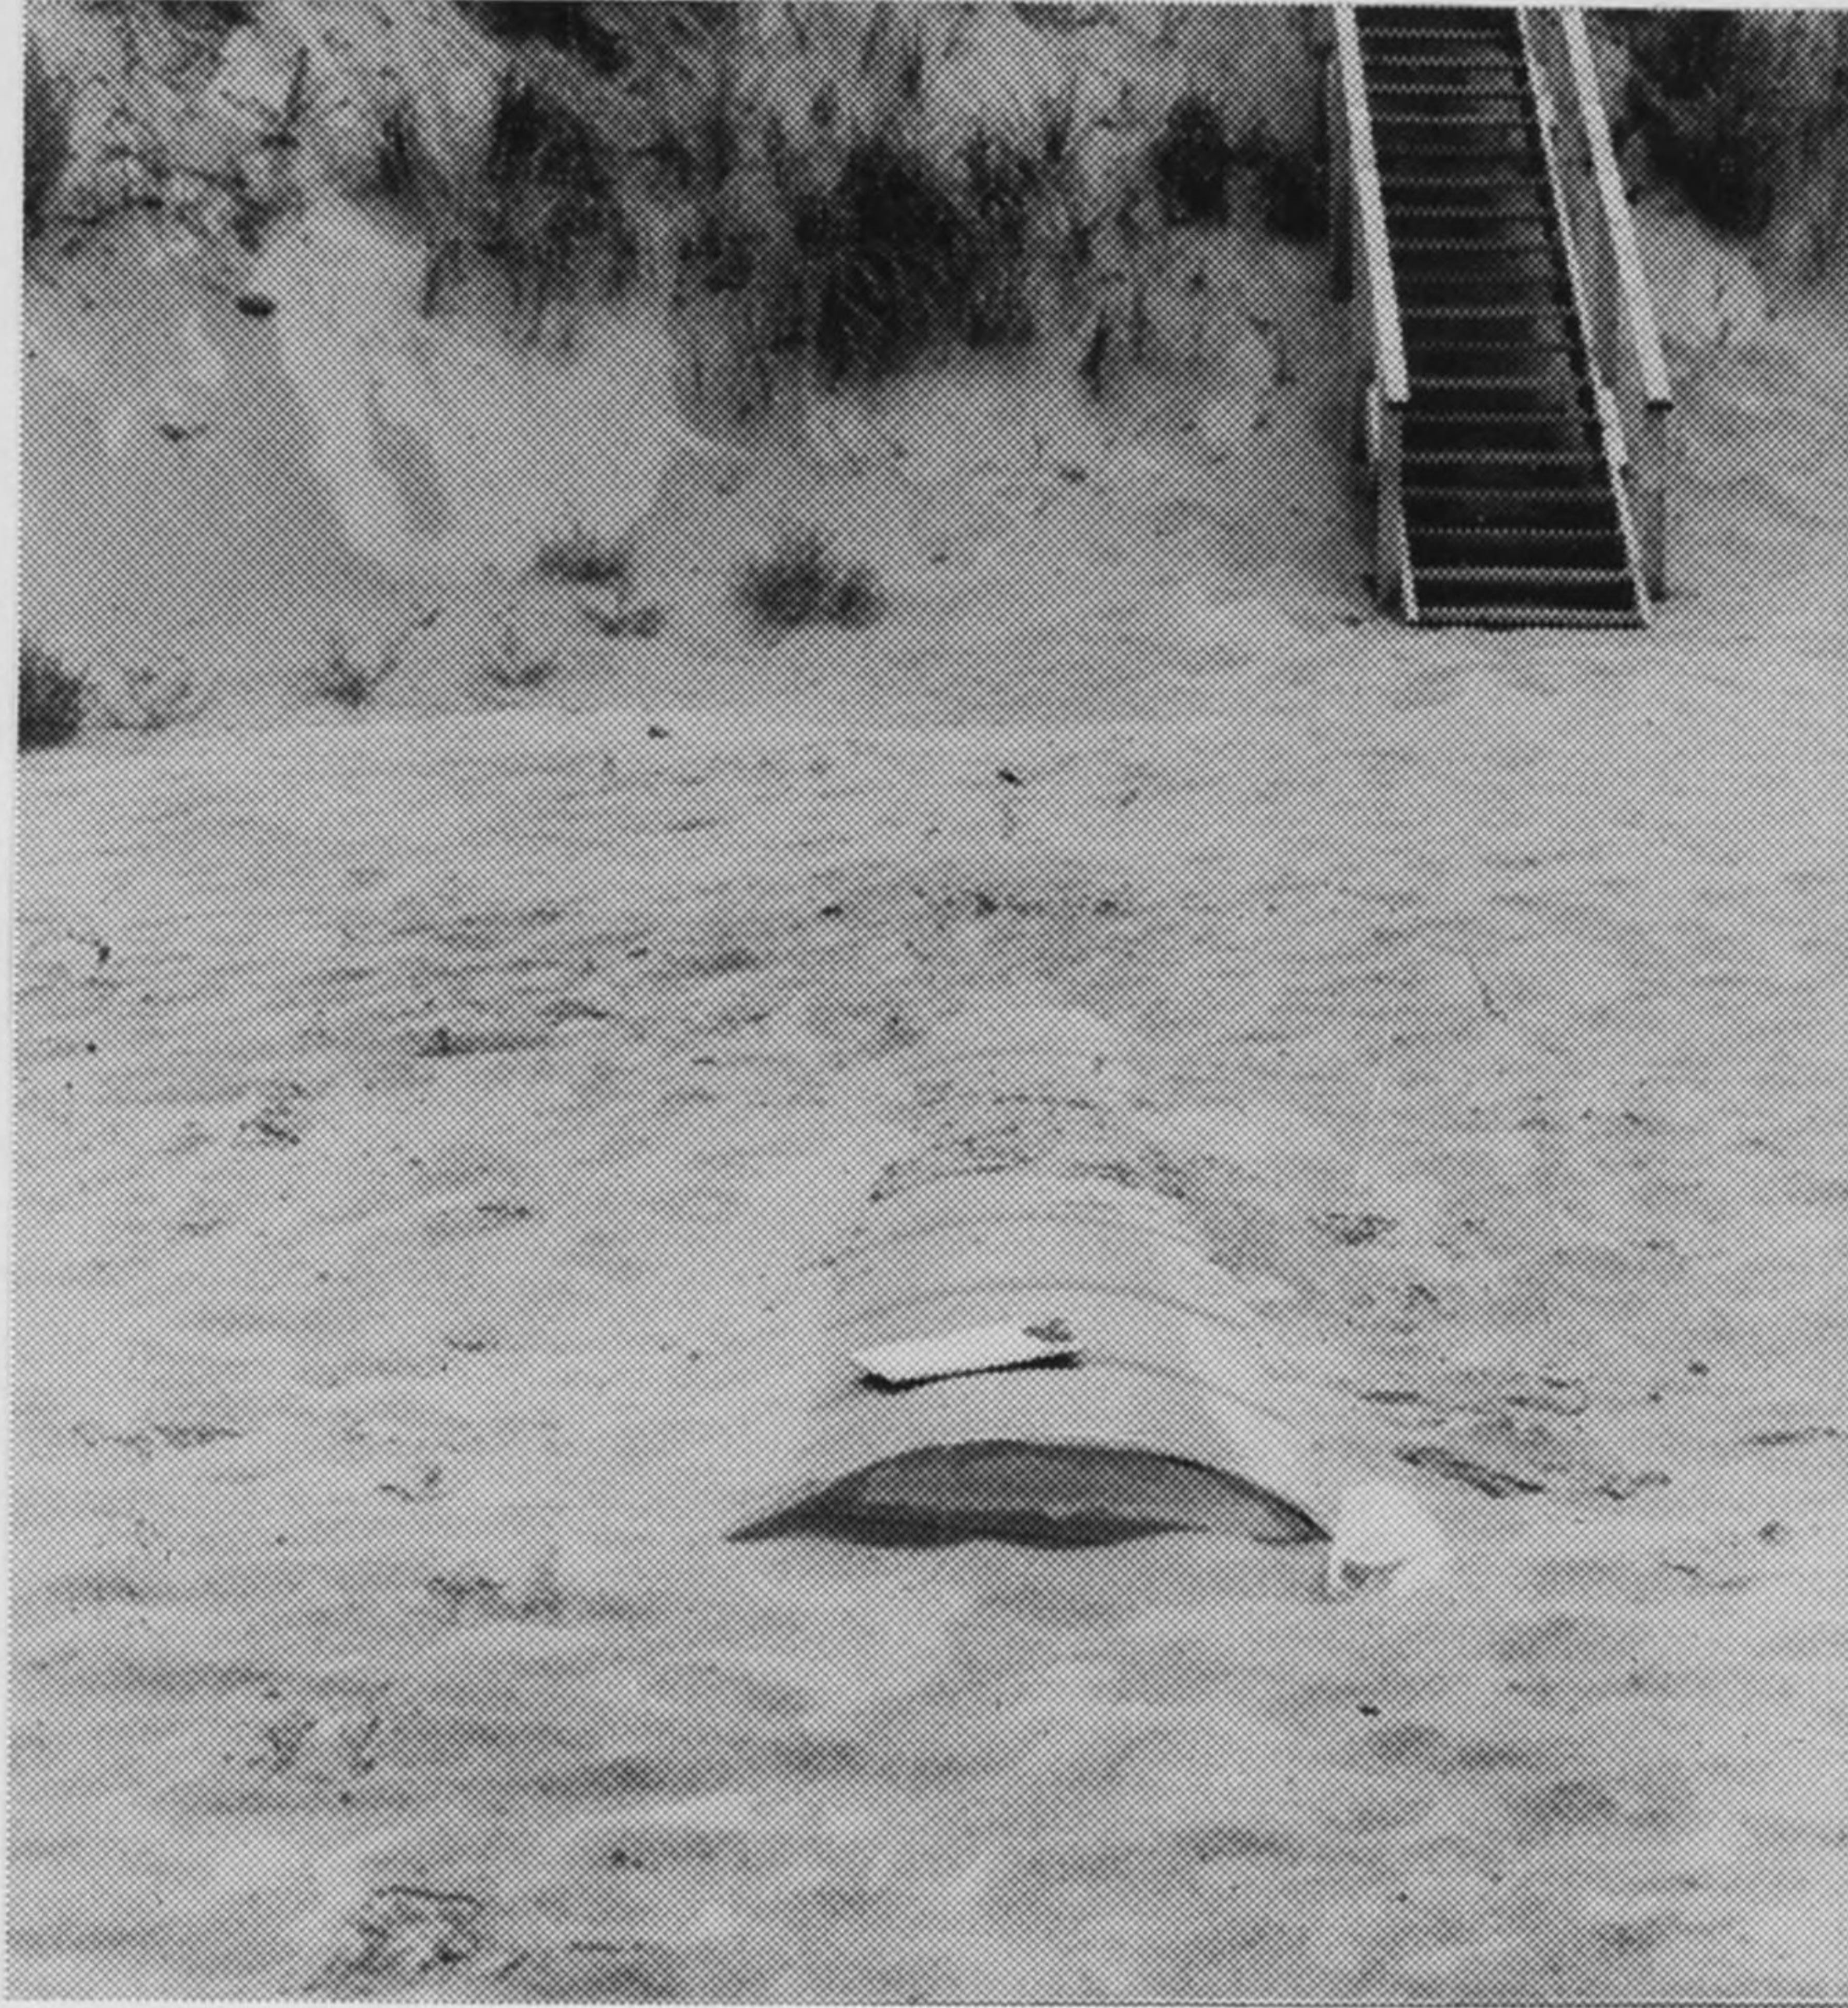
Figure B16. Site G: Looking directly onshore from beyond end of groin, Note that groin is almost completely buried with no beach elevation difference across groin.

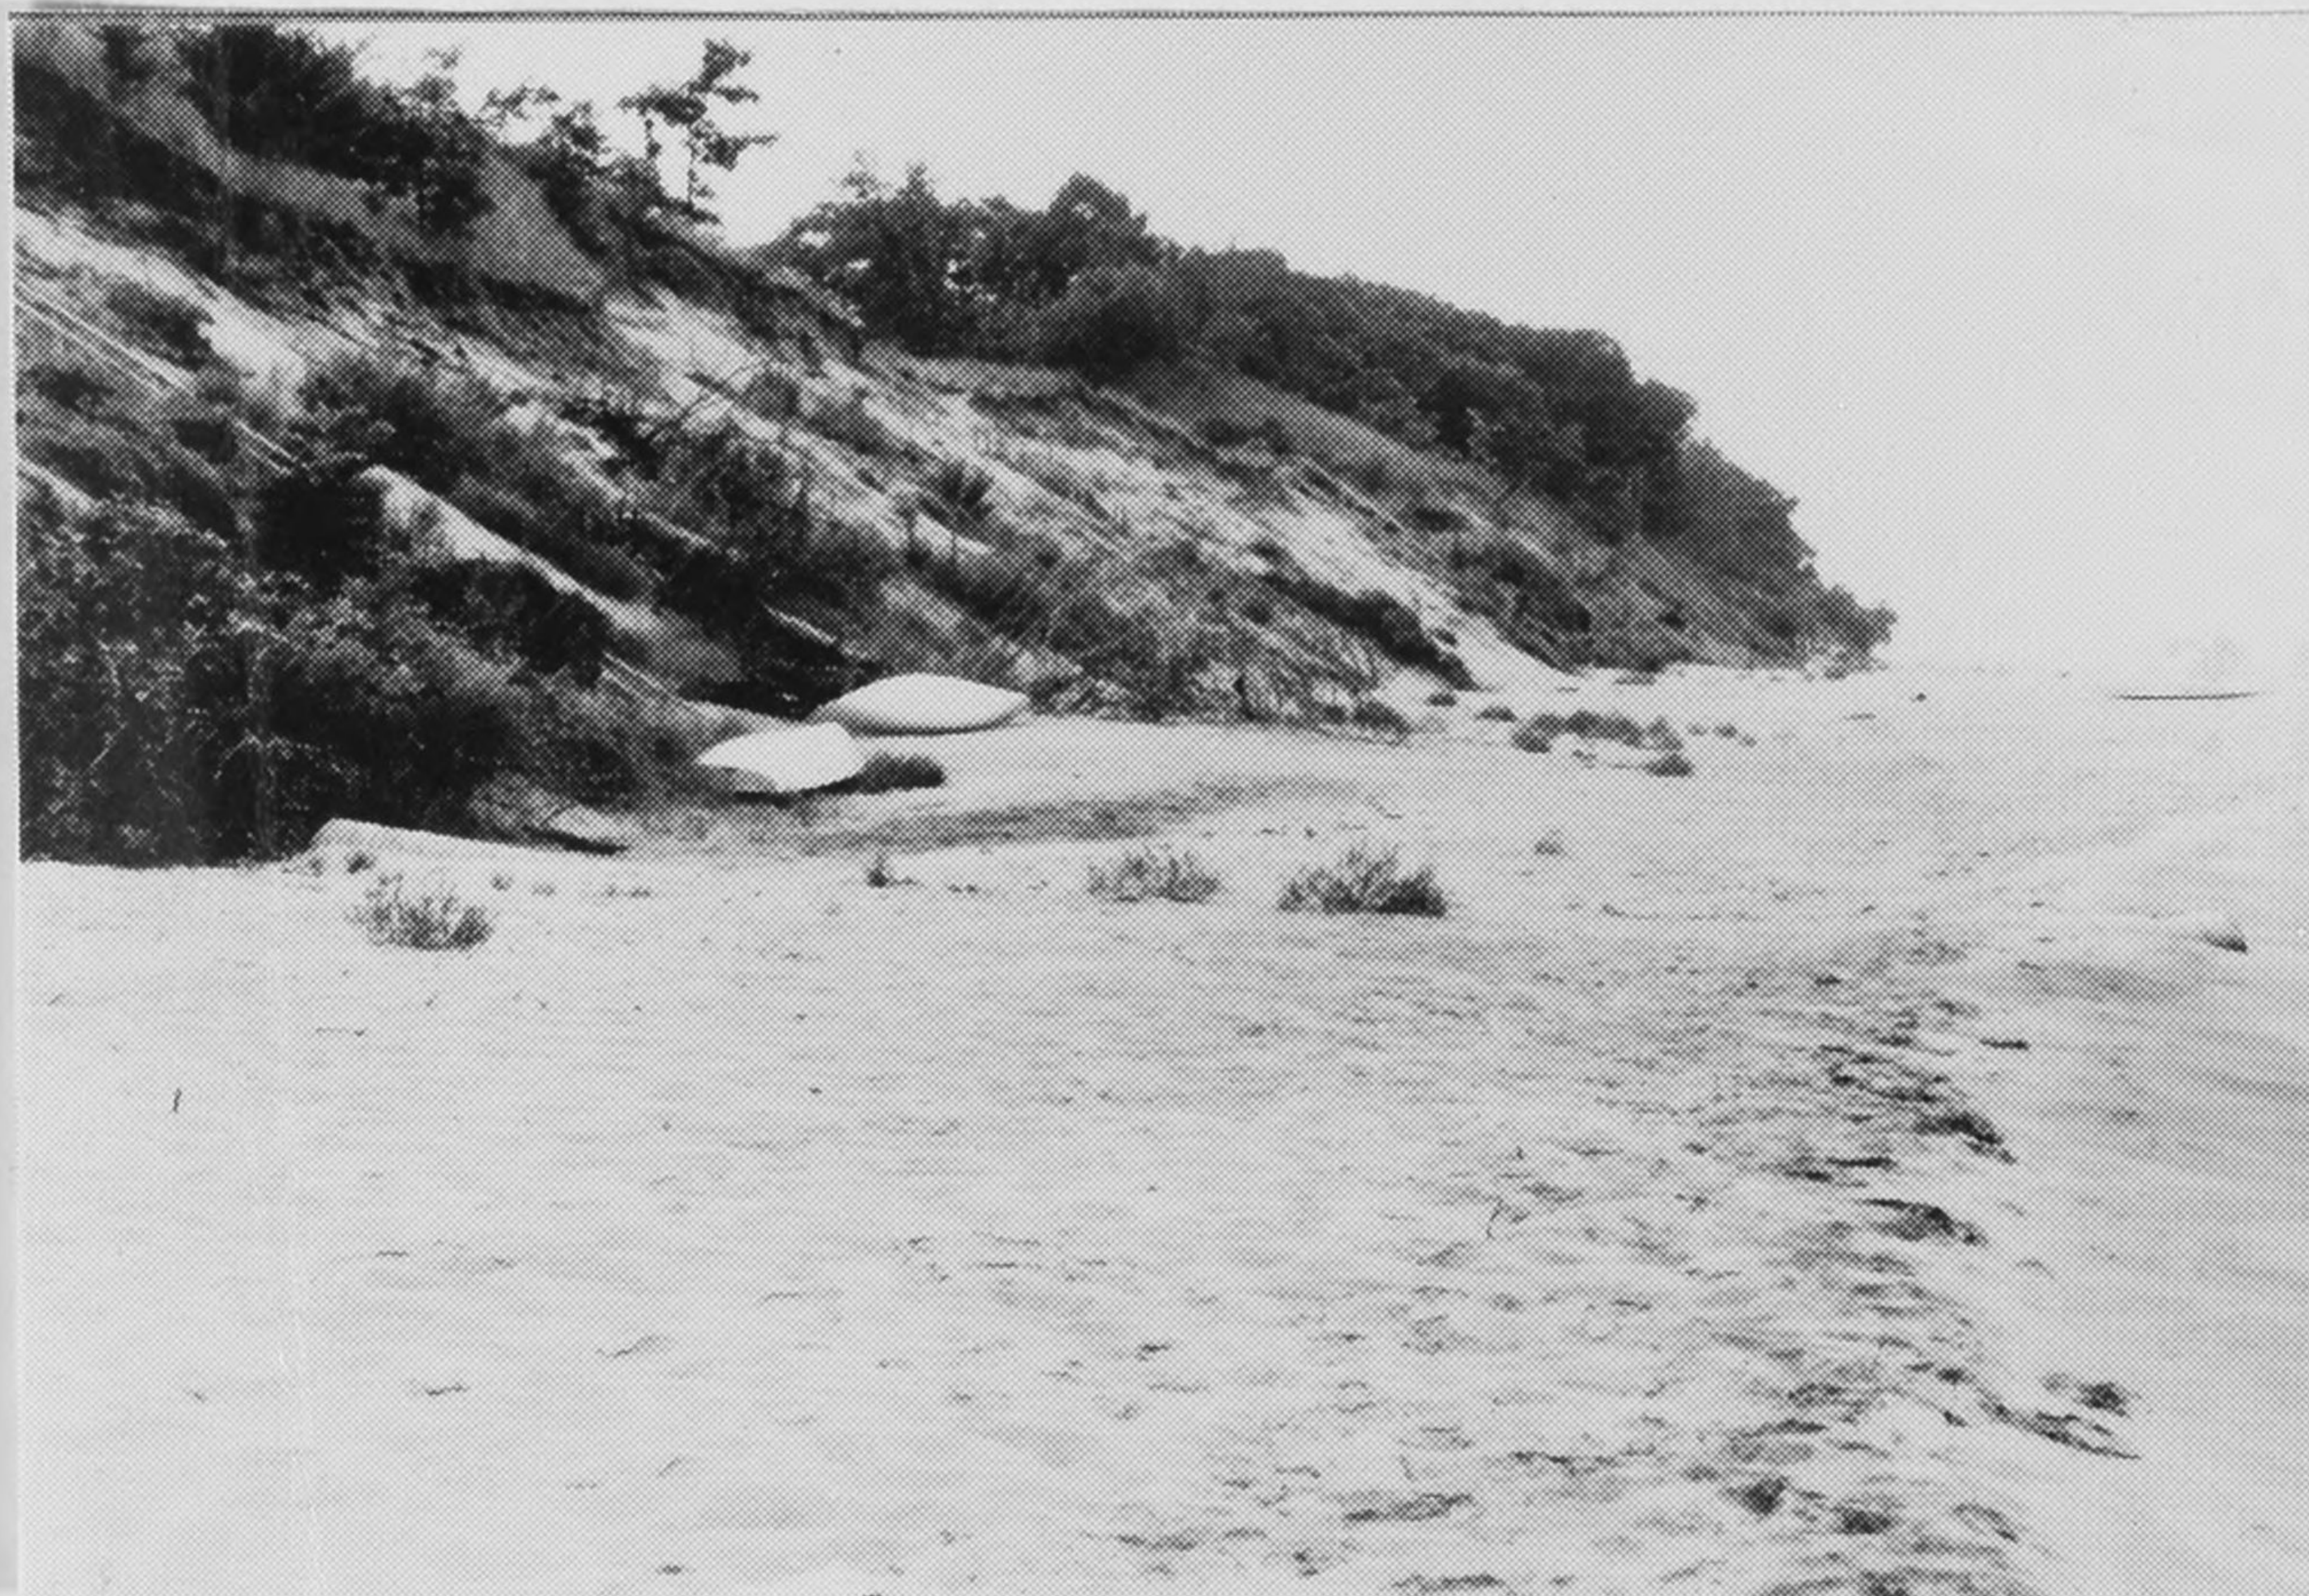
Figure B17. Site G: Looking south at groin. Both end of groin are visible in center of photograph.

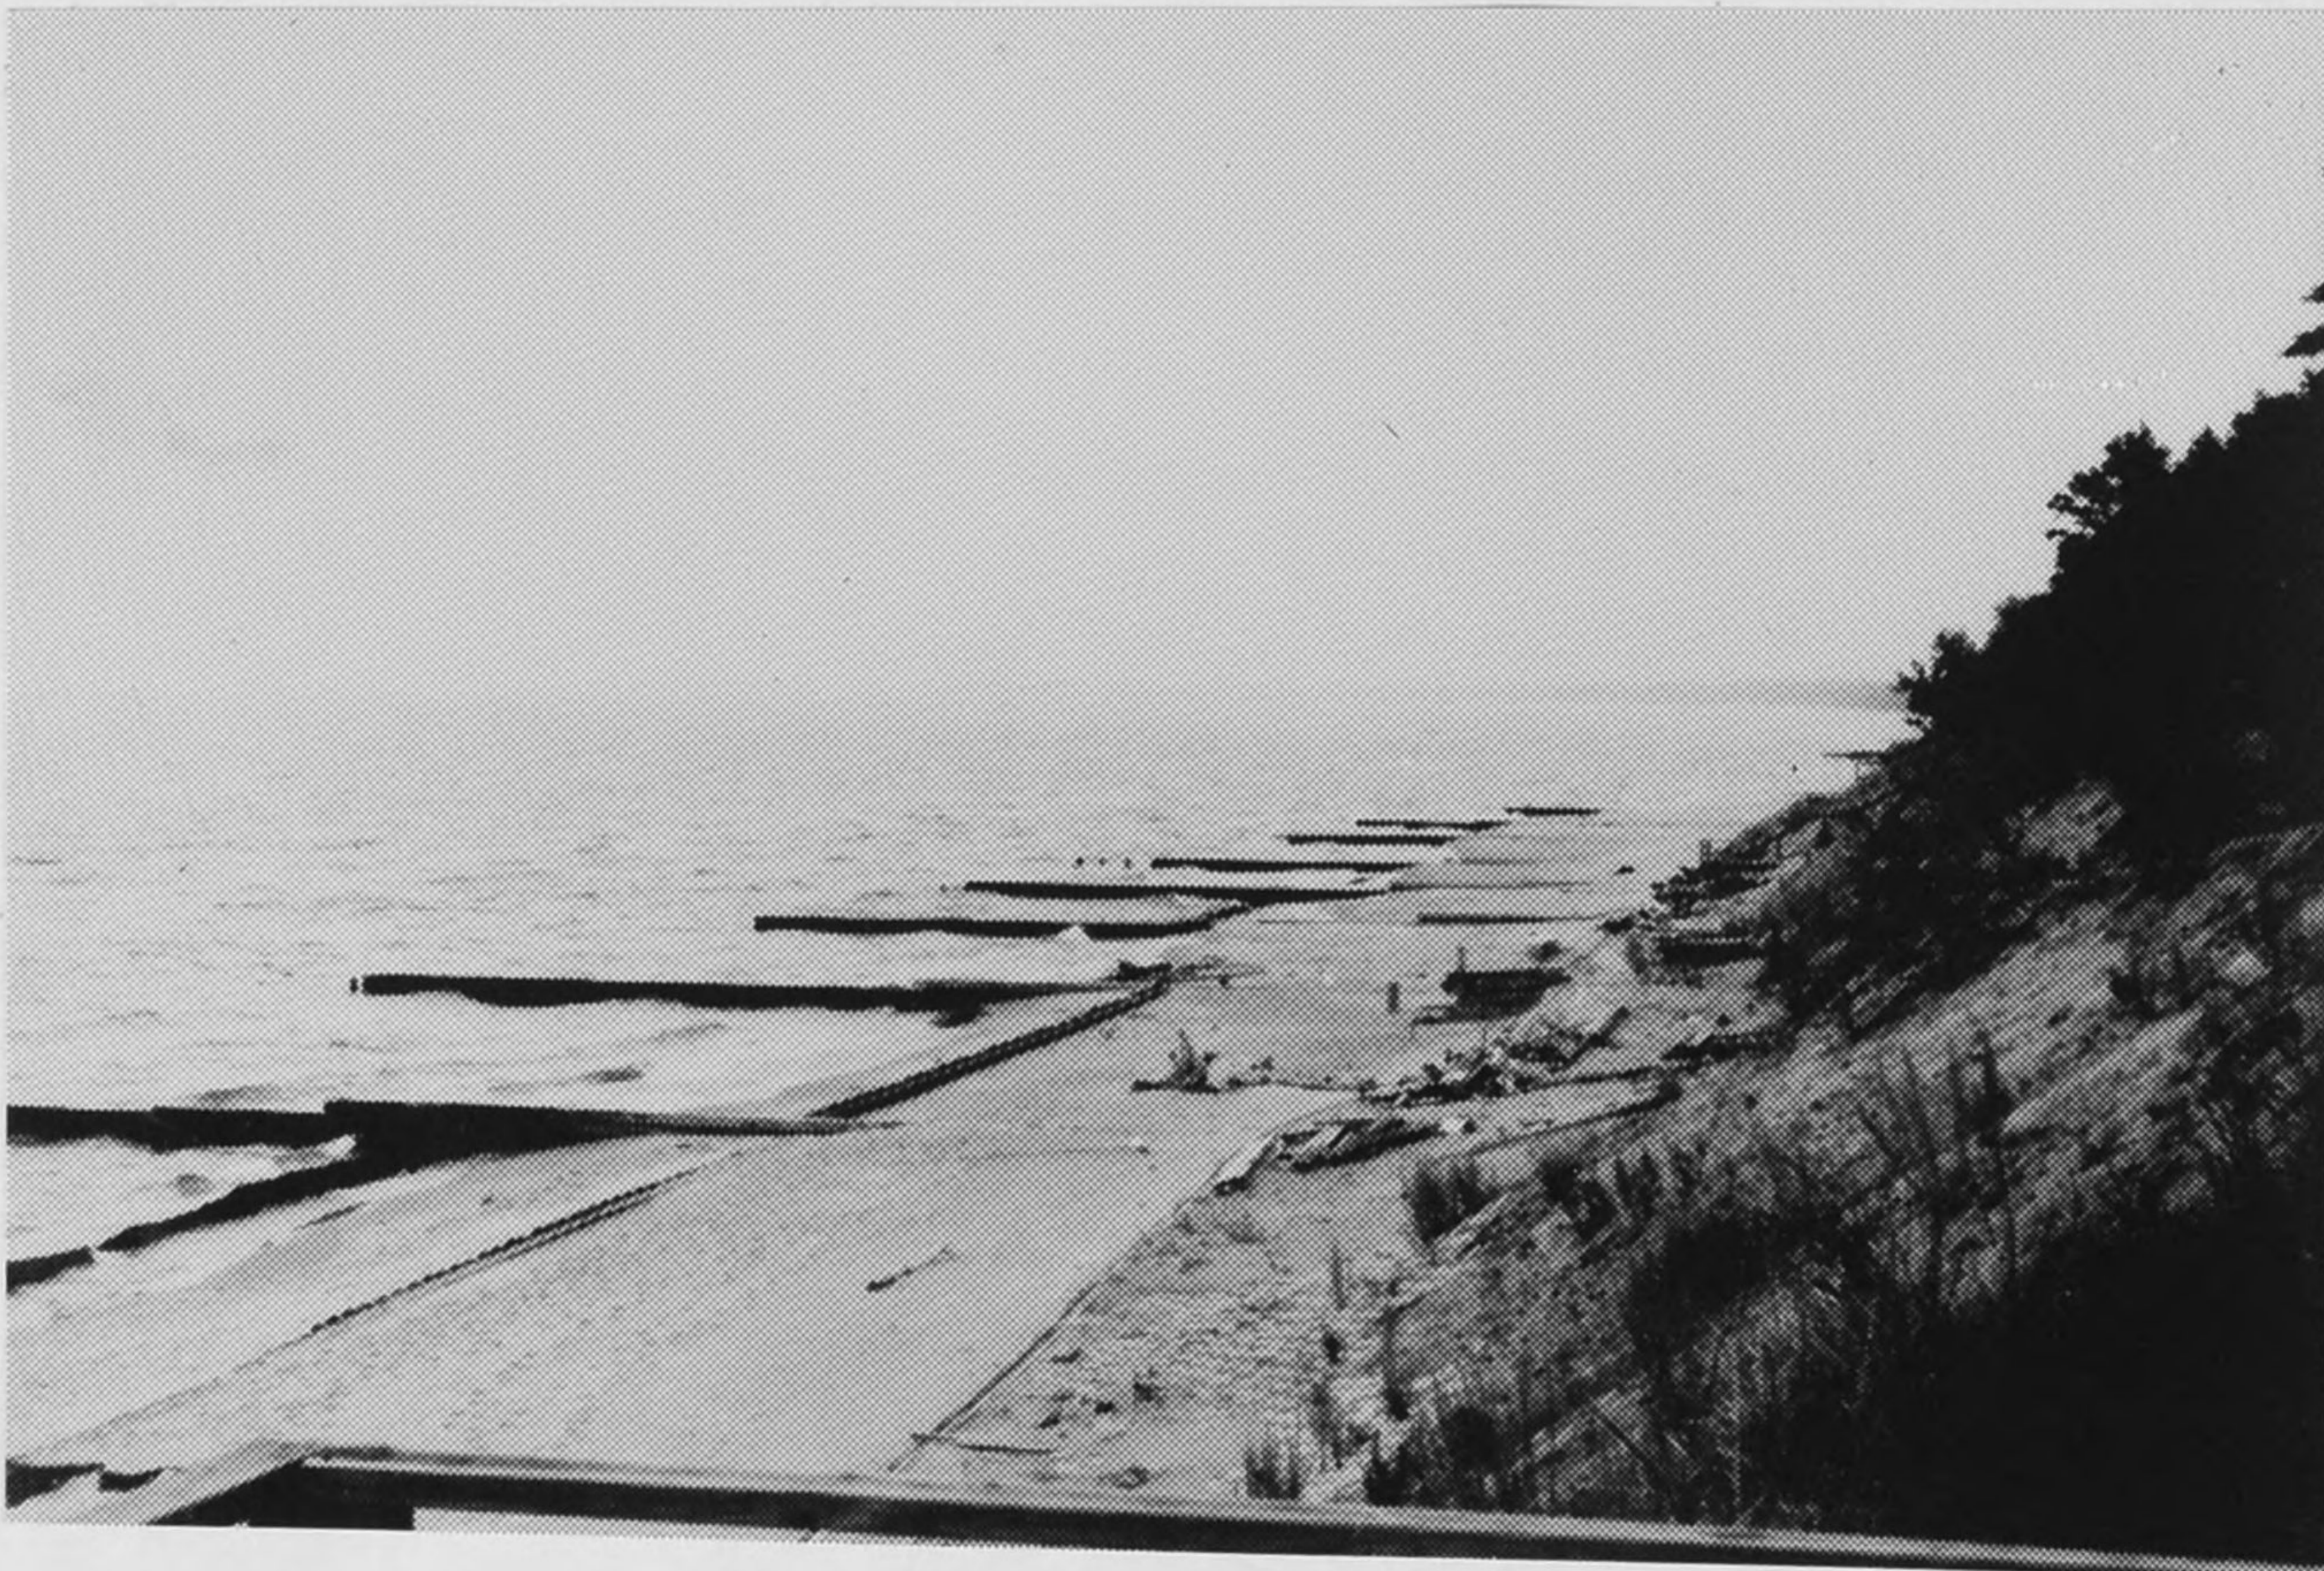
Figure B19. Site H: View towards the north of the last eight groins at the northern side of the system. Tops of wavebusters are visible at lower left side of photograph. Flex-blocks are visible in foreground at toe of bluff.
