**EVALUATION OF GREAT LAKES
SHORE PROTECTION STRUCTURES**

Report UMCEE 88-8

**THE UNIVERSITY OF MICHIGAN
DEPARTMENT OF CIVIL ENGINEERING
ANN ARBOR, MICHIGAN**

**Michigan Department of Natural Resources
Coastal Management Program
Land and Water Division**

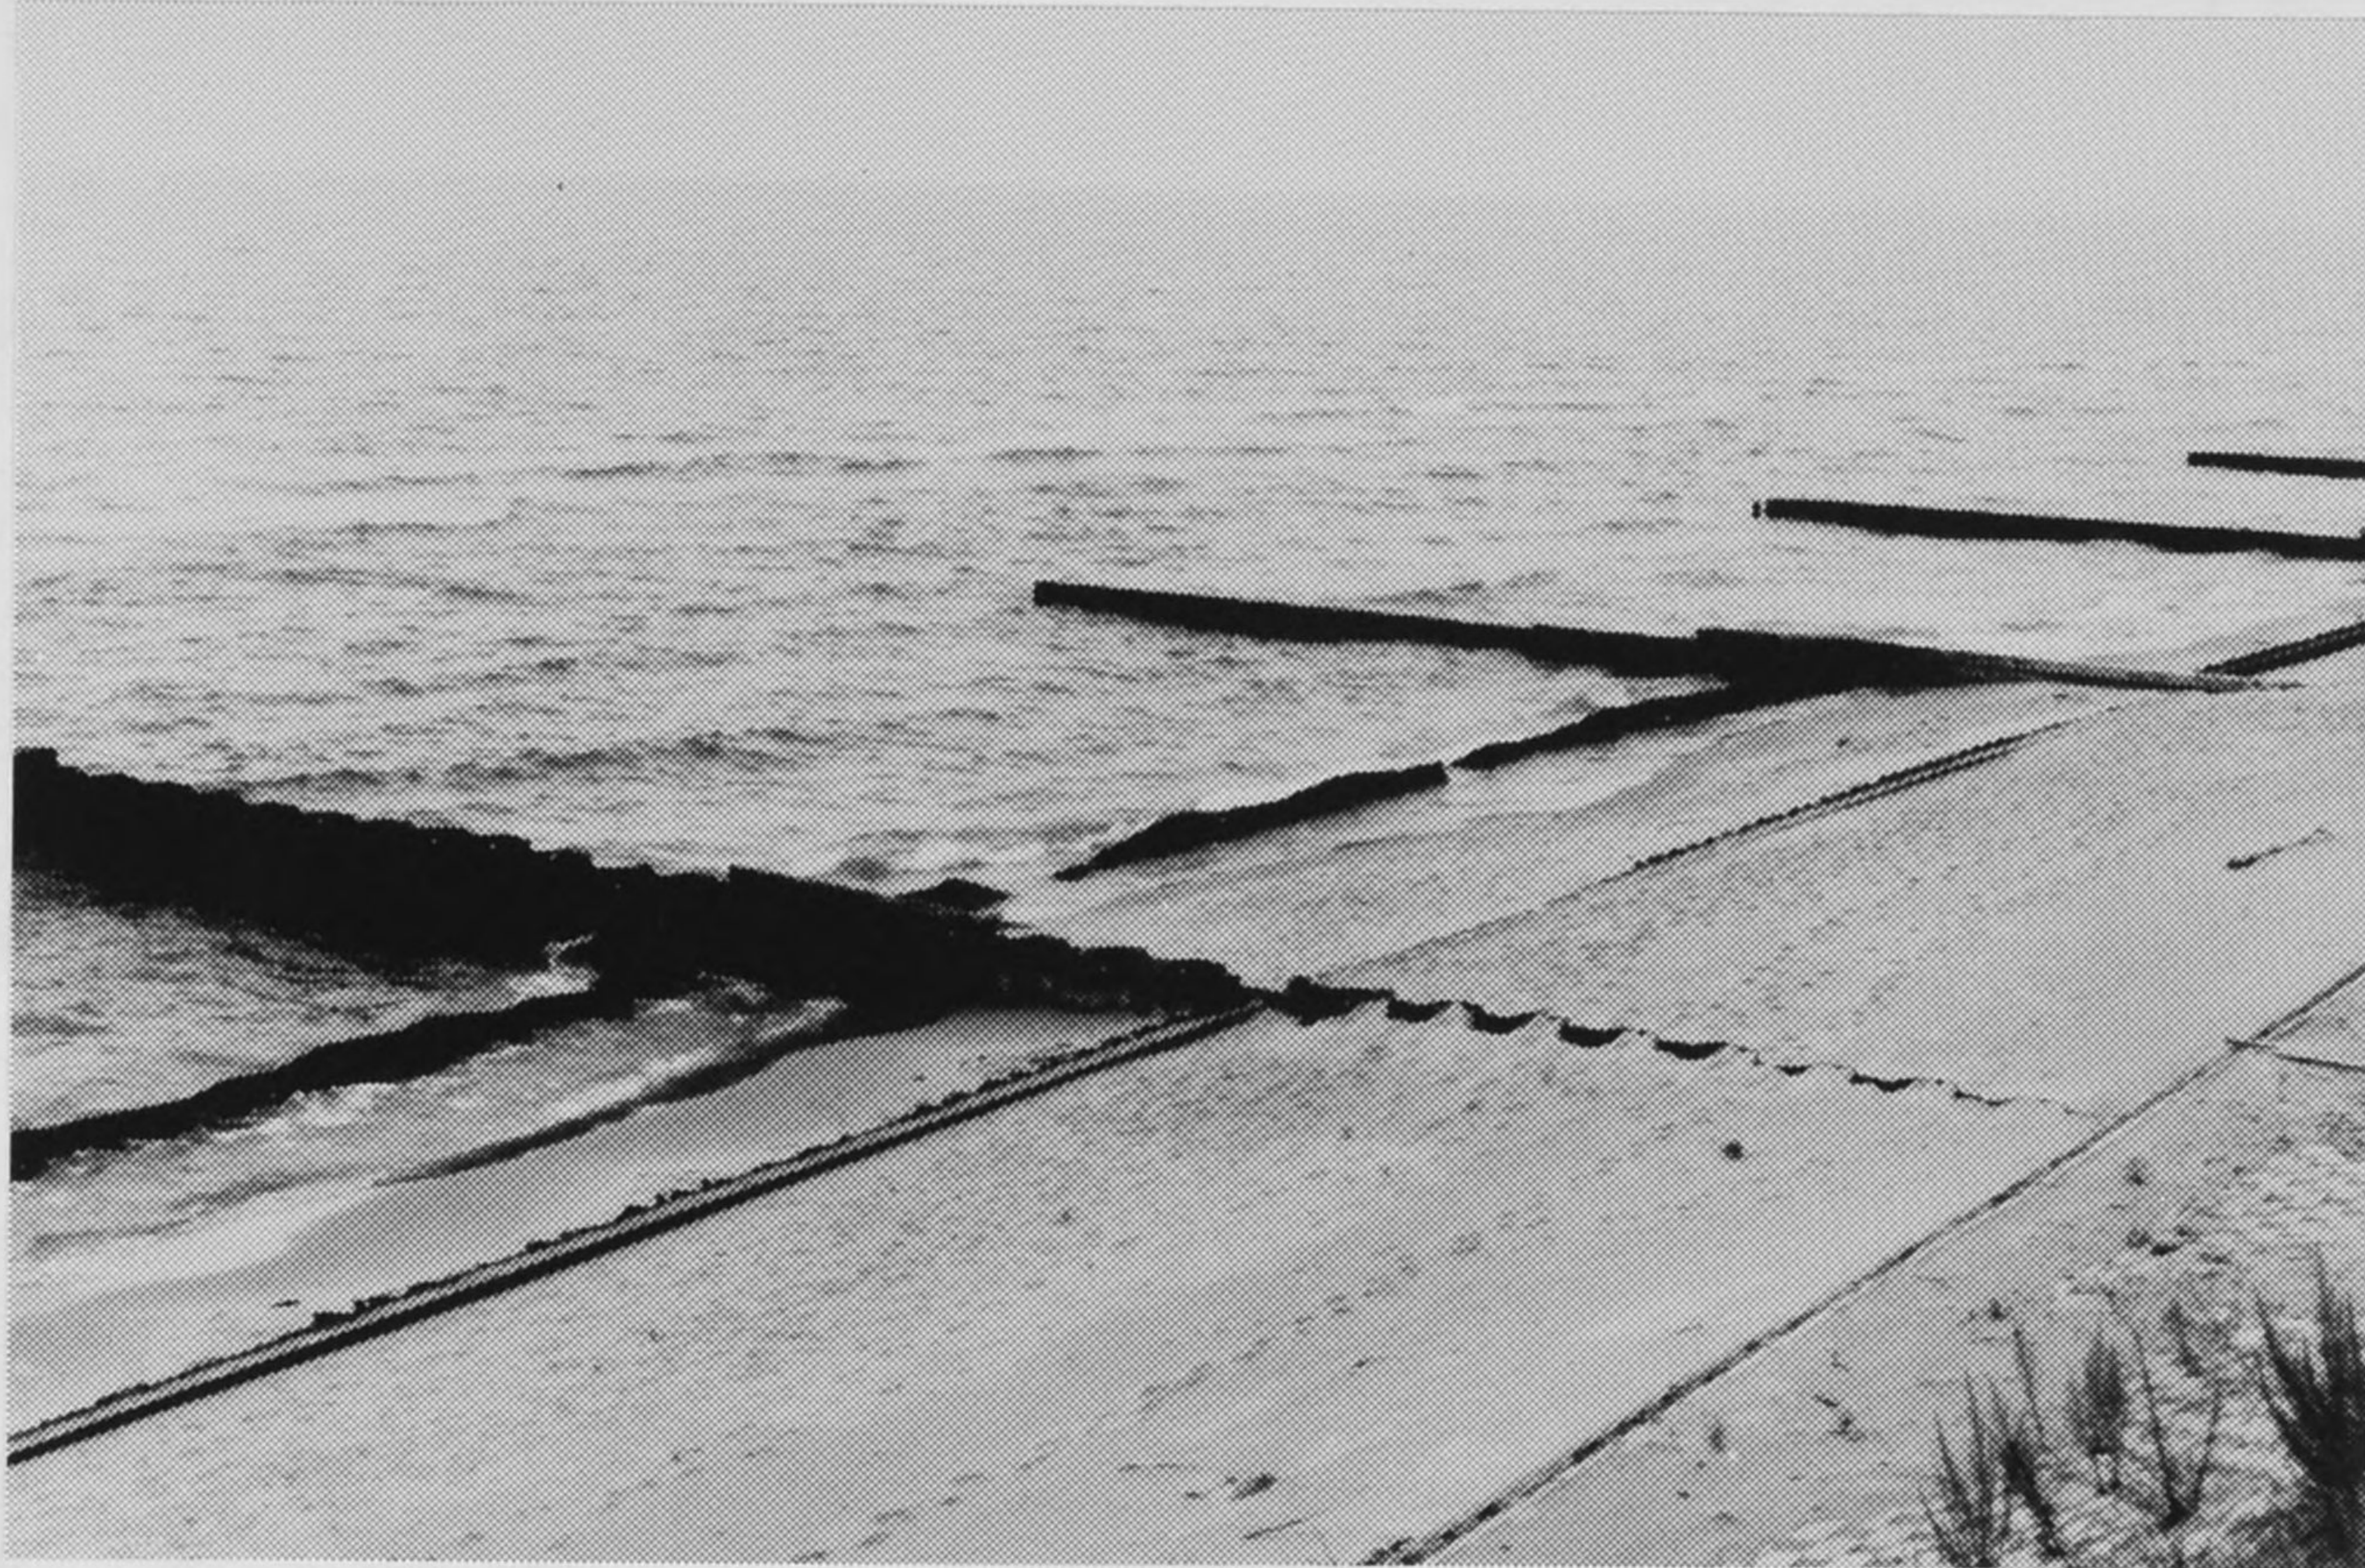
Figure B20. Site H: View of tops of wavebusters between groins 8 - 10 from north end of site. Wavebusters in center are also visible in Fig. B19. Note sills onshore from wavebusters.

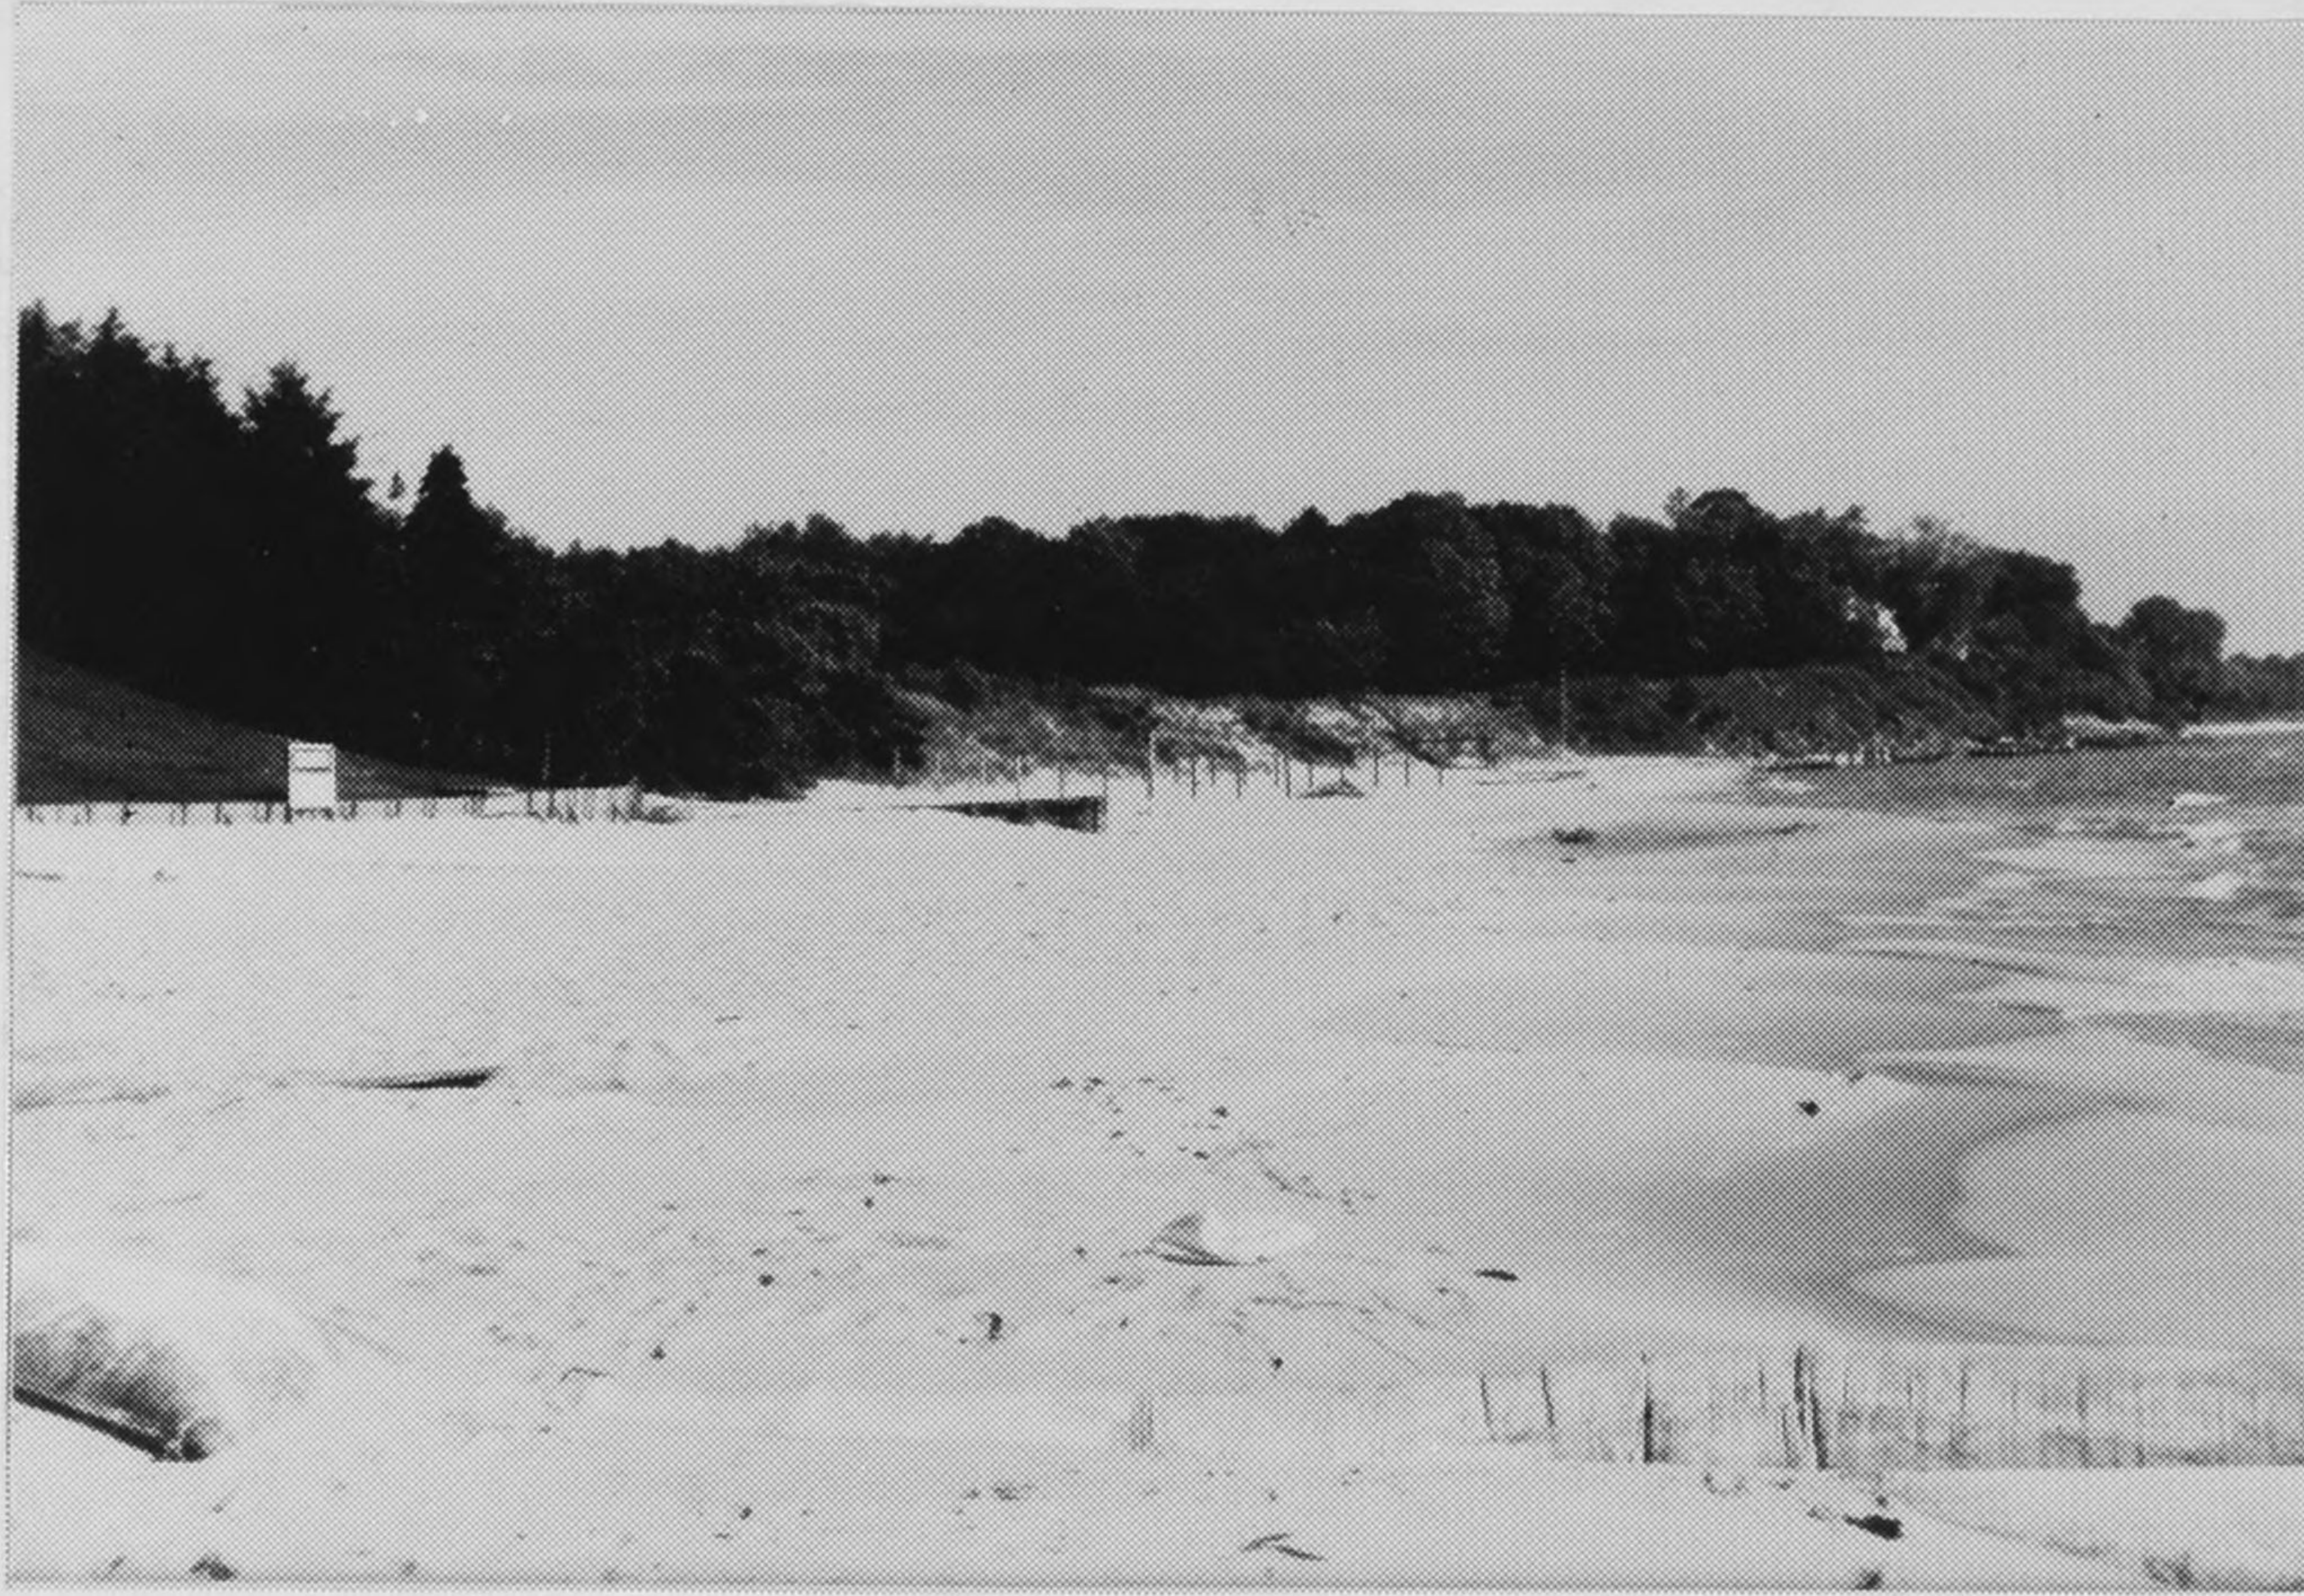
Figure B22. Site I: Looking south across Reid property, standing on Epworth property (site J). Tube groin on south side of Epworth property is in foreground, Light colored tube groin at center of property is barely visible below and right of sign. Timber groin at south side of property is also visible and note lack of beach farther south.

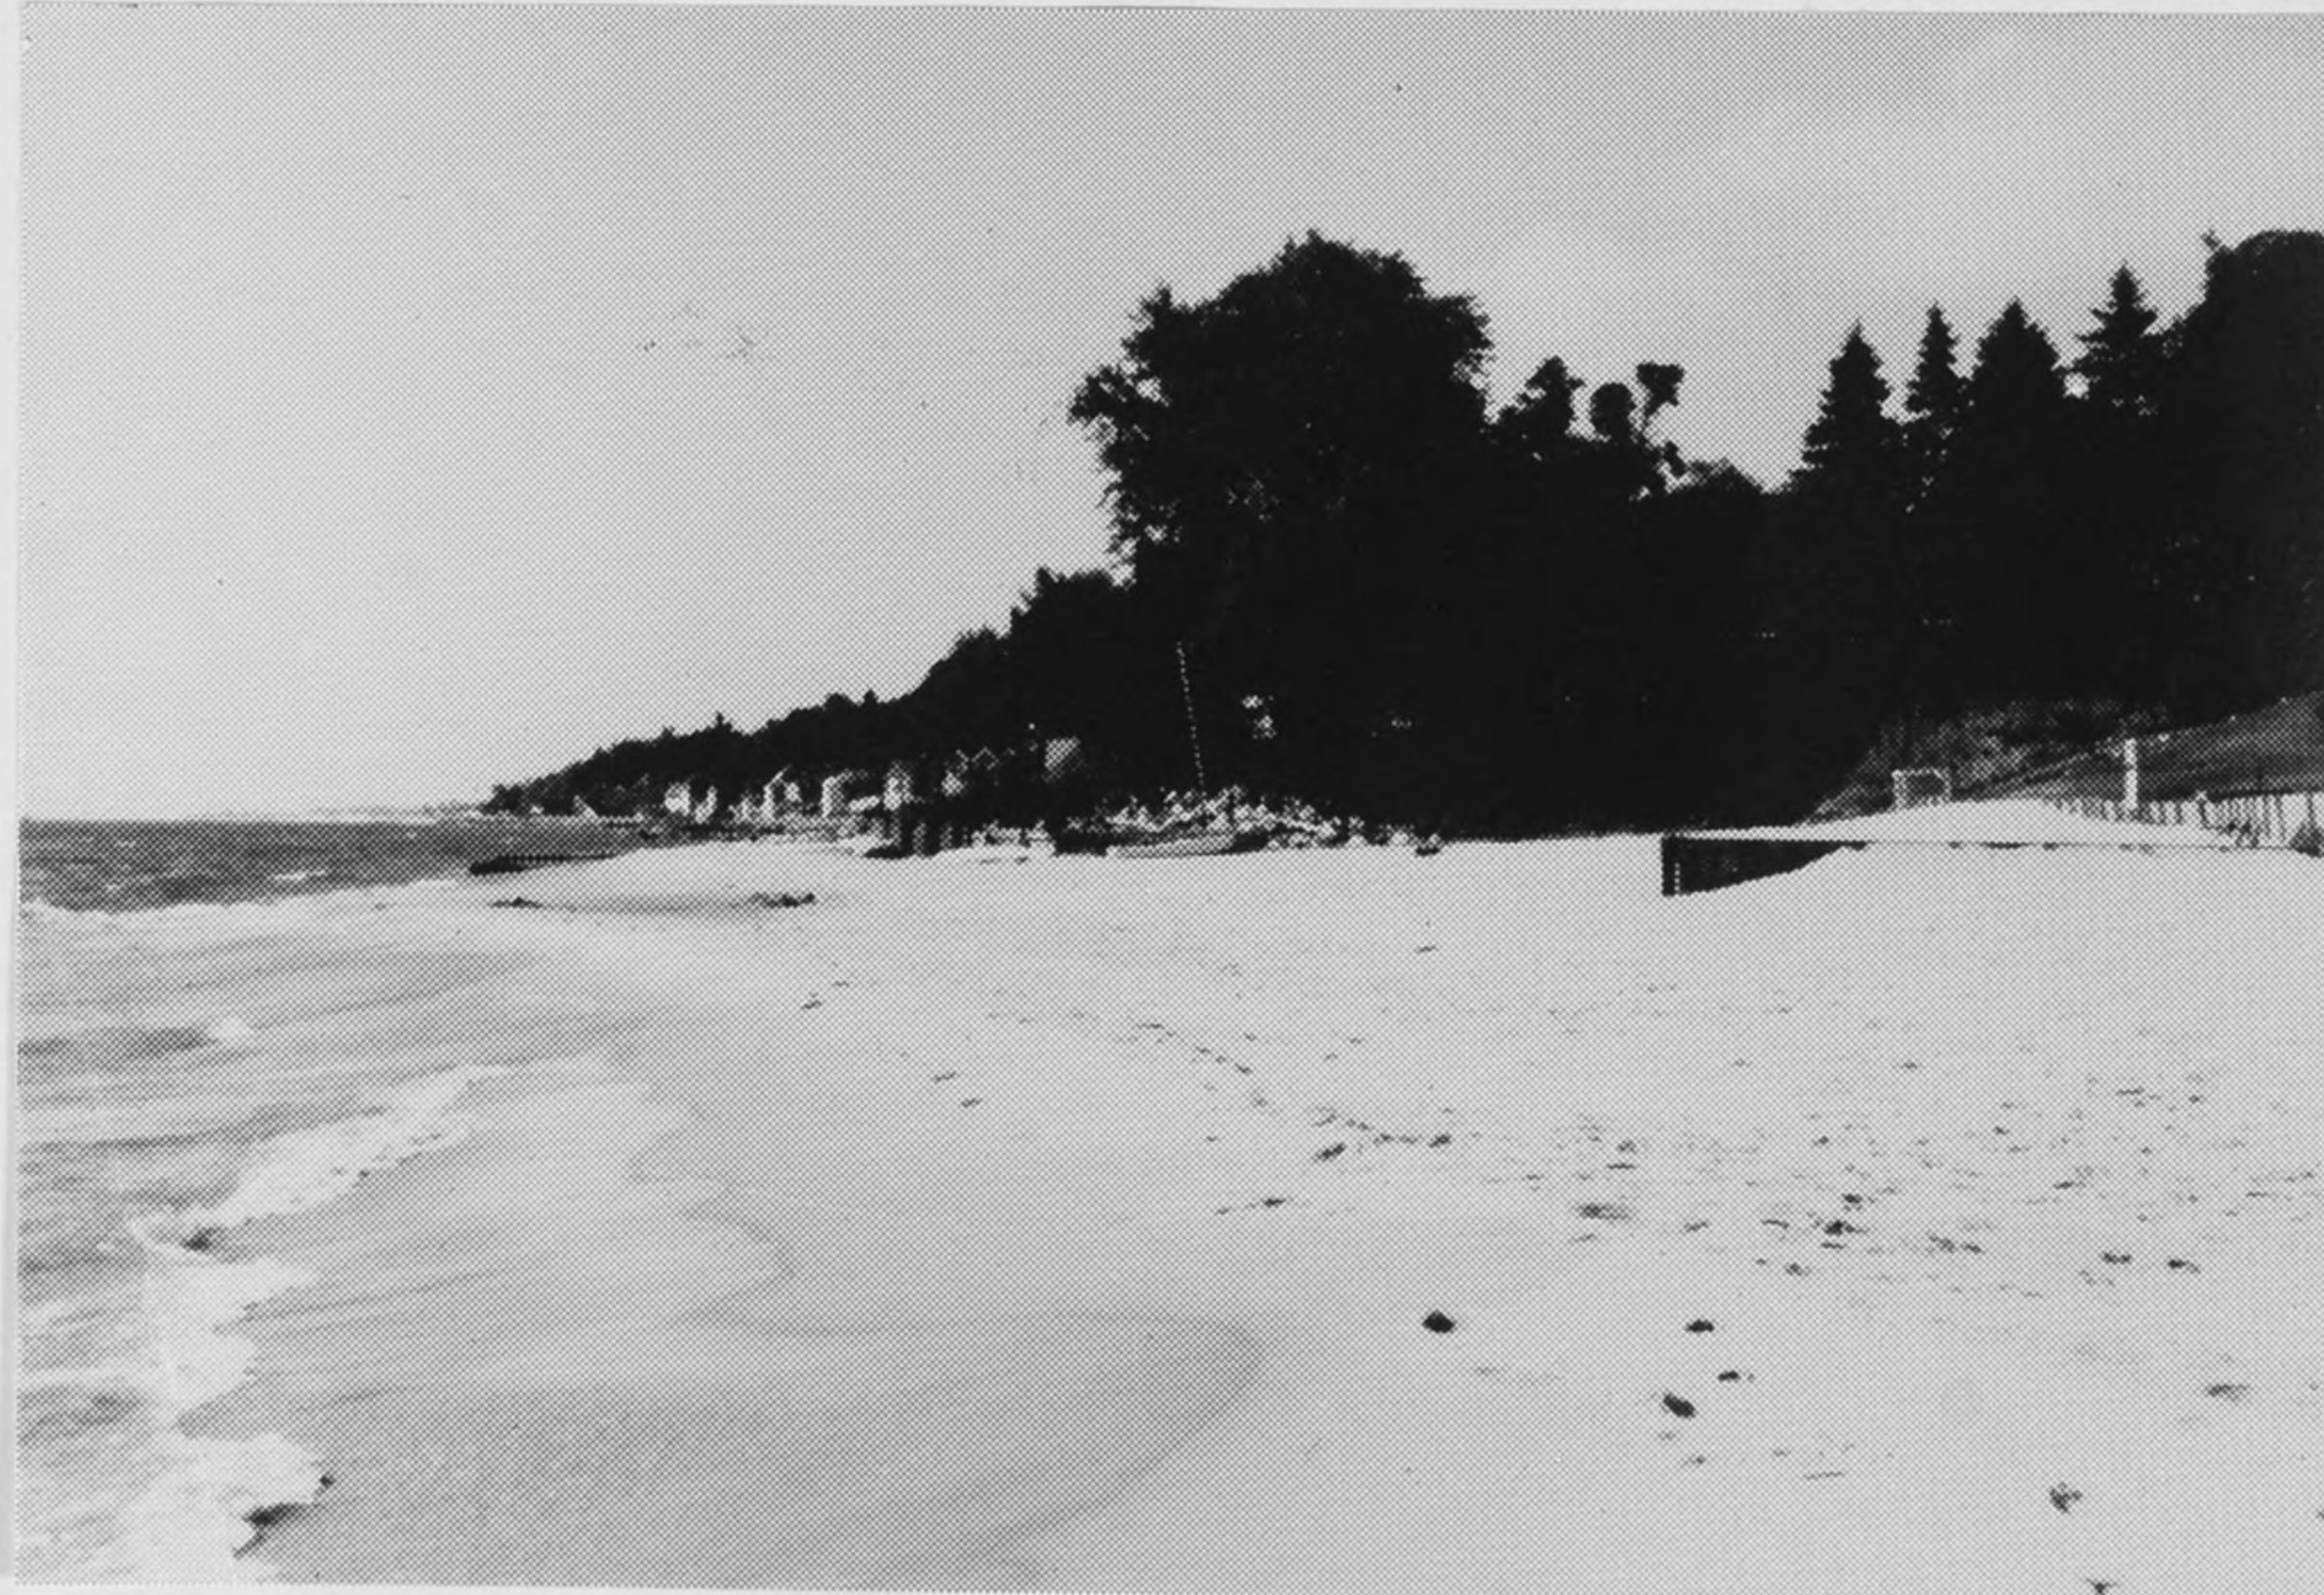
Figure B23. Site I: Looking north across property. Timber groin at south property boundary is present at center right and end of tube groin on Epworth property is also visible below edge of line of trees. Epworth property is on other side of sailboat.

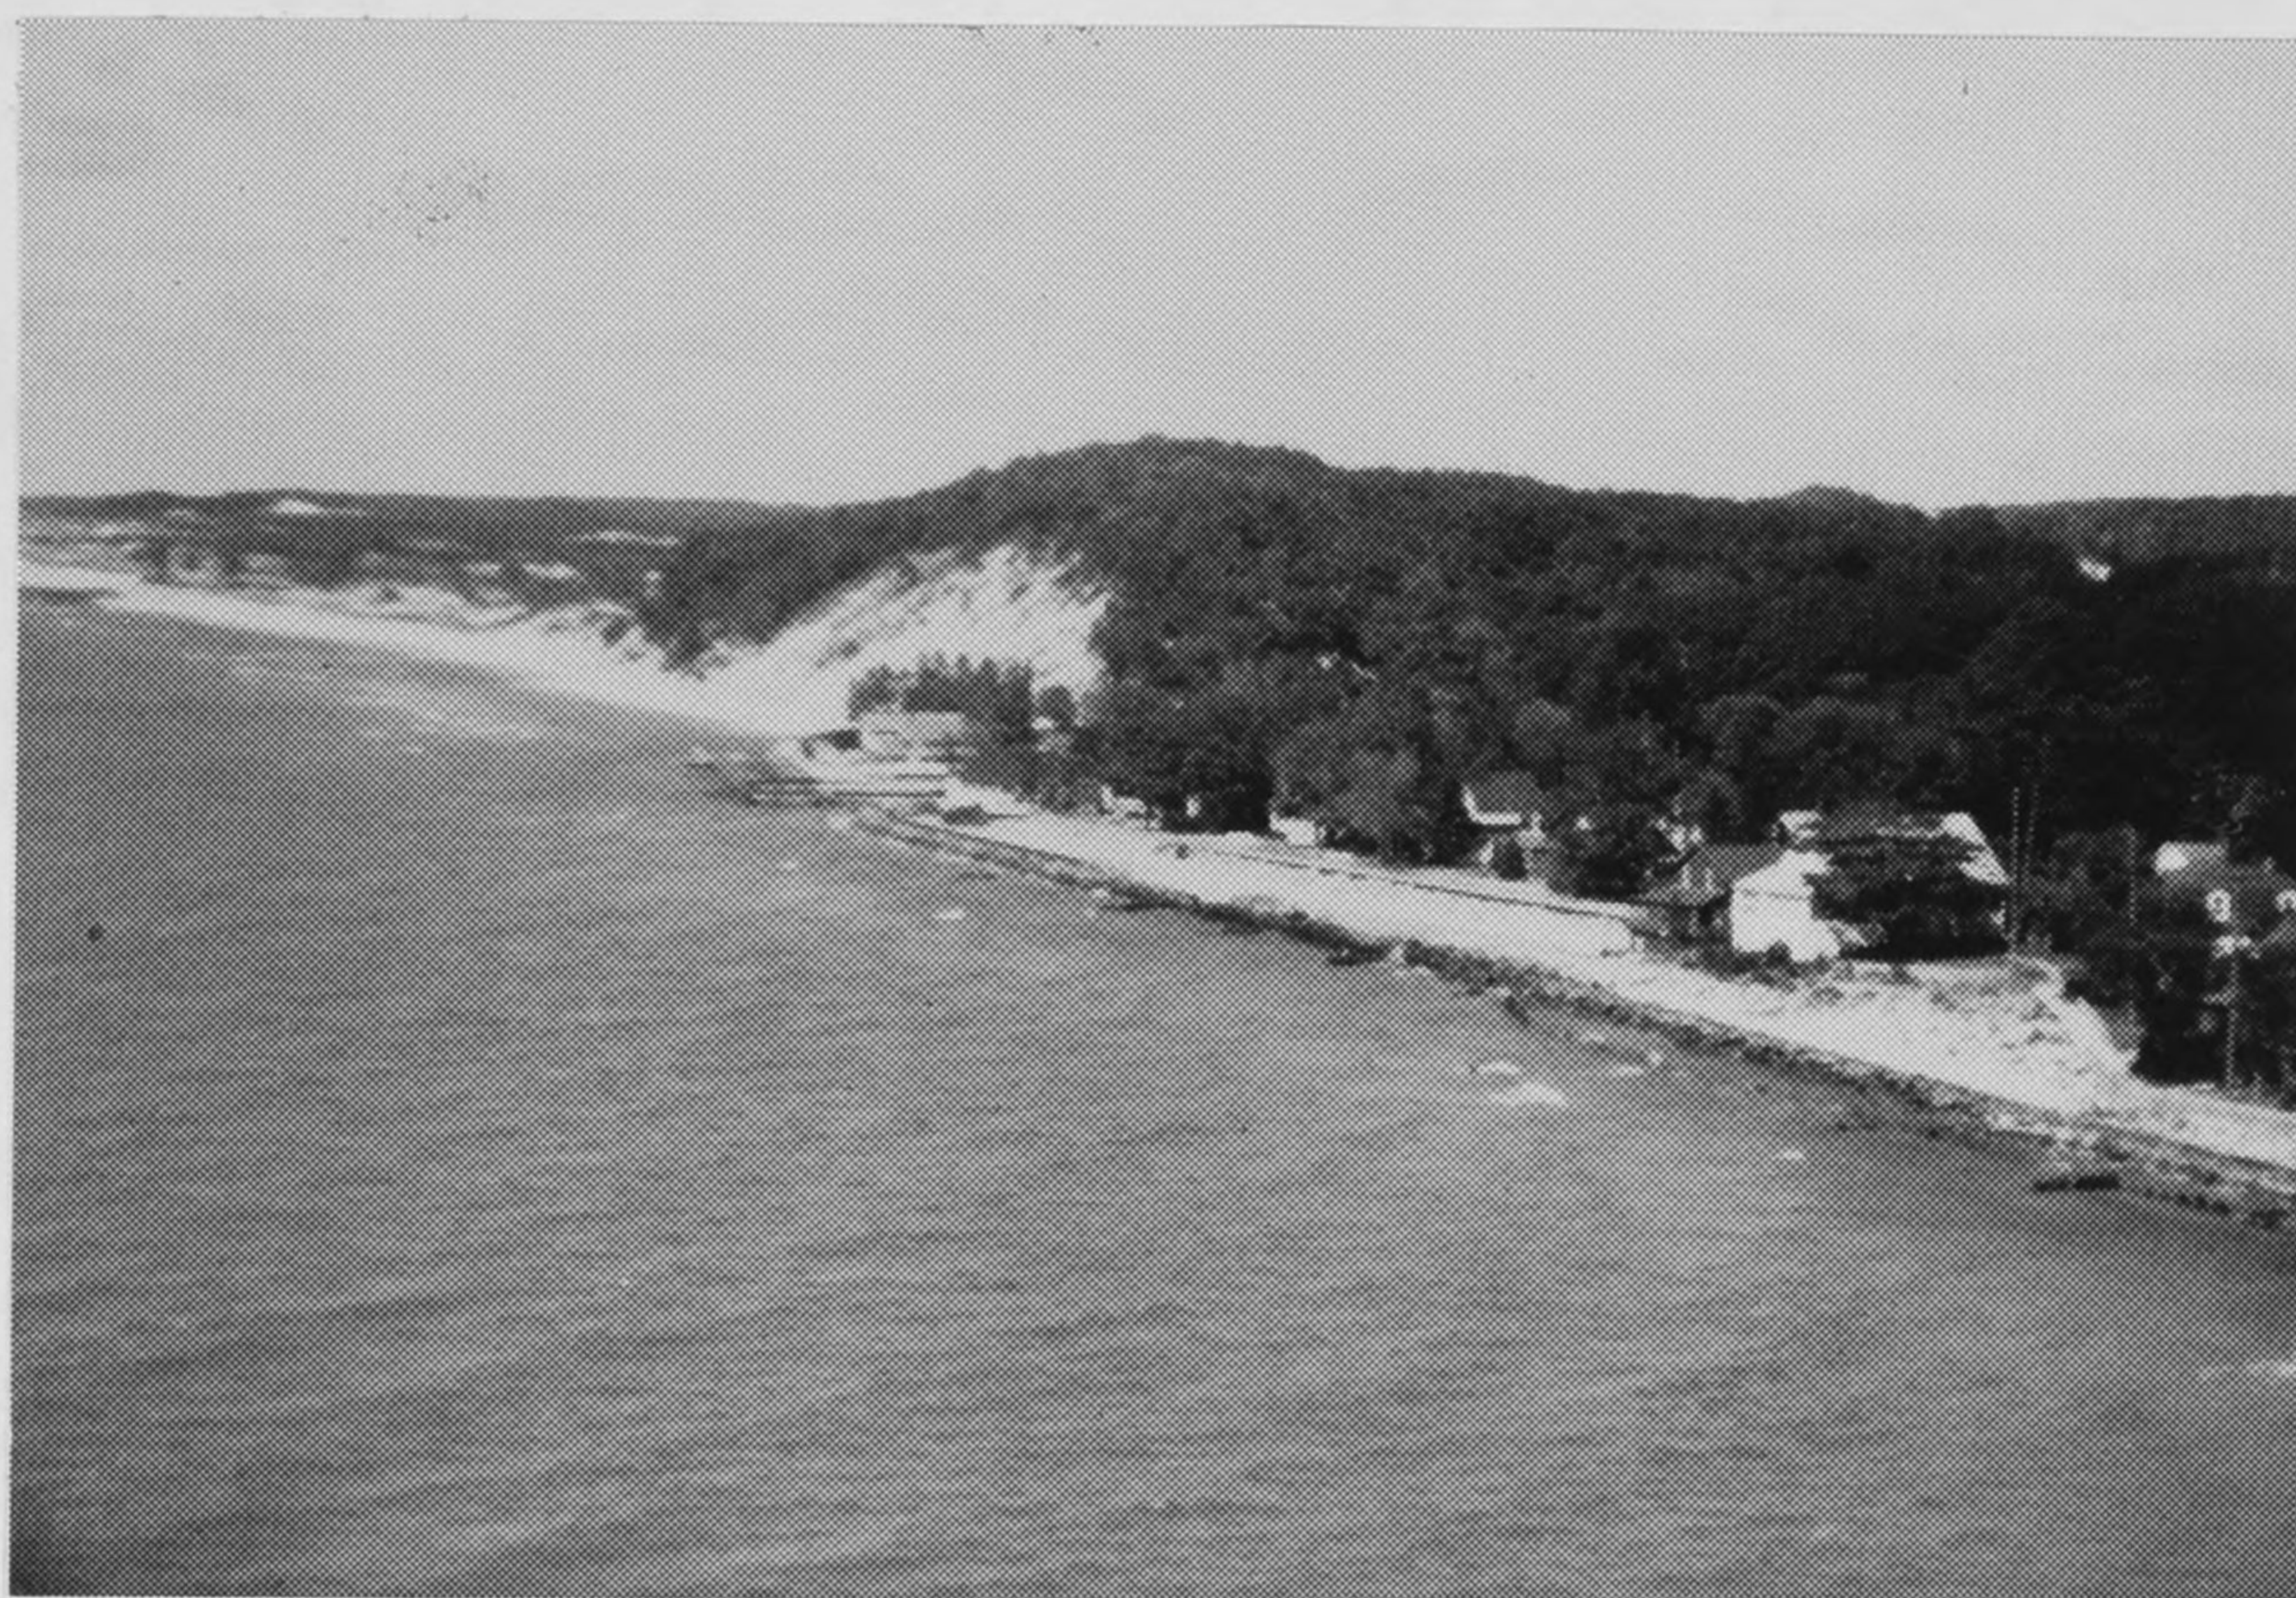
Figure B26. Site J: Aerial view of northern part of Epworth property. Revetment is visible along shoreline with remnants of old shore protection systems.

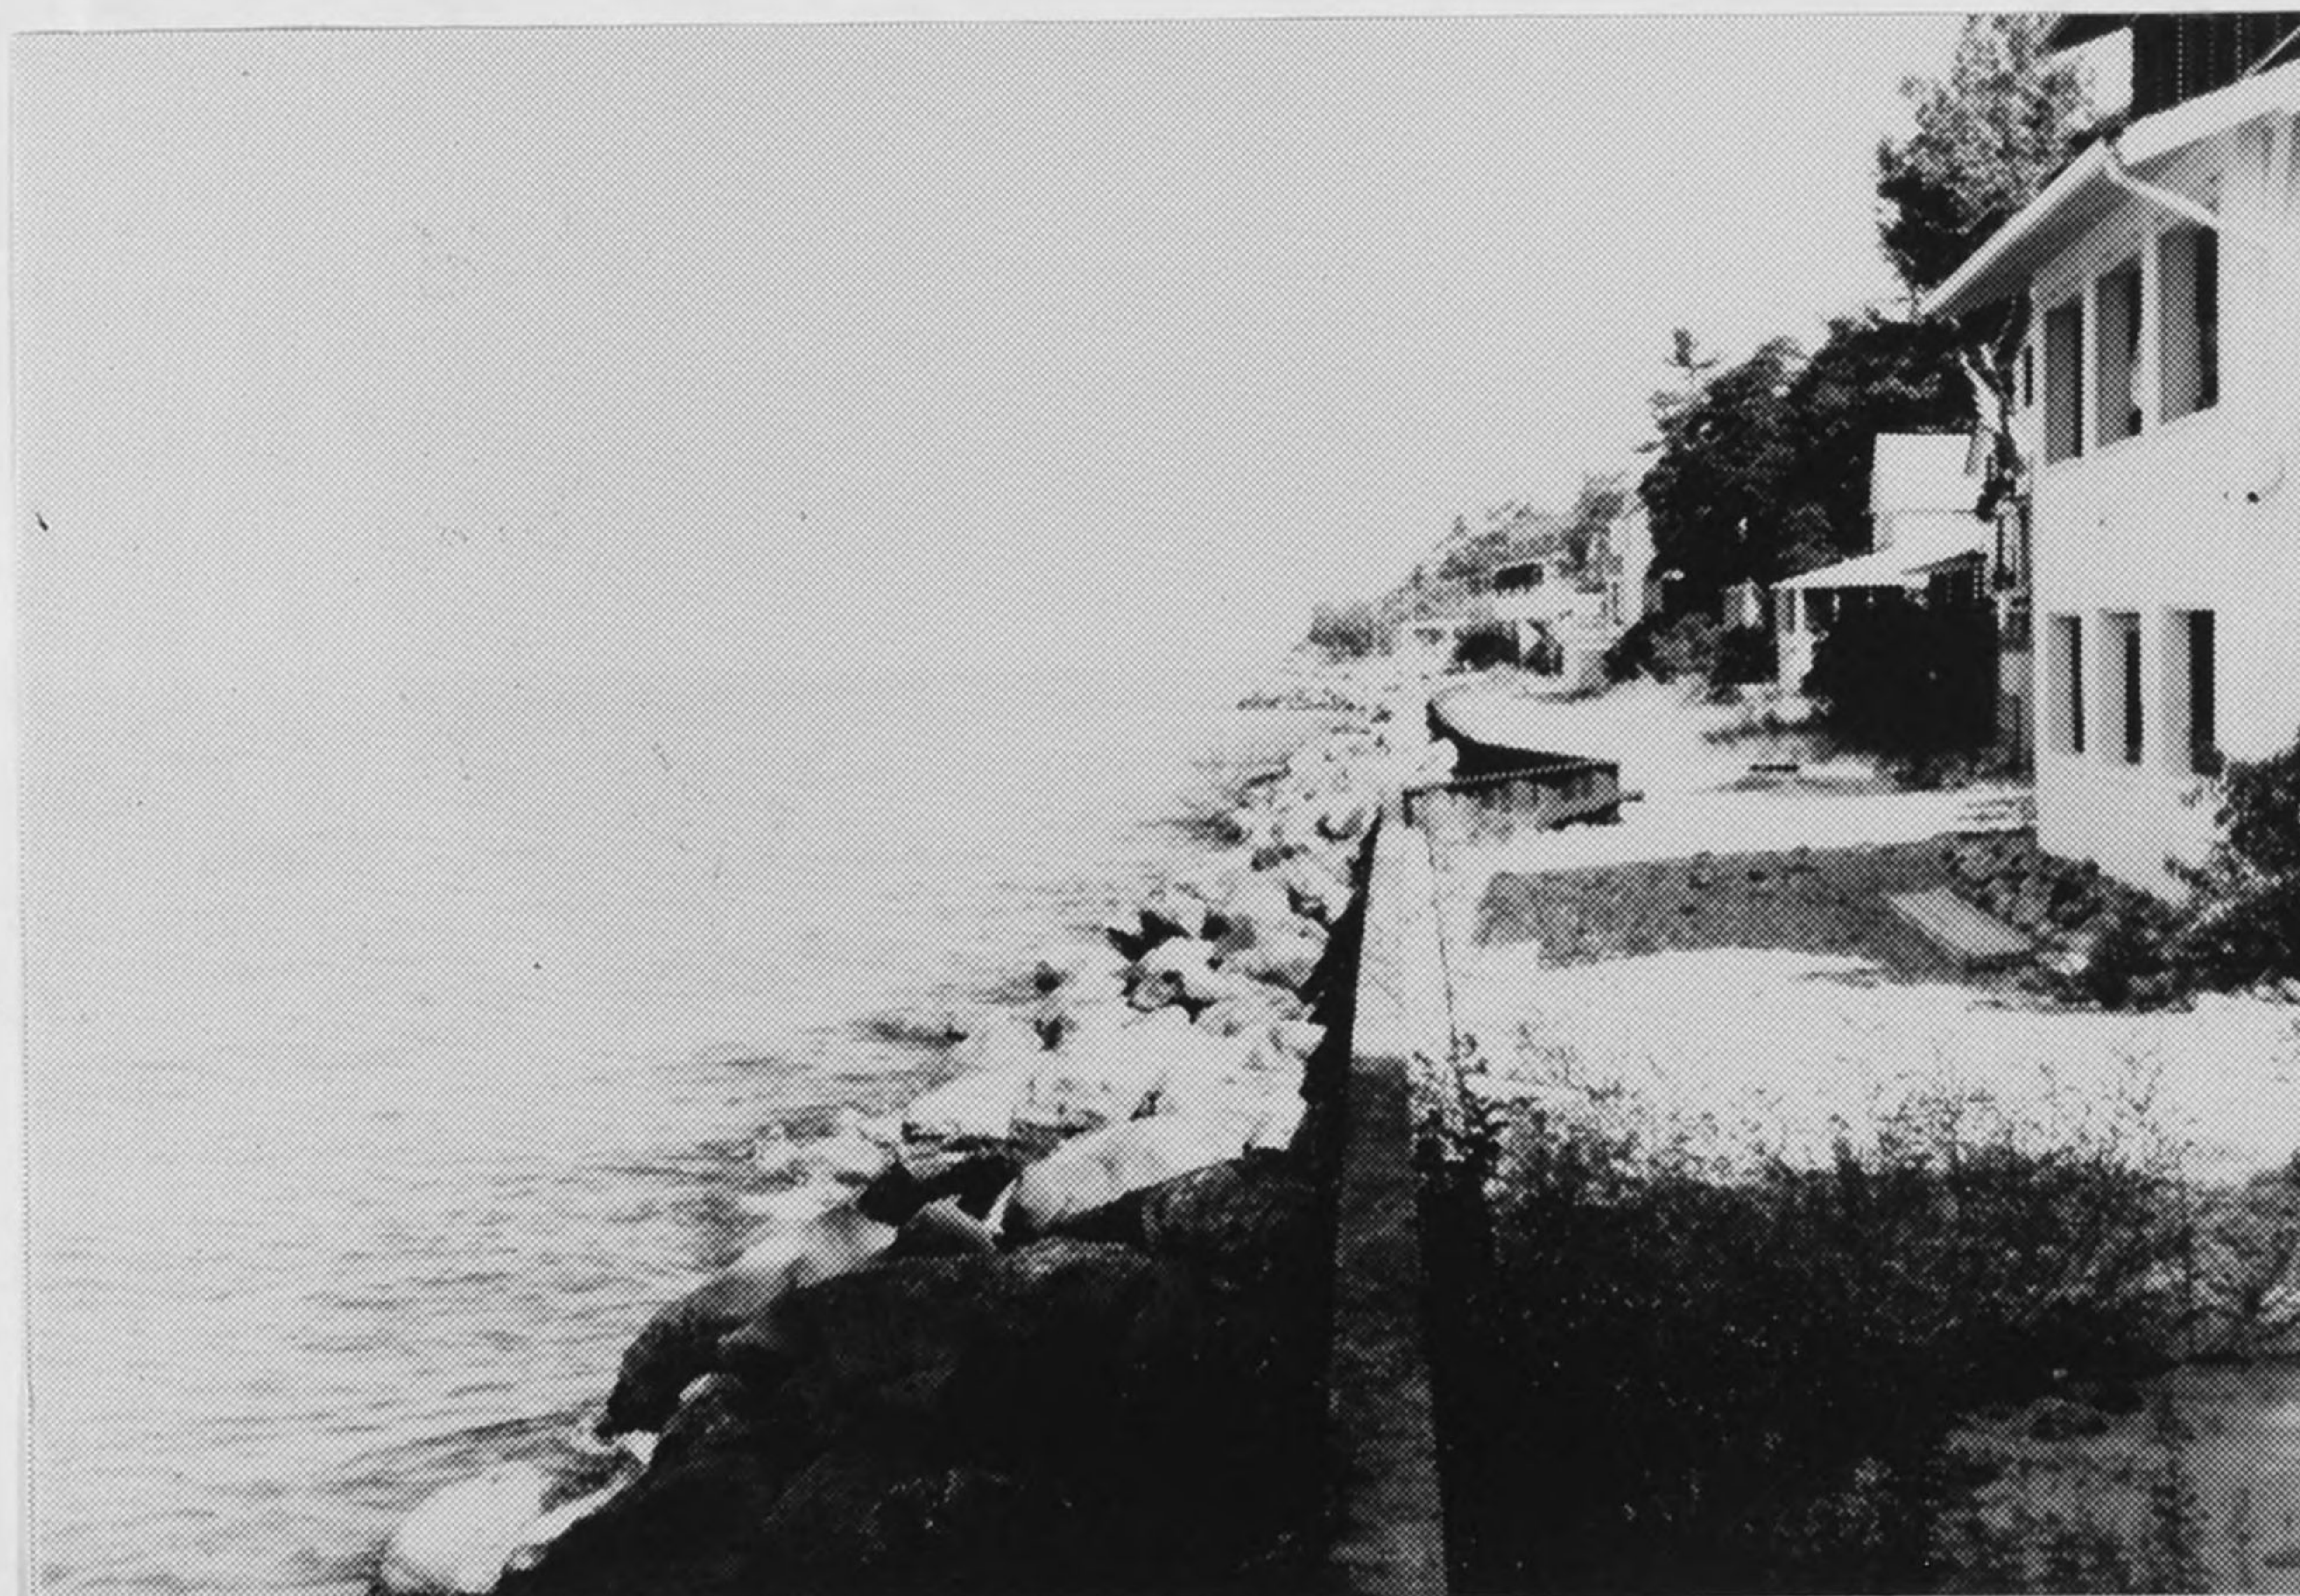
Figure B27. Site J: Closer view of revetment at location where it is backed by a retaining wall.

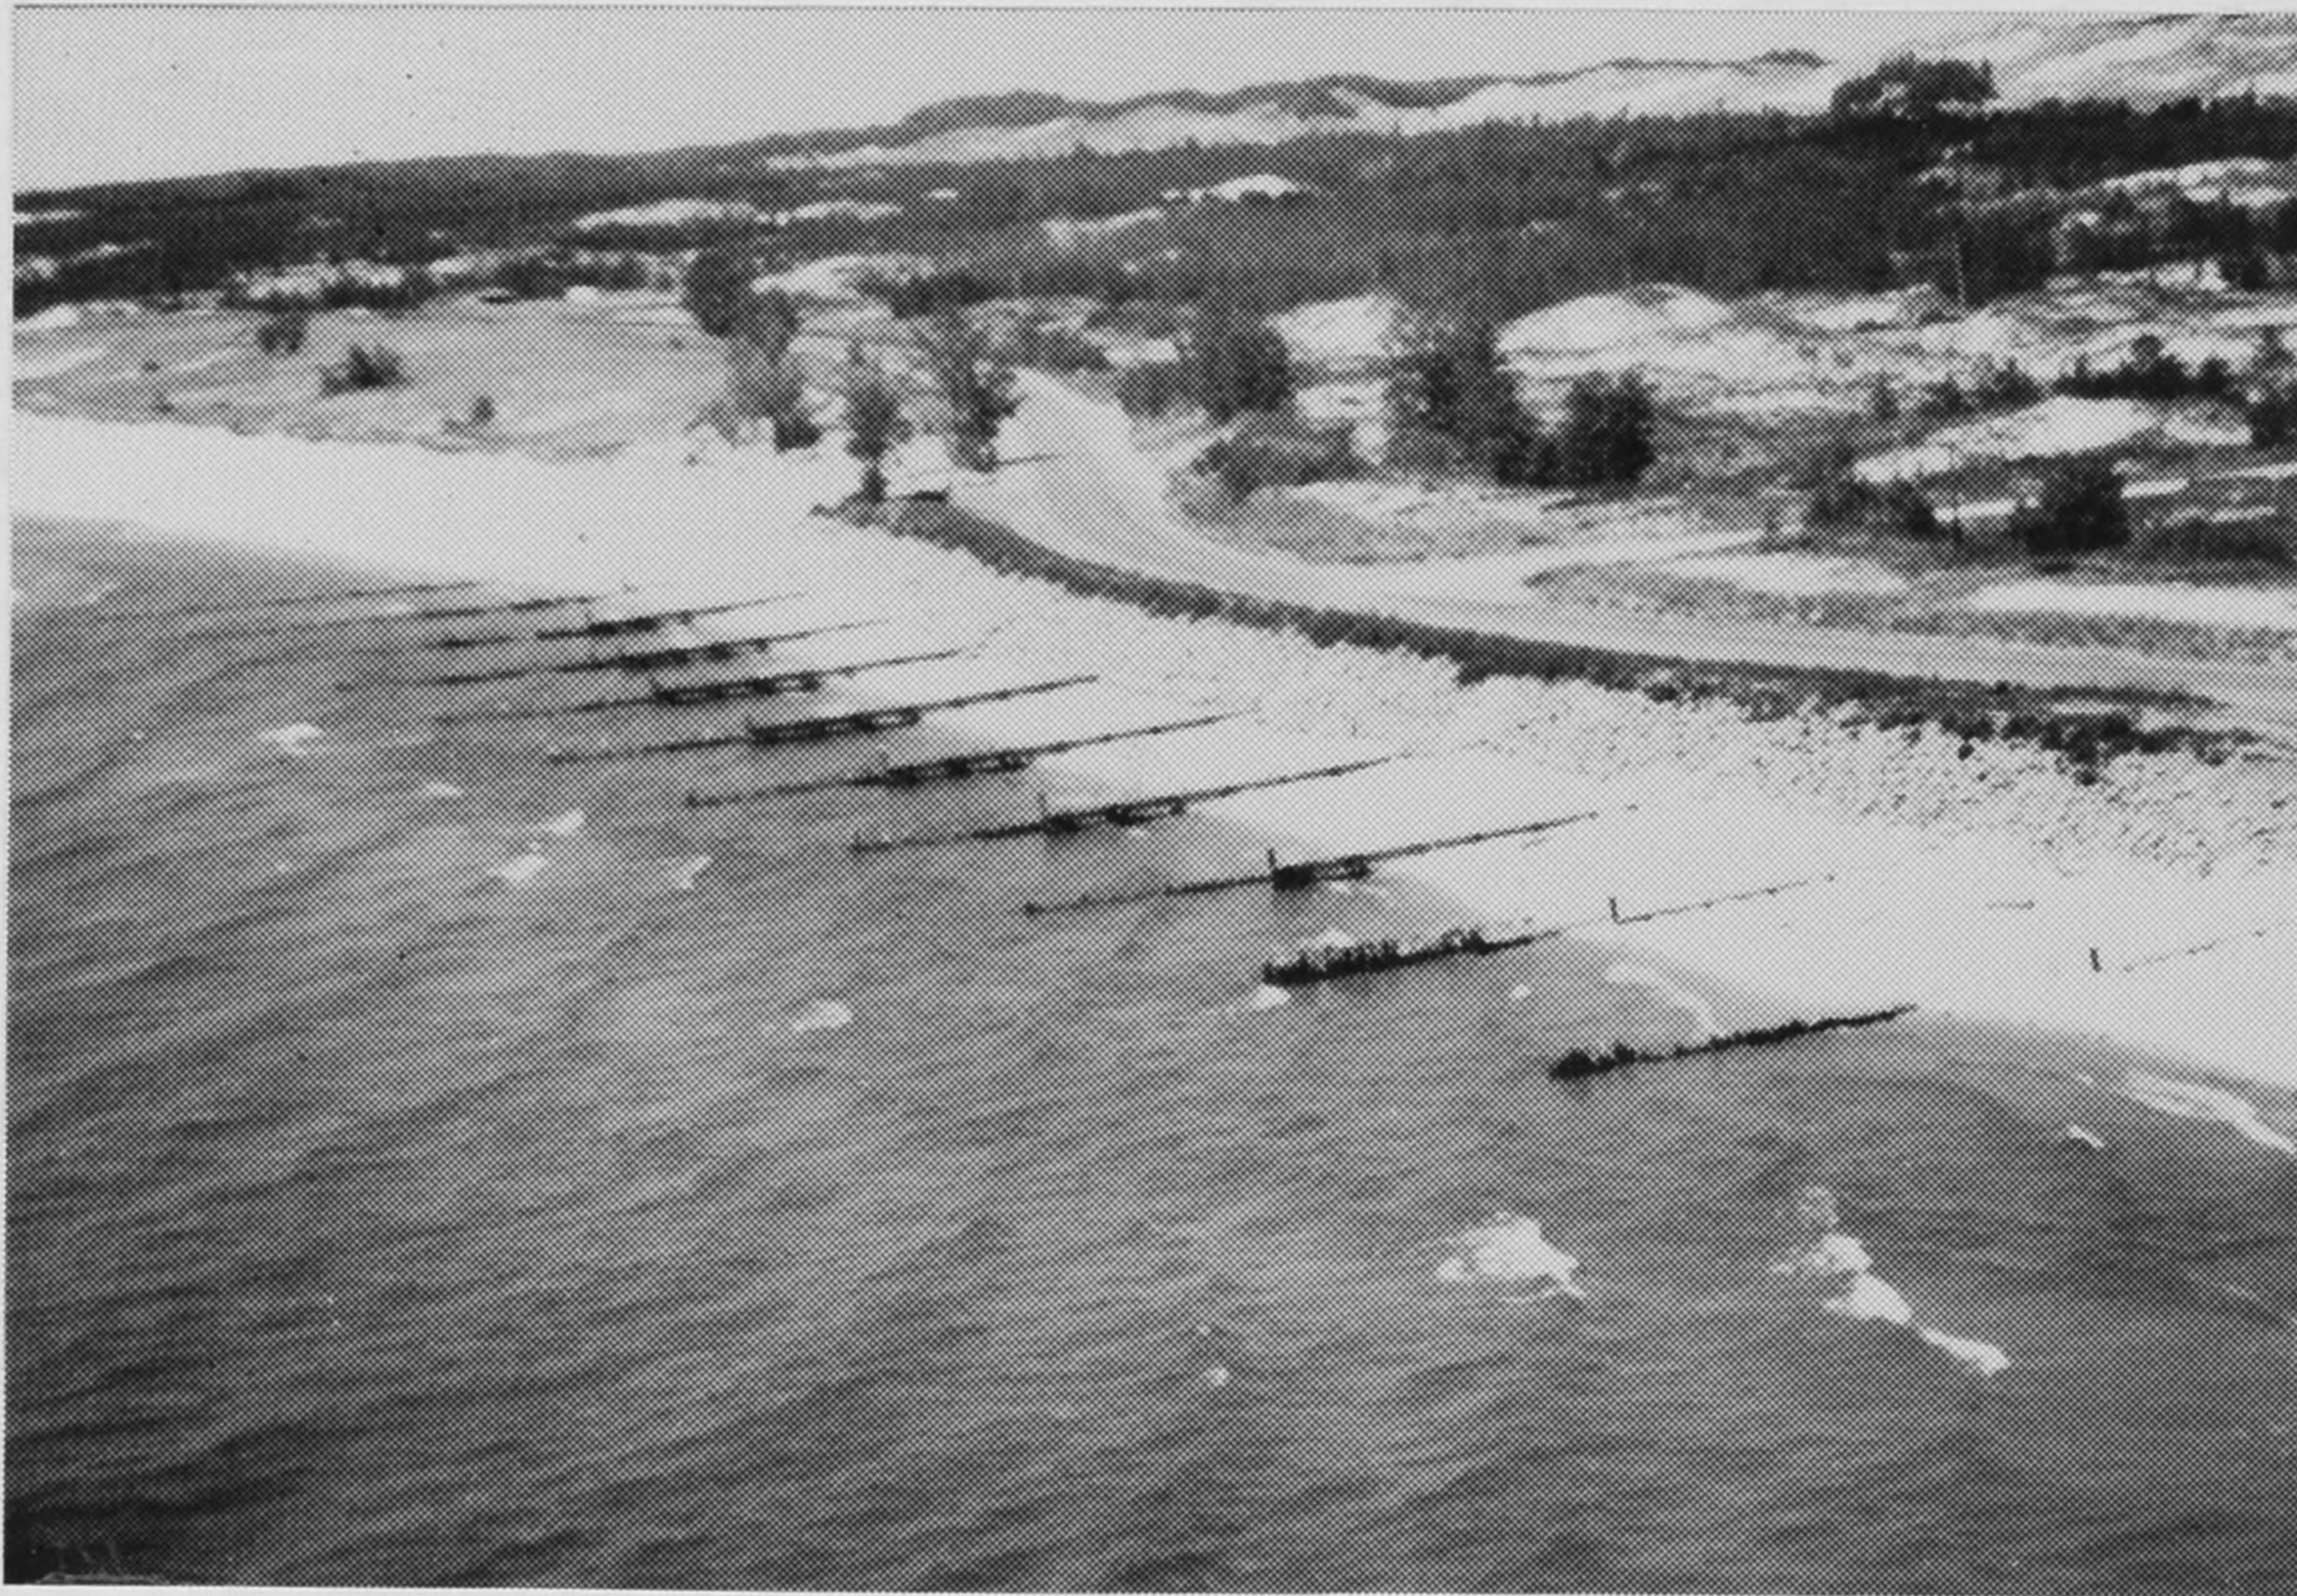
Figure B28. Site K: Aerial view of 13 groin field. Note remnants of old groin system.
