**EVALUATION OF GREAT LAKES
SHORE PROTECTION STRUCTURES**

Report UMCEE 88-8

**THE UNIVERSITY OF MICHIGAN
DEPARTMENT OF CIVIL ENGINEERING
ANN ARBOR, MICHIGAN**

**Michigan Department of Natural Resources
Coastal Management Program
Land and Water Division**

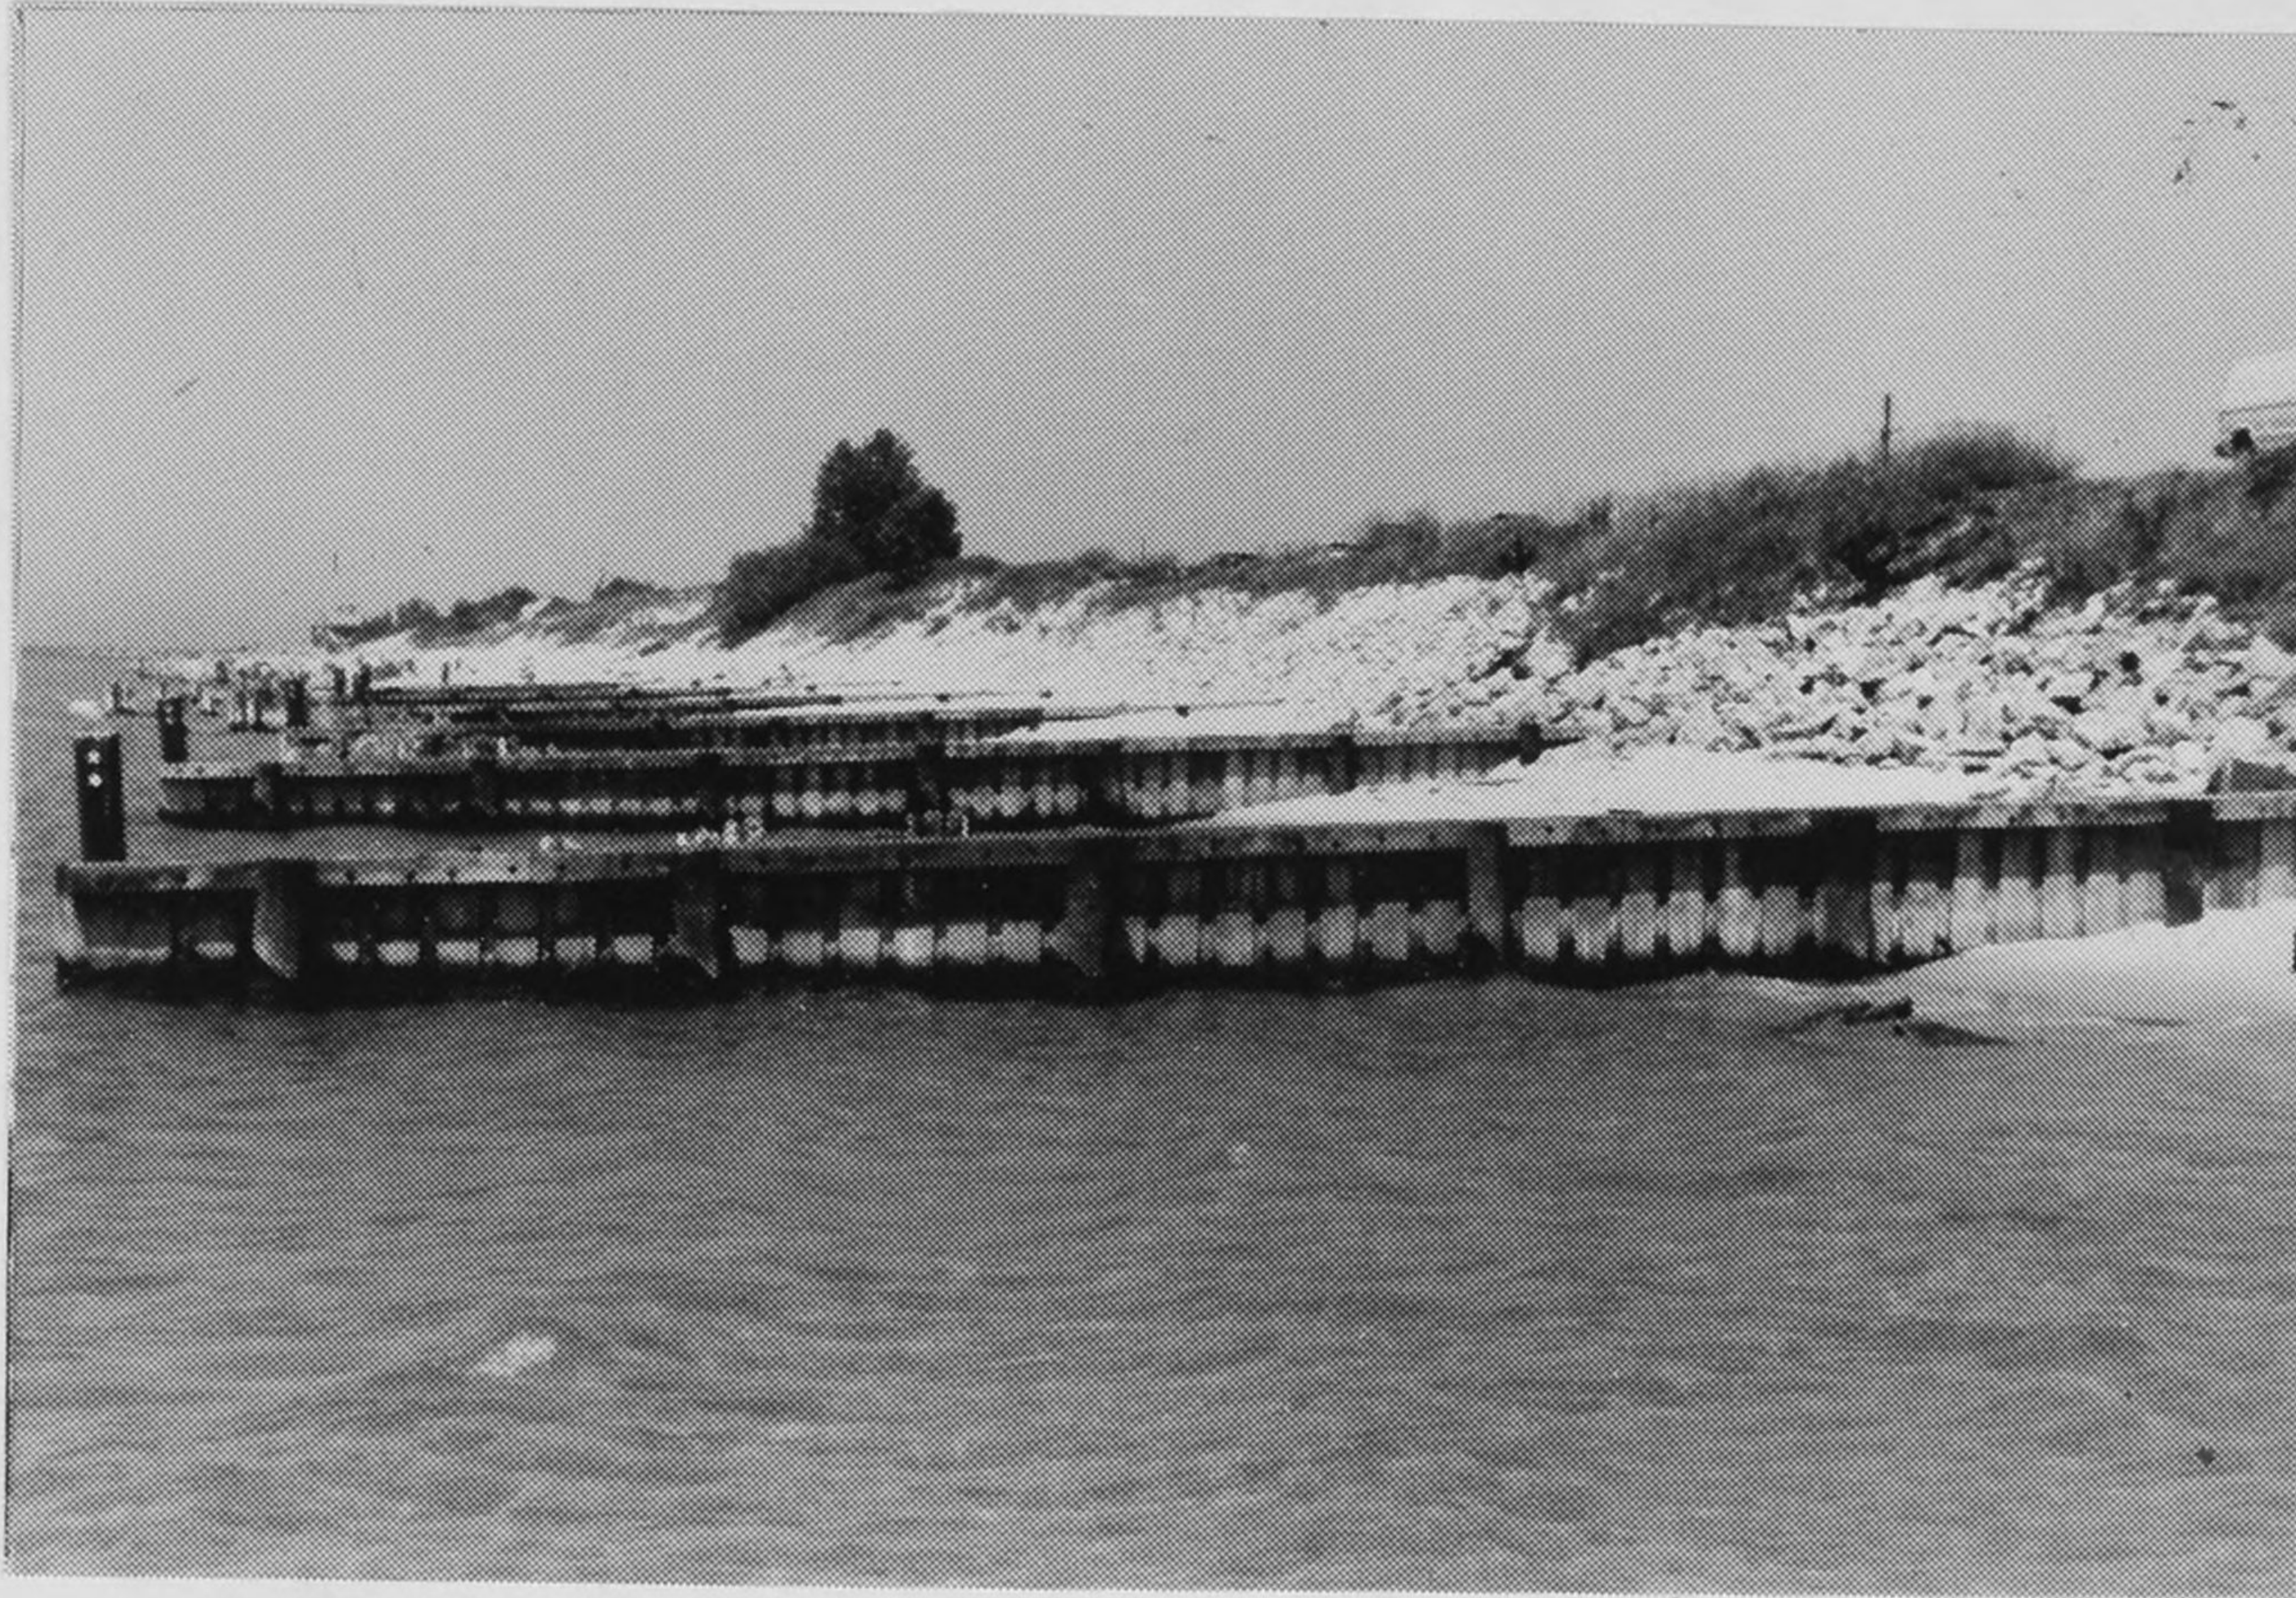
The above interpretation would be more or less consistent with the observations in the long (58 groins) groin field north of Ludington (site K) in which it is observed that the compartments within the groin field are filled more towards either end than in the center (Figs. B29 and 30). Since the original groin system also never filled at the center in the 25-plus year period of time after it was constructed, it would support the general conclusions drawn above. All of the other groin systems (including the 13 groin system just to the south) investigated were considerable shorter and the same features were not observed and conclusions are more difficult.

Figure B32. Site K: Looking north across long groin field. Groin in foreground is 50th from southern end of system or close to northern end.

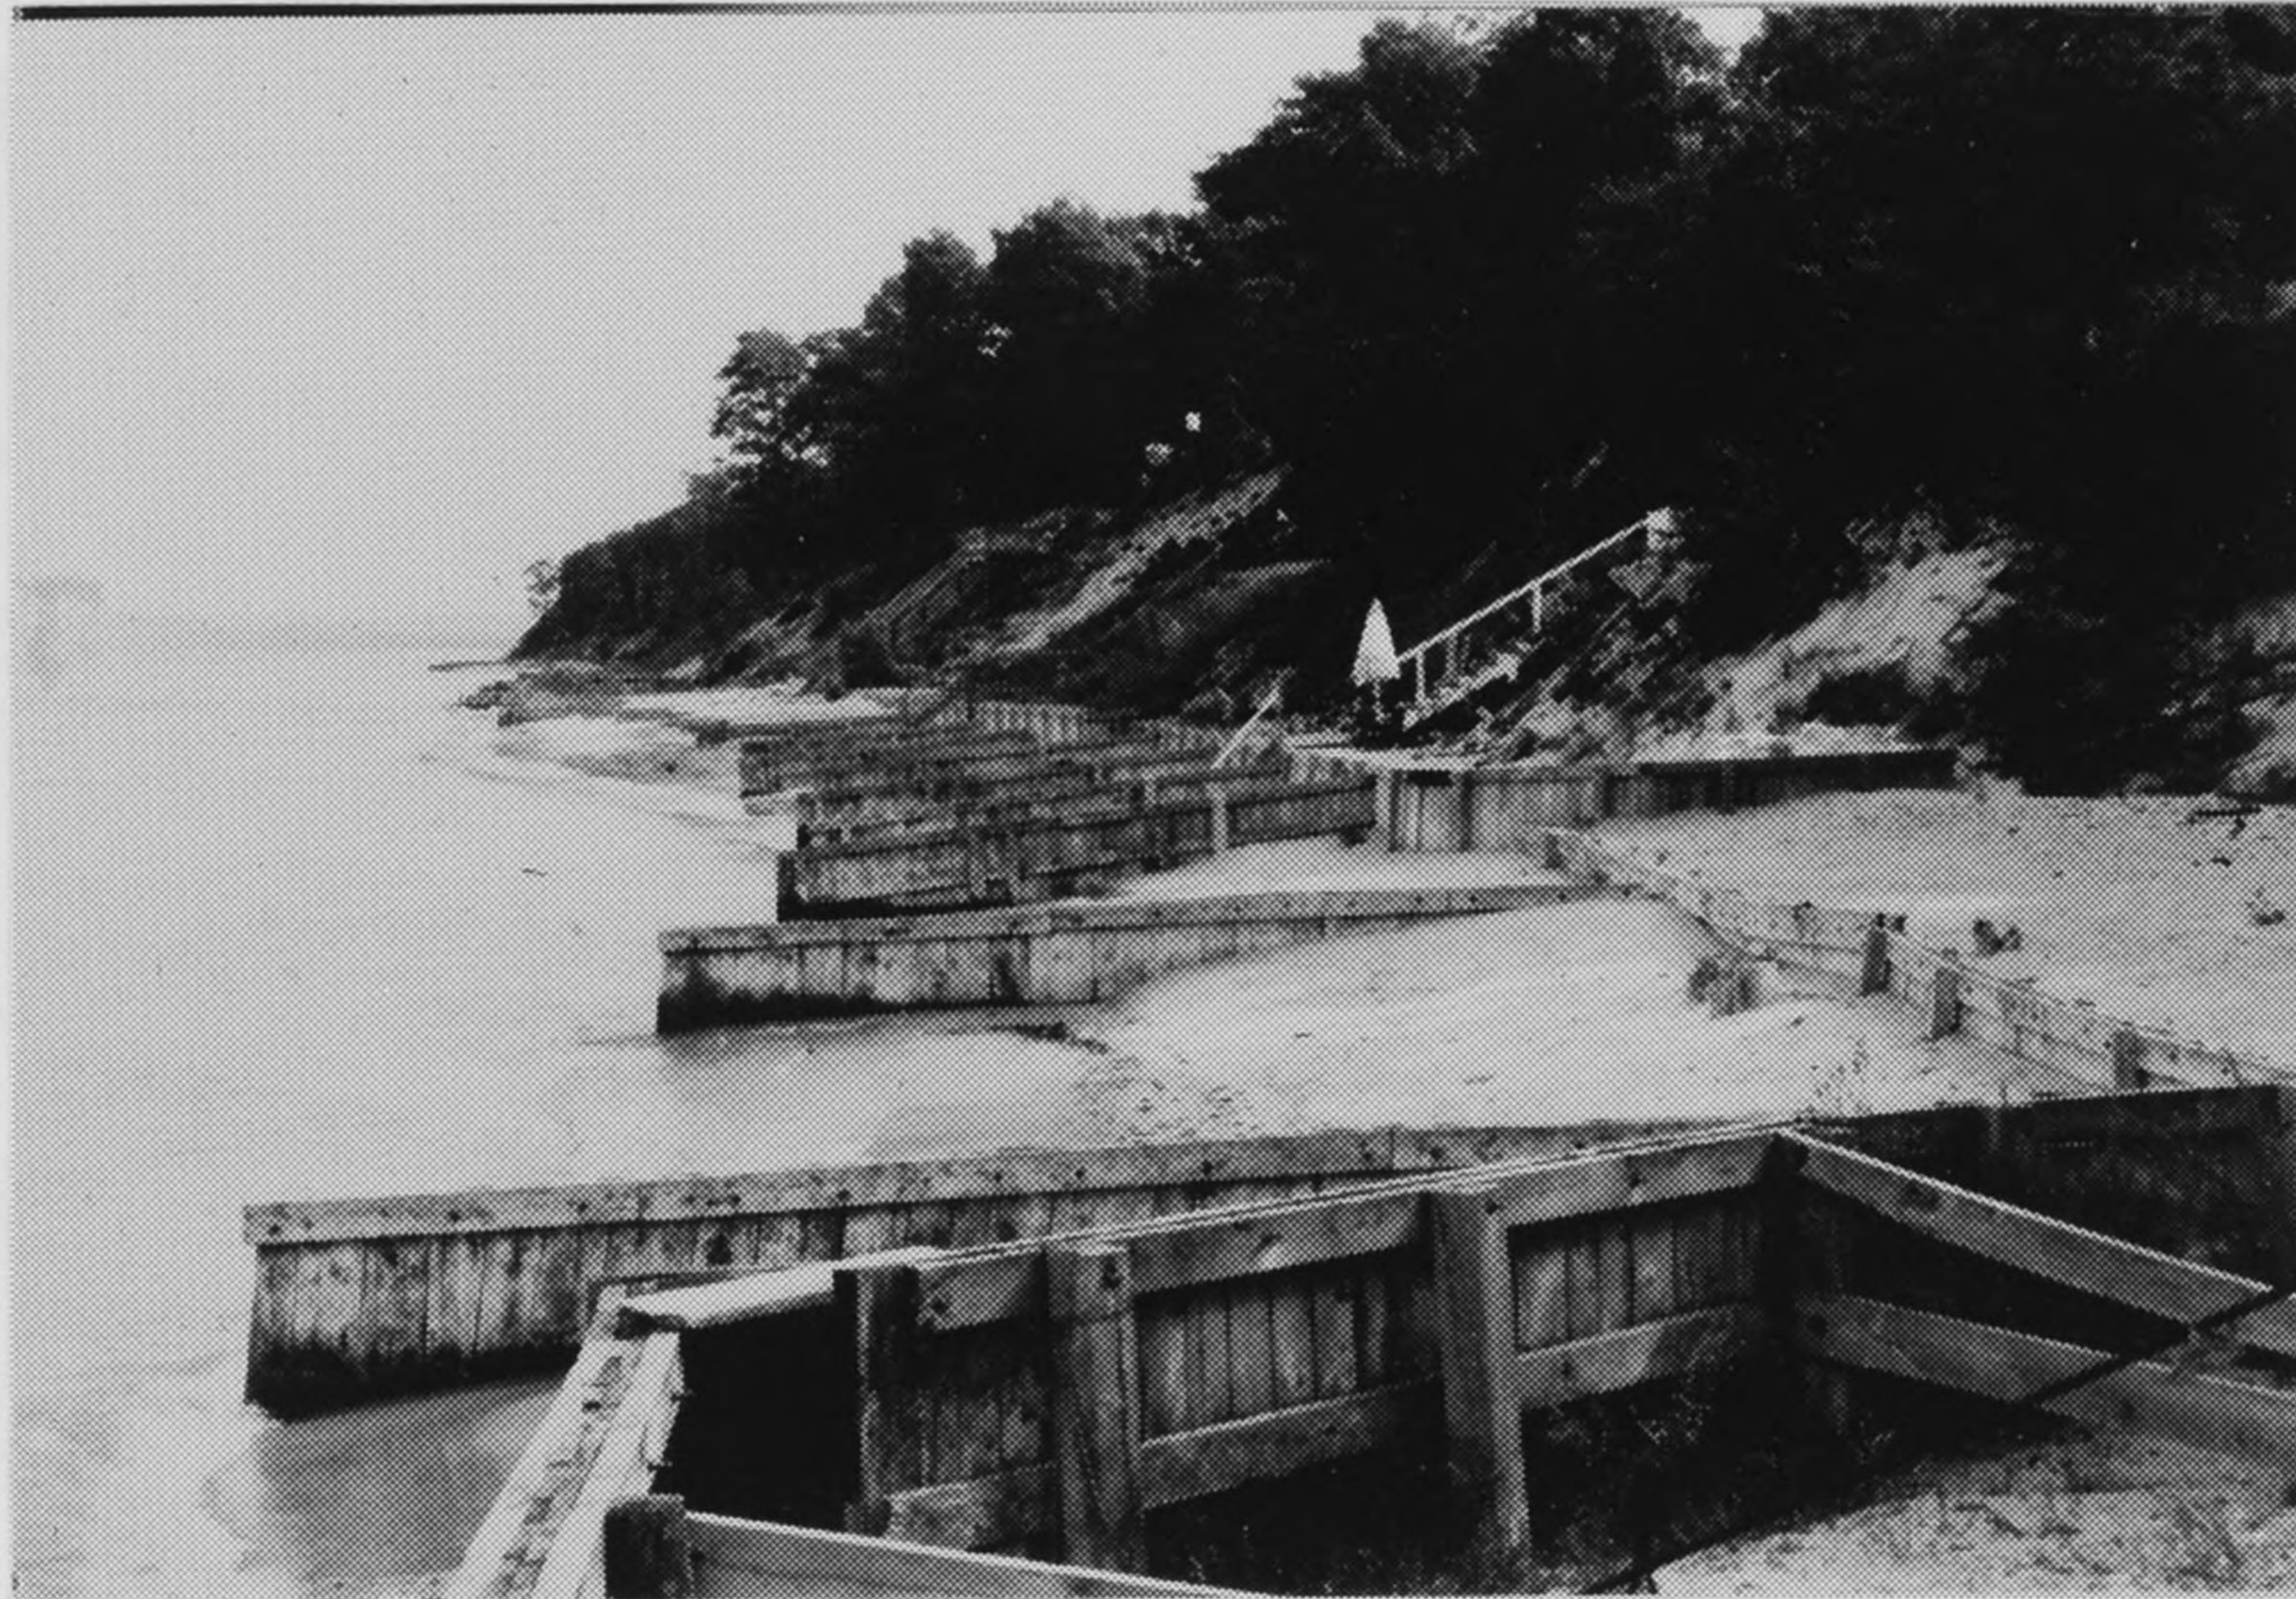
Figure B34. Site L: Looking north across site from the property to the south. Two groins and low retaining wall beyond high retaining wall are part of this system. Note other shore protection along shoreline.

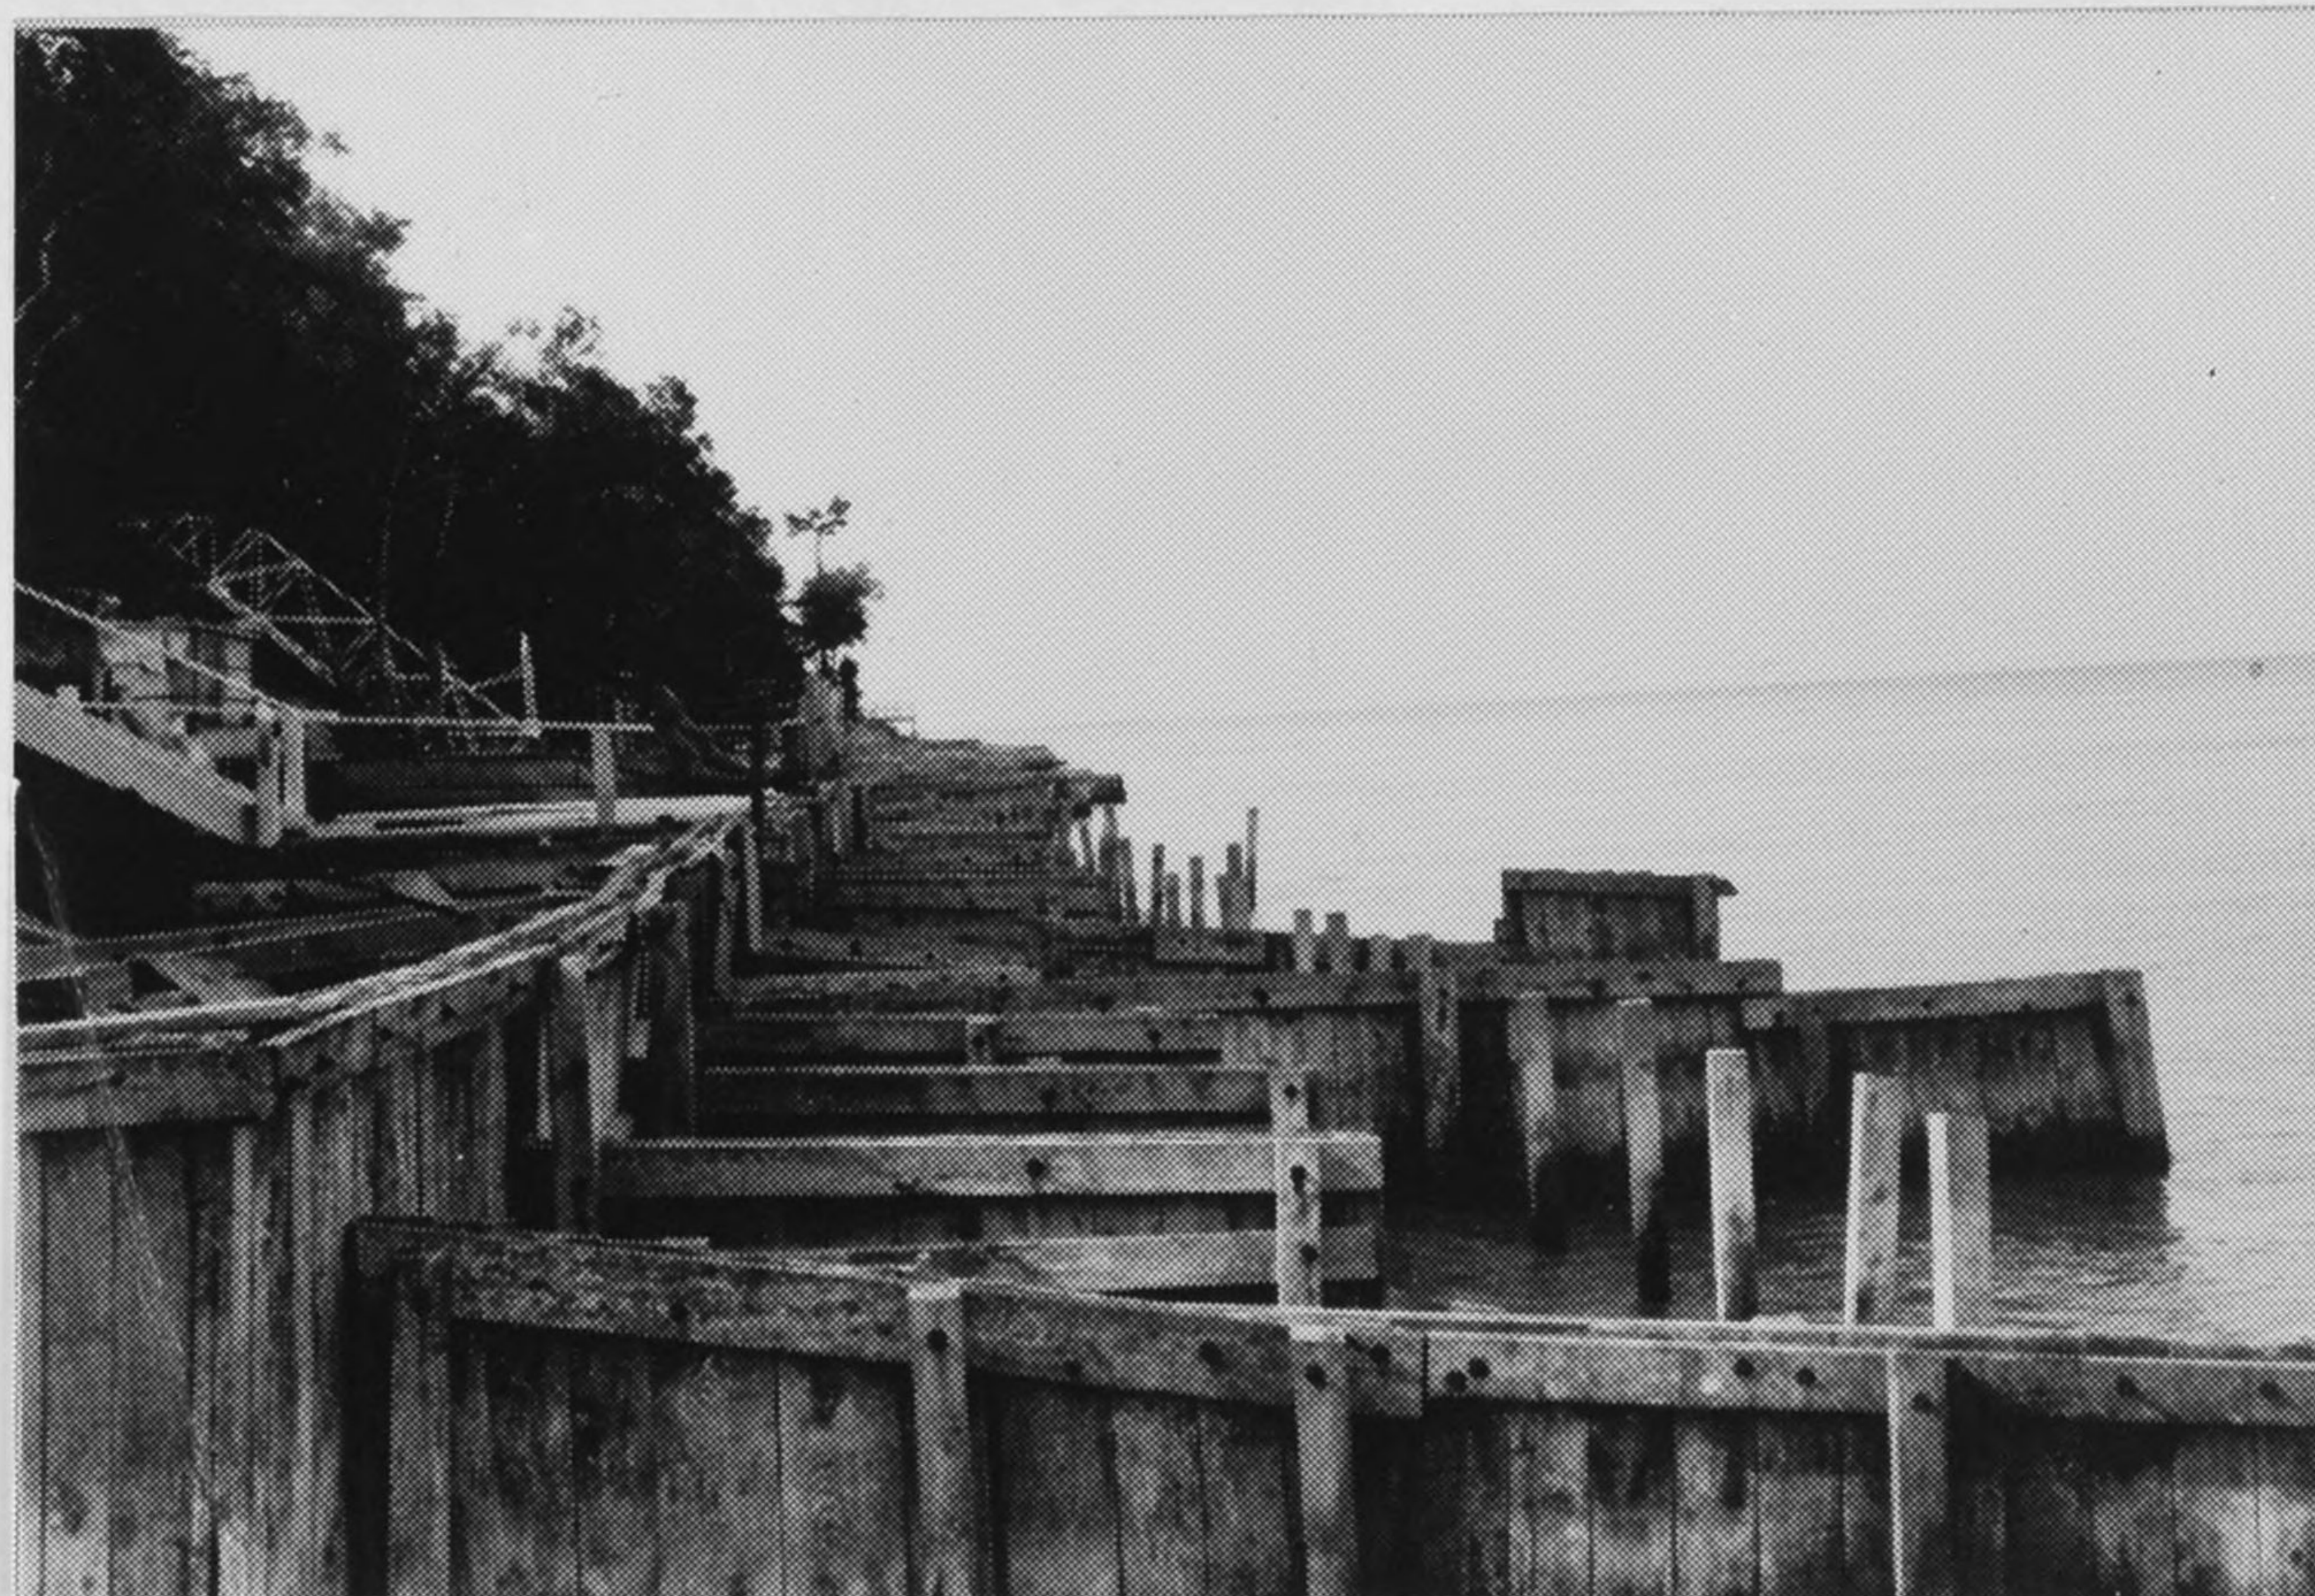
Figure B35. Site L: property just to south of site. Note closely spaced short timber groins projecting from retaining wall.

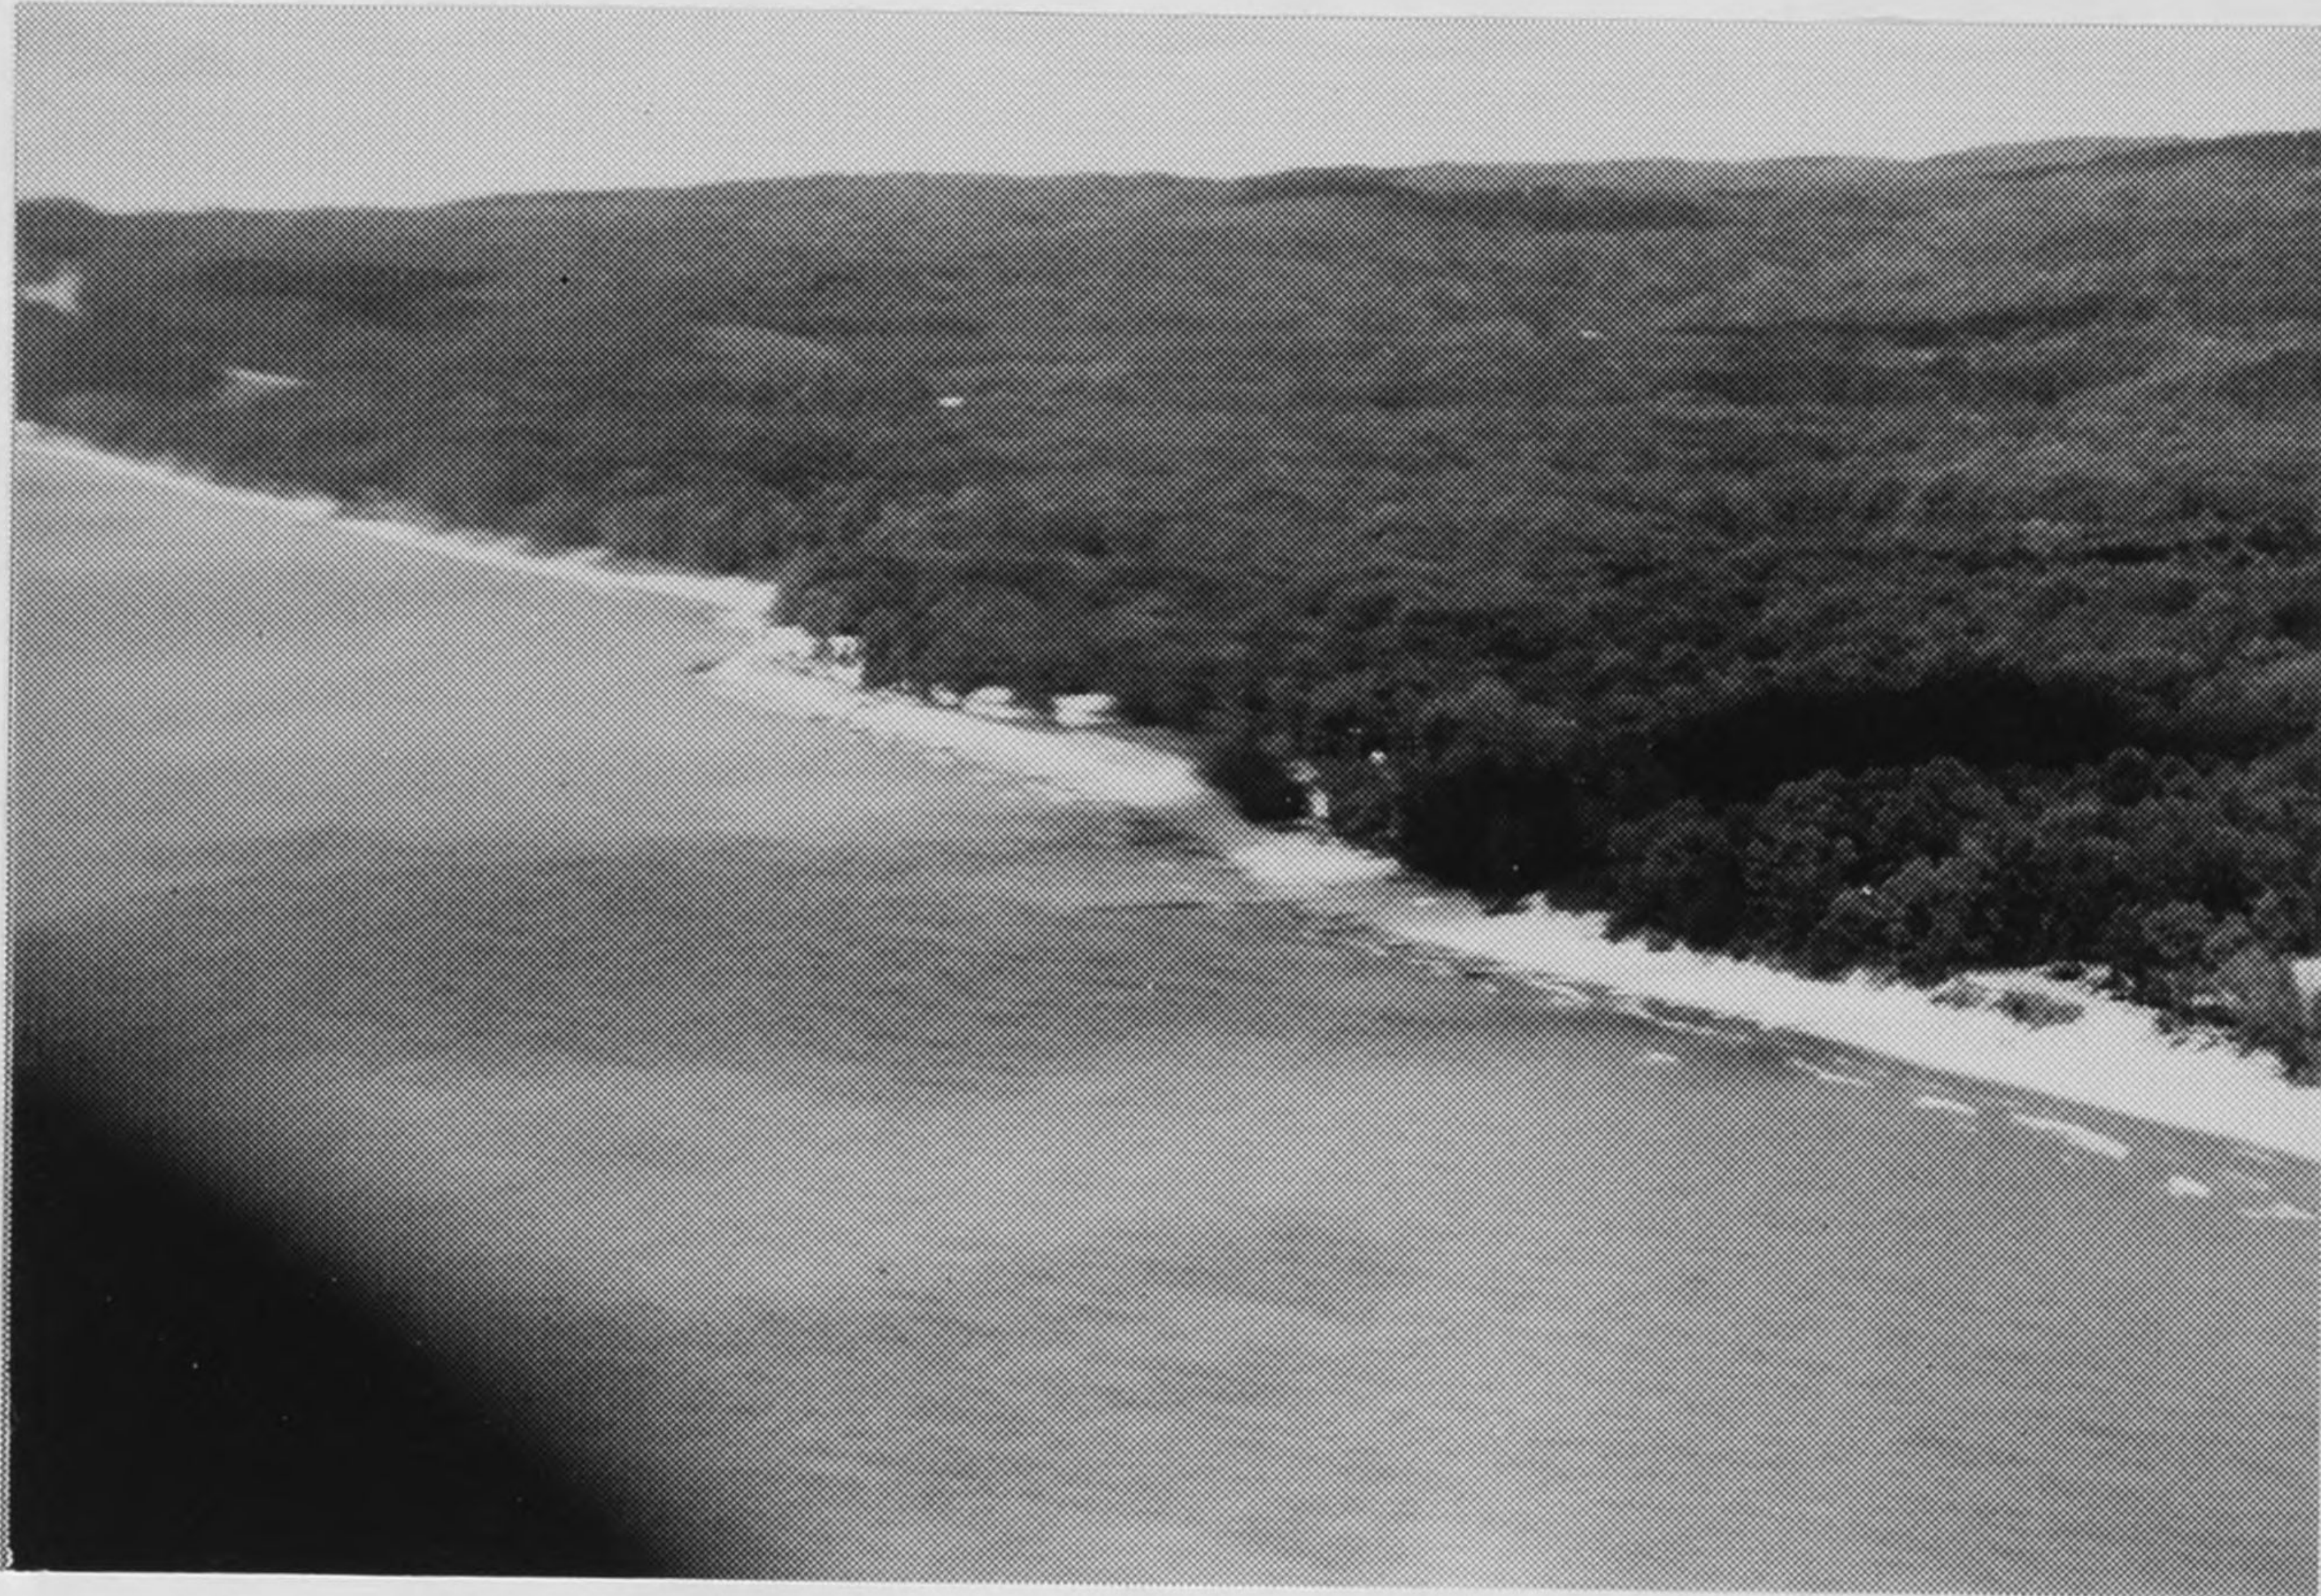
Figure B36. Site M and O: Aerial view of shoreline in general vicinity. Photograph indicates series of groins near center of photo. Long revetment at site O exists just south of where shoreline shifts to the right beyond the point. Two long concrete groins are barely visible in photo.

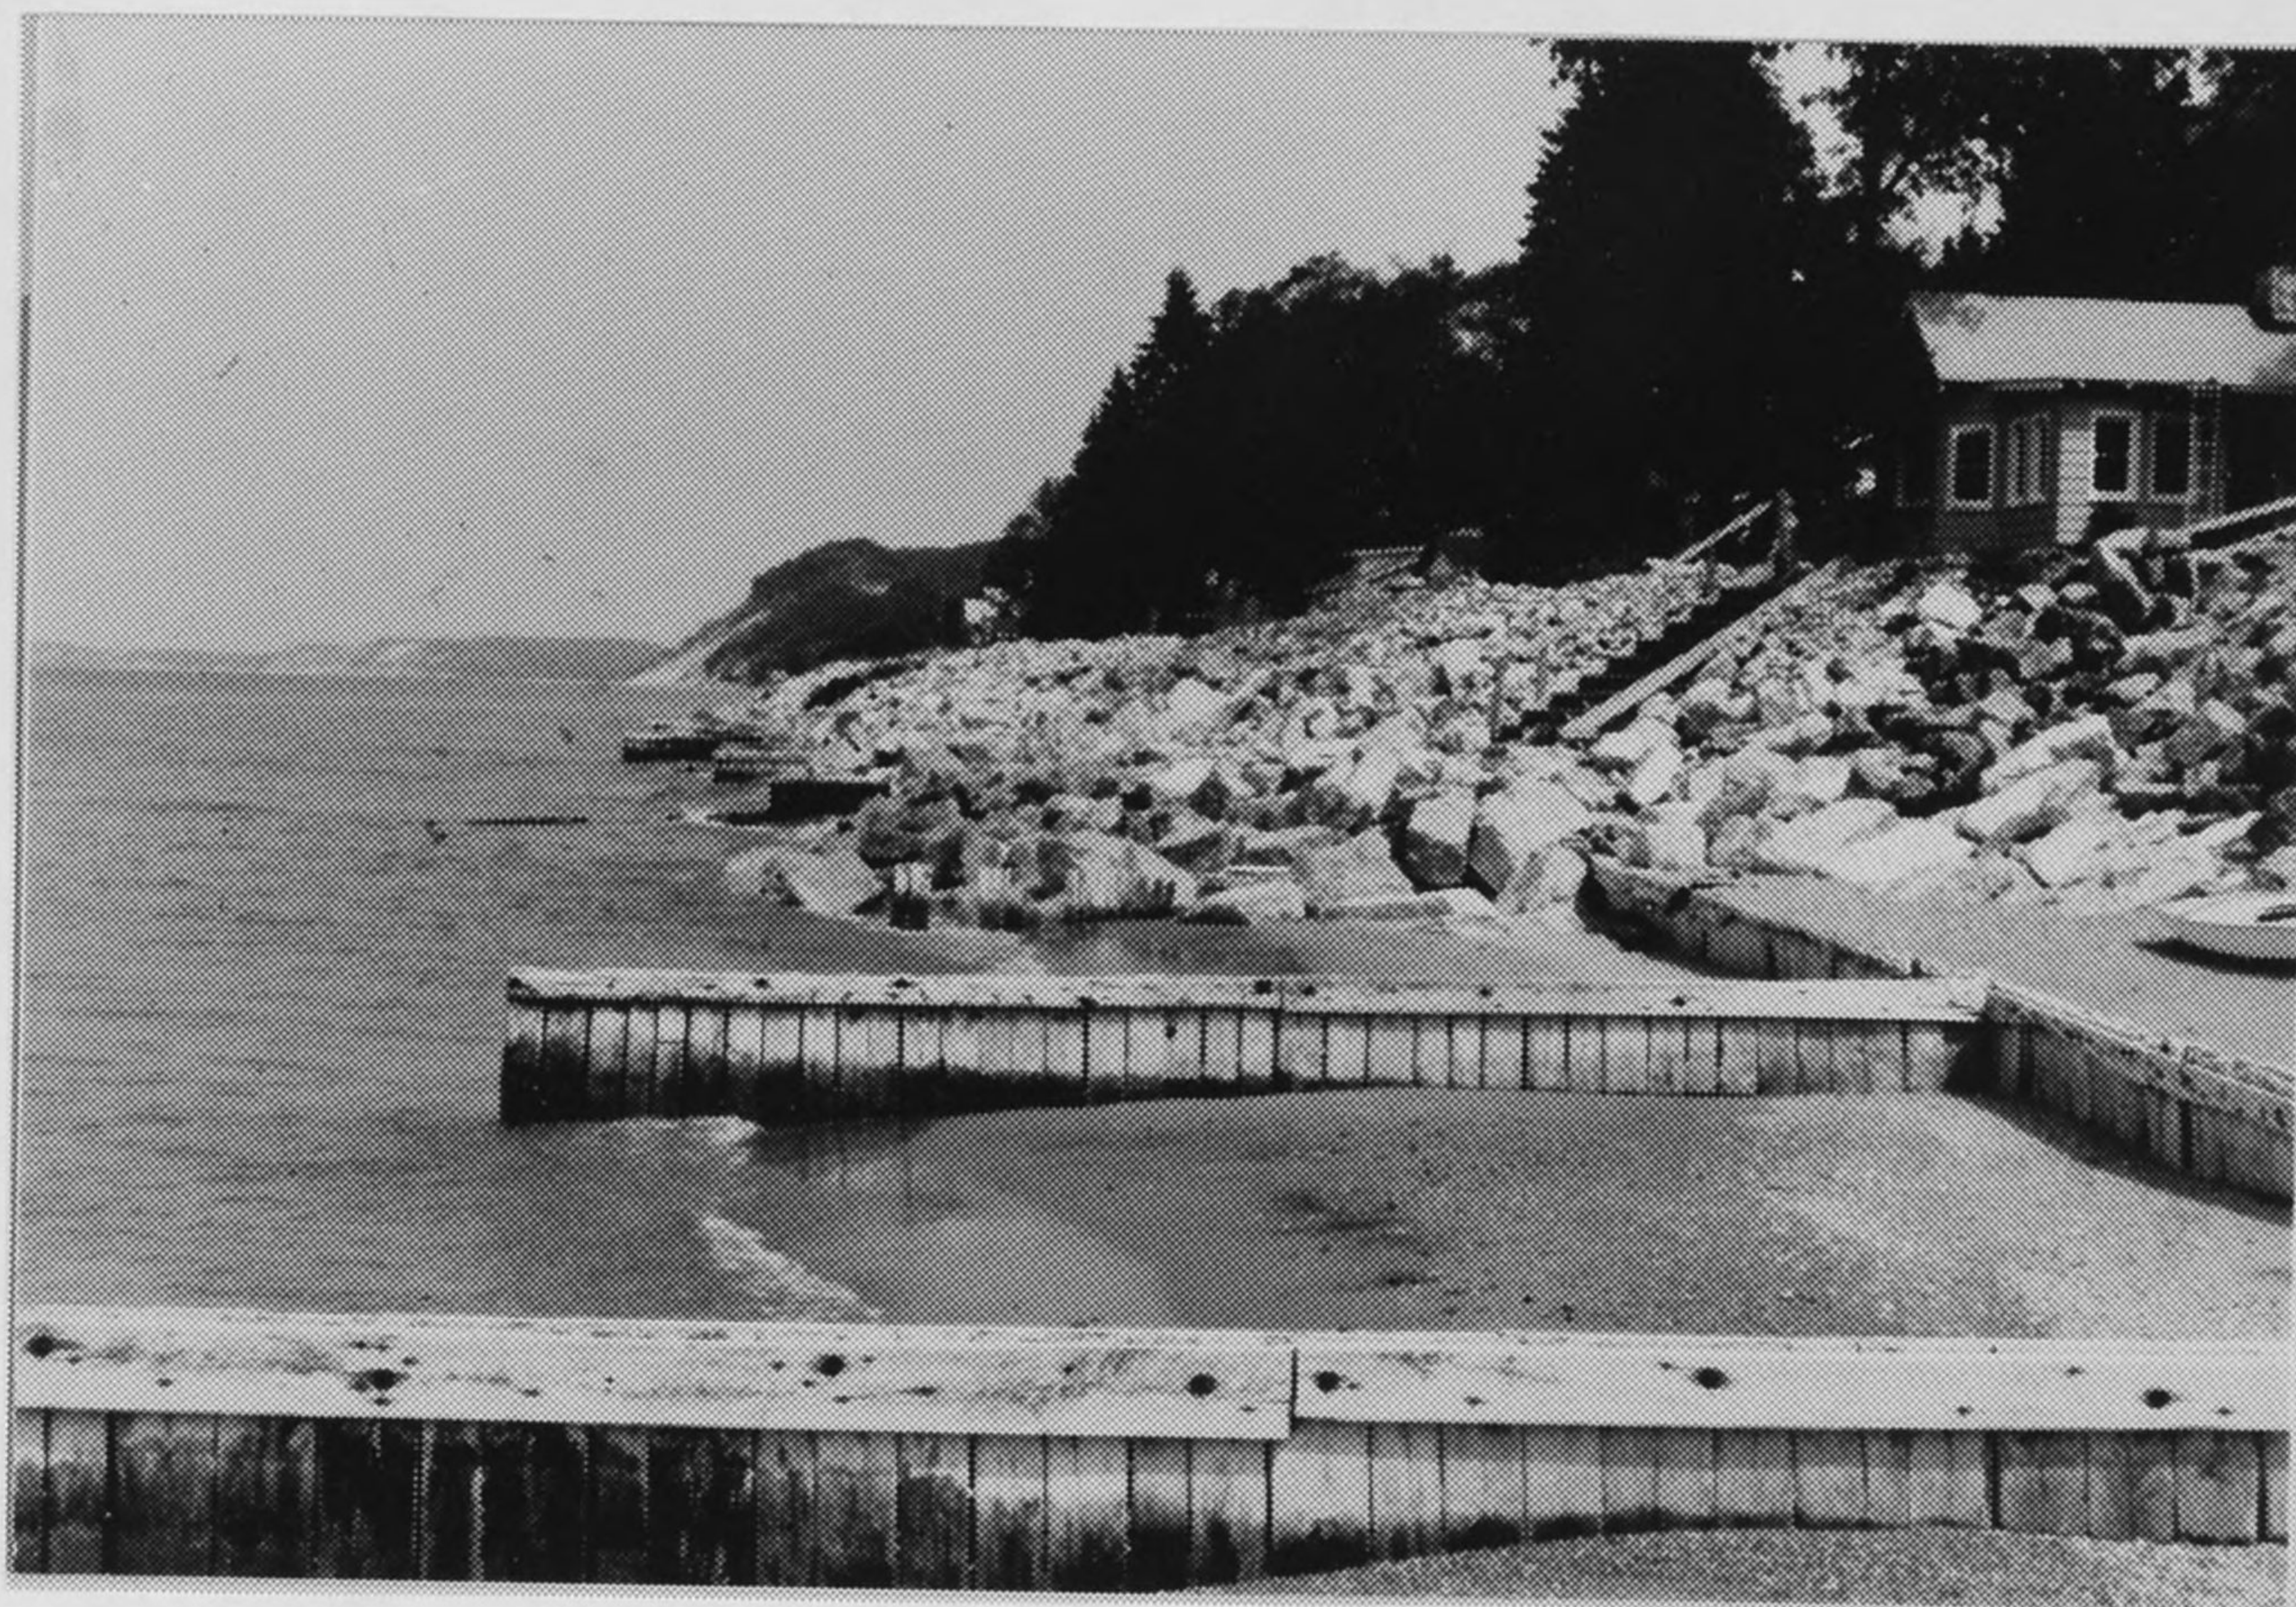
Figure B40. Site N and O: Looking north towards the long revetment on site O from Site M and N property. Revetment on site N is just visible to the right and well up above the existing water level. Also groin and sill system exists between revetment and shoreline. Note old groins within revetment on site O.

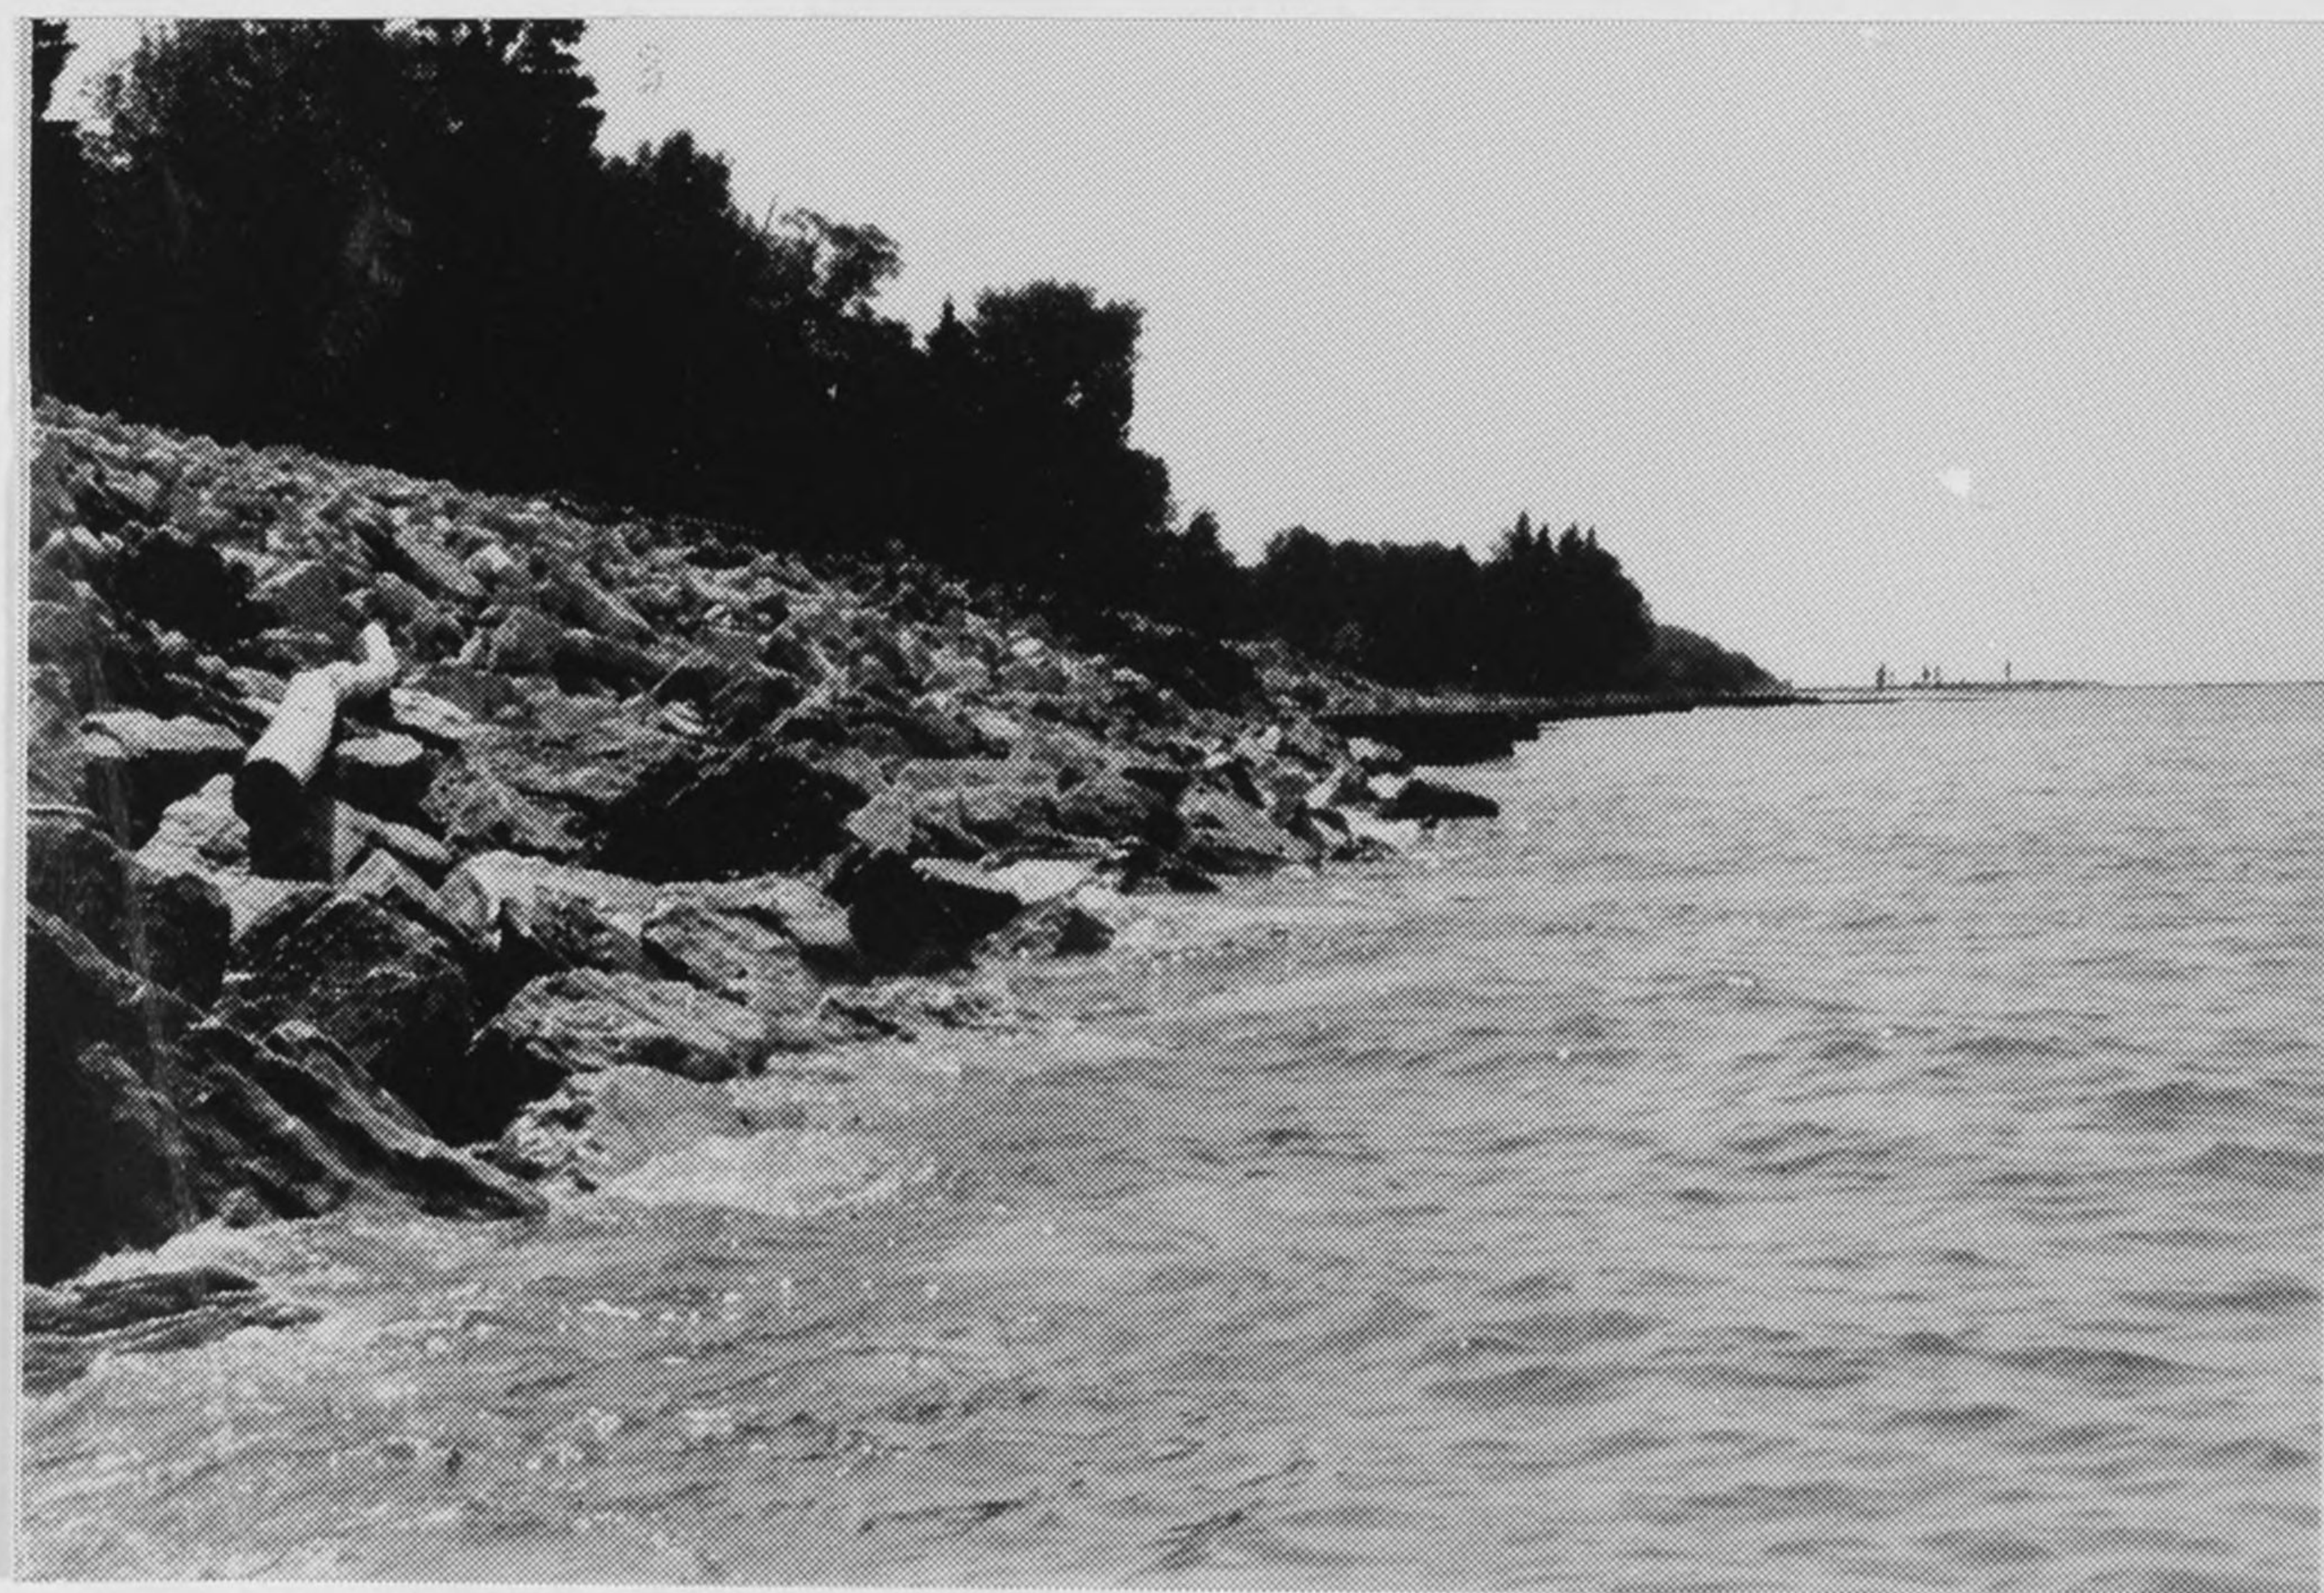
Figure B41. Site O: Looking south along revetment from location in Fig. B36 where abrupt turn in shoreline occurs.
