**EVALUATION OF GREAT LAKES
SHORE PROTECTION STRUCTURES**

Report UMCEE 88-8

**THE UNIVERSITY OF MICHIGAN
DEPARTMENT OF CIVIL ENGINEERING
ANN ARBOR, MICHIGAN**

**Michigan Department of Natural Resources
Coastal Management Program
Land and Water Division**

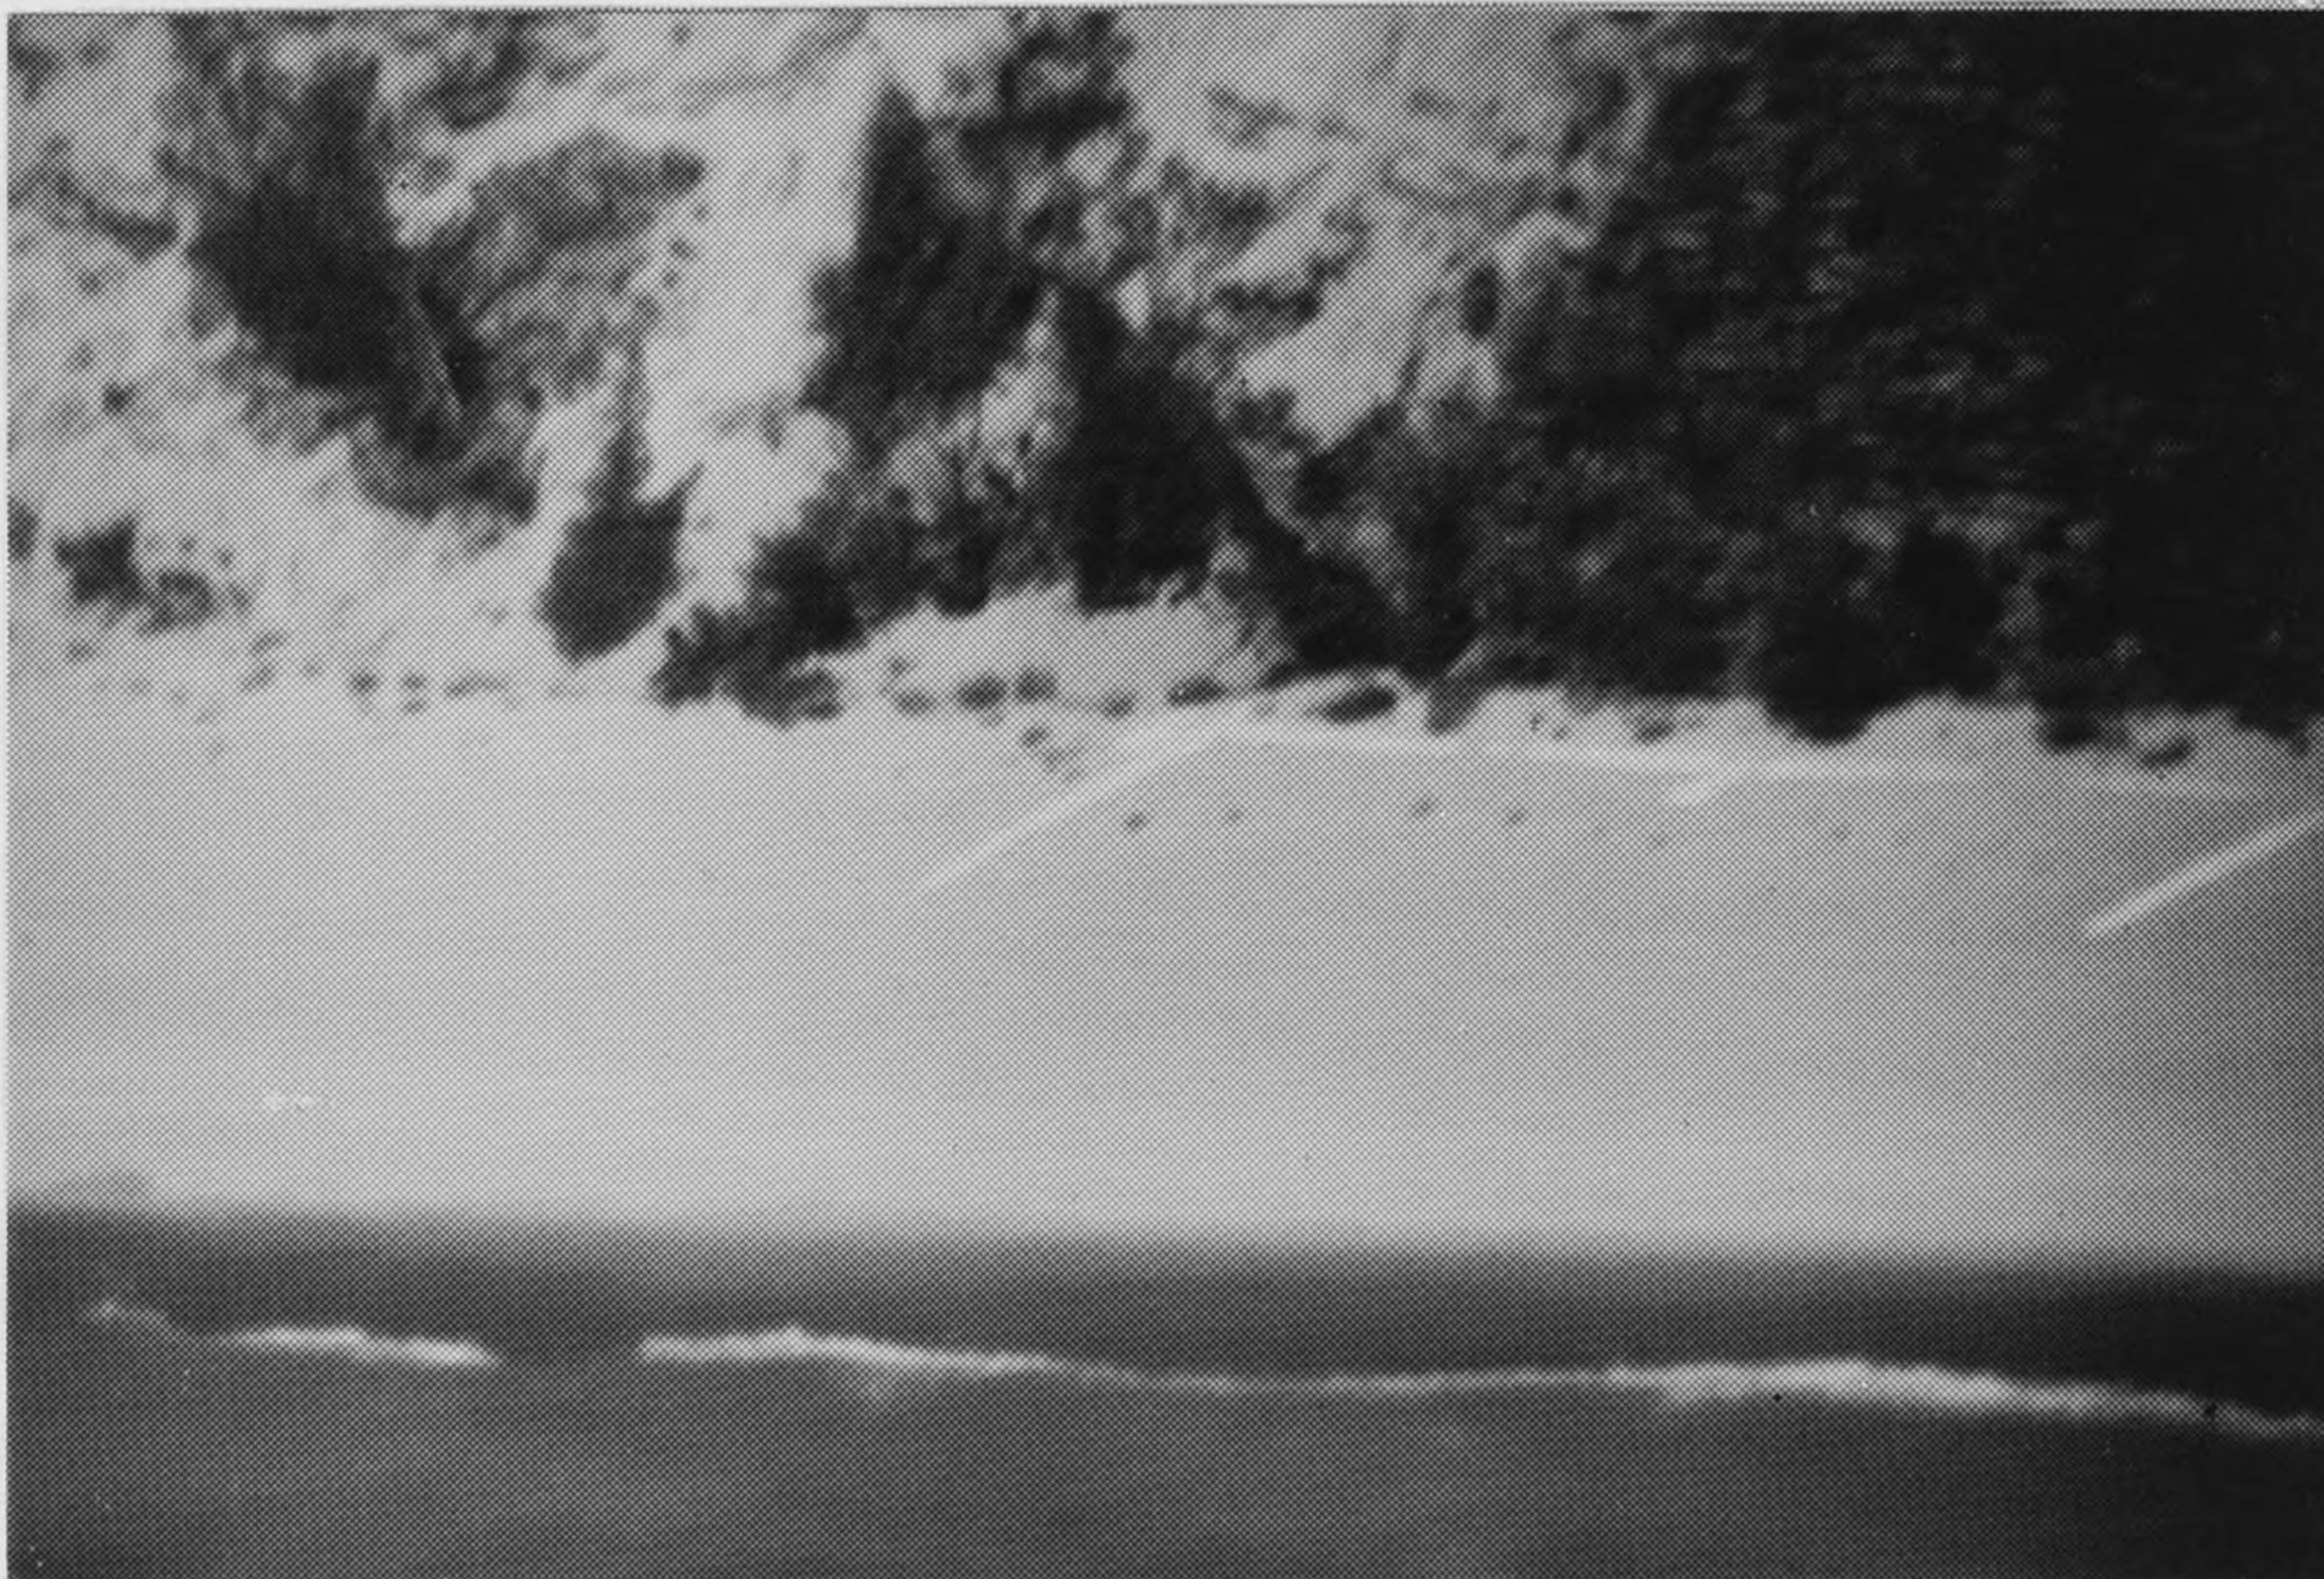
Figure B43. Site P: Aerial view of site, visible parts of groins are second tier of tubes.

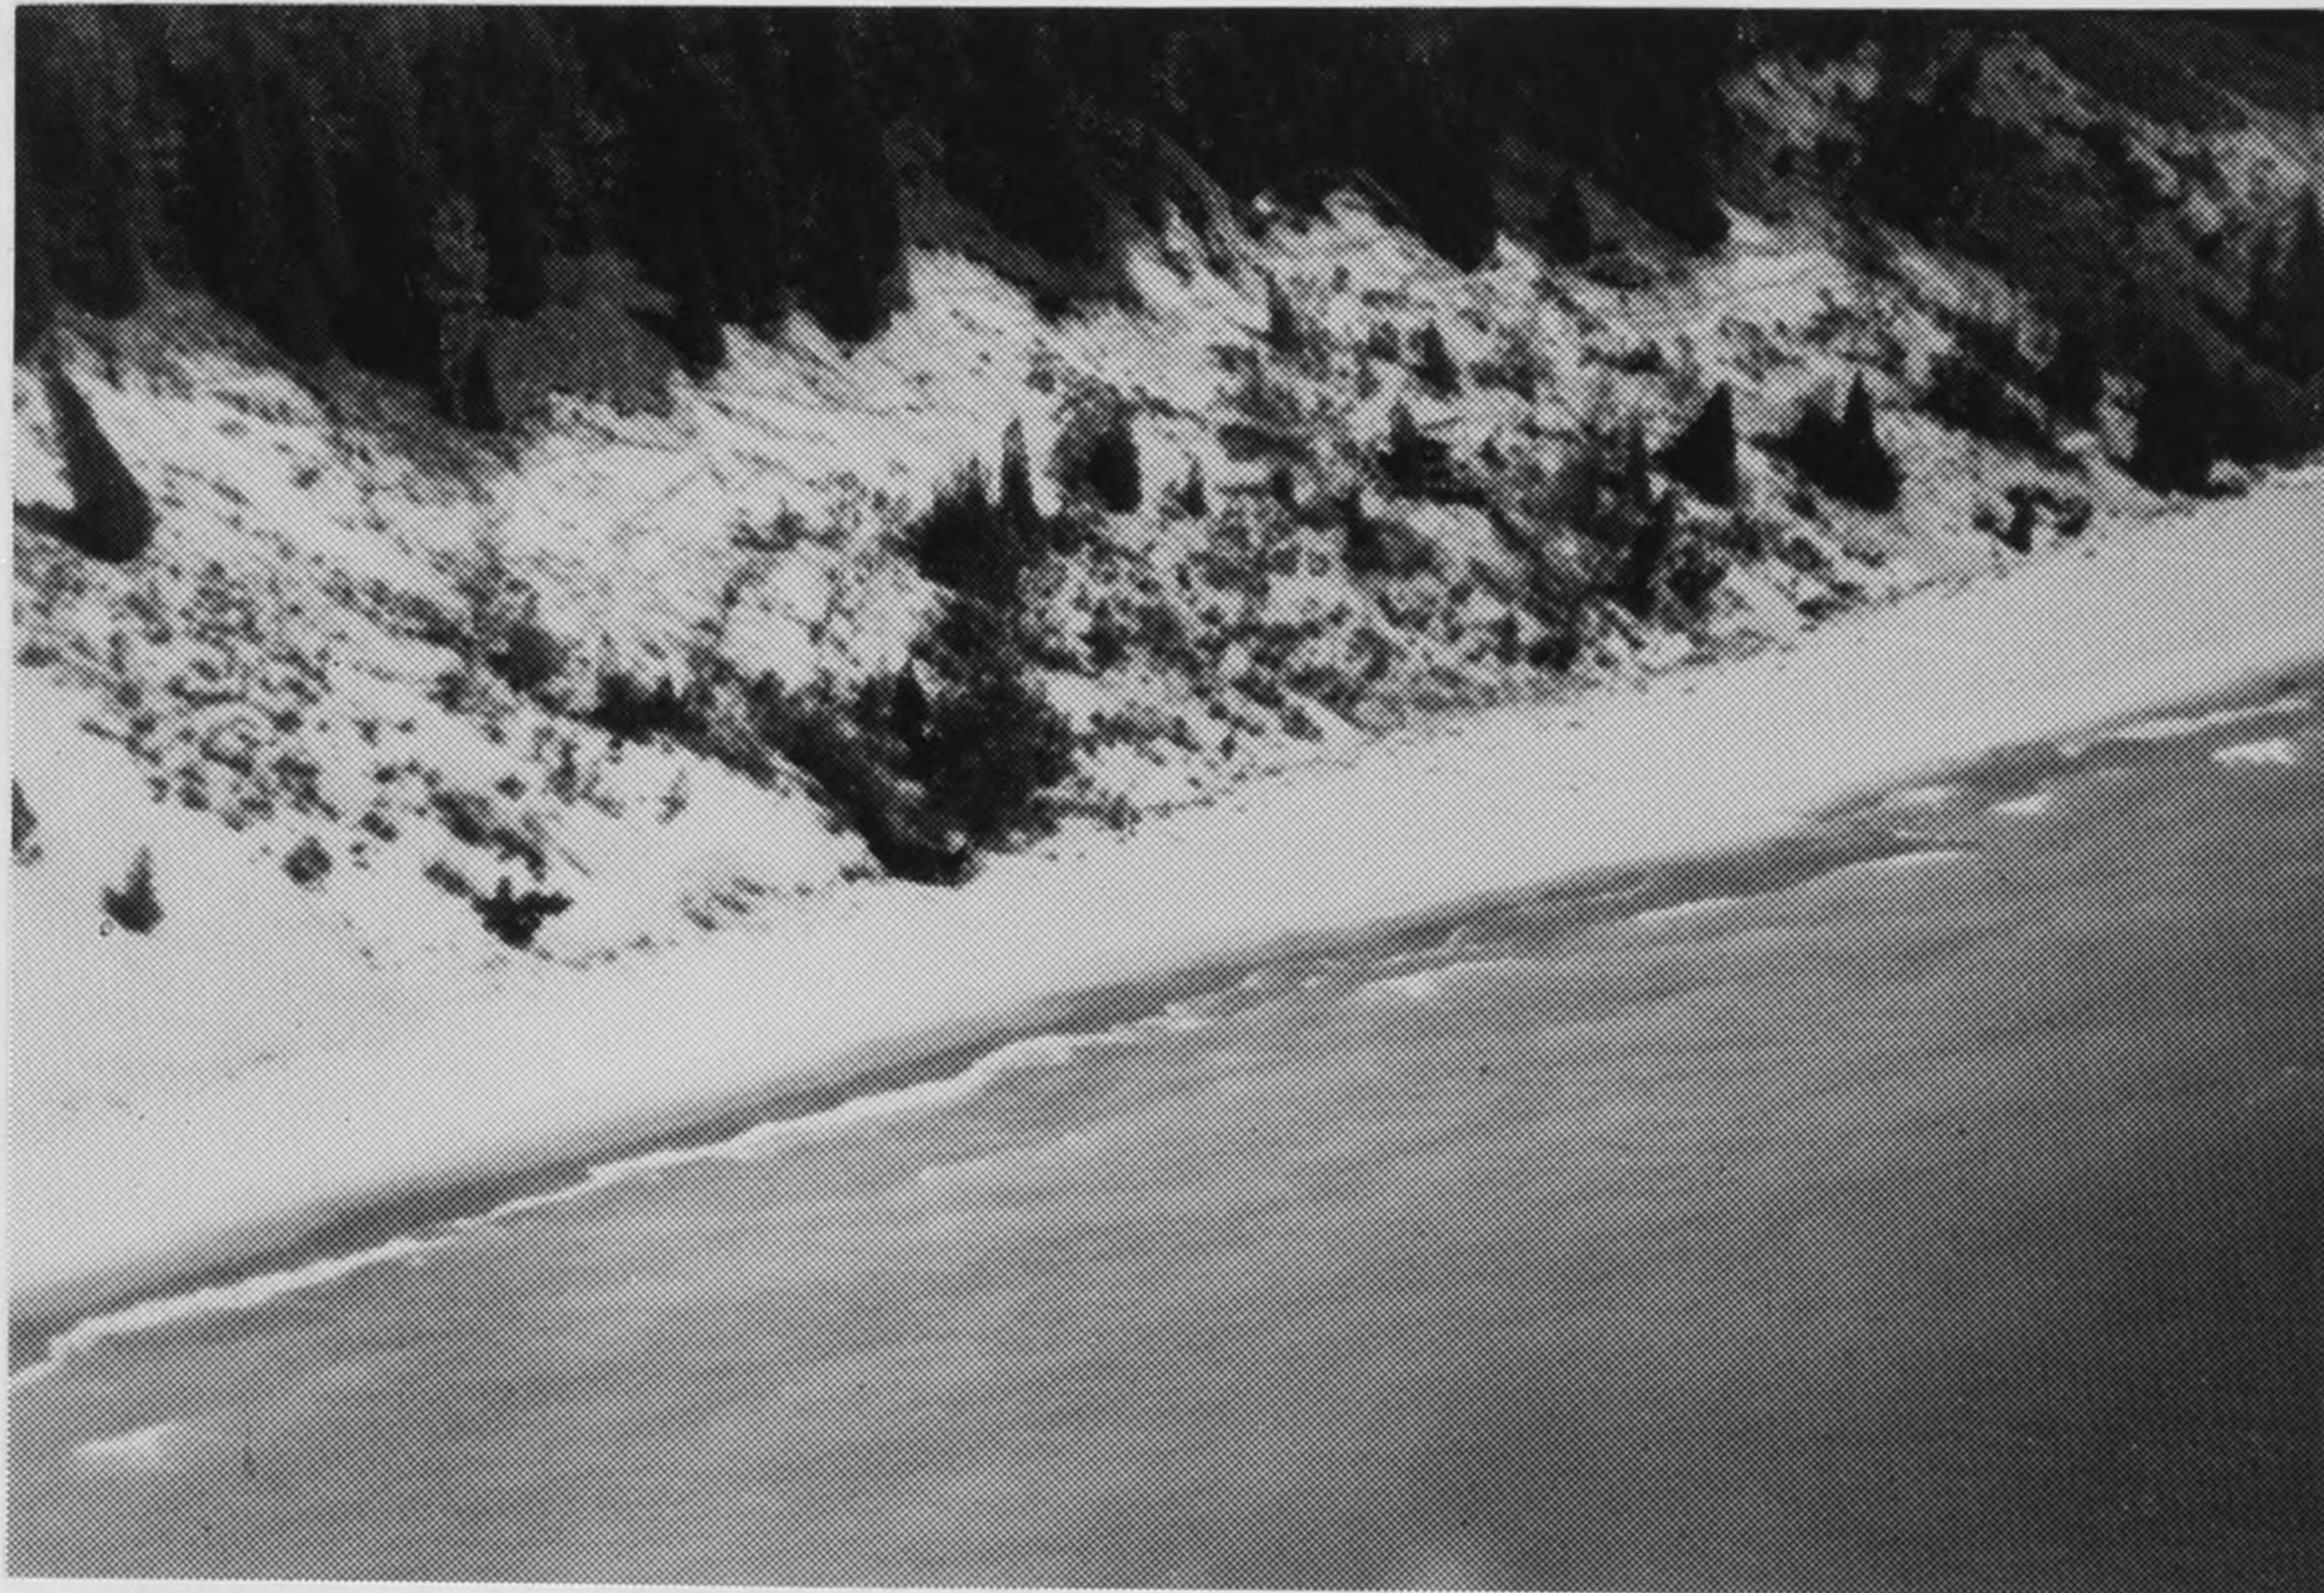
Figure B46 Site Q: Aerial view of site, (3) groins are barely visible on right side of photograph.

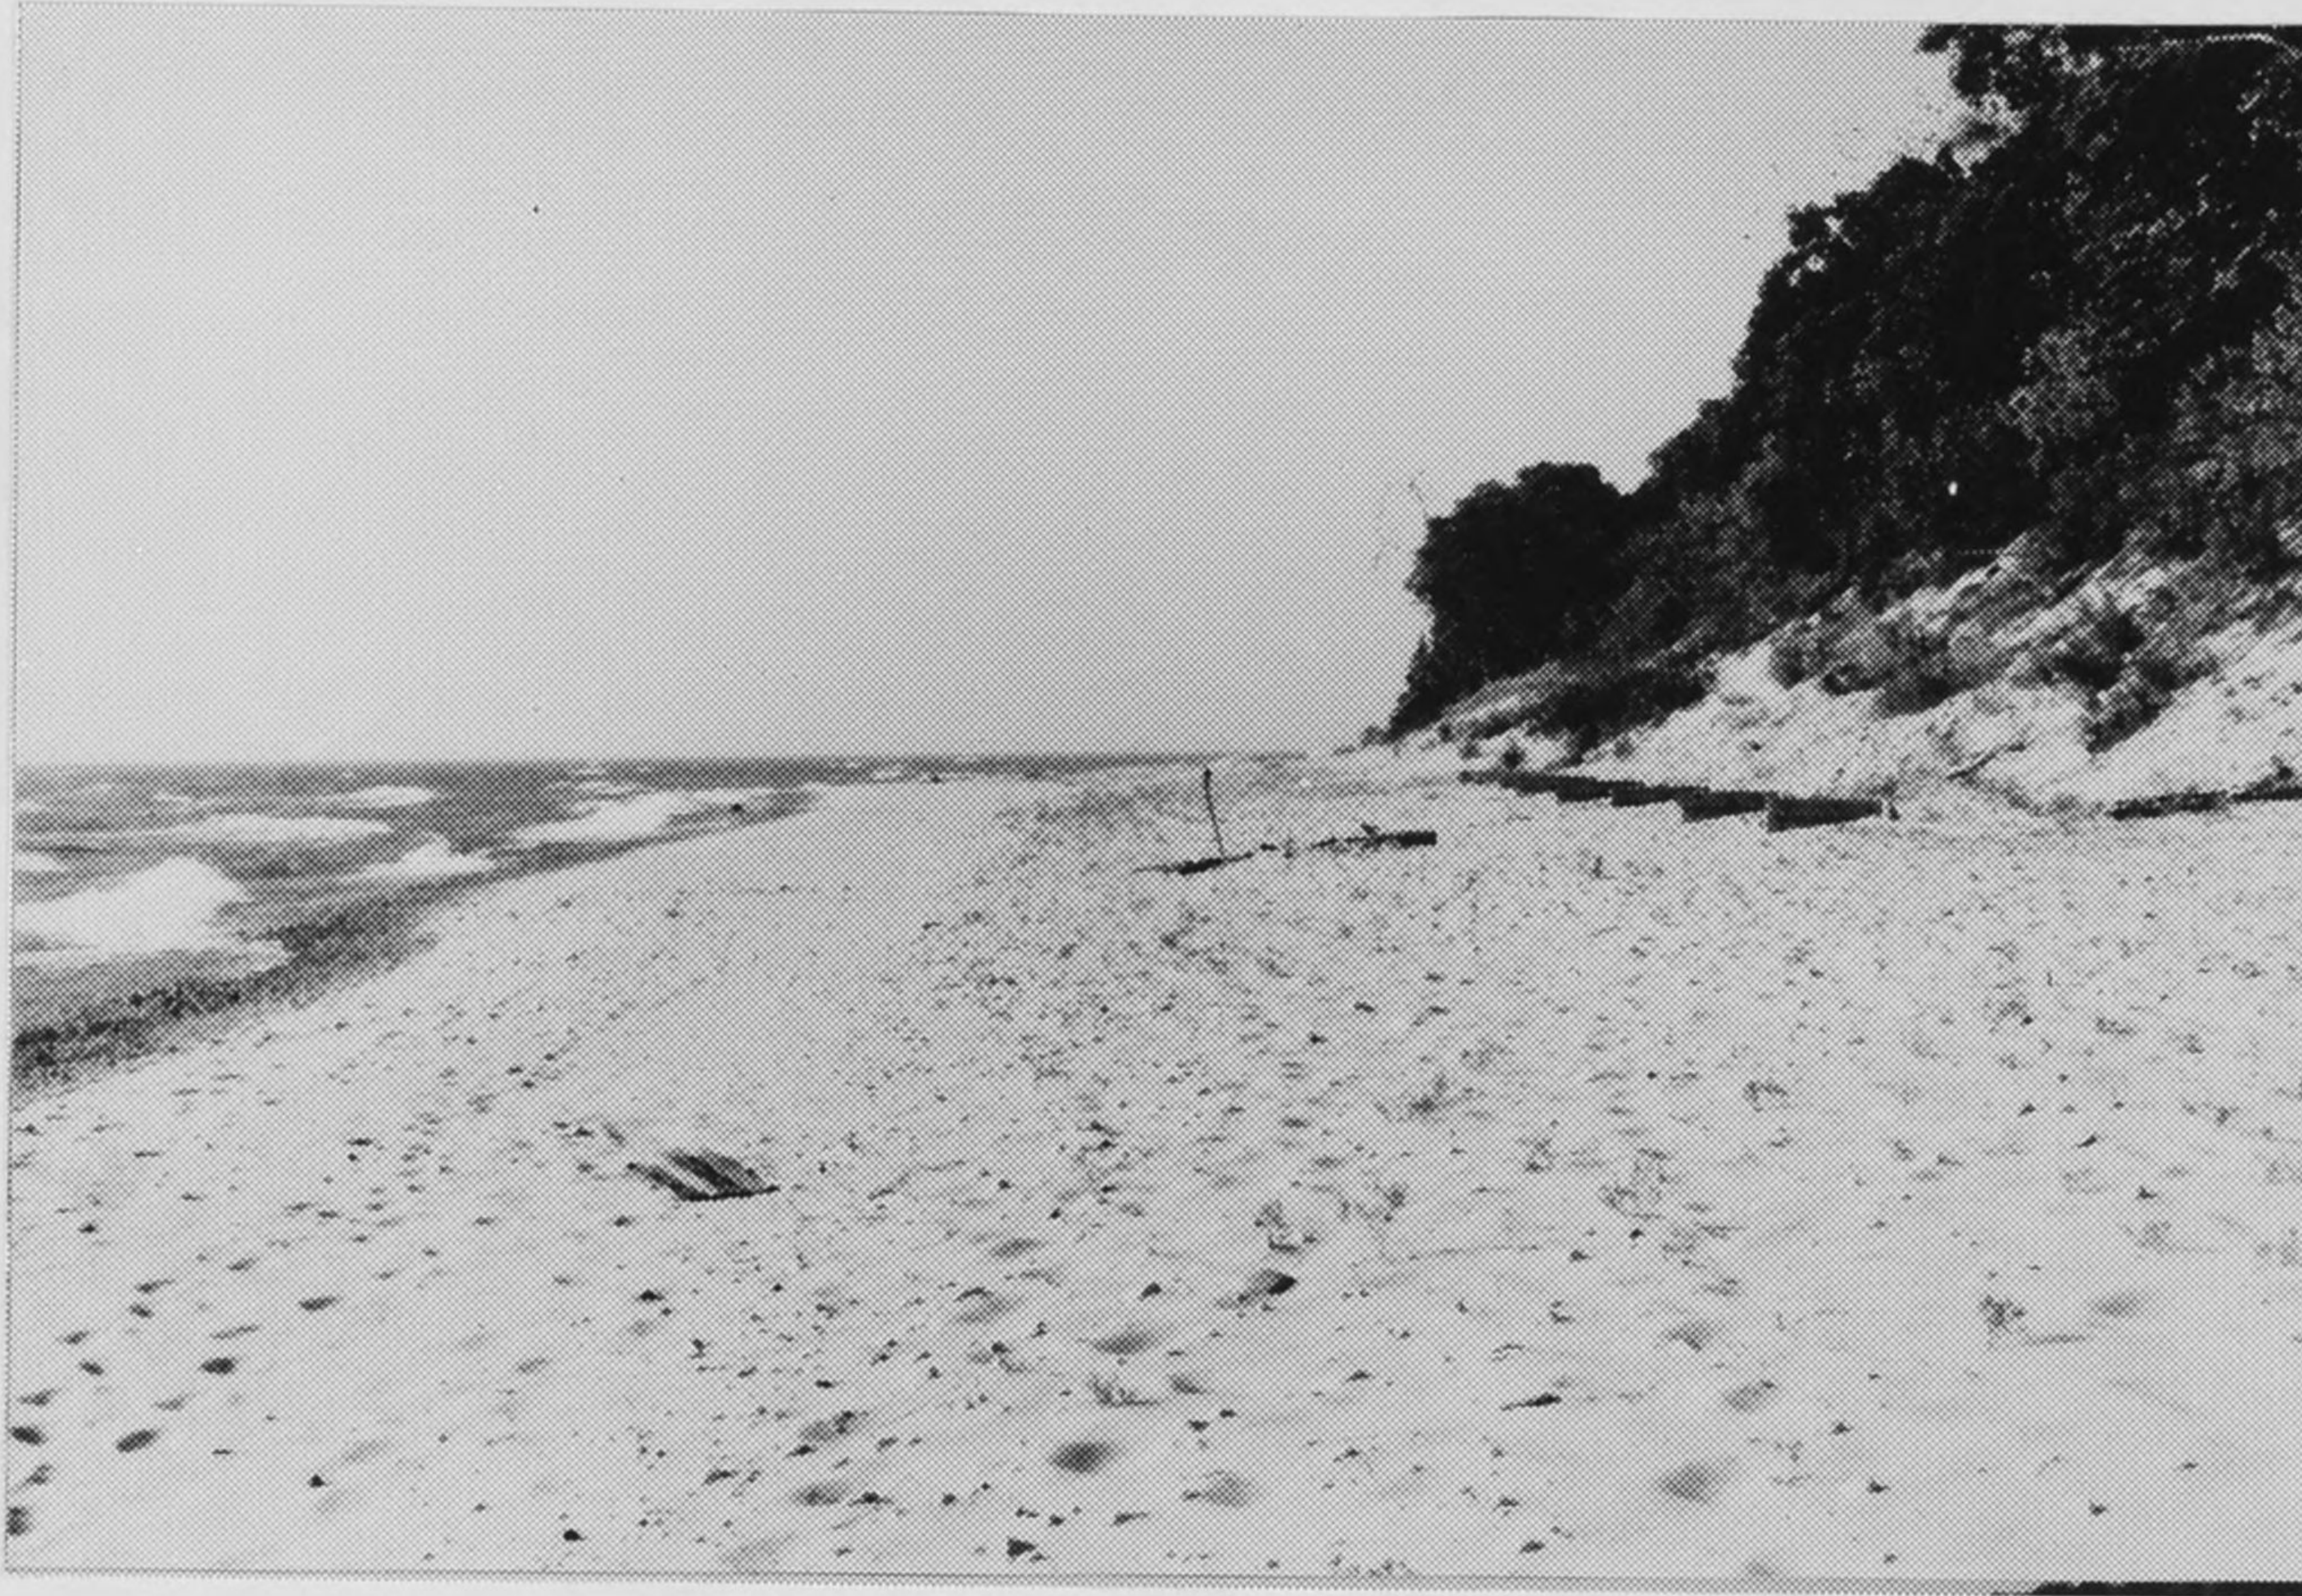
Figure B48. Site S: Looking north at retaining wall just visible at toe of bluff.

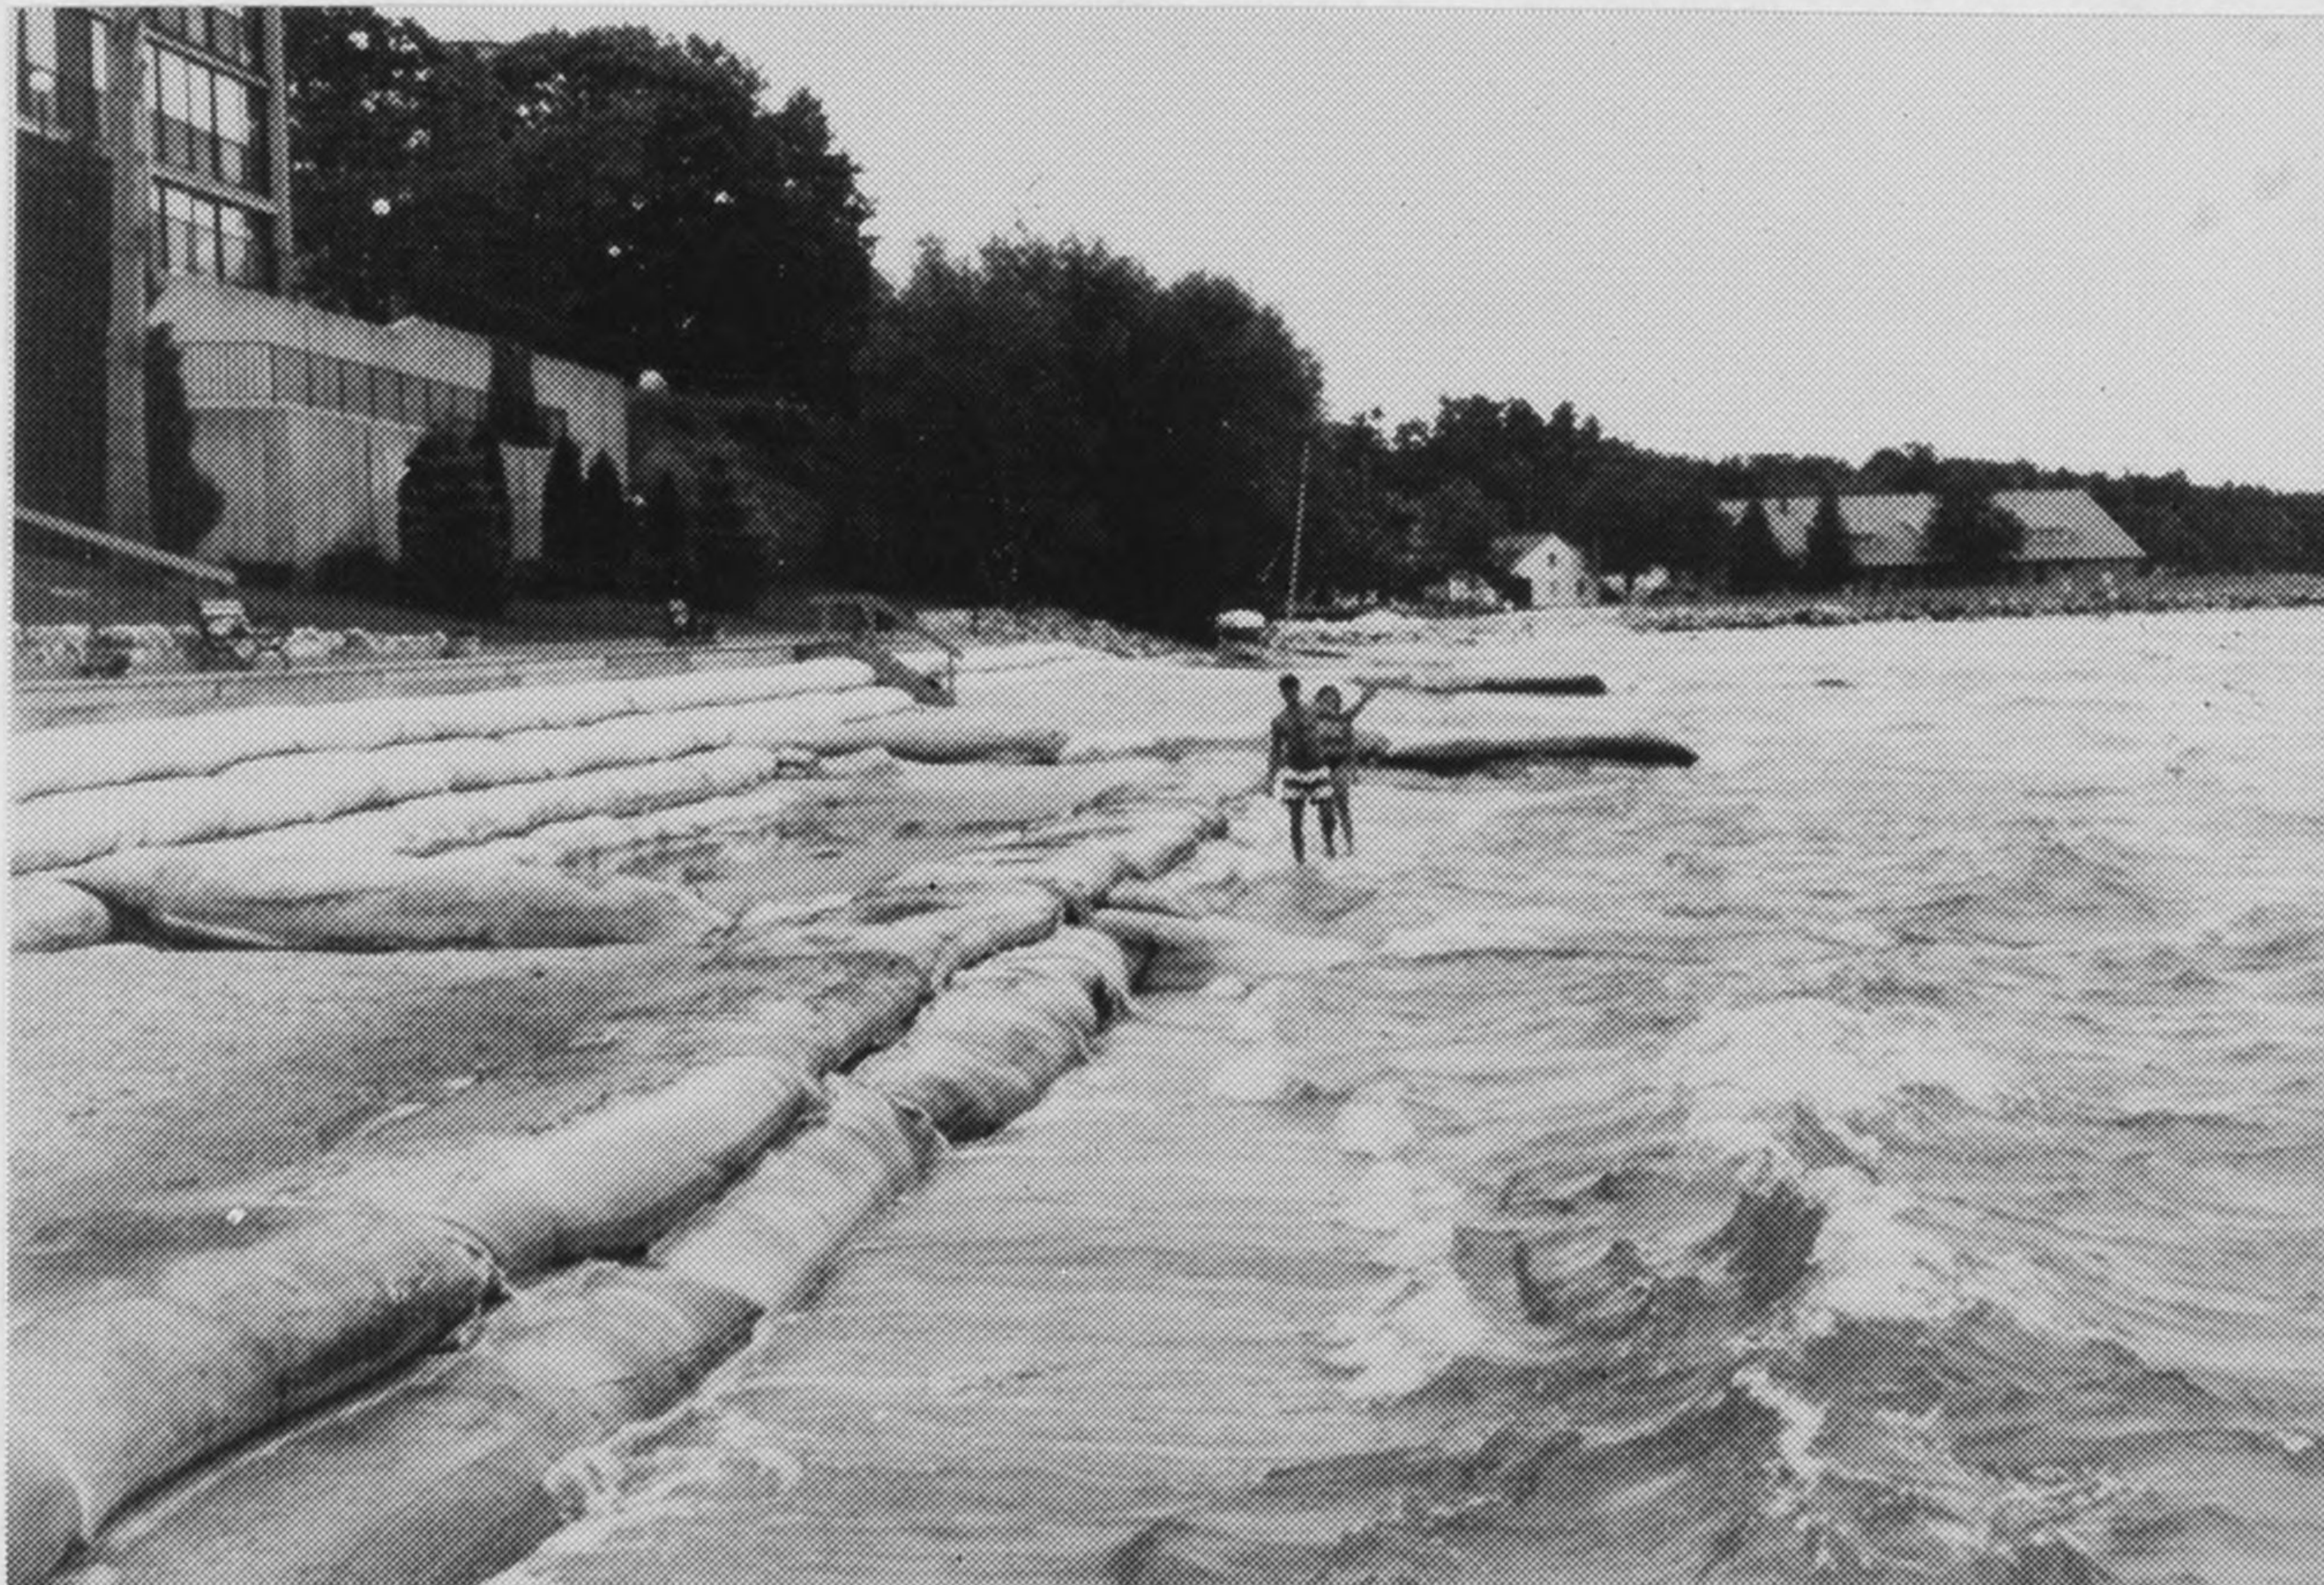
Figure B52. Site U: Looking towards the southwest from the most northerly groin in the system. Beach is higher behind bathers, may be due to artificial filling or littoral drift from the southwest.

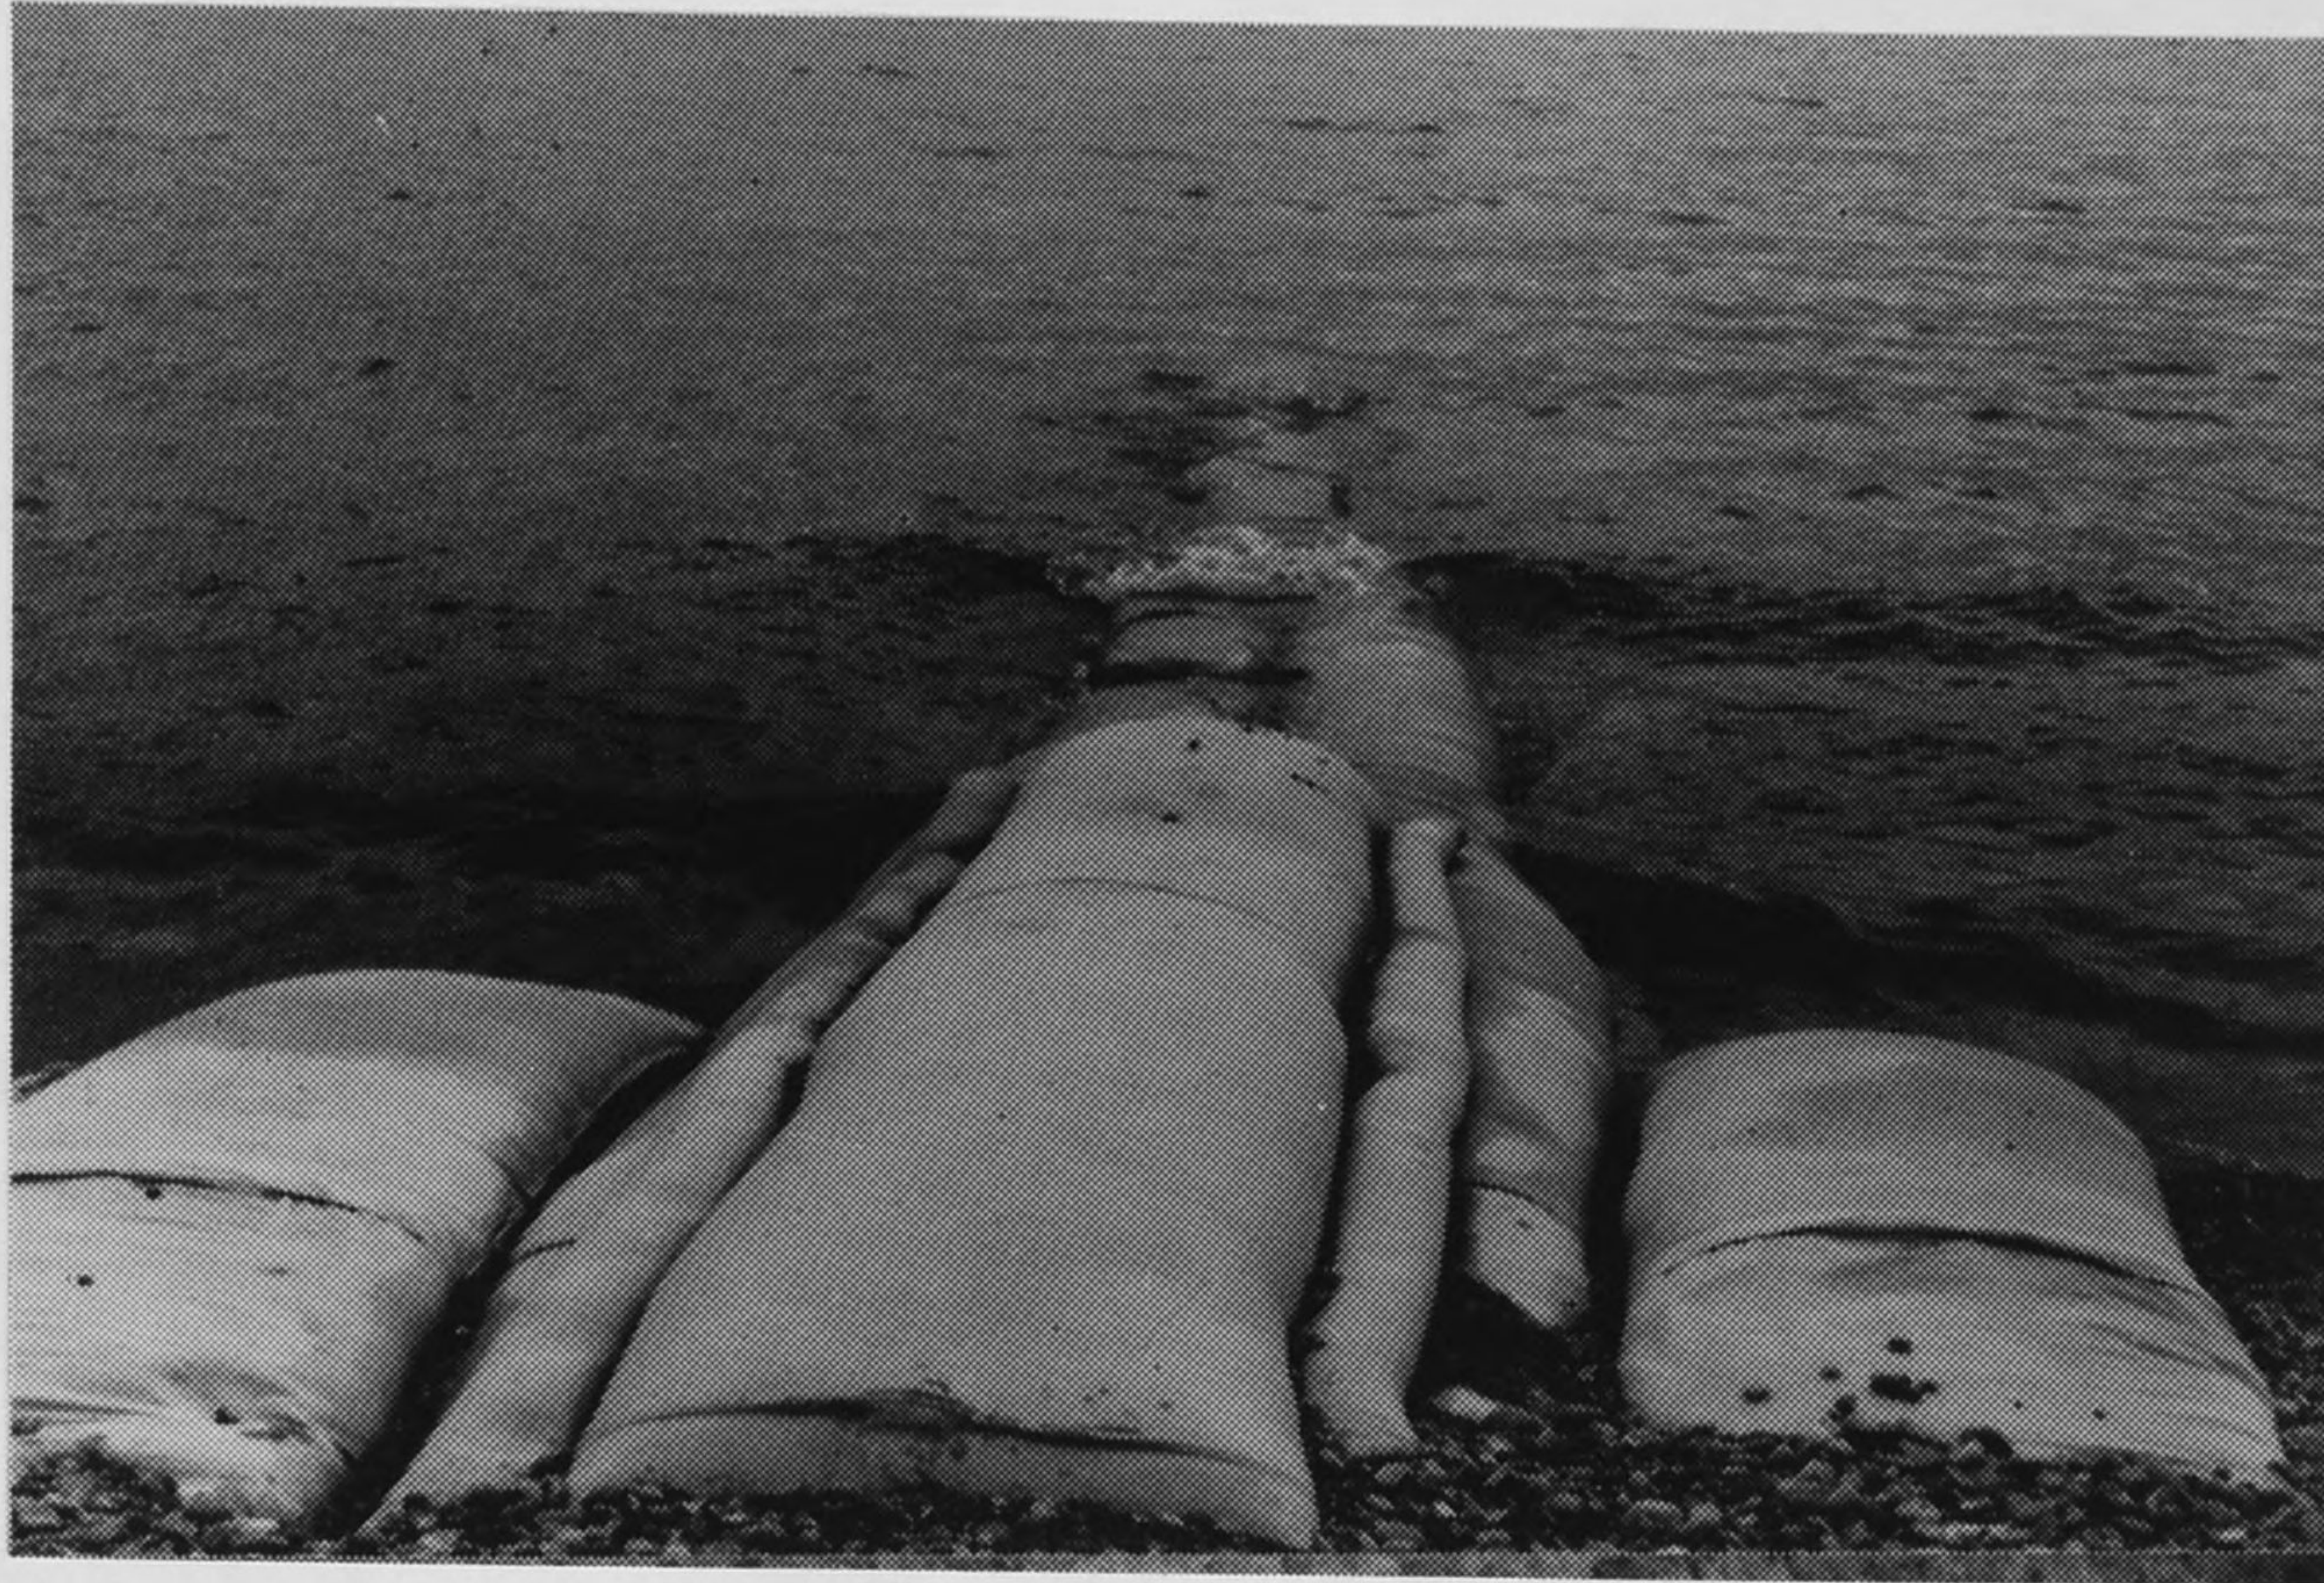
Figure B55. Site V: Same location as Fig. B54 except looking offshore along tube groin.

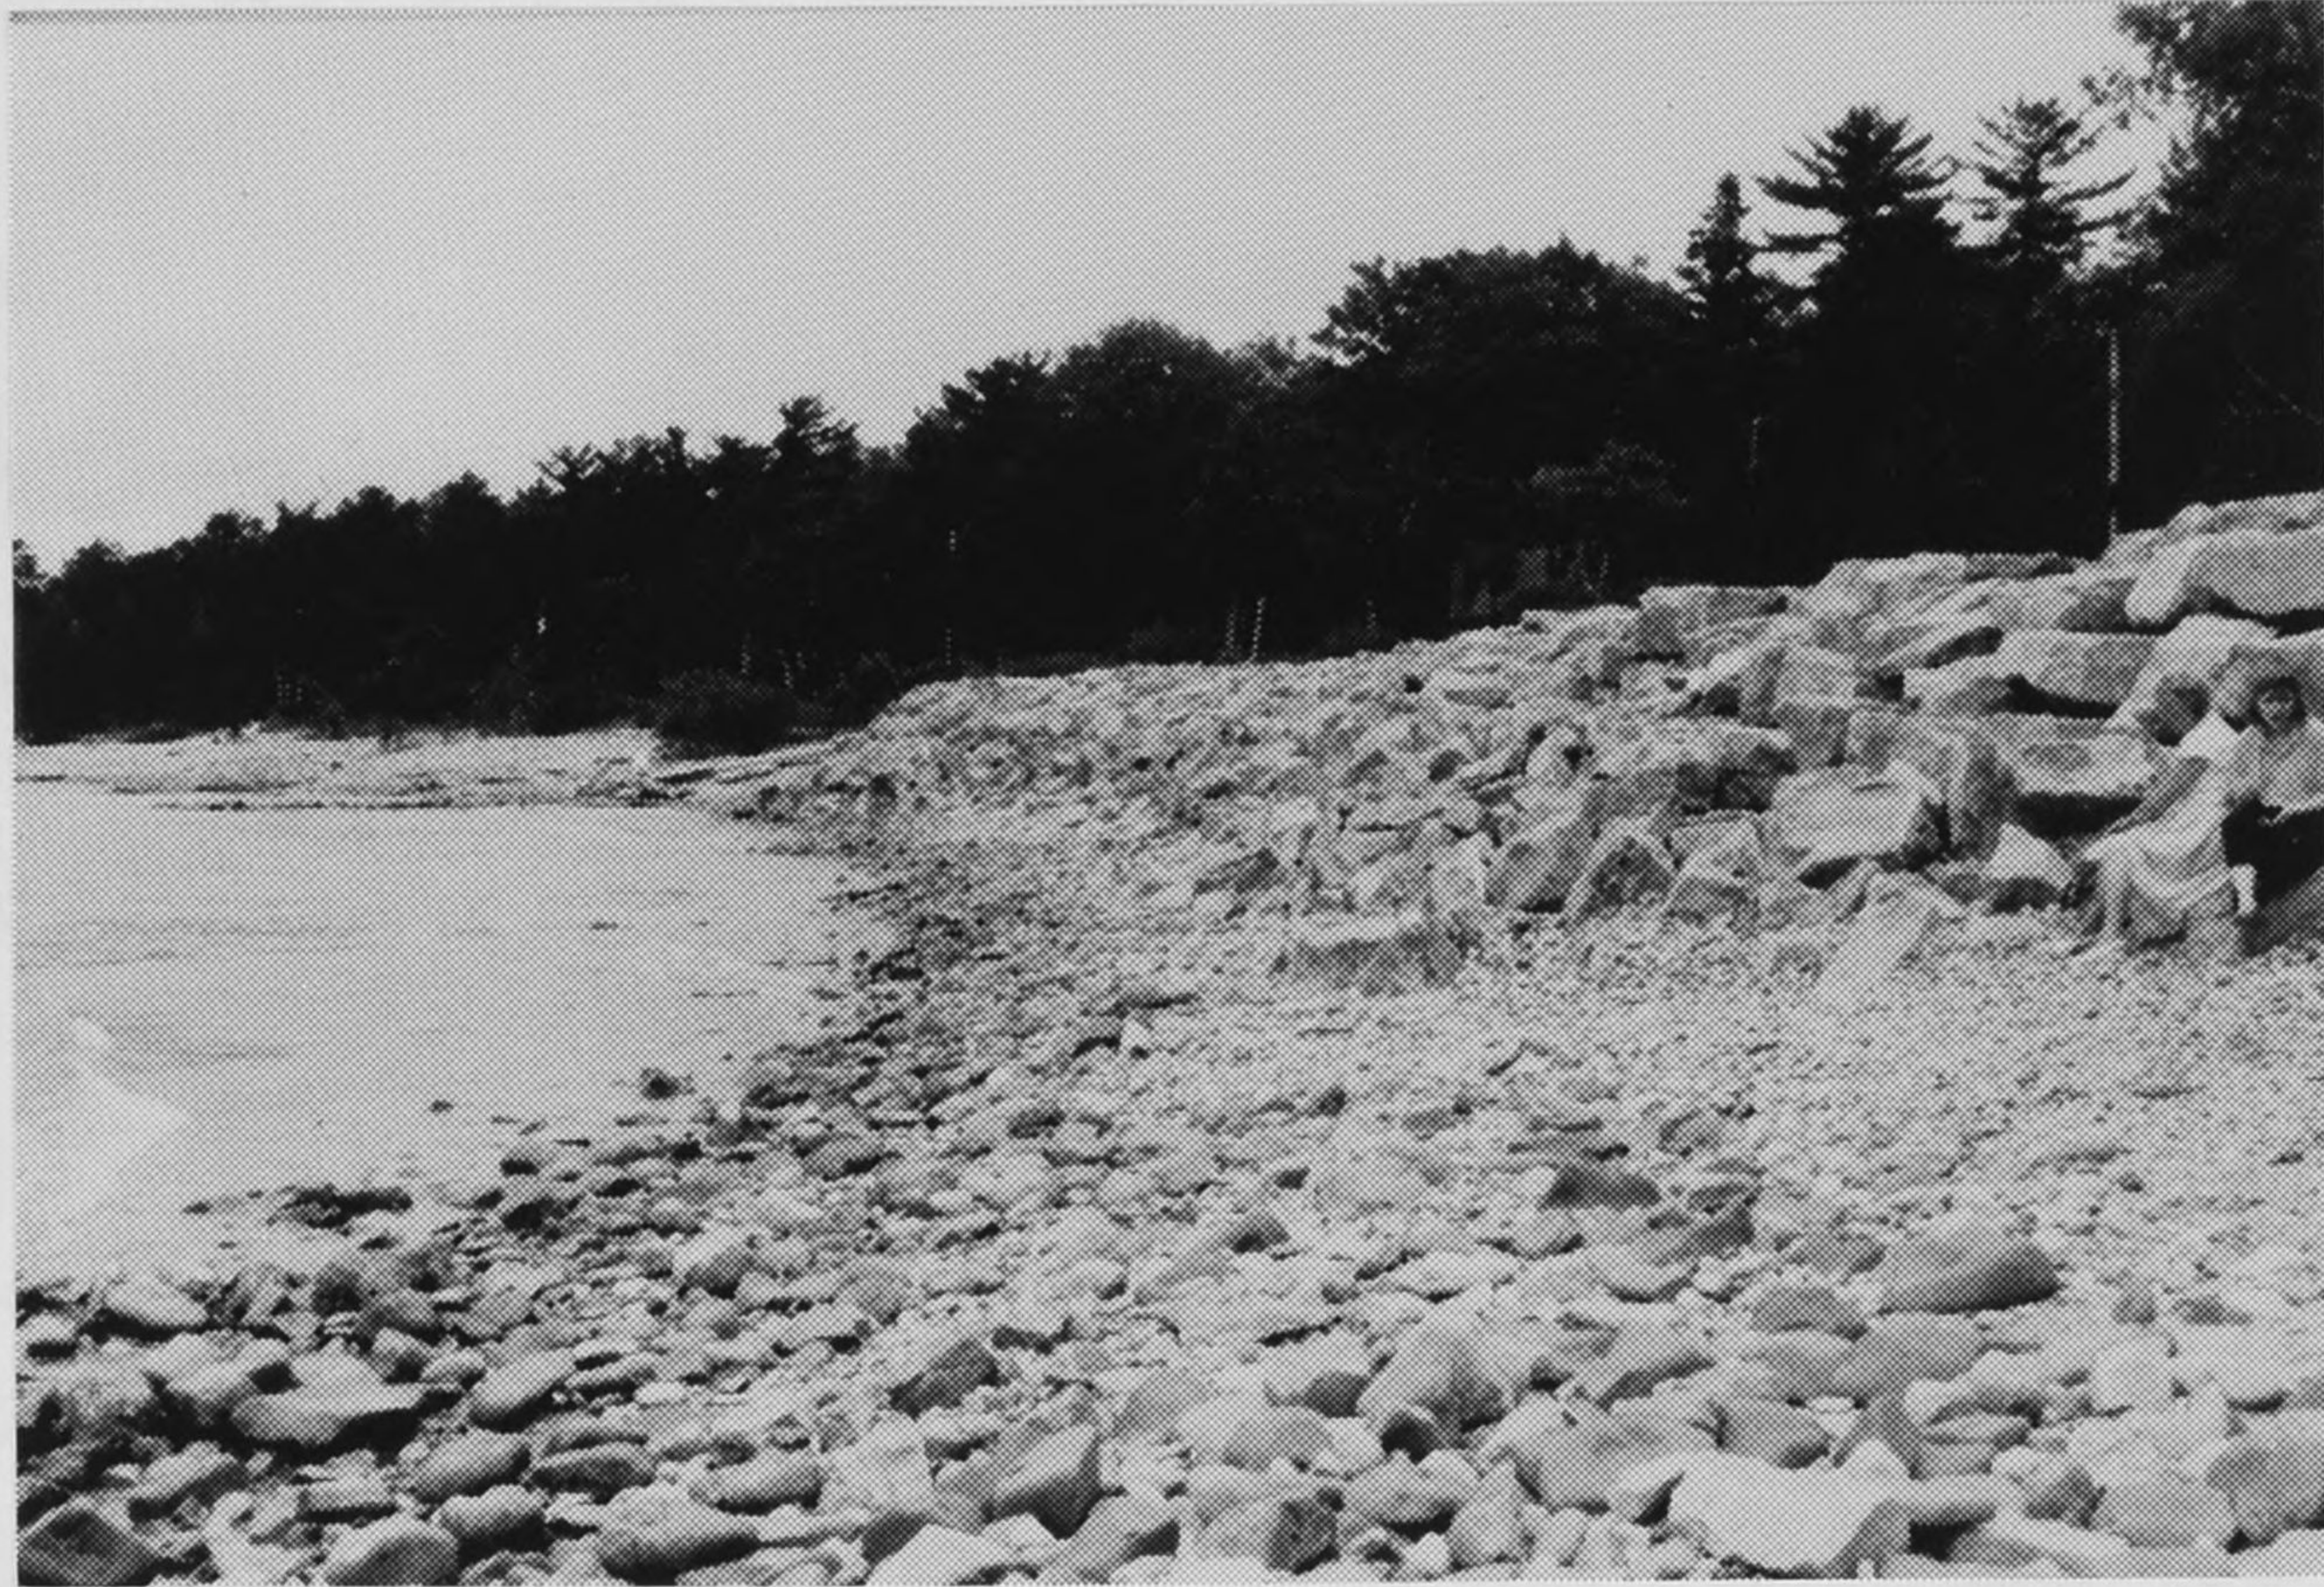
Figure B59. Site W: Looking at coarse beach in front of revetment.
