**EVALUATION OF GREAT LAKES
SHORE PROTECTION STRUCTURES**

Report UMCEE 88-8

**THE UNIVERSITY OF MICHIGAN
DEPARTMENT OF CIVIL ENGINEERING
ANN ARBOR, MICHIGAN**

**Michigan Department of Natural Resources
Coastal Management Program
Land and Water Division**

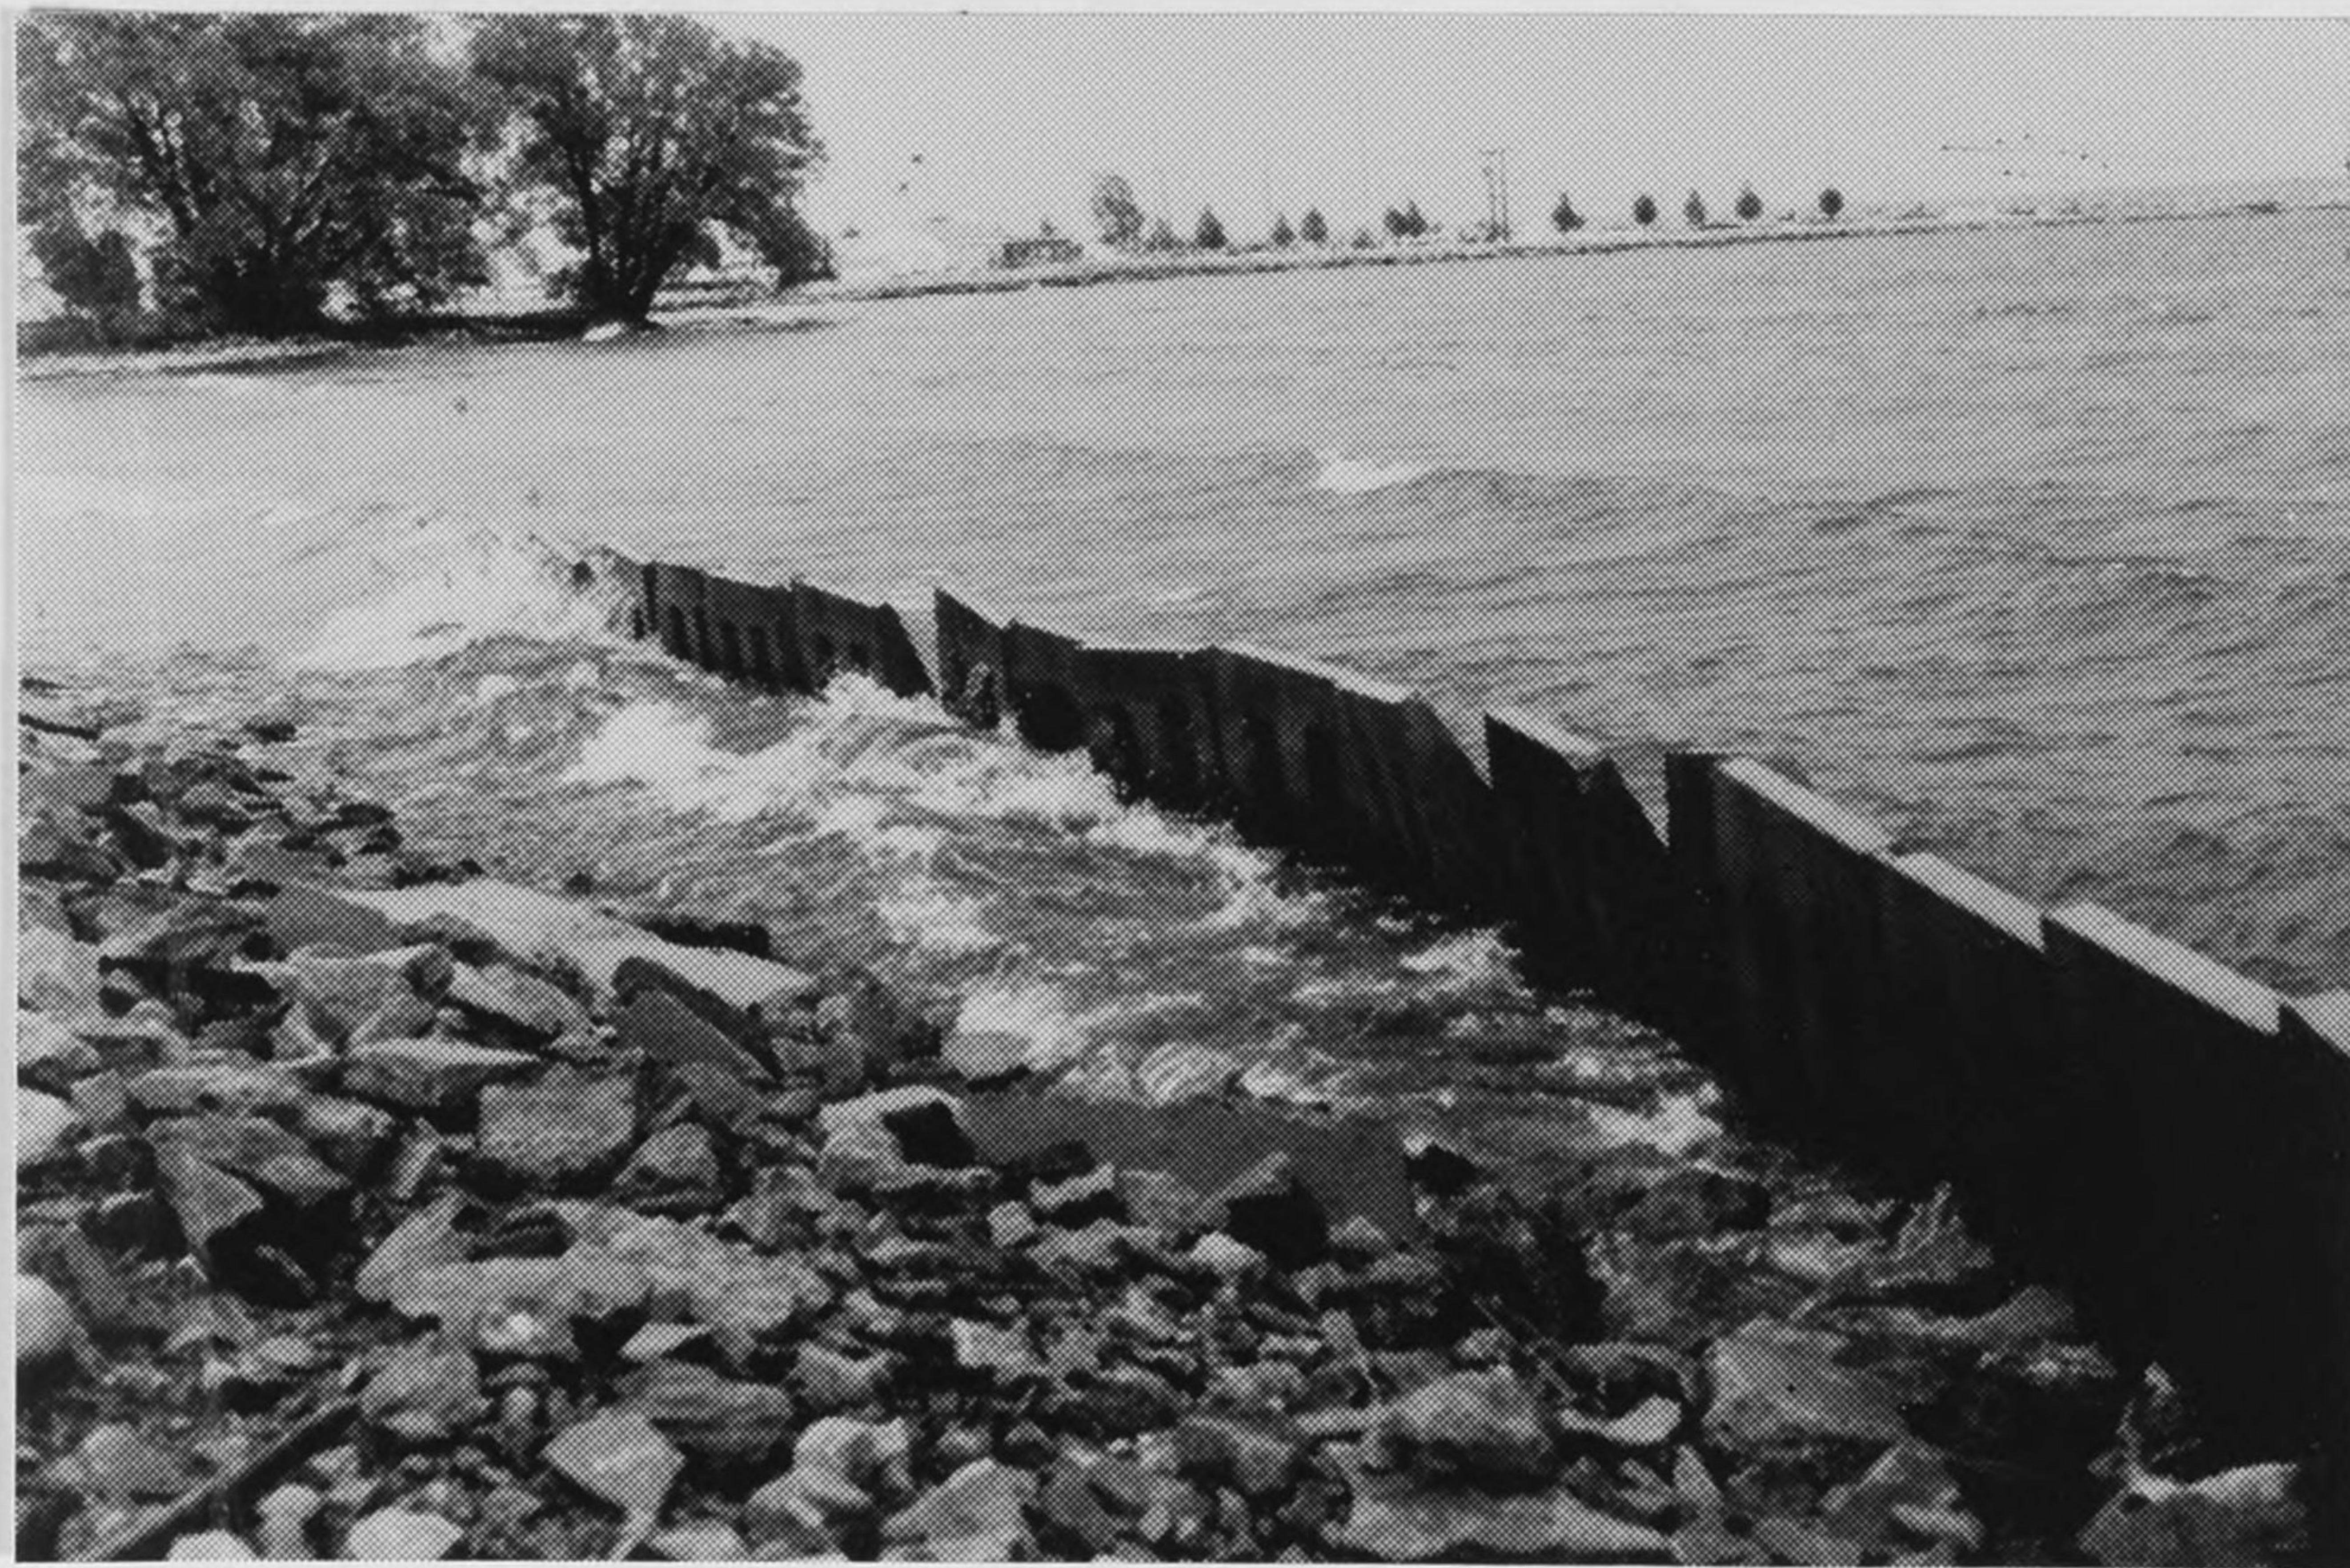
Figure B60. Site X: Normandy type wavebusters in front of 240 S. State. Note revetment almost immediately behind wavebusters.

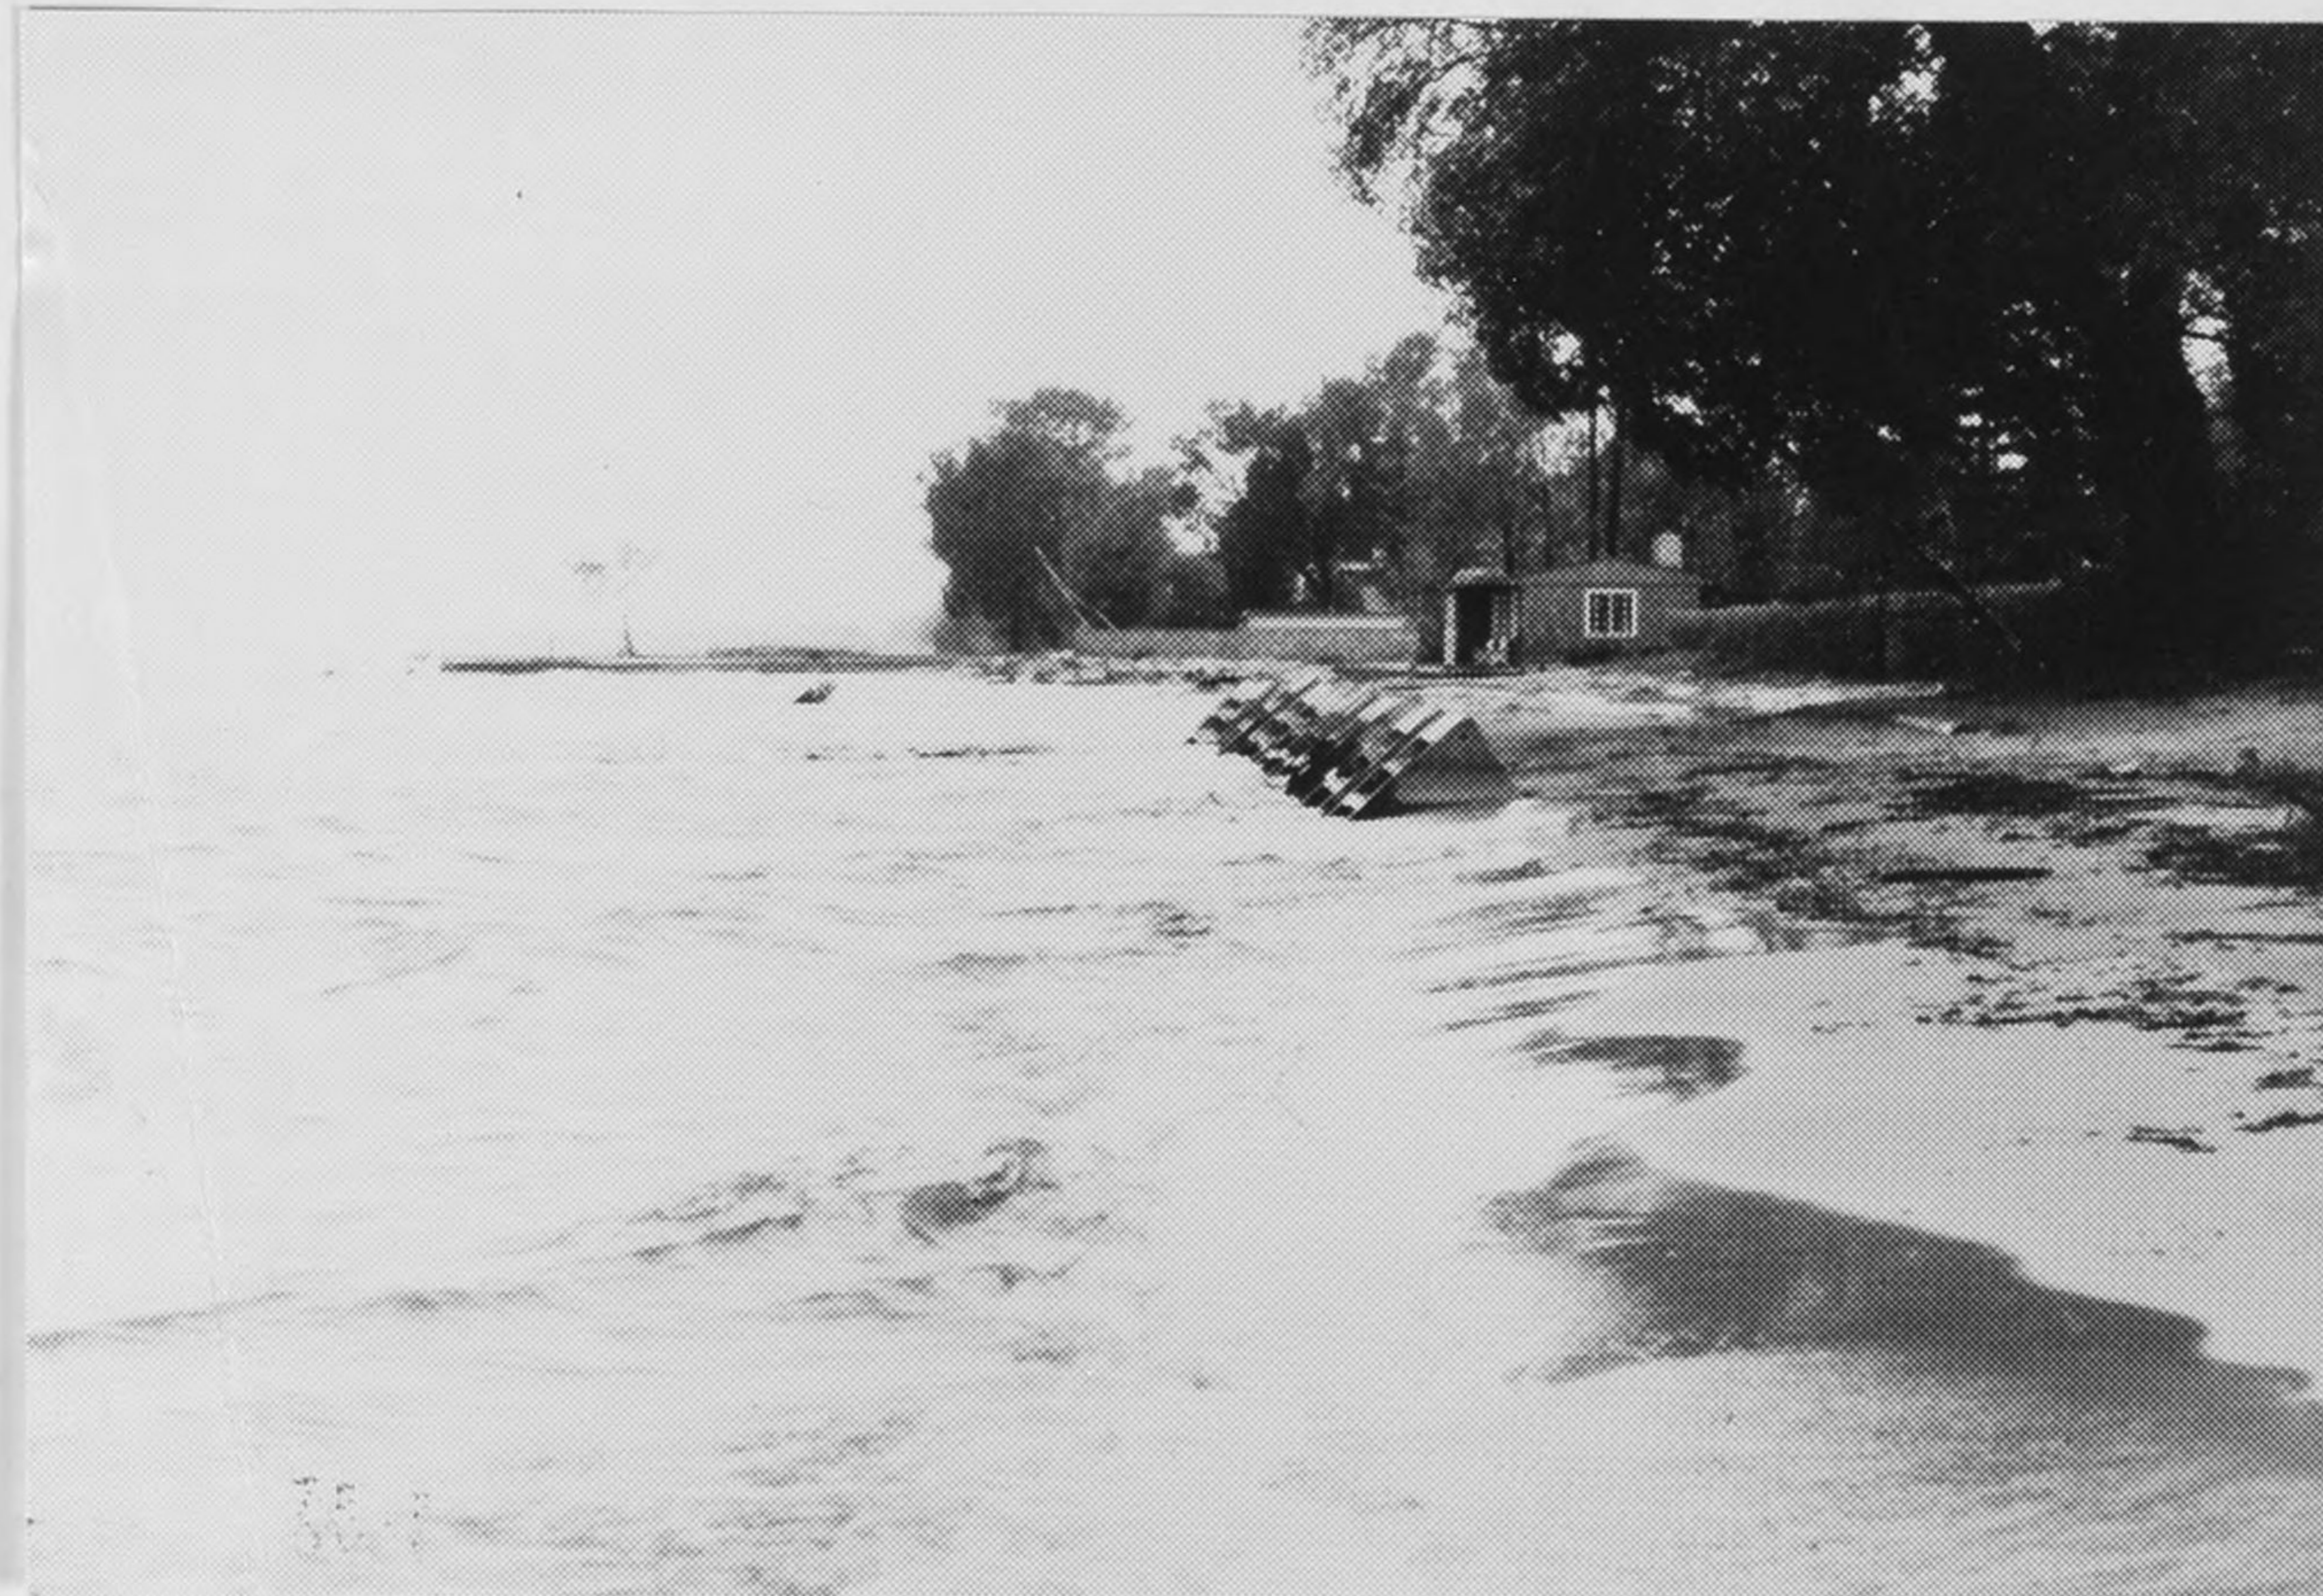
Figure B62. Site X: Looking south at wavebusters at 430 S. State. Note shore protection allows property to south to project farther lakeward.

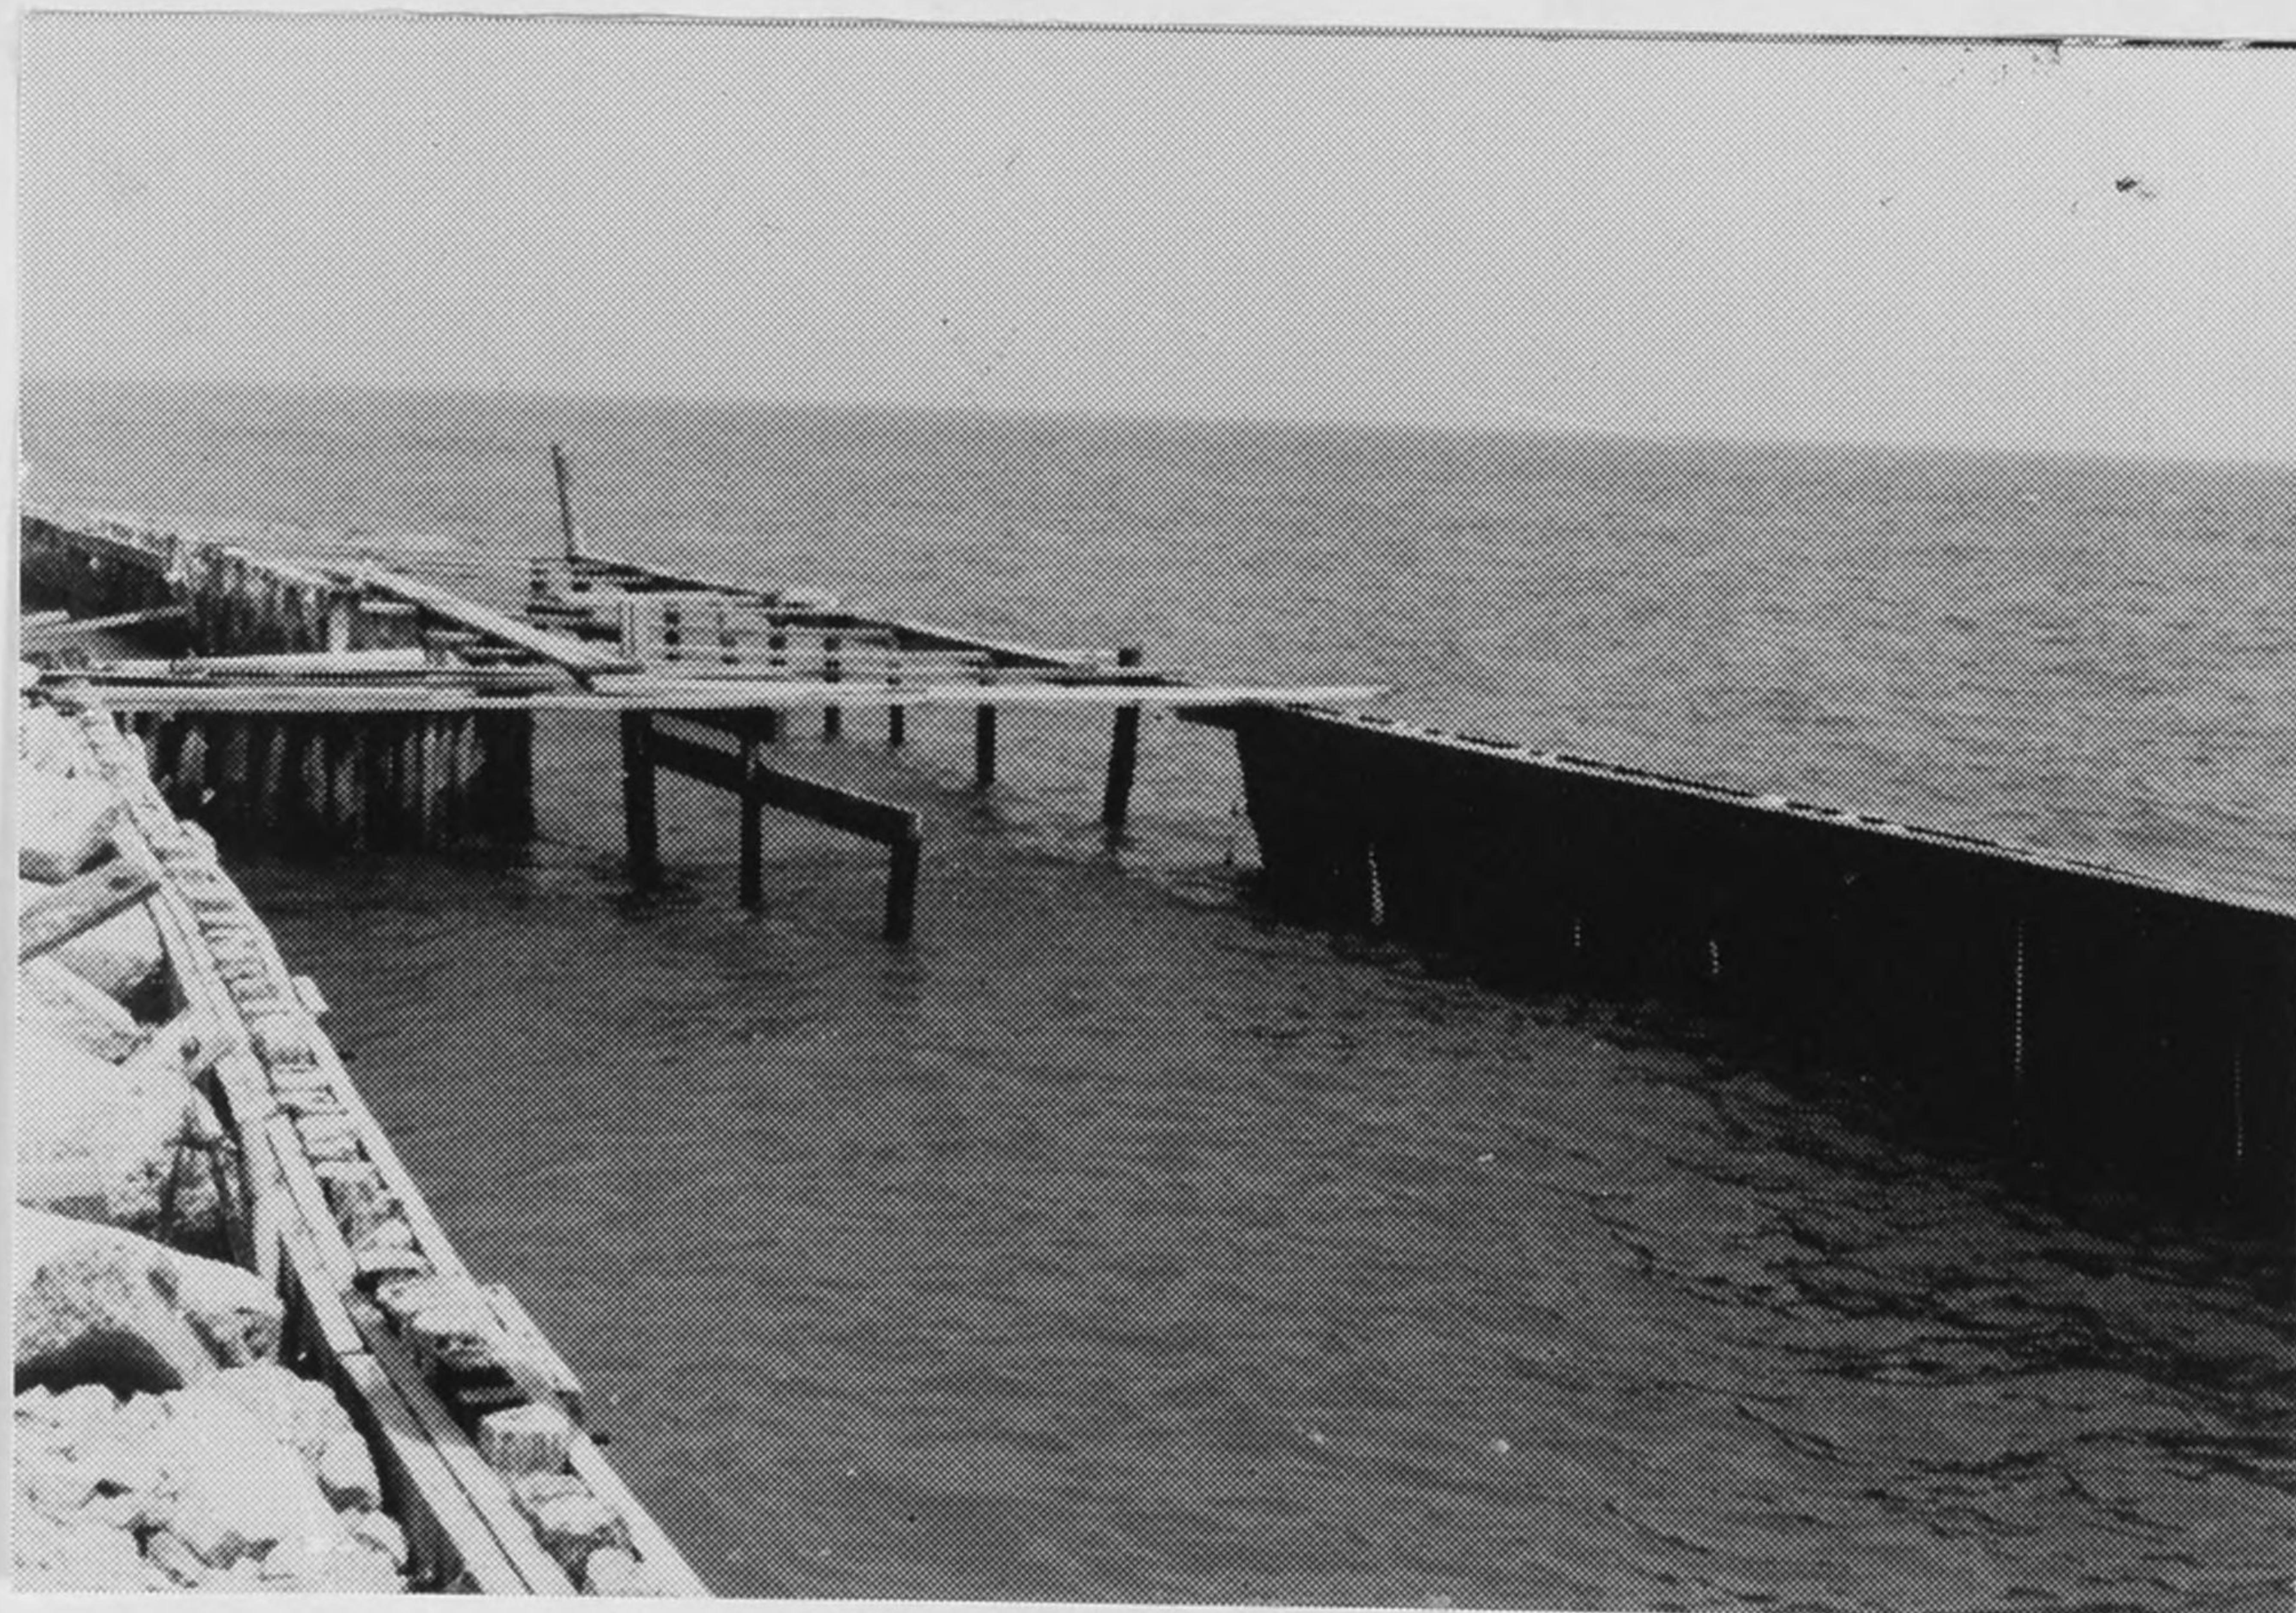
Figure B64. Site Y: New wall construction at Heller property.

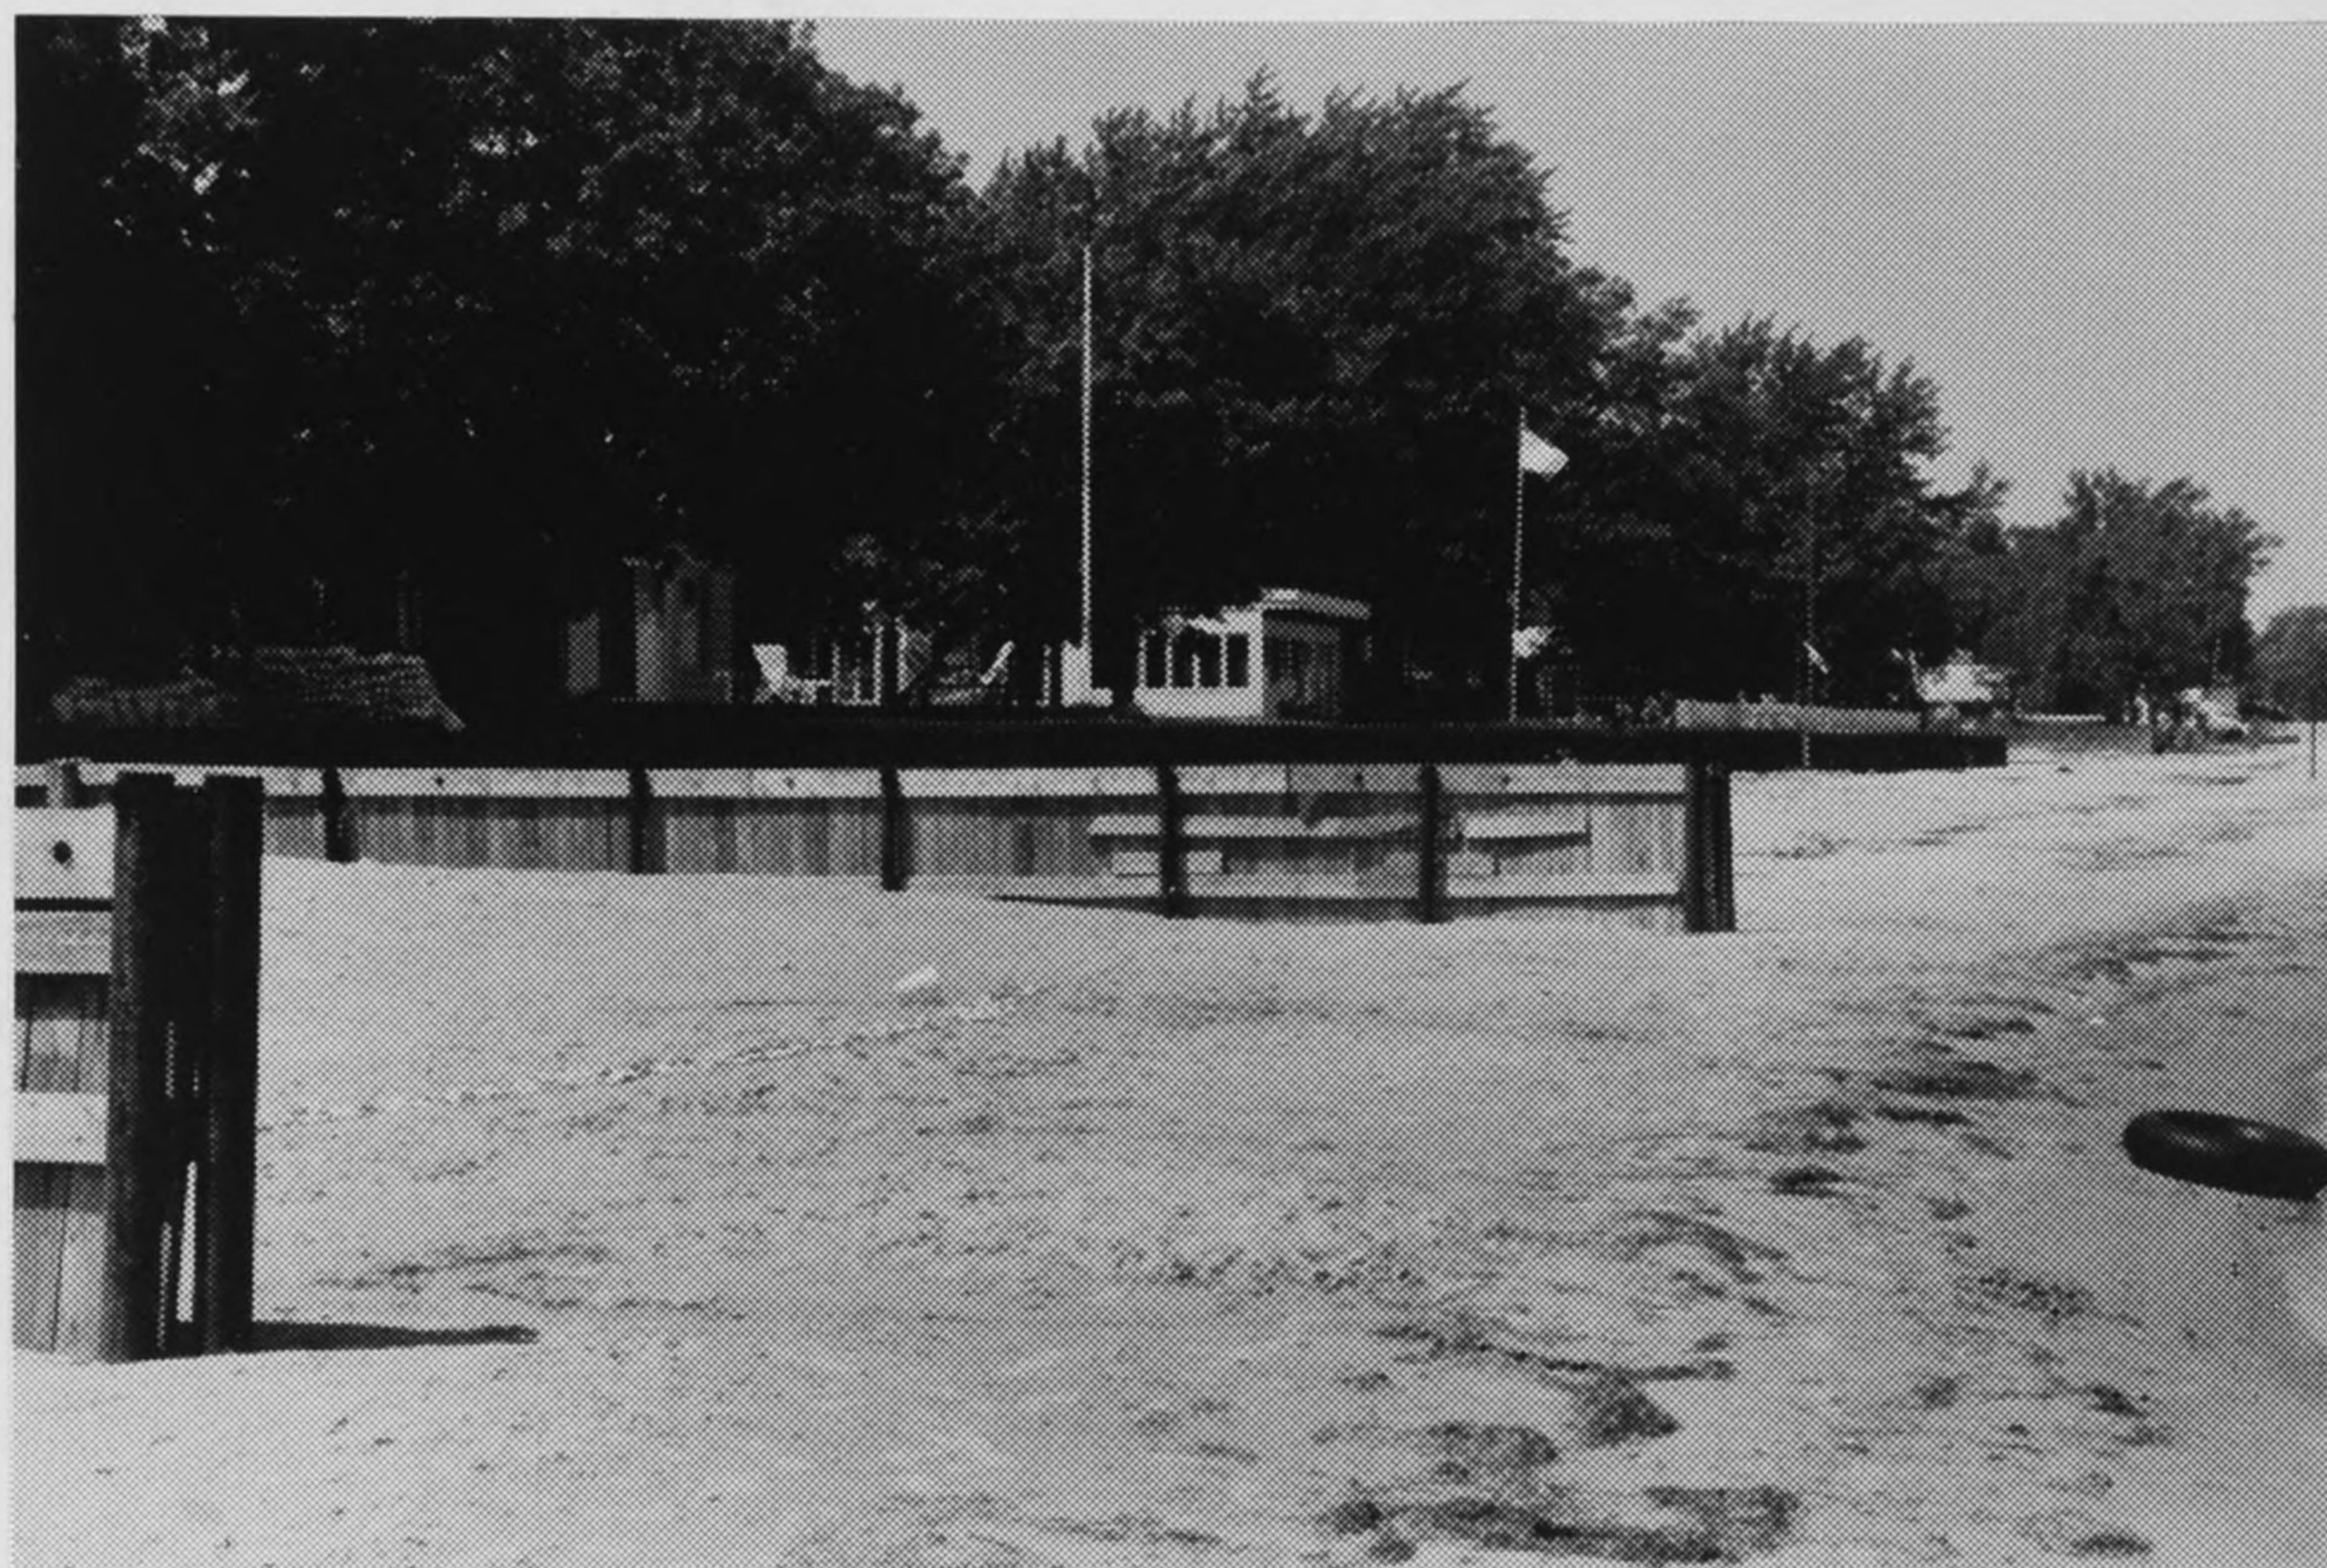
Figure B67. Site AA: Looking north towards groin. Note shoreline considerably beyond end of groin. Also note similar structure to south at left side of photo.

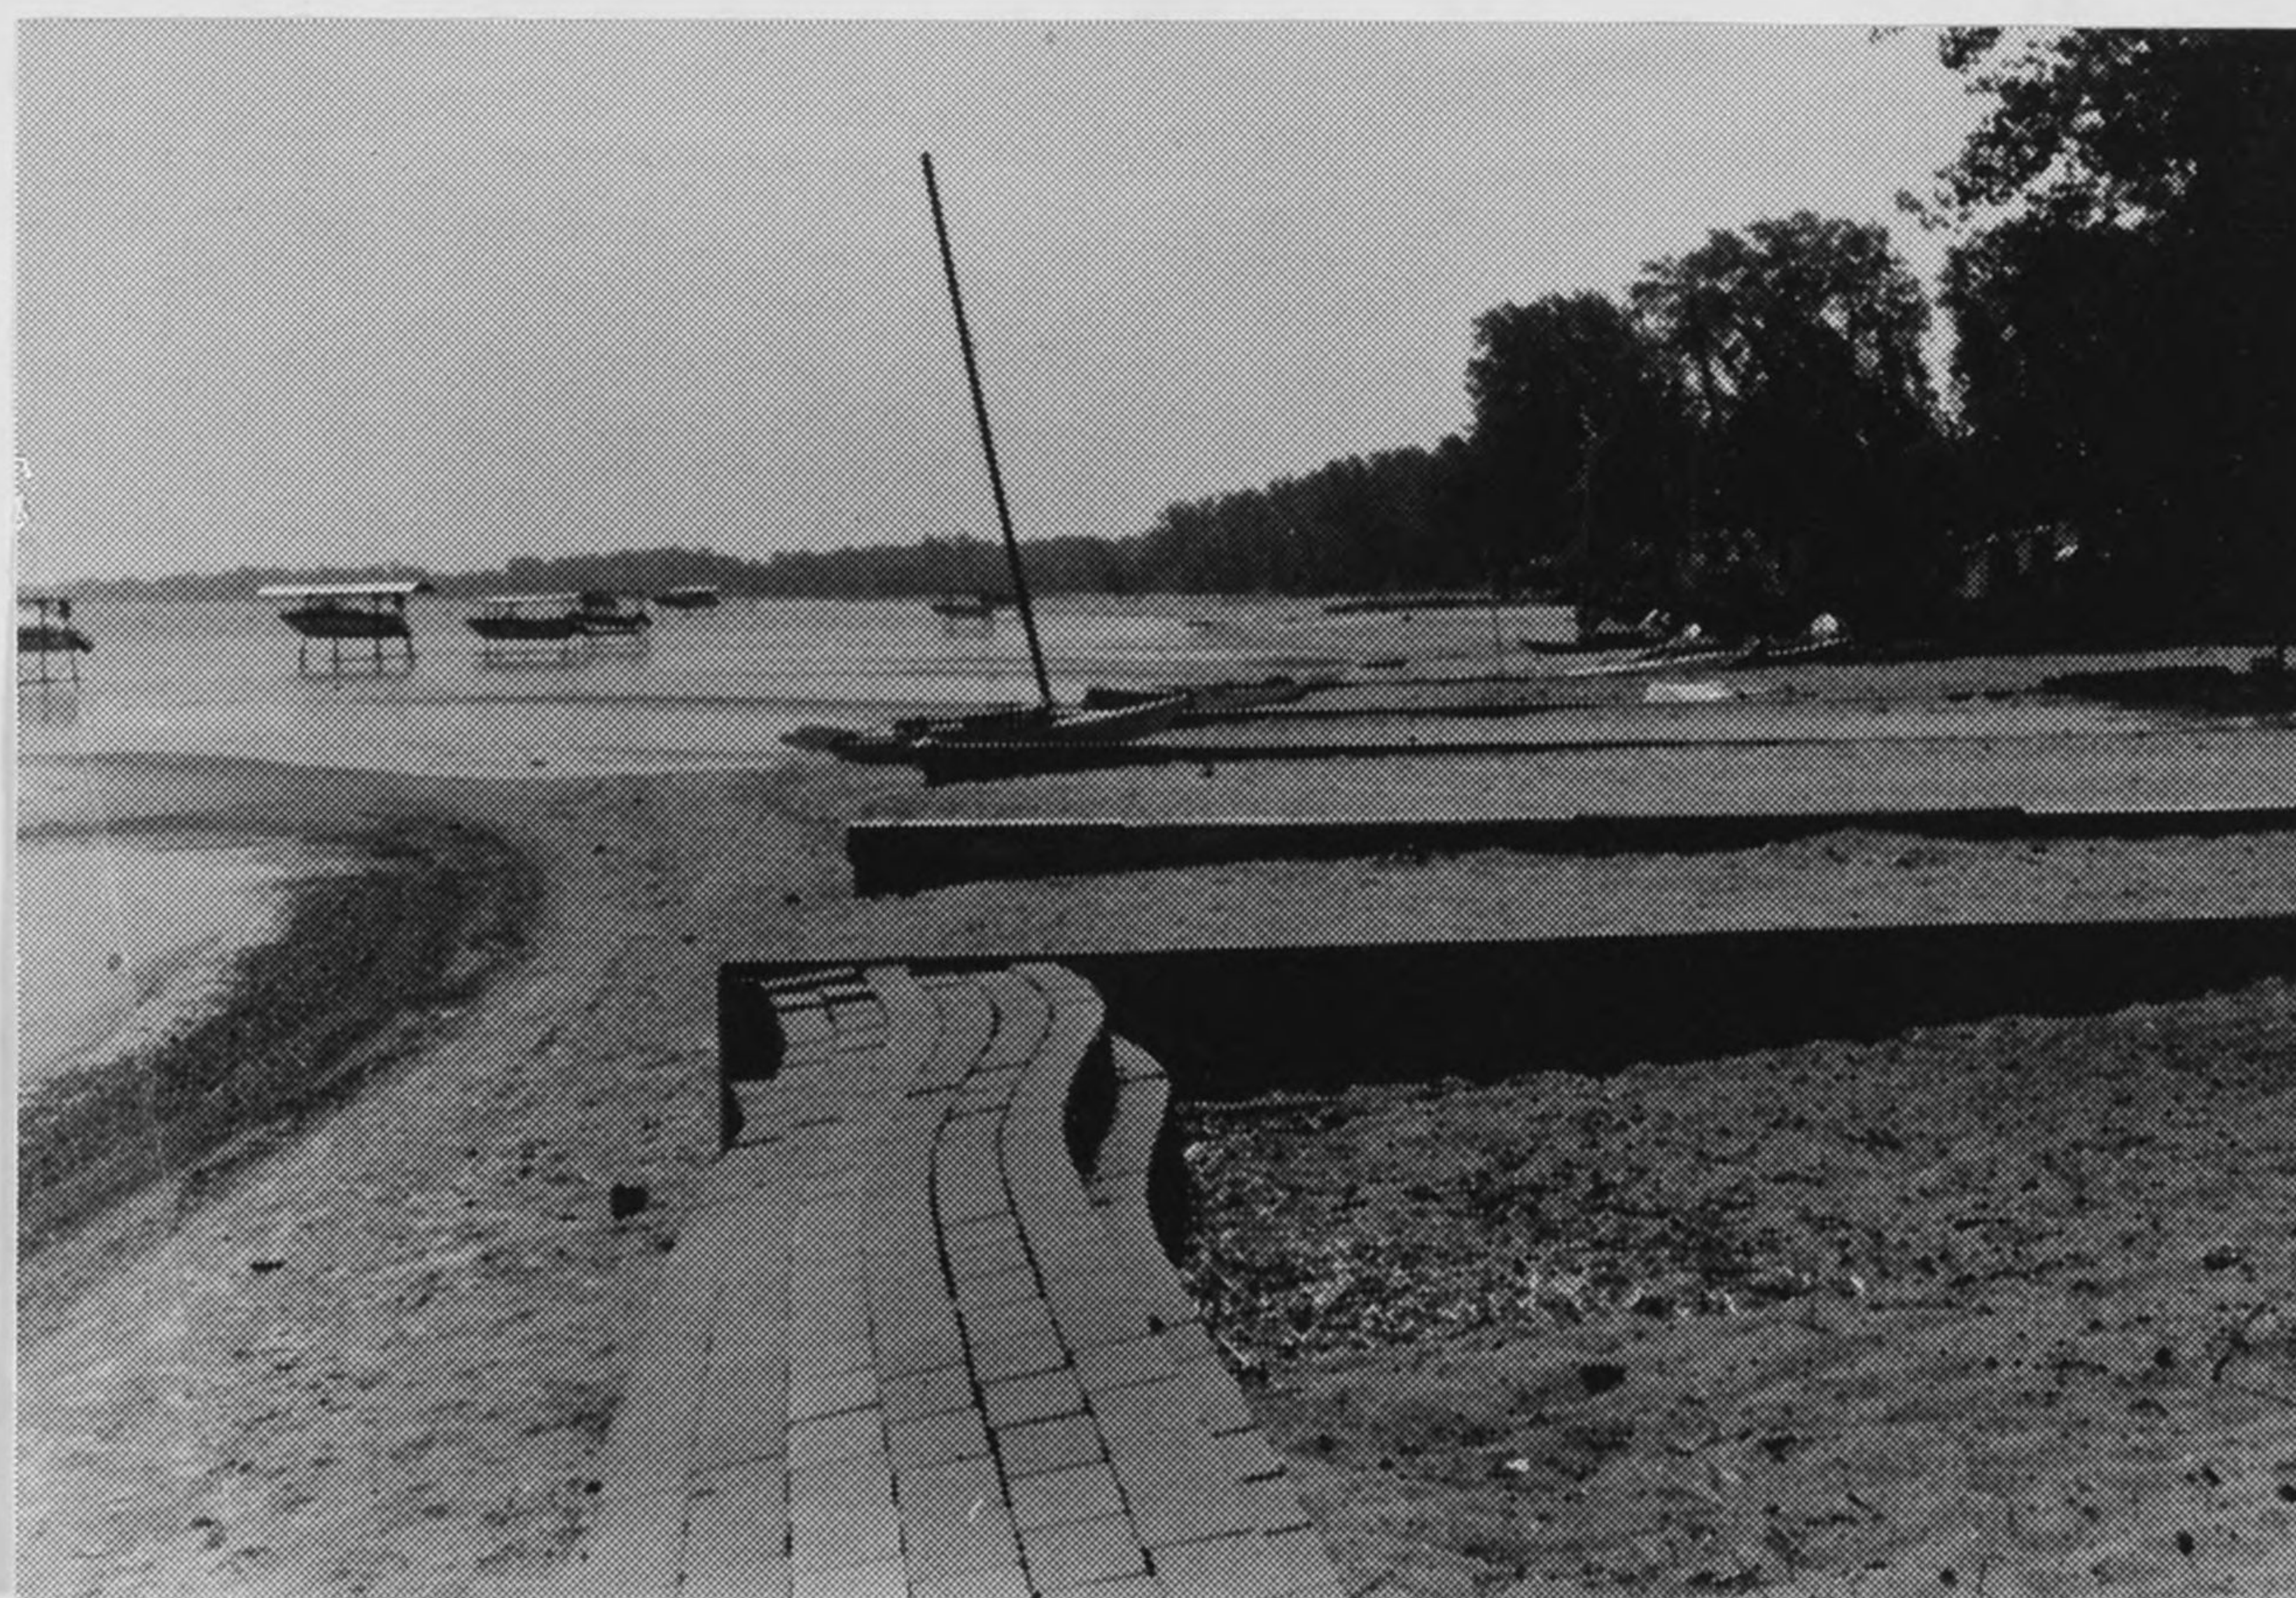
Figure B68. Site BB: Looking south towards site. Property is between two groins between catamaran and sandgrabber wall in foreground. Note sand spit offshore.

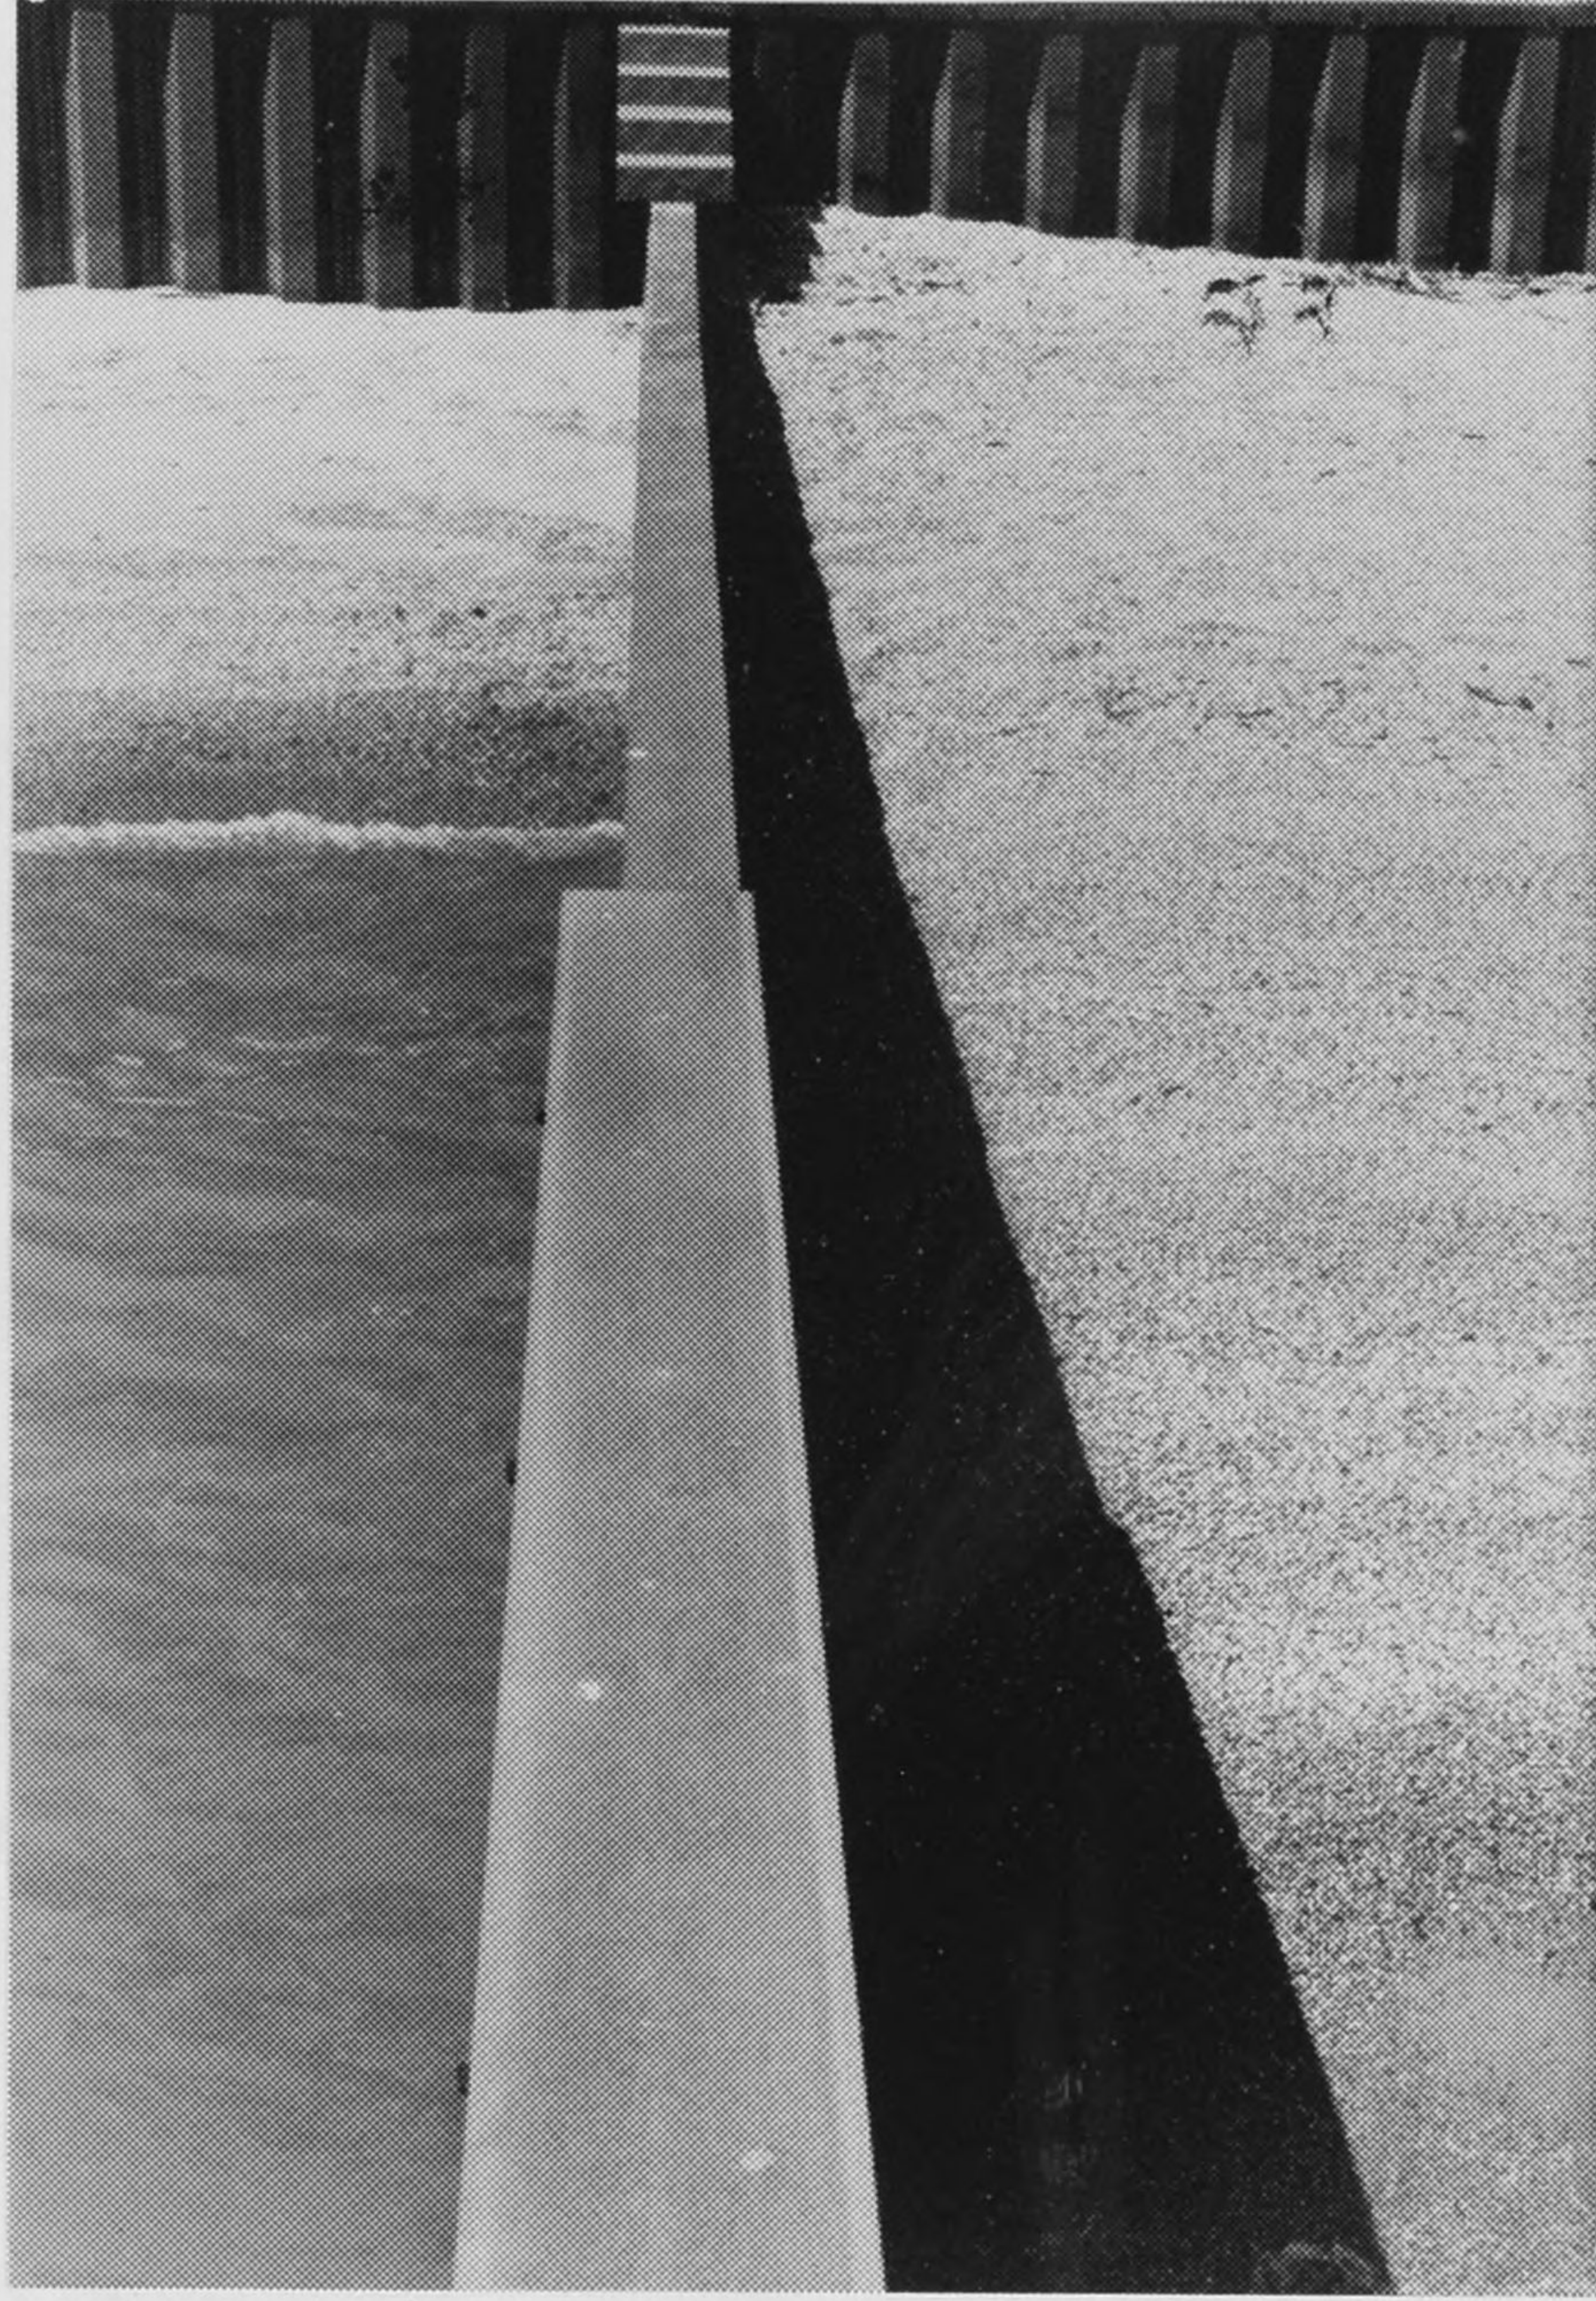
Figure B70. Site DD: Looking shoreward along groin on north side of Sharpe property. Littoral drift is right to left. Total groin length is about 50 feet.
