**EVALUATION OF GREAT LAKES
SHORE PROTECTION STRUCTURES**

Report UMCEE 88-8

**THE UNIVERSITY OF MICHIGAN
DEPARTMENT OF CIVIL ENGINEERING
ANN ARBOR, MICHIGAN**

**Michigan Department of Natural Resources
Coastal Management Program
Land and Water Division**

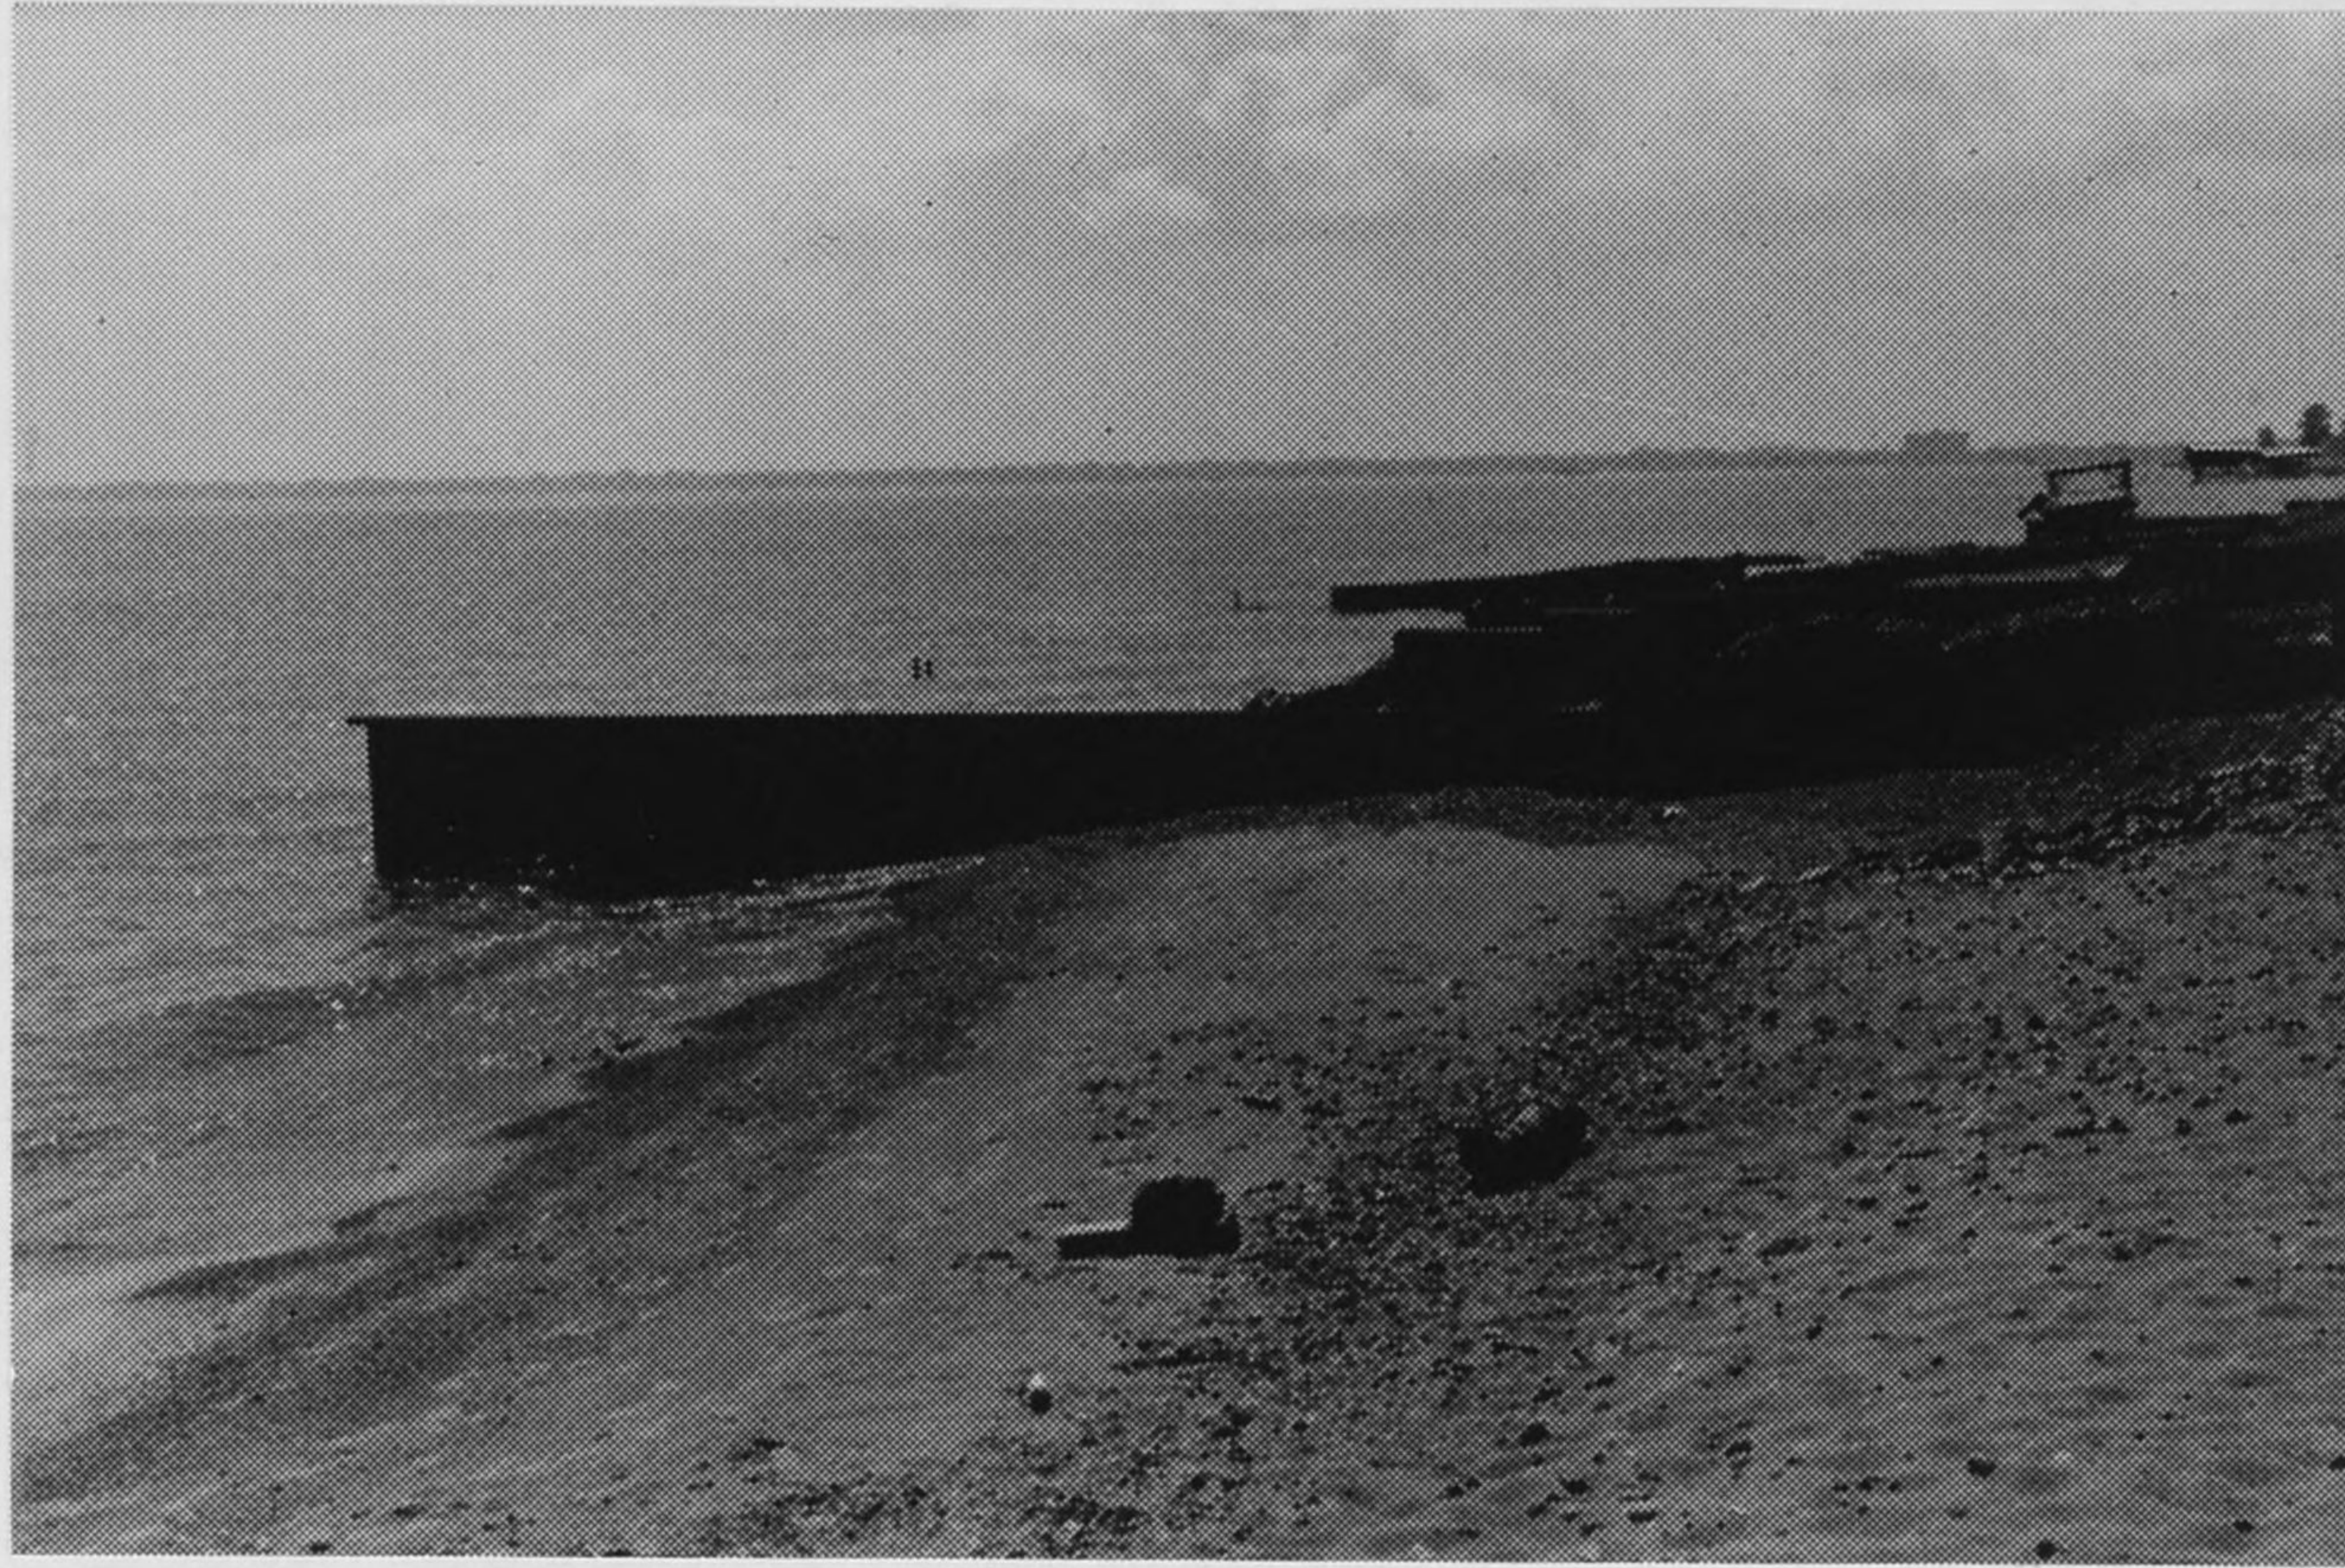
Figure B71. Site GG: Looking south at Durand groin. Sand on beach is just a fine layer with coarse cobbles underneath.

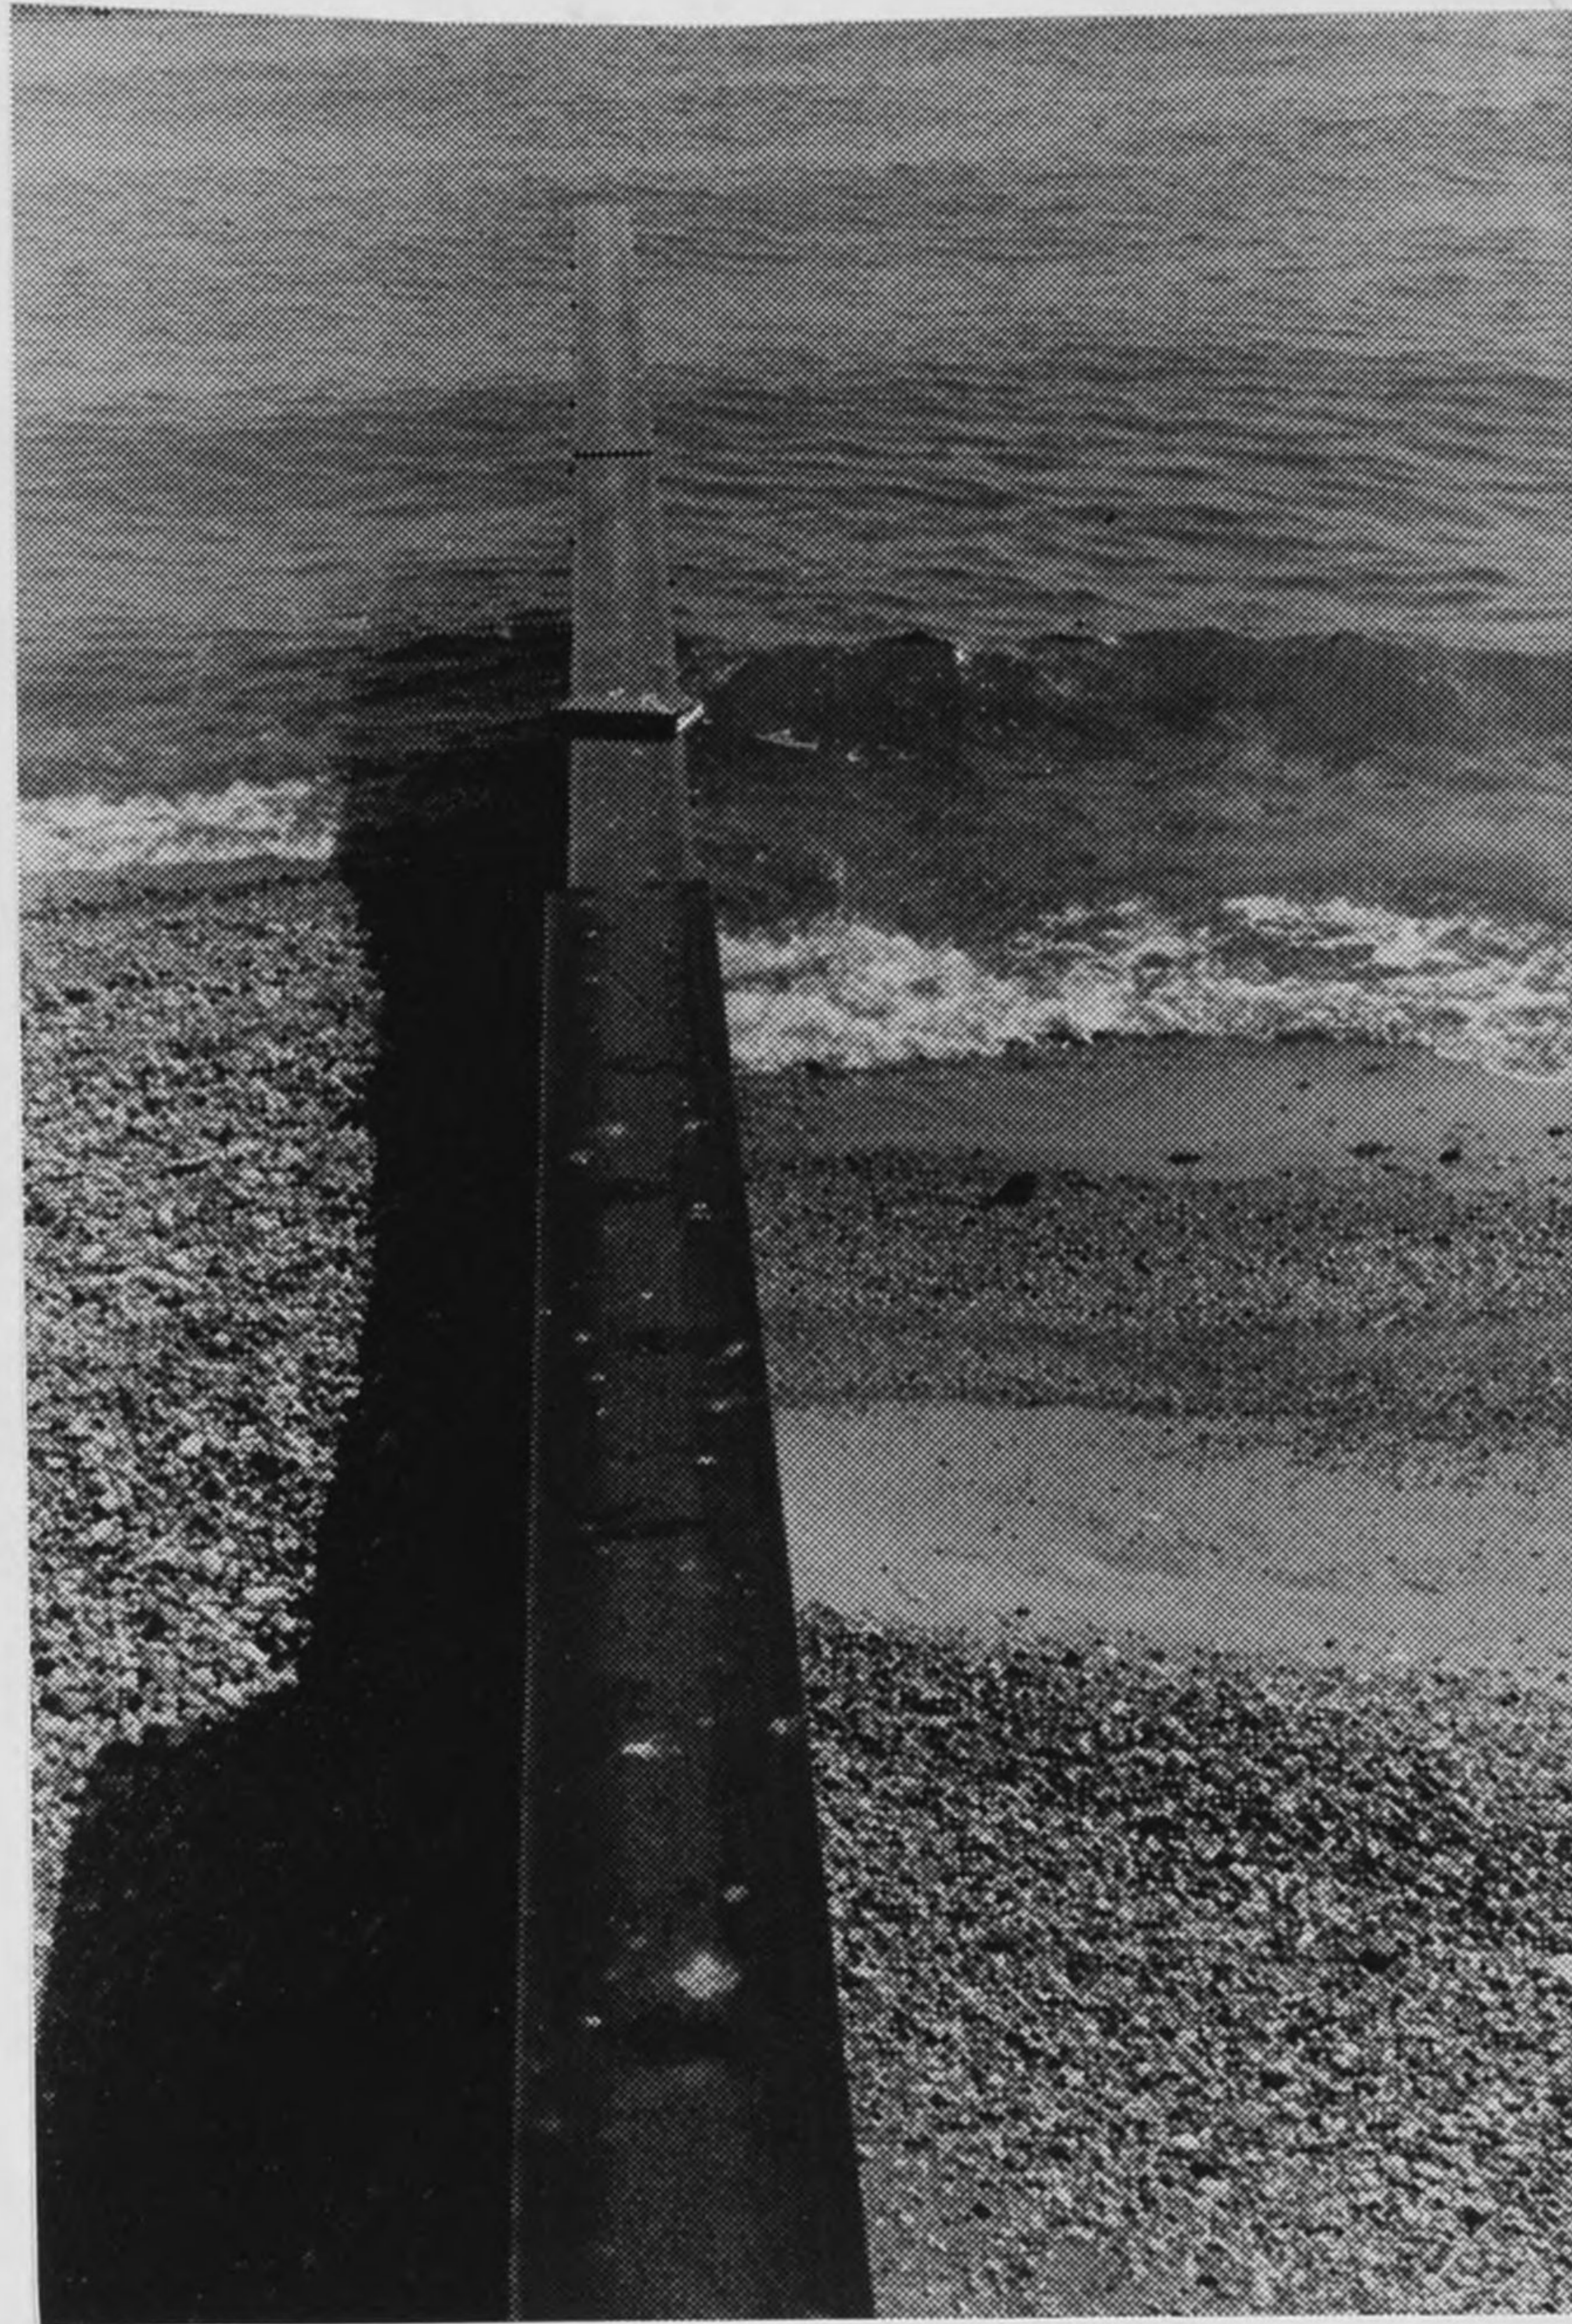
Figure B72. Site GG: Looking offshore along Durand groin. Littoral drift is left to right.

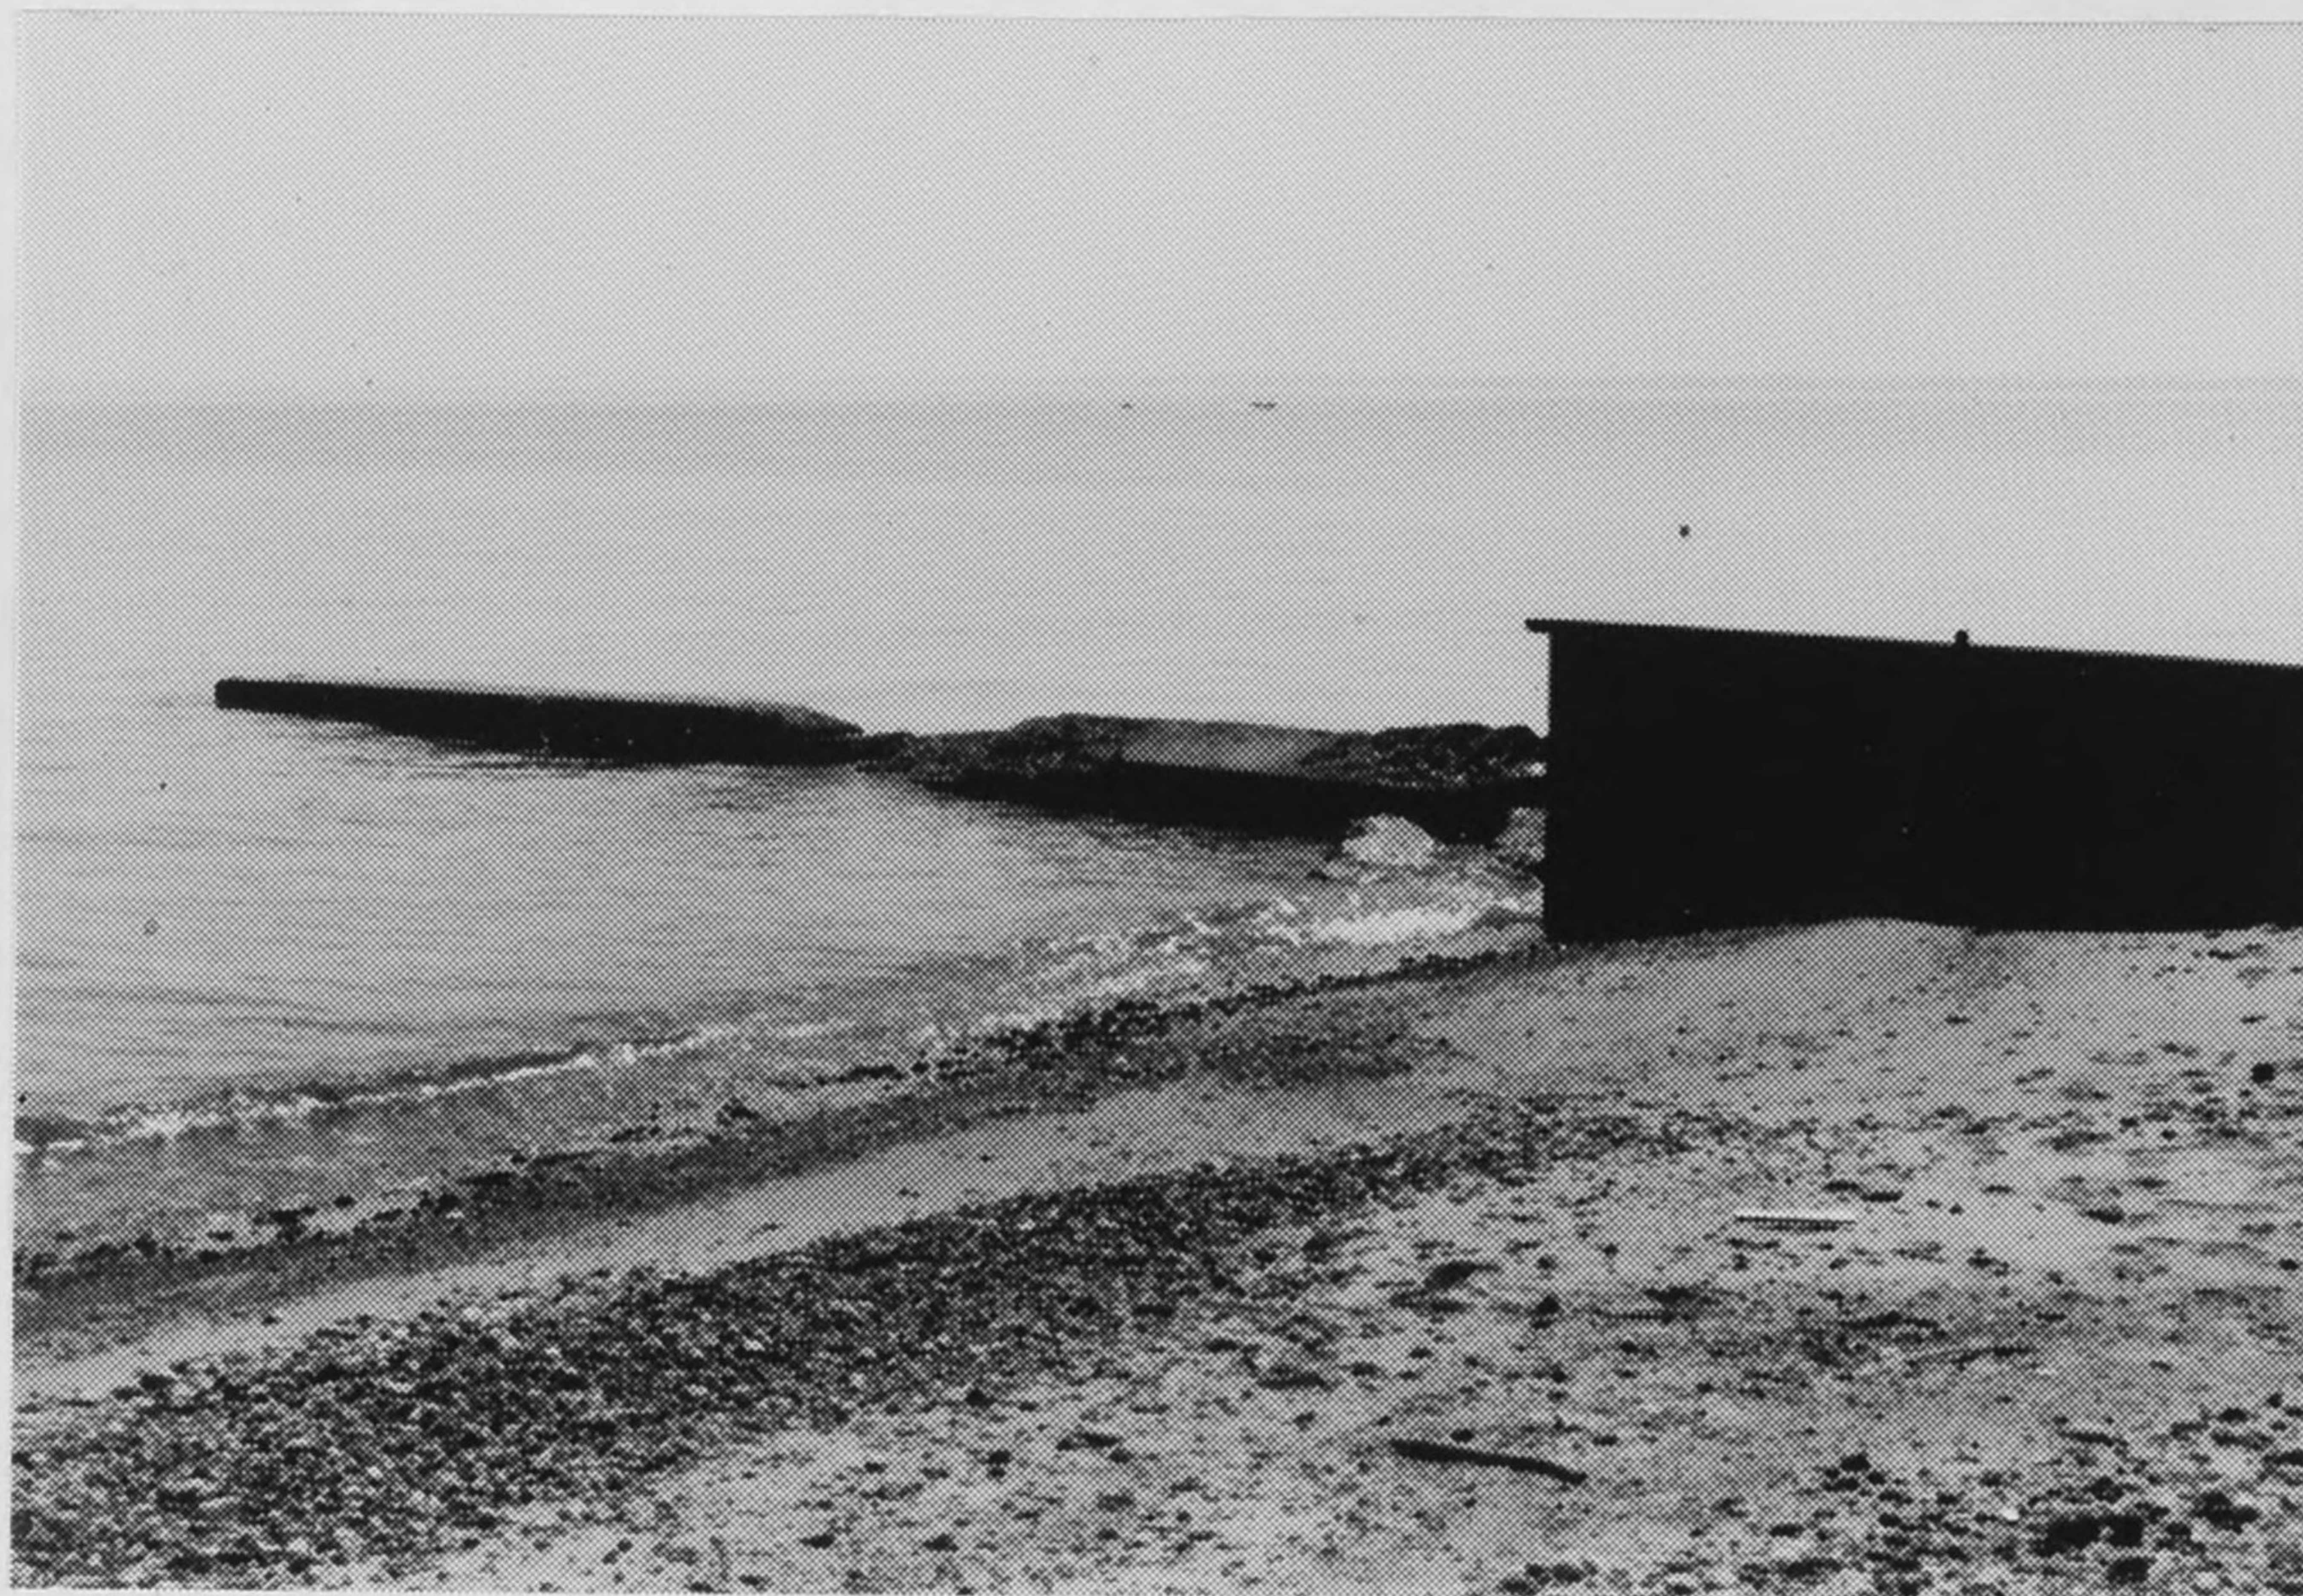
Figure B73. Site HH: Looking towards the southeast from north corner of Wines' beach. Remnant of old concrete groin extends beyond steel groin.

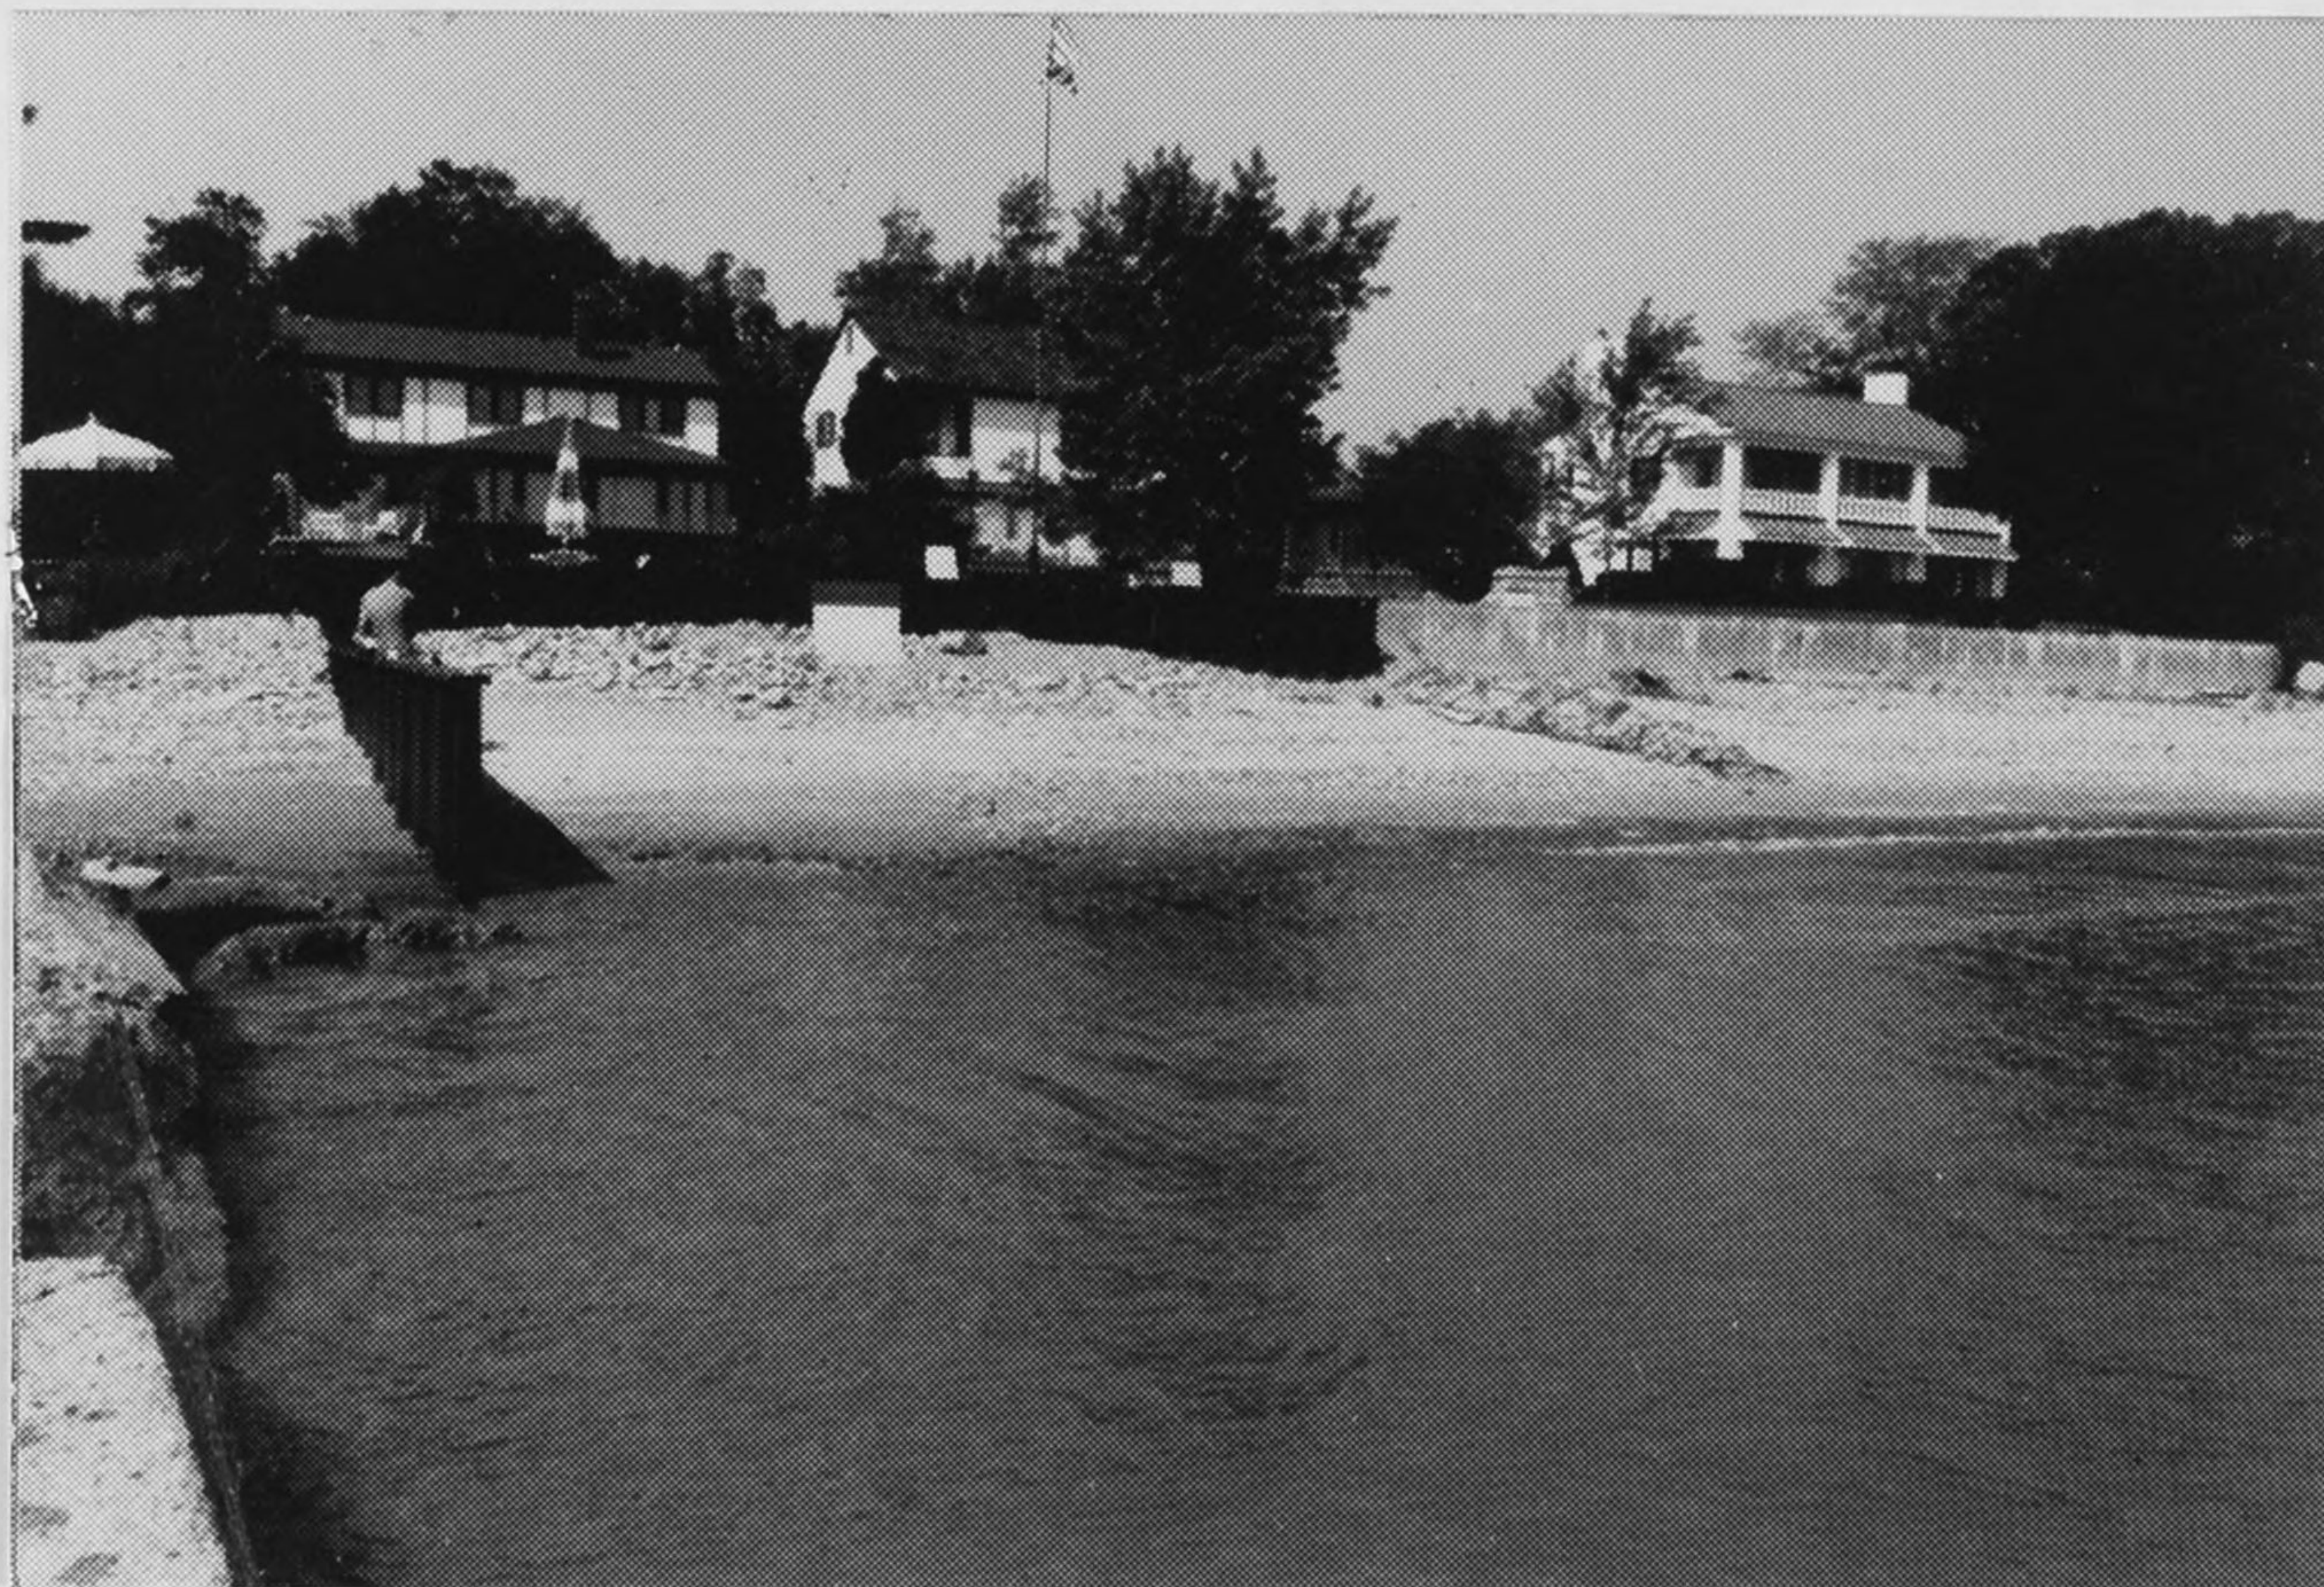
Figure B74. Site HH: Looking onshore from end of old concrete groin (Fig. B73) towards new steel groin and beach.
