THE ENERGY-ABSORBING STEERING COLUMN

A Study of Collision Performance
in Fatal and Nonfatal Accidents

HIGHWAY SAFETY RESEARCH INSTITUTE
The University of Michigan • Ann Arbor
1968

HSRI Report No. Bio-7

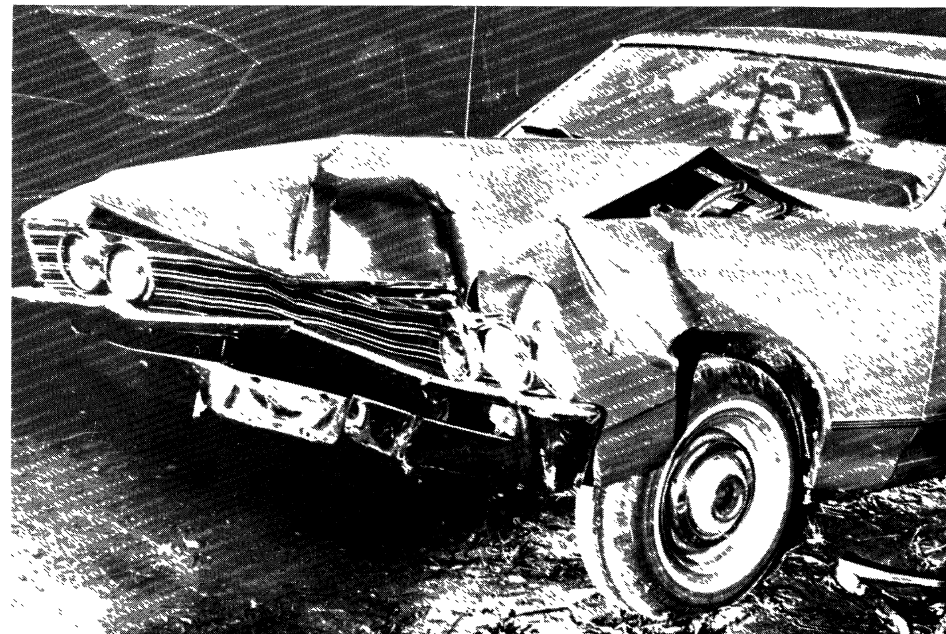
1967 Chevelle (Figures 1 and 2). In this intersection collision, the Chevelle struck another car in the side at 20 mph. The underhood portion of the energy-absorbing column telescoped $3\frac{1}{8}$ inches. There were no reported injuries to the unrestrained 29-year old male driver. The in-car energy-absorbing section of the column was not collapsed.

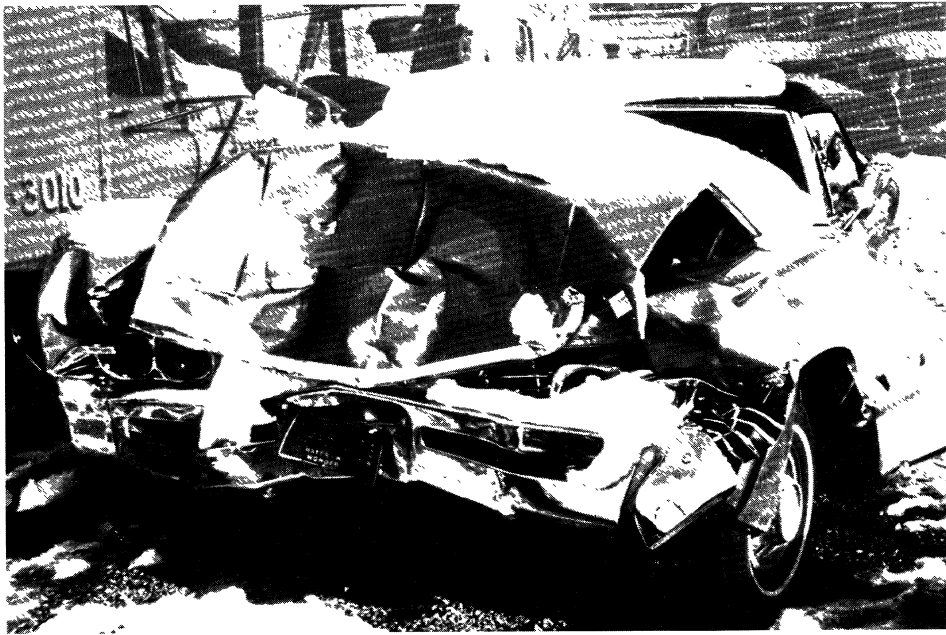
1967 Chevrolet (Figures 3 and 4). This vehicle struck a van which had turned in front of the case vehicle. The impact speed was estimated at 20-25 mph. The in-car portion of the energy-absorbing column compressed approximately $1\frac{1}{2}$ inch. The unrestrained 18-year old male driver sustained a 4 cm laceration in the left eyebrow area from steering wheel impact, a right knee abrasion (lower instrument panel), and a bruise to his right forearm (instrument panel?). (Case #182/12/8/66)

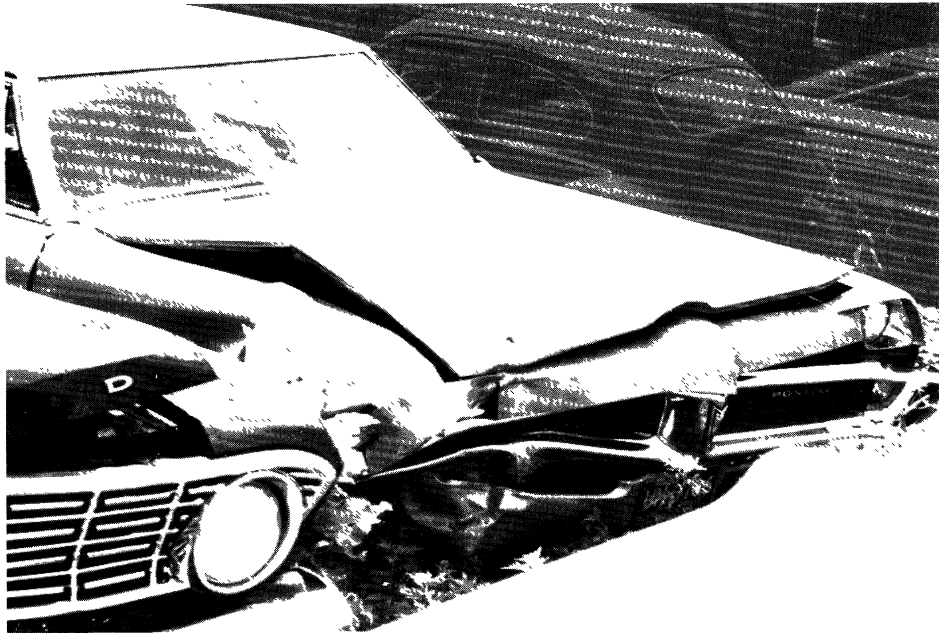
1967 Pontiac (Figures 7 and 8). This vehicle was driven by a 28-year old female (5 ft, 6 in., 143 lb), who was not wearing a seat belt because she was 7 months pregnant. The car had just started up from a parking space when it hit a parked car at an impact speed of approximately 15-20 mph. The driver struck the wheel and compressed the column approximately $\frac{1}{2}$ inch. She lacerated her lower lip and loosened a tooth (steering wheel) and had a right knee bruise (lower instrument panel). She also recalls hitting the steering wheel with her abdomen but did not have any bruises from this impact. Two months later, she delivered a normal, healthy baby.

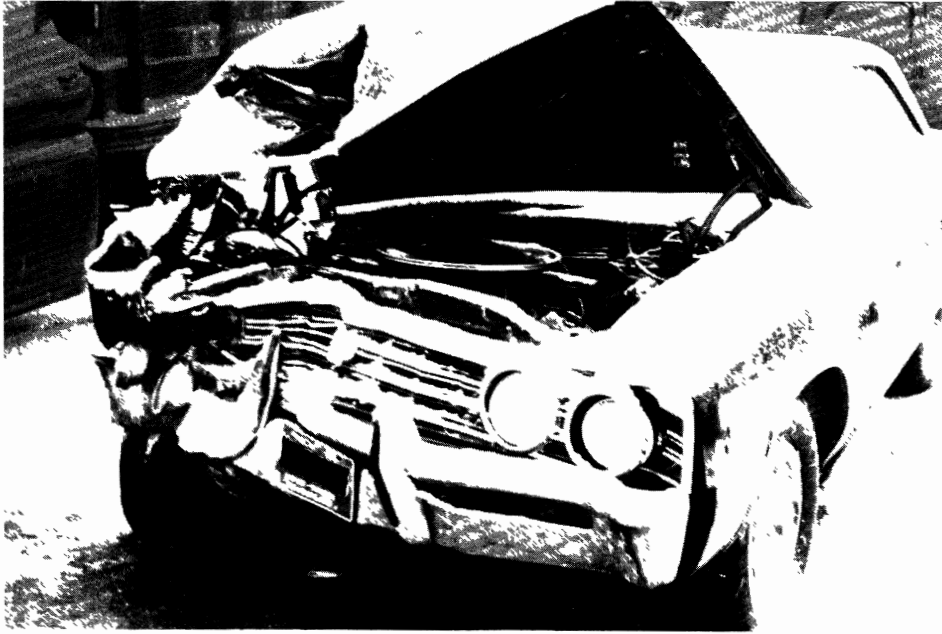
1967 Chevelle (Figures 15 and 16). This is an intersection collision at approximately 25 mph. There was no compression of the energy-absorbing column. The 25-year old driver complained of chest pain (steering wheel), a bump on the head (rear view mirror), and a bruised left knee (lower instrument panel).
(Case #202/3/9/67)

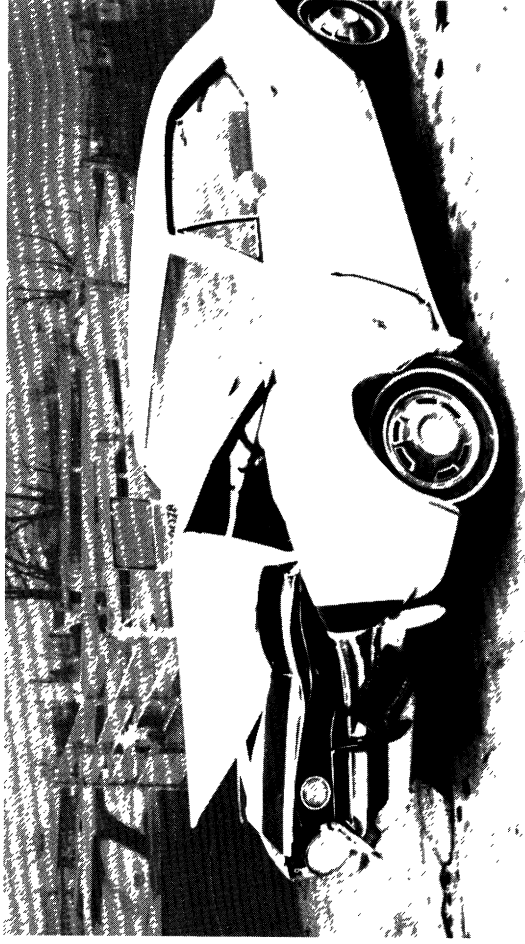
37

1967 Camaro (Figures 37, 38, 39, and 40). On a clear afternoon on a straight road, a 20-year old male driver (5 ft, 10 in., 180 lb) swerved to avoid another vehicle headed toward him. His Camaro went off the roadway and struck a utility pole at an impact speed of 25 mph. The column compressed about 1½ inches from the impact of the occupant with the steering wheel and another 7 inches because of vehicle deformation, for a total column compression of 8½ inches. The wheel rim was bent. The lap-seat belted driver sustained forehead and nasal abrasions and right chest bruises from steering wheel impact. His lower back was sore on both sides; he had a seat-belt bruise across his lower abdominal area. Instrument panel contact produced superficial abrasions of both legs. His right ankle was sprained. (Case #UM-20-68)

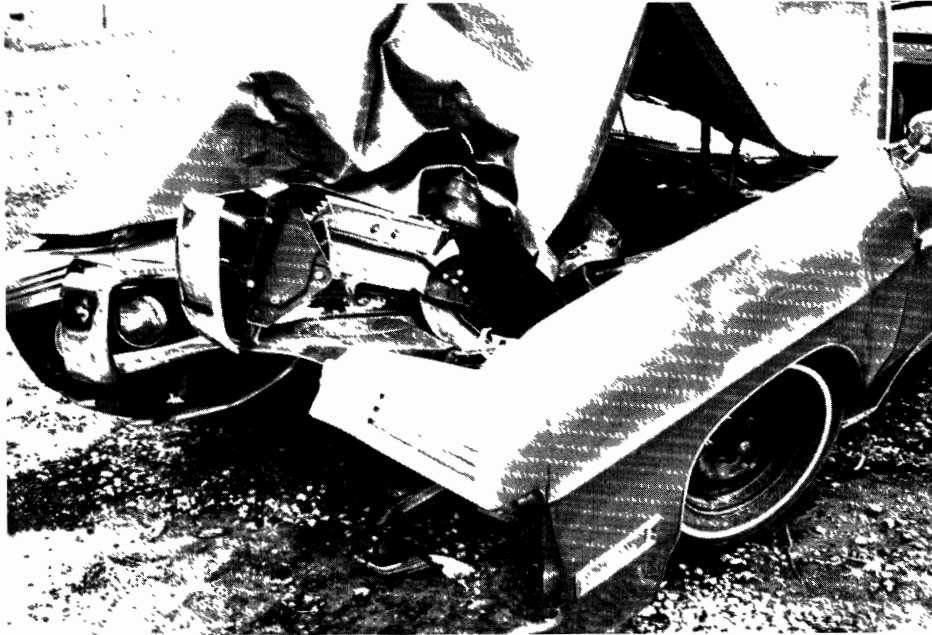
41

1967 Pontiac (Figures 41, 42, and 43). This vehicle "ran out of road" and hit a clump of trees at an estimated speed of 40-45 mph. The 40-year old male driver (5 ft, 10 in., 170 lb) sustained a laceration across his forehead (steering wheel), chest bruises (steering wheel and column), and a fracture of the right leg above the ankle. He was wearing a lap seat belt. The in-car energy-absorbing mesh section compressed 8 inches. The upper half of the wheel was markedly bent forward.

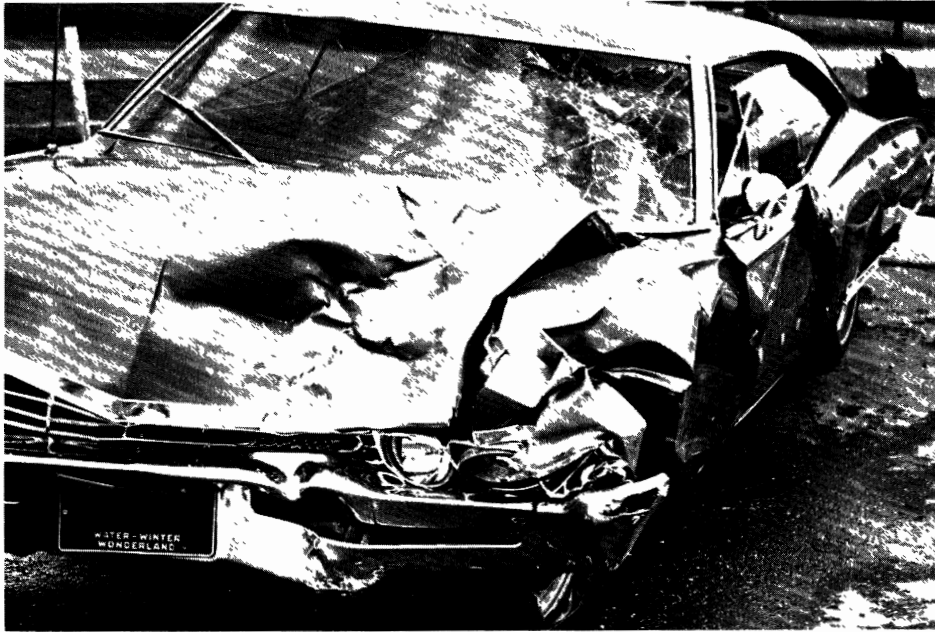
47

1967 Chevrolet (Figures 47, 48, and 49). This vehicle, driven by a 52-year old male, was involved in an intersection collision. The in-car energy-absorbing column compressed about 3 inches. The unrestrained driver sustained a laceration above his left eyebrow (windshield). No other injuries were reported. (Case #219/5/5/67)

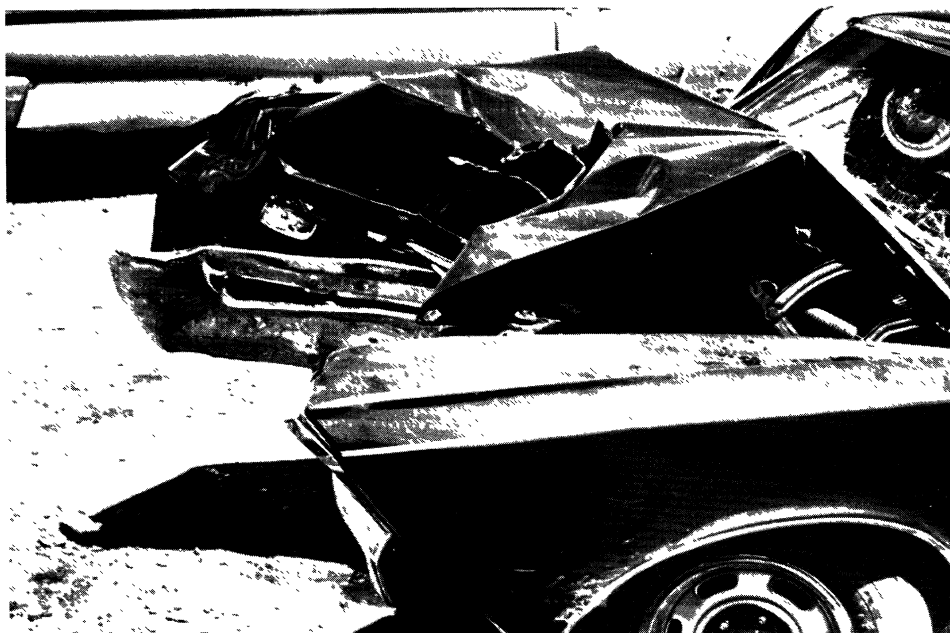
51

1967 Pontiac GTO (Figures 50, 51, and 52). This vehicle left the roadway and struck a 32-inch diameter tree at an estimated impact speed of 45-50 mph. The 23-year old male driver (6 ft, 1 in., 150-160 lb), wearing a seat belt at the time of the accident, was killed. He compressed the in-car energy-absorbing column 6 inches. The under-hood portion of the column telescoped 8 inches. He sustained a fracture of the right fifth rib (which did not perforate the pleura) probably caused by the wheel-column impact; also, slight mediastinal hemorrhage was found. There were a few slight hemorrhagic areas in the intestinal wall due to either the seat belt or steering wheel impact. He flexed over the steering wheel and struck the instrument panel in front of, and to the left of, the steering wheel. He died of a basilar skull fracture and cerebral injury. (Case #12/8/13/67)

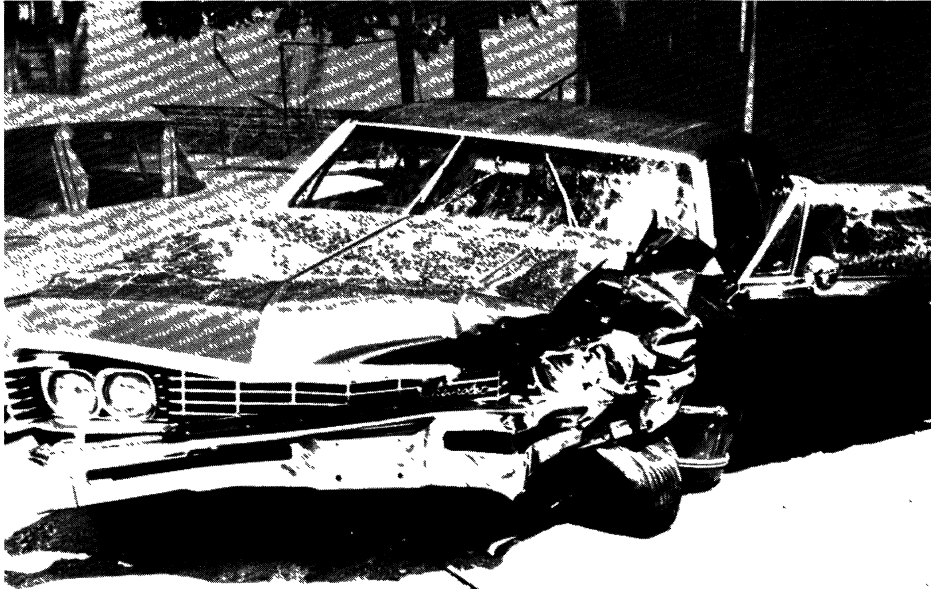
59

1967 Chevrolet (Figures 59, 60, and 61). This vehicle was involved in a head-on collision on a blind rise in the road. (See Figs. 25 and 26.) Both cars were traveling at 35-40 mph. The 24-year old male driver (5 ft, 4 in., 158 lb) was wearing a seat belt but did not have seat belt abrasions. He had a sore chest from steering wheel impact and "ached all over." The column was compressed $3\frac{3}{4}$ inches. In addition, he sustained abrasions to the face and nose (windshield), lacerations inside the mouth, a fracture of his maxilla, and a cervical sprain syndrome ("A" pillar or windshield). Both knees were bruised (lower instrument panel). He also had bruises of both arms. He was not hospitalized.
(Case #231/6/18/67)

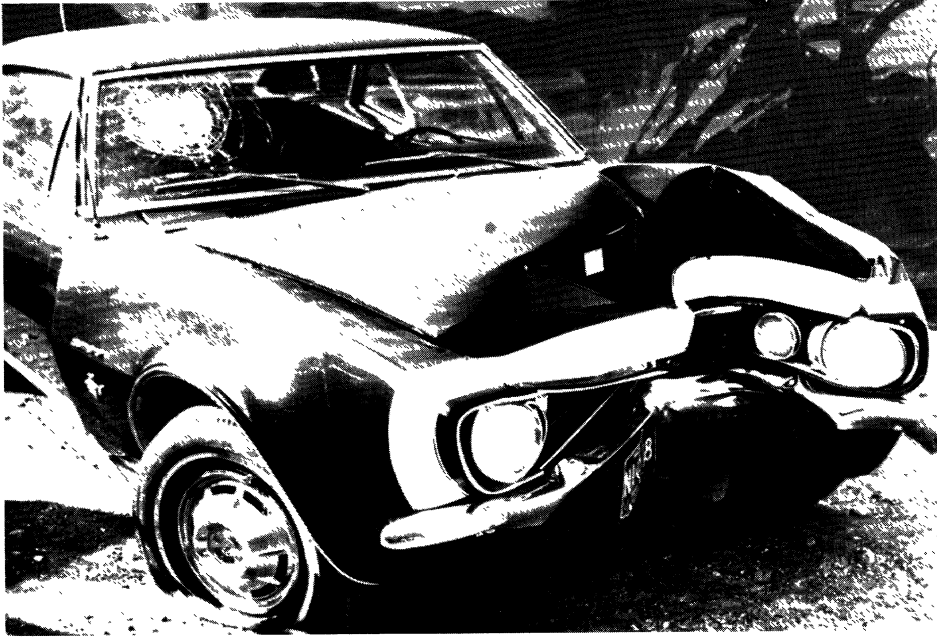
65

1967 Camaro (Figures 65, 66, and 67). A 24-year old male driver (5 ft, 11 in., 150 lb) lost control of his car on a curve and went off the roadway. In this collision, estimated at 20 mph, the column compressed approximately 2 inches. The unrestrained driver sustained bruises to his lower ribs and a laceration to the left side of his chin (steering wheel).
(Case #279/12/16/67)

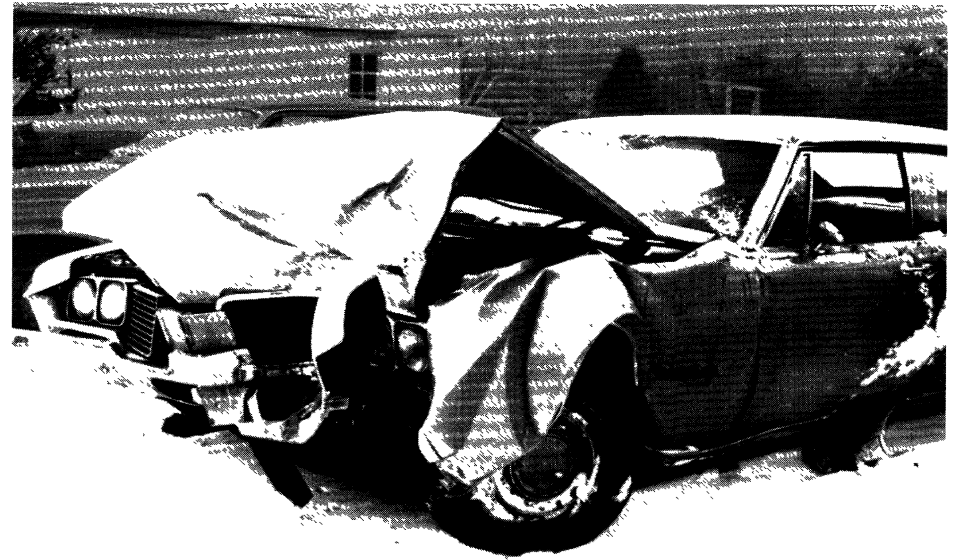
68

1968 Oldsmobile (Figures 68, 69, and 70). A 28-year old male driver (6 ft, 195 lb) lost control of his car on a curve, went off the road, and struck a tree at an estimated speed of 25 mph. The column compressed approximately $2\frac{3}{4}$ inches. No injuries were reported from steering column impact. The unrestrained driver sustained lacerations to his head and face from windshield contact. (Case #UM-05-68)

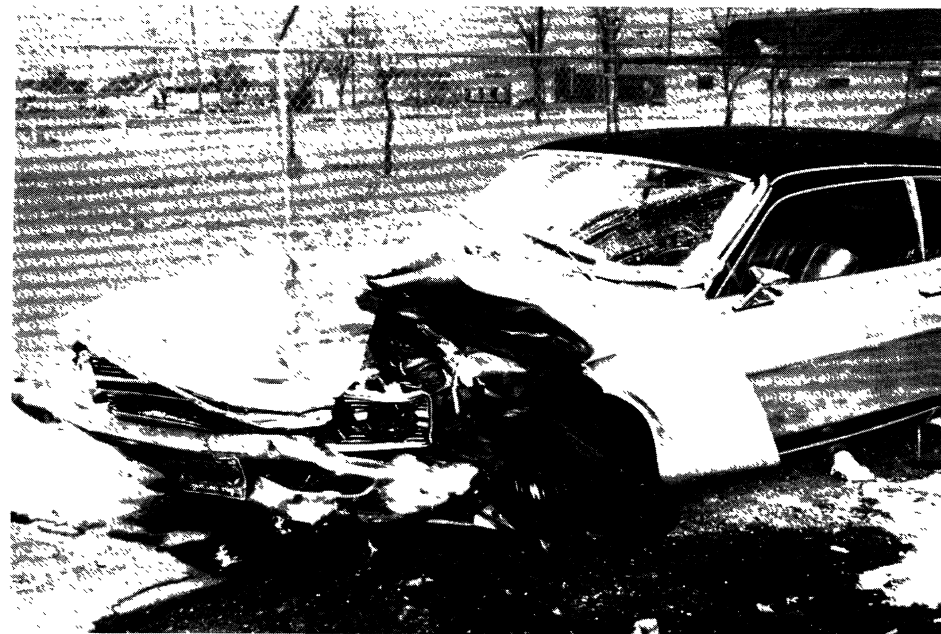
74

1968 Ford (Figures 74, 75, and 76). The 21-year old unrestrained driver of this vehicle struck a cement spillway after crossing an ice-covered lake at high speed. The estimated speed at impact was 25 mph. The driver sustained minor facial lacerations from impact to the windshield and rear view mirror. The column was compressed 11½ inches. No chest injuries were reported. (Case #UM-21-68)

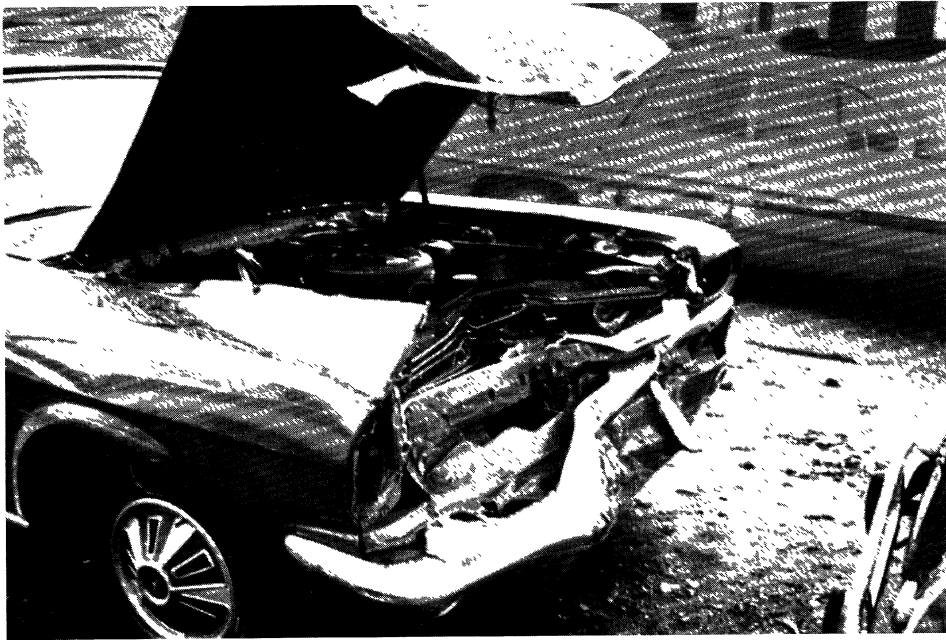
1966 Mustang (Figures 103 and 104). This was an intersection collision. The vehicle, driven by an unrestrained 24-year old male, struck a 1964 school bus which made a left hand turn in front of the Mustang. The driver of the Mustang sustained a 1-inch laceration of his left scalp and a 1-inch laceration of his right eyebrow when he struck the steering wheel. Also, he had contusions and abrasions to the left knee (lower instrument panel).
(Case #269/11/1/67)

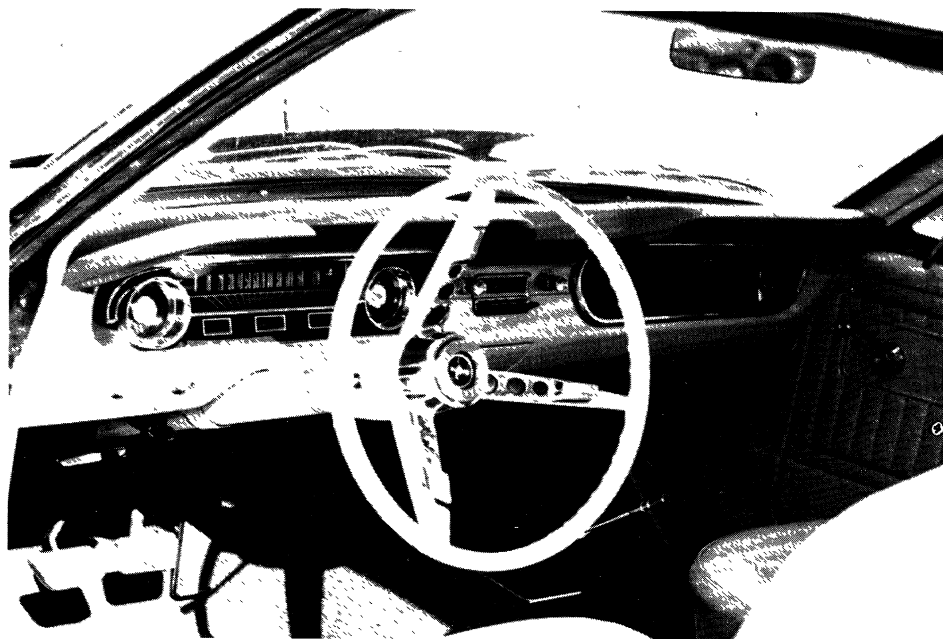
1965 Mustang (Figures 105 and 106). This vehicle went out of control on a curve, crossed over a curb, and struck a concrete stairway at approximately 15 mph. The unrestrained 25-year old male driver sustained a laceration to his lower lip and tongue and a bite wound of the tongue from contact with the steering wheel.
(Case #221/5/13/67)

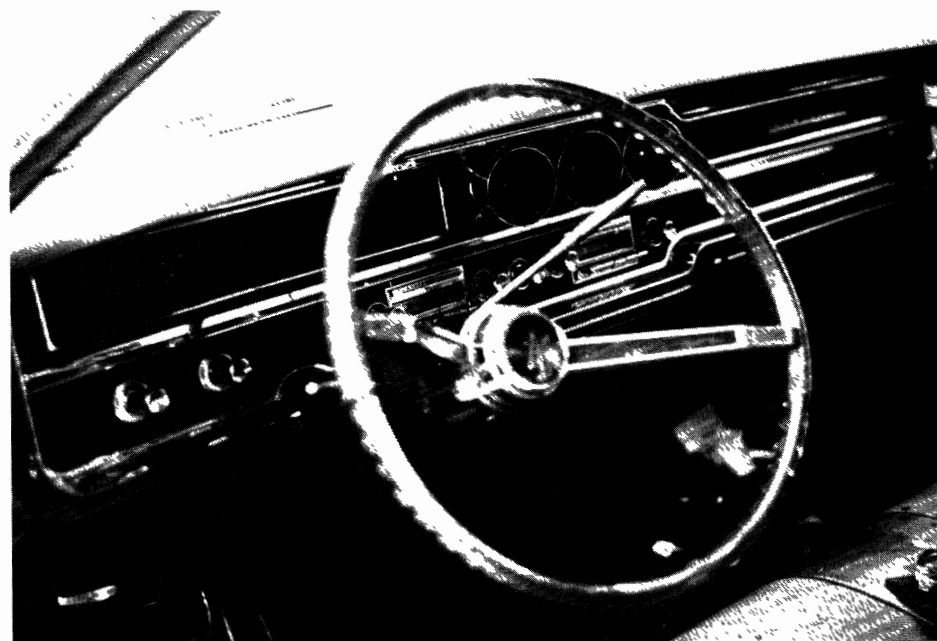
108

1965 Pontiac (Figures 107 and 108). This vehicle drove through a stop sign and across a “T” intersection, hitting a small sign and traveling on into a field. The unrestrained 27-year old male driver (6 ft, 4 in., 215 lb) sustained a severely lacerated nose from impact to the steering wheel.
(Case #265/9/28/67)
