UM-HSRI-81-32

**A STUDY OF
WINDSHIELD-RELATED INJURIES
IN CARS OF
JAPANESE MANUFACTURE**

Appendices

**FINAL REPORT
JUNE 1981**

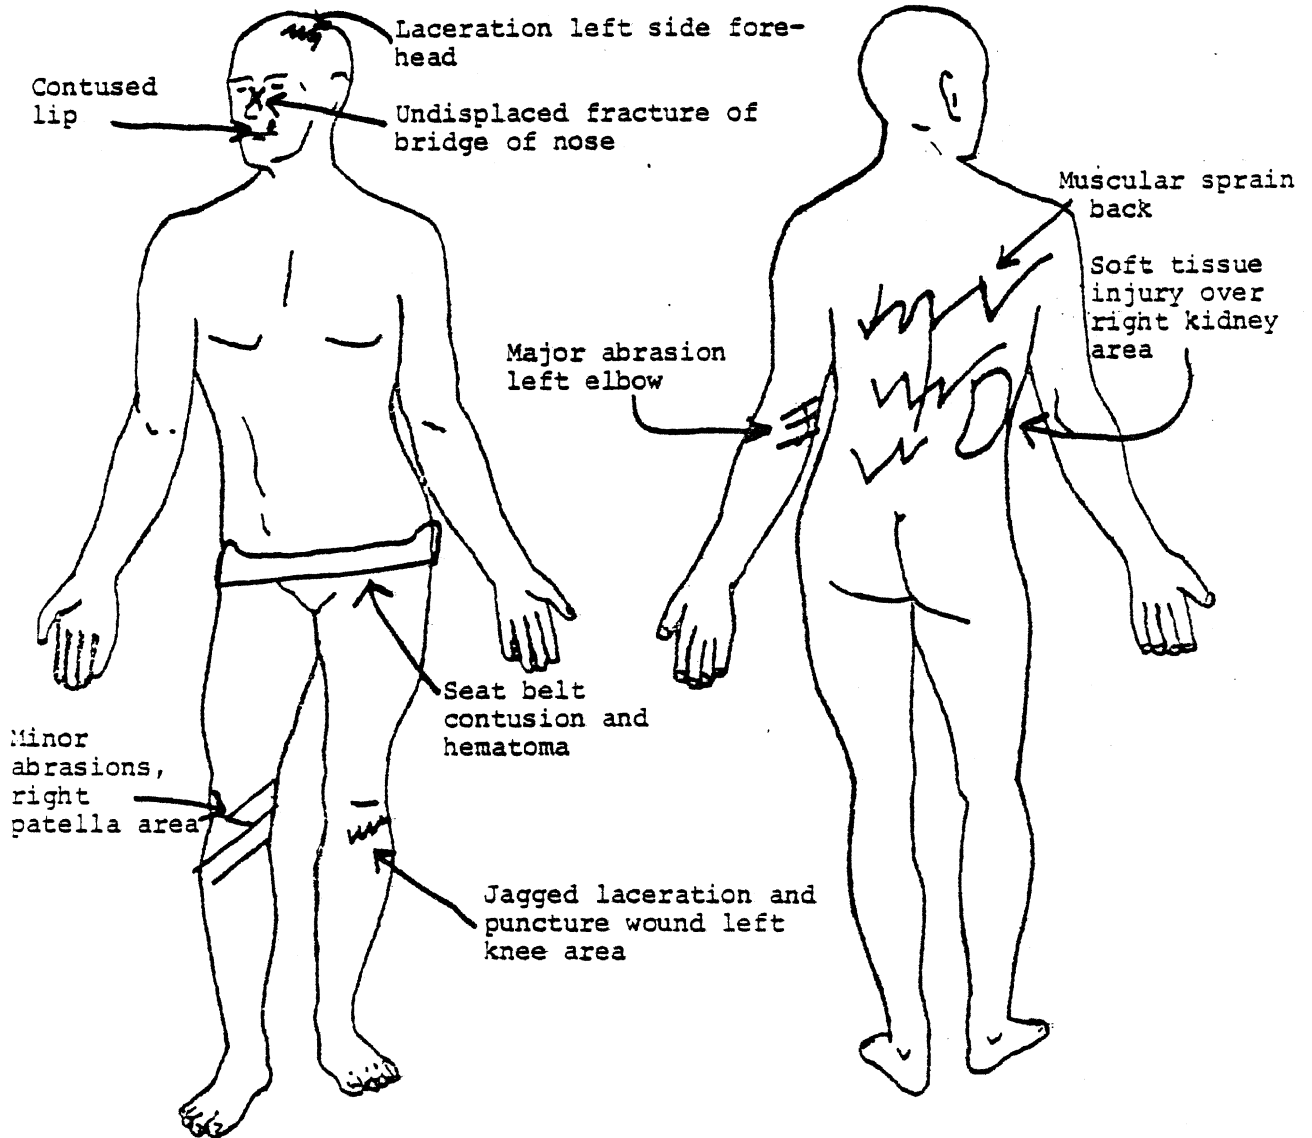
Case: UNM #18

- a. Severe laceration of the left side of forehead, just below the hair line.
- b. Undisplaced fracture of bridge of nose.
- c. Contusion of upper lip and cuts on the tongue.
(Sutures not required)
- d. Comminuted simple fracture of middle third of both bones of left forearm.
- e. Minor abrasions and lacerations of left elbow.

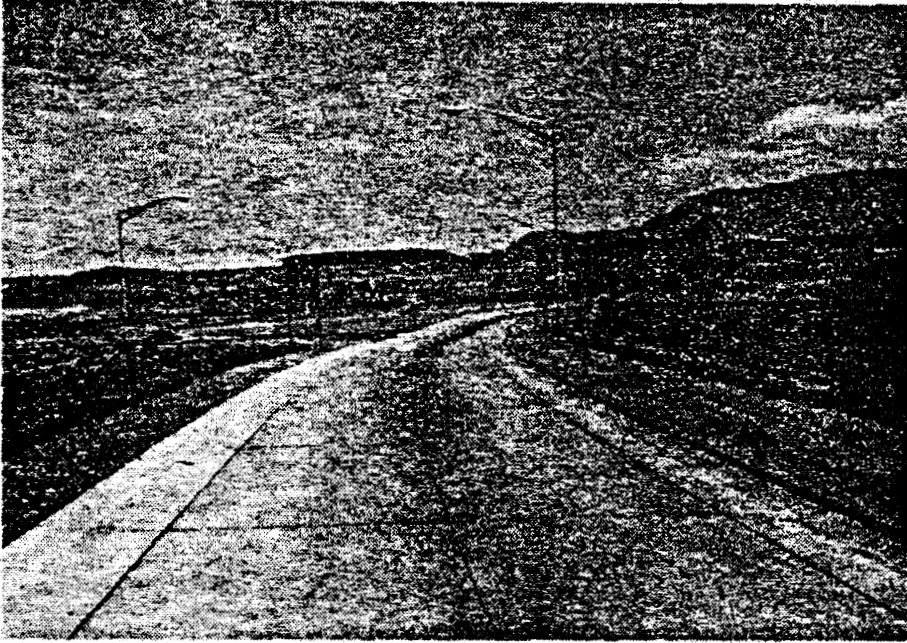
#1 Offramp traveled by vehicle #1 showing 1500-foot radius curve, tangent, and 20 MPH advisory signs.

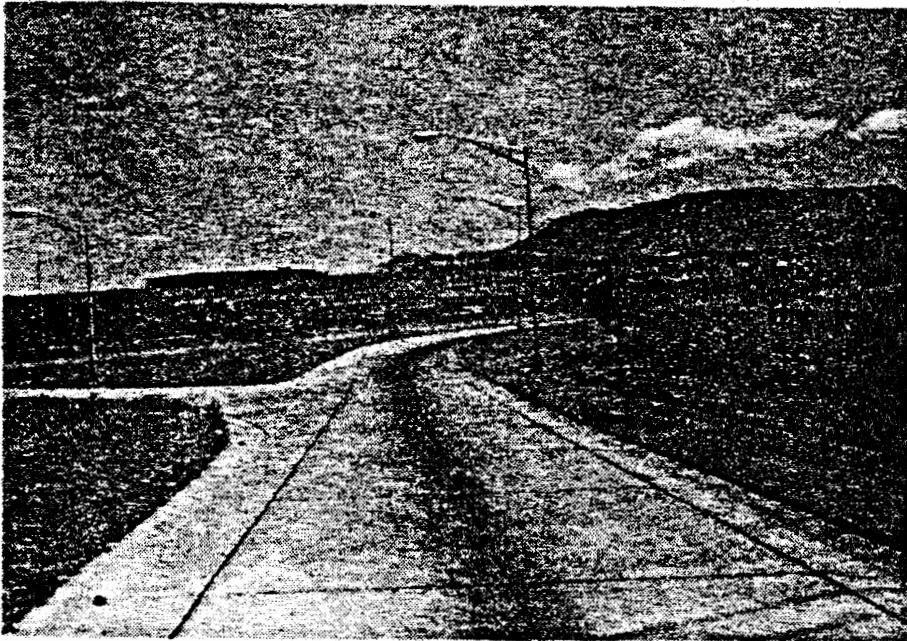
#2 Offramp traveled by vehicle #1 showing straight approach to sharp curve.

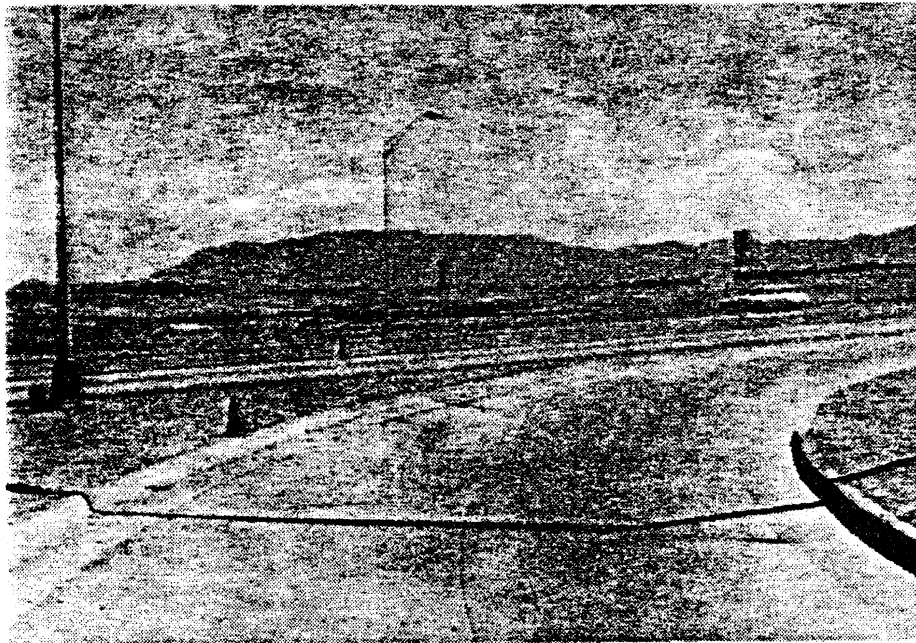
#3 Sharp, 120-foot radius curve at end of ramp tangent. Note how gravel on traffic island blends with concrete pavement and absence of any visual indication of sharpness of curve. Traffic cones mark path of left rear tire of vehicle #1.

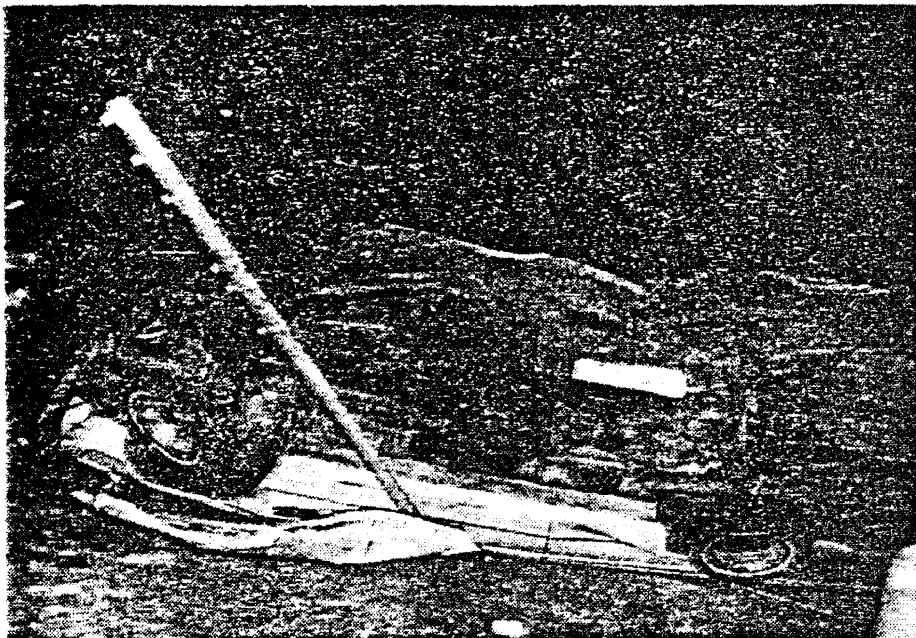
#8 Vehicle #1 in final position.

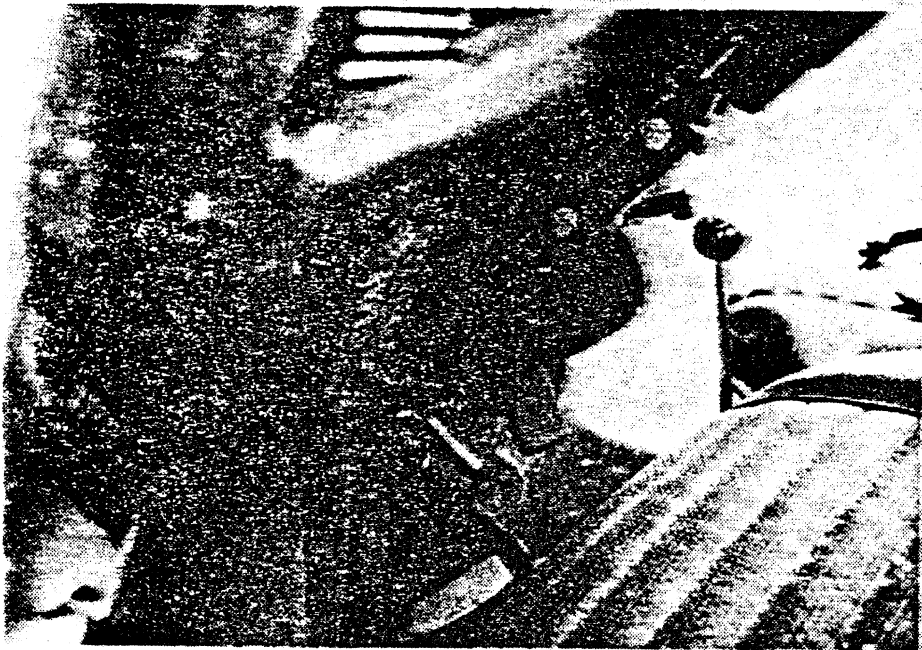
The interior dimensions at the driver's location were reduced. The left side of the dashboard was moved inward and backward, see photograph no. 10. This photograph also shows that the horn ring was broken off, exposing the sharp edges of the hardware beneath. Photograph no. 11 shows several important points concerning the car's interior. It is seen that the floorboard and sidewall have moved inward and to the right. The sharp broken edges of the hard plastic sidewall were one of the factors contributing to the driver's knee injury (the doctor found several flakes of plastic from this area in a cut on the patient's leg). The photograph also shows the brake and clutch pedal bent drastically to the right. This deformation was caused by the inward excursion of the floorboard since these controls had a geometry and rigidity which would surely cause foot injury if the feet had played a part in their deformation. Lastly, the fuse panel may be seen dangling on the underneath side of the steering column, as well as other sharp edges.

#11 Case vehicle showing displacement of instrument panel, and bending and shifting of clutch and brake pedals.

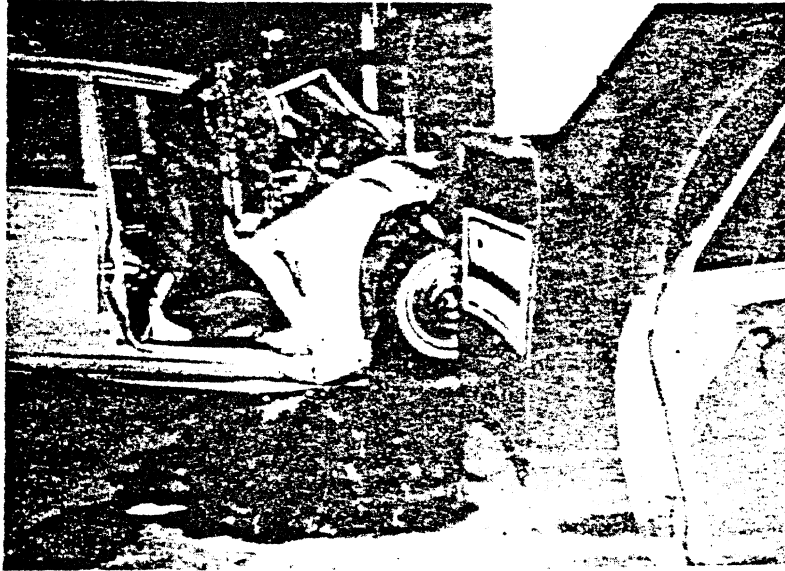
Figure 7. Side view of POR

After the impact, Vehicle #1 was entangled with Vehicle #2 as shown in Fig. 7 and was dragged until Vehicle #2 stopped on the shoulder of the roadway.

As stated previously, Vehicle #1 was trapped under Vehicle #2 after the impact in the position shown in Fig. 7, with the undercarriage near the firewall in contact with the roadway. Gouge marks were left in the roadway that trace the path of Vehicle #1 from impact to the time when Vehicle #2 came to rest on the shoulder of the highway as shown in Fig. 1. The gouges appear clearly in Figs. 4, 5, and 6; they show that Vehicle #2 traveled 375' from the POI to the point where it stopped on the shoulder of the highway. It is unknown why it did not stop sooner as it would certainly have been possible for the driver to have done so.

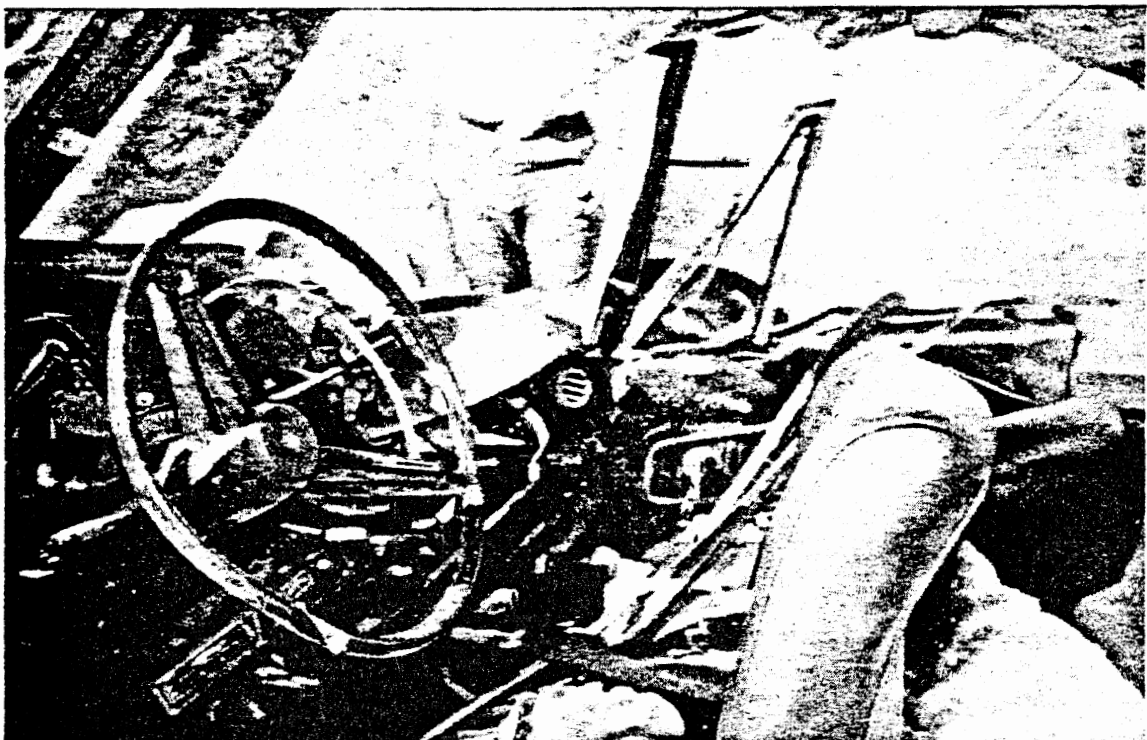
INTERIOR VIEW OF FRONT OCCUPANT COMPARTMENT IN VEHICLE NO. 2

frame, engine mounts, engine, exhaust system, sheet metal, seat tracks, seats, pillars, doors, locks, and hinges. The primary vehicle damage index was O2RYAW4. Secondary damage was to the left side with 2-in. sheet metal deformation and a vehicle deformation index of OOLYHO1. Interior damage resulting from occupant contact was noted on the steering wheel rim, midpanel, air-conditioner outlets, ignition key, right sunvisor, left "A" pillar, left side door, and right side door. Other areas of contact without damage are numerous due to the vehicle dynamics and injuries to the occupants; however, because of the extent of the damage and amount of dirt, blood, and glass in the occupant compartment, they are indistinguishable. Vehicle data are presented in the attached "Collision Performance and Injury Report" Long Form (Revision No. 3) Report No. 7147-2, and "Vehicle Condition and Maintenance Report Form." The vehicle replacement cost was estimated at \$1,000.

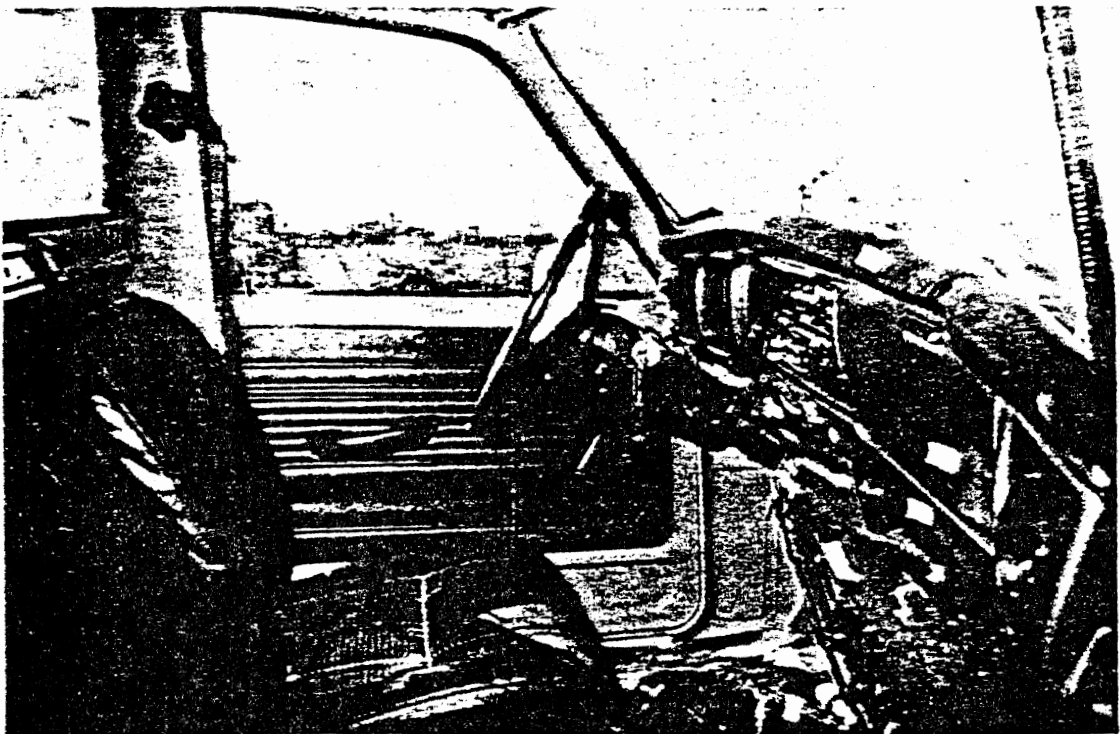
INTERIOR VIEW OF VEHICLE NO. 1

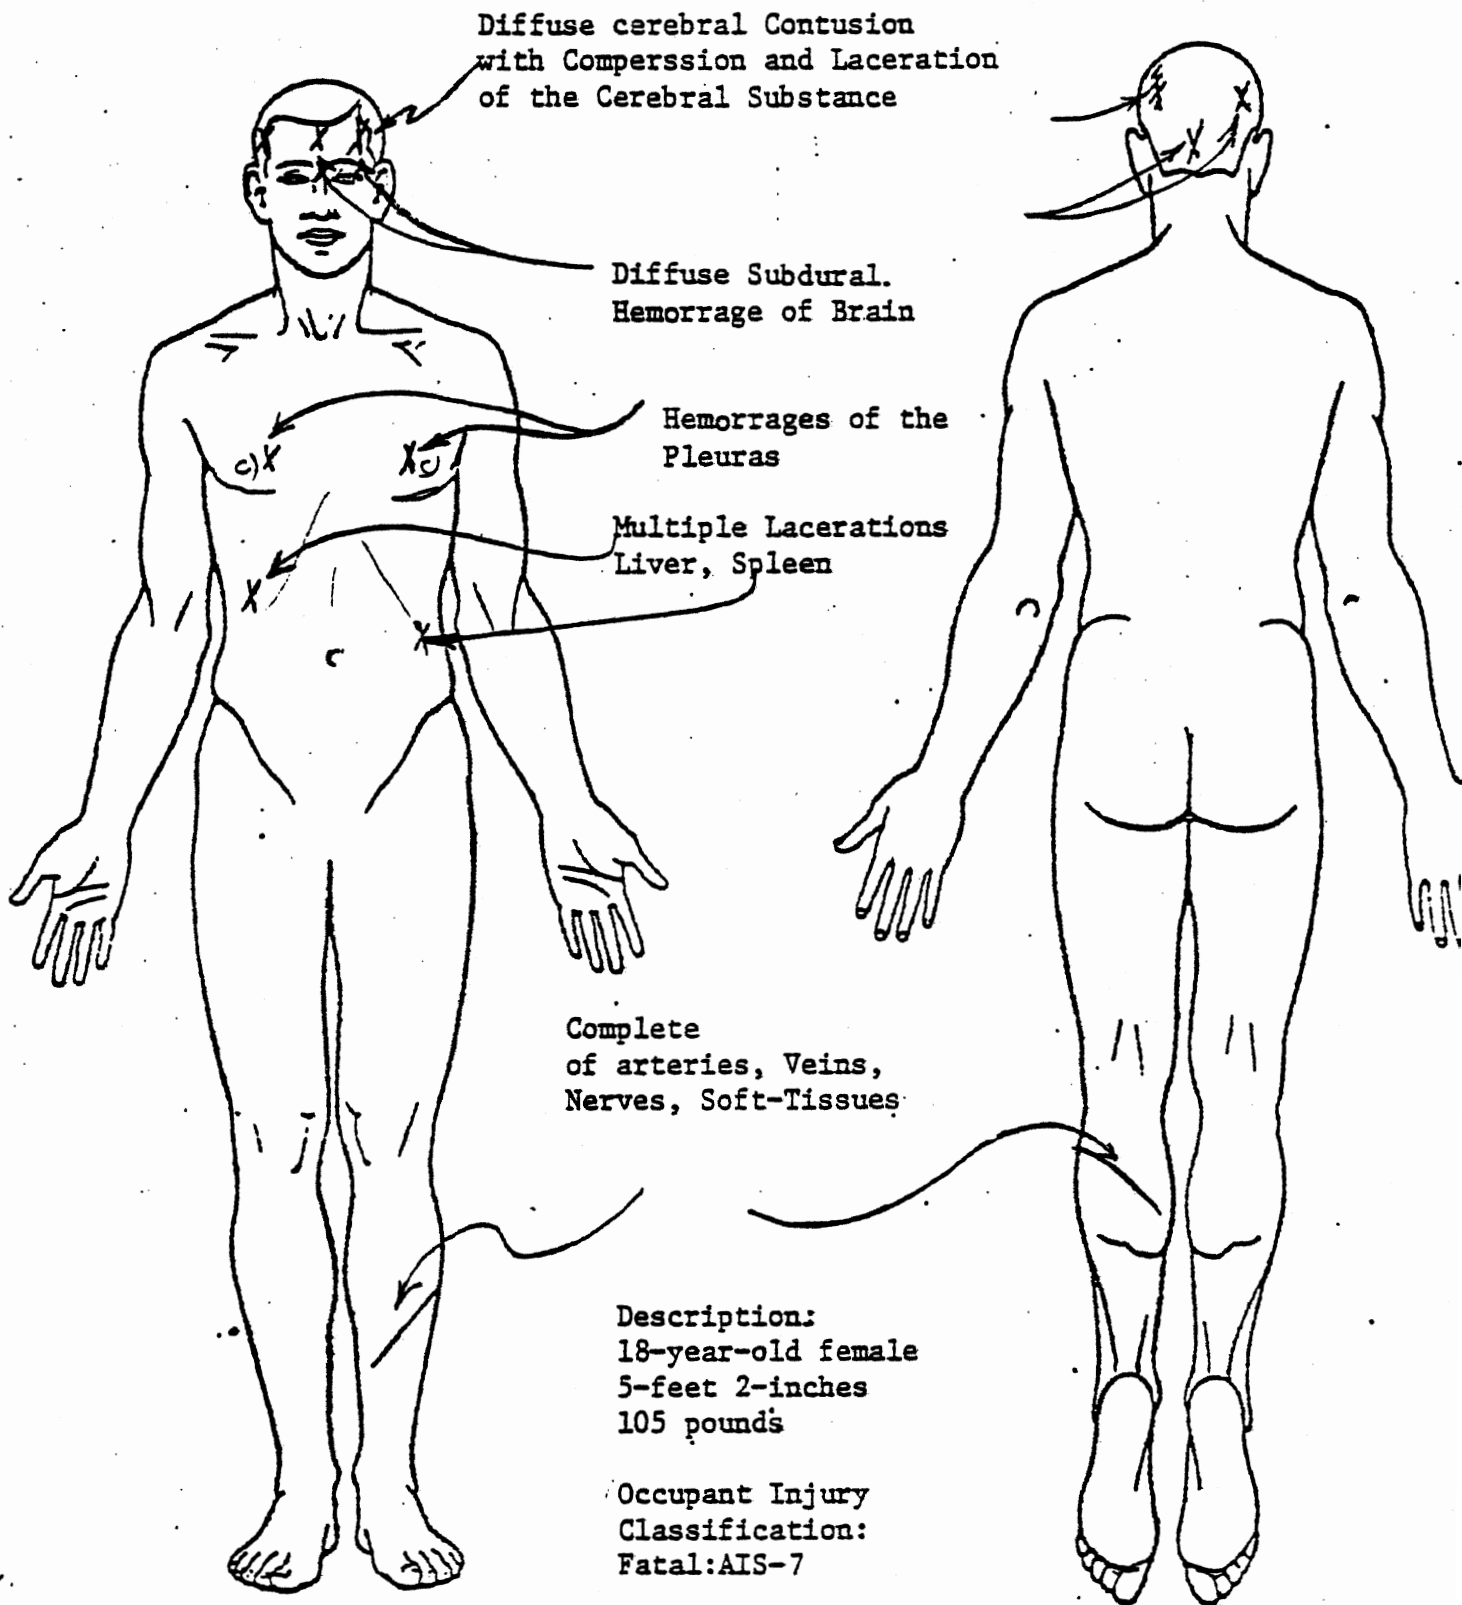
Figure 15- Internal Injury Diagram, Driver, Vehicle No.2
Case No. UTAH-74-198

There are diffuse cerebral contusions with compression and laceration of the cerebral substance at the level of the left frontal and left temporal lobes with penetration through the gray and white matter of numerous particles of fractured left temporal bone, which are found imbedded deeply within the brain substance; diffuse subdural hemorrhage involving the frontal, parietal and occipital regions of the brain bilaterally; multiple lacerations of the liver; fragmentation of the spleen; diffuse hemorrhages of the pleura in both lungs (see Figure 15). An autopsy was performed on this driver.

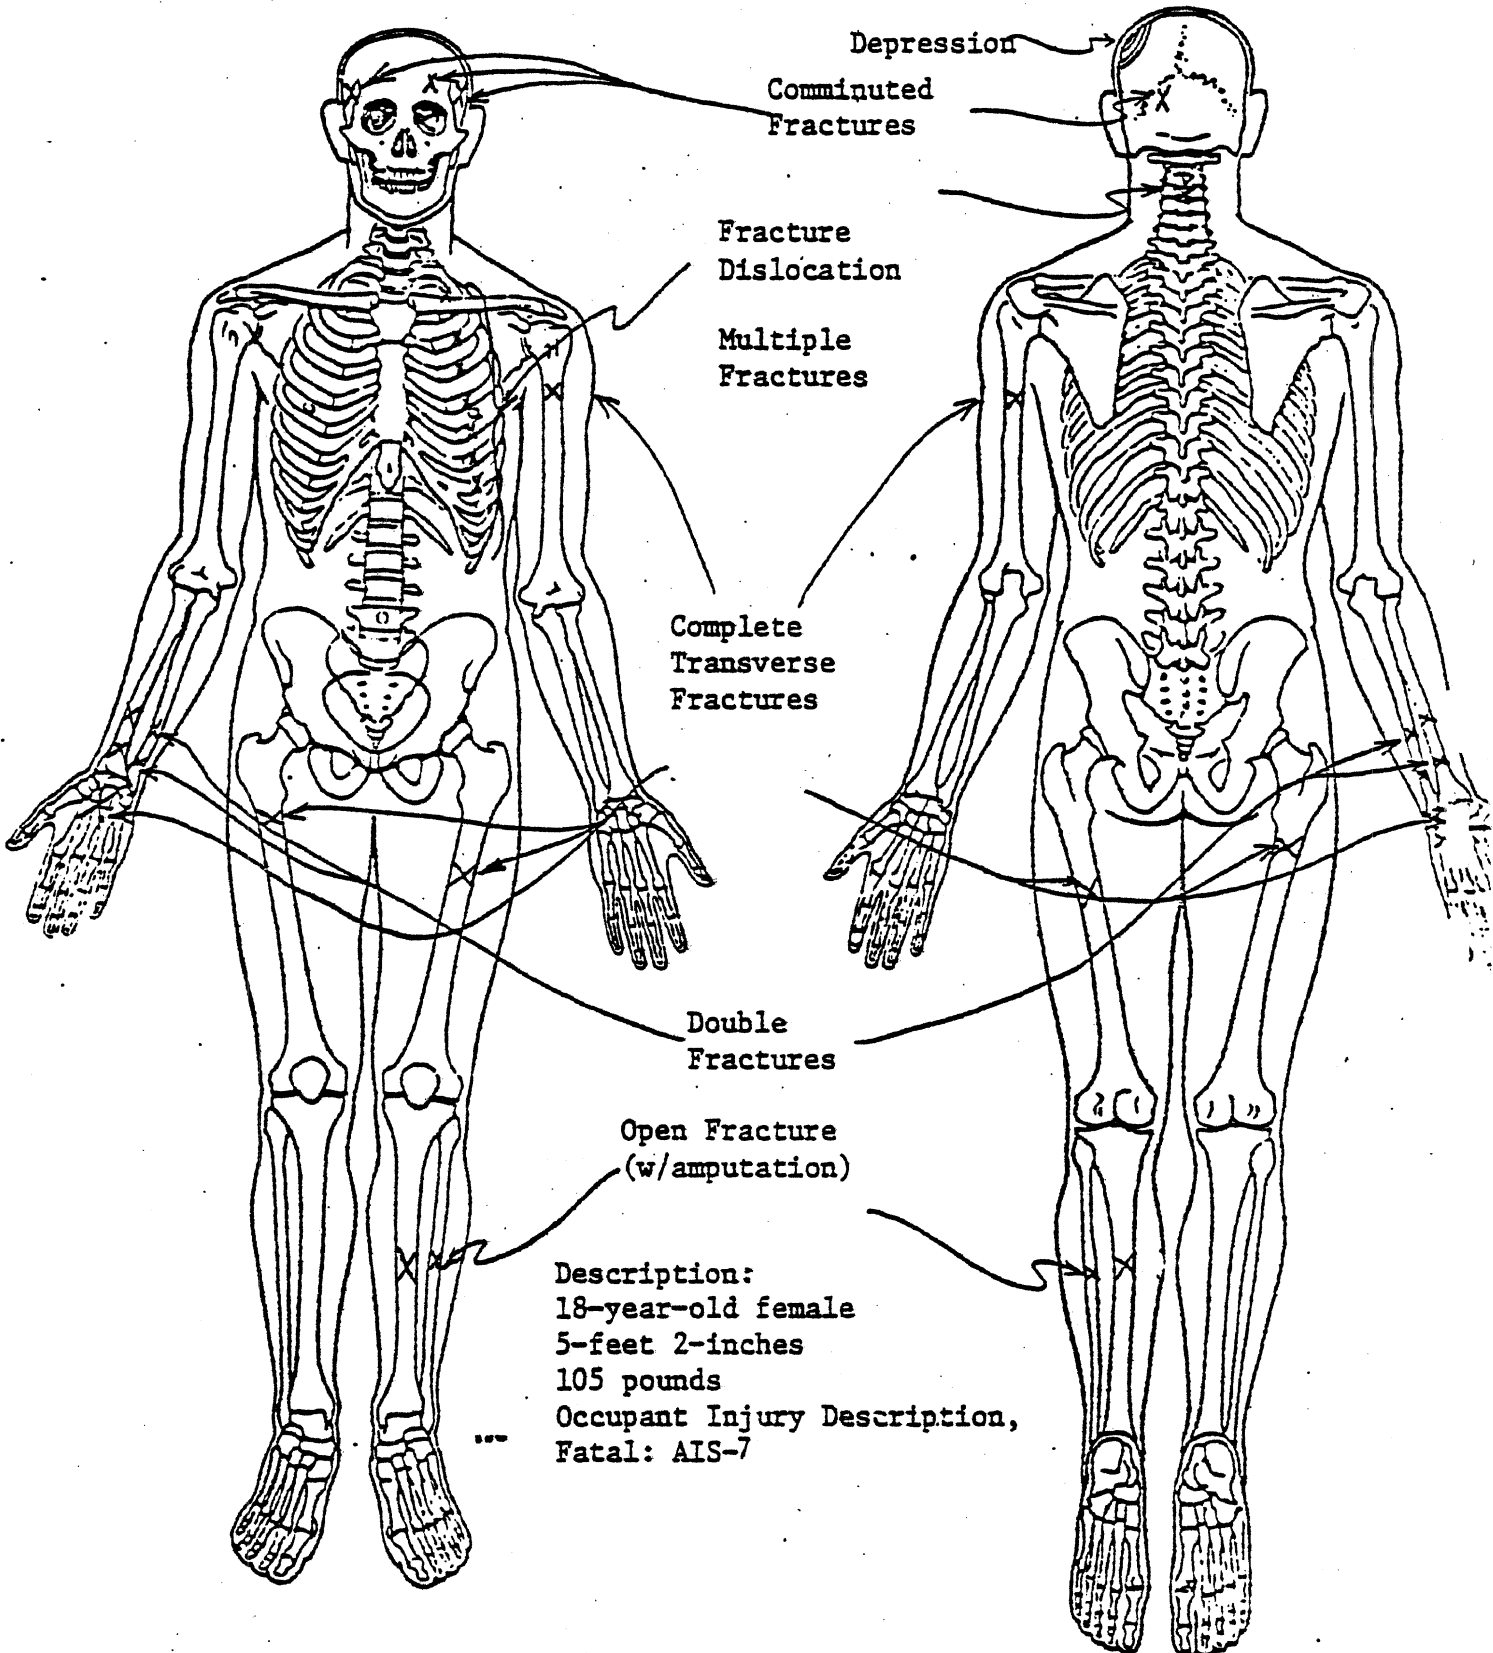
Figure 16- Skeletal Injury Diagram, Driver Vehicle No.2.
Case No. UTAH-74-198

There was a comminuted fracture of the skull involving the left temporal bone, left half of the frontal bone, left half of the occipital bone and right temporal bone. In the fractured area to the left of the midline the skull is depressed with an inward angulation compressing the adjacent left cerebral substance; fracture dislocation of the cervical vertebrae at the level of C-1 and C-2; multiple fractures of the anterior left ribs from the second to the 9th rib at the level of the mid-clavicular line; complete transverse fractures of the right wrist, of both femurs at the level of the upper third on the right and mid third on the left; open fractures of the left tibia and fibula at the level of the mid third with complete transection of the arteries, veins, nerves, soft tissues and skeletal muscles. The severed leg is held on by a thin strip of ecchymotic skin, otherwise there is an almost complete amputation of the left leg at this level; complete transverse fracture of the left humerus at the level of the deltoid region; double fracture of the left humerus at the level of mid third and right wrist (see Figure 16).

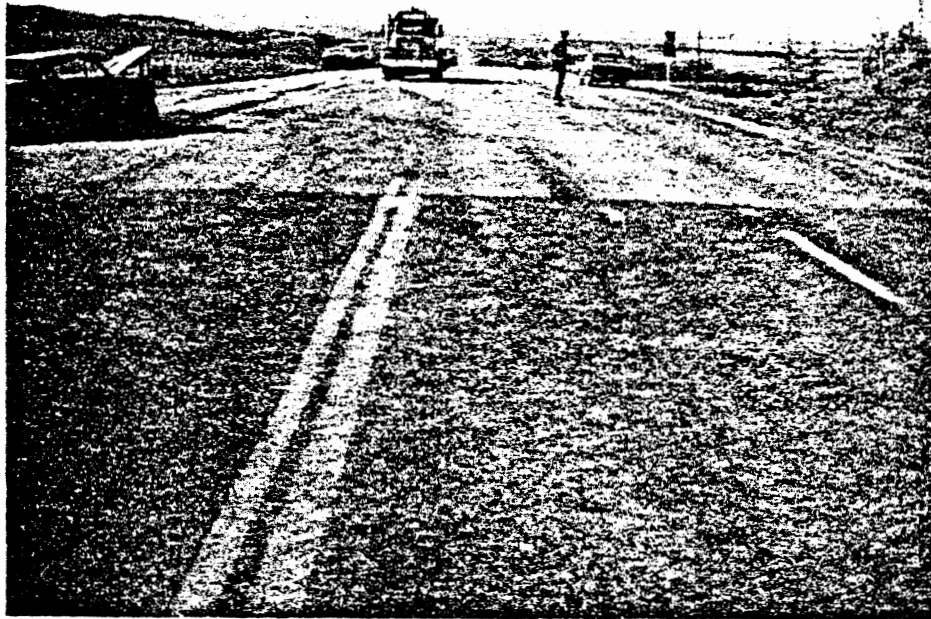
1

View of accident scene from the south, showing Vehicle 2, a 1968 Barracuda, in final resting position.

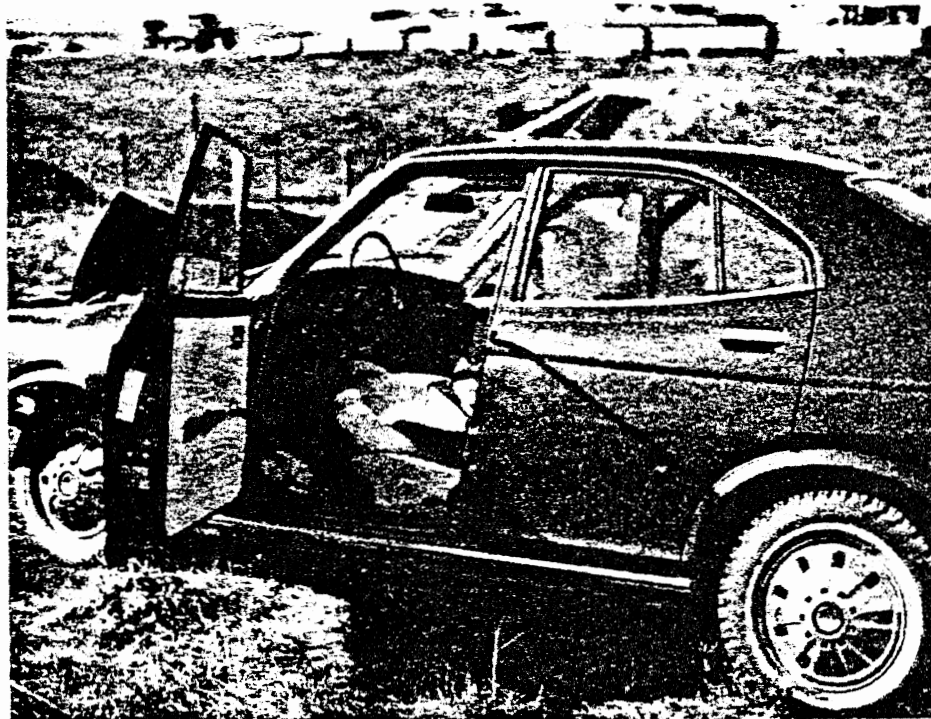
2

View of Vehicle 1 in position of rest, showing deceased driver in final position.

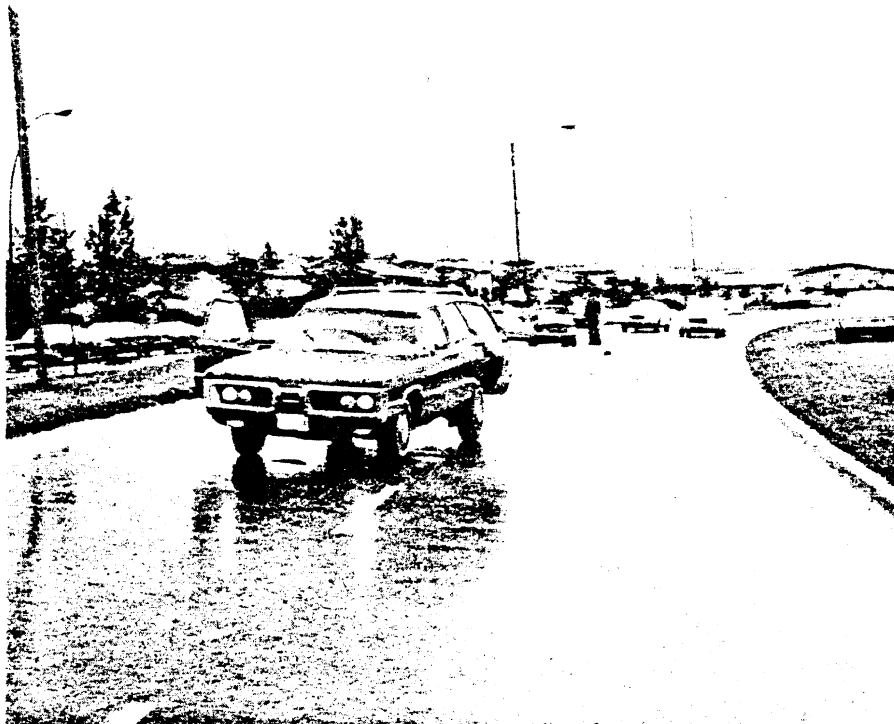
1

Accident scene showing vehicles in positions of rest.

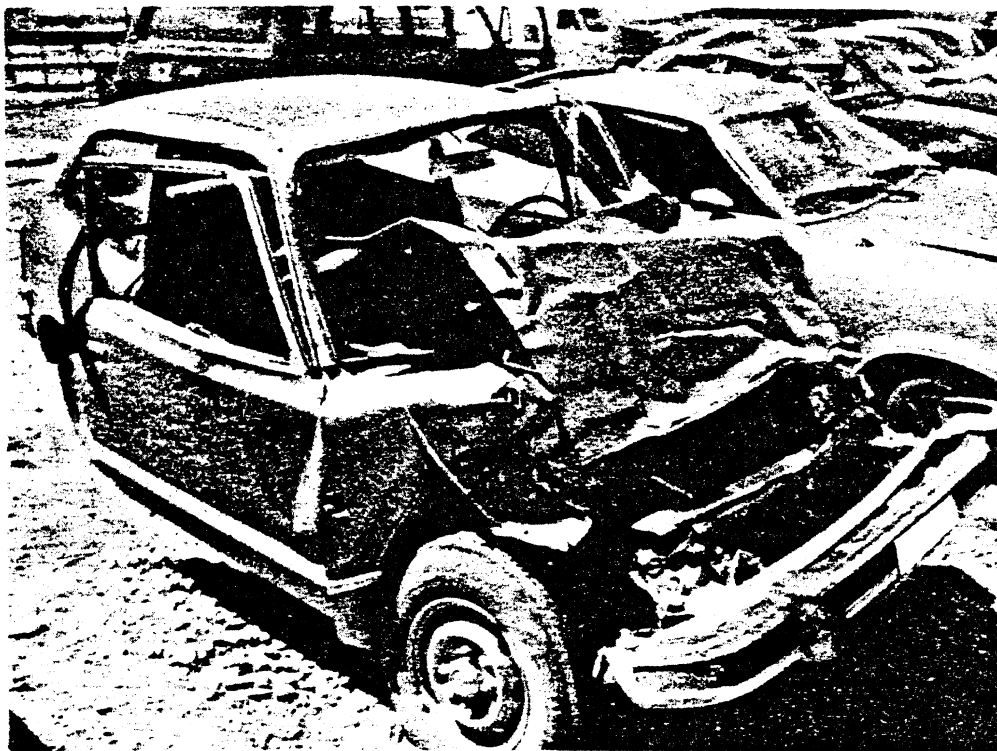
2

The damage to Vehicle 1 extended across the full width of its front end with all the direct impact damage occurring above the frame. The crush from the front varied from 33 inches at the left front fender to a maximum of 38 inches at the right front fender. The windshield separated, leaving the moulding in place. The hood latch, at the rear of the hood, released and the rear edge of the hood intruded into the passenger compartment about 12 inches. The upper and lower A pillars, the windshield header, the roof and roof siderails, the right door and right front wheel rim all buckled from the impact. The vehicle damage index was 12-FDMW-4.

Exterior damage to Vehicle 1.

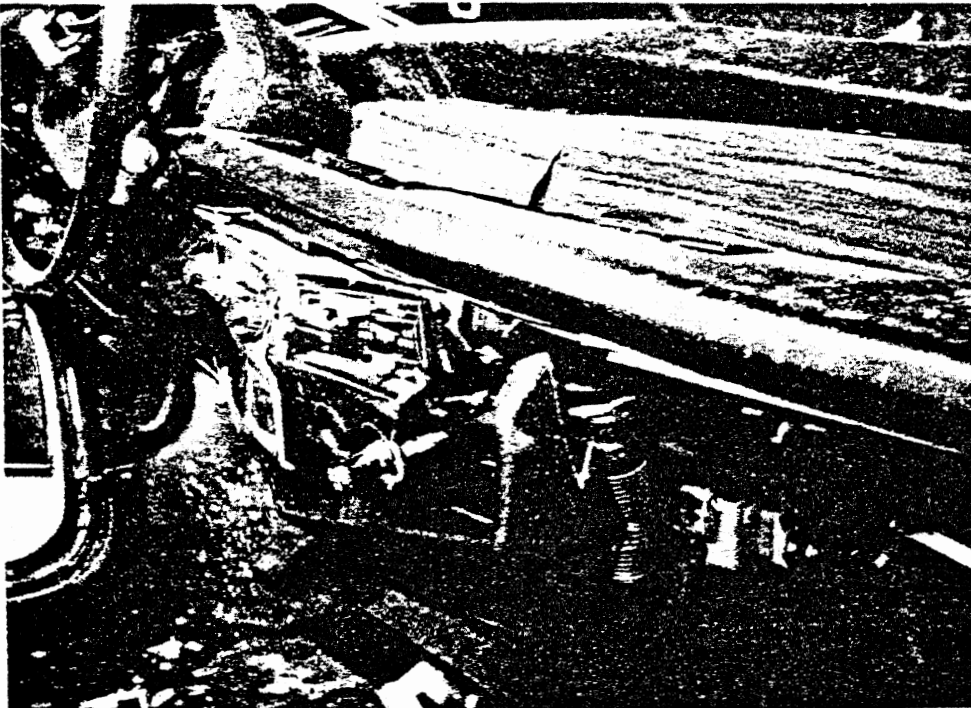
4

Steering wheel and spokes were bent and the steering column was rotated upwards through 17°. Instrument panel was lifted and rotated 15°. Windshield was cracked and sunvisors and windshield header were dented. There was 100% separation of the windshield bond. The driver's seat track separated completely and the passenger's partially. Right side of driver's head restraint was bent 1 inch. The firewall was distorted and the foot controls damaged. The plastic panelling on instrument panel, rear defogger switch, heater unit controls and ducts, glove compartment and parcel tray were all damaged. Right hand door buckled, above the interior handle. ↗

Close up of Vehicle 1's instrument panel and steering column.

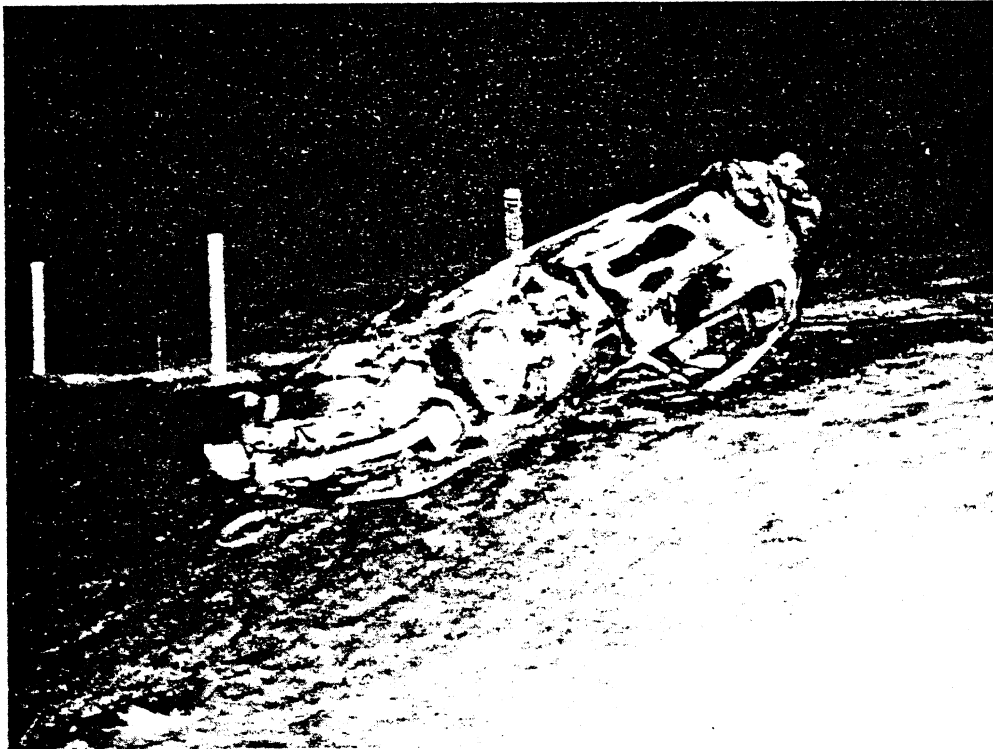
3

View of passenger side of case vehicle in final resting position. Photo looks in Vehicle 1's direction of travel.

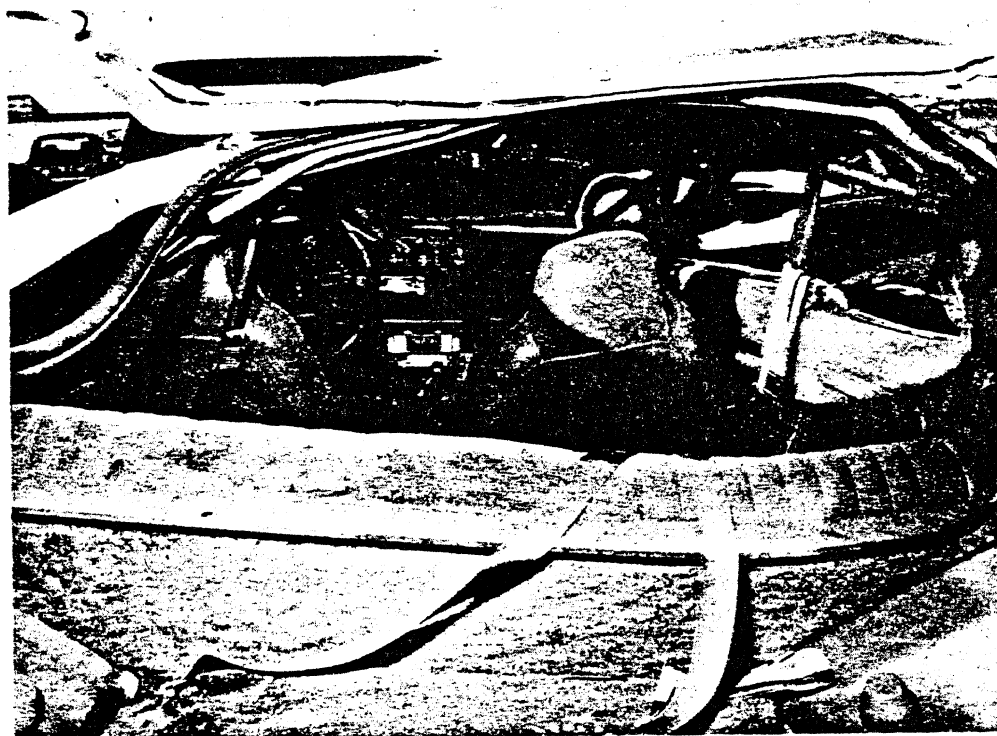
6

Interior view of case vehicle through backlight opening. (Slide #22)

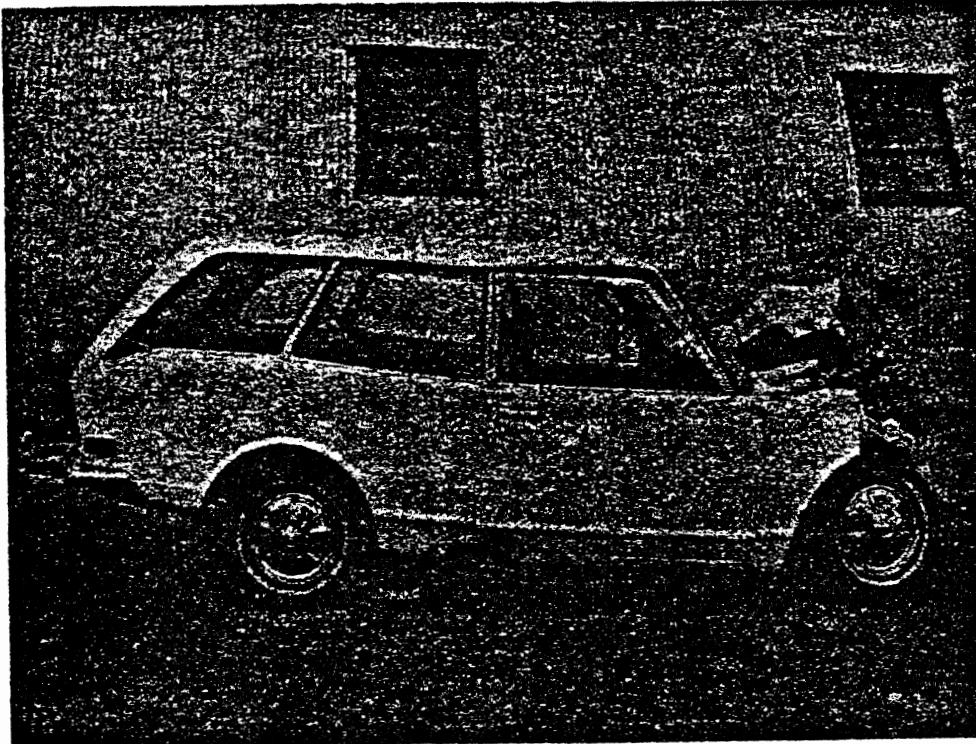
3.

Case vehicle right side view. (slide 15)

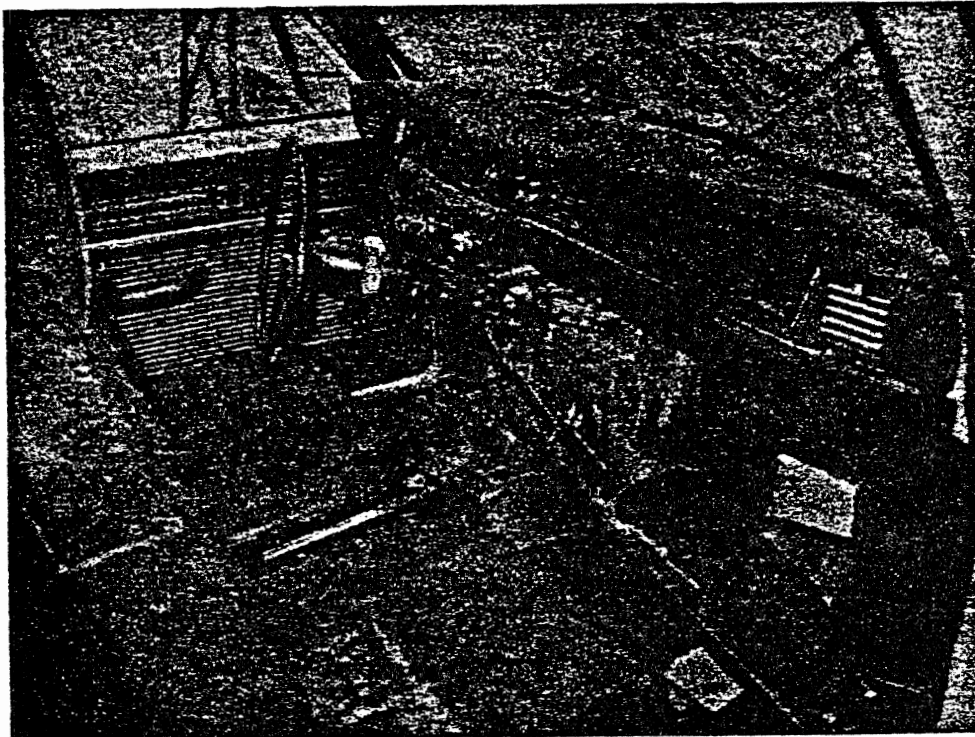
4.

Case vehicle right to left front interior view. Note relative lack of compartment intrusion. Damage to steering column occurred during driver extrication. (slide 23).
