DYNAMIC TESTING OF RESTRAINT
SYSTEMS AND TIE-DOWNS FOR USE
WITH VEHICLE OCCUPANTS SEATED IN
POWERED WHEELCHAIRS

INTERIM REPORT

Lawrence W. Schneider
The Highway Safety Research Institute
The University of Michigan
Ann Arbor, Michigan 48109

August 1980

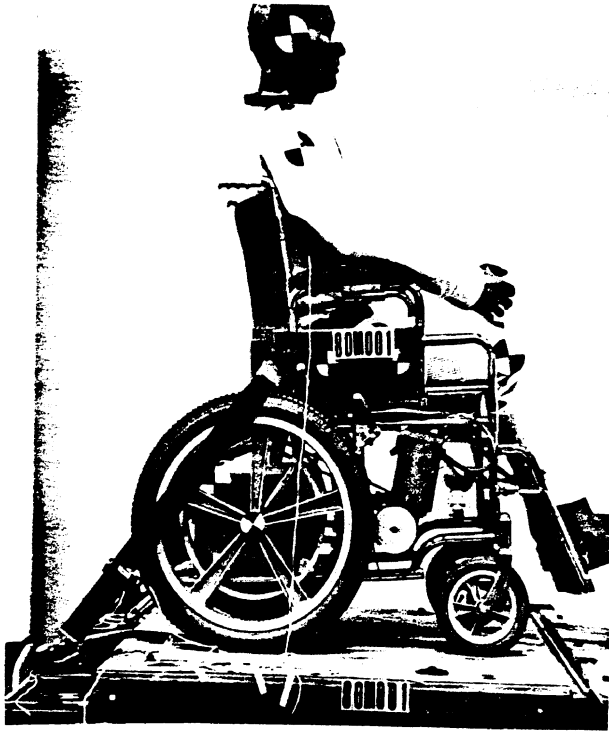
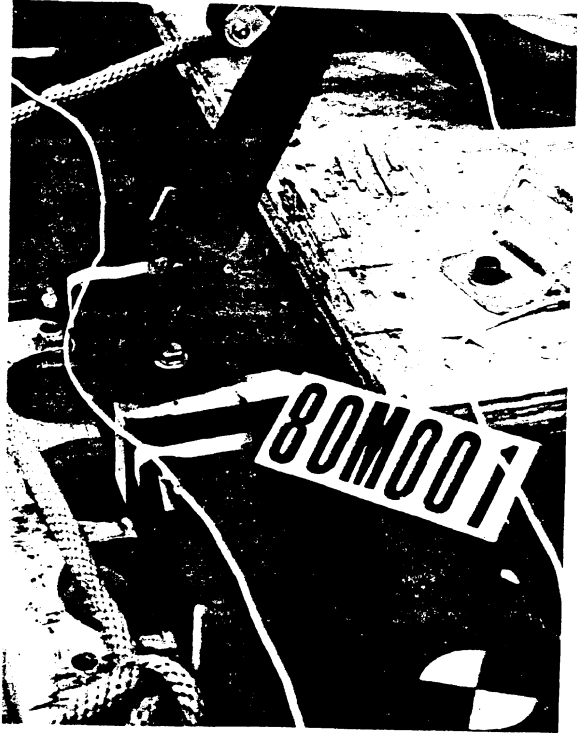
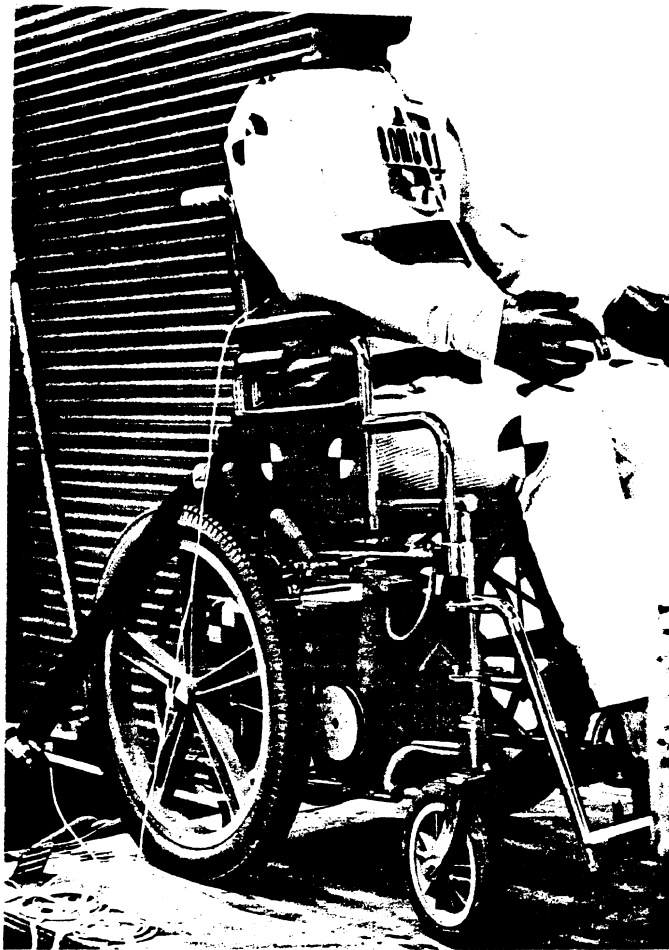
Set-up Photos for Test 80M001

Prior to impact the chair moved backward on the sled due to the sled acceleration (approx. .5 G) producing slack in the lap belt. The ring of the right lift ring assembly broke at the sharp bend on impact releasing the lap belt and allowing the wheelchair to move unrestrained into the padded front of the sled. The velcro fastening on the chest belt did not hold. The chair sustained little or no damage.

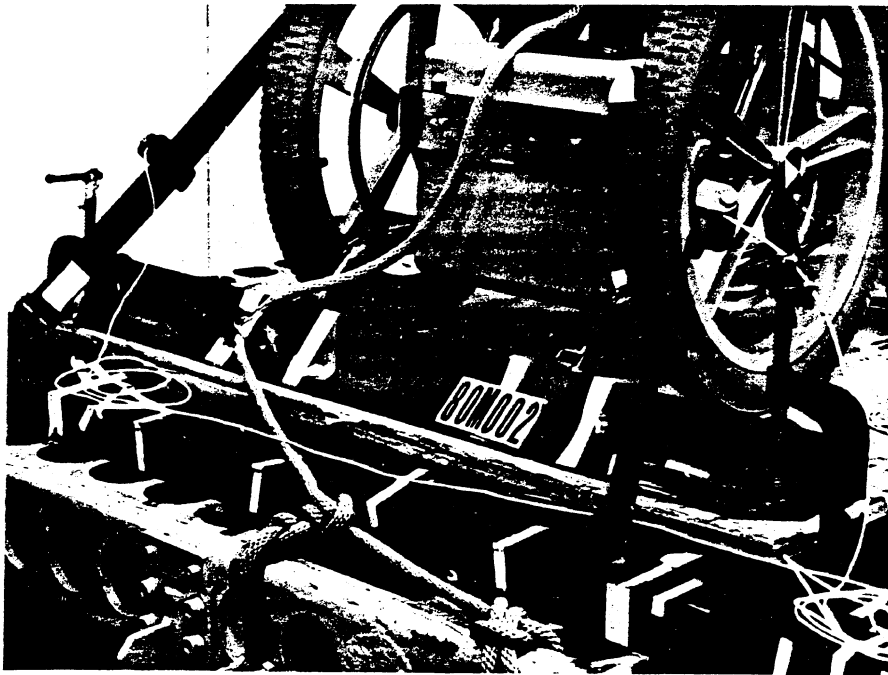
Set-Up Photo for Test 80M002

The chair did not move on sled acceleration and the lap belt remained taut until impact. Upon impact the ring of the left ring assembly broke at the sharp bend releasing the chair and dummy which moved forward and impacted with the padded front of the sled. The velcro belt released allowing the dummy's torso to flex forward. The chair back upholstery was torn loose on dummy rebound. The chair sustained little or no damage to the frame.

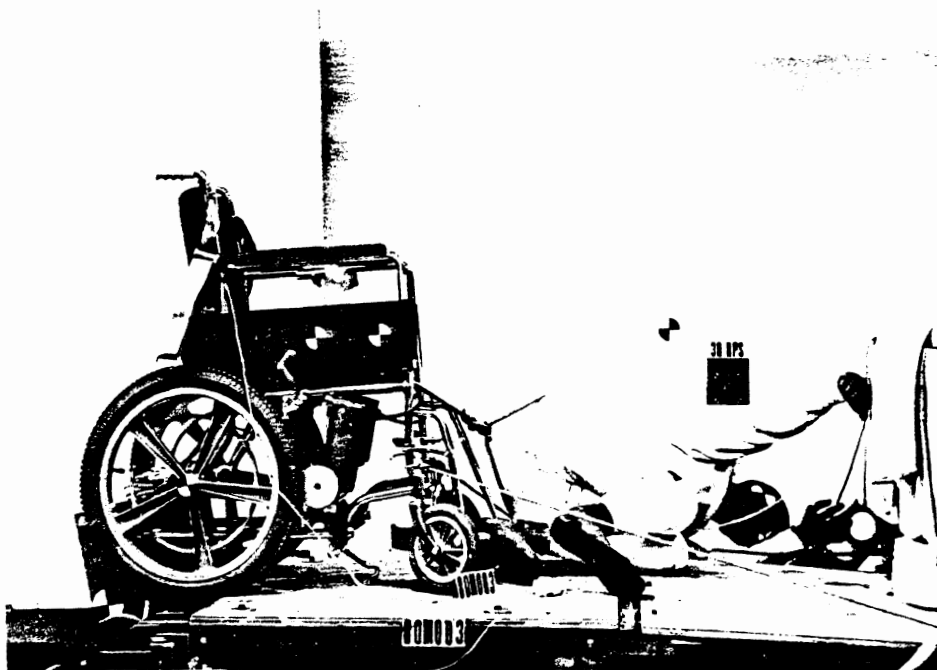
Post-Test Photos for Test 80M003

The ring of the lift ring assembly broke at the sharp bend releasing the wheelchair to move forward into the padded front of the sled. The T-bar and hook bolt bent significantly and the velcro belt came loose allowing the dummy to fall to the floor.

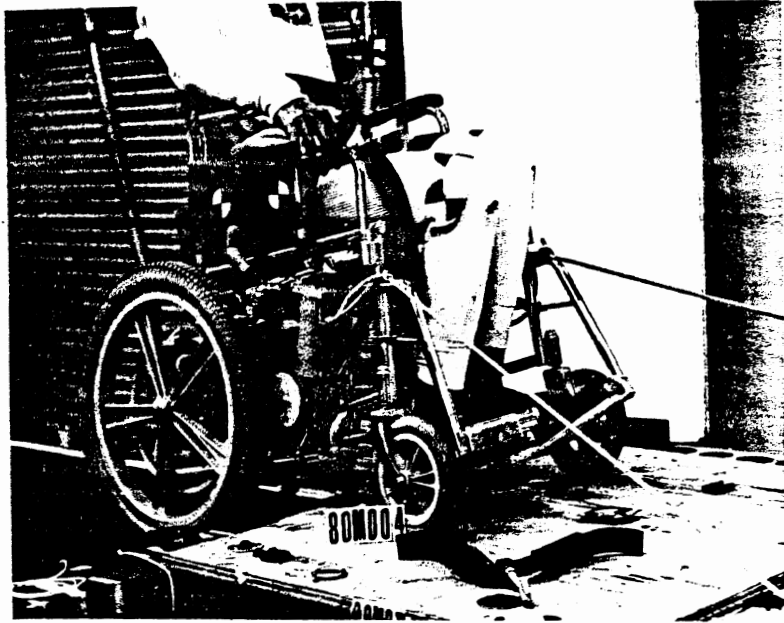
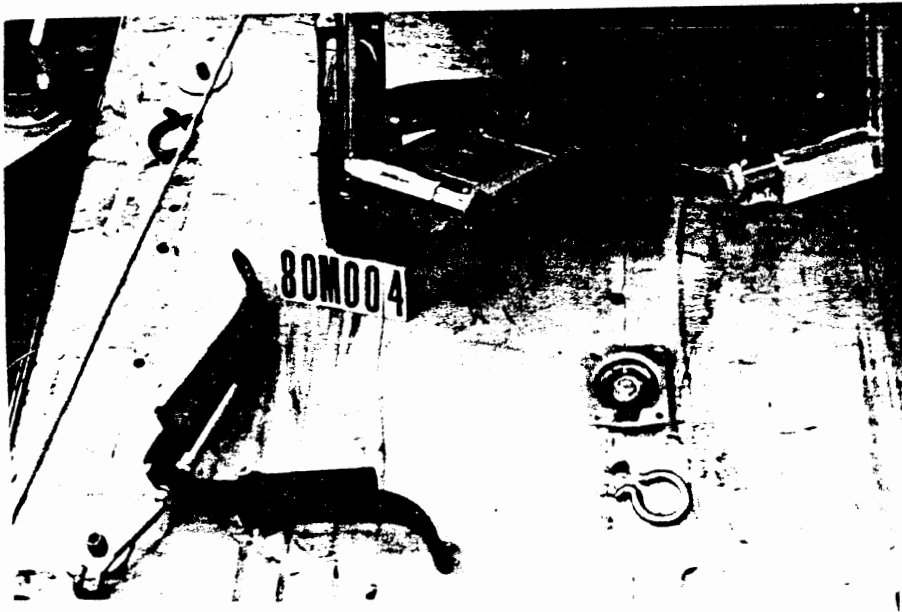
Post-Test Photos for Test 80M004

The rings from the lift ring assemblies securing the T-bar and one side of the lap belt broke at the sharp bends allowing the wheelchair to move into the padded front of the sled. The T-bar itself bent and fractured, and the lap belt also unbuckled. Although the velcro on the chest belt held, the stitching tore out allowing the belt "D" ring to slide through the double webbing and result in significant belt slack.

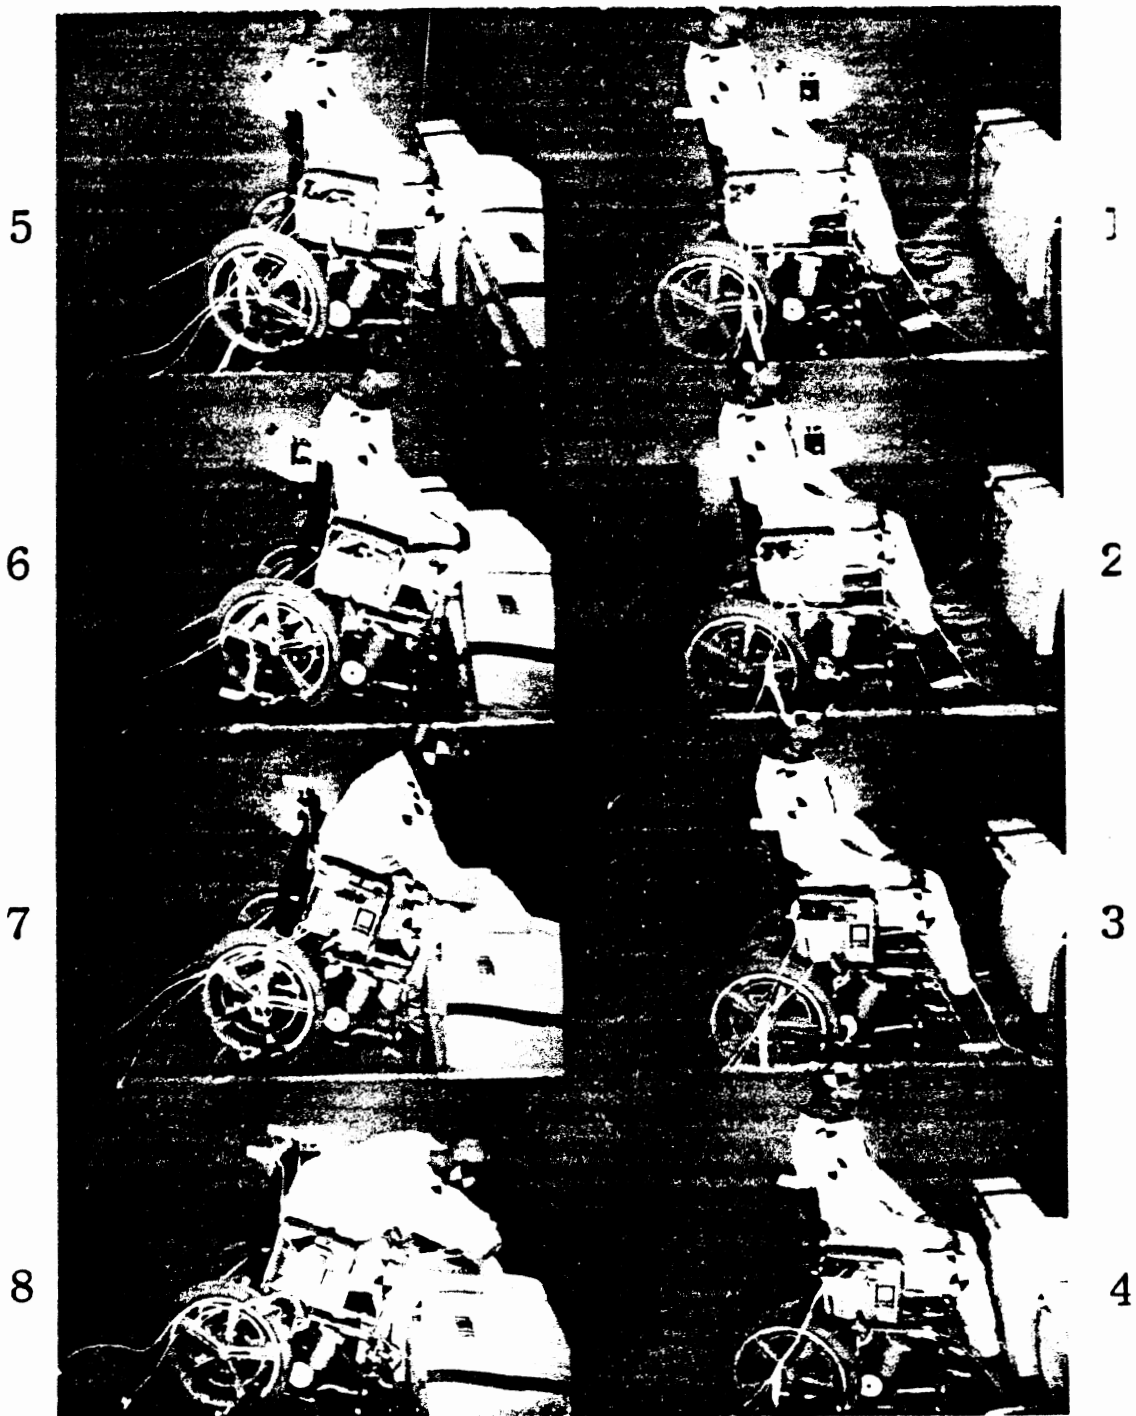
Time Sequence Photo for Test 80M005

There was no significant restraint of the chair by the power lock-down. The lock-down arm slid off the frame with little apparent effect on wheelchair movement. When the arm did interact with the chair frame at the cross-bars, the power lock-down rotated out of the way as the chair moved forward. The chair moved into the padded front of the sled with little or no turning so that the dummy's knees absorbed most of the energy. During the test the lap belt stayed secure and the dummy remained in the chair. The chair sustained little damage other than bending of the motor brackets.

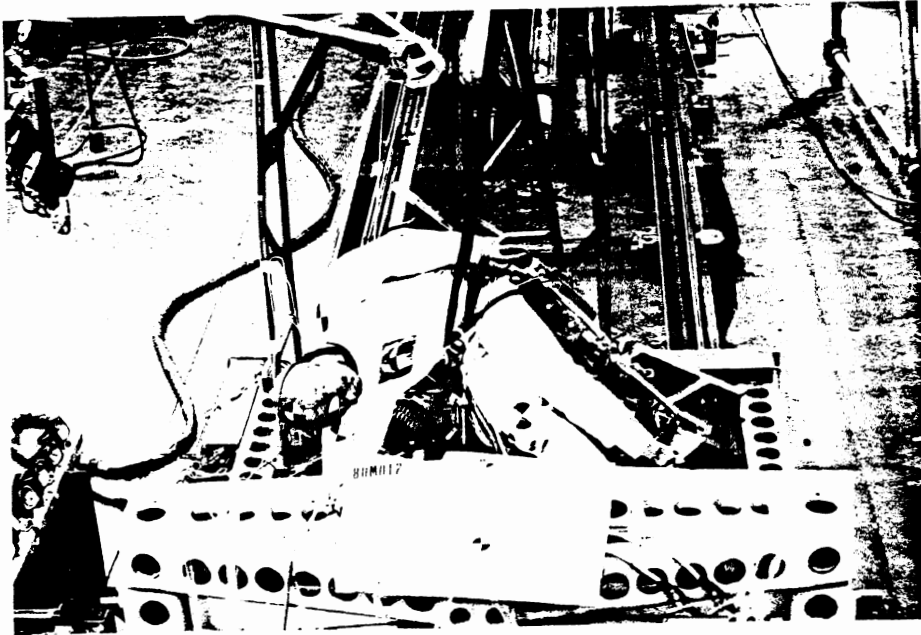
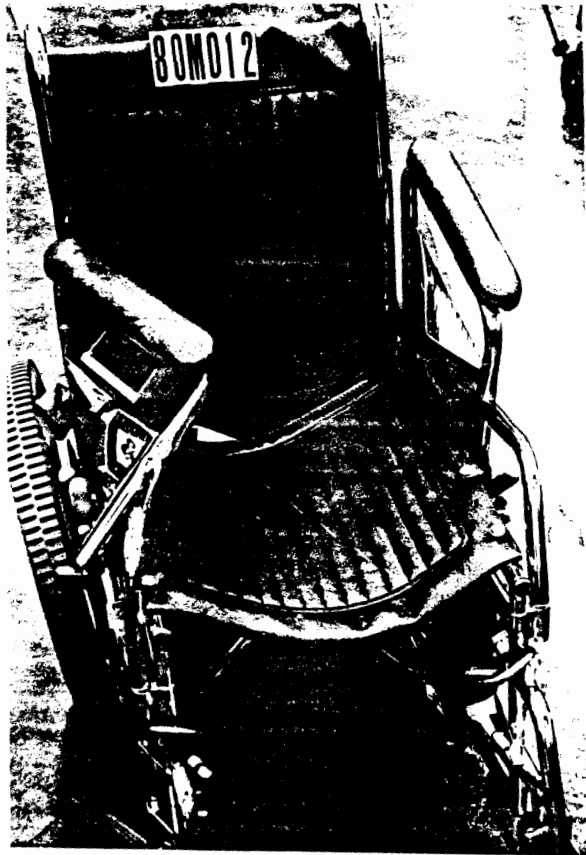
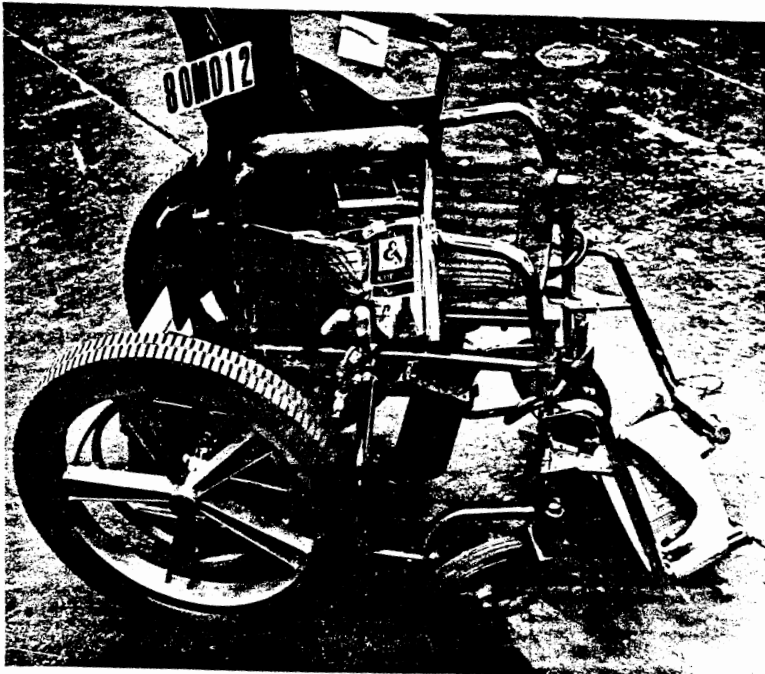
Post-Impact Photos for Test 80M012

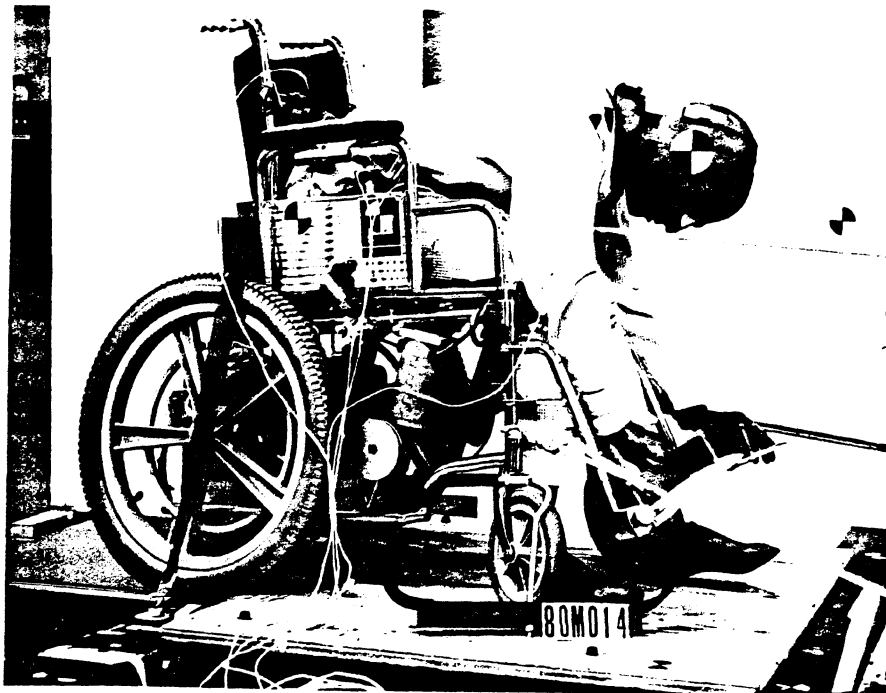
Post-Impact Photo for Test 80M014

Industries T-bar which is constructed of a 1" square steel extrusion does appear to have good strength but in test 80M014 where this was used the hook bolt straightened out and released the T-bar. Thus, the hook bolts provided by these manufacturers are also inadequate for the forces generated in an impact.

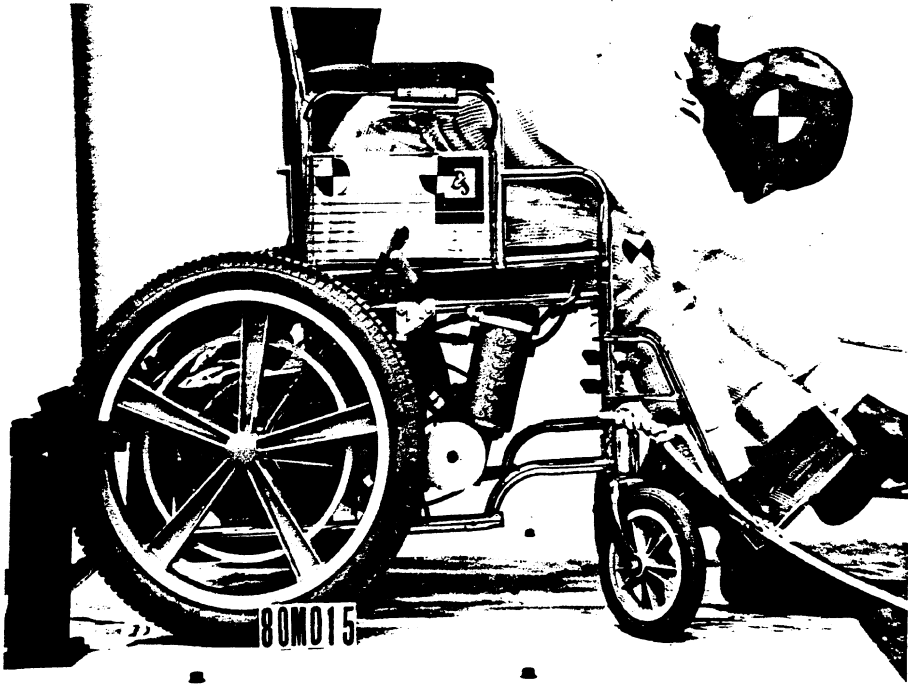
Post-Impact Photo for Test 80M015

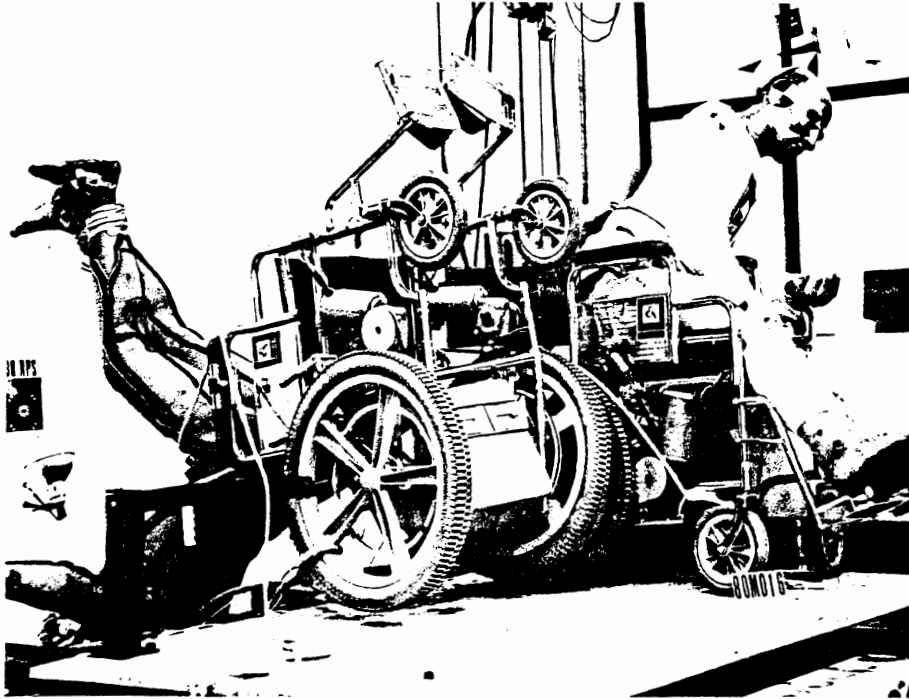
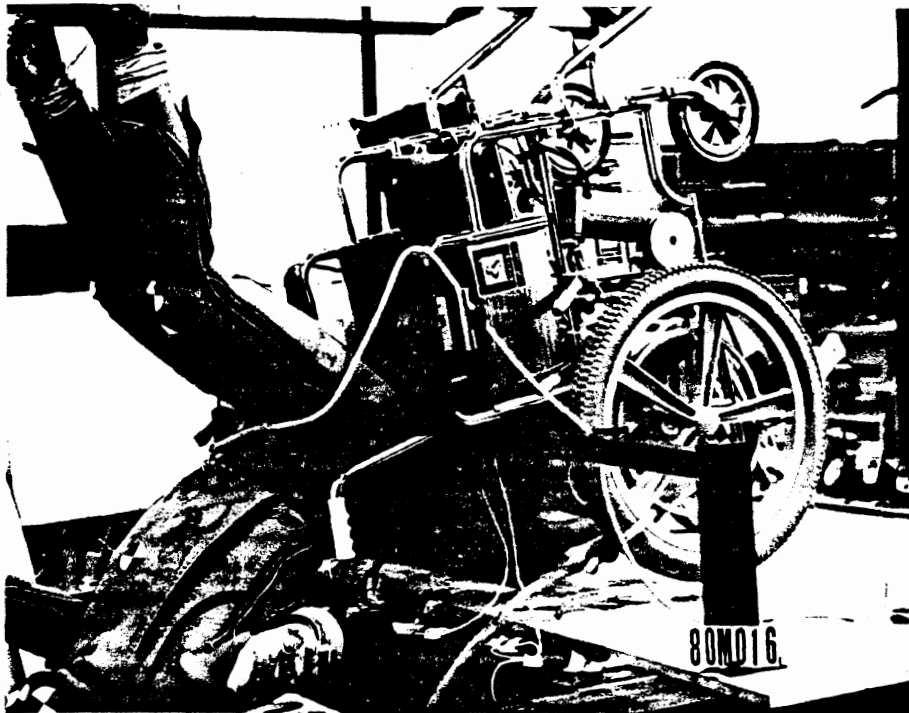
The rim pin fixtures of the stanchion slid along the bar to the front of the stanchion bar. The front chair impacted into the padded front of the sled fracturing the left magnesium wheel rim and badly bending the chair. The rear chair impacted into the front chair and then flipped backward over the stanchion with the dummy ending upside down and hanging off the side of the sled. Both lap belts held the dummy's in the chairs.

Post-Impact Photos for Test 80M016

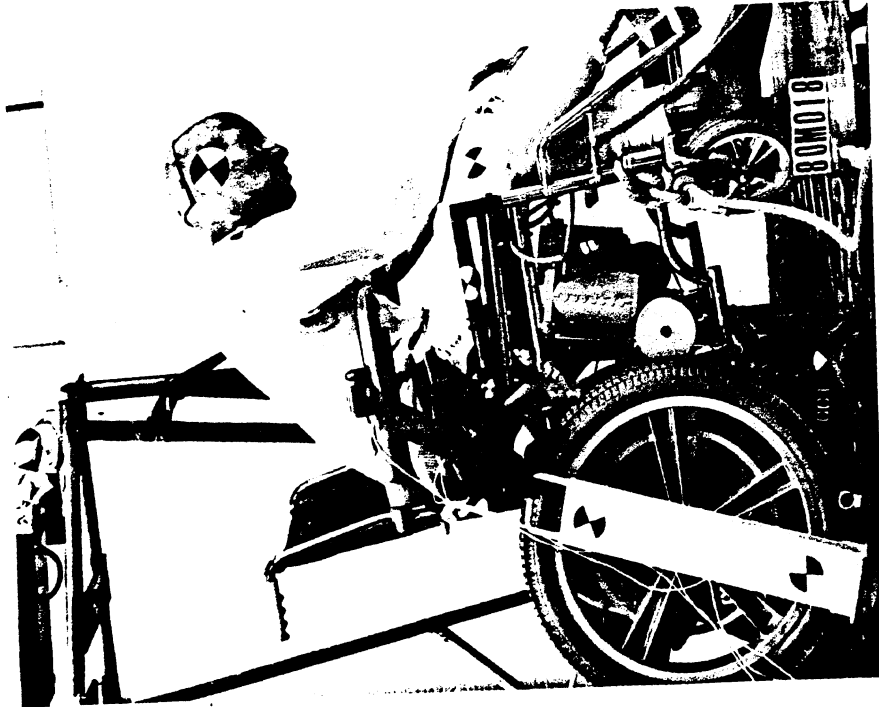
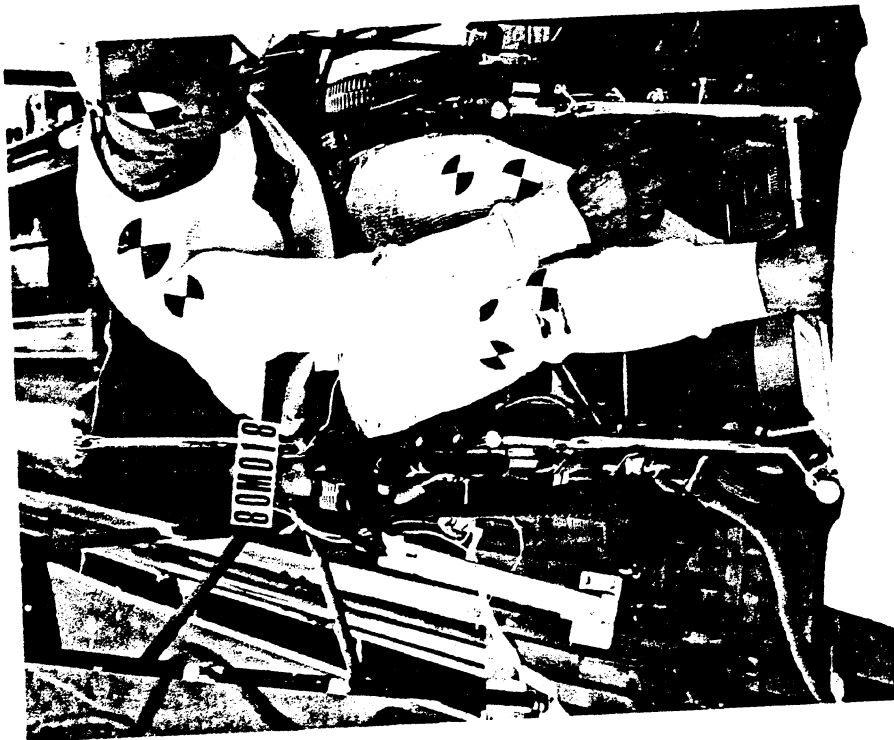
Post-Impact Photos for Test 80M018

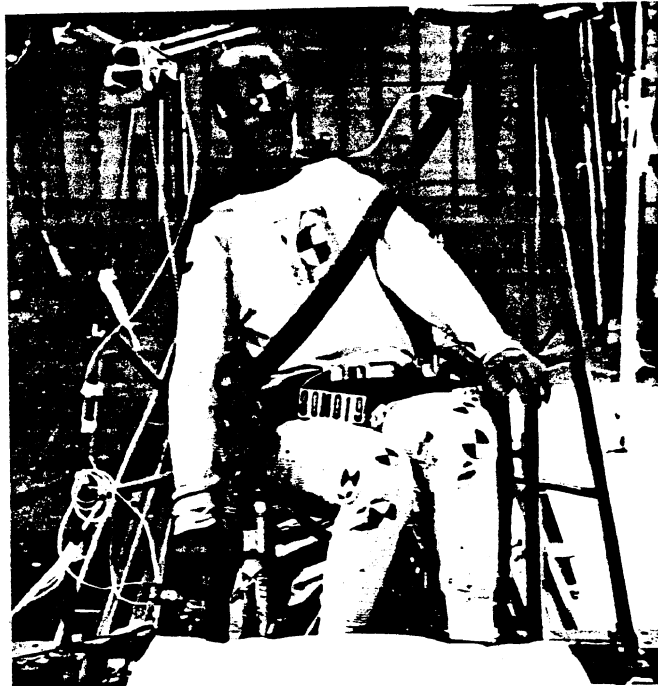
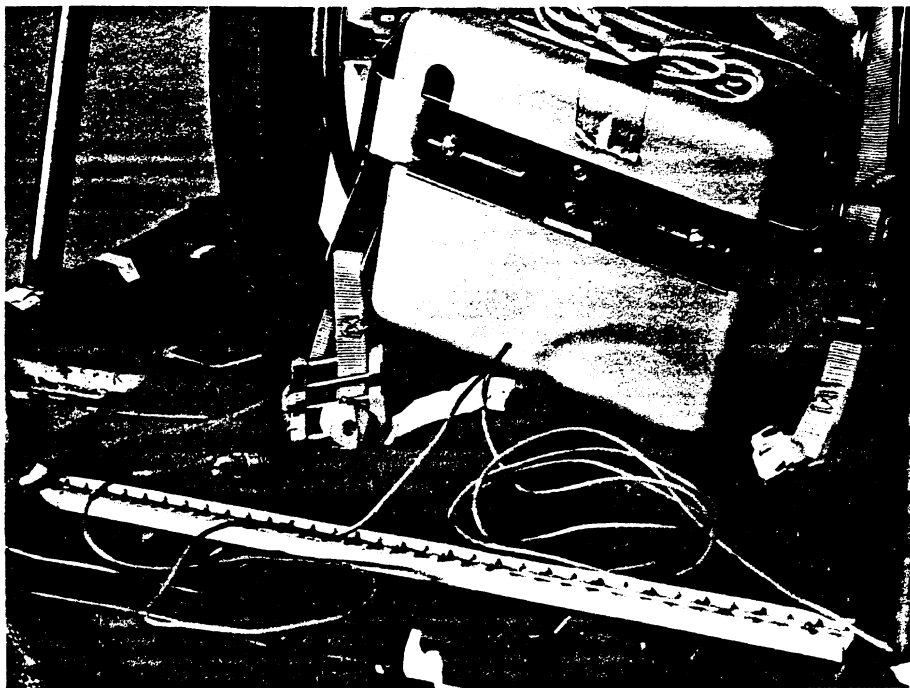
Both rear Aeroquip plugs pulled out of the "G" track simultaneously due to fracturing of metal collars on the plugs. The Bud passive belt system provided good occupant restraint taking an extra load after the Aeroquip plugs released.

Post-Impact Photos for Test 80M019

While the Aeroquip straps can provide an effective means of securing a wheelchair the metal collars on the "G" track plugs fractured in test 80M019 allowing the plugs to pull out and release the chair. The use of a stronger material for this collar should make this an effective manual tie-down procedure.

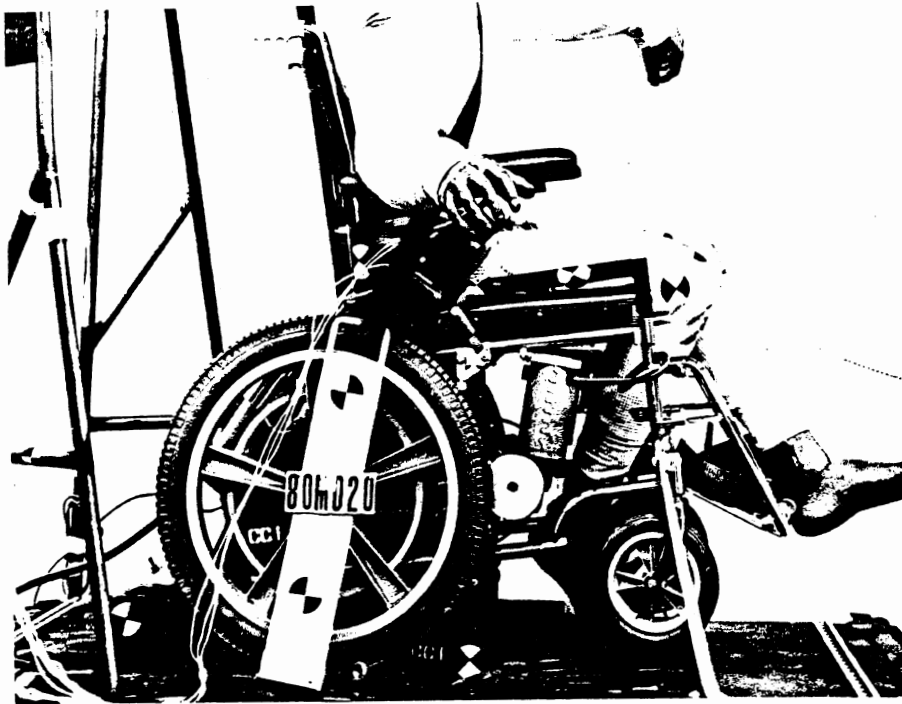
Post-Impact Photo for Test 80M020

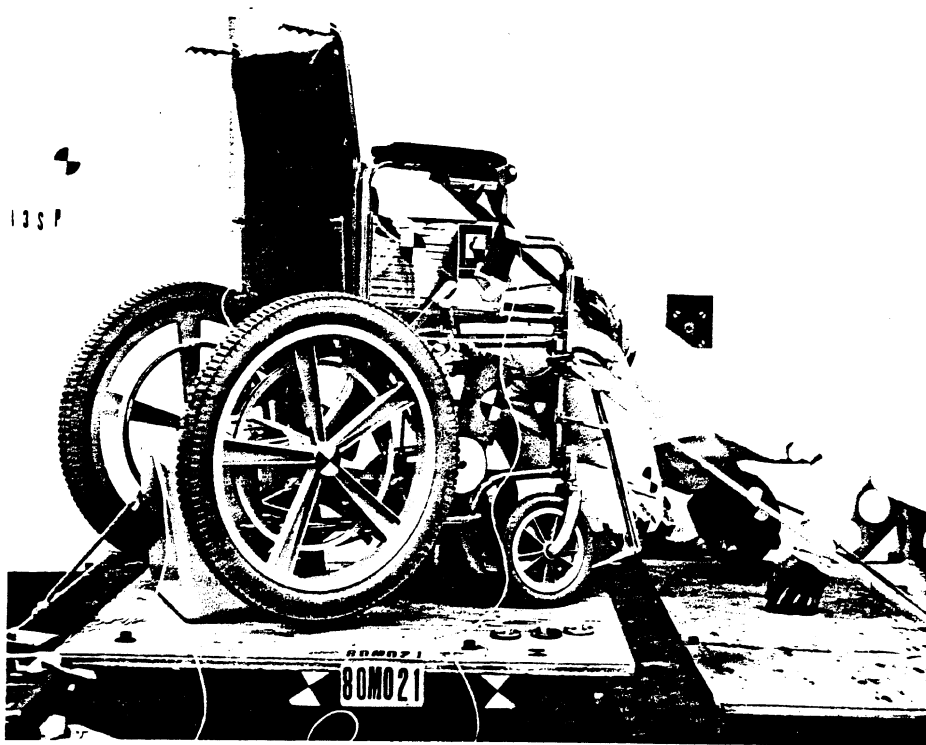
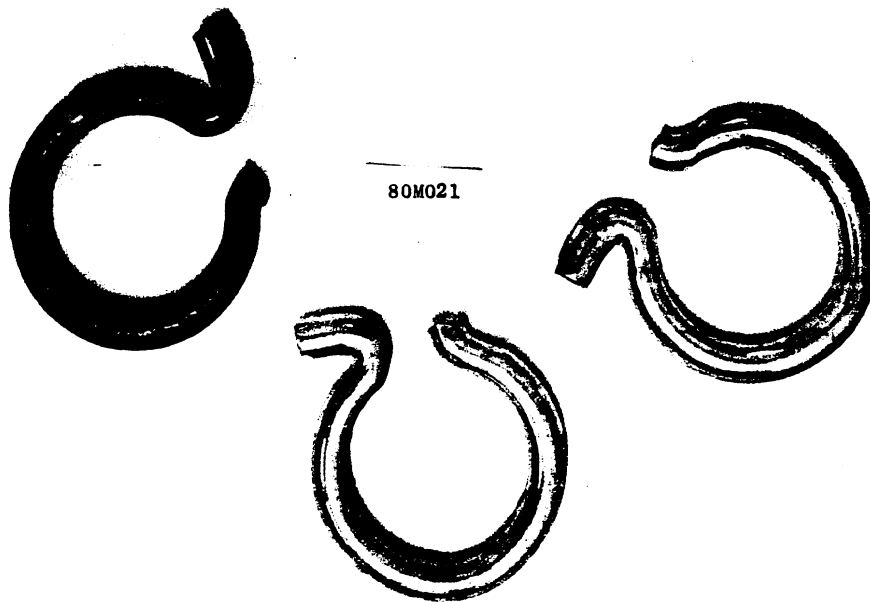
Post-Impact Photos for Test 80M021

All three of the lift rings broke at the sharp bend completely releasing the chair and dummy to impact into the padded front of the sled. After impact the dummy fell to the floor unrestrained. The wheelchair sustained little or no damage.

The lift ring assemblies currently in use for anchoring lap belts and T-bar bolts were simply not intended for forces generated by a 110 pound wheelchair in any kind of a crash. These are "off-the-shelf" trap door rings which can be purchased in most any hardware store. The weak point is clearly the sharp bend in the ring which appears to have been cold bent from a piece of standard rod. Replacement of these ring assemblies by heavy duty eye bolts or some other strengthened hardware is essential for wheelchair restraint and occupant protection.

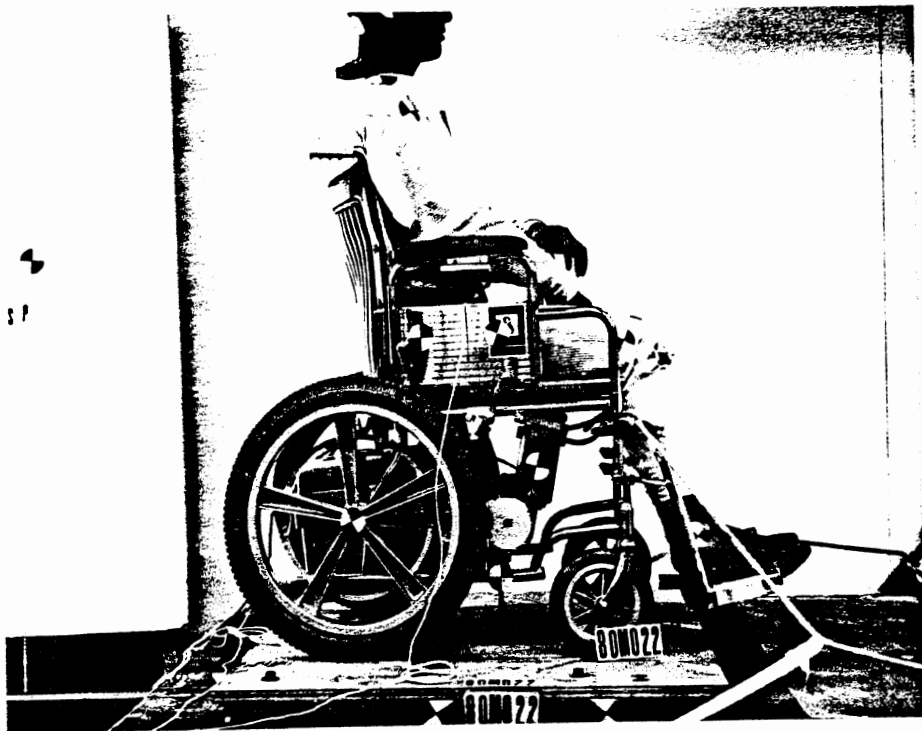
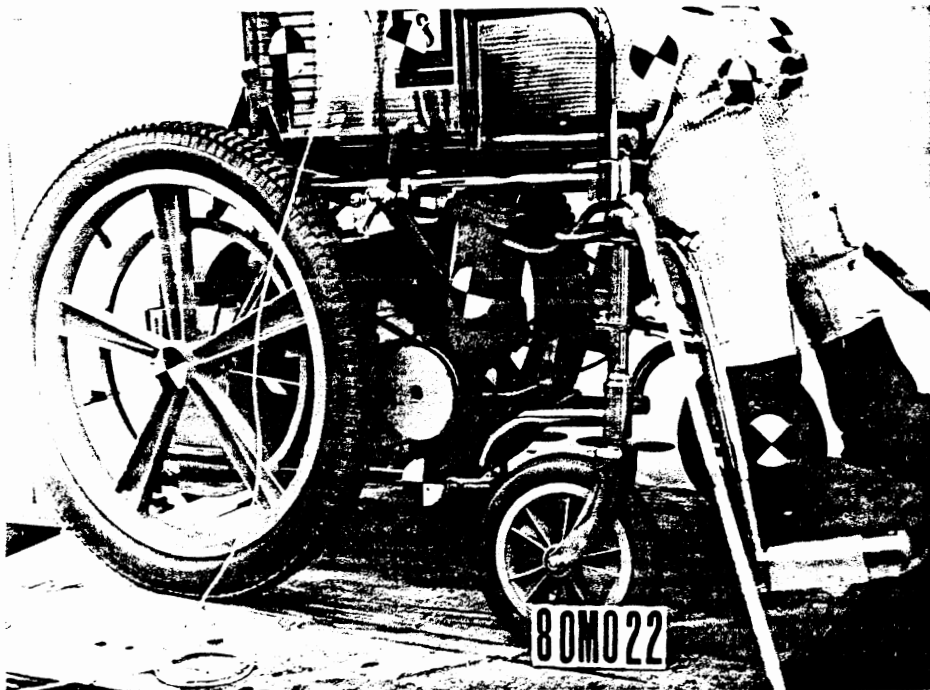
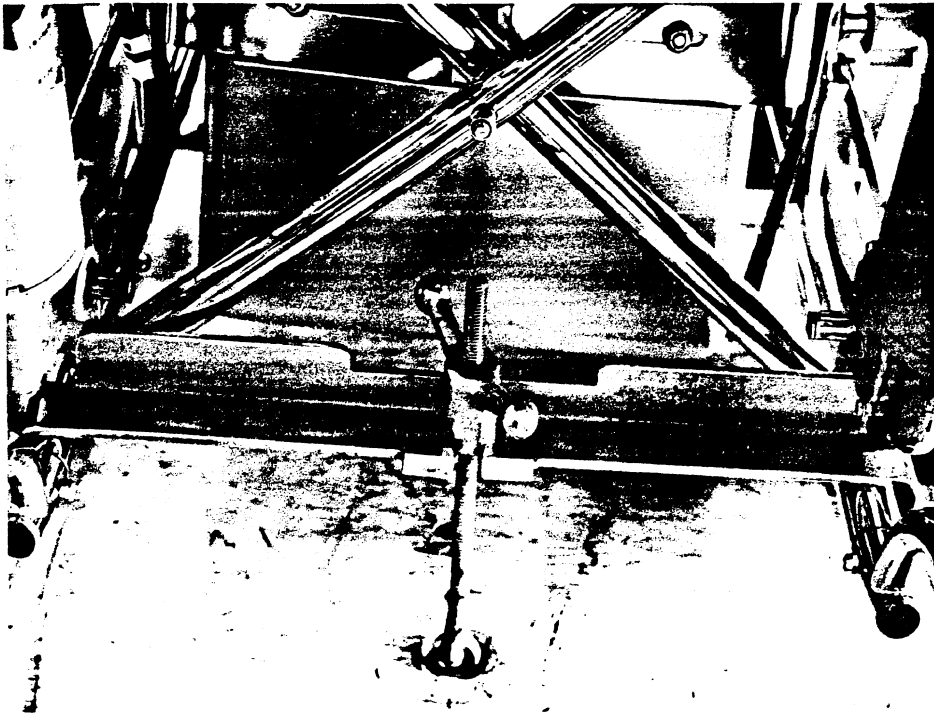
Set-Up Photos for Test No. 80M022

The wheelchair was restrained facing forward on the sled by a T-bar assembly from Target Industries. A heavy duty eye bolt replaced the lift ring assembly and the hook end of the hook bolt was welded closed around the eye bolt. The dummy was secured to the wheelchair by a lap belt attached to the back wheelchair posts. The T-bar was torqued down until substantial compression of the pneumatic tires was achieved.
