# **PROFILE ANALYSIS OF THE LTPP SPS-9P SITE IN ARIZONA**

**STEVEN M. KARAMIHAS**

1. Report No. UMTRI-2007-18		2. Government Accession No.		3. Recipient's Catalog No.	
4. Title and Subtitle Profile Analysis of the LTPP SPS-9P Site in Arizona				5. Report Date May 2007

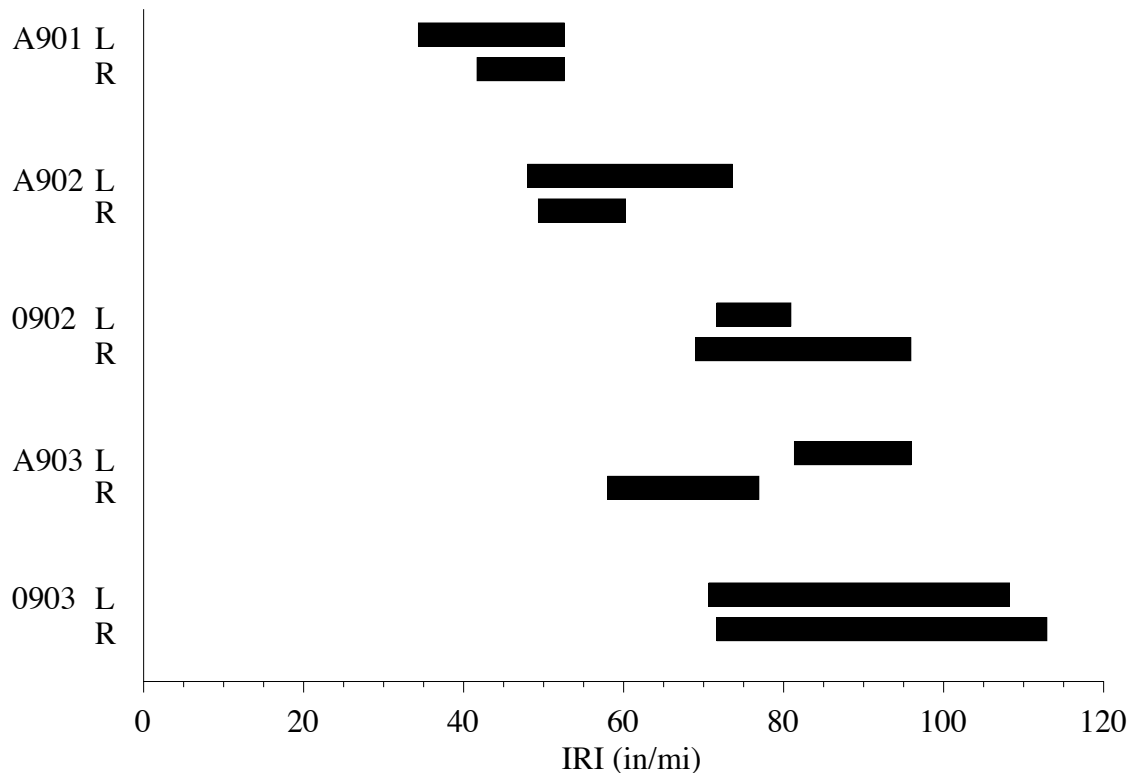
**Figure 9. Summary of IRI ranges.**

The rest of this report provides a summary of the most important observations made about each test section. The summaries are extracted from the Detailed Observations section of this report. To help provide context for the summary statements below, Figure 9 shows the range of left and right IRI for each section. Note that the highest IRI value for some of the sections did not occur in the final visit. (See Appendix A or Figures 1 through 5.)

Section A901: The left side profiles included two patches of sinusoidal chatter in all visits, and included the chatter over the first half of the section in visits 04 and 11. This affected the look of the profiles tremendously, but it did not affect the IRI much. A bump appeared about 400 ft from the start of the section that became rougher with time, and caused localized roughness by visit 13.
