**Report to the Test Director**

**DAMAGE TO COMMERCIAL  
AND INDUSTRIAL BUILDINGS  
EXPOSED TO NUCLEAR EFFECTS**

February 1956

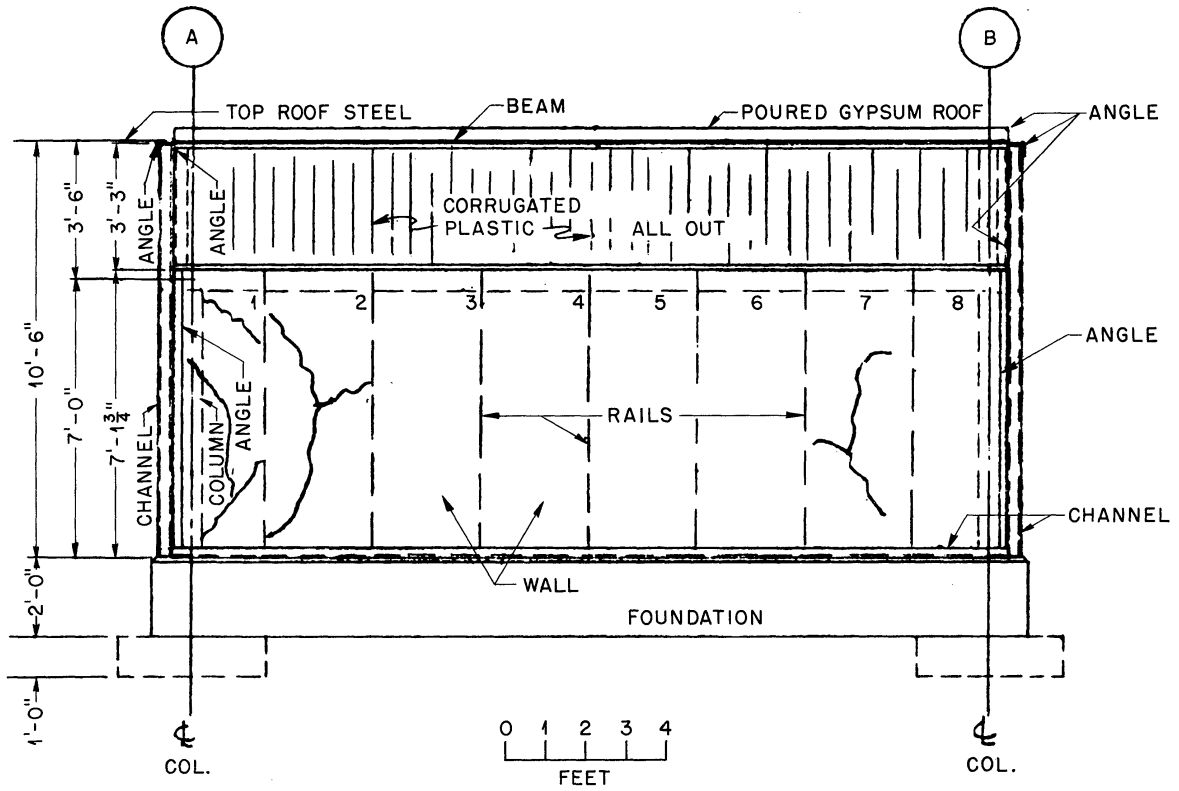
Fig. 1.3—Front elevation of Union Carbide building.

The reinforced-gypsum walls suffered only slight damage. The wall facing the blast (Fig. 1.3) showed moment cracks on the interior surface. These cracks were a maximum of  $\frac{1}{32}$  in. in width, and they occurred in three of the panels formed by the vertical steel rail studs. The south wall, away from the blast center (Fig. 1.4), developed a horizontal crack approximately  $\frac{1}{16}$  in. in width, starting near the southeast building column and extending across one-third of the bay. The east and west walls showed no moment cracks, but several shear cracks developed in the west wall at the top of the panels at roof level near the door opening, as shown in Figs. 1.6 and 2.16.

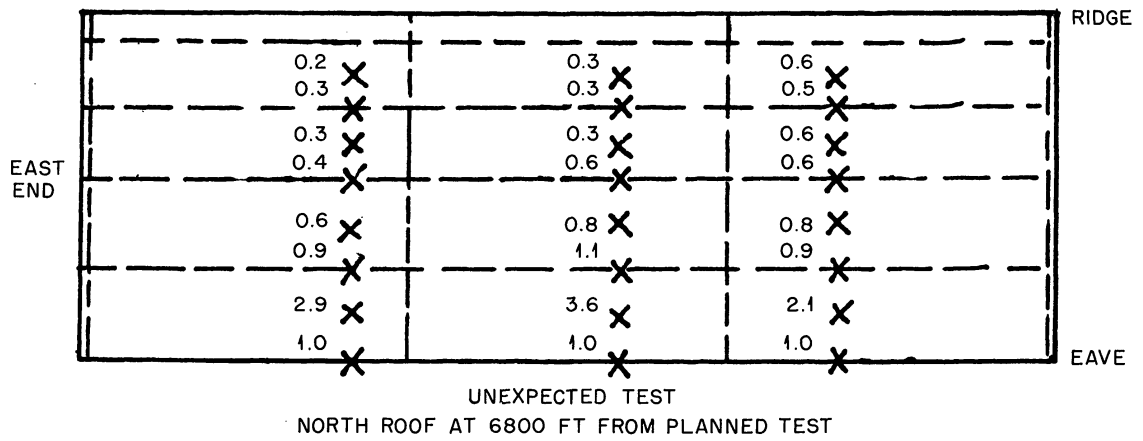
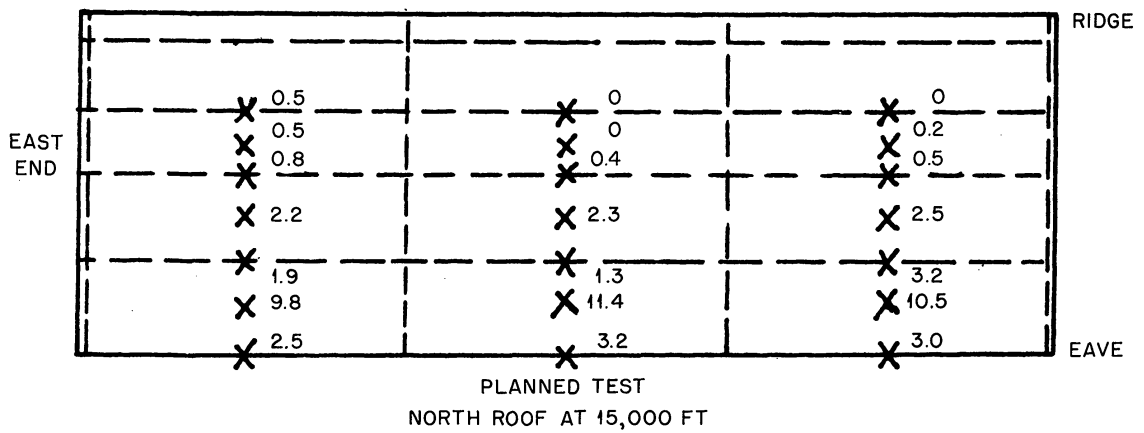
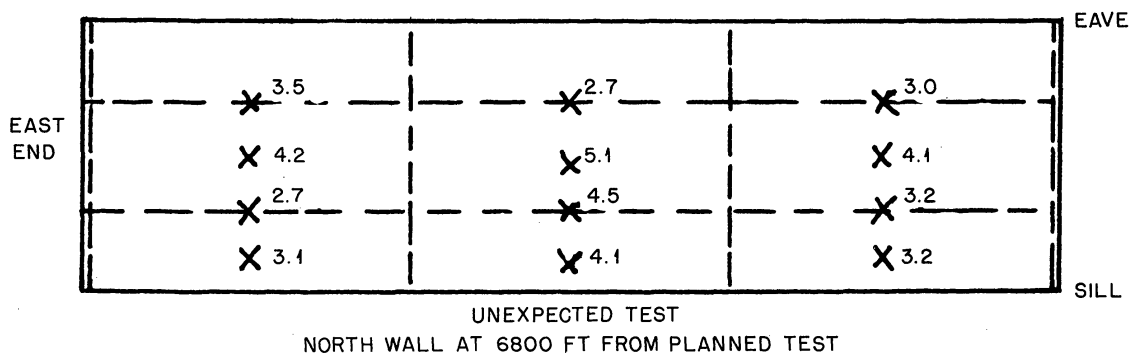
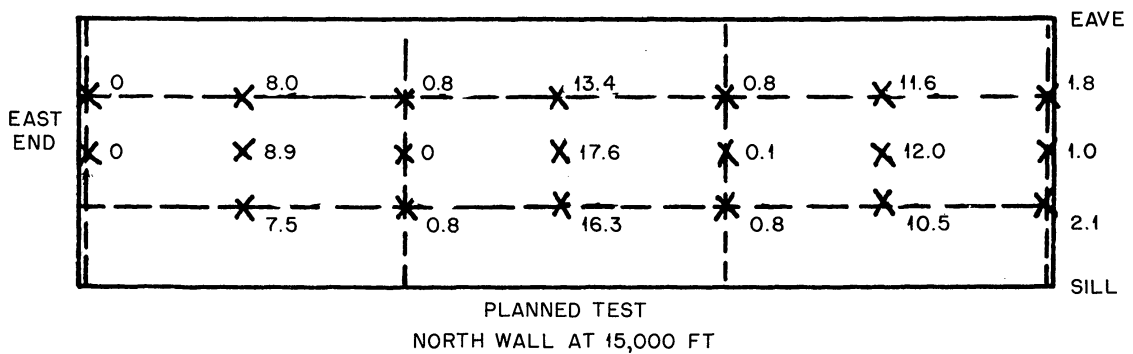
Figure 2.1 gives a general indication of the damage from the unexpected test to the north wall of Reynolds-Butler Building 31.2-a1, which was left with permanent inward deflections up to 5 in. The offset measurements, as recorded at the site, are tabulated in Fig. 2.2 for both the unexpected and planned tests. The two wall girts were bent in along with the paneling, and the bolt heads of the panel fasteners were generally pulled through the sheeting. Washers had been omitted along these two lines of bolts, and hence no definite conclusion can be made as to the probable extent of pull through if they had been included. The roof sheeting was left with downward permanent sets, especially in the span immediately adjacent to the eaves, where the permanent deflections, as shown in Fig. 2.3 and recorded in Fig. 2.2, were measured up to 3 in. The roof purlins were not deformed appreciably. The interior view of the wall (Fig. 2.4) shows how twisting of the girts occurred with measured values up to 43°. It is also of interest to note the imprint of the wind-bracing ties on the wall paneling, indicative of the initial deflections that were experienced. A dynamic analysis of wall behavior in both the unexpected and planned tests is provided in Appendix A.

Fig. 2.2—Offset measurements of permanent wall and roof deflections in inches in Reynolds-Butler buildings in which sheeting remained in place.

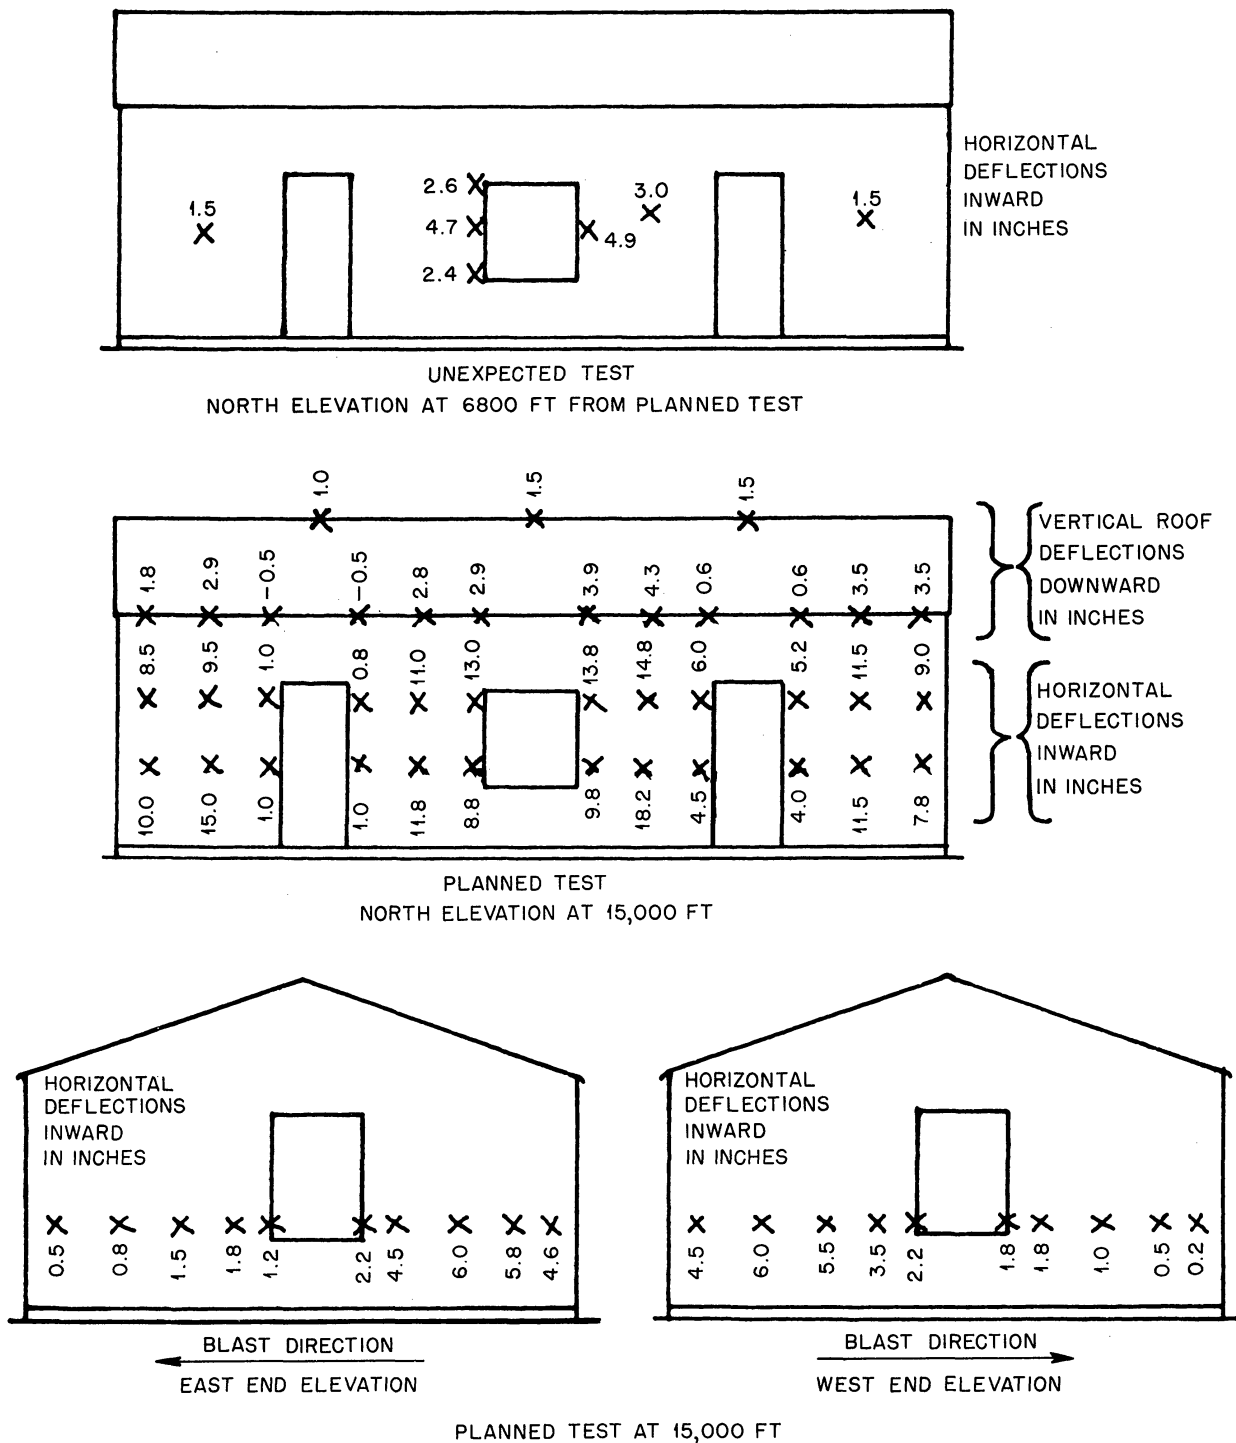
Fig. 2.7—Offset measurements of permanent wall and roof deflections in inches in Armco buildings that remained intact.

Permanent deflections along the north side of Armco Building 31.2-d1 are shown in Fig. 2.6 and are recorded in Fig. 2.7. The first five wall panels on the east and nearest the blast origin were damaged to a lesser extent. Maximum permanent deflections of the north wall, amounting to 4.8 in., were measured adjacent to the north window. Figure 2.8 shows the local buckling on the inside of the north wall near the location of maximum deflection. This building,

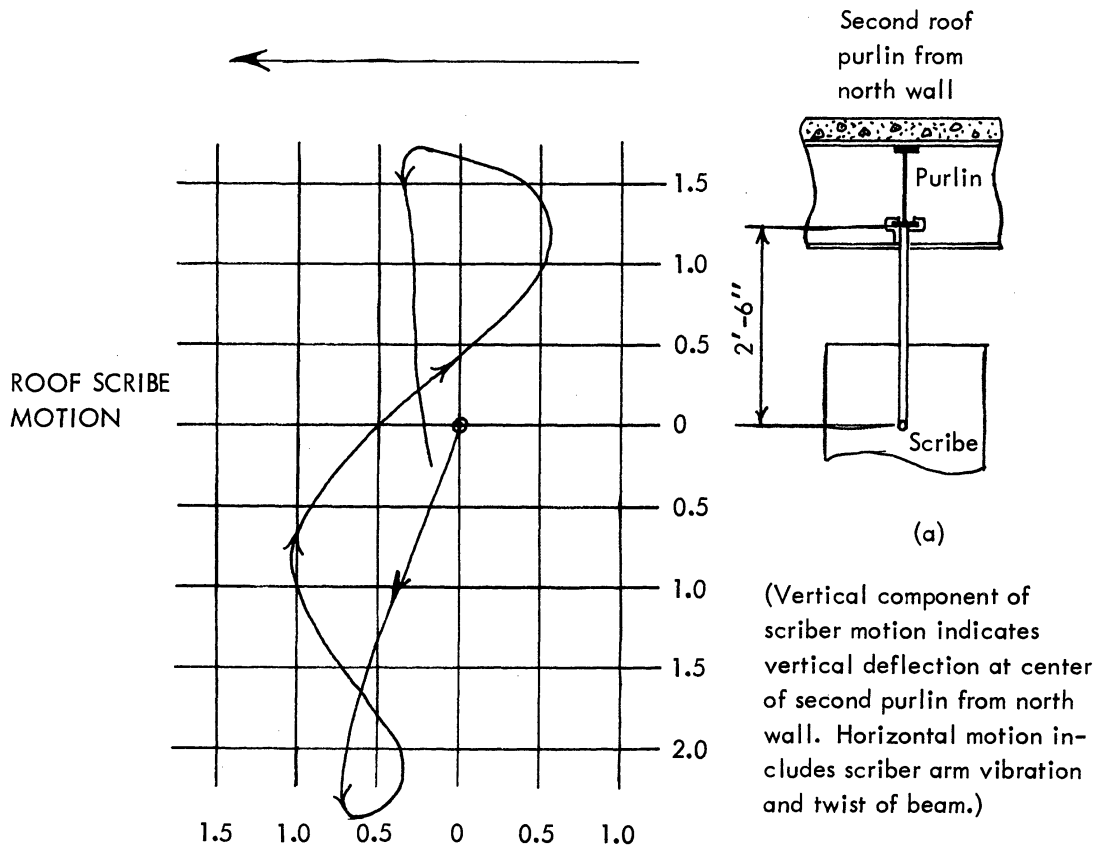
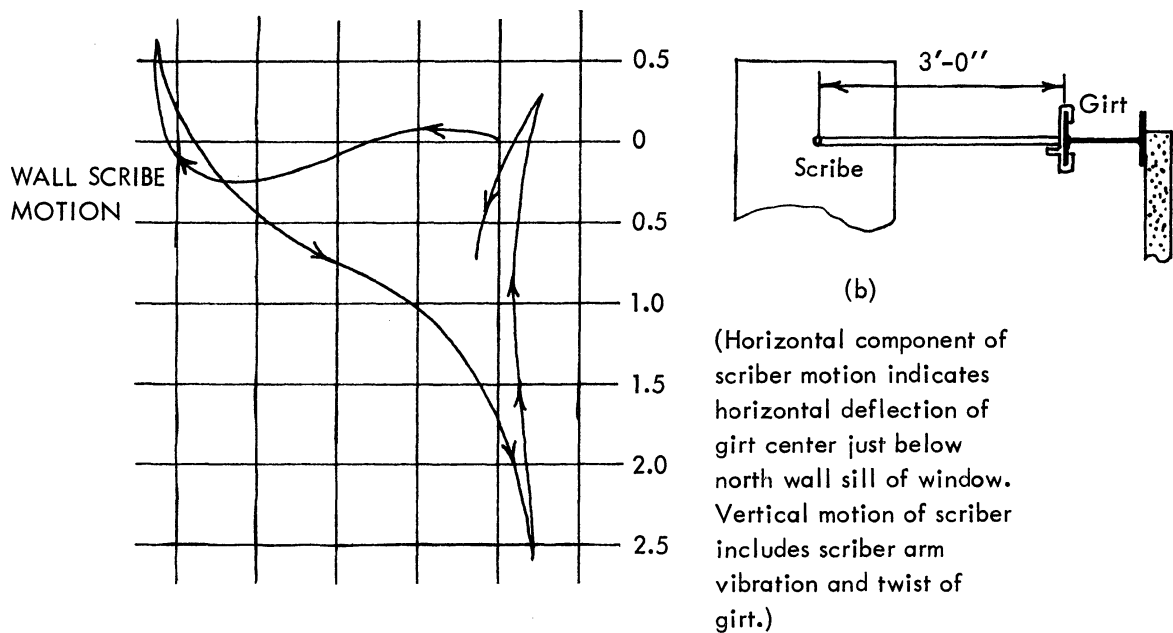
Severe vertical roof movements were indicated on scratchboards, and these movements are recorded in Fig. 2.14 at the one available location. No permanent deflections were recorded for any roof beams, except for the beam one panel from the south wall, which had a permanent upward deflection of  $\frac{1}{8}$  in. at the center of the beam.

1. Horizontal girt in north wall: torsion and horizontal deflections, as shown in Fig. 2.14.
2. Roof girder at east wall: torsion in the girder, as shown by the impact mark on the scratchboard by the stylus pipe arm.
3. Roof beam, just north of center line: vertical displacement coupled with some torsional movement, as shown in Fig. 2.14.
4. Column in southeast corner (near girder): displacement approximately  $\frac{1}{4}$  in. in north and south directions.

Fig. 2.14—Deflections of roof and north wall in Union Carbide building during planned test.

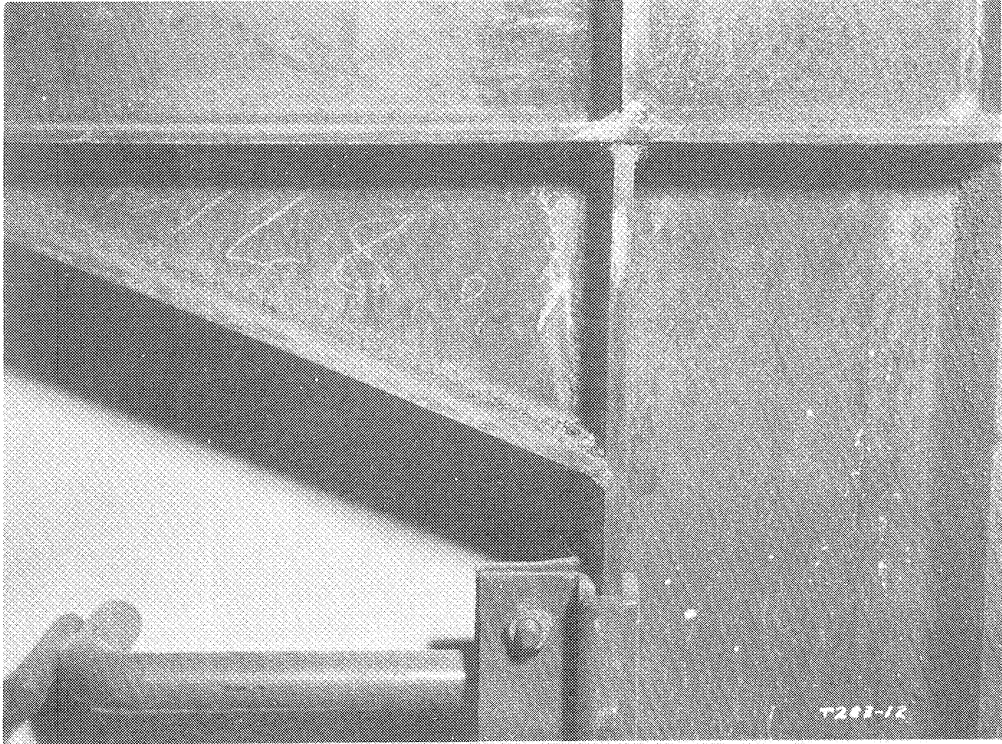
None of the steel details or welded connections showed any serious indication of yielding or failure. Figure 2.15 shows the typical condition of a welded detail at the main frame connection after the test.

Fig. 2.15—Southeast corner frame connection of Union Carbide building.

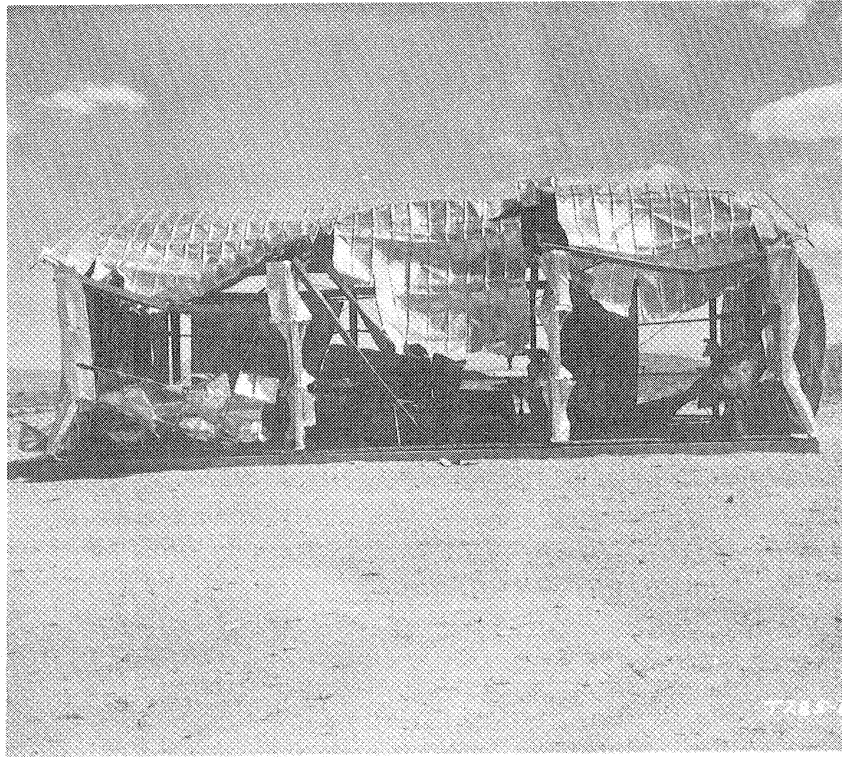
In addition, the two end frames at the north corners were bowed laterally inward, a distance of about 11 in. at each end, toward the center of the building. This inward deflection is quite noticeable in the general view of the north side, as shown in Fig. 2.17. The unbalanced tension in the girts at the ends, as well as the inward pressure, was undoubtedly a factor contributing to this inward movement. In addition, the girts showed evidence of having hung on the corner columns longer than on the interior columns, thus exerting a twisting and pulling action accentuated by drag on the crumpled mass of sheeting that remained attached to these girts.

Fig. 2.17—North side of Reynolds-Butler Building 31.2-a1 after planned test.

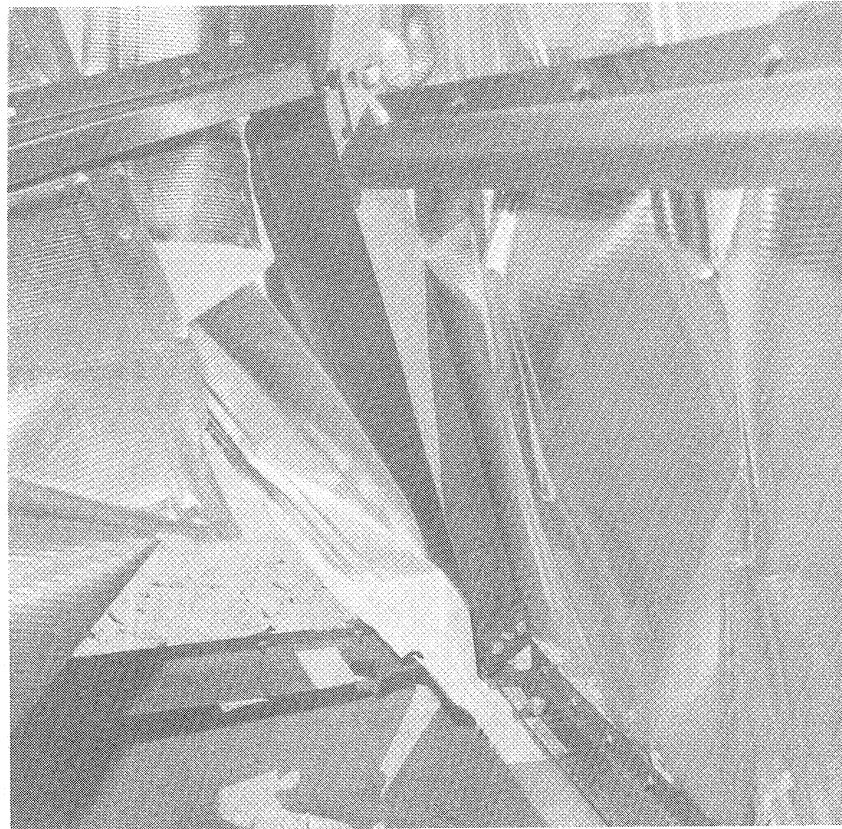
Fig. 2.18—Interior detail of northeast column in Reynolds-Butler Building 31.2-a1 after planned test.

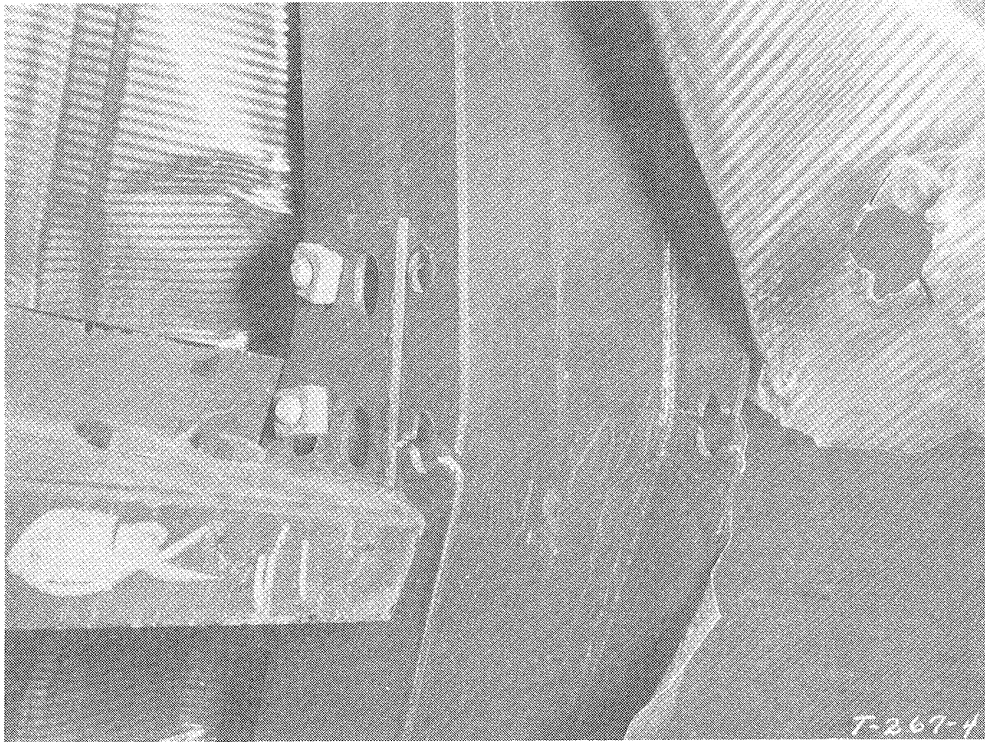
Fig. 2.19—Interior detail of northwest column in Reynolds-Butler Building 31.2-a1 after planned test.

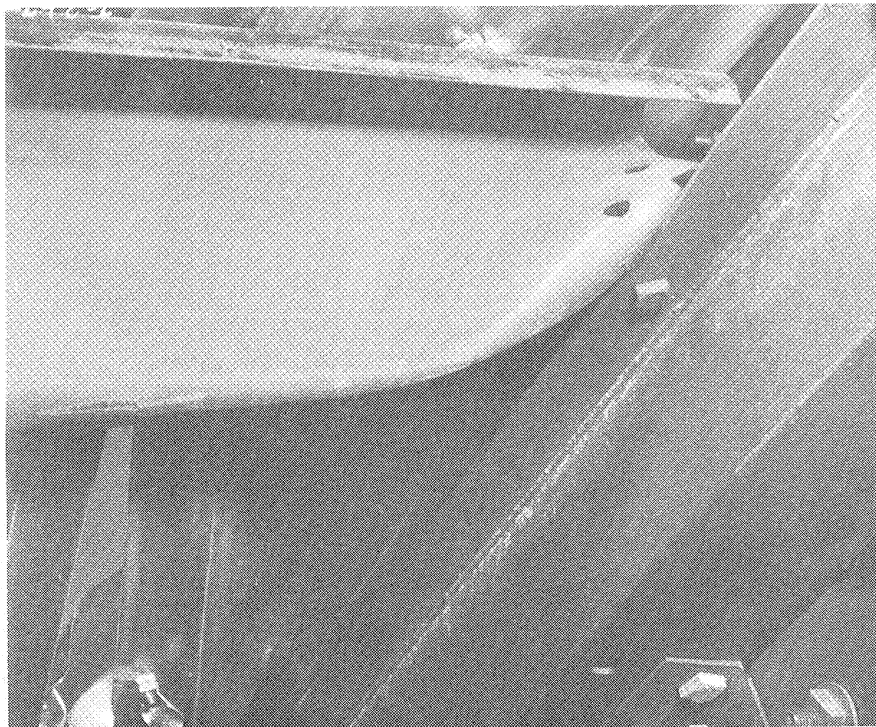
Fig. 2.25 — Underside of roof at northwest corner of Reynolds-Butler Building 31.2-a1 after planned test.

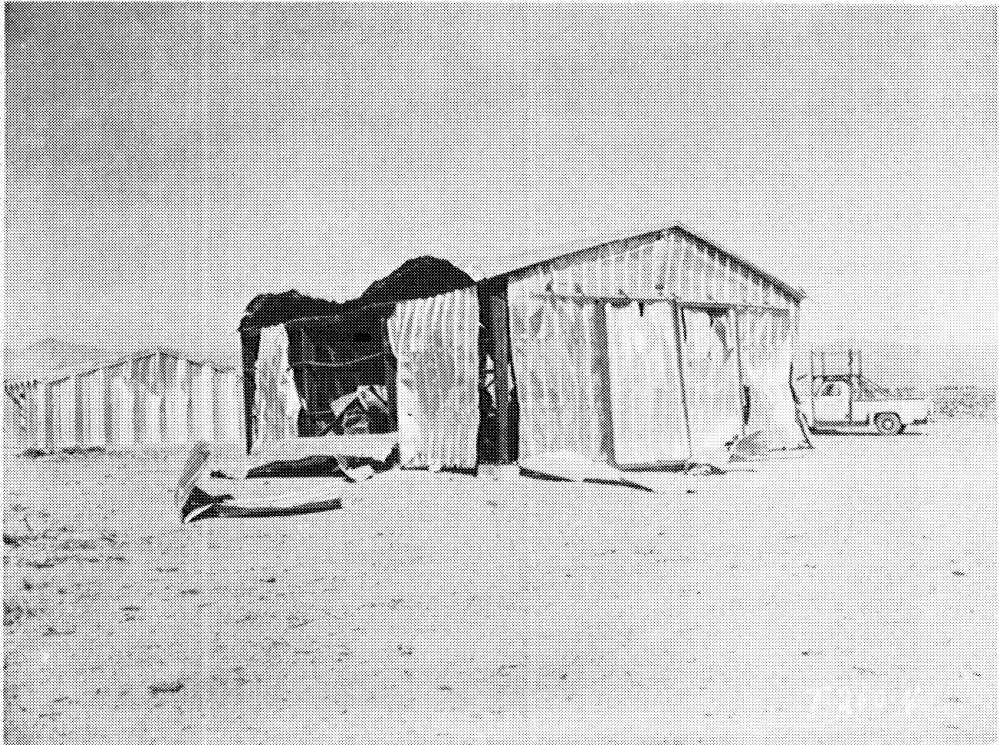
On the south wall the sheeting was all detached from girt fasteners, except for two segments that remained hanging along their top attachment to the eave members (Fig. 2.26). All the girts on the south side remained attached at their end connections to the main frames, as

Fig. 2.26 — South side and east end of Reynolds-Butler Building 31.2-a1 after planned test.

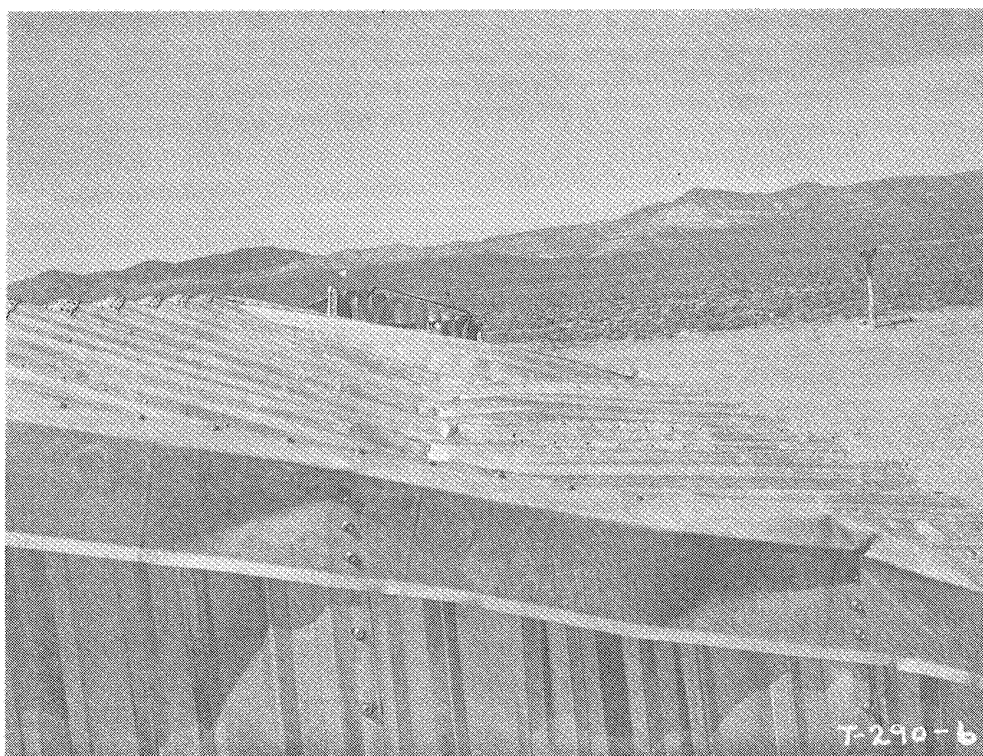
As shown in Figs. 2.31 and 2.32, the major structural damage to this building resulted from the bending and local buckling of the roof units. The roof along the ridge line had been depressed approximately 1.25 in. as a result of the unexpected test, and there was little additional roof deflection. At the center the additional downward deflection relative to the ends amounted to a maximum of only 0.7 in. at the center of the ridge line. The deflection of the roof panel units from a straight line connecting the ridges and eaves was quite uniform (Fig. 2.31), amounting to 12 to 14 in. at points of permanent deflection. The motion pictures of this structure during the test show clearly that the maximum deflection was appreciably greater than the permanent deflection, indicating some elastic recovery from the most deflected condition. Figure 2.33 shows a typical cross section of Behlen Building 31.2-b1 after the planned test.

Fig. 2.32—View looking along north roof of Behlen Building 31.2-b1 after planned test.

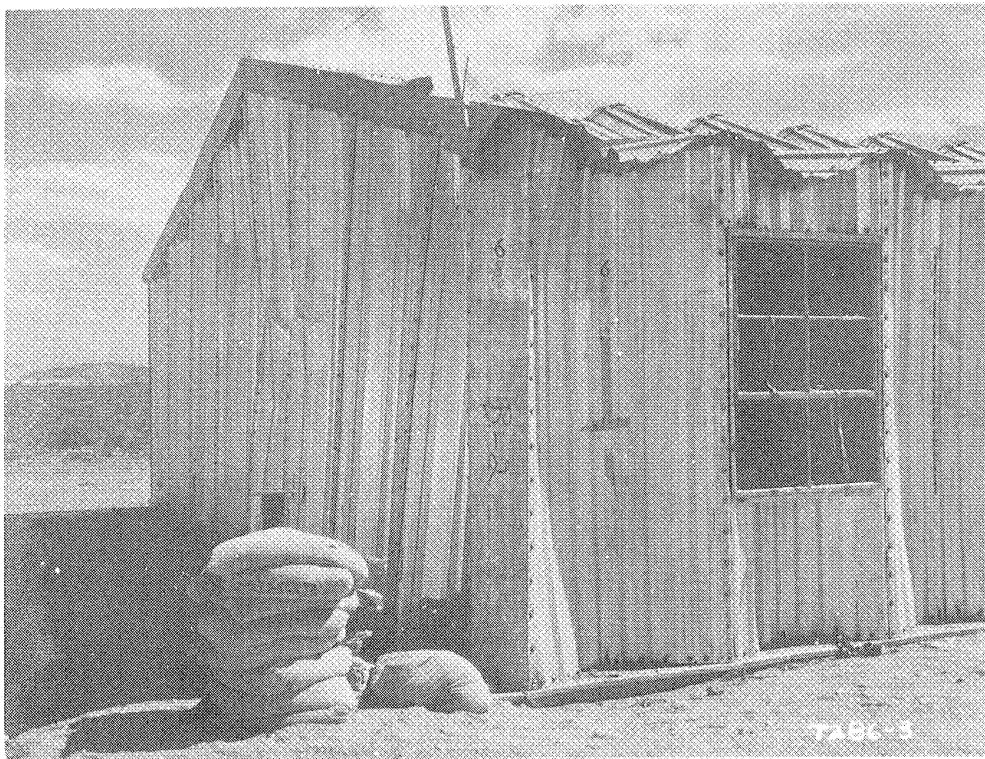
The ends of the building suffered minor damage, as shown in Figs. 2.34 and 2.35. The north half of the east end of the building was tilted toward the west, or center of the building, by varying amounts. In addition, the central panel was bent inward approximately 7 in. at mid-height. Along the sloping northeast corner of the roof, the inward tilting of the end wall segments (Fig. 2.35) varied from 11 in. at the panel next to the eave corner to 2 in. at the ridge. At the west end of the ridge, the end wall remained essentially plumb, but it was bent inward locally about 2 in. near the center. Also, adjacent to the west end, there was severe local buckling near the top, which can be noted from the interior close-up view shown in Fig. 2.36. At this point, also, can be noted the failure between the longitudinal end strut and its connection to the end wall of the building, with permanent displacement in the direction of the ridge line of about 4 in.

Fig. 2.35 — Northeast corner of Behlen Building 31.2-b1 after planned test.

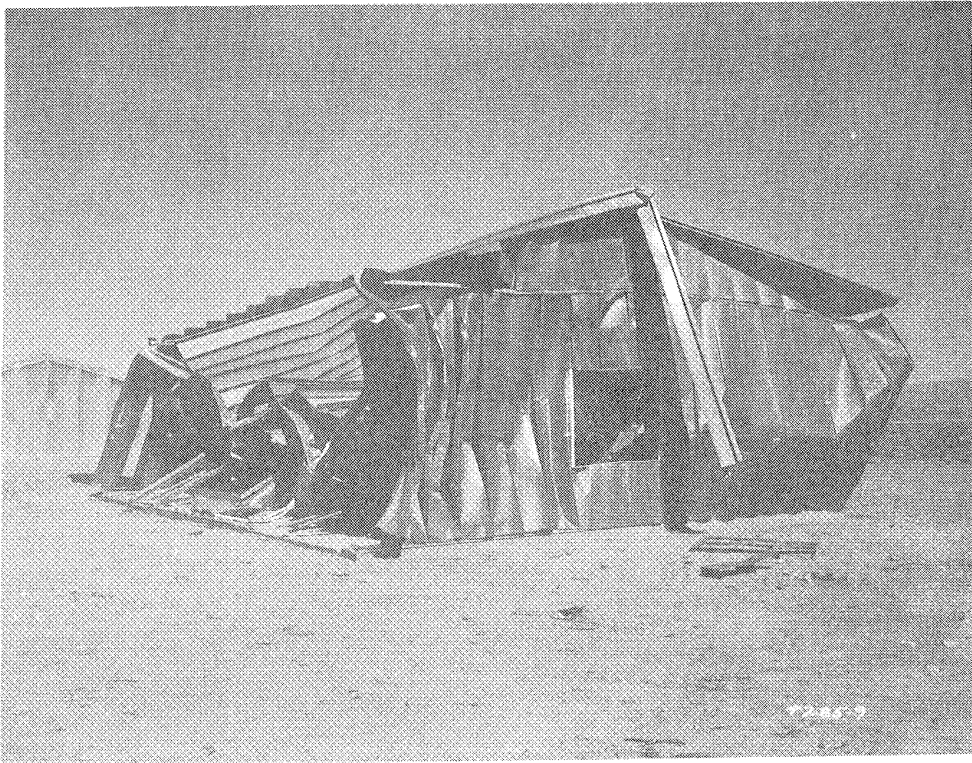
The north side of the building is shown in Fig. 2.37, which also indicates the sag in the roof. Figures 2.38 to 2.41 show various views of the crumpled ends and the south side of the building. Most of the wall segments remained on site, although the wall panels along the north side were largely torn loose from the wall sill connections, as shown in detail in Fig. 2.42, and one piece swept downblast about 50 ft. At the southwest corner of the building, the sill was also torn loose, as shown in Fig. 2.43. The wall paneling remained attached to the sill along 75 per cent of the east end and all the west end.

Fig. 2.38 — West end of Armco Building 31.2-d1 after planned test.

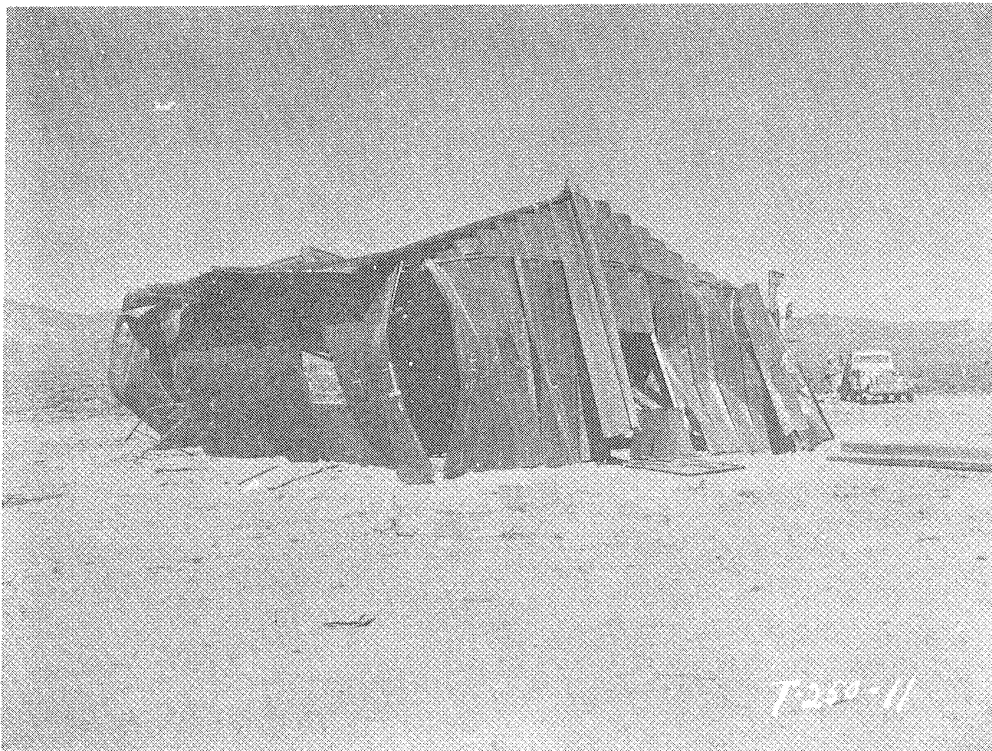
Fig. 2.41 — East end and south side of Armco Building 31.2-d1 after planned test.

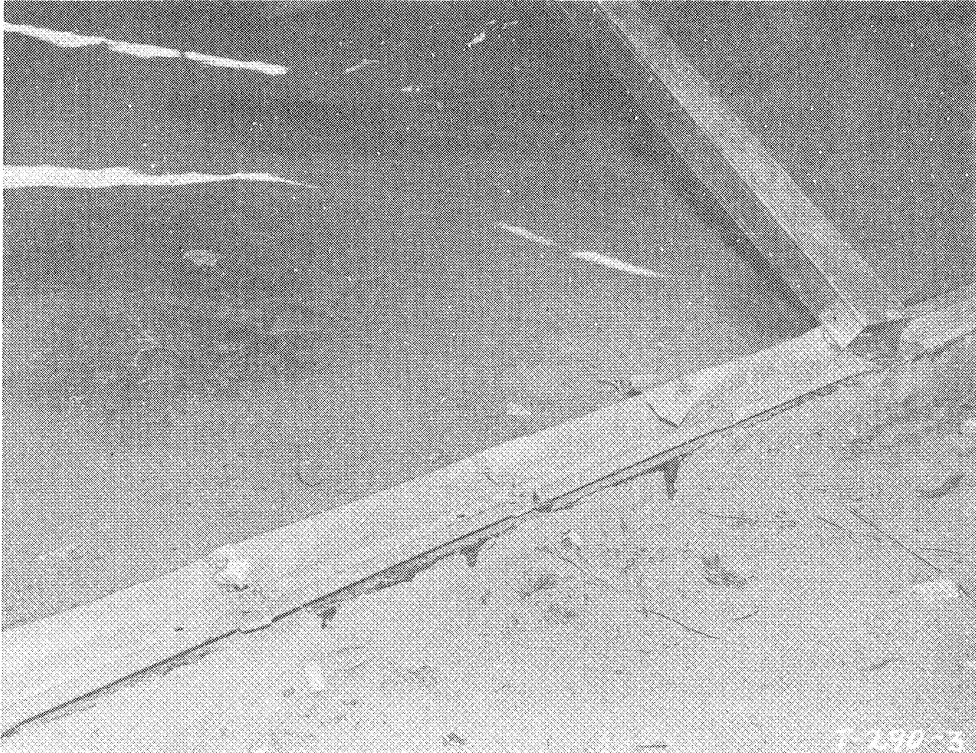
Fig. 2.42—Sill along north wall of Armco Building 31.2-d1 after planned test.

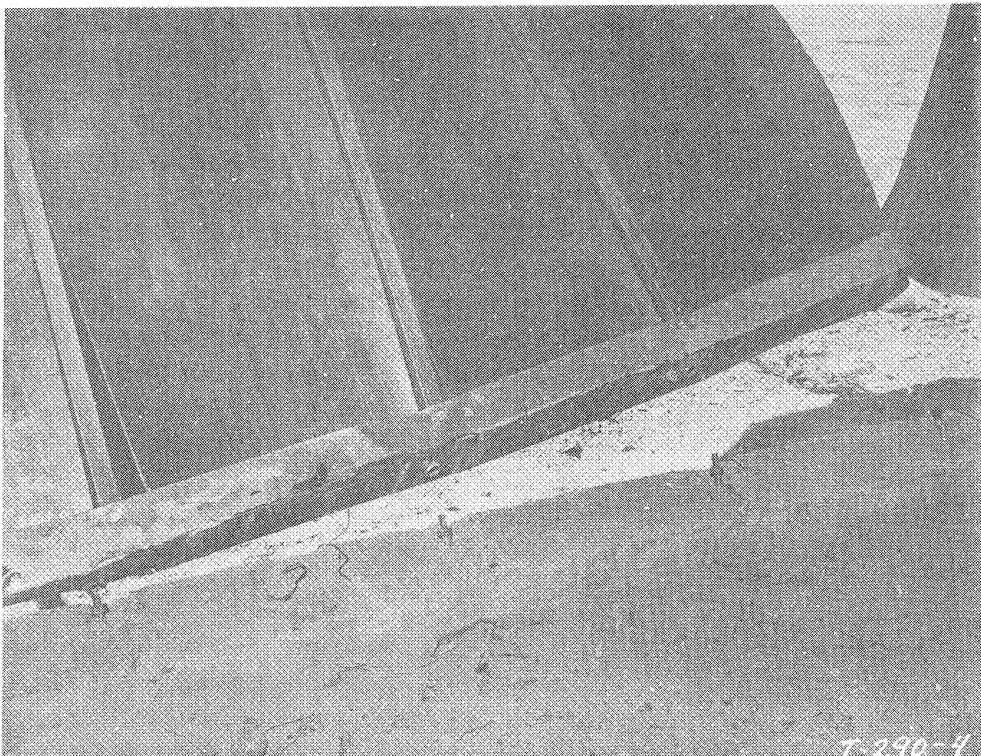
Fig. 2.43—Interior detail of sill at southwest corner of Armco Building 31.2-d1 after planned test.

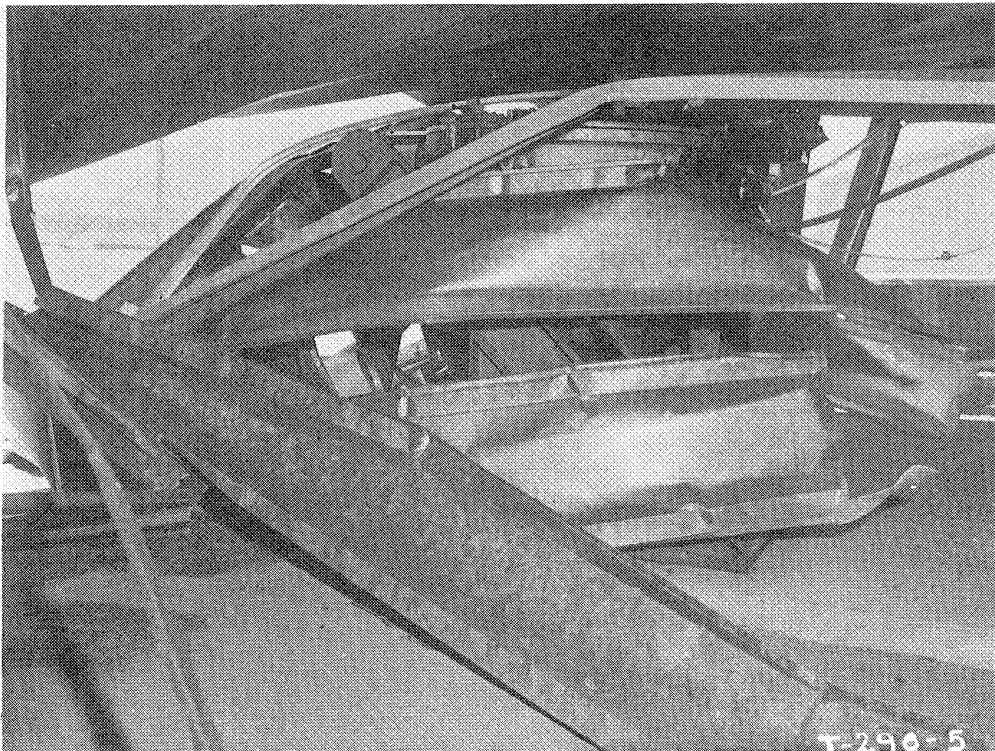
Figure 2.44 shows the inward breakage of the northeast door frame. The brittle type fracture introduced into the door frame reinforcing channel is of interest. Another interior view (Fig. 2.45) shows how the machinery blocked further downblast movement of the north panels of the building.

Fig. 2.45—Interior view of Armco Building 31.2-d1, showing front paneling draped around machinery after planned test.

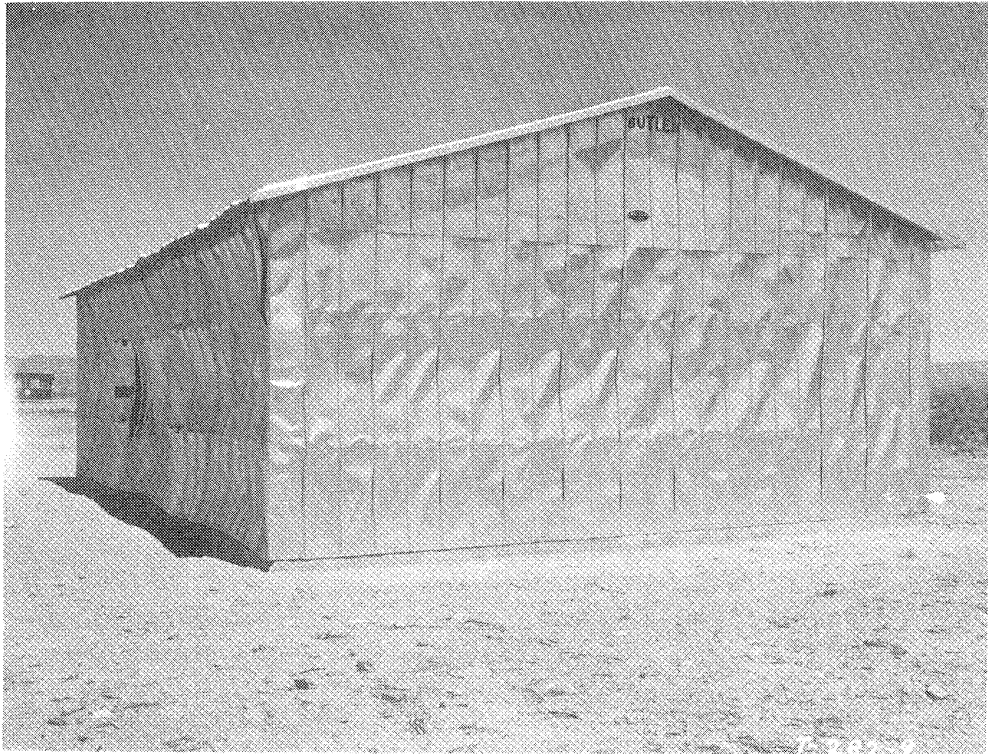
Fig. 2.48—West end of Reynolds-Butler Building 31.2-a2 after planned test.

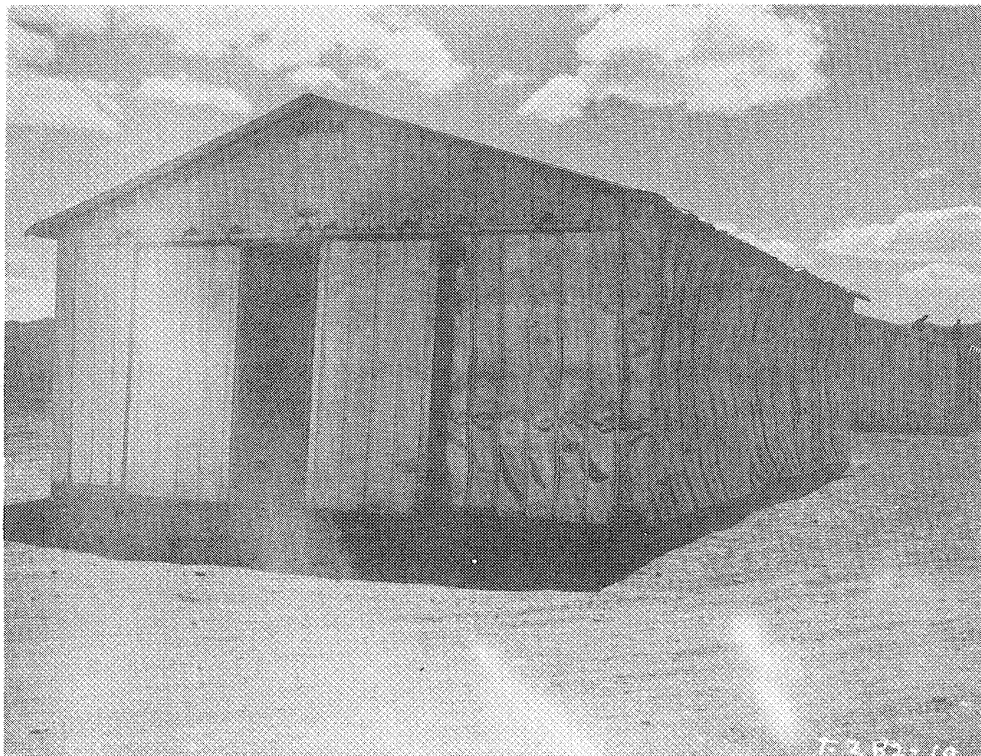
Fig. 2.49—East end of Reynolds-Butler Building 31.2-a2 after planned test.

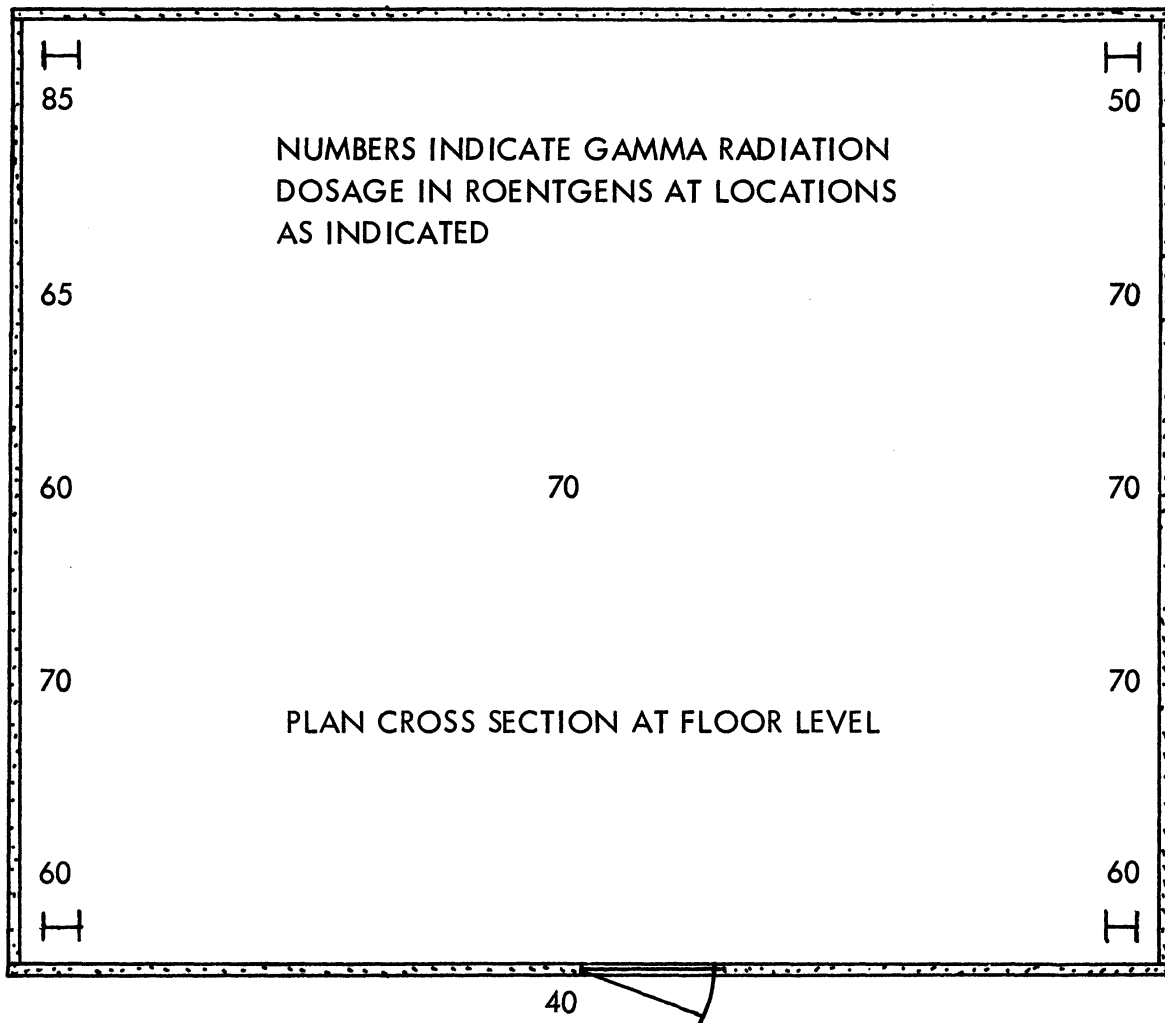
Fig. 2.54—Gamma radiation measurements in Union Carbide building.

In the case of the Union Carbide building at 5500 ft, with 4-in. reinforced-gypsum walls, there were significant variations in film-badge readings. A vertical cross section running north and south at the center line of this building and a horizontal cross section at floor level are shown in Fig. 2.54. The only reading not recorded in Fig. 2.54 is one on the outside center line of the east wall at about mid-height of the building which gave a reading of 80 r. The gauge near ground level at the same location had a reading of 45 r, as shown. The reduction in radiation levels behind the structure, as compared with those in front of the structure, is quite significant.
