RUPTURE PROPERTIES OF 2-1/4 Cr - 1 Mo, CMo, 3 Cr - 1 Mo, AND TYPE
347 STAINLESS STEEL PIPES FROM ESSEX, SEWAREN, BURLINGTON AND
KEARNY GENERATING STATIONS OF THE PUBLIC SERVICE ELECTRIC AND
GAS COMPANY

A. I. Rush

J. W. Freeman

July 18, 1955

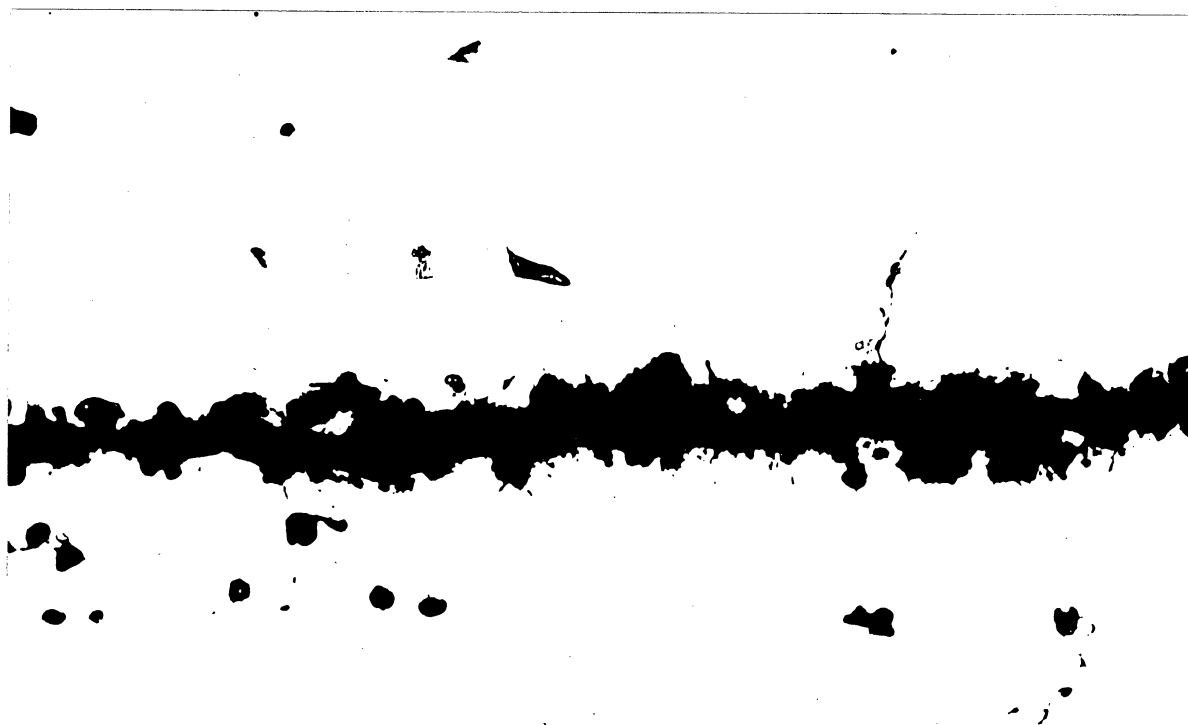
X1000D - Unetched

During the sectioning to obtain test bars, it was noted that the 8-inch full ring had circumferential cracks visible to the eye parallel to the length of the pipe and approximately in the center of the wall. Consequently, care was exercised to avoid the cracked area in removing test coupons.

tion of the defect detected during sectioning of the pipe.

Plate 8. - Defect in Carbon-Molybdenum Steel Pipe (RT-2) from Essex Generating Station, No. 7 Unit. In Service 75,054 Hours at Normal Operating Temperature of 950°F.

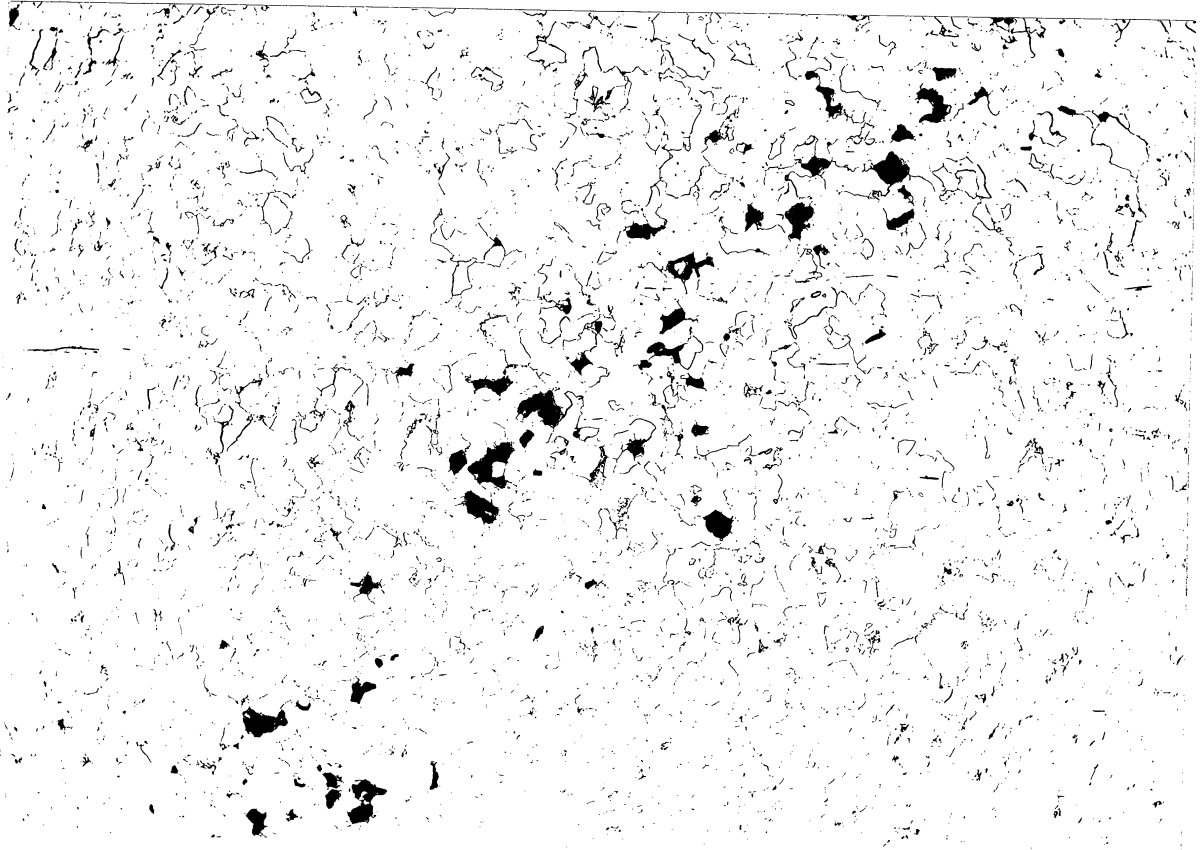
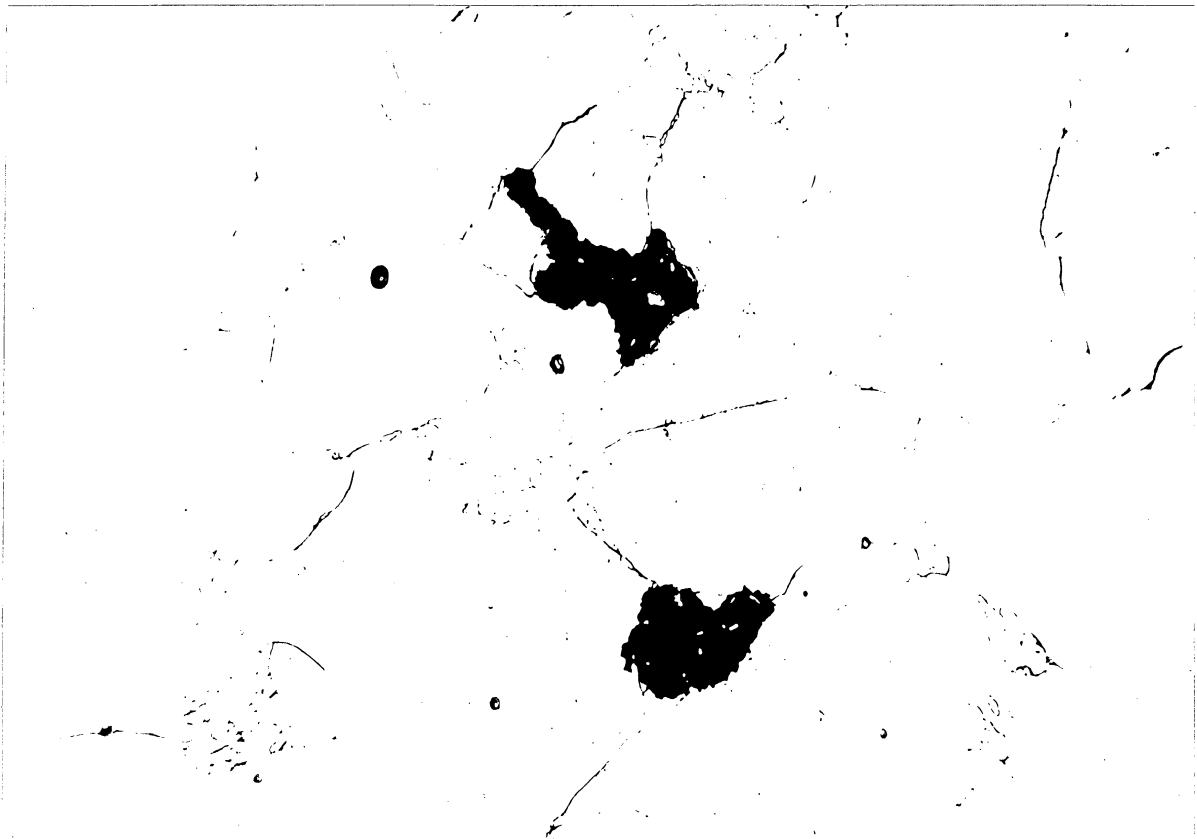
Plate 9. - Original Microstructure of Carbon-Molybdenum Steel Pipe (RT-3) from Essex Generating Station, No. 26 Boiler Steam Lead. In Service 81,536 Hours at Normal Operating Temperature of 950°F.

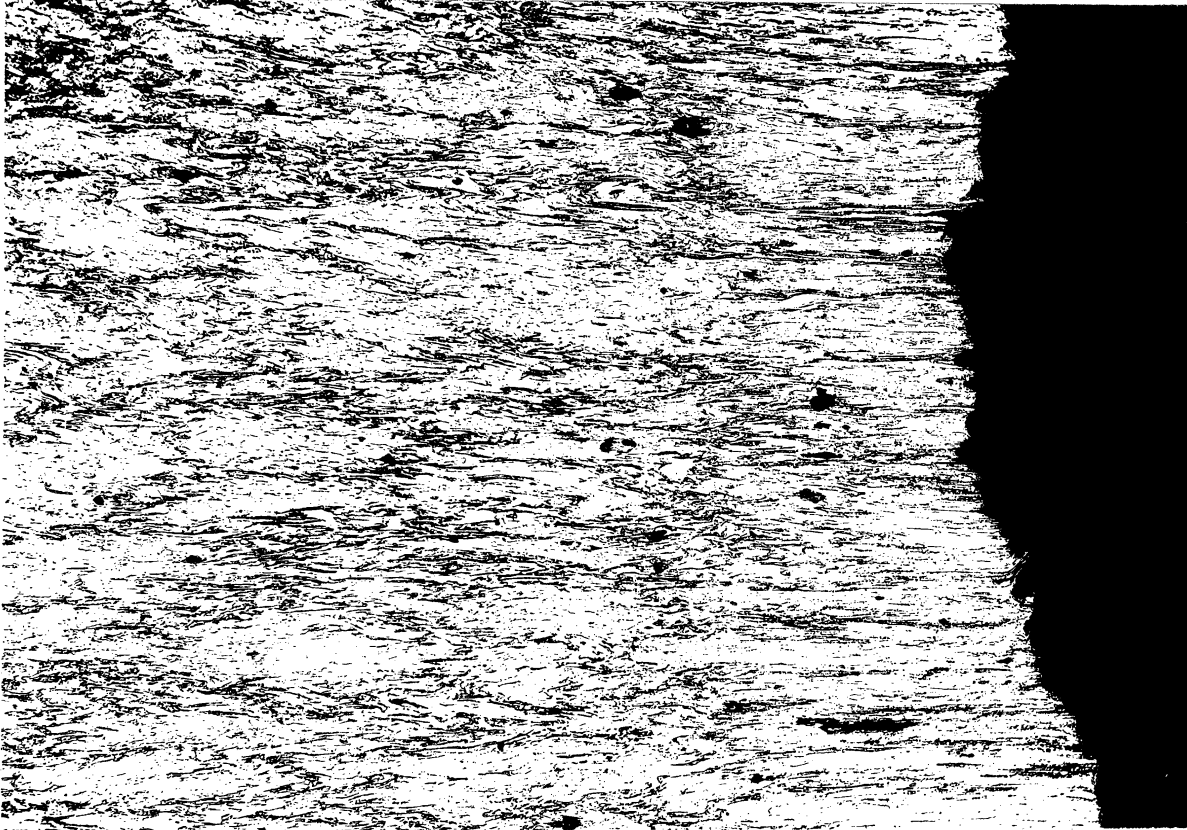
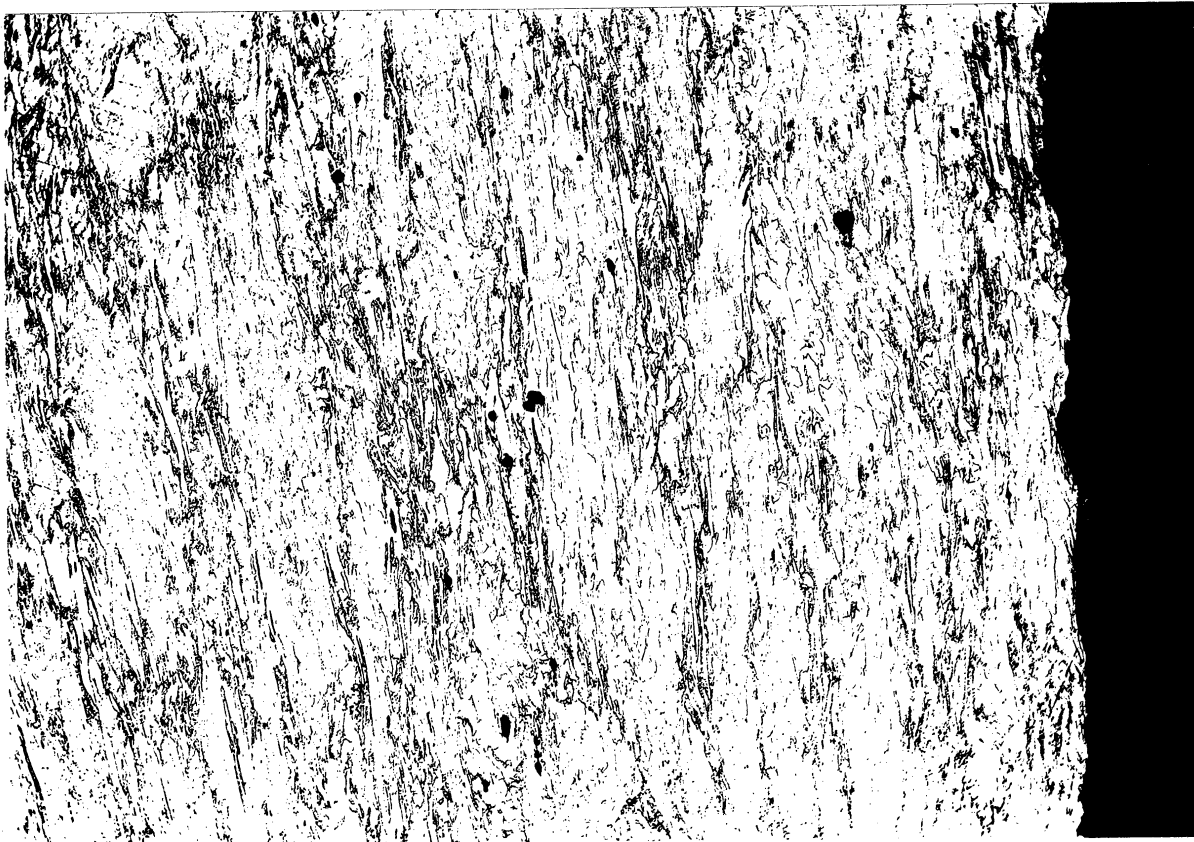
Plates 15 and 16 show that the fractures were transgranular through highly elongated grains. There was no evidence of intergranular cracking or oxidation. The structures were in accordance with the normal characteristics of 3Cr - 1Mo steel with the initial structure observed.

Plate 15. - Microstructure of Stress-Rupture Specimen from 3 Cr - 1 Mo Steel Pipe (RT-4) Fractured in 780 Hours Under 17,000 Psi at 1050°F.

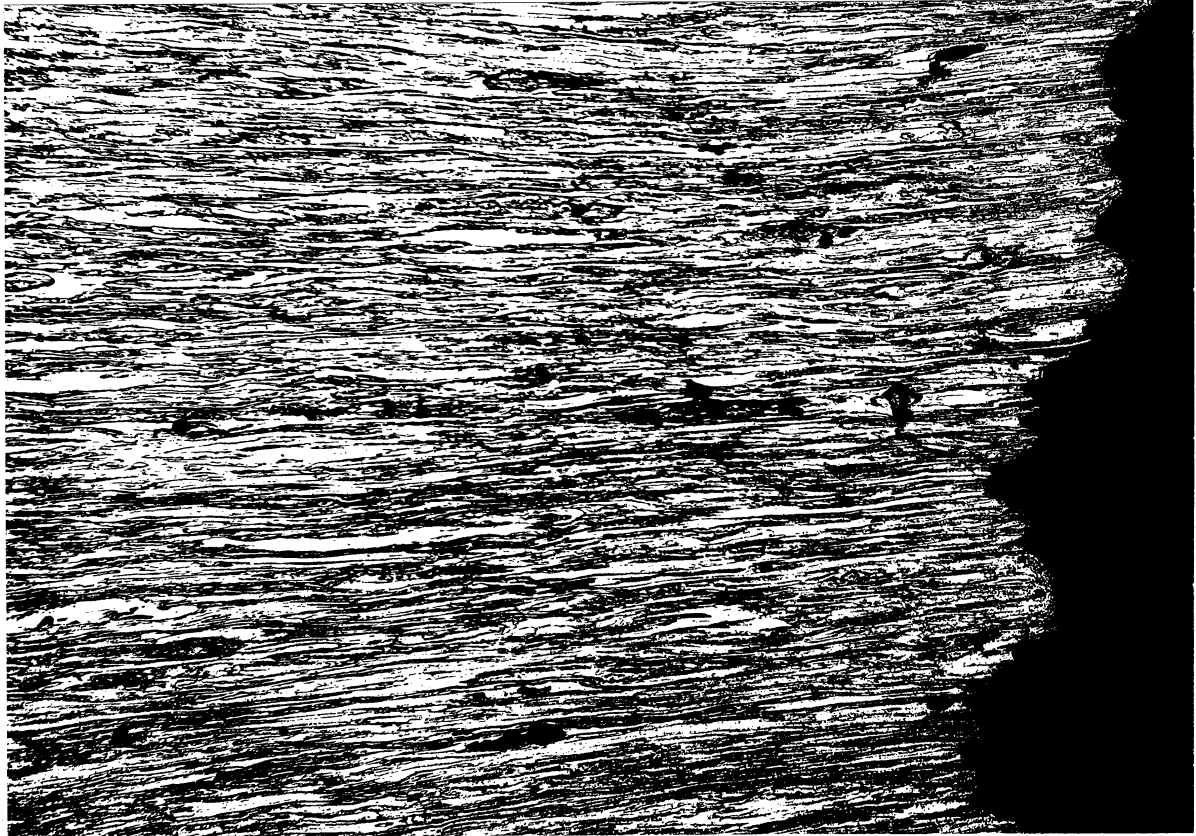
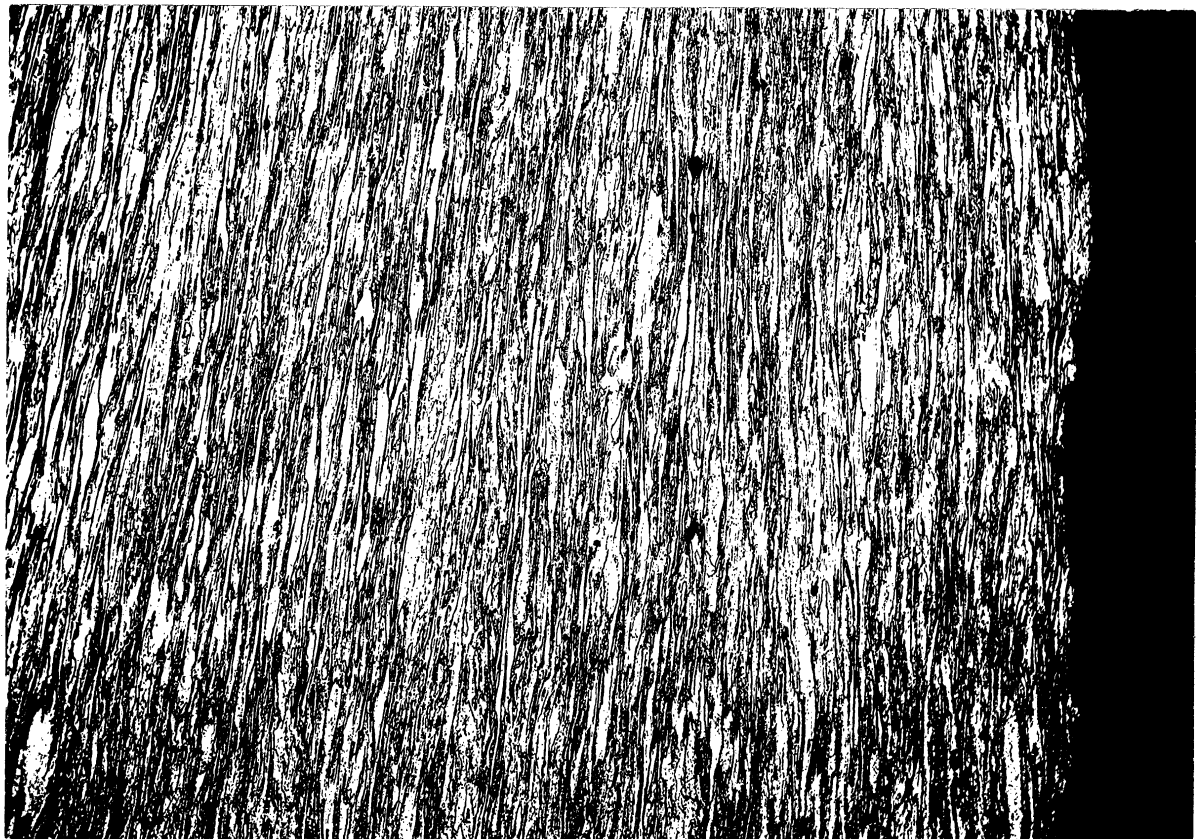
Plate 16. - Microstructure of Stress-Rupture Specimen from 3 Cr - 1 Mo Steel Pipe (RT-4) Fractured in 1108 Hours Under 12,500 Psi at 1100°F.

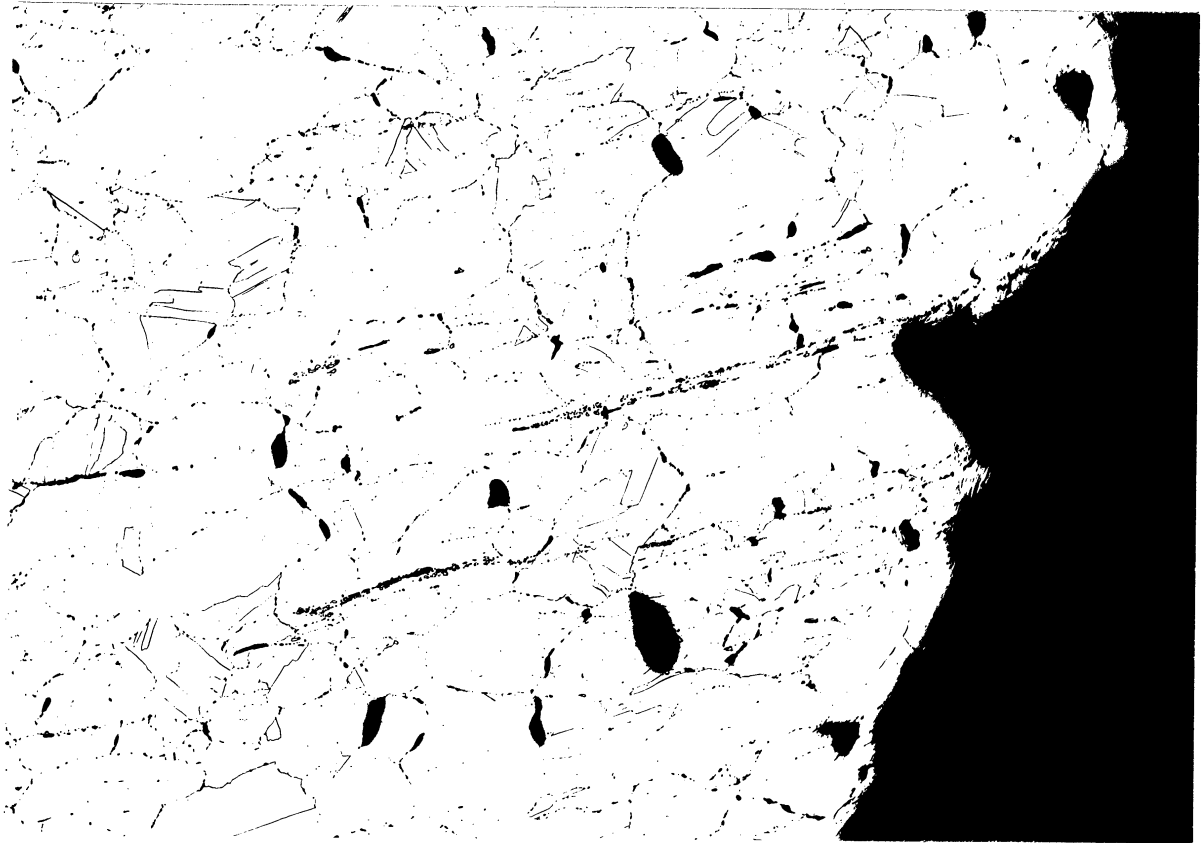
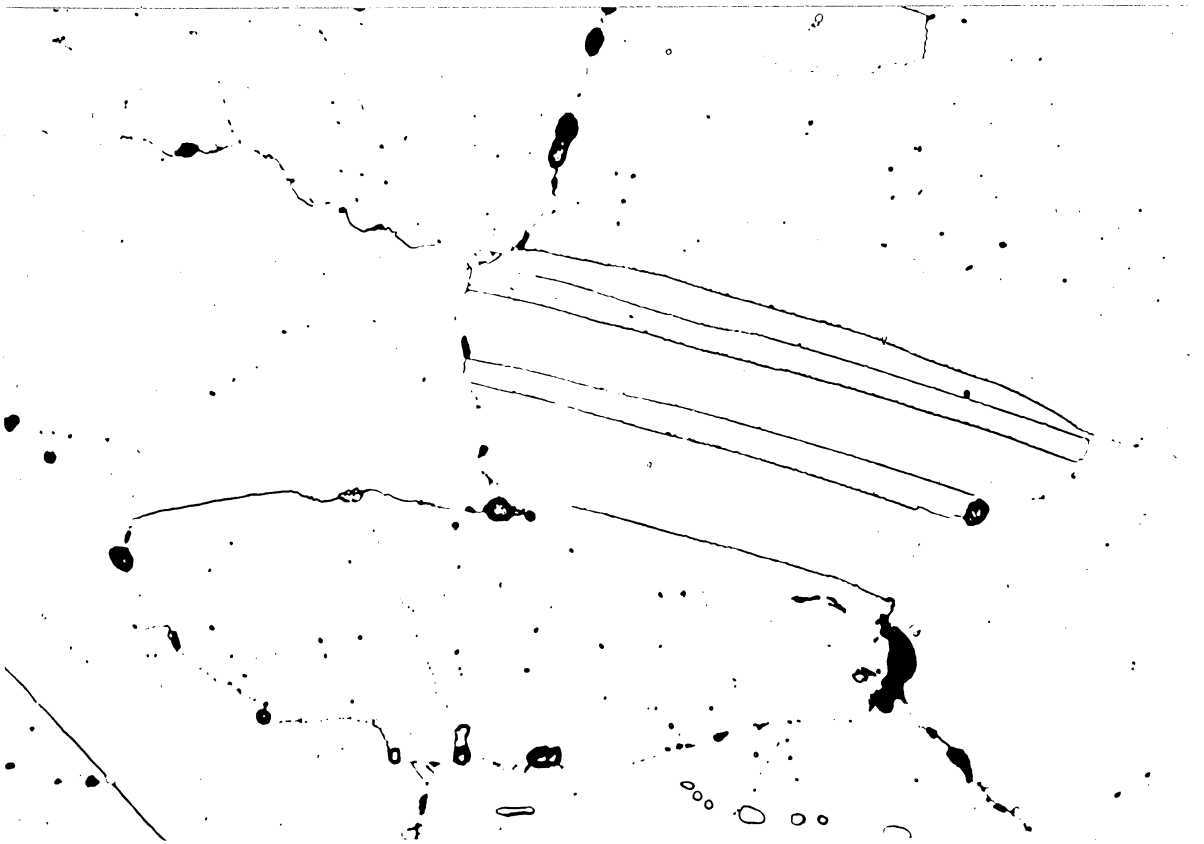
tion for the unwelded sample RT5. However, the photomicrographs of the fractured specimens, Plates 21 and 22, show that apparently the grain size was somewhat variable since Plate 21 indicates a grain size of about 2 to 4 and Plate 22 shows a grain size of 3 to 5.

Plate 21. - Microstructure of 18-8 + Cb Steel Pipe (RT-6) Fractured in 708 Hours Under a Stress of 33,000 Psi at 1050°F.

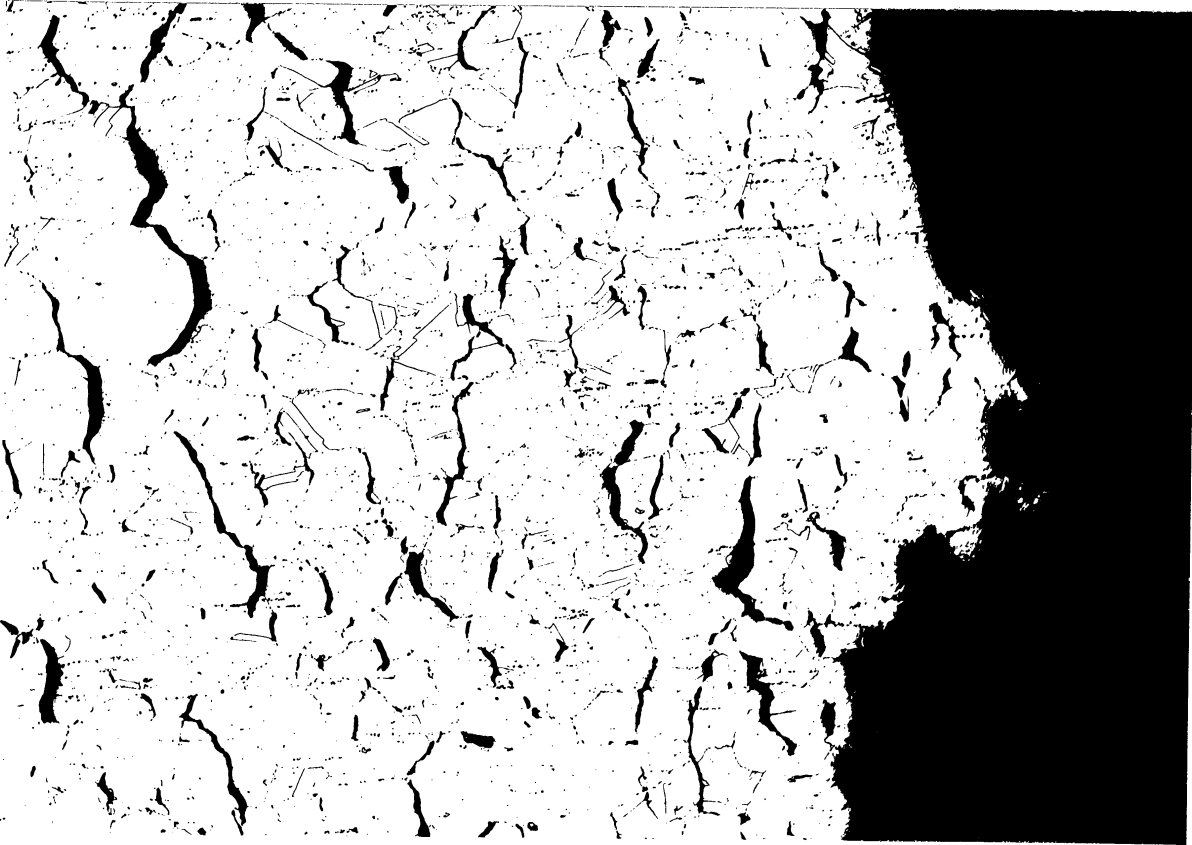
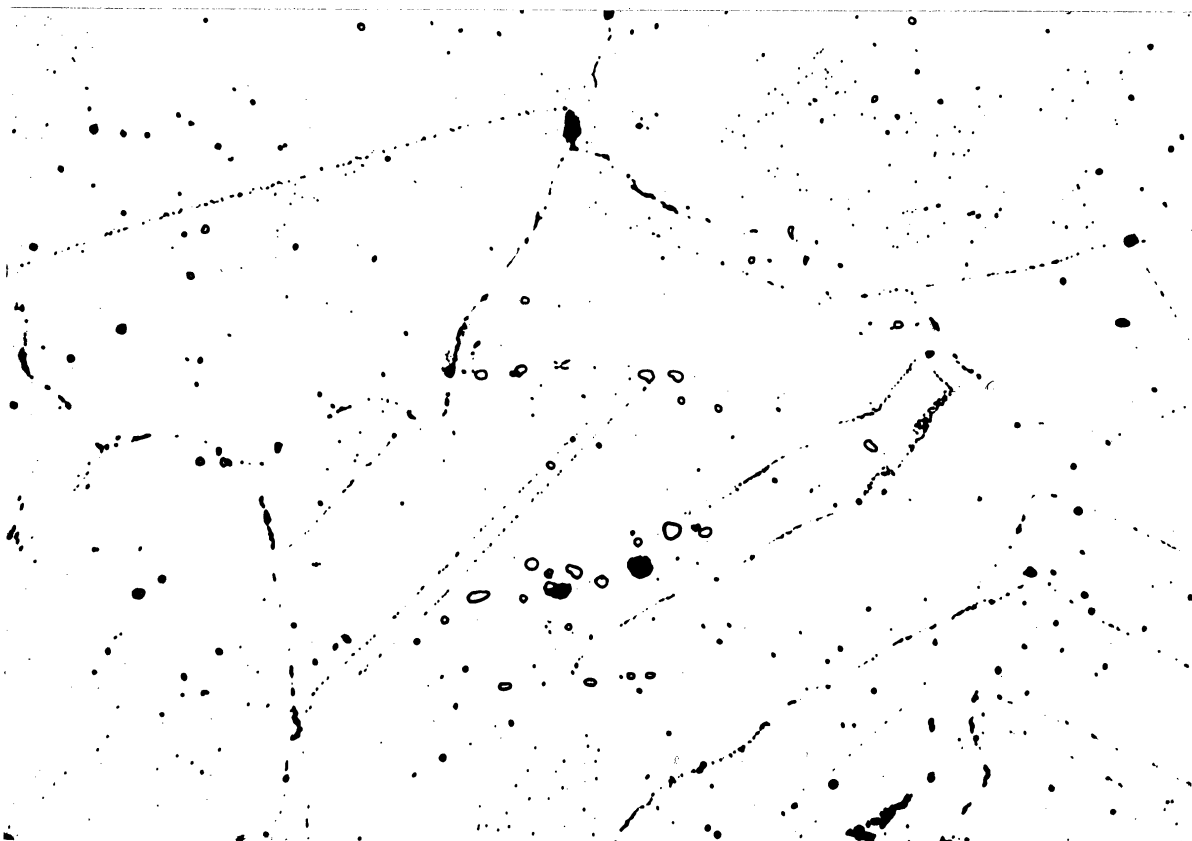
Plate 22. - Microstructure of 18-8 + Cb Steel Pipe (RT-6) Fracture in 1,444 Hours Under a Stress of 27,000 Psi at 1100°F.

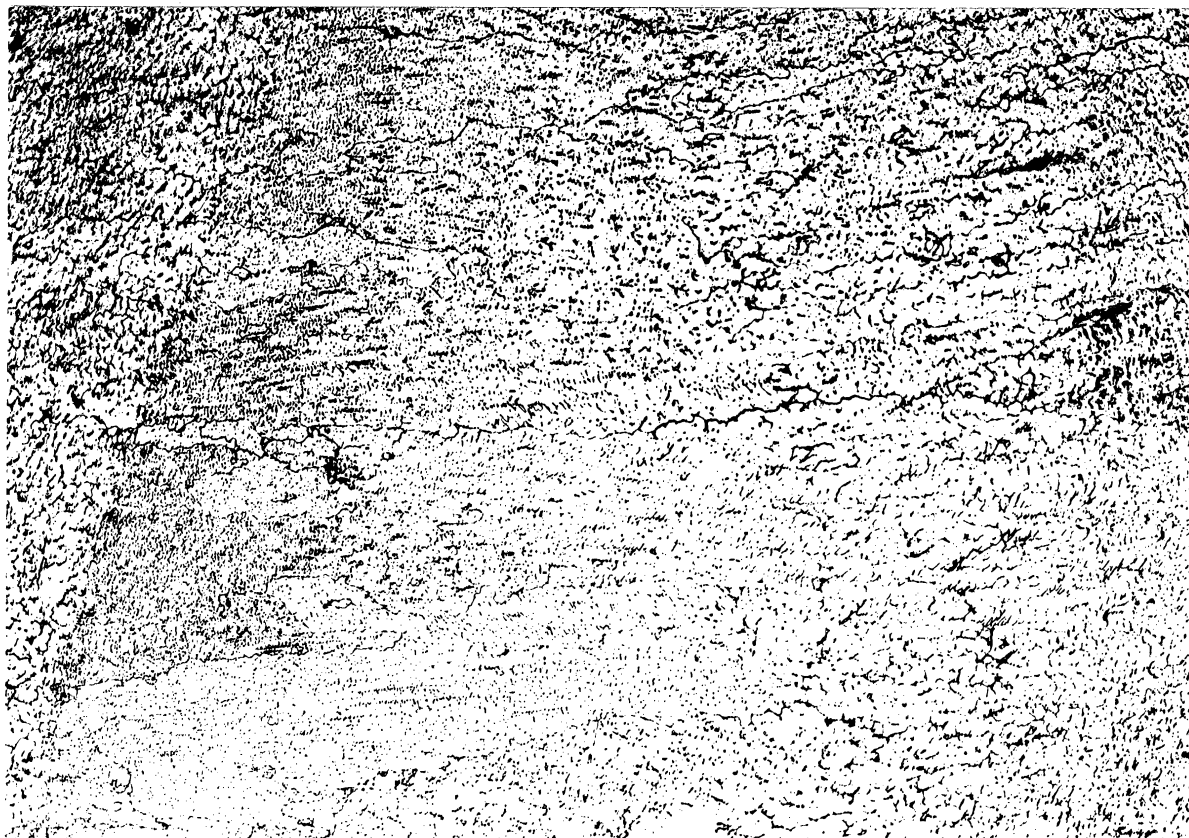
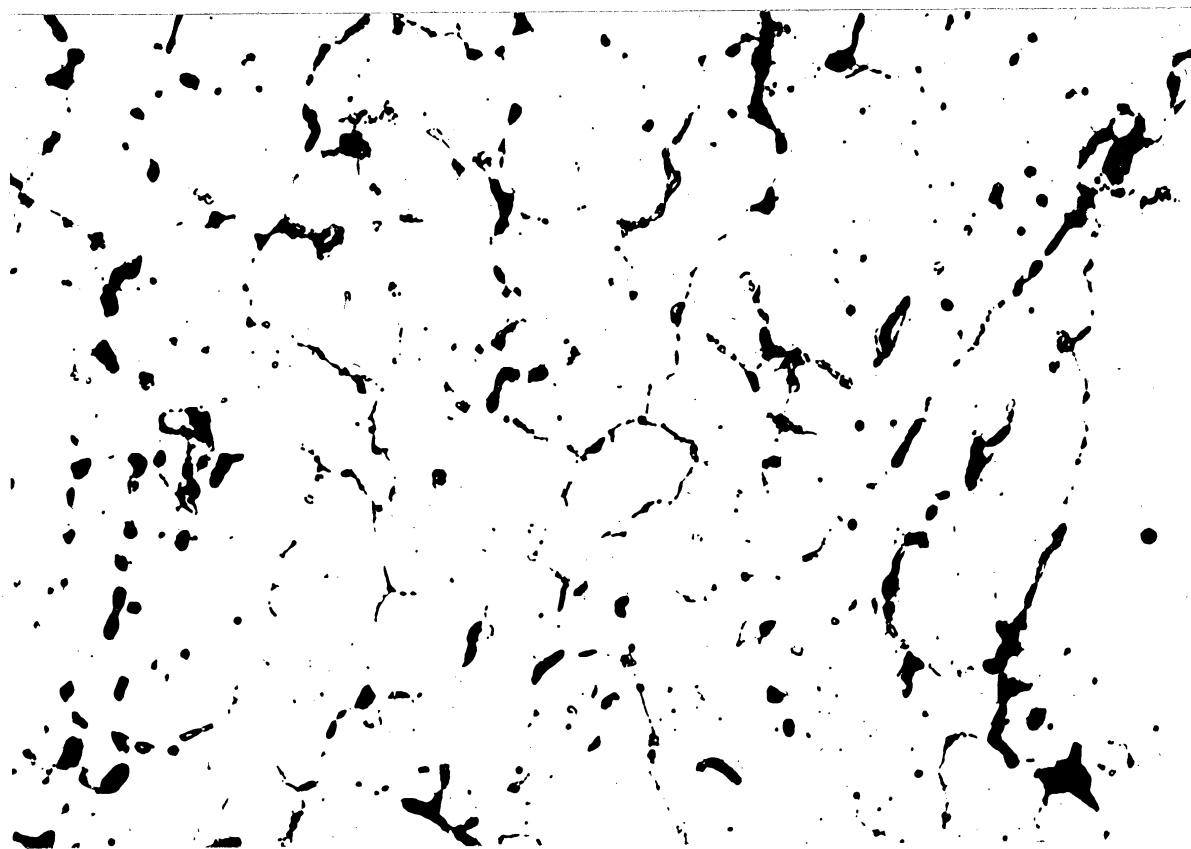
Plates 23 and 24 illustrate the appearance of the weld metal and heat-affected zone, respectively, in the as-received condition. These plates show the presence of a rather heavy precipitate in the grain boundaries of the weld metal. The precipitate appears to be sigma phase although this supposition has not been verified.

Plate 23. - As-Received Microstructure of Weld Metal of Welded Sample of 18-8 + Cb Steel Pipe (RT-6) after 22,716 Hours Service at 1050°F at the Sewaren Generating Station.

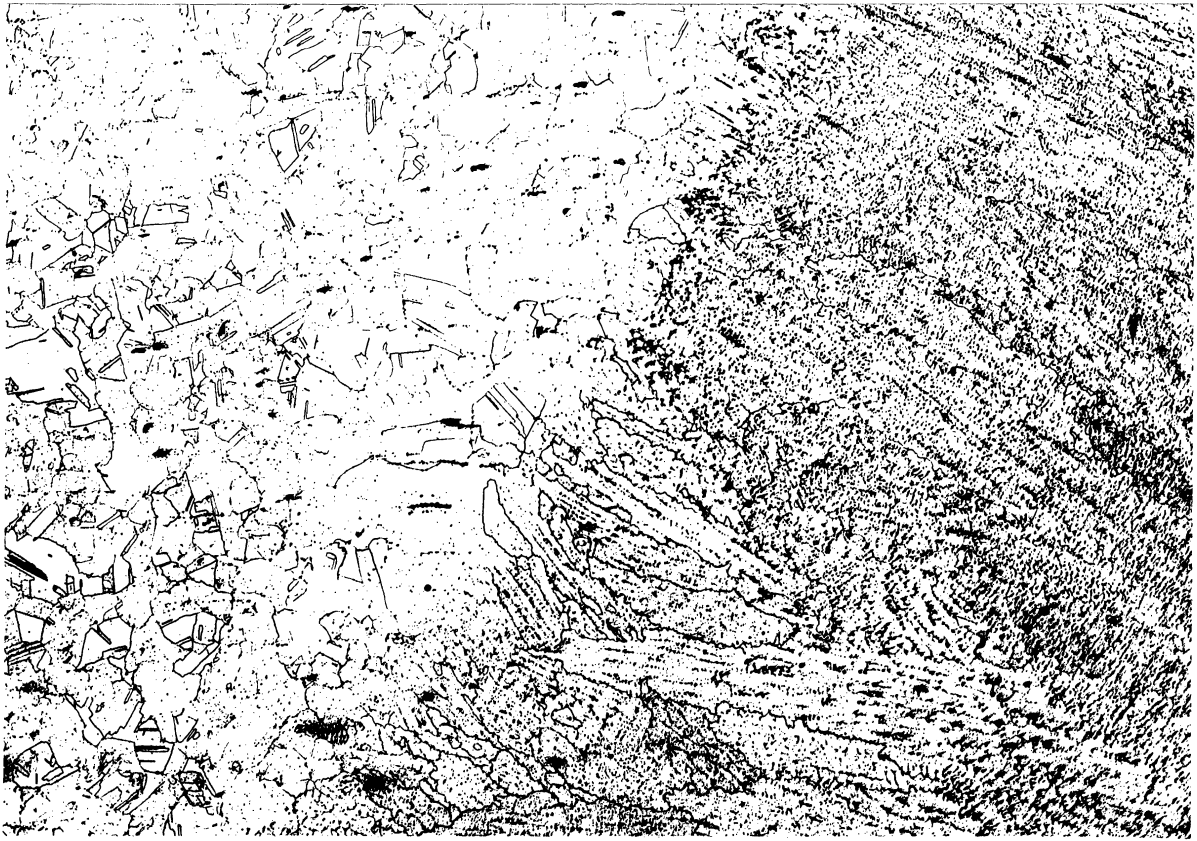
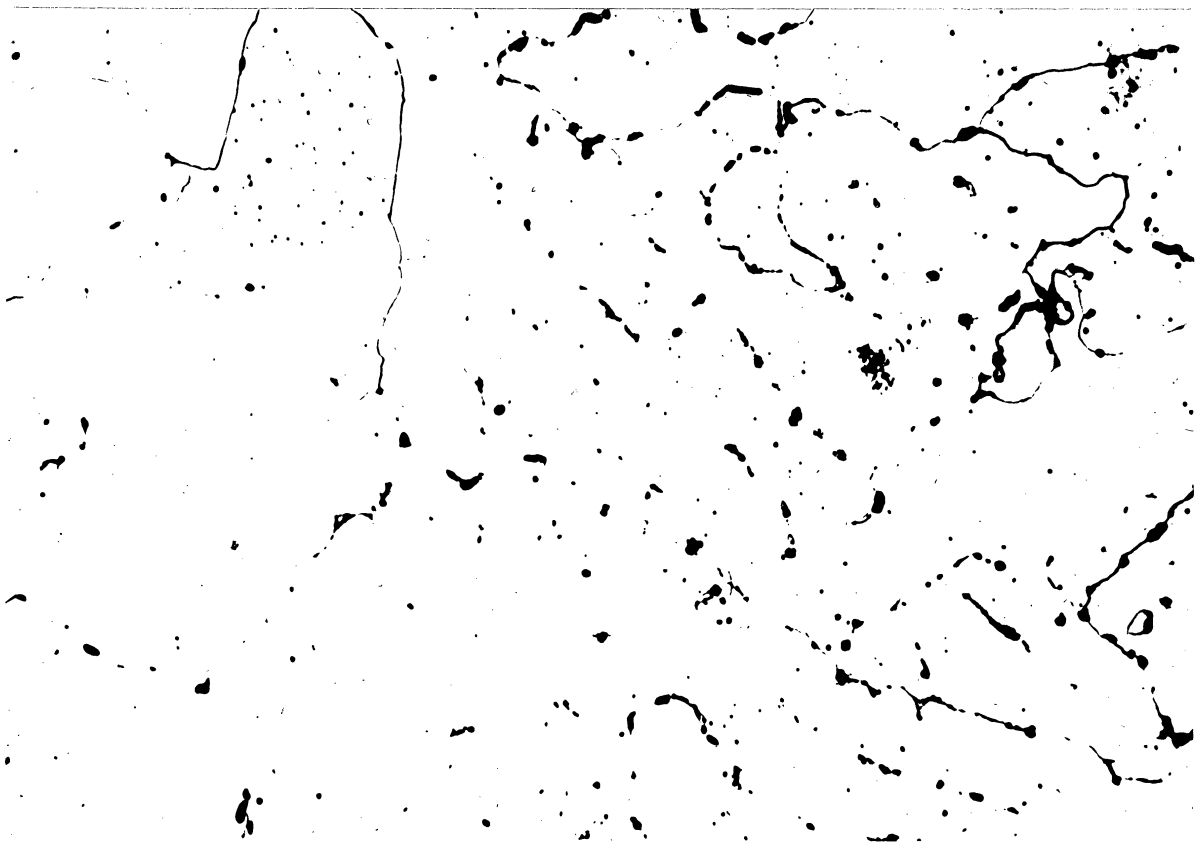
Plate 24. - As-Received Microstructure of Heat-Affected-Zone of Weld in 18-8 + Cb Steel Pipe (RT-6) after 22,716 Hours Service at 1050°F at the Sewaren Generating Station.

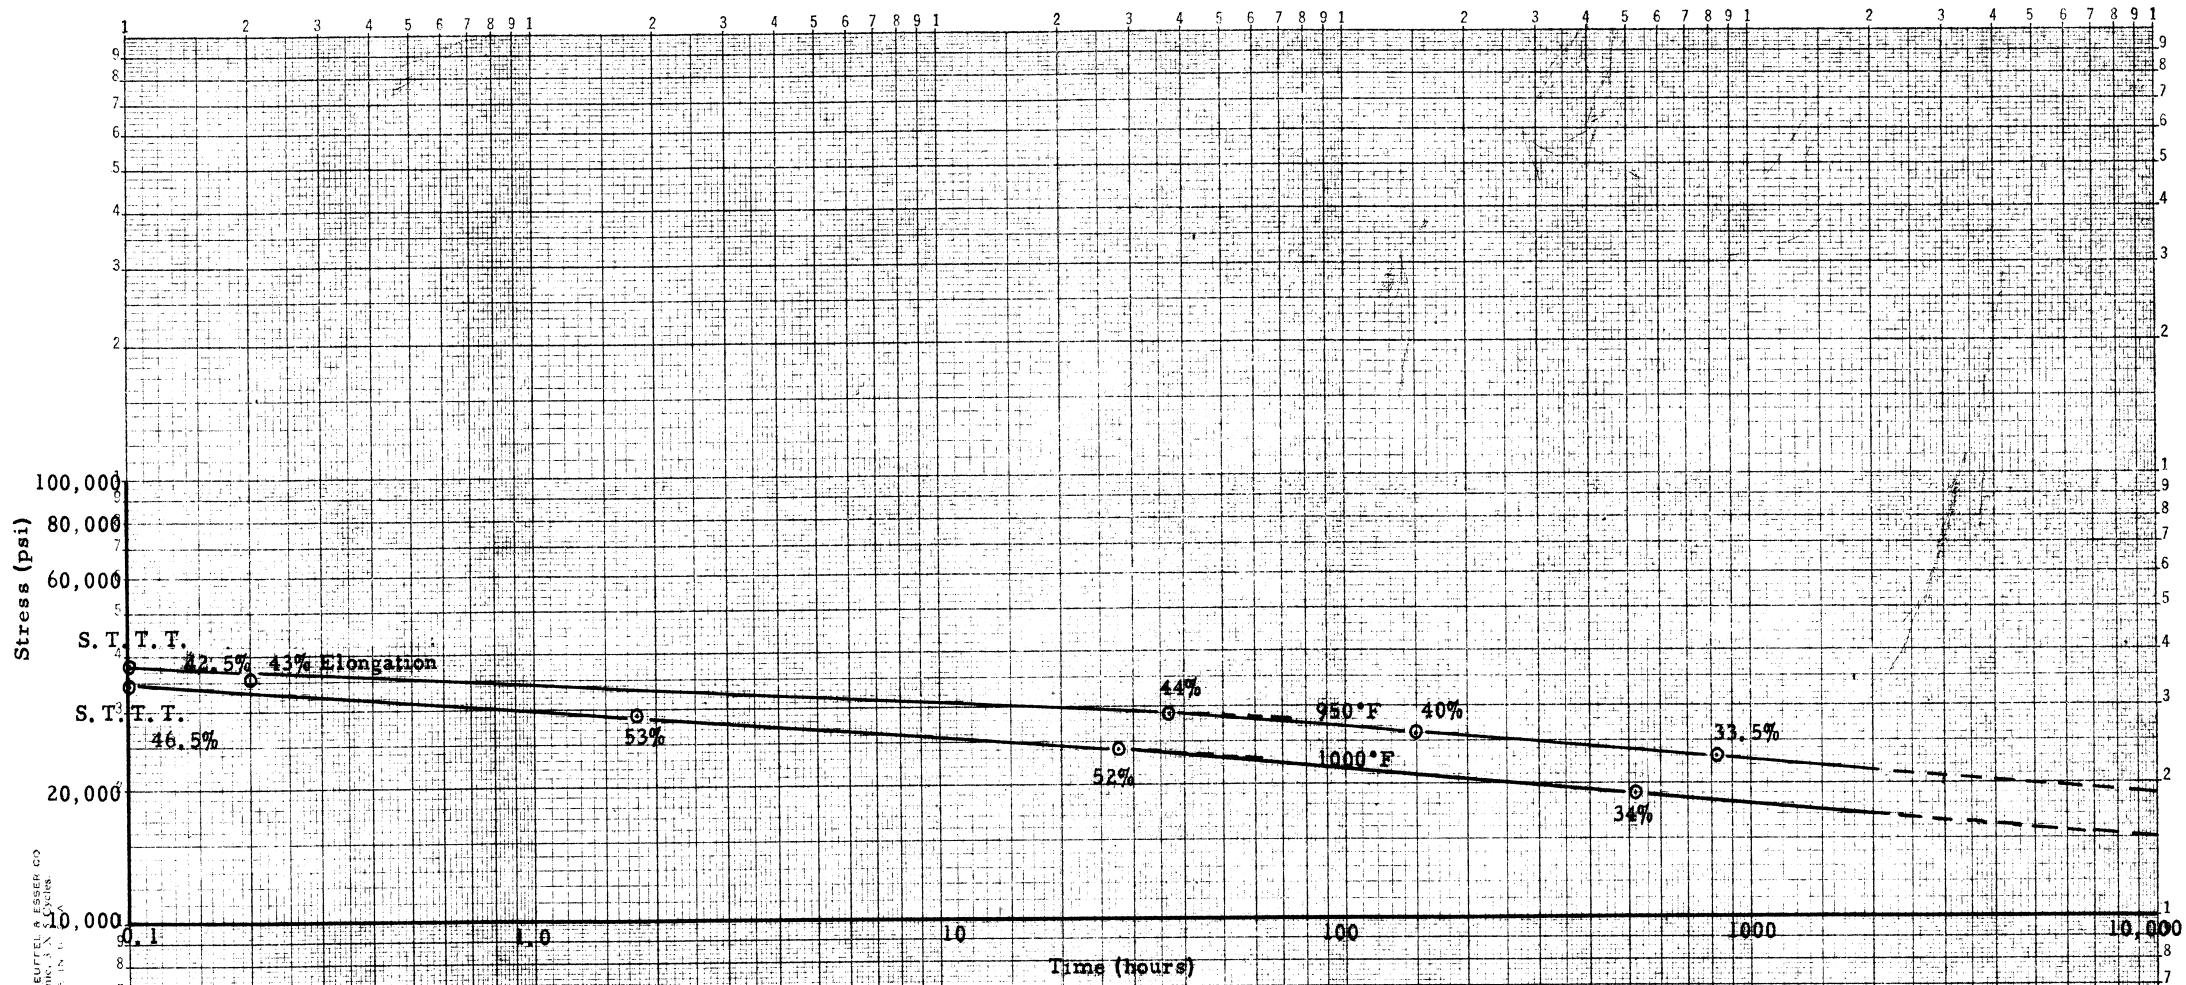
(Sample RT7)

The individual stress-rupture test data are listed in Table XIV and are plotted on logarithmic coordinates as stress-rupture time curves in Figure 11. The stress-rupture strengths for failure in 10, 100, 1000, 10,000 and 100,000 hours derived from these curves are shown in Table XV.

The stress-rupture time curves of Figure 11 show that the slope of both the 950° and 1000°F curves tends to increase at about 20 to 35 hours and that the curves are virtually parallel for the longer time periods. It is believed that longer duration tests would not substantially change the slope of the curves, and that, therefore, the stress-rupture strengths obtained by extrapolation to 10,000 and 100,000 hours are quite reliable.

Figure 11. Stress-Rupture Time Curves at 950° and 1000°F for C-Mn Steel Steam Pipe after 93,144 Hours of Service in the Number 5 Unit of the Burlington Generating Station.

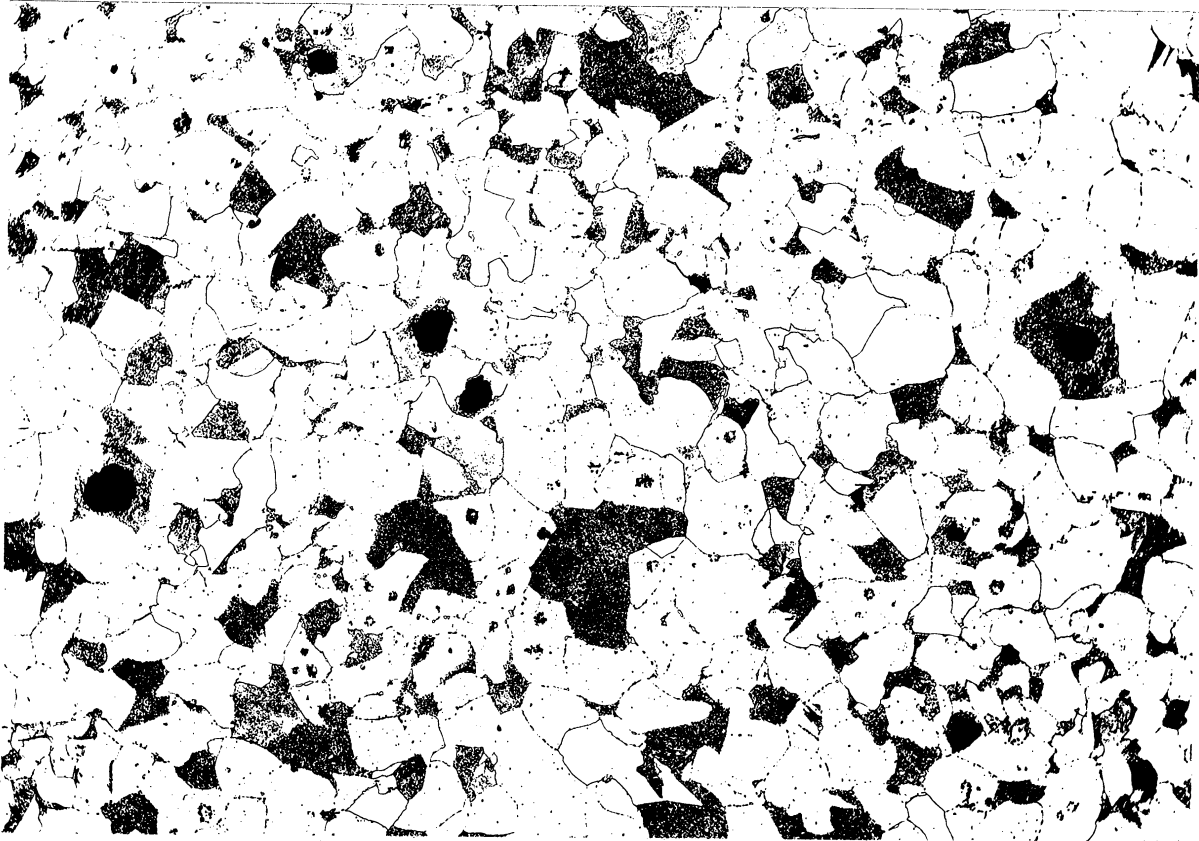
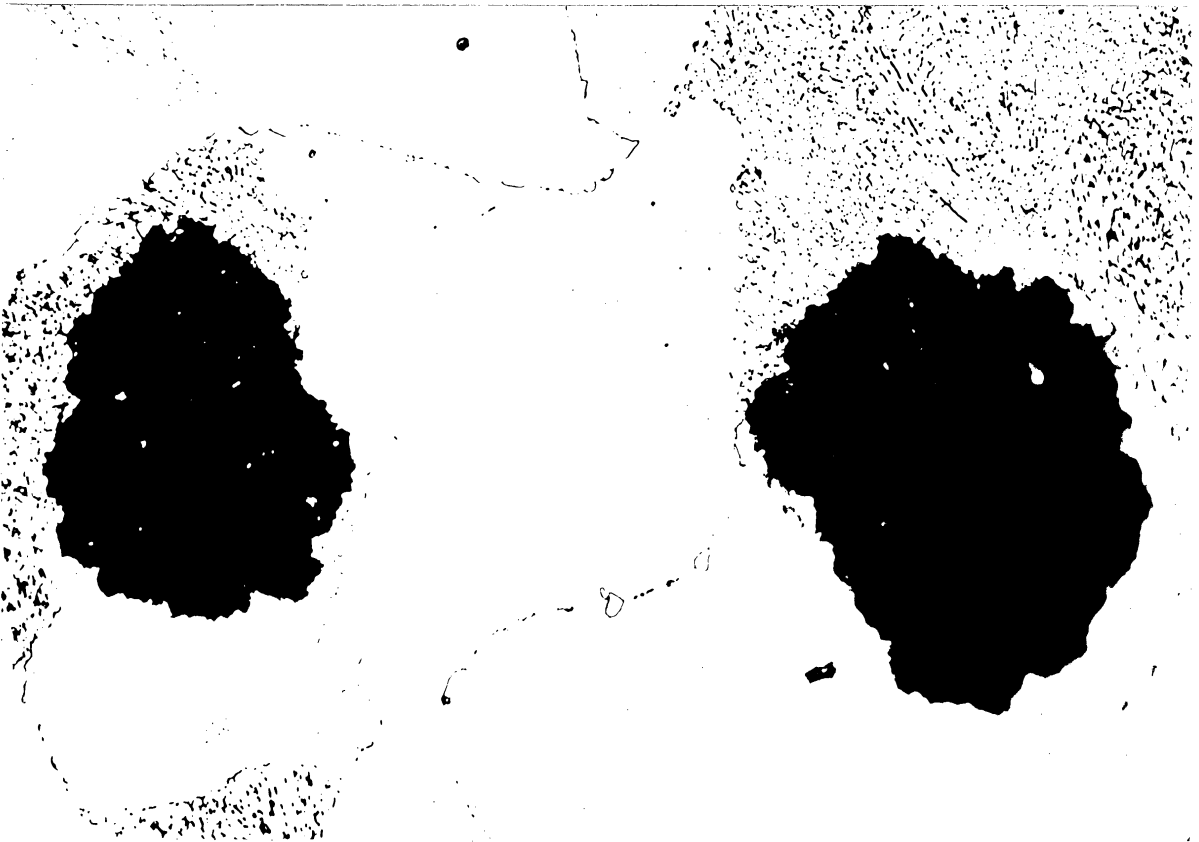
The hardness tests and microscopic examination on the as-received pipe did not reveal any evidence of non-uniformity of test material. Uniform hardness values of 123 to 127 Brinell were obtained around the circumference of the half ring. Plate 28 shows the typical as-received structure of ferrite and finely spheroidized pearl-

Plate 28. - As-Received Microstructure of C-Mo Steel Pipe (RT-7)
After 93,144 Hours of Service at 950°F in Burlington
Generating Station Number 5.
