RUPTURE PROPERTIES OF 2-1/4 Cr - 1 Mo, CMo, 3 Cr - 1 Mo, AND TYPE
347 STAINLESS STEEL PIPES FROM ESSEX, SEWAREN, BURLINGTON AND
KEARNY GENERATING STATIONS OF THE PUBLIC SERVICE ELECTRIC AND
GAS COMPANY

A. I. Rush

J. W. Freeman

July 18, 1955

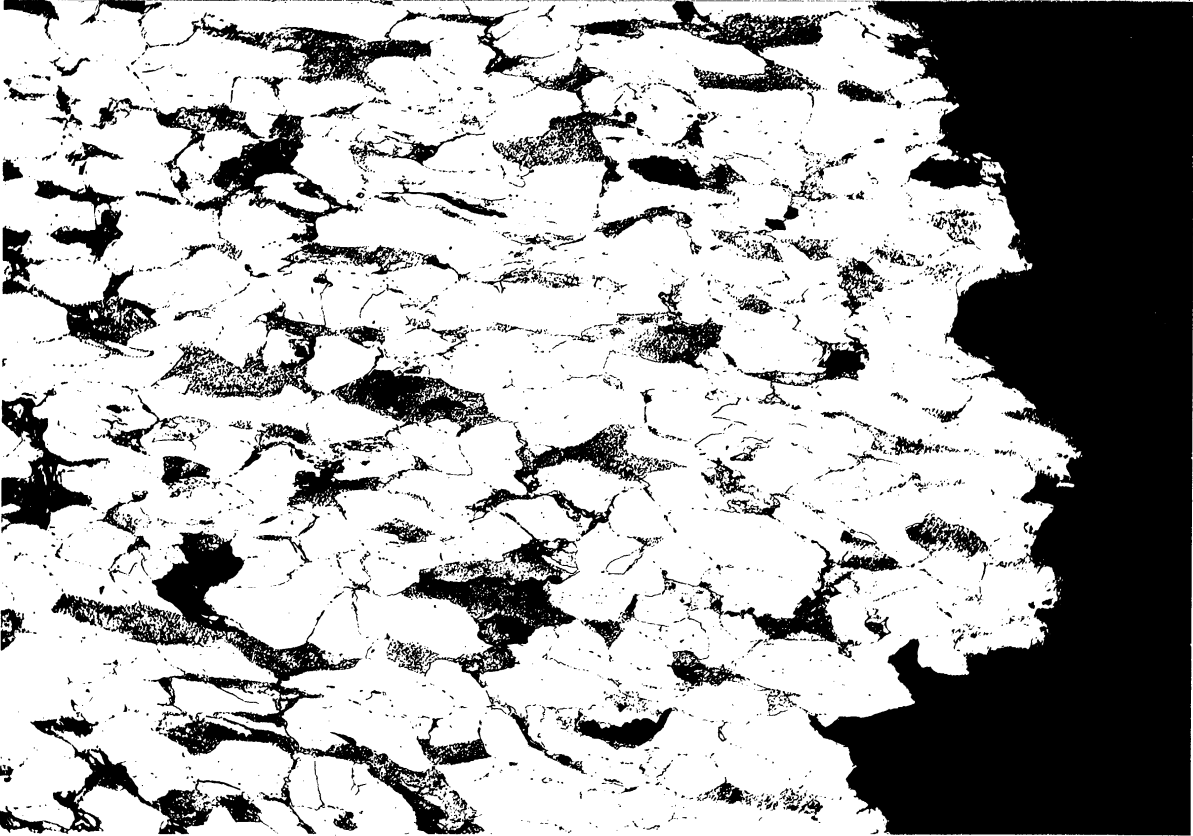
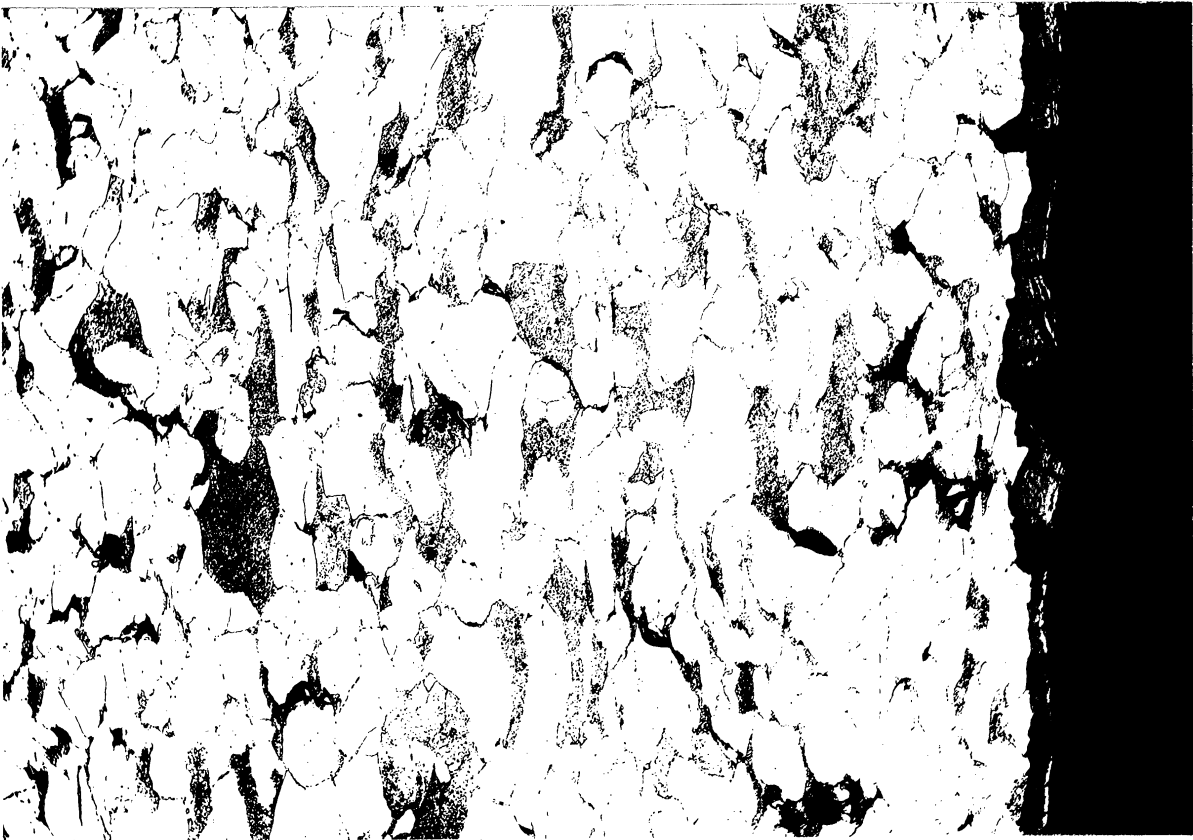
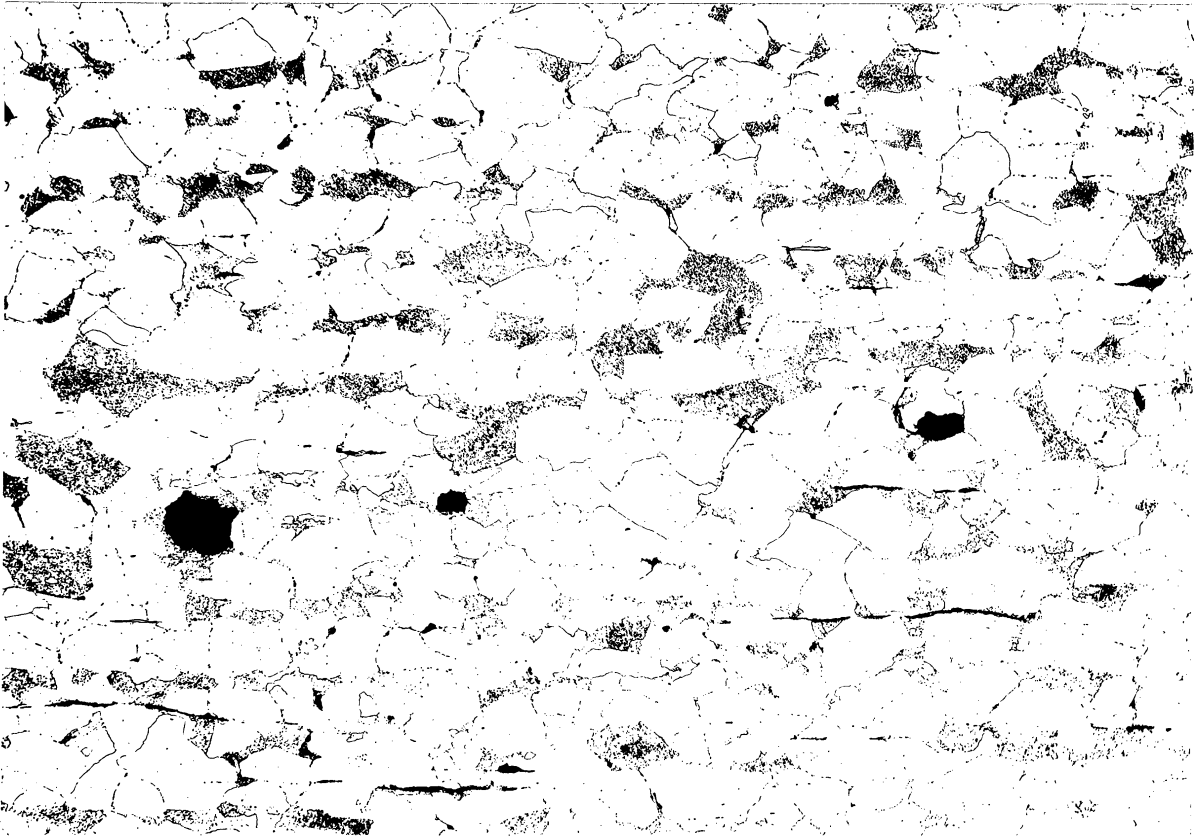
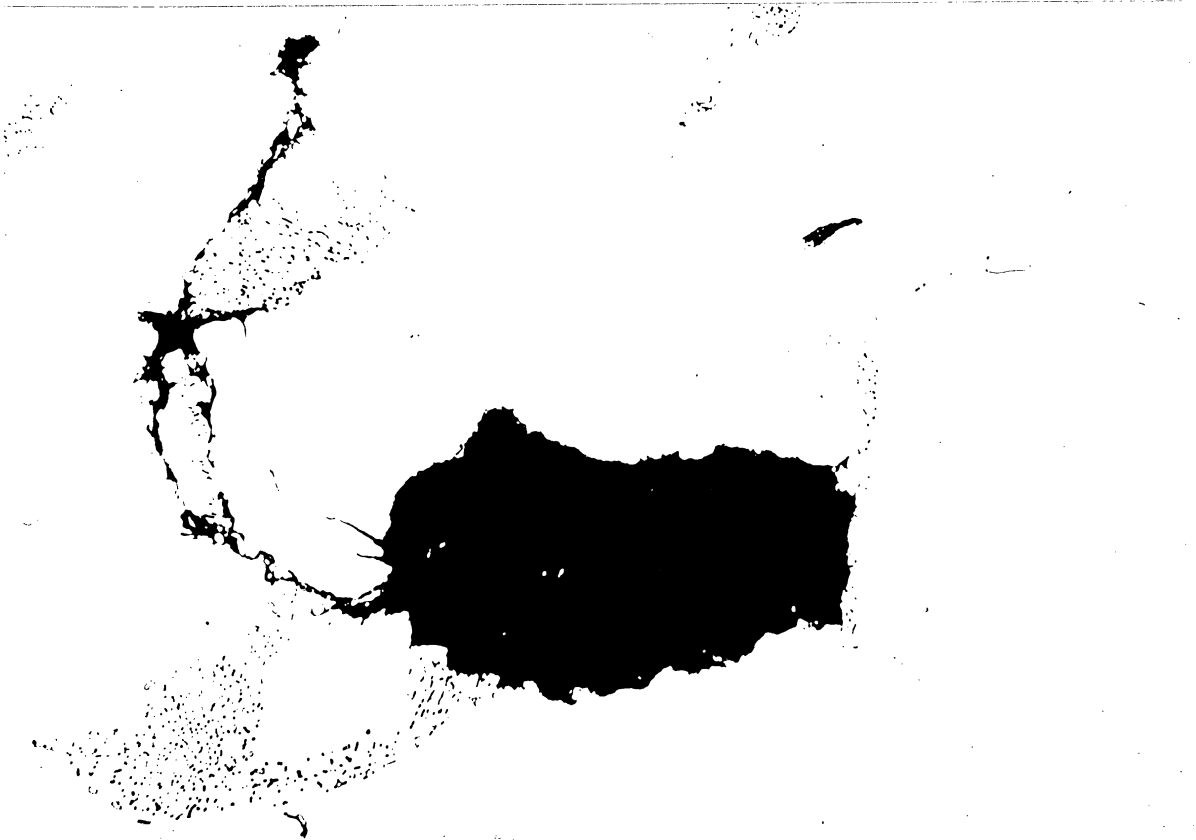
Microscopic examination of the longer time stress-rupture test specimens revealed the fractures at 950° and 1000°F to be both intergranular and transgranular in nature with considerable deformation of the grains in the direction of applied stress. The appearance of the metal in the vicinity of the fracture after testing at 1050° and 1100°F is shown in Plates 29a and b and 30 a and b, respectively. Some intergranular cracking occurred adjacent to the fracture and at the surface at both 950° and 1000°F but was more pronounced at the higher temperature. No appreciable spheroidization of the pearlite occurred during testing at either 950° or 1000°F.

The appearance of some of the nodules of graphite after testing is shown in Plates 29c and d and 30 c and d.

Plate 29. - Microstructure of C-Mo Steel Pipe (RT-7) Fractured in 820 Hours under a Stress of 23,000 Psi at 950°F.
(Continued on following page).

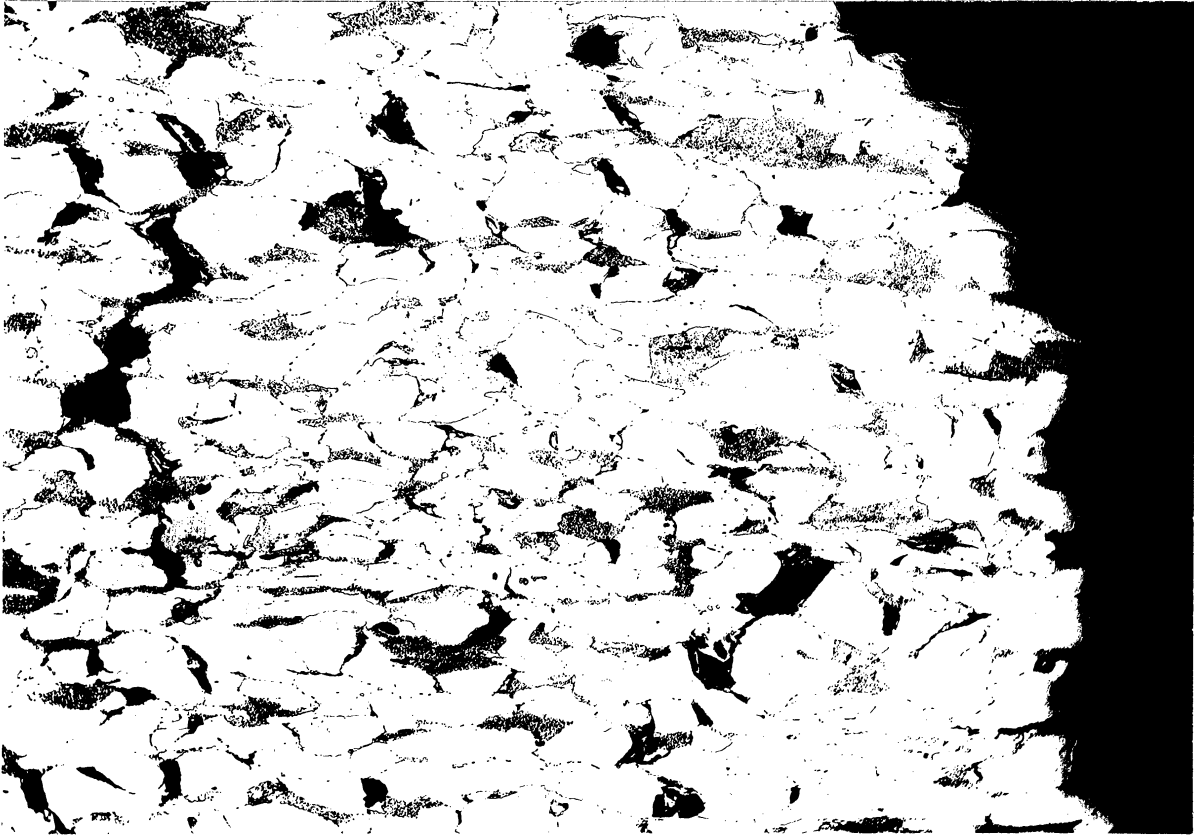
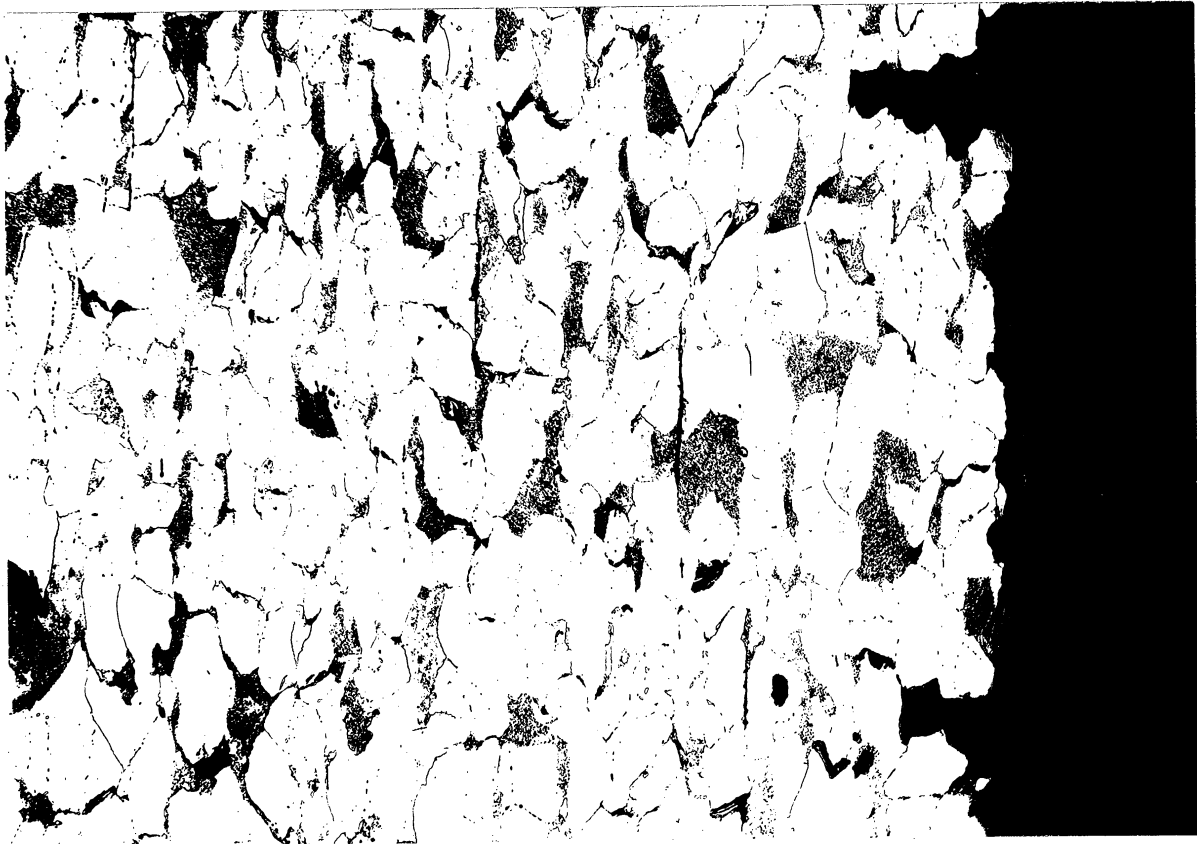
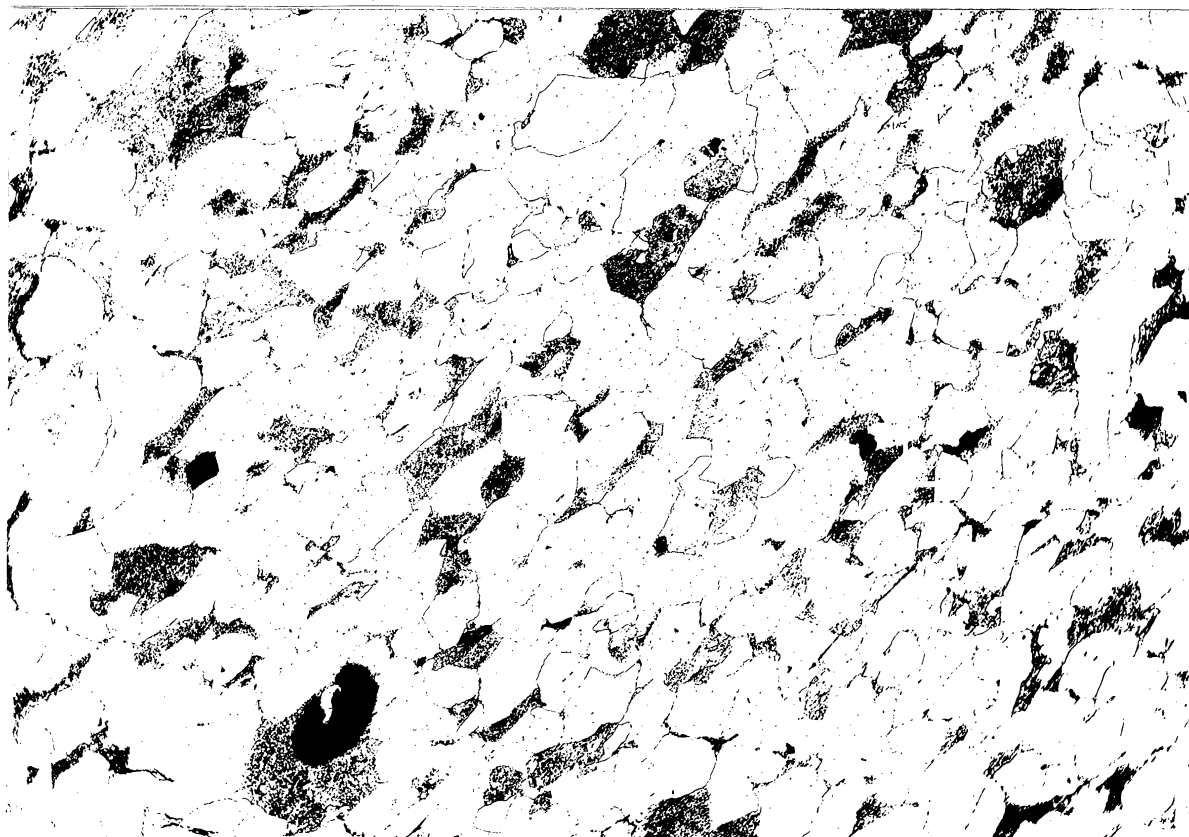
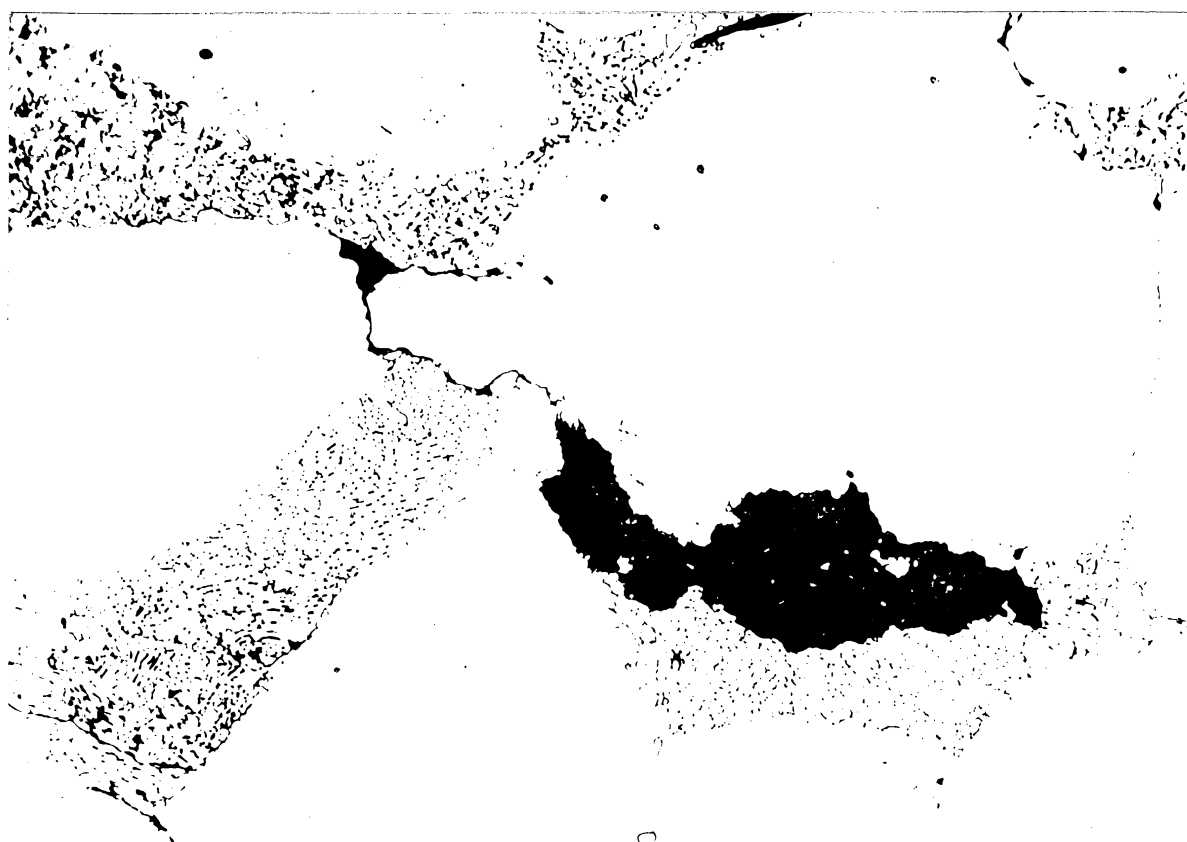
Plate 30. - Microstructure of C-Mo Steel Pipe (RT-7) after Fracture in 518 Hours Under a Stress of 19,000 Psi at 1000°F.
(Continued on following page.)

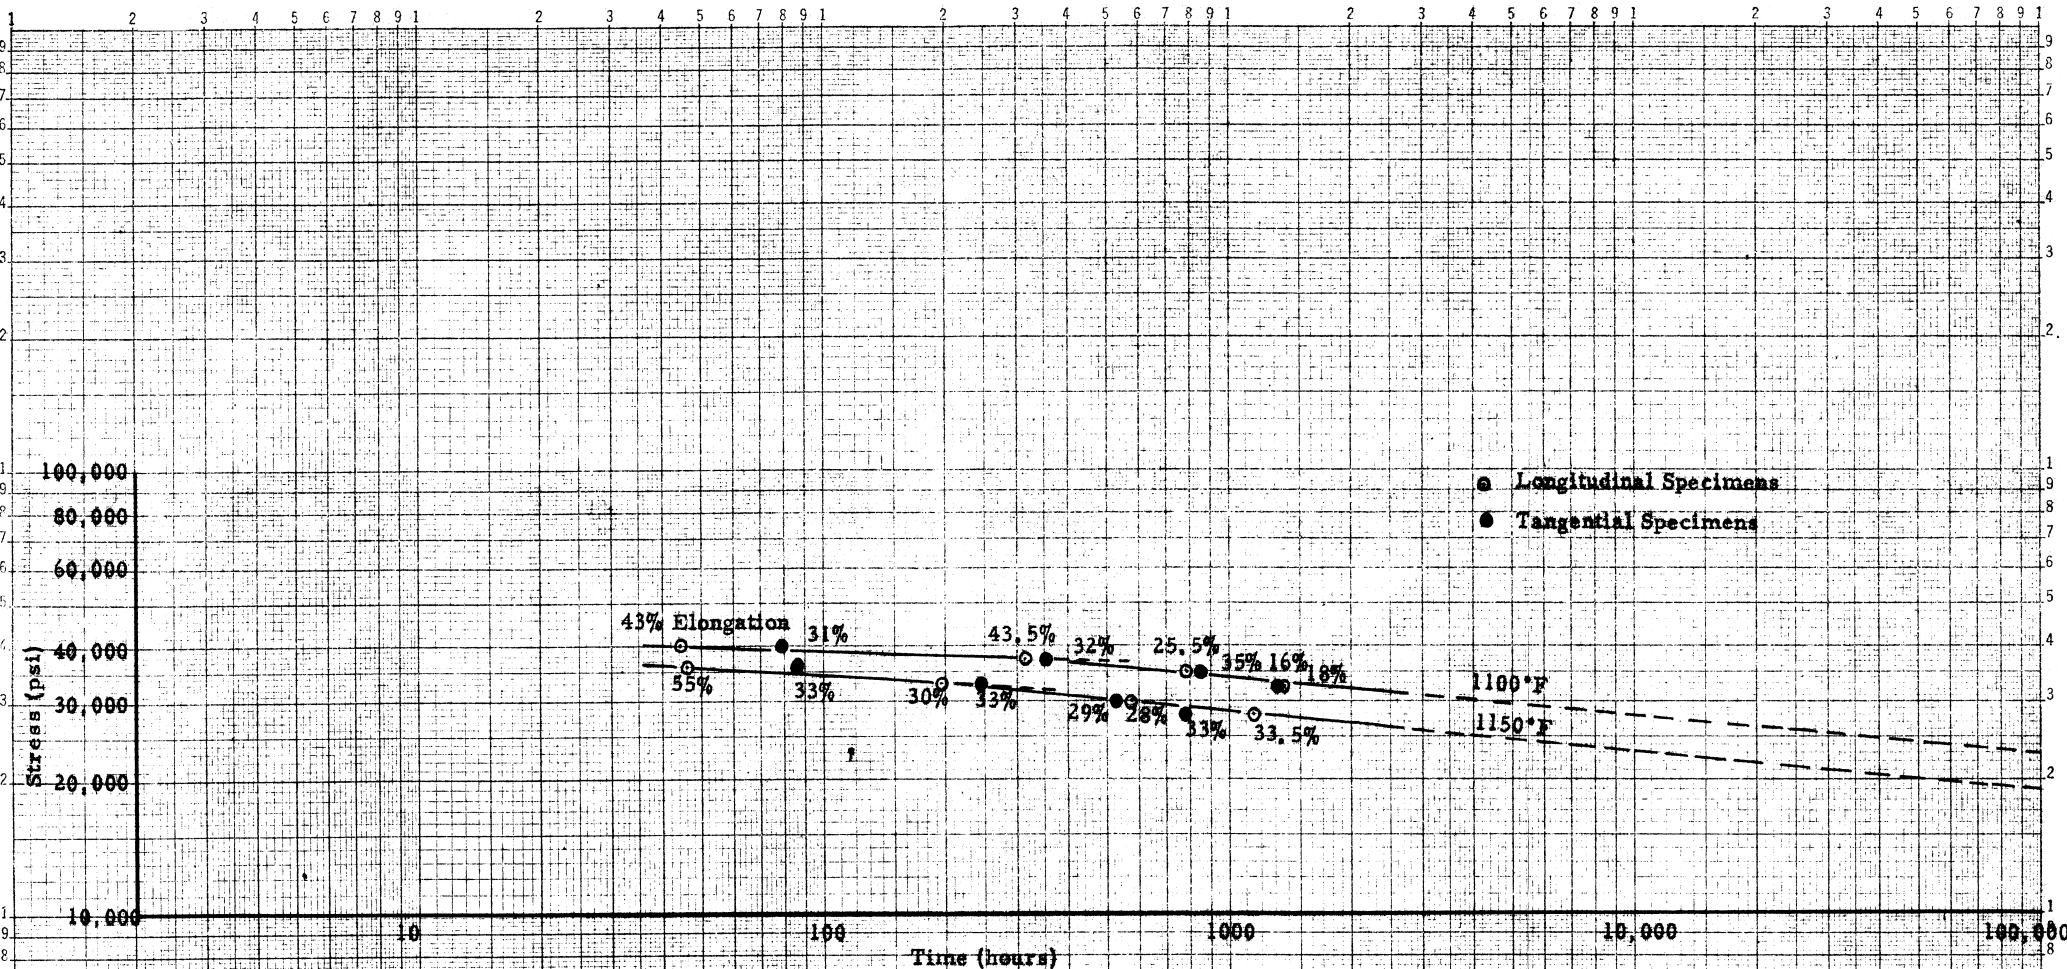
(Sample RT8)

The individual stress-rupture test data are given in Table XVI and are plotted on logarithmic coordinates as stress-rupture time curves in Figure 12. The stress-rupture strengths derived from the curves of Figure 12 for time periods of 100, 1000, 10,000, and 100,000 hours are shown in Table XVII.

The stress-rupture time curves of Figure 12 show that the longitudinal and tangential specimens exhibited very similar strength and ductility properties. With the exception of a small amount of scatter that might be expected from samples taken around the circumference of a pipe, the tangential and longitudinal specimens show excellent agreement and plot on the same stress-rupture time curve at both 1100° and 1150°F.

Figure 12. - Stress-Rupture Time Curves at 1100° and 1150°F for 18-8 + Cb Steel Pipe Intended for Service in the Number 7 Unit of the Kearny Generating Station.

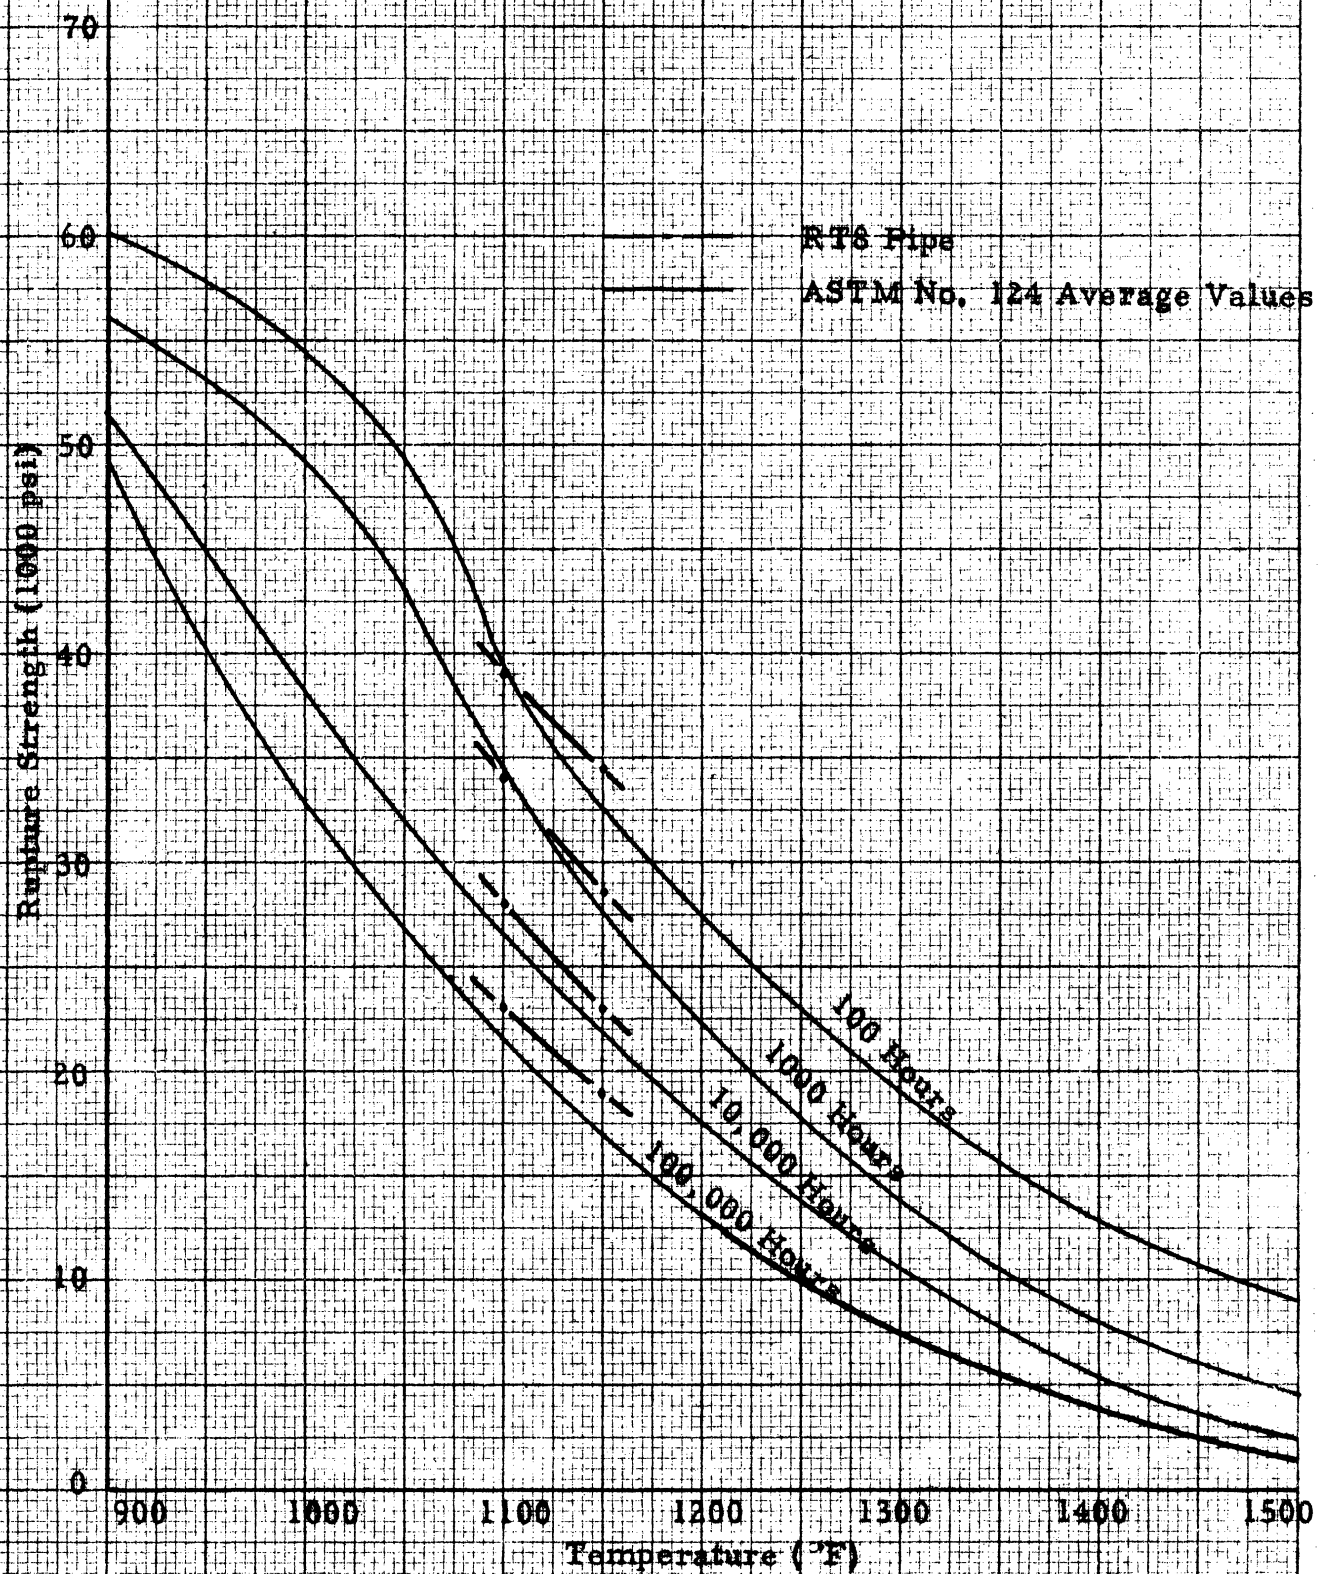
The rupture strength obtained from the samples cut from the pipe are very close to average values for Type 347 steel as is shown by the comparative data in Figure 13 and Table XVII. The breaks in the stress-rupture time curves are usually found for this steel in the heat-treated condition. The elongations of the specimens were also quite average for the alloy with the probable heat treatment.

Figure 13.- Comparative Rupture Strengths for 18-8 + Cb Pipe (RT8) and Average Values for Annealed 18-8 + Cb Steel.

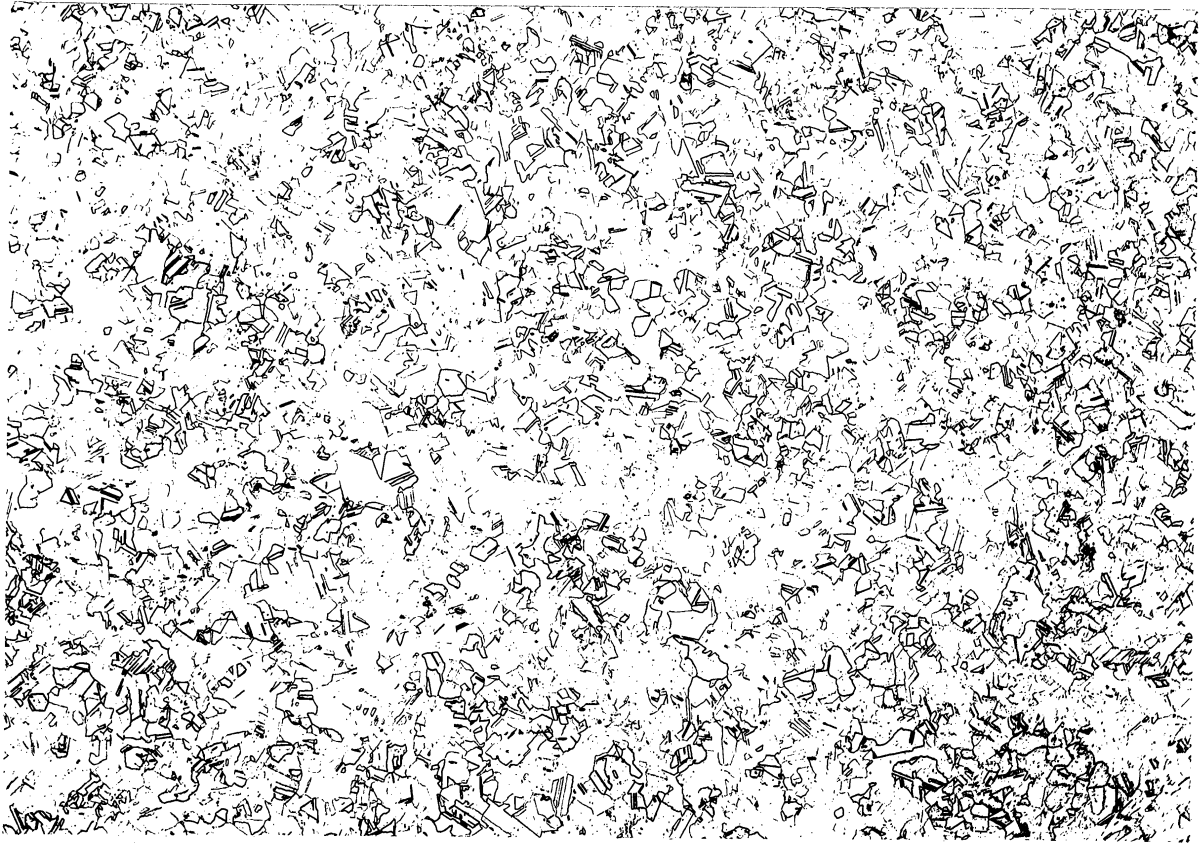
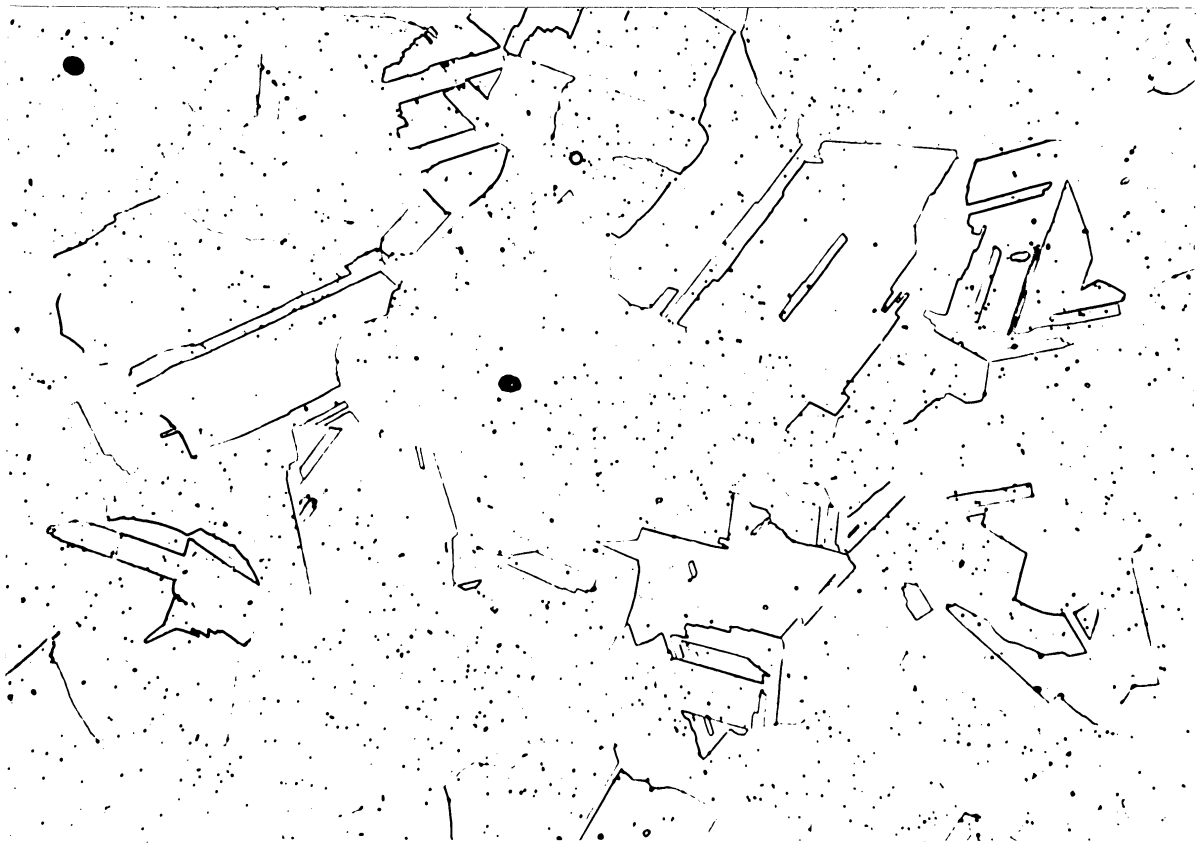
The preliminary examination revealed that the microstructure and hardness of the pipe material were quite uniform. The hardness values around the circumference were 137 to 142 Brinell, and Plate 31 illustrates the structure typical of the entire pipe.

Plate 31. - As-Received Microstructure of 18-8 + Cb Steel Pipe(RT-8).
Intended for Service in the Kearny Generating Station,
Number 7 Unit.

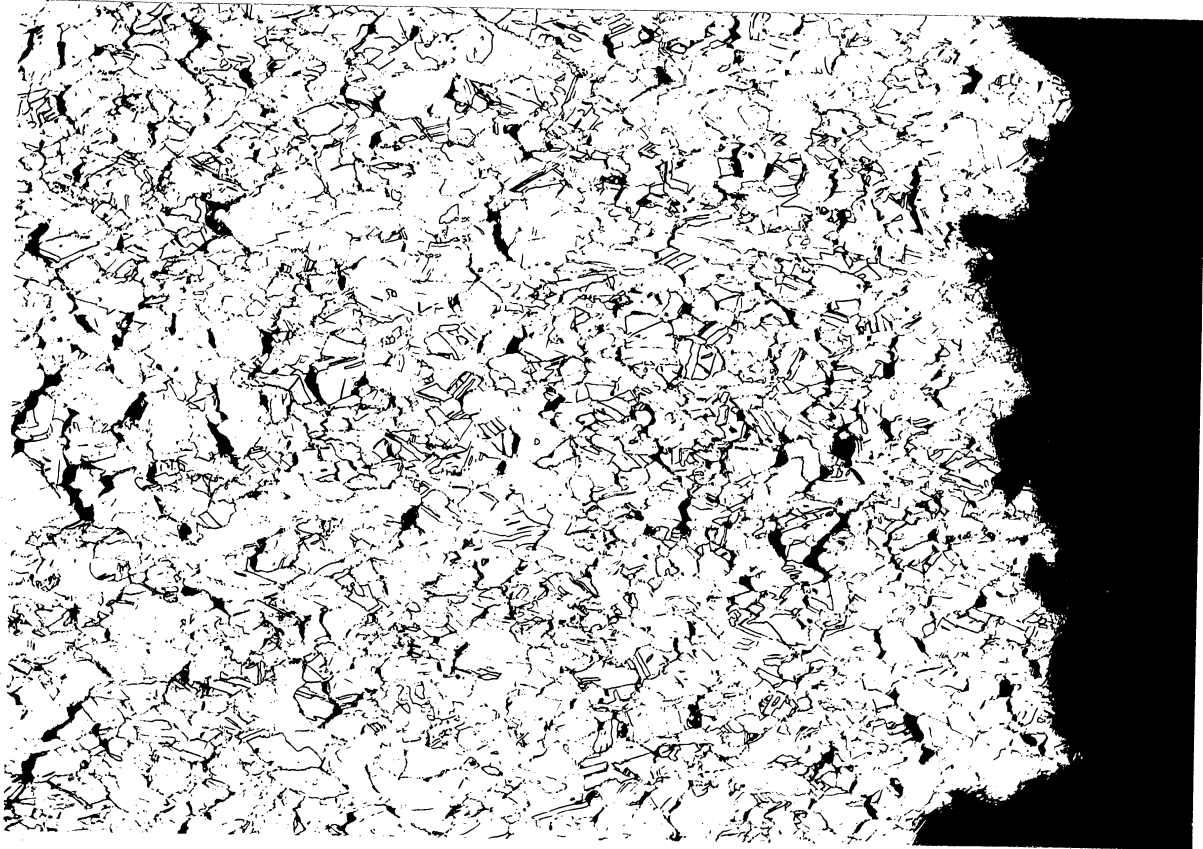
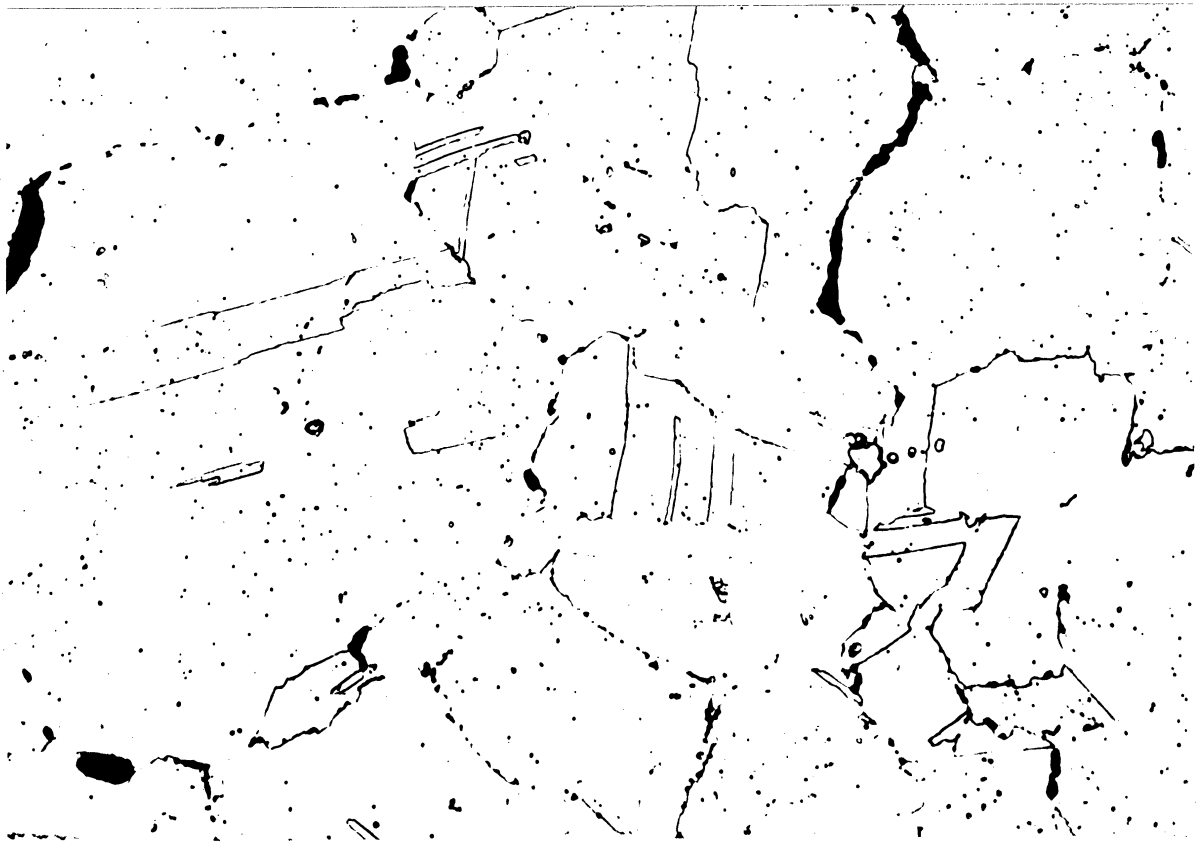
Metallographic examination after testing of the longest duration tests revealed the fractures to be both intergranular and transgranular with considerable intergranular cracking in the vicinity of the fracture at both 1100° and 1150°F as shown in Plates 32 and 33. These plates reveal somewhat more intergranular cracking at 1150°F than at 1100°F. However, the degree of intergranular cracking observed was normal for this material and the testing temperatures involved.

Plate 32. - Microstructure of 18-8 + Cb Steel Pipe (RT-8) Fractured in 1356 Hours Under a Stress of 32,500 Psi at 1100°F.

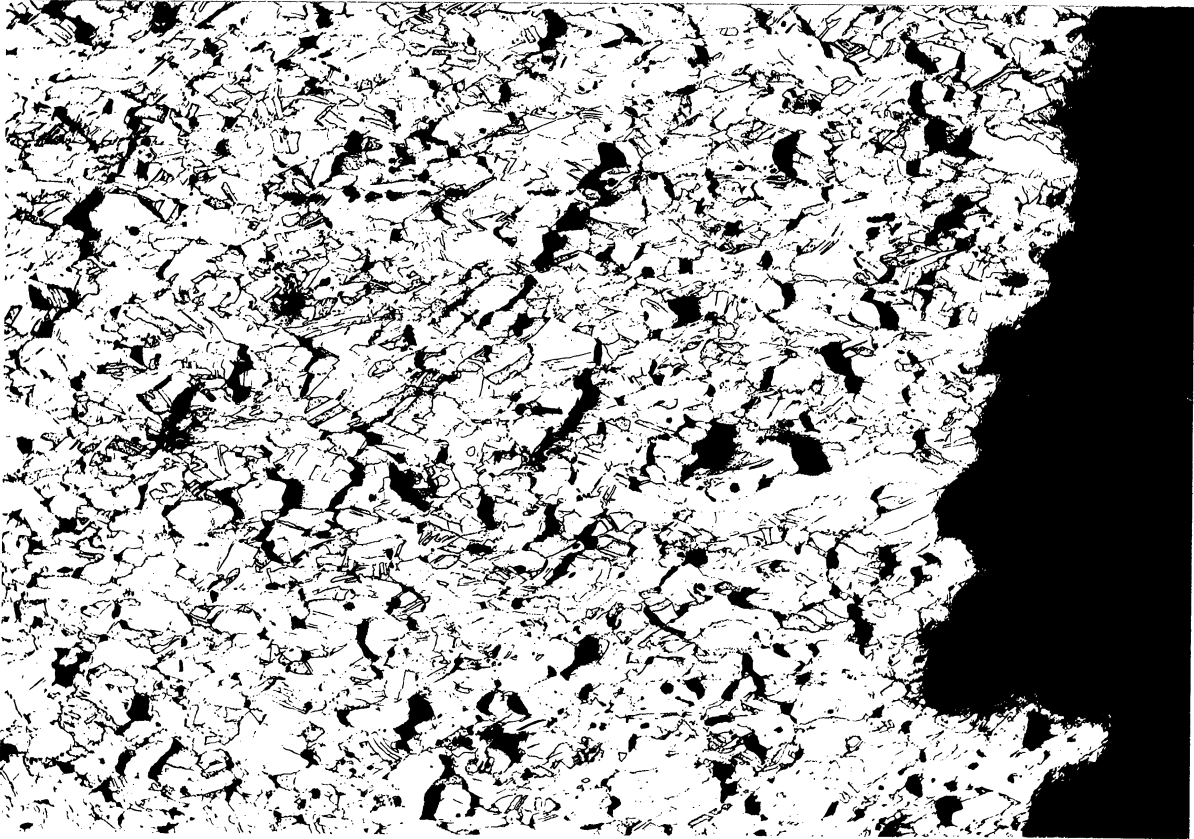
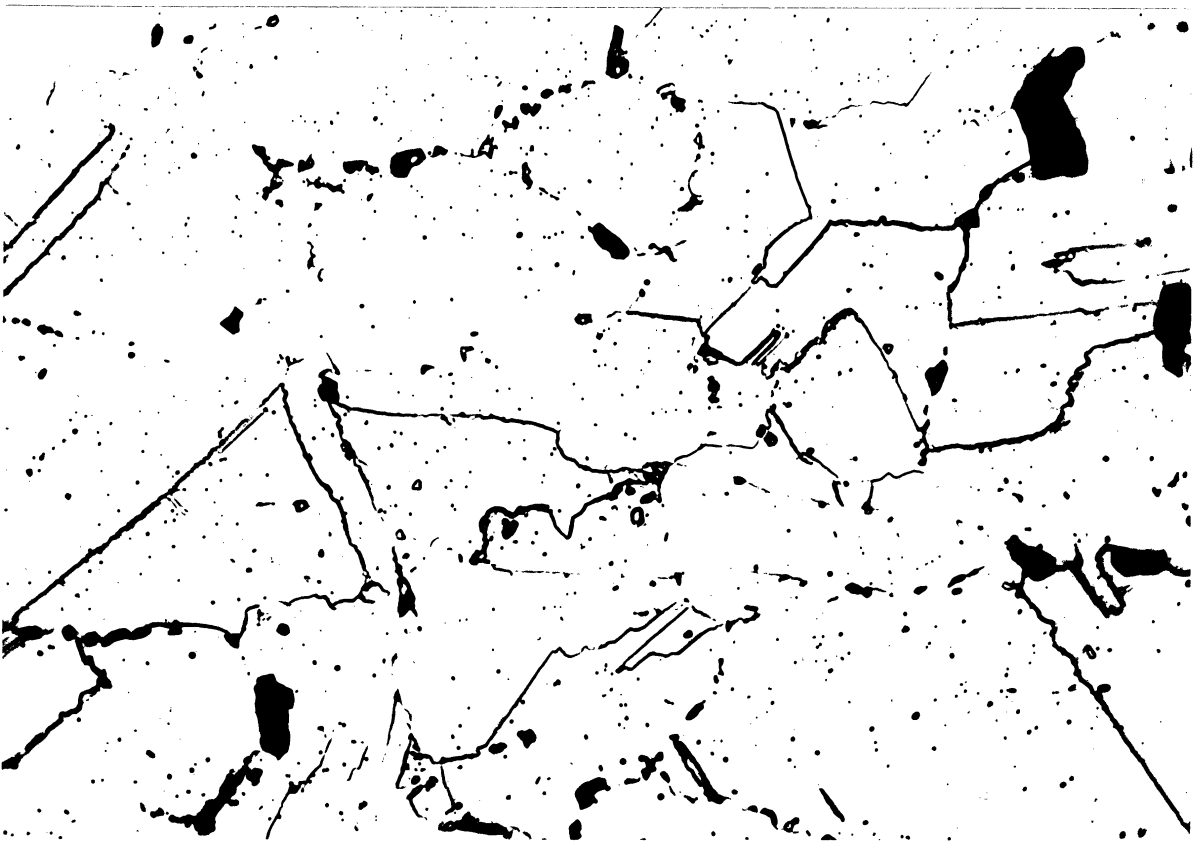
Plate 33. - Microstructure of 18-8 + Cb Steel (RT-8) Fractured in 1140 Hours Under a Stress of 28,000 Psi at 1150°F.
