SCANNER STABILITY

Table A6.2.1 Equipment for fMRI

Table A6.2.2 Stability of MR Signal Intensity for Echo-Planar Imaging at 1.5 and 3.0 T

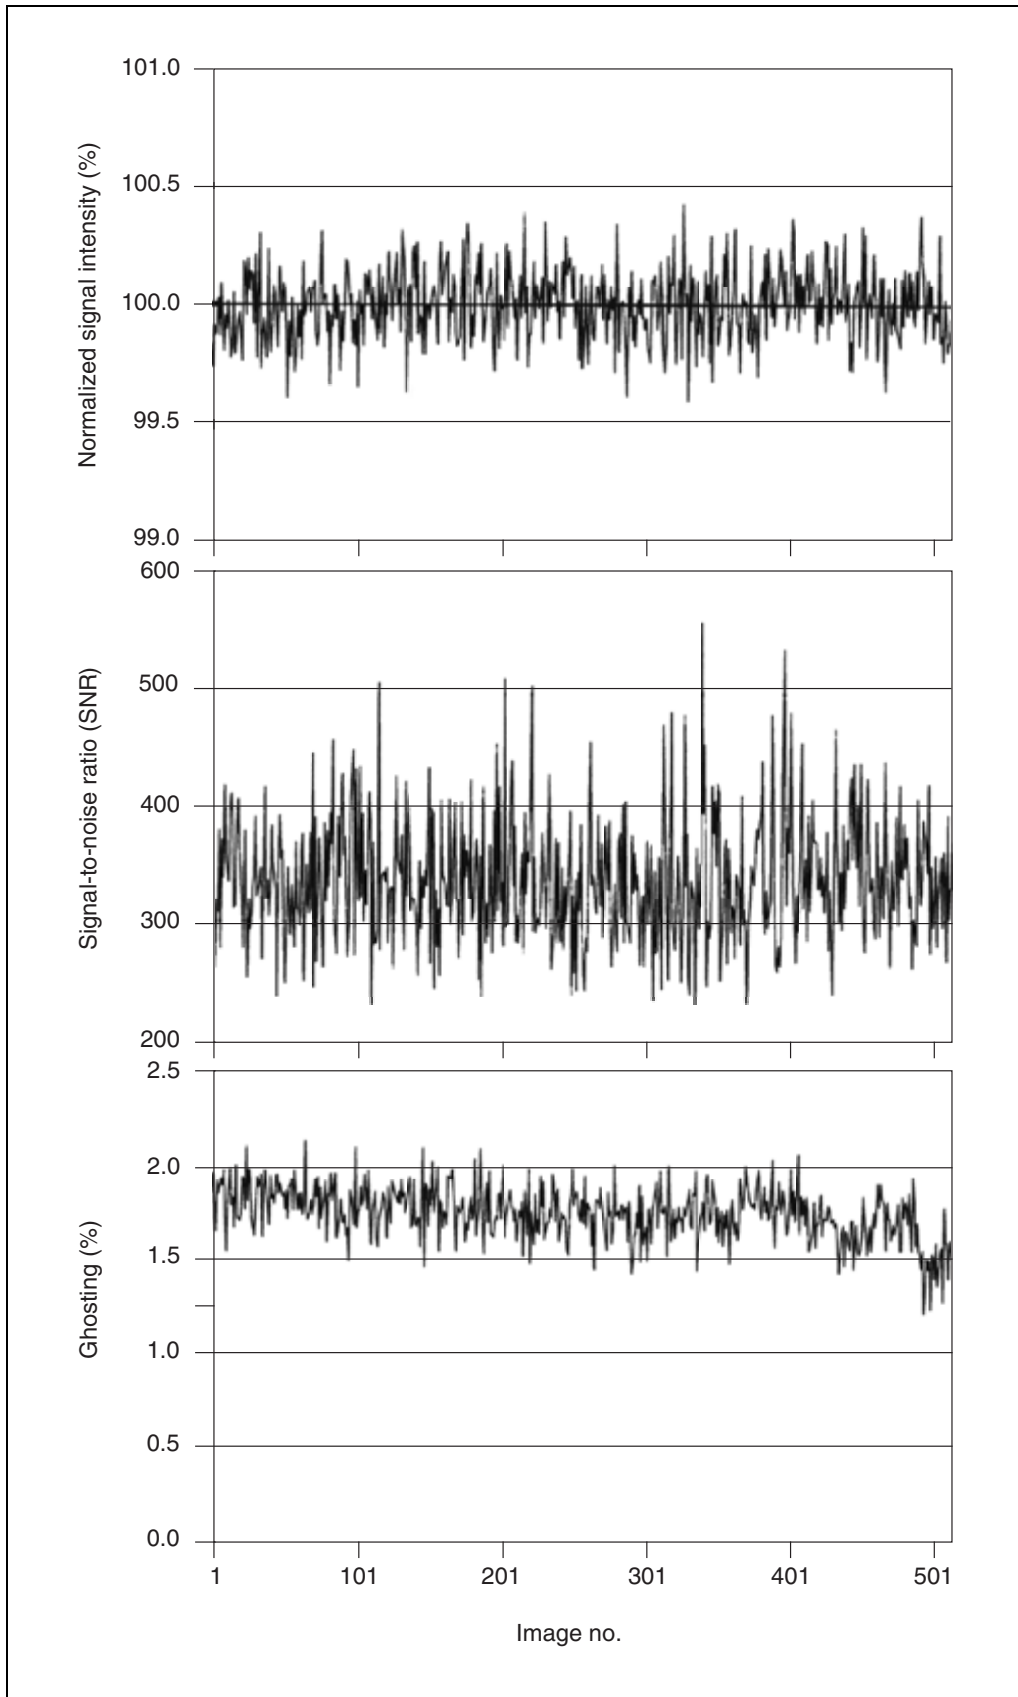
Figure A6.2.1 Representative results of the quality assurance protocol for one day from a 1.5 T scanner. **(A)** Normalized signal intensity over 512 images showing a peak-to-peak variation of less than 1%. **(B)** Signal-to-noise ratio over 512 images showing a mean value above 300. **(C)** Percentage ghosting over 512 images showing a mean value of less than 2%.
