**TRI-LEVEL ACCIDENT
INVESTIGATION STUDY
Volume 2
Final Technical Report**

**Contract No. DOT-HS-031-2-454
September 1973
Final Report**

7. Author's P. Cooley, J. De Beaumont, T. Gates, D. Swartz, D.J. Minahan, P. Van Loven	8. Performing Organization Report No. UM-HSRI-SA-73-5
9. Performing Organization Name and Address Highway Safety Research Institute University of Michigan Ann Arbor, Michigan 48105	10. Work Unit No.	11. Contract or Grant No. DOT-HS-031-2-454

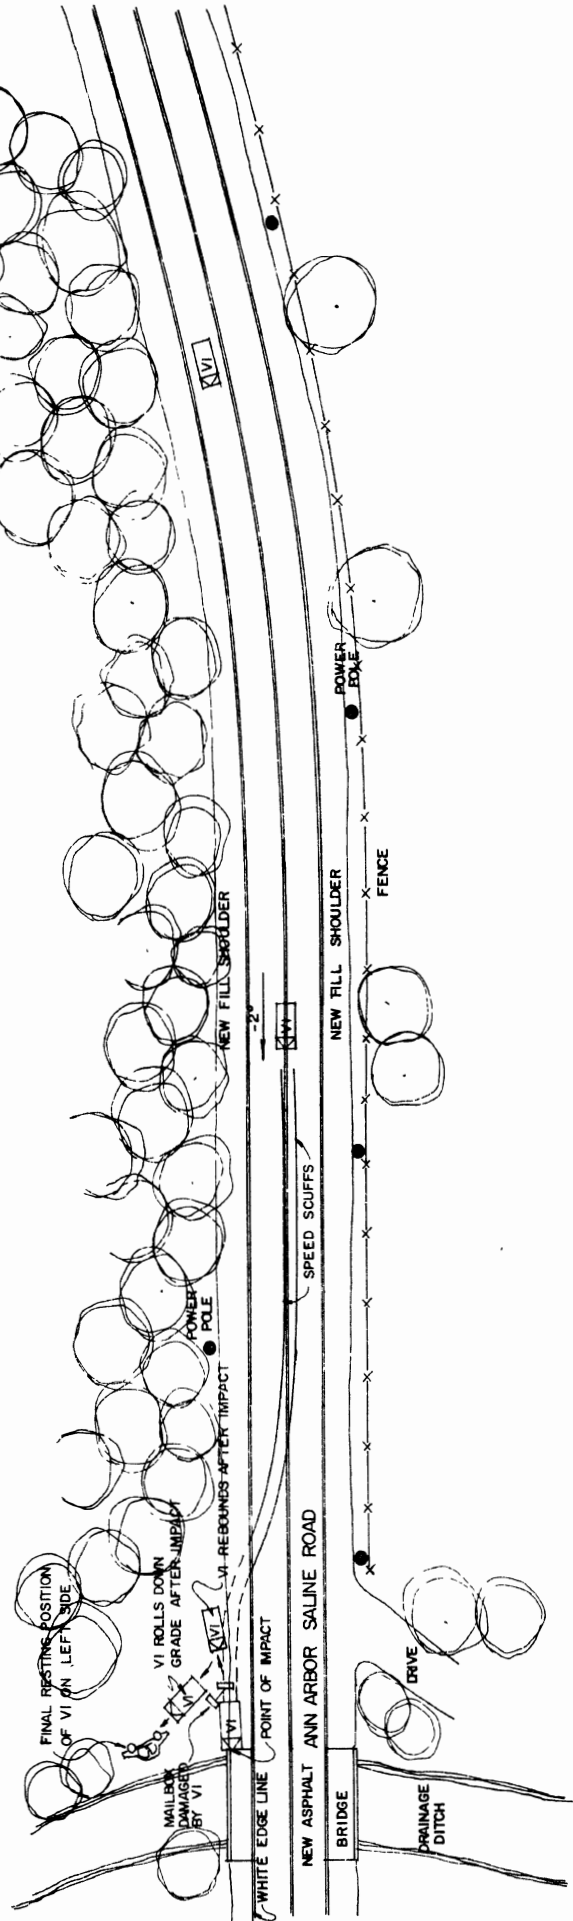
ACCIDENT SCHEMATIC AA 305

SHOULDER	ROADWAY	SHOULDER
-20°	-3 1/2°	-2°
		5°
		15°

SECTION THROUGH ROADWAY AT POINT WHERE VI LEFT ROADWAY
LOOKING NORTHEAST

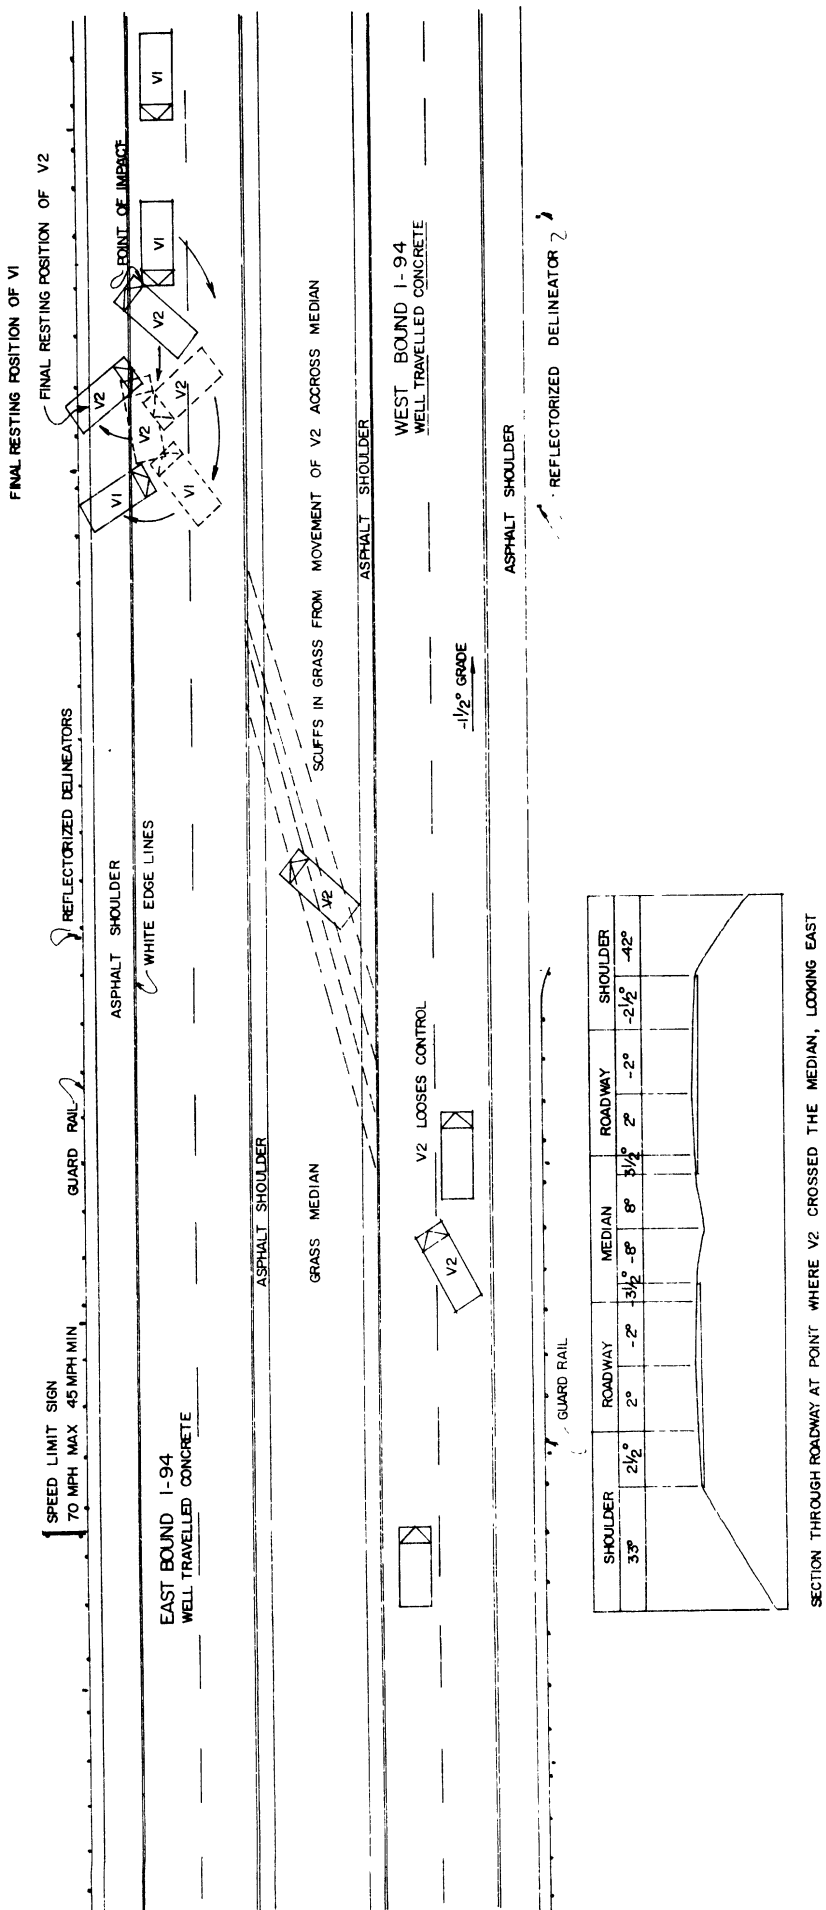
SECTION THROUGH ROADWAY AT POINT WHERE V2 CROSSED THE MEDIAN, LOOKING EAST

SHOULDER	ROADWAY	MEDIAN	ROADWAY	SHOULDER
3°	2°	-3 1/2°	2°	-2 1/2°
	-2°	8'	8'	-42°
		3 1/2'	2'

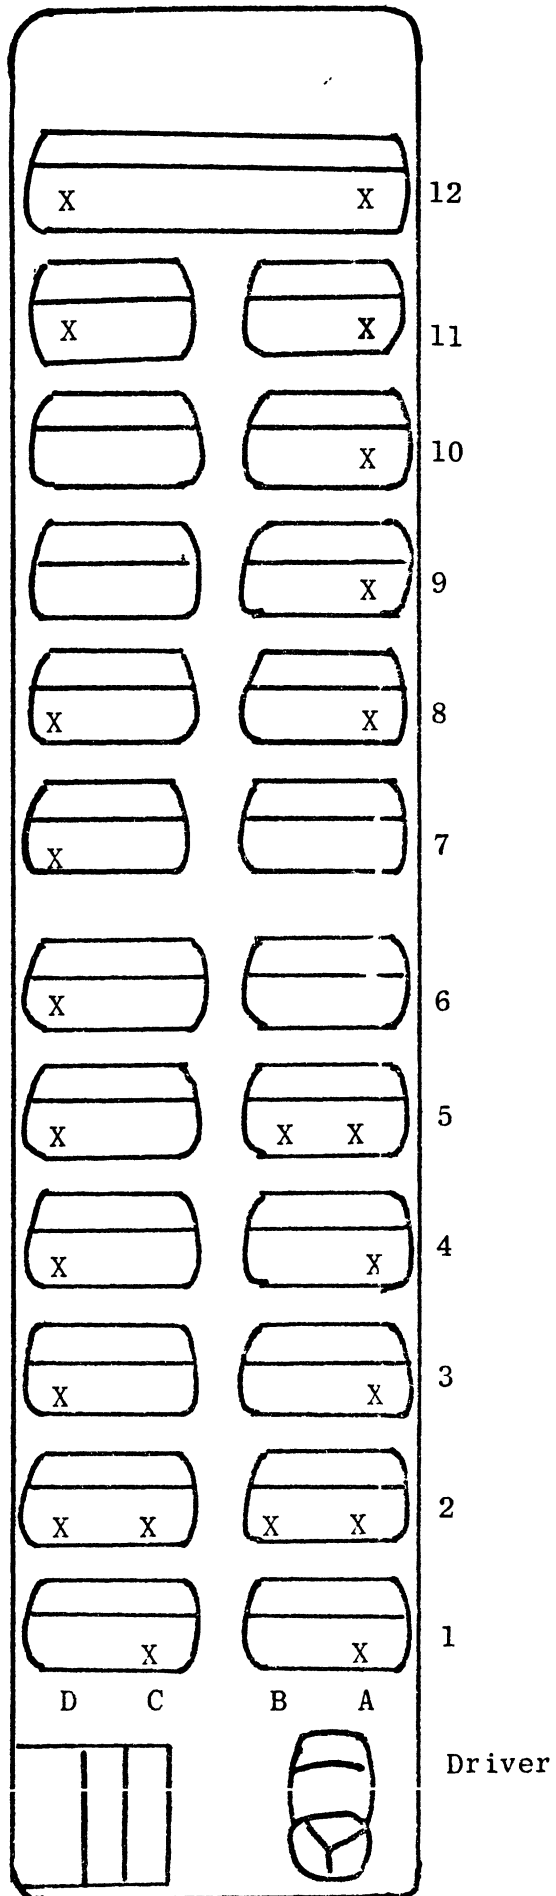
Diagram of Bus and Positions at which Occupants were Seated.
81

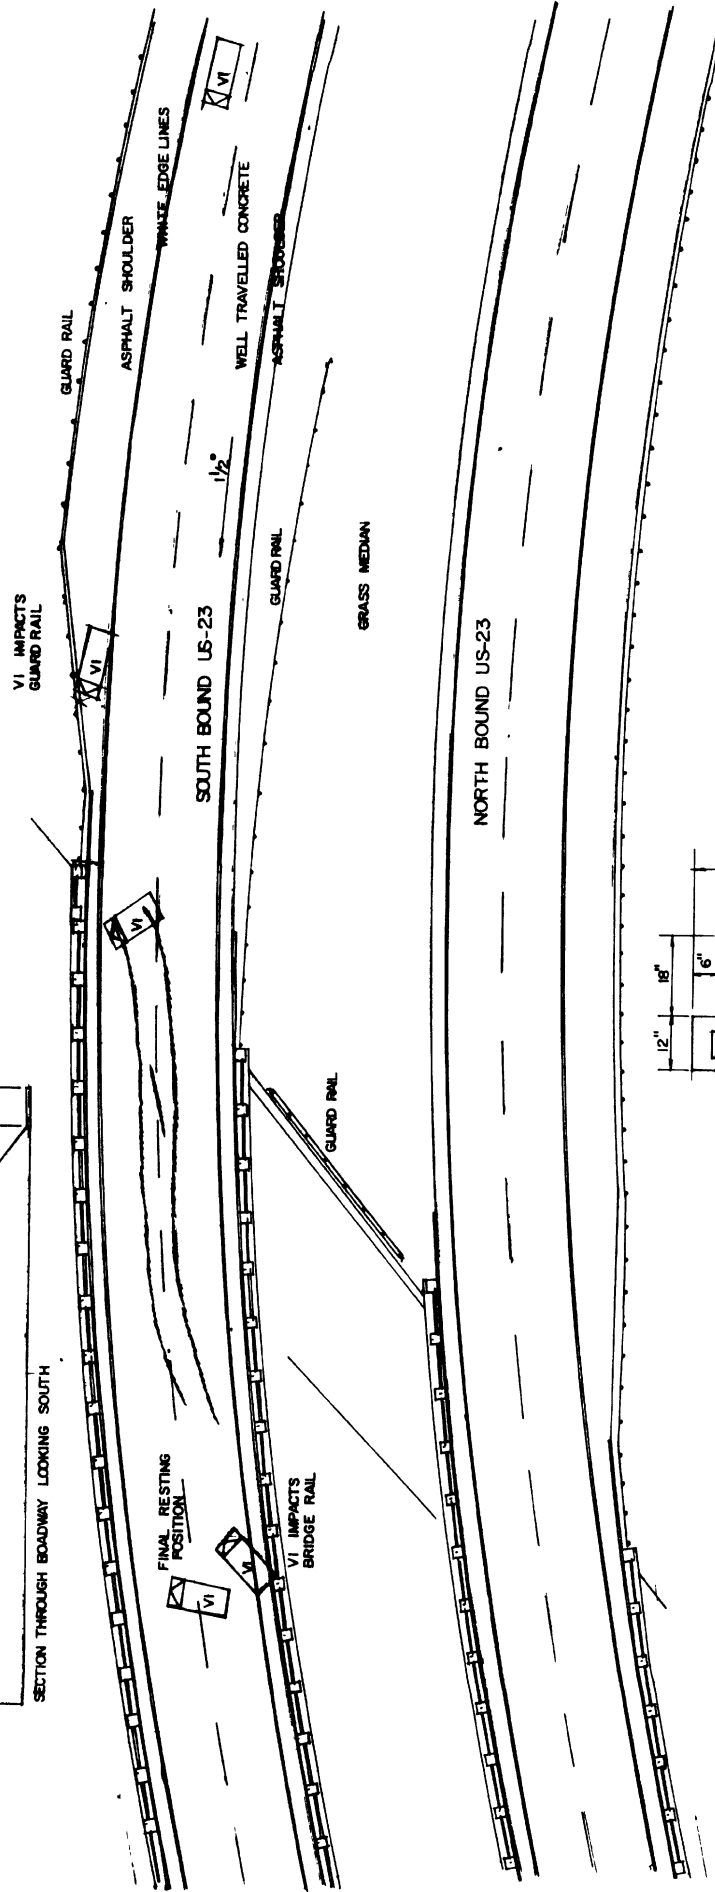
ACCIDENT SCHEMATIC AA 333

ROADWAY			
8°	4°	3°	0°
		-1°	0°
			-40°
			0°

SECTION THROUGH ROADWAY LOOKING SOUTH

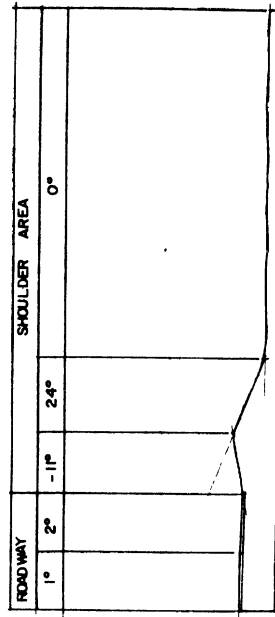
SECTION WHERE VI LEFT ROADWAY AFTER IMPACT

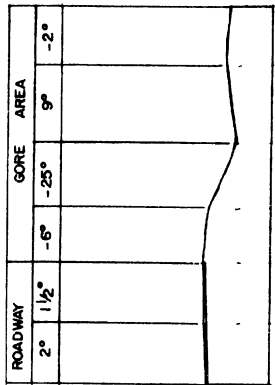
SECTION WHERE VI LEFT ROADWAY PRIOR TO IMPACT
