COMPARATIVE TESTING OF
ANTHROPOMORPHIC DUMMY AND A STANDARDIZED
IMPACTOR FOR GLAZING MATERIAL

D. H. Robbins, Ph.D.
Biomathematics Department
Highway Safety Research Institute
The University of Michigan
Ann Arbor, Michigan 48109

Date: October 15, 1976

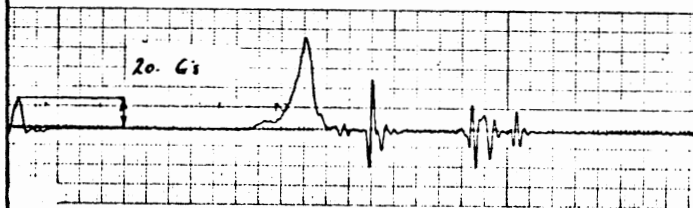
Figure 2. Accelerometer Data from Punching Bag Drop Tests

The accelerometer and motion picture data from the six drop tests using the filled leather punching bag were combined to produce force-penetration curves for the impacts. The accelerometer data were played out from the tape recorder onto a Brush recorder and are shown in Figure 2. The initial large pulse represents the contact between the bag and the panel. Any additional pulses represent the bag hitting the floor of the laboratory. The force of impact was computed by multiplying the weight of the bag (100 lbs) by the G-level. Penetration of the bag into the panel of glazing material was determined by film analysis of the movie during impact. Movement of the bag was manually measured directly from individual frames of the movie using a Vanguard Film Analyzer. Because timing markers were on the movies, it was possible to construct a displacement-time curve.
