# Duplication Images in Vascular Sonography

**Objective.** The purpose of this study was to determine the characteristics and phenomena of duplication (or mirror) images in vascular sonography. **Methods.** We retrospectively reviewed 5 cases of vascular sonography that produced duplication images performed between June 30, 2009, and January 10, 2010. The 5 vascular studies included the subclavian artery (2), subclavian vein (1), carotid artery (1), and abdominal aorta (1). The characteristics of the color flow images and spectral Doppler waveforms in the artifactual vessels and in the true vessels were analyzed. Sources and mechanisms of producing duplication images were assessed. **Results.** We were able to generate color flows in the artifactual vessels that were the same as in the true vessels in 2 cases. However, we were able to generate images in which the apparent flow directions in the artifactual vessels differed from the actual flow observed in the true vessels in all 5 cases by changing the orientation of the ultrasound beam relative to the true flow and the reflecting surface. **Conclusions.** Duplication images result from mirror reflections producing multipath artif

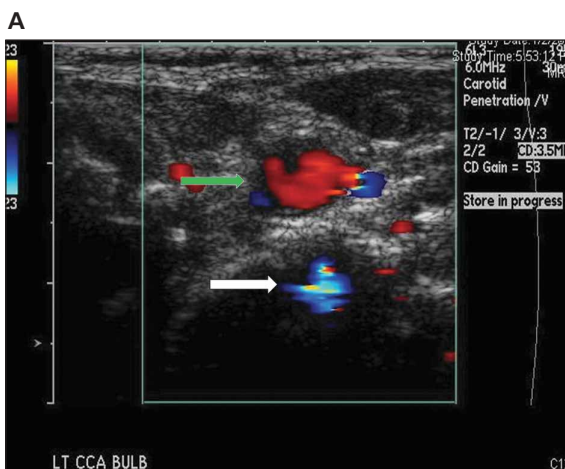
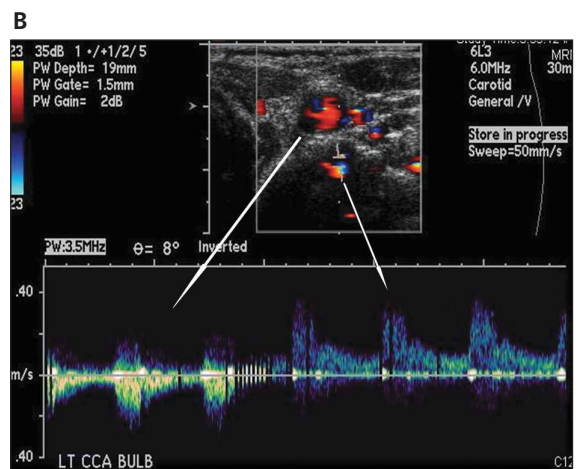
**Figure 3. A,** Duplication image generated in a transverse color flow image of the carotid bulb. The incident sound beam is nearly perpendicular to the arterial wall and reflector. Antegrade flow is seen in the true carotid bulb (green arrow), and retrograde flow is visualized in the artifactual carotid bulb (white arrow). **B,** Spectral Doppler imaging confirms that the flow direction in the artifactual carotid bulb differs from that in the true carotid bulb. A slow recording rate allows a single spectral Doppler trace to be displayed from both the true and artifactual carotid bulbs on one image. The spectral Doppler waveform is inverted on the image. CCA indicates common carotid artery; and LT, left.

Of the 5 cases, 2 were duplication artifacts of the subclavian artery, the long axis of which was nearly parallel to the orientation of the interface of the lung apex. Scanning parallel to the long axis produced antegrade flow in both the artifactual and the true subclavian arteries with Doppler angle correction by steering the color box (Figure 1, A–C). However, when the scan plane was rotated from the long axis to the near short axis, the flow in the artifact reversed compared to the true vessel. The artifactual artery developed flow away from the scan head, while the true subclavian artery had flow toward the scan head (Figure 1D). Moreover, the direction of the artifactual flow differed from the true flow on color flow imaging in the short axis in the remaining 3 cases, including the subclavian vein (Figure 2), carotid artery (Figure 3), and abdominal aorta (not shown).

inal vessel.<sup>10,11</sup> However, we have shown that the apparent flow direction in the artifactual vessel can vary substantially from the true flow (Figures 1D, 2, and 3A) and can actually vary in any given case depending on the orientations of the transducer to the true vessel and its flow. The appearance of the flow in an artifactual vessel on color
